TOP-OF-RAIL LUBRICATION ENERGY TEST

DOT/FRA/ORD-98/01

February 1998
Final Report

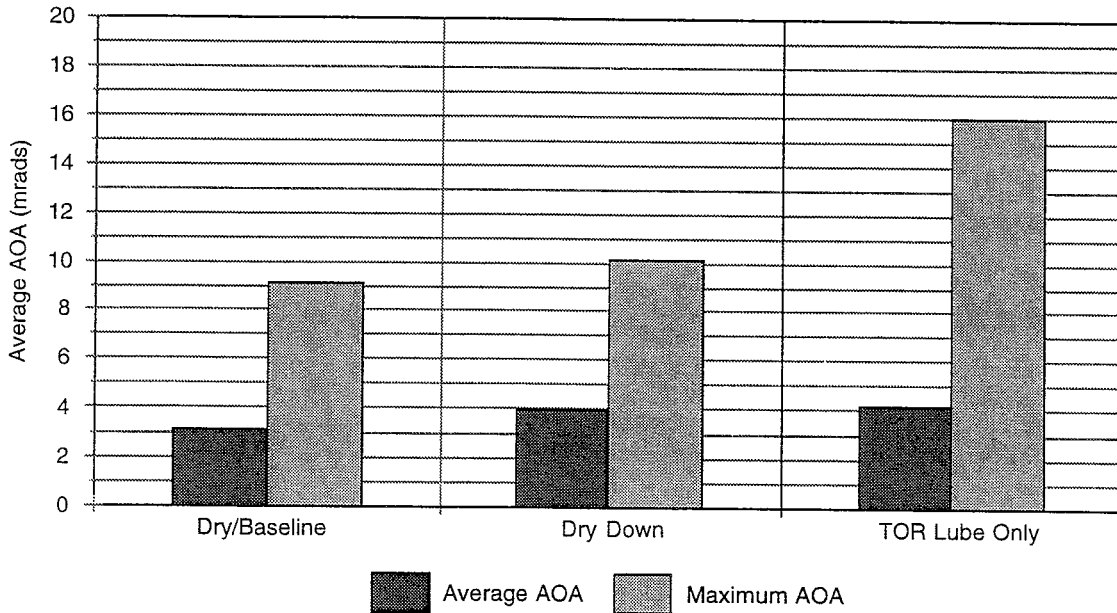
Figure 16. Average and Maximum Angle of Attack — 7.5-Degree Curve

Angle of Attack on 7.5-Degree Curve
Averages

Angle-of-attack data was collected in the 7.5-degree and 3-degree curves. The angle-of-attack history and averages for each condition are shown in figures 15, 16, 17, and 18. Data for operations during the "flange-only" and "combined top-of-rail and flange" lubrication operations at the 7.5-degree curve is not available, as the data-collection system (computer) failed during these laps. Similar data was collected at the 3-degree curve site. For laps where both databases are available, they show a similar trend.

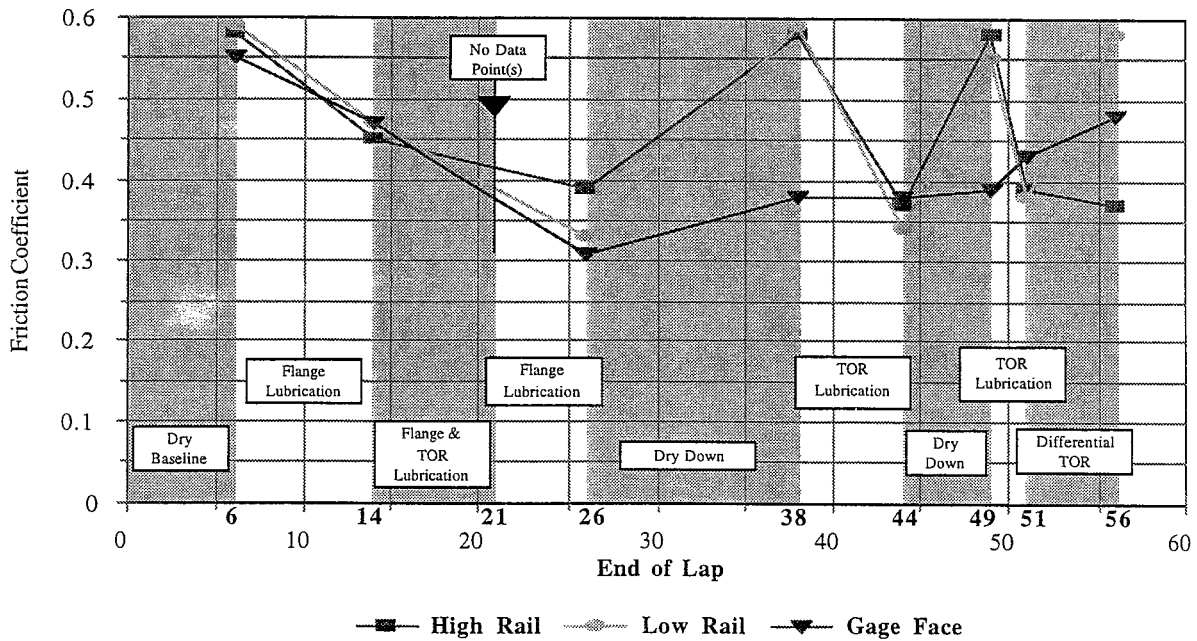
Figure 20. Lap History of Rail Friction — 4-Degree Curve

Lap History of Rail Friction
AAR WRM Loop, 6/5/97, 4° curve, 30 mph

It was observed that for both flange lubrication as well as top-of-rail lubrication, the friction level decreased as compared to clean, dry baseline readings. This indicates the flange lubricant was creeping on top of the rail as has been observed by many railroads. The friction level for top-of-rail lubrication was in the same range (0.25 to 0.4) as for flange lubrication. After reducing the top-of-rail lubrication level below the present levels so that no residue is left on the rails, tests should be done to measure the new friction levels on the railhead.
