U.S. Department  
of Transportation  
**Federal Railroad  
Administration**

# Thermal Insulation Systems Study for the Chlorine Tank Car

Department of Army  
Ballistic Research Laboratory  
Aberdeen Proving Ground, Maryland 21005-5066

1. Report No. FRA/ORD-85-10		2. Government Accession No.		3. Recipient's Catalog No.	
4. Title and Subtitle THERMAL INSULATION SYSTEMS STUDY FOR THE CHLORINE TANK CAR				5. Report Date APRIL 1985

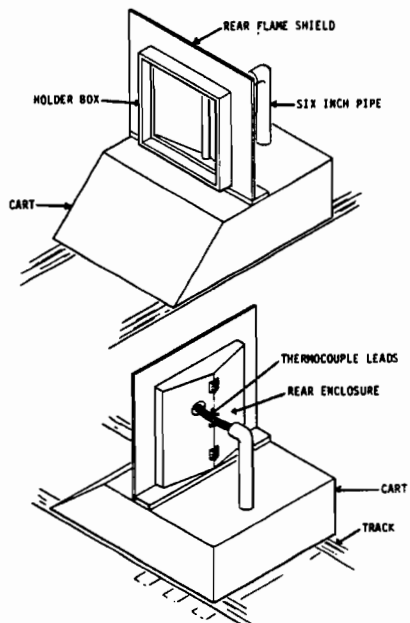
The configuration of the insulation test assembly holder and the supporting cart were as shown in Figure 1. The cart was setting on a track so that the TN/SS Distance could be changed to fit the need of a specific test. The holder, which actually supported the test specimen assembly, was mounted vertically on top of the cart. The holder consisted of a holder box, a rear flame shield, and a rear enclosure. On the test assembly and locations on the holder were mounted thermocouples. The leads to these thermocouples were passed through the six inch pipe indicated in Figure 1. The purpose of the rear flame shield was to prevent flames from wrapping around the holder box and heating up the outside surface of the rear enclosure. The inside surfaces of the holder box and the rear enclosure were lined with insulation, 5.08 cm (2 in) thick, to minimize the loss of heat. A thermal blanket was placed over the rear enclosure and the six inch pipe to further protect against significant heat transport out of or into the rear enclosure.

Figure 1: The Insulation Test Assembly Holder and Cart

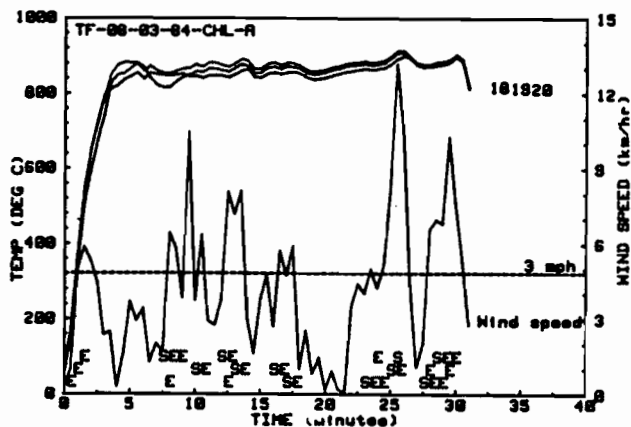
Figure 7 contains the jacket temperatures and the wind speed for the second torch fire test of the Kaowool-Fiberglass System. There were several large peaks in the wind speed that far exceeded the desired wind speed criteria. The highest value reaching above 12 km/hr (7.46 mi/hr). At 25 minutes, a peak in the jacket temperatures showed a clear correlation with the wind speed. However, the other peaks caused only slight variations in the temperatures. The jacket temperatures essentially matched the values from the previous test.

Figure 7: Jacket Temperatures and Wind Speed For the Second Torch Fire Test of Kaowool (A-2)
