DEVELOPMENT OF A PROTOTYPE EMAT SYSTEM FOR INSPECTION OF RAILS

SEPTEMBER 1980
FINAL REPORT

Prepared for
U.S. DEPARTMENT OF TRANSPORTATION
FEDERAL RAILROAD ADMINISTRATION
Office of Research and Development
Washington, D.C. 20590

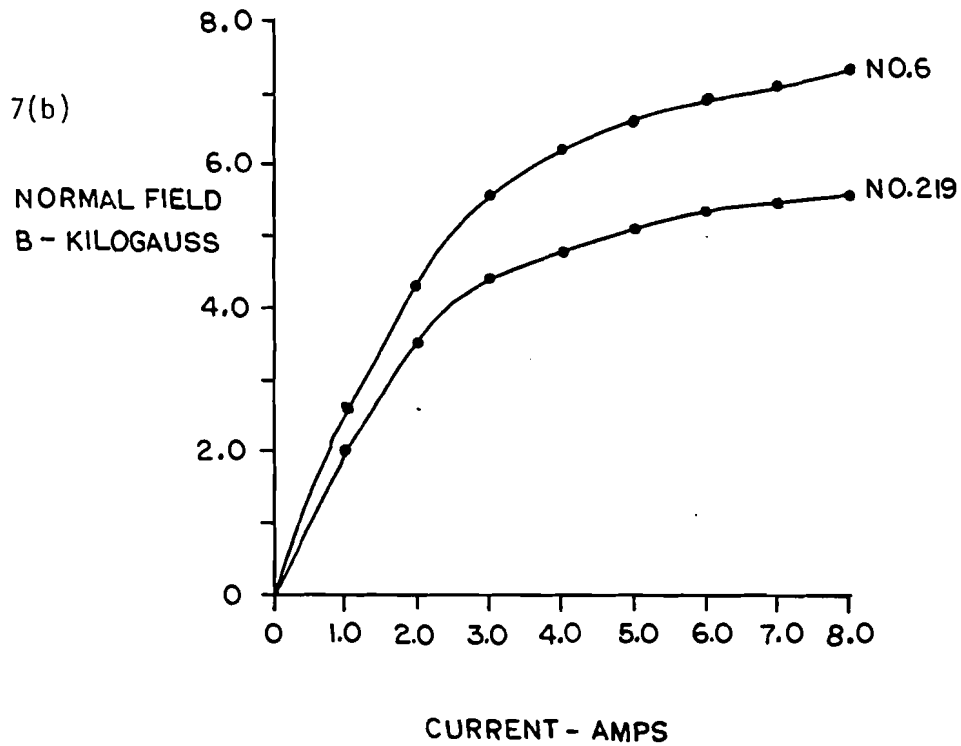
Fig. 7 Field versus electromagnet current characteristics observed with pole piece #2 on rails #6 and #219 with a 0.31" gap between the pole piece and the rail head. (a) Tangential field, (b) Normal field. 15

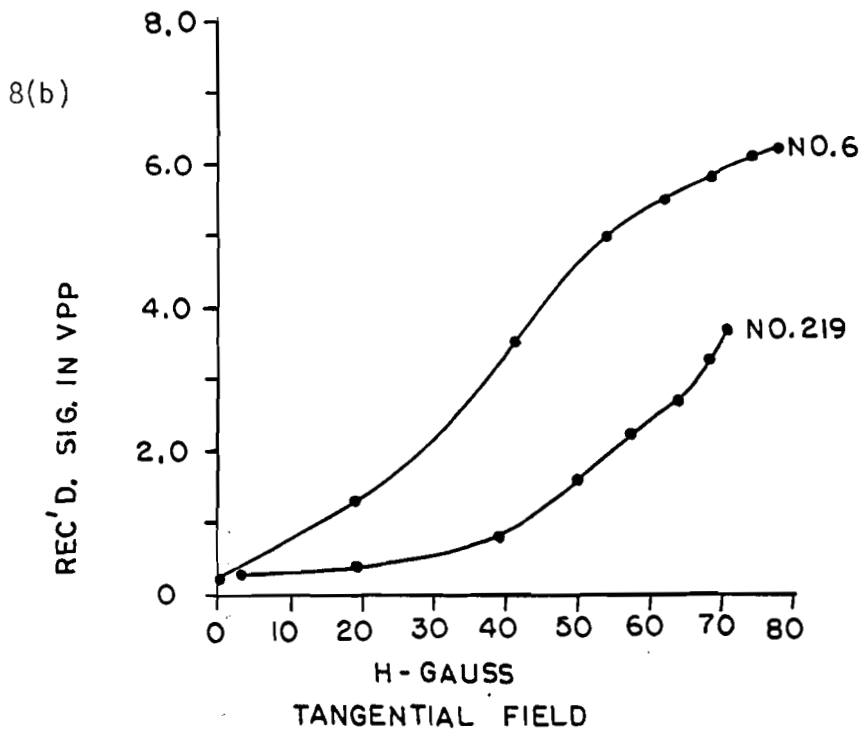
Fig. 8 Using pole piece #2, EMAT signals observed as a function of magnetic field at the EMAT for two orientations of the field and for two rails. (a) Normal field, (b) Tangential field.

Figure 8 shows the dependence of the total generation-reception efficiency of an EMAT transducer pair as a function of magnetic field for two different rail samples. Figure 8(a) shows the results obtained when the EMATs were placed in the gap beneath the pole piece where the field is presumably normal to the rail head and Figure 8(b) shows the signals from EMATs located between the pole pieces--under nominally tangential magnetic field conditions. A gap field of 5 to 6 KG corresponds to an equivalent tangential field of 50 to 60 G. The important feature to perseve is that for normal fields the signal levels obtained on these two different rail specimens are approximately the same (within 25%). However, for the tangential field configurations, gross signal level differences are observed for rail #219 compared to #6. Vastly different EMAT efficiencies have been observed in inspection of other kinds of ferromagnetic samples (inspected on other EMAT programs) and is understood to arise due to magnetostrictive contributions to the transduction process which are critically dependent upon the track manufacturing process, its stress history, and its chemical nature (percent carbon content). Since there is so much variability in EMAT coupling in the tangential inspection case, it is advisable to always operate EMATS in the normal field configuration. Thus EMAT inspection signals derived from normal magnetic field operation should be effected only minimally by differing (real world) rail conditions.

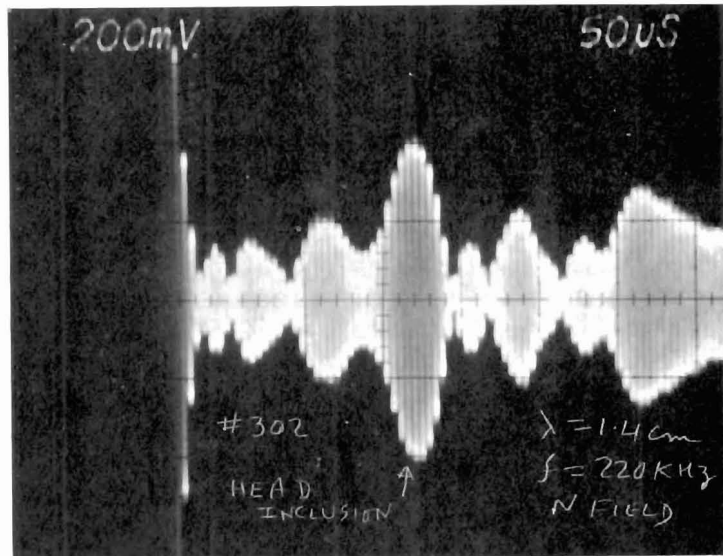
Fig. 27 Echo observed from an inclusion in the head of a welded rail. Rail No. 302, using the two electronic systems.

Figure 27 shows the echo received from the head inclusion specimen. Sperry identified this specimen as a head inclusion, which means a defective weld or an inclusion of foreign matter within the weld. The specimen

we have received also has a prominent weld bead with sharp edges on the underside of the head. The signals observed in Fig. 27 may be an echo due to the side defect, since the surface wave transducer is known to be sensitive to such surface flaws. At this time, we are not sure whether the echo observed with the low frequency EMAT has come from the inclusion or from the weld edge on the rail head.
