U.S. Department
of Transportation
**Federal Railroad
Administration**

Results From the Car Coupling Impact Tests of Intermodal Trailers and Containers

**IIT Research Institute
10 West 35th Street
Chicago, Illinois 60616**

1. Report No. DOT/FRA/ORD-88/08		2. Government Accession No.		3. Recipient's Catalog No.	
4. Title and Subtitle Results from the Car Coupling Impact Tests of Intermodal Trailers and Containers				5. Report Date March 1988

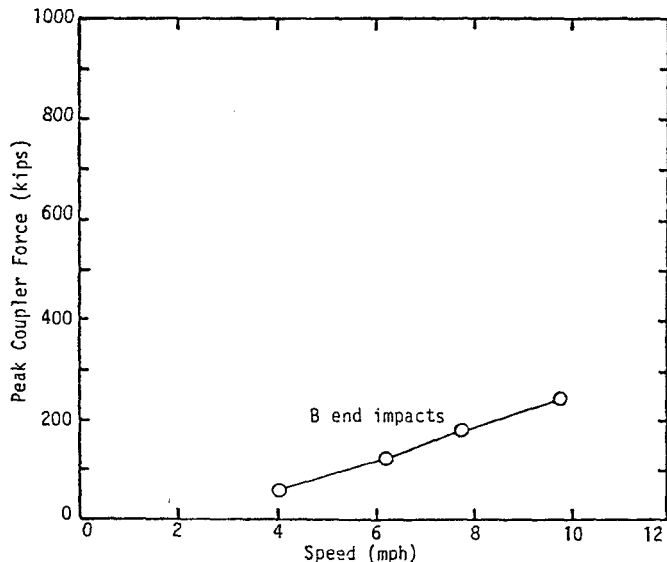
a. Peak Trailer Hitch Pin Force Vs. Impact Speed

b. Peak Coupler Force Vs. Impact Speed

FIGURE 14. CONFIGURATION 2 TEST RESULTS

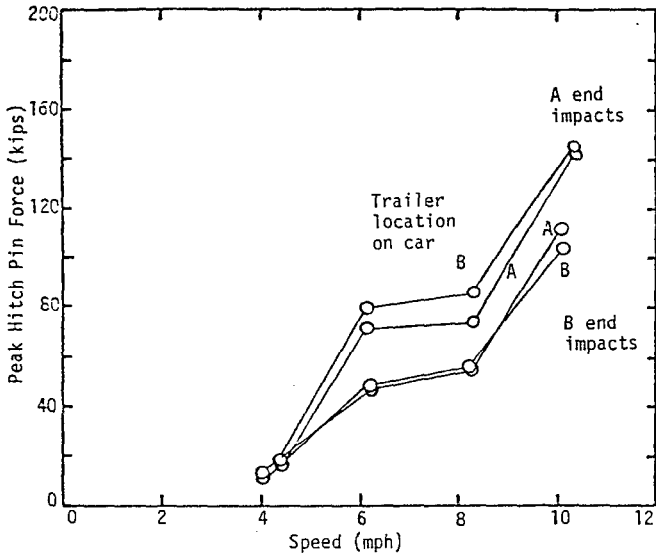
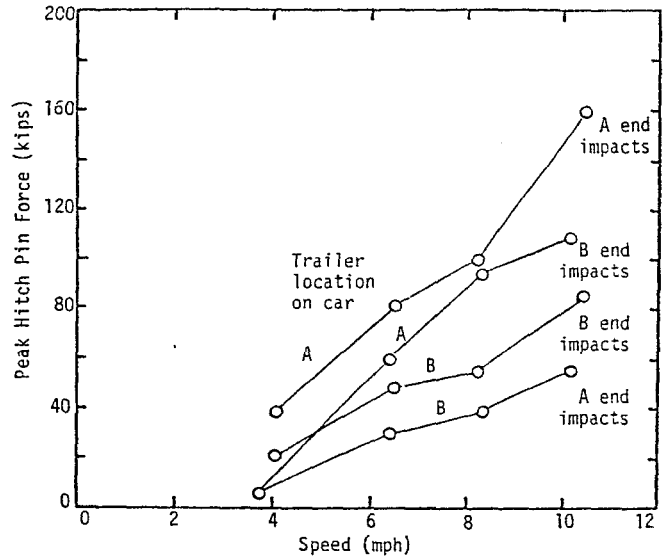
a. Peak Trailer Hitch Pin Forces Vs. Impact Speed

b. Peak Coupler Force Vs. Impact Speed

FIGURE 15. CONFIGURATION 3A TEST RESULTS

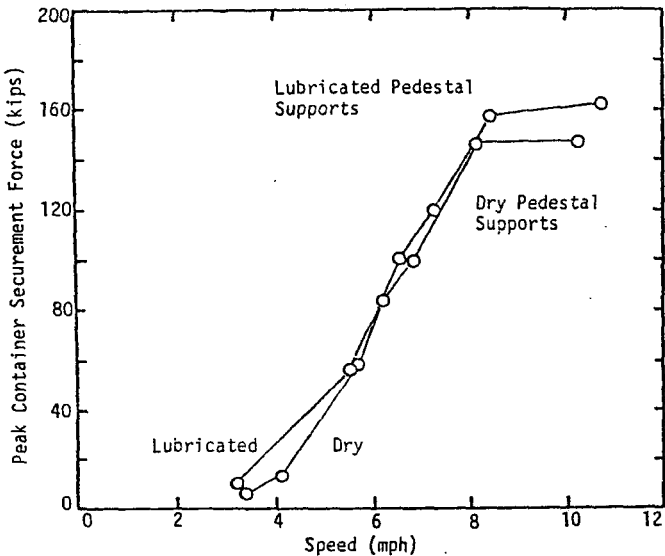
a. Peak Longitudinal Container Securement Force Vs. Impact Speed

b. Peak Coupler Force Vs. Impact Speed

FIGURE 21. CONFIGURATION 4E TEST RESULTS

Comparing the results from the two sets of tests as presented in Figure 21 shows no significant differences in the maximum peak container securement forces for the dry and lubricated tests. This indicates that the load cell arrangement was not being significantly affected by the alternate path through the friction surfaces. It demonstrates the validity of the measurement of longitudinal container loads for other test configurations. Peak longitudinal container securement forces exceeded the 135 kip test load given in AAR Specification M-952 and the 157 kip container securement design load given in AAR.600-19b on the 8 and 10 mph impacts.

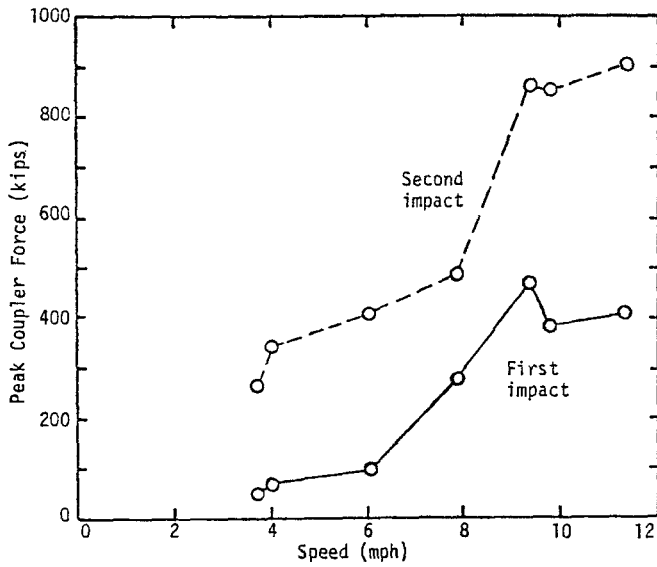
a. Peak Longitudinal Container Force Vs. Impact Speed

b. Peak Coupler Force Vs. Impact Speed

FIGURE 23. CONFIGURATION 7 TEST RESULTS

The results for the Configuration 7 tests are summarized in Table 9. Peak coupler and container securement forces are shown in Figure 23. The objective of this test was to develop a 4g longitudinal load at the container pedestal supports. This would require the development of a 197 kip load for the loaded intermodal container which was used in the tests. The data shows that the maximum longitudinal load which was achieved was 153 kips. Tests were conducted at speeds up to 11.2 mph. Tests were not conducted beyond this speed because of the danger of a derailment. The plot of peak coupler forces shows that the maximum impact force was achieved on the 9.3 mph impact. Figure 23 also shows the peak coupler force which occurred when the hopper and flat car struck the standing cars.

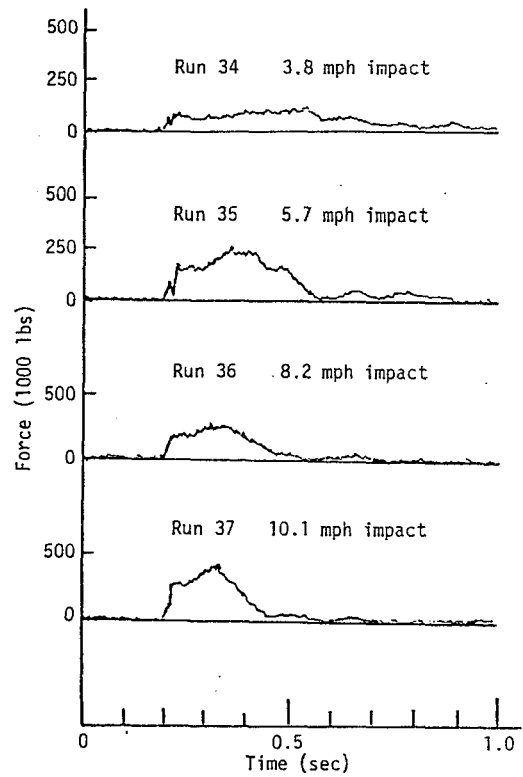
FIGURE 27. COUPLER FORCE VERSUS TIME RECORDS FROM CONFIGURATION 4B, B END IMPACT TESTS

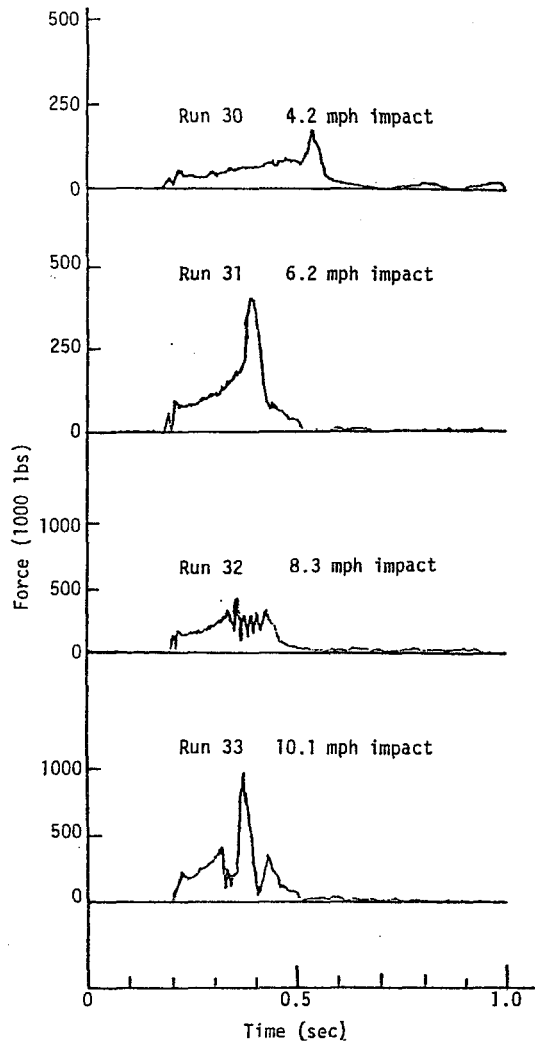
FIGURE 28. COUPLER FORCE VERSUS TIME RECORDS FROM CONFIGURATION 4A, A END IMPACT TESTS
