Rail Neutral Temperature Test on CSX

FINAL REPORT

1. Report No. FRA/ORD-90/11		2. PB92-193333		3. Recipient's Catalog No.	
4. Title and Subtitle RAIL NEUTRAL TEMPERATURE TESTS ON CSX				5. Report Date September 21, 1990

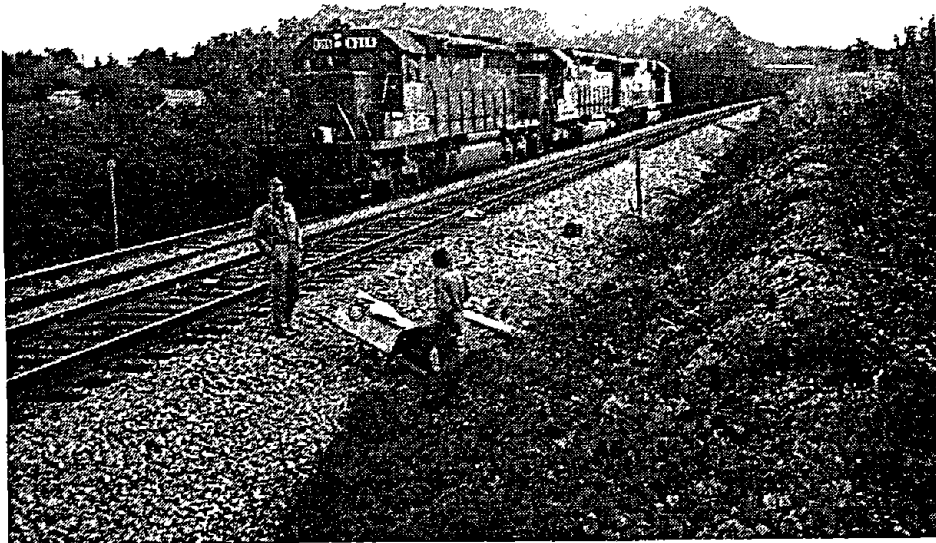
FIGURE 2-3. VIEW OF TANGENT TRACK TEST SECTION

Instrumentation was applied to the tangent track section during the week of October 31, 1988. Surveying benchmarks were set in beside each site on the west side of the track. Because of traffic density, the strain gage circuit calibration (destress) operation was postponed until a later date, when a track curfew could be imposed. The calibration was finally achieved nearly two months later, on December 20, 1988. A view of the test section and a typical site installation are shown in Figures 2-3 and 2-4, respectively.

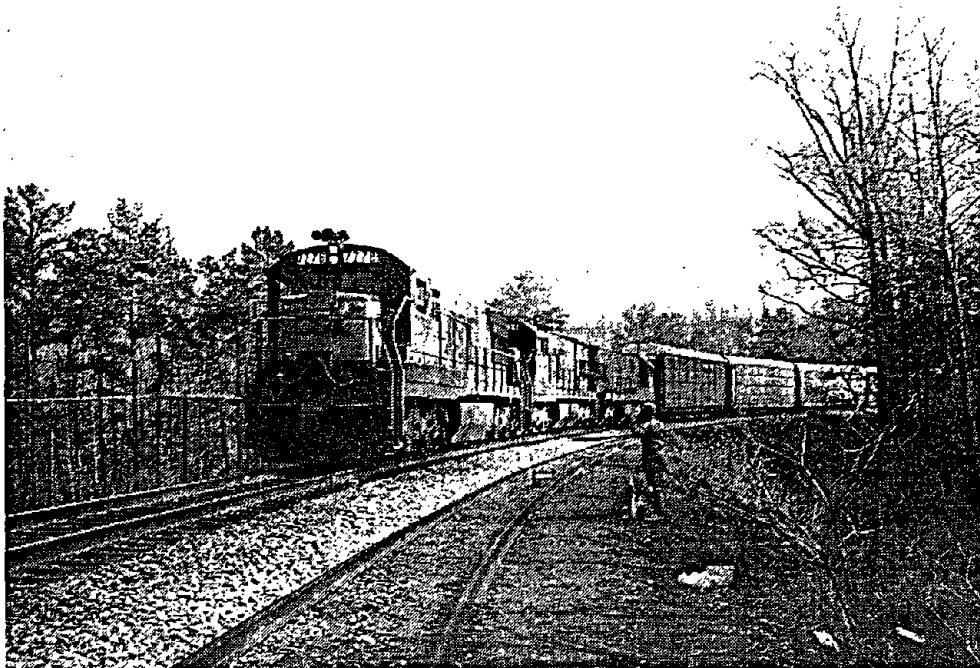
FIGURE 2-6. VIEW OF CURVED TRACK TEST SITE

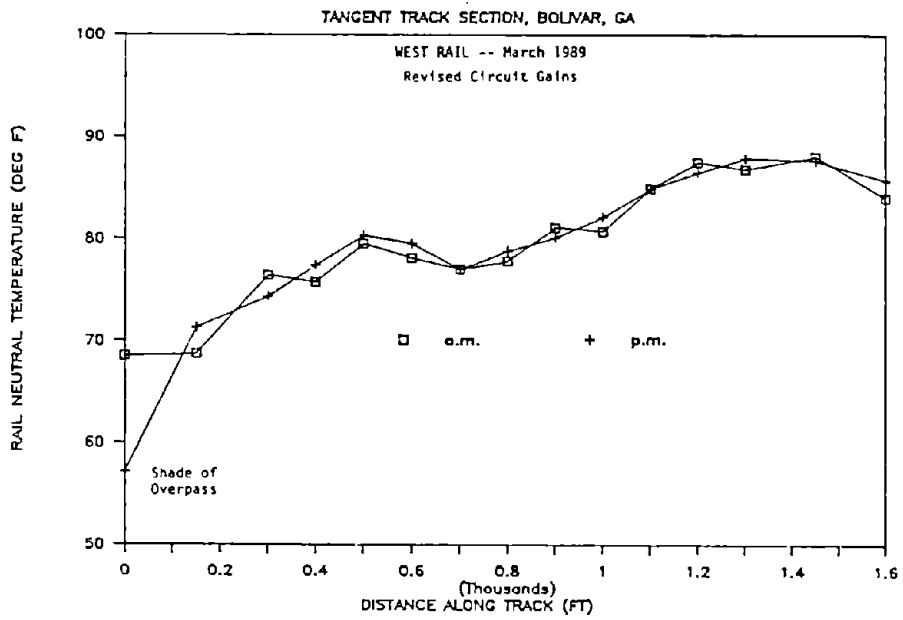
a. Nominal (Ideal) Rail Circuit Gains

b. Revised Rail Circuit Gains

FIGURE 2-7. COMPARISON OF CALCULATED RNT WITH NOMINAL AND REVISED GAINS

From Section 2.1, it was shown that the nominal "gain" of the RNT strain gage circuit was 19.5 counts/deg F (195 psi/deg F) of increased compression, based on nominal rail material parameters. This is predicated on an ideal "locked in" longitudinal load due to increased rail temperature. From RNT experiments on the Northeast Corridor (NEC) concrete tie track, the circuit gain was found to range from 183 to 203 psi/deg F (191 ± 8.0) on tangent track, and from 162 to 185 psi/deg F (173 ± 8.5) on the high and low rails of a one-degree curve. Circuit gain may range from 182 to 198 psi/deg F based on expected variations in material properties. Lower values of gain result from actual movement of the rail: a nearby joint, slack in rail anchors, or lateral movement of the track in a curve.

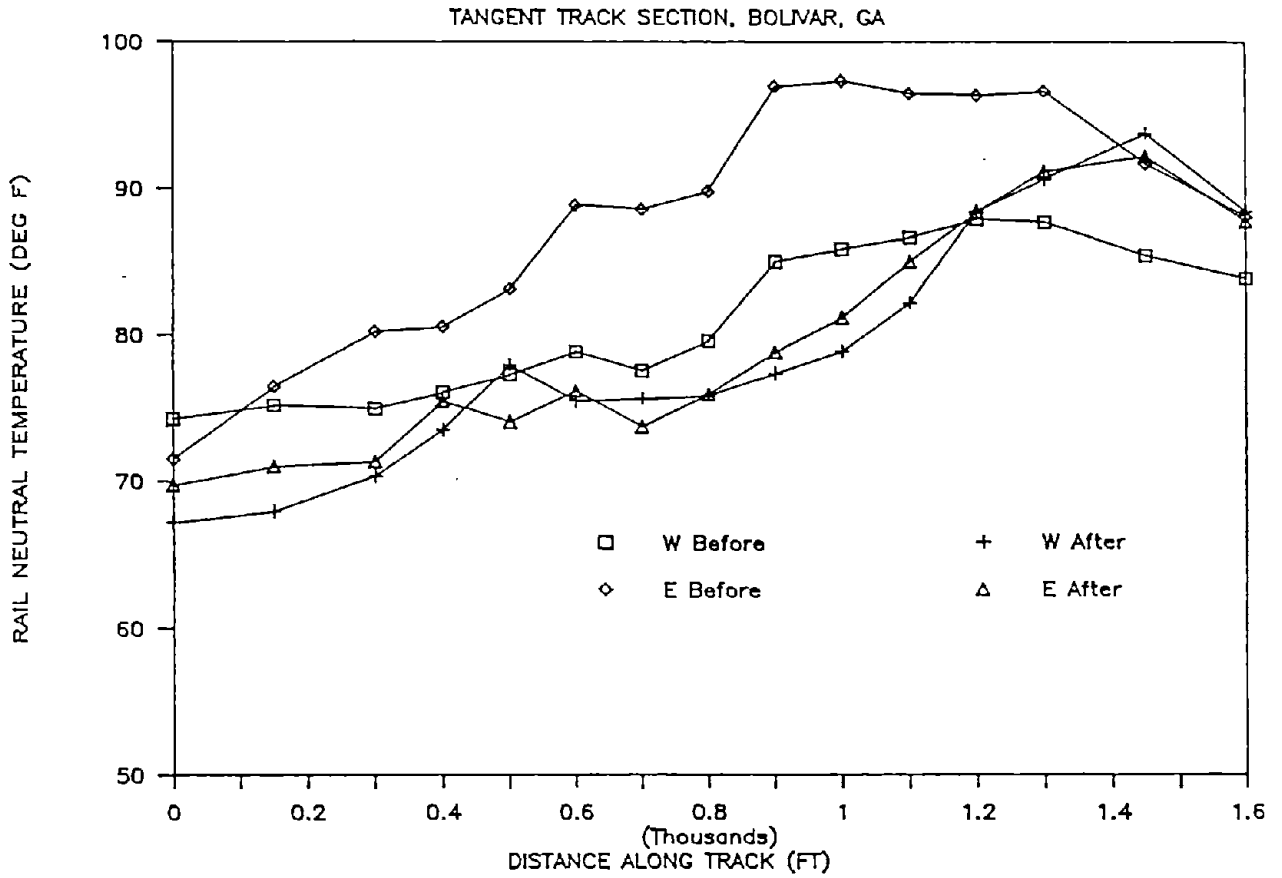
FIGURE 3-1. EFFECTS OF RAIL DESTRESS ON CALCULATED RAIL NEUTRAL TEMPERATURE AT THE TANGENT TRACK TEST SECTION

Since the rails were heated from the rail gaps between Sites 12 and 13 to almost Site 15 (about 350 ft) before welding, a higher RNT was again achieved at this end of the section. Rails at the gaps between Sites 2 and 3 were welded without heating. As a result of heating over such a limited section of rail, up to 20 degrees in RNT were lost over portions of the section.

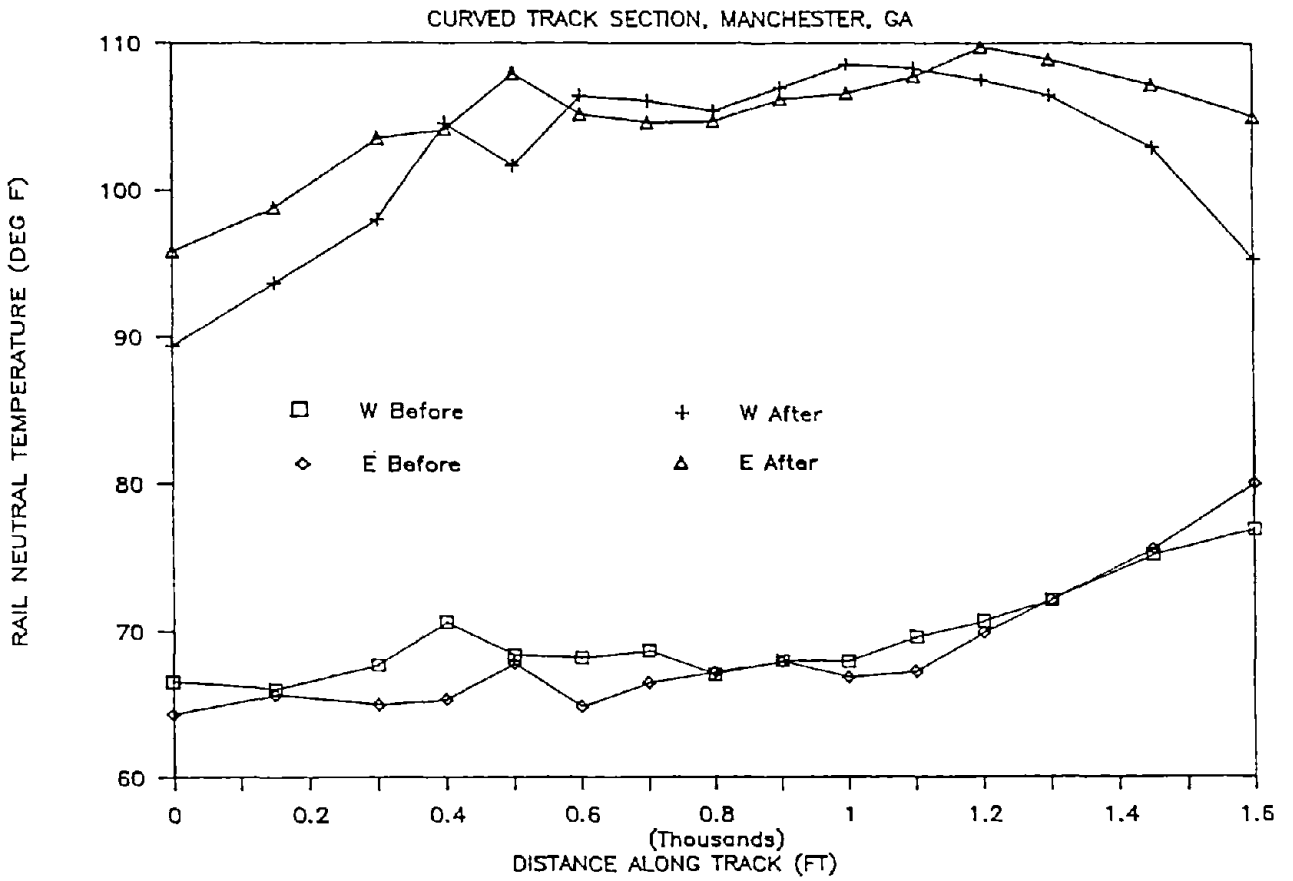
The effects of distress at the curved track section are shown in Figure 3-2. At this test section, the "before" readings were taken on the afternoon of February 27, 1989 with rail temperatures between 67 and 69 degrees F. The "after" readings were taken on the morning of March 15, with rail temperatures between 69 and 79 F, and after traffic had passed over the section all night. A fairly uniform (but somewhat low) RNT existed throughout the body of the curve prior to distress, both in distance along the rail, and

FIGURE 3-2. EFFECTS OF RAIL DESTRESS ON CALCULATED RAIL NEUTRAL TEMPERATURE AT THE CURVED TRACK TEST SECTION

from high to low rail values. Since rail temperatures rose to over 100 F by the time the rails were rewelded, an increase in RNT of 20-30 F was achieved throughout the curve. The lowest RNT values were noted at Site 1 (just past the spiral-curve point). Destress was conducted at nearly the original curve RNT, so that "rail break" pull effects were minimal due to the first rail cuts.

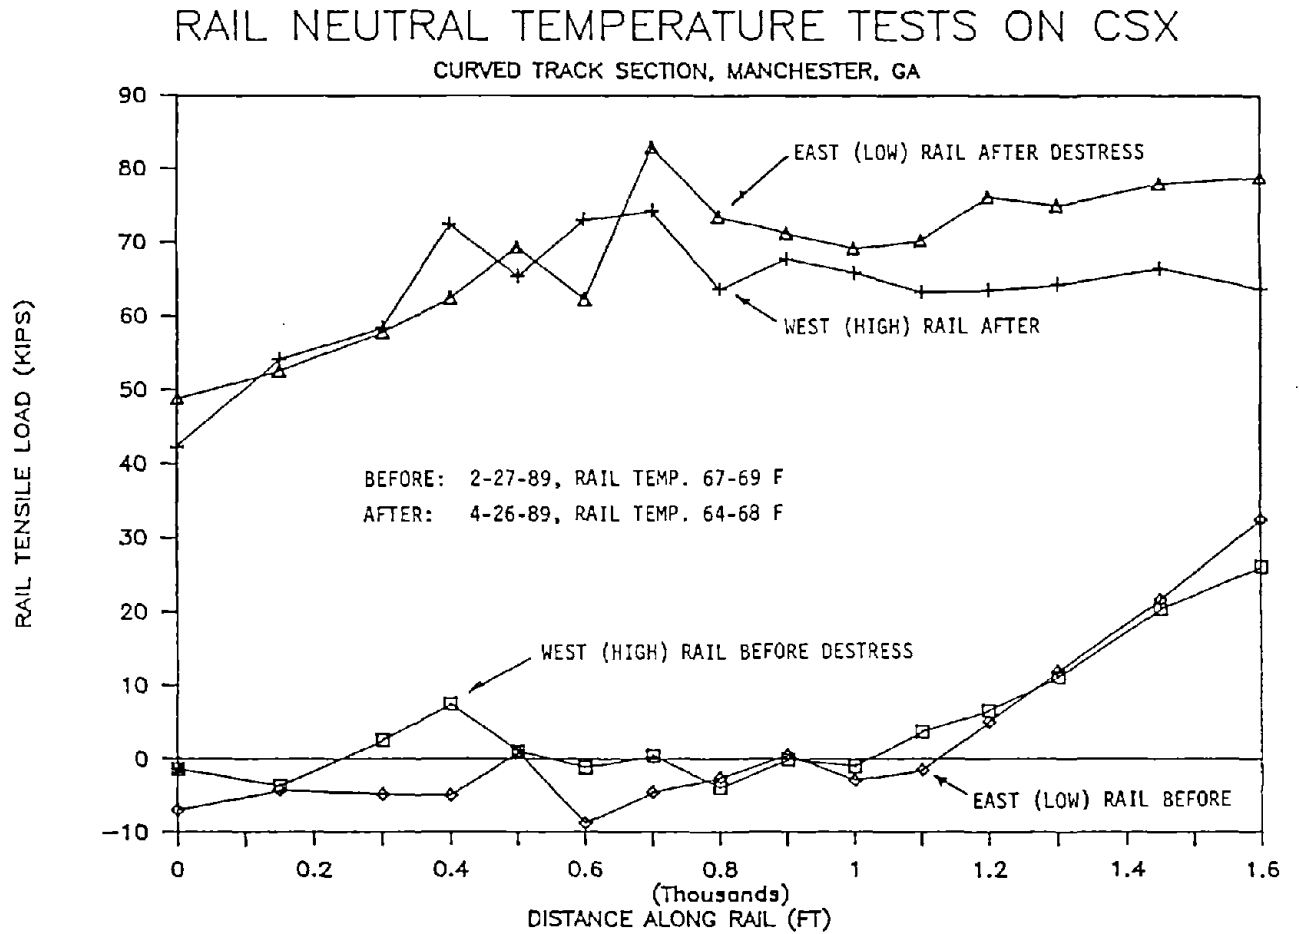
FIGURE 3-4. EFFECTS OF RAIL DESTRESS ON RAIL LONGITUDINAL LOAD AT THE CURVED TRACK TEST SECTION

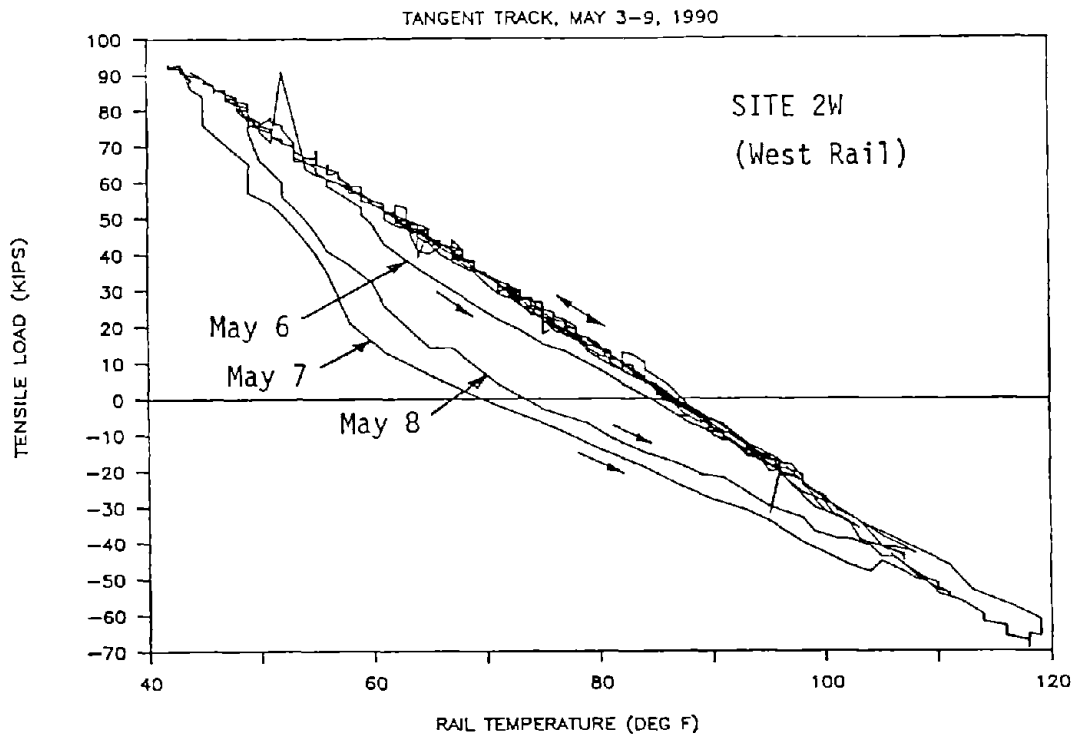
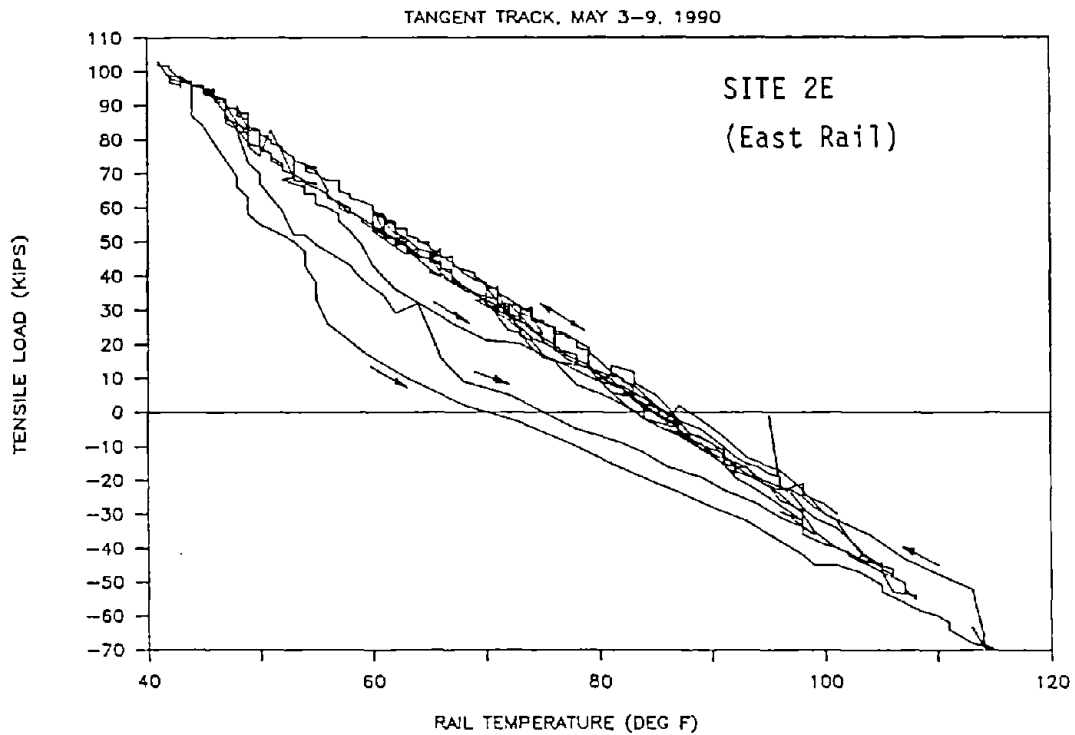
Other sites in the test section were not as well-behaved in the sense of following the expected load/temperature curve. In Figure 3-14, plots of load versus temperature from Site 2 show a reasonably linear relationship for the first three days (May 3-5, 1990), followed by three decidedly non-linear morning heating cycles (May 6-8). It is instructive to look at the prevailing weather conditions (an average for Atlanta and Chattanooga) for this 7-day period, as shown in Table 3-1.

FIGURE 3-14. CYCLIC VARIATION OF RAIL LONGITUDINAL LOAD VERSUS RAIL TEMPERATURE OVER 7-DAY PERIOD, TANGENT TRACK SITE 2

The load/temperature "hysteresis loops", as seen in Figure 3-14, are consistent to a particular location (site): a track location that produces a counter-clockwise loop one day will produce a similarly oriented loop on subsequent days when similar weather conditions exist. The loops are similar for both rails of the given site. However, moving from site to site, the loops appear to change direction (counter-clockwise to clockwise) on a cyclic basis. This is illustrated in Figures 3-15 through 3-17, moving north along the west rail. It can be seen from these curves that, for any given site and under "normal" weather conditions, the RNT may be calculated from the measured rail stress and temperature within an accuracy band of about five degrees F. Given the weather conditions that prevailed on May 7 and 8, 1990, however, calculation of RNT can be in error by 10 degrees F or more.

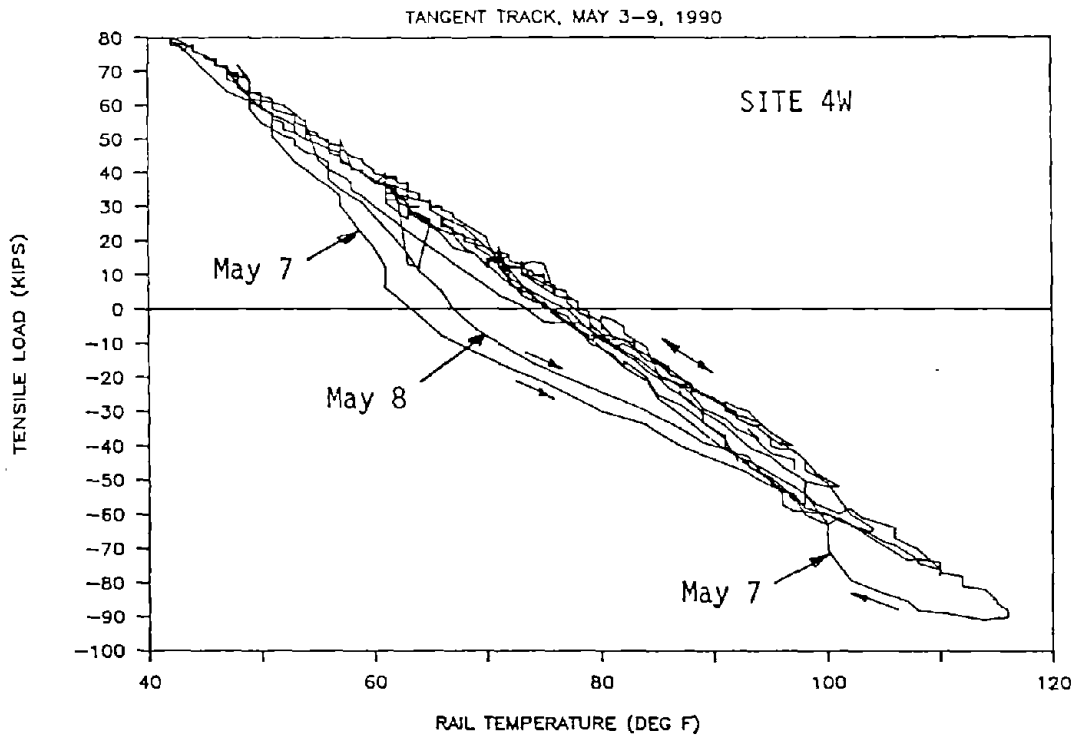
FIGURE 3-15. CYCLIC VARIATION OF RAIL LONGITUDINAL LOAD VERSUS RAIL TEMPERATURE OVER 7-DAY PERIOD, WEST RAIL SITES 4 & 5

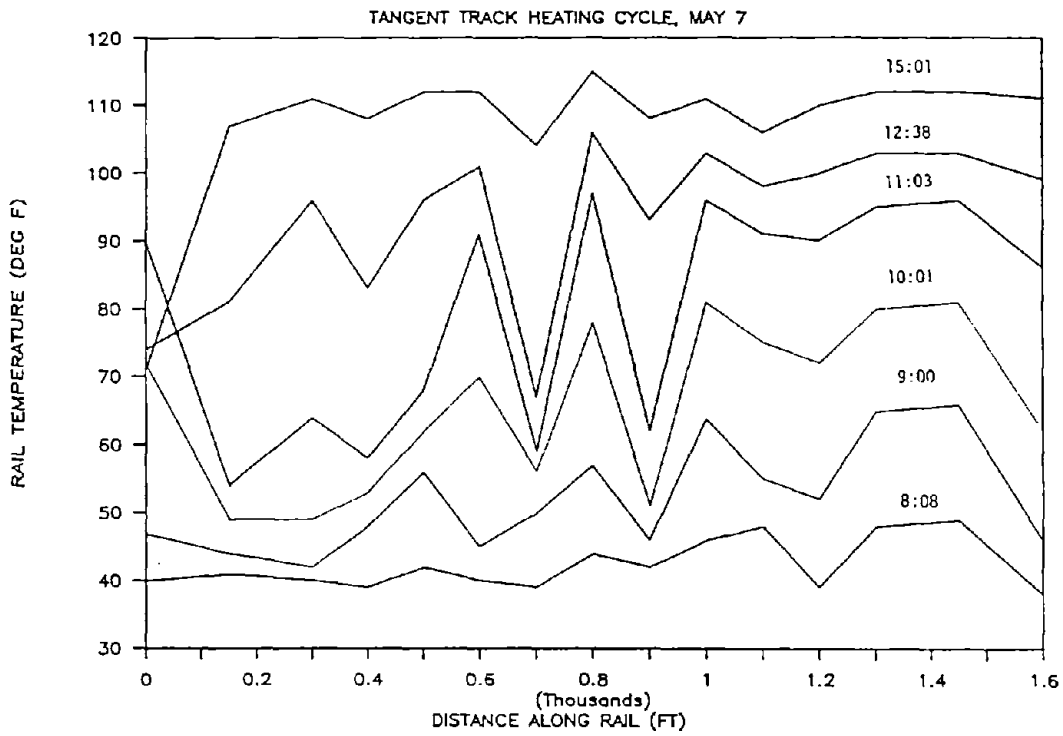
FIGURE 3-18. VARIATION OF RAIL LONGITUDINAL LOAD VERSUS DISTANCE DURING MORNING SOLAR HEATING CYCLE, MAY 7, 1990

behavior. The heating cycle, Figure 3-18, started at 8 a.m. with stable rail temperatures in the low to mid-40s. Significant local temperature variations were then developed along the track as direct sunlight hit the rail at certain sites, while adjacent sites remained in shade. This is particularly evident at Sites 6 (600 ft) and 8 (800 ft), in direct sunlight from 10 a.m. on, compared with Sites 7 (700 ft) and 9 (900 ft), in shade until after noon. Note that Site 1 (0 ft) was in direct sunlight from before 10 a.m. until about noon, and then went into the shadow of the overpass. Shade conditions at the tangent section are described in Table 3-2.

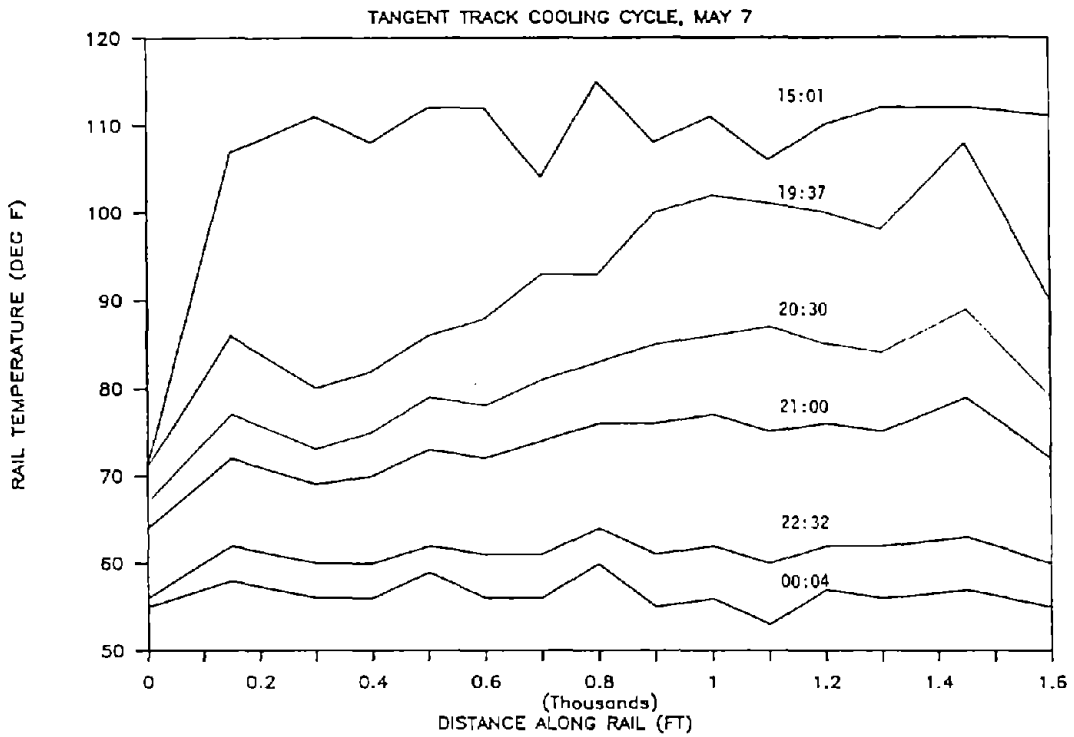
FIGURE 3-19. VARIATION OF RAIL LONGITUDINAL LOAD VERSUS DISTANCE DURING EVENING COOLING CYCLE, MAY 7, 1990
