REPORT NO. FRA/ORD-80/21

# OPERATIONAL PARAMETERS IN ACOUSTIC SIGNATURE INSPECTION OF RAILROAD WHEELS

UNIVERSITY OF HOUSTON  
Department of Mechanical Engineering  
Houston TX 77004

U.S. DEPARTMENT OF TRANSPORTATION  
FEDERAL RAILROAD ADMINISTRATION  
Office of Research and Development  
Washington DC 20590

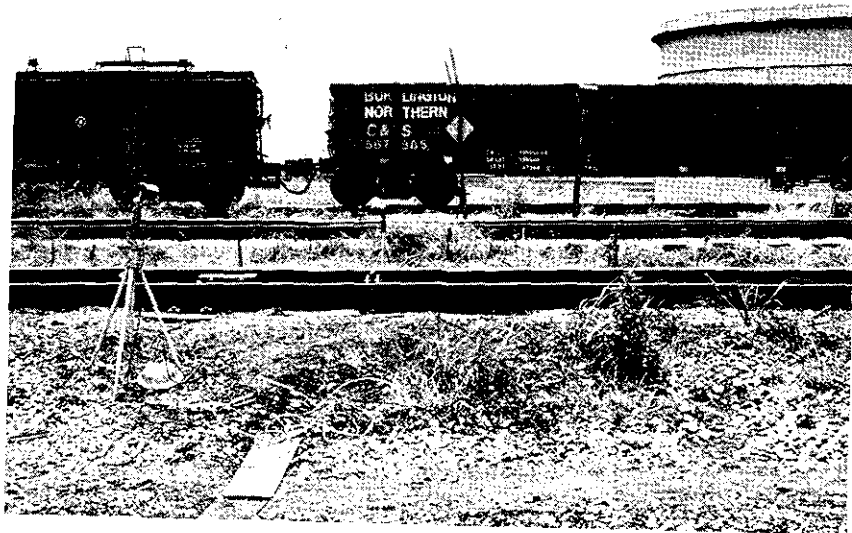
FIG. 6.5.3 VIEW OF THE MICROPHONES, EXCITERS AND WHEEL SENSORS THROUGH THE WINDOW OF THE TRAILER

The trailer and the outdoor hardware are shown in Fig. 6.5.2. Through the window on the left the test controller could watch the cars moving uphill towards the crest. The schematic of the inspection system is shown in Fig. 6.5.2b, distances between different devices being marked on the drawing. The exciter and the wheel sensors were mounted between the ties. The clearance was very small, and therefore inevitably there was some difference in the time between the triggering pulse and the impact on the two sides of the track. During the TTC and simulation tests, the exciter-wheel sensor alignment was much better. In Fig. 6.5.3, the microphones, exciters and wheel sensors are shown from the same angle as seen by the test controller looking through the window of the trailer. In Fig. 6.5.4a,b the system and the east part of the hump are shown. The inspection pits are indicated by arrows (Fig. 6.5.4a).

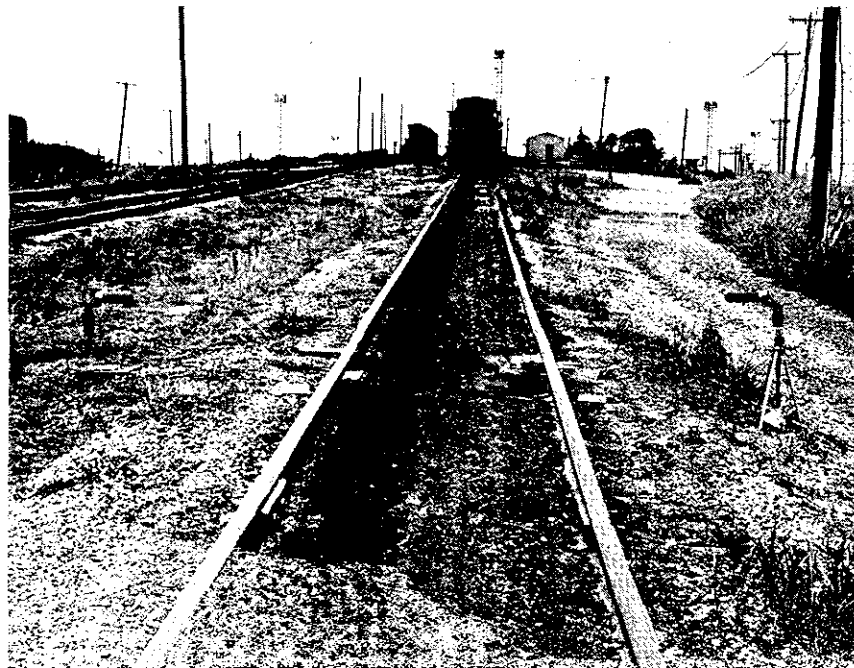
FIG. 6.5.4a VIEW OF THE EAST SIDE OF THE HUMP, INSPECTION PITS  
ARE INDICATED BY ARROW  
b VIEW OF THE MICROPHONES, EXCITERS AND WHEEL SENSORS
