## FIELD TESTING OF A WAYSIDE WHEEL CRACK DETECTION SYSTEM

Association of American Railroads  
Research and Test Department  
Transportation Test Center  
Pueblo, Colorado

DOT/FRA/ORD-92/07

May 1992  
Final Report

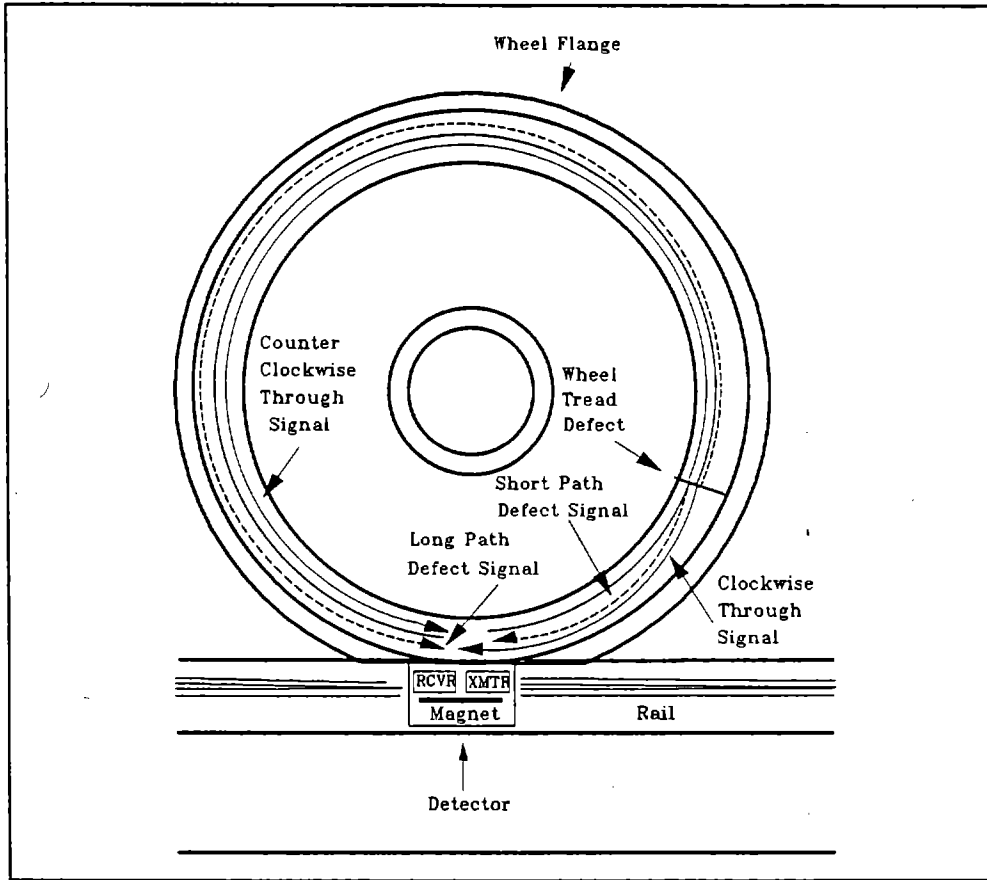
**Figure 1. Diagram of Wheel Set on WCD System**

Figure 1 is a diagram showing a wheel with a tread defect located at an angle of 60 degrees relative to the WCD rail mounted instrumentation, along with the various signals that are generated during the inspection process.

As illustrated in Figure 1, the WCD system uses two electromagnetic-acoustic transducer (EMAT) coils, a permanent magnet, and triggering circuitry to generate and detect sound energy in the test specimen. Each EMAT package contains a transmitter coil, a receiver coil, and the triggering circuitry. The coils are laminated with a flexible type of plastic which allows the coils to conform to the profile of the wheel tread.

The EMAT transmitter coil is powered by a high current amplifier designed to produce 500 kHz current pulses. The design of the transmitter coil and the presence of a magnetic field, caused by the permanent magnet, produces bi-directional Rayleigh waves or surface waves that travel around the wheel tread but do not penetrate into the bulk of the wheel. These waves are shown in Figure 1.

A wheel with a single tread defect, as illustrated in Figure 1, should theoretically produce a WCD signature with the characteristics illustrated in Figure 3.

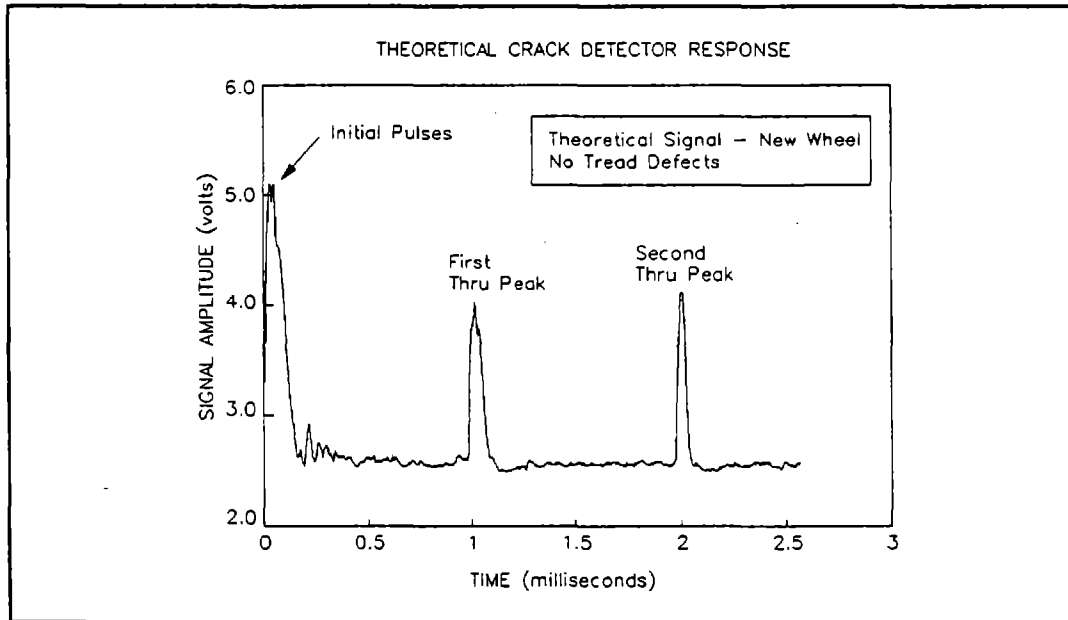
**Figure 2. WCD Signature for a Wheel with No Defects**

A wheel with no tread defects should theoretically produce a WCD signature with the characteristics illustrated in Figure 2.

Referring to Figure 2, the first peak occurring at time zero is due to the initial output pulses from the transmitter coil inducing a series of pulses in the receiver coil and saturating the receiver coil amplifier. The initial transmitter input is commonly referred to as the main bang. During the time period that the receiver coil amplifier is saturated (recovery time), the system is not able to detect signals reflected from defects. The next peak, occurring at approximately 1 millisecond, is the first through peak from the initial pulses detected by the receiver coil. The detection of this peak indicates that the initial pulse has traveled around the entire circumference of the wheel (1<sup>st</sup> round trip). The next peak occurring at approximately 2 milliseconds is the second through peak. The detection of this peak indicates that the initial pulses has traveled around the circumference of the wheel twice (2<sup>nd</sup> round trip).

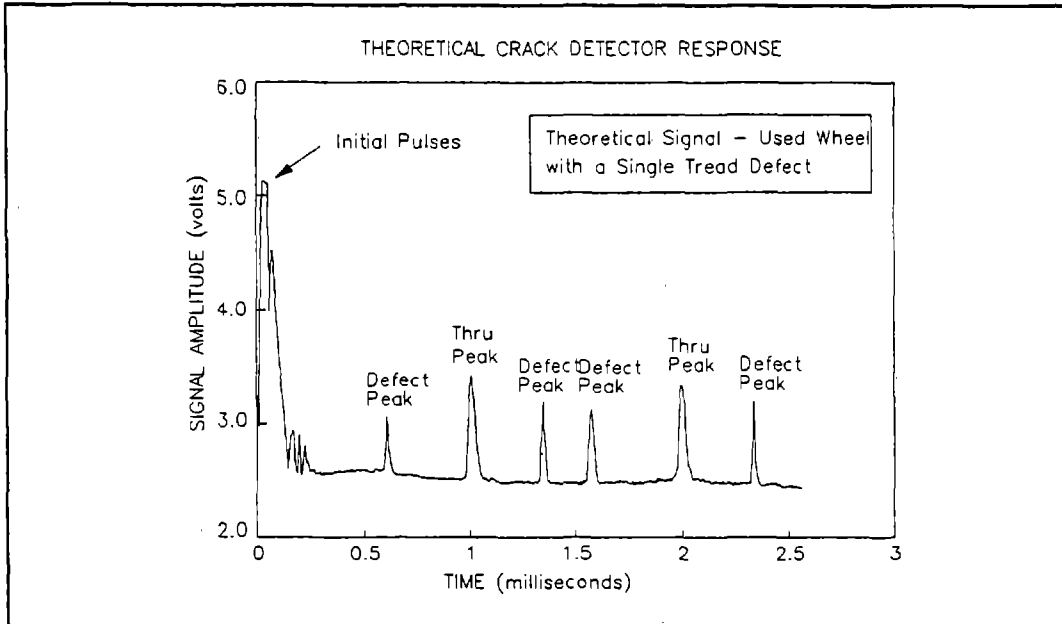
**Figure 3. WCD Signature - Single Tread Defect**

Referring to Figure 3, the first peak occurring at time zero and those occurring between time zero and 0.2 milliseconds are due to the main bang saturating the receiver coil amplifier. The first defect peak, caused by the short path defect signal, occurs at 0.66 millisecond. The first through peak detected by the receiver coil occurs at approximately 1 millisecond. The peak at 1.34 milliseconds is caused by the long path defect signal. The second through peak occurs at 2 milliseconds. The peak occurring at 1.66 milliseconds is caused by the short path defect signal from the first through signal, and the peak occurring at 2.34 milliseconds is caused by the long path defect signal from the first through signal (not shown in Figure 1).

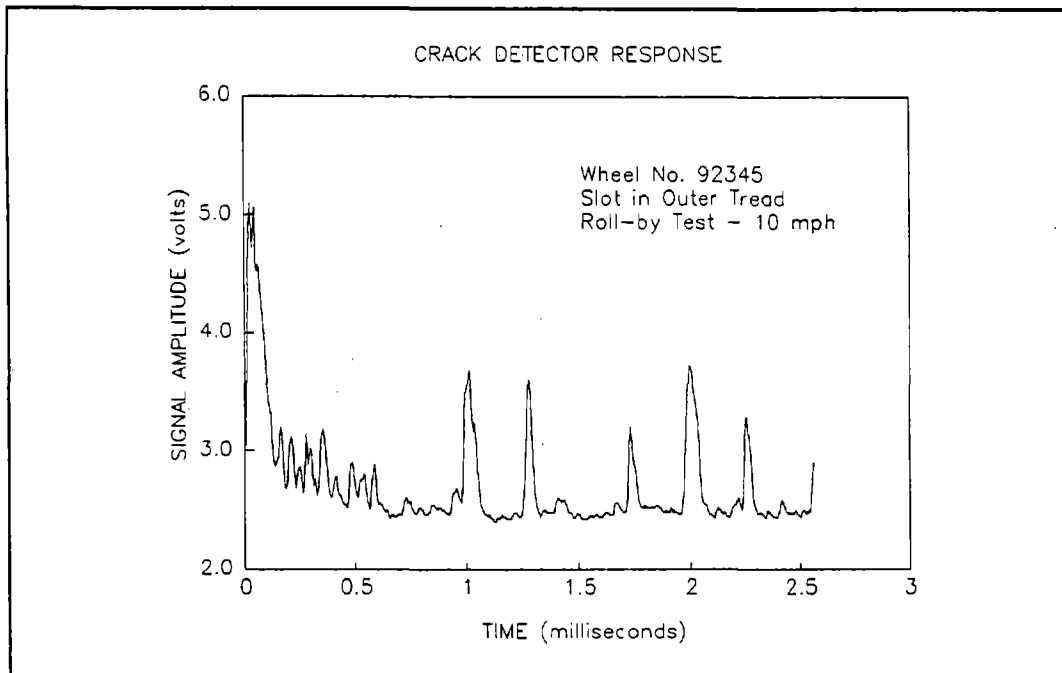
**Figure 10. Detector Response for Wheel No. 92345  
Roll-by Test -- 10 mph**

Inspection of Figures 8 through 10 shows that the detector response signals for the slot defect exhibits distinct defect and through peaks at each of the test speeds. The peaks occurring at approximately 1 and 2 milliseconds are the through peaks, and those occurring at approximately 1.3, 1.7, and 2.3 milliseconds are the defect peaks. When comparing these results to the theoretical results illustrated in Figure 3, it should be noted that the initial defect peak that was expected to occur between the main bang and the first through peak is not clearly discernable in the actual signature. As stated previously, the WCD system tested at the TTC was designed to use the amplitude of the defect peak occurring between the main bang and the first through signal as an indicator of the defect size. The absence of a distinct defect peak in this region suggests that an alternate scheme for estimating defect size will be required.

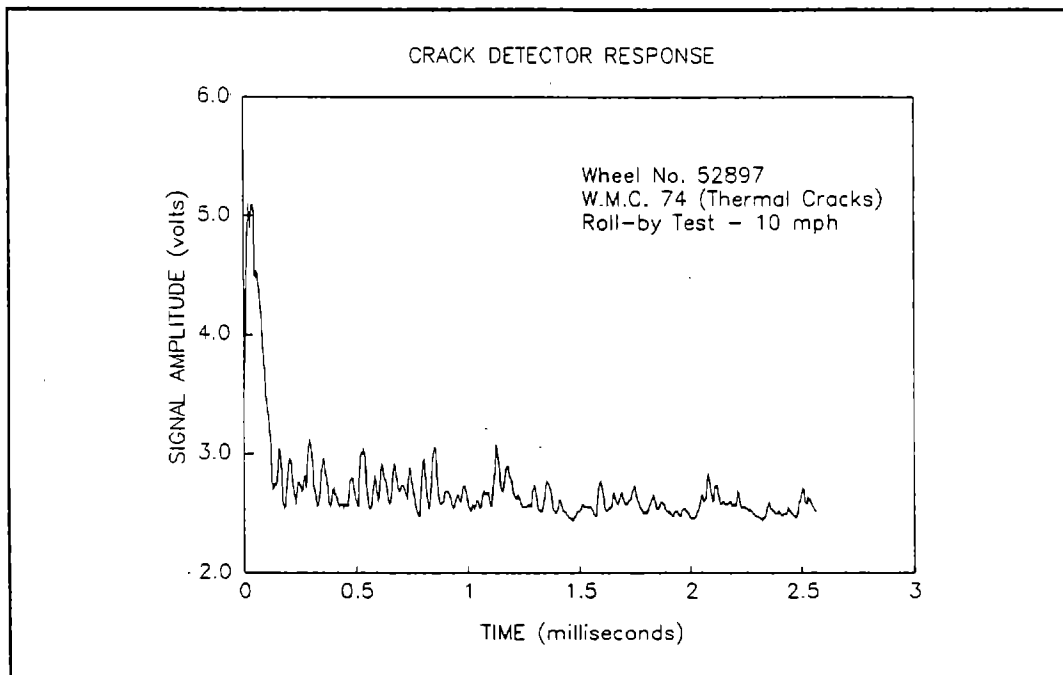
**Figure 14. Detector Response for Wheel No. 52897  
Roll-by Test -- 10 mph**

Inspection of Figures 12 through 14 shows that the detector response signals for the thermal crack defects exhibits multiple defect peaks, but no distinct through peaks for any of the test speeds including the stationary test.

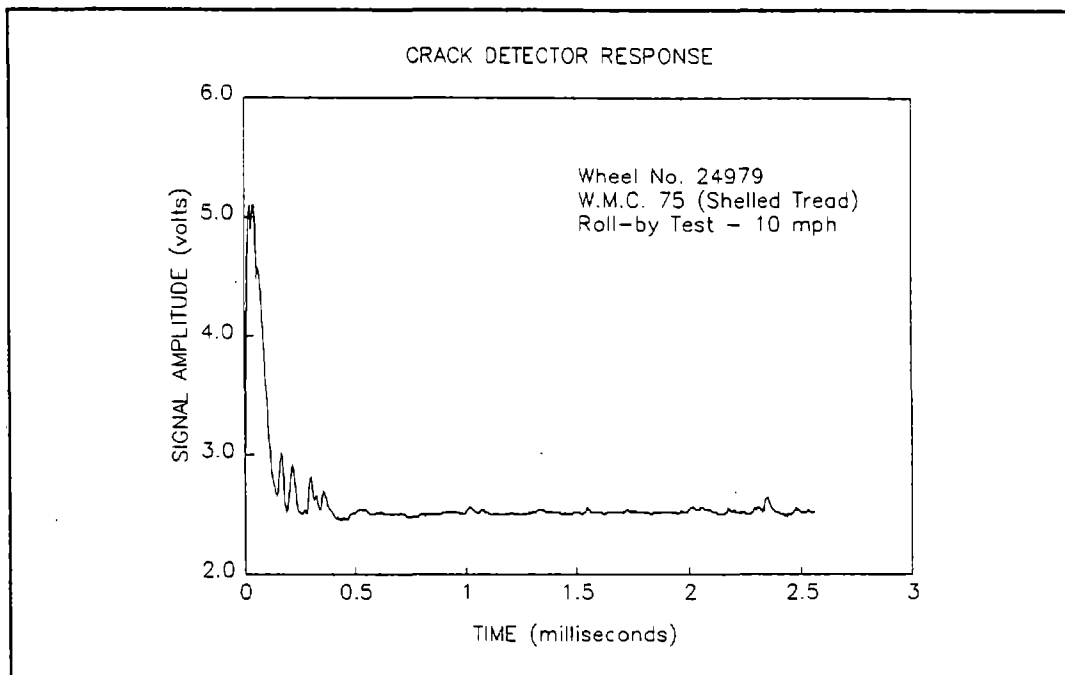
**Figure 18. Detector Response for Wheel No. 24979  
Roll-by Test -- 10 mph**

Inspection of Figures 16 through 18 shows that the energy from the initial pulses is almost completely scattered by the shelled tread defect resulting in little or no detector response signal for any of the speeds tested including the stationary test. This characteristic may be useful in distinguishing wheels with tread shelling defects from those with tread thermal crack defects.

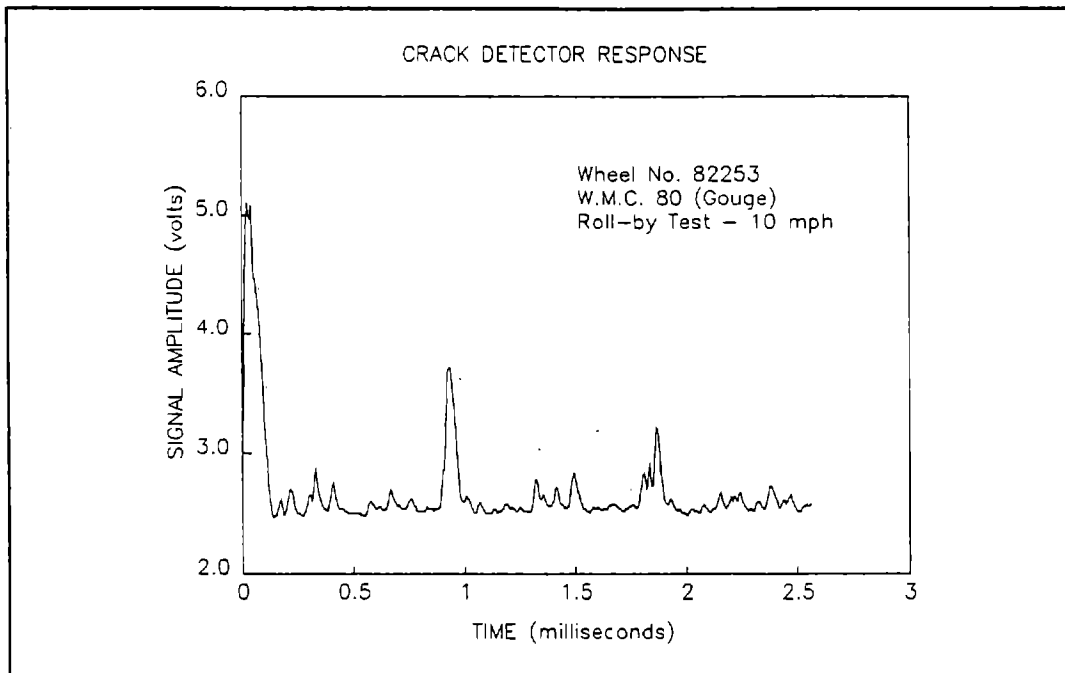
**Figure 22. Detector Response for Wheel No. 82253  
Roll-by Test -- 10 mph**

Inspection of Figures 20 through 22 shows that the detector response signals for the gouge defect in the rim exhibits distinct defect and through peaks for each test speed. For this wheel, the through peaks occurred at 0.9 and 1.8 milliseconds.

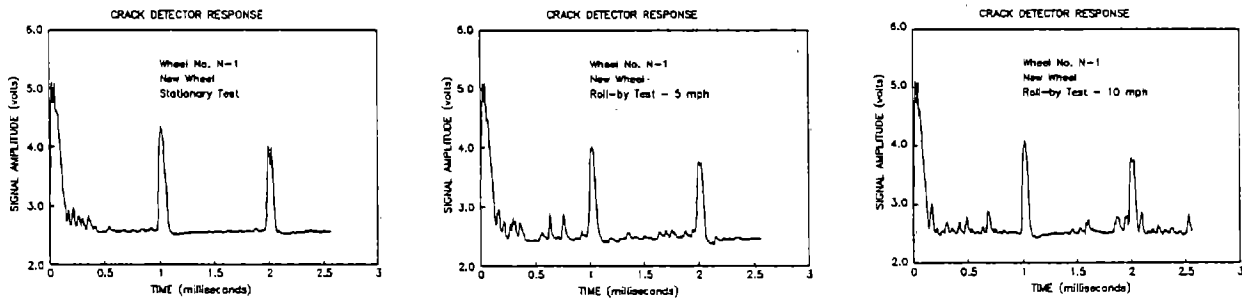
**Figure 27. Detector Response for Wheel No. N-1  
Stationary Test, 5-mph and 10-mph Tests**

Inspection of Figure 27 shows that two distinct defect peaks were detected at approximately 0.7 and 0.8 milliseconds in the 5-mph roll-by test. Similar results were obtained for the 10-mph test. These defect peaks were not actually associated with any wheel defects and would result in the generation of a false alarm by the WCD system.

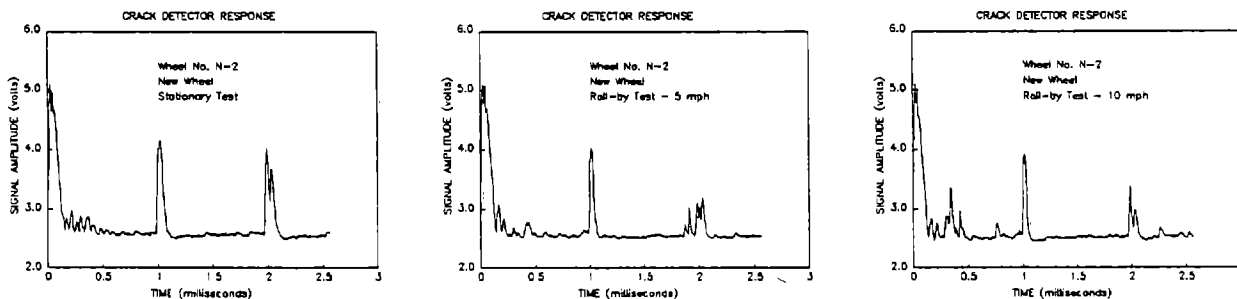
**Figure 28. Detector Response for Wheel No. N-2  
Stationary Test, 5-mph and 10-mph Tests**

Inspection of Figure 28 shows that a distinct defect peak was detected at approximately 0.3 milliseconds in the 5-mph roll-by test. Similar results were obtained for the 10-mph test. The defect peak was not actually associated with any wheel defect and would result in the generation of a false alarm by the WCD system.

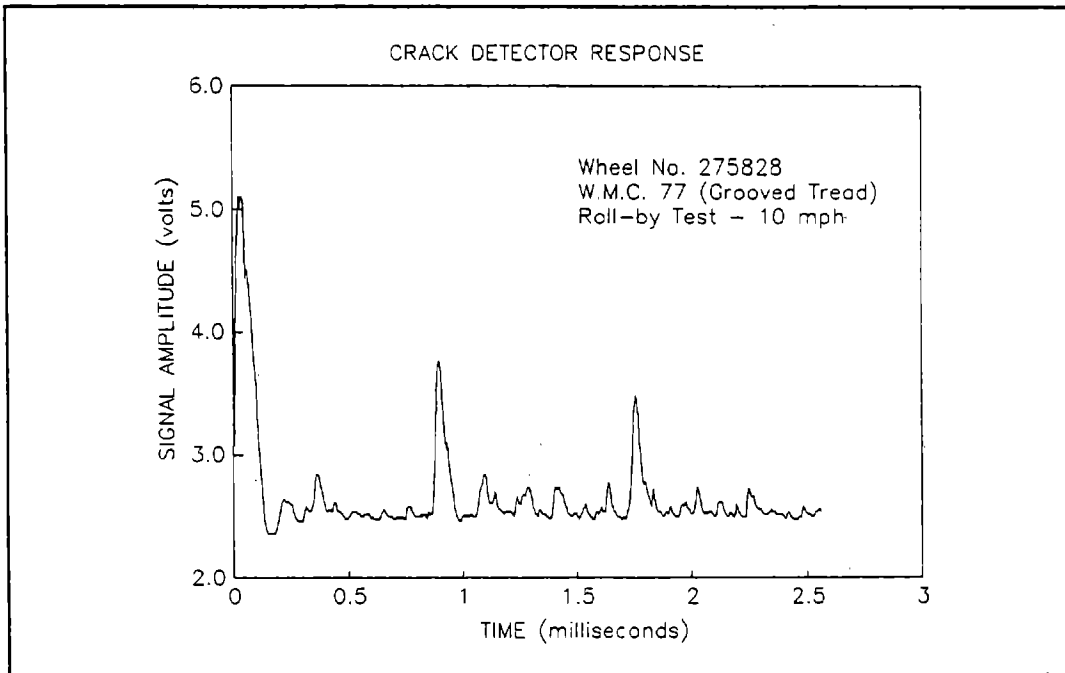
**Figure 26. Detector Response for Wheel No. 275828  
Roll-by Test -- 10 mph**

Inspection of Figures 24 through 26 shows that the detector response signals for the grooved rim defect exhibits defect and through peaks for each test speed. For this wheel, the through peaks occurred at 0.8 and 1.6 milliseconds.

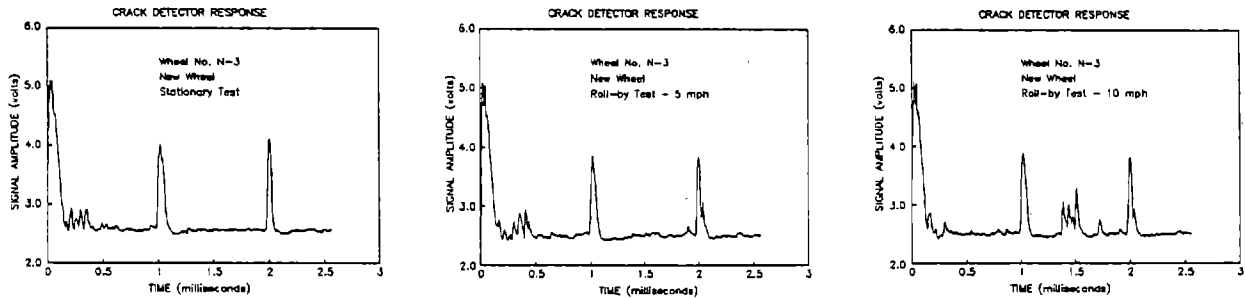
**Figure 29. Detector Response for Wheel No. N-3  
Stationary Test, 5-mph and 10-mph Tests**

Inspection of Figure 29 shows that a distinct defect peak was detected at approximately 0.4 milliseconds in the 5-mph roll-by test and three-defect peaks were detected in the 10-mph test. The defect peaks were not actually associated with any wheel defects and would result in the generation of a false alarm by the WCD system.

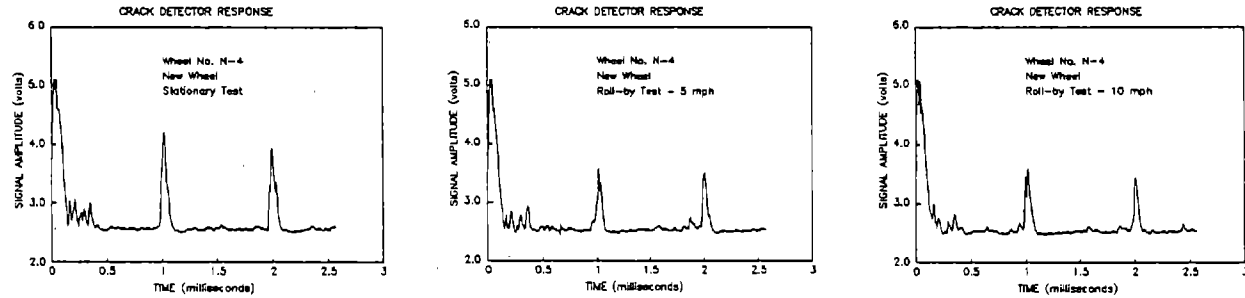
**Figure 30. Detector Response for Wheel No. N-4  
Stationary Test, 5-mph and 10-mph Tests**

Inspection of Figure 30 shows that a distinct defect peak was detected at approximately 0.3 milliseconds in the 5-mph test. Similar results were obtained in the 10-mph test. The defect peak was not actually associated with any wheel defect and would result in the generation of a false alarm by the WCD system.
