# Experimental Residual Stress Measurement of New and Used Commuter Rail Wheels

FRA/ORD-94/12

January 1994

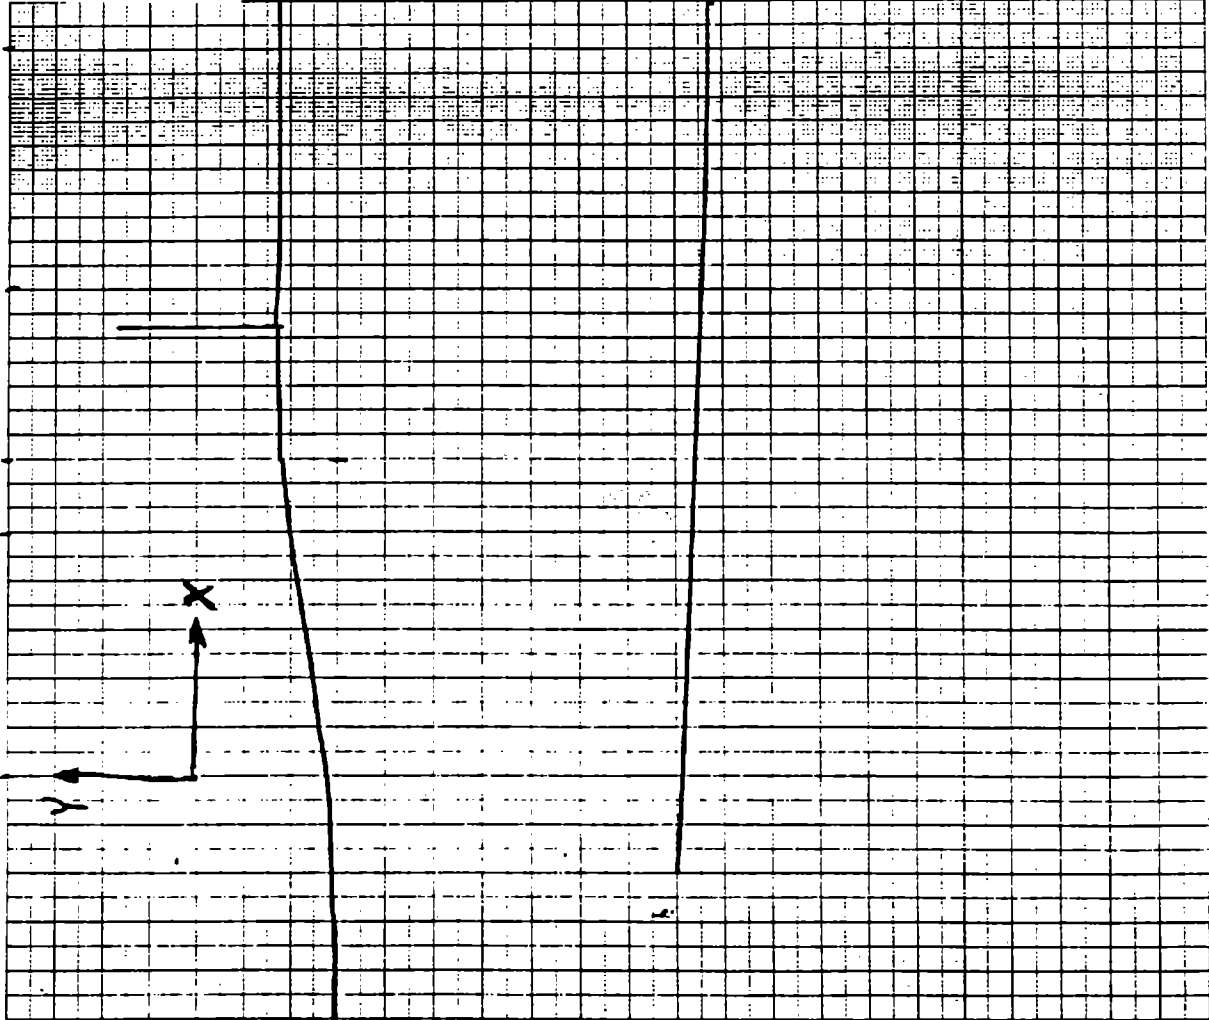
CLIP GAGE DATA  
USED WHEEL (#1501)

POSITION #4

X SCALE: 0.20" PER MAJOR DIVISION

Y SCALE: 0.005" PER MAJOR DIVISION

DATE: 3/31/92
