Railroad Rail Flaw Detection System Based on Electromagnetic Acoustic Transducers

**George A. Alers
Magnasonics, Inc.
215 Sierra Drive, S.E.
Albuquerque, NM 87108**

1. Report No. Report No. DOT/FRA/ORD-88/09		2. Government Accession No. PB89 163091AS		3. Recipient's Catalog No.	
4. Title and Subtitle RAILROAD RAIL FLAW DETECTION SYSTEM BASED ON ELECTROMAGNETIC ACOUSTIC TRANSDUCERS				5. Report Date September 1988

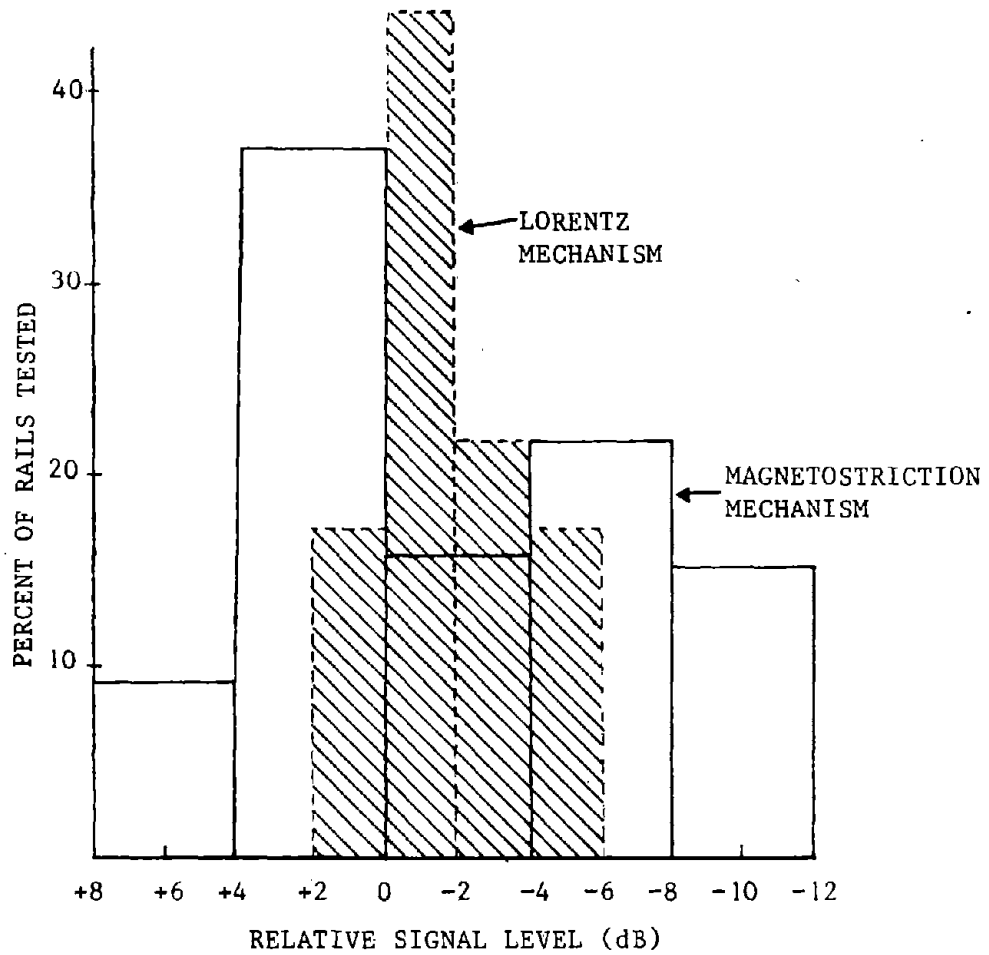
Figure 3. Histograms showing the distributions in efficiency for the magnetostriction mechanism and the Lorentz mechanism on the 32 sample rails containing defects.

SH waves. However, the magnetostrictive mechanism exhibited a higher absolute efficiency and, even though the histogram shows a wider range of efficiencies, it was felt that this inherently higher efficiency would make up for the low efficiency on a few rails.

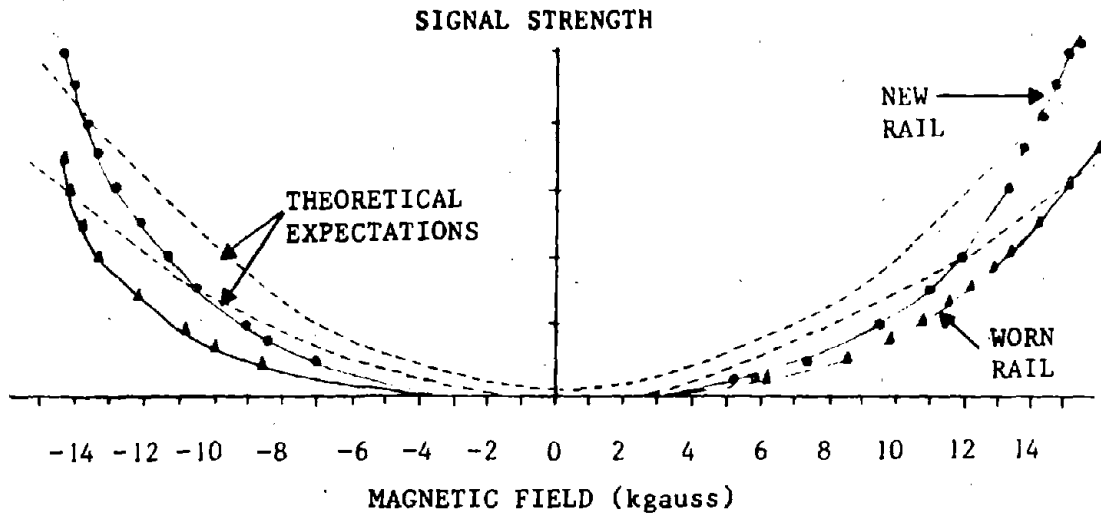
Figure 5. Efficiency of the 0° EMAT (Lorentz mechanism) as a function of magnetic field in the gap under the dc electro-magnet used on the inspection vehicle.

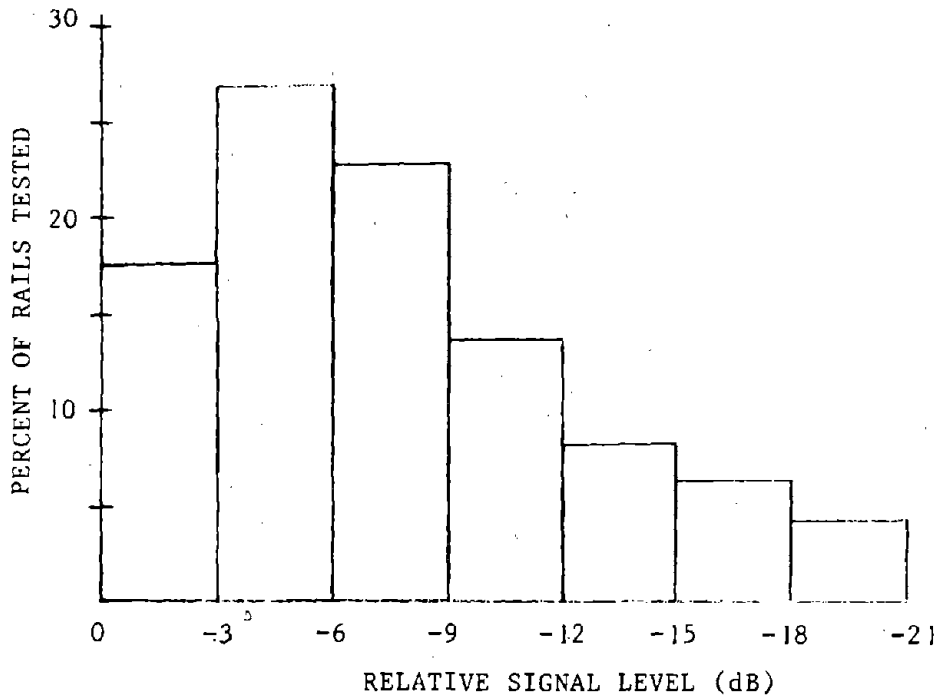
Figure 6. Histogram of the efficiency of the 0° EMAT operating on Section 10 of the TTC test track.

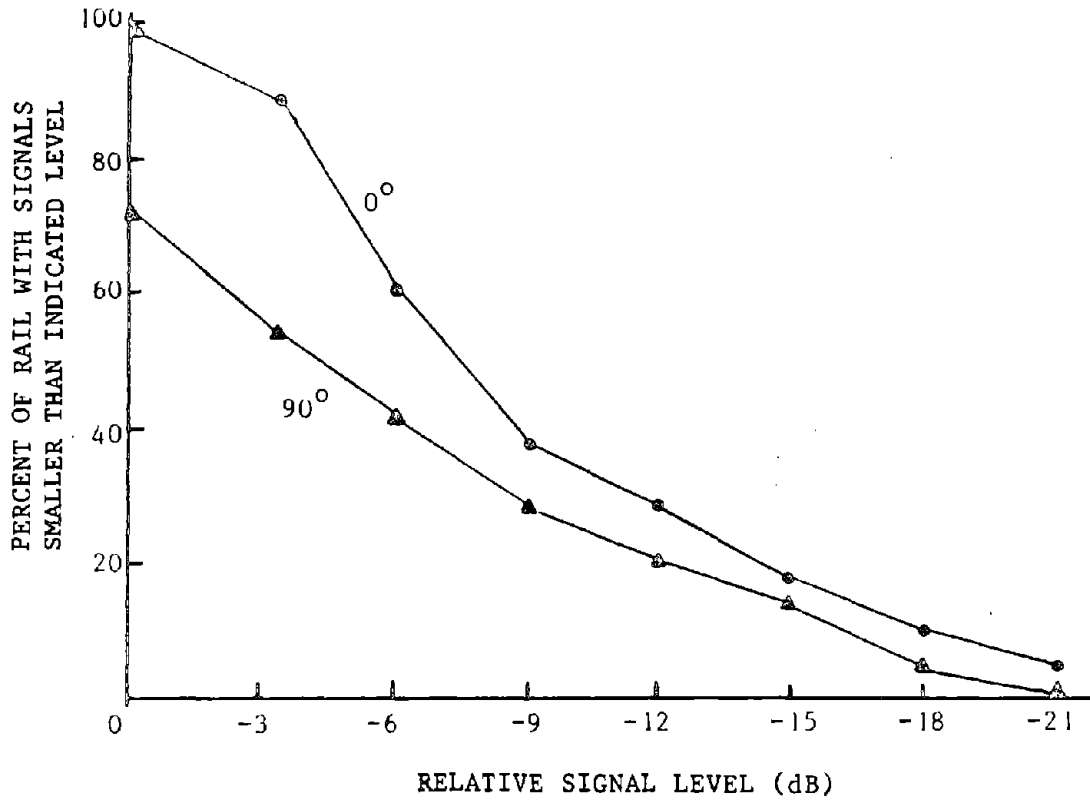
Figure 24. Statistical distribution of EMAT efficiencies along all of Section 10 of the FAST tracks.
