FAST/TTC/TN-80/04

EVALUATION OF RAIL WEAR AT THE FACILITY
FOR ACCELERATED SERVICE TESTING

SUMMARY

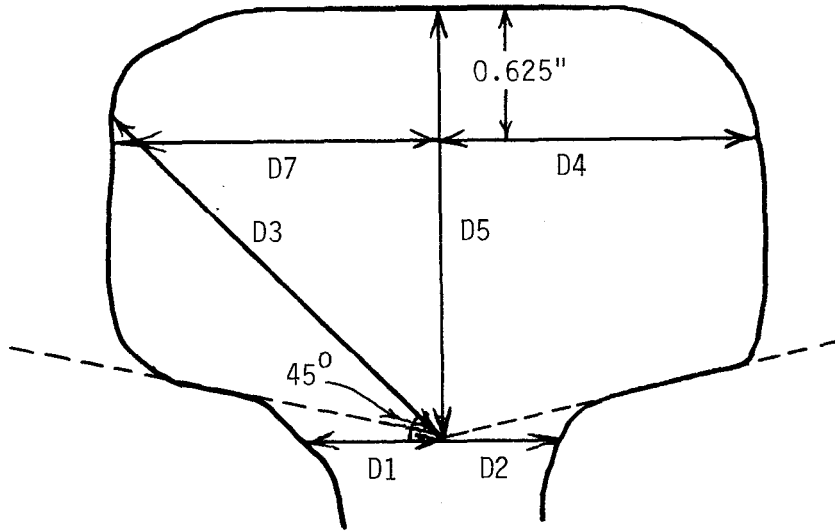
FIGURE 3. PROFILE DIMENSIONS.

Profiles were digitized and then processed to produce the dimensions shown in figure 3 along with gross area (complete area above lines projected from fishing surfaces) and total head area (above projections from fishing surfaces, but within the original profile). Portions of these data have been subject to two types of statistical analysis by independent organizations. The Association of American Railroads (AAR), Washington D.C., made the more elaborate (and more rigorously correct) analysis of covariance using all original data for decisions about statistical significance wherein wear is described by a linear wear model. For data taken before the lubrication transition only, the best-fit line was not constrained to go through the mean zero wear at 0 MGT, but it did, in fact, come very close to doing so.

Wear measurements were taken with profilometers that produce transverse 1:1 tracings of the rail head, beginning at the fishing surface under one side of the head and tracing around to the other. Correction procedures were applied to compensate (sometimes only partially) for instrument and operator variability. In addition, a change in profile correction procedure was introduced at 80 MGT; this change was believed to be responsible for the transients in wear data observed at that tonnage. Measurements were taken at approximately 20-25 MGT intervals with a minimum of two measurement sites on each test rail.

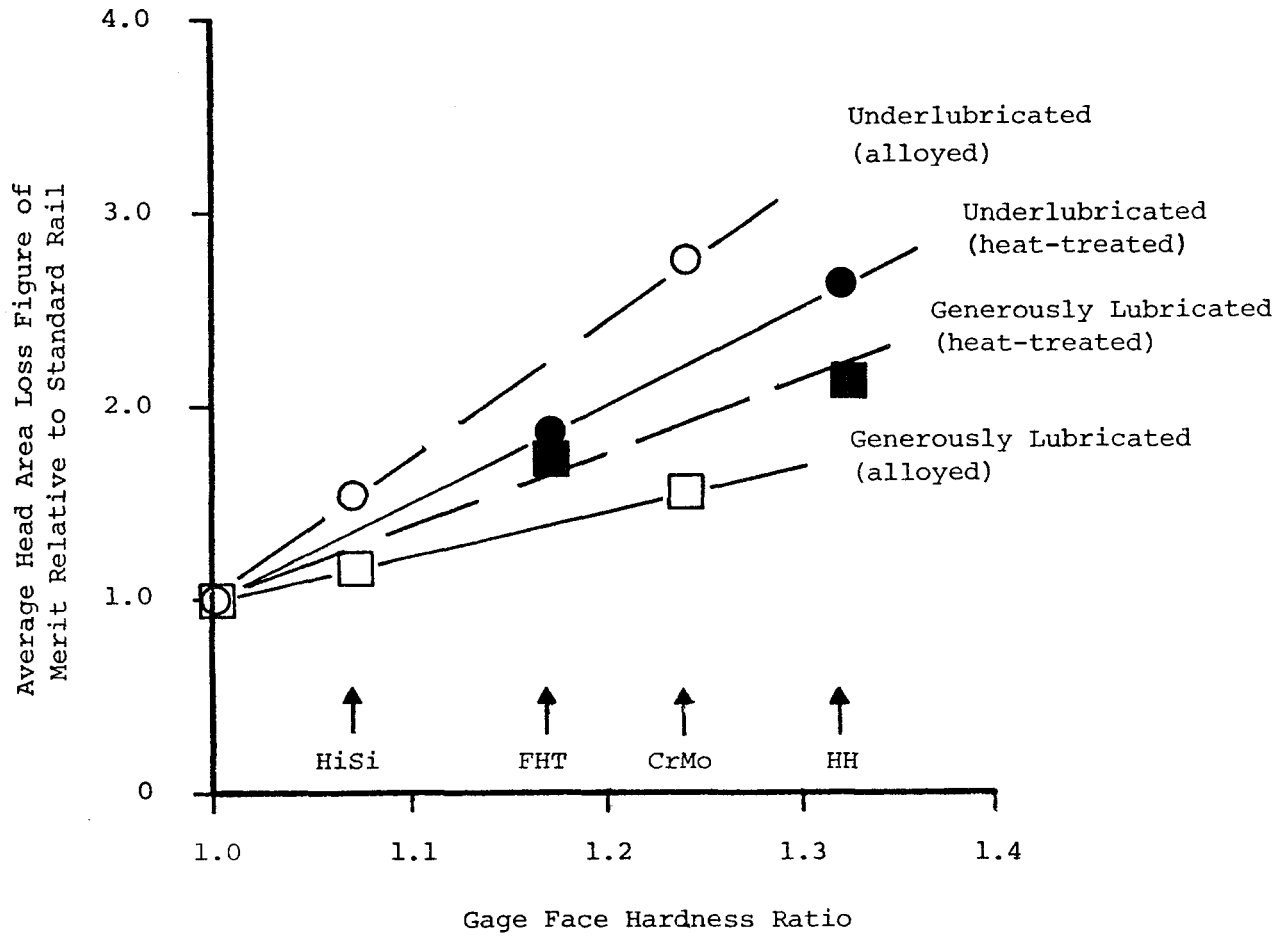
FIGURE 8. EFFECT OF RELATIVE GAGE FACE HARDNESS UPON HEAD AREA LOSS FIGURE OF MERIT.

The presumption is that lateral force, lateral and vertical creep, and the angle of the gage face to the lateral force vector are not functions of metallurgy. Thus, the ratio V₁/V₂ is really a FM if V₁ is taken to represent Std rail. If volumetric wear is thought to be best represented by head area loss, the FAST FM can be plotted as shown in figure 8 against the gage face hardness ratio.

Two different linear plots ($\alpha_1, \alpha_2 = 1$) appear to obtain for the premium rails--one for heat-treated rails and the other for alloy rails. Furthermore, the slopes of the lines appear to be a function of lubrication, with the heat-treated rails being less influenced by lubrication than were alloy rails. Whether the gage face wear results of the CrMo rail in the second experiment are a contradiction to this will not be known until the head area loss data are analyzed and hardnesses are taken on the gage face.

The expression proposed by Kalousek and Bethune⁴ for volumetric wear can be recast into the form:

$$\frac{V_1}{V_2} = \frac{C_1}{C_2} \cdot \frac{H_2^{\alpha_2}}{H_1^{\alpha_1}}$$

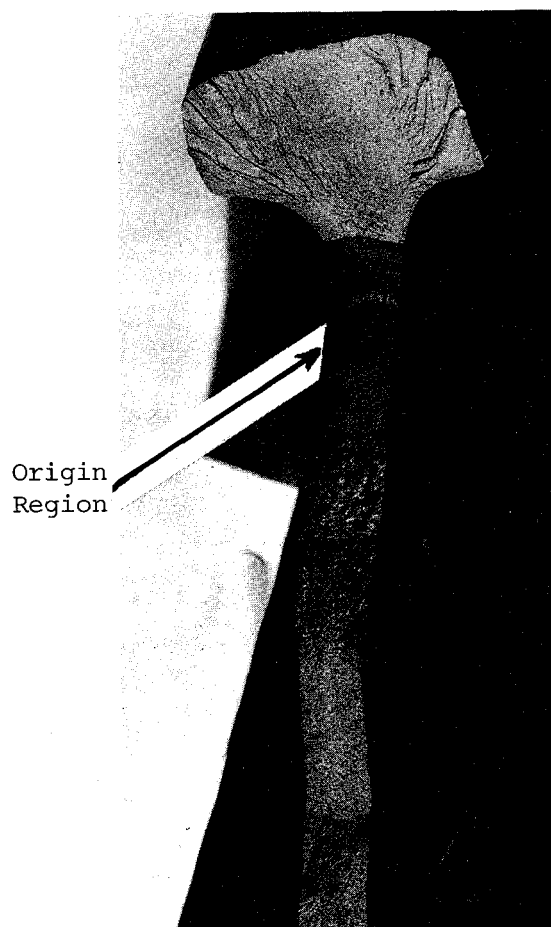
Figure 12 illustrates the fracture appearance of frequently occurring plant weld and field weld failures. Typically, both have a nearly horizontal web crack extending to either side of the weld region. However, the plant weld failure originates from a transverse vertical crack which develops at the edge of the shear drag region under the gage side head-web fillet. A substantial period of vertical fatigue growth (> 20 MGT) frequently occurs before the crack turns horizontal in the web. On the other hand, the field weld failure sometimes appears to be initiated in the heat-affected zone, with the crack then propagating through the weld itself.

FIGURE 12. WELDMENT FAILURES - (A) PLANT WELD FAILURE ORIGINATING AT SHEAR DRAG REGION. (B) FIELD WELD FAILURE INITIATION IN THE HEAT-AFFECTED ZONE.
