Next-Generation Foundations for Special Trackwork Phase III

| REPORT DOCUMENTATION PAGE | | | <i>Form Approved</i> <i>OMB No. 0704-0188</i> |
|--|--|---|--|
| 1. AGENCY USE ONLY (Leave blank) | 2. REPORT DATE May 2016 | 3. REPORT TYPE AND DATES COVERED Technical Report – December 2015 | |
| 4. TITLE AND SUBTITLE Next Generation Foundations for Special Trackwork - Phase III | | 5. FUNDING NUMBERS DTFR53-11-00008 Task Order 308 | |

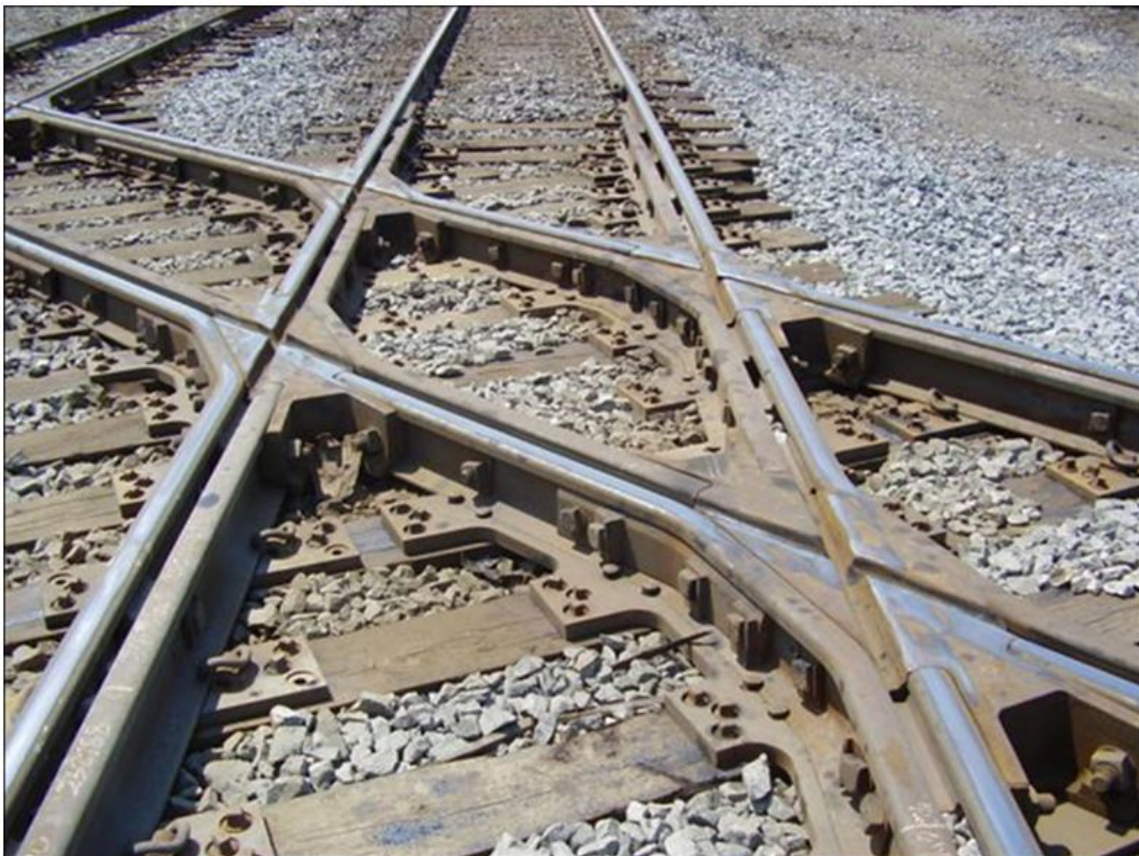
Figure 1. An Intermediate Angle Cast Crossing in Revenue Service

- The cast crossing with running rails and the flangeway cast in one piece with the crossing connected to the running rails through bolts, as Figure 1 shows, or through the leg rail and bolts as Figure 2 shows. This type of diamond is generally stiffer and has fewer parts.
- The three-rail crossing where the running rails in two lines are cut through and connected with leg rails, as Figure 3 shows. This type of diamond is easier to fabricate and does not require a casting pattern (mold). It can be made to any angle using the same basic pieces. There is a definite mainline route for this design. As Figure 3 shows, the running surfaces do not conform to the wheels on the crossing route.

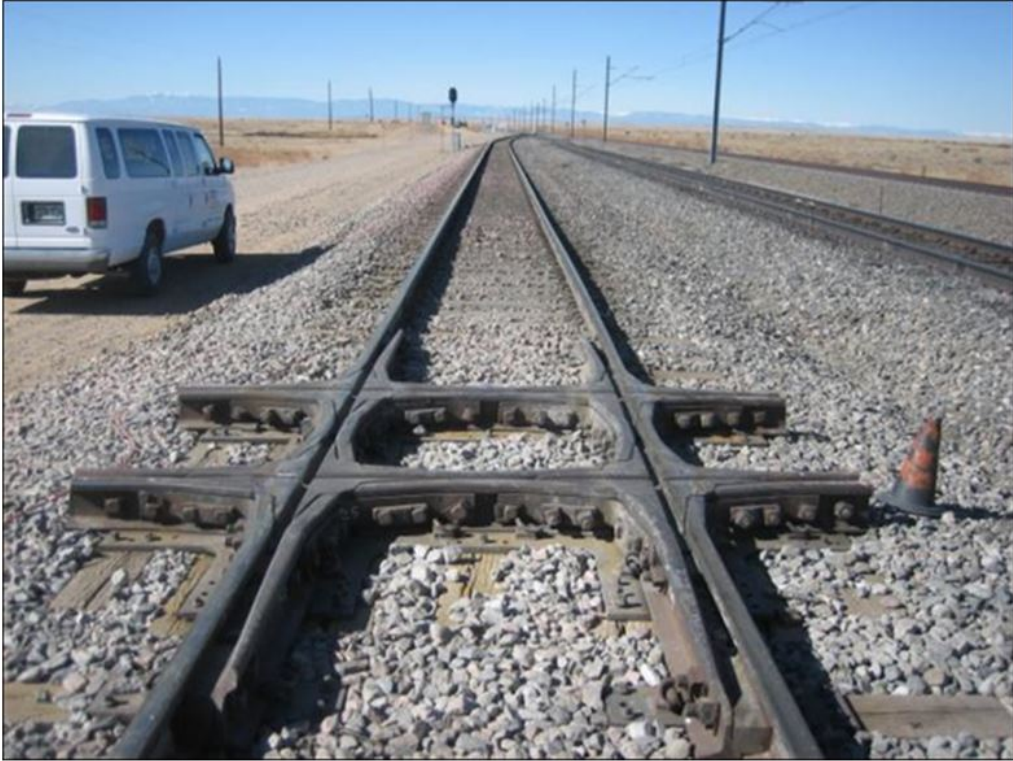
Figure 2. Cast Diamond Crossing Tested at FAST

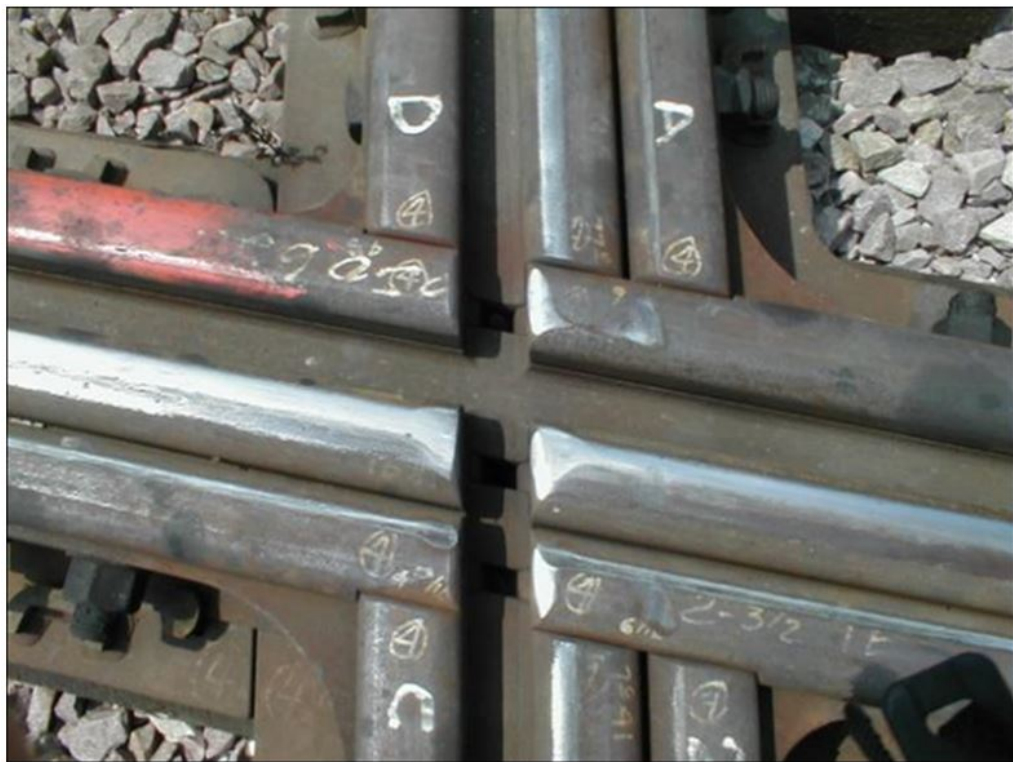
Figure 3. Three-Rail Crossing Diamond

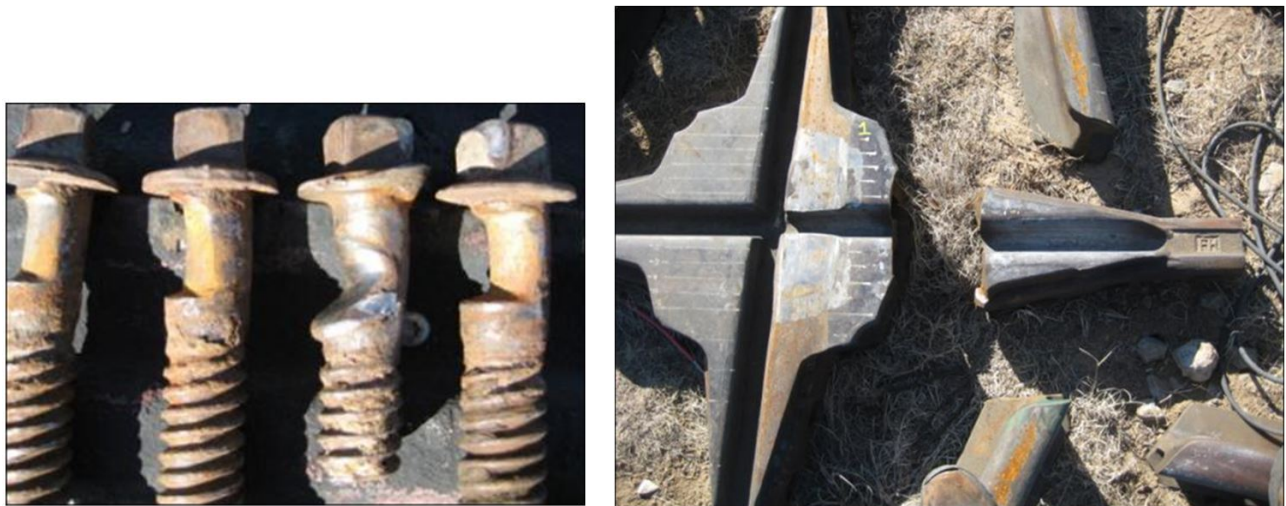
Figure 4. Components Failures in Cast Crossing

However, both testing at FAST and practice in revenue service showed that the cast flangeway wore faster than expected, and the crossing performance deteriorated quickly because of the impact. The stronger, stiffer frogs cause higher dynamic loading at the same speeds as the three-rail design crossing diamond. At FAST, the high wheel-rail impacts broke not only the fastening components and the leg rail, but also the arm of the casting itself, as Figure 4 shows.

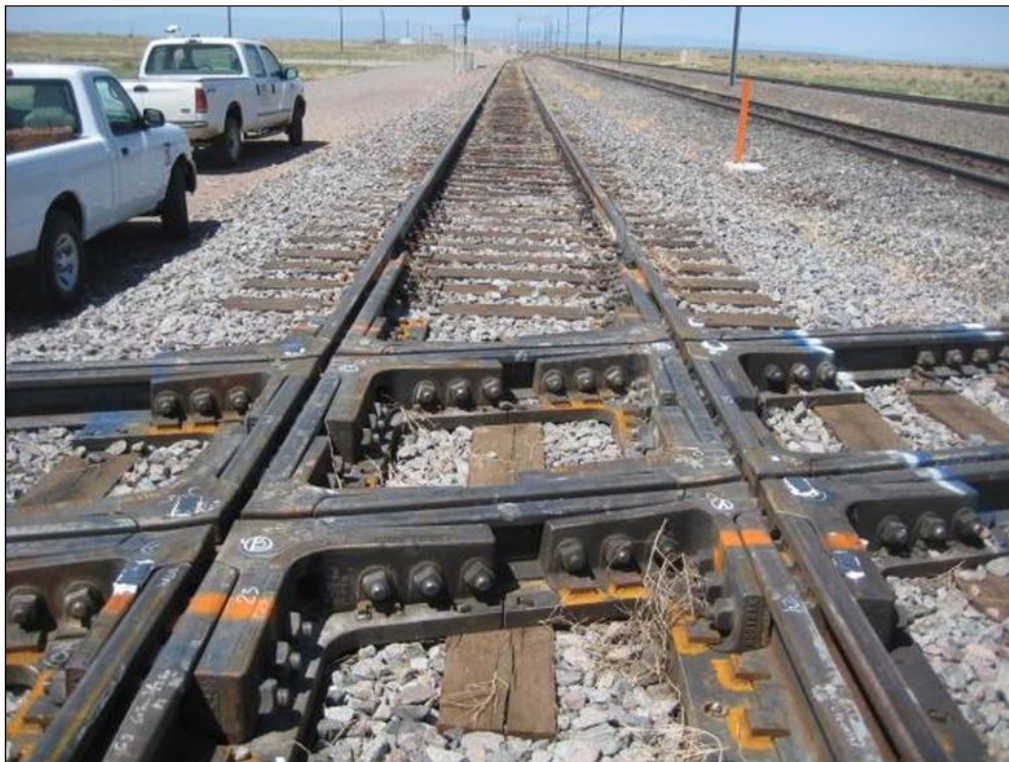
Figure 5. The test prototype crossing diamond as installed is a modified version of the basic SRR crossing diamond design

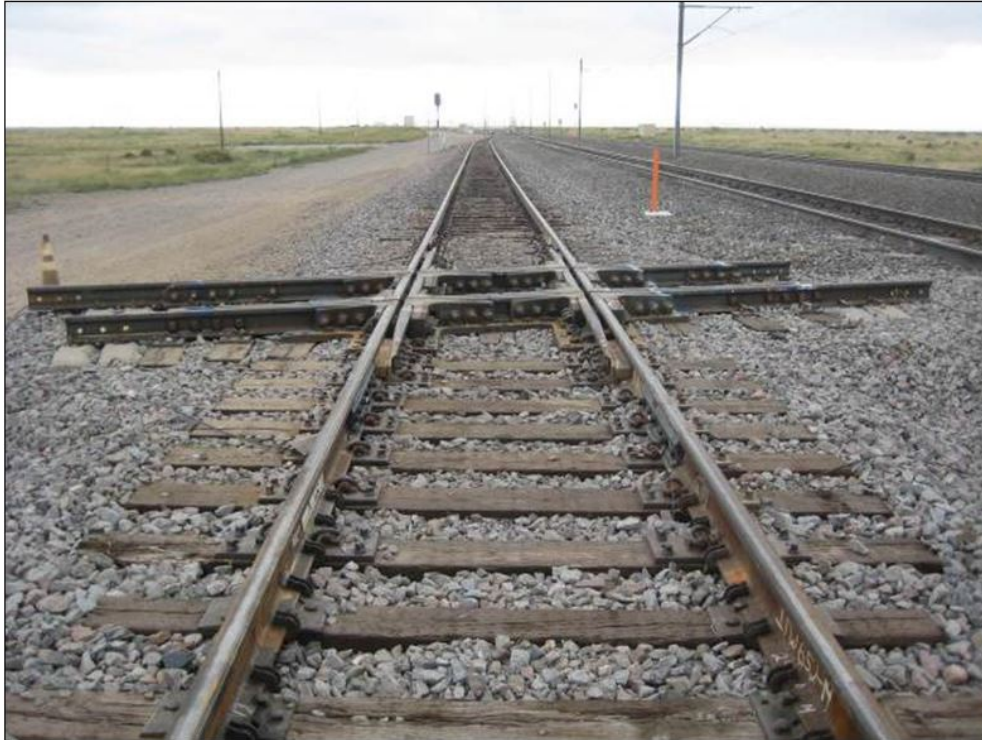
Figure 6. The crossing diamond was installed in typical HTL test configuration, where traffic runs over a single route

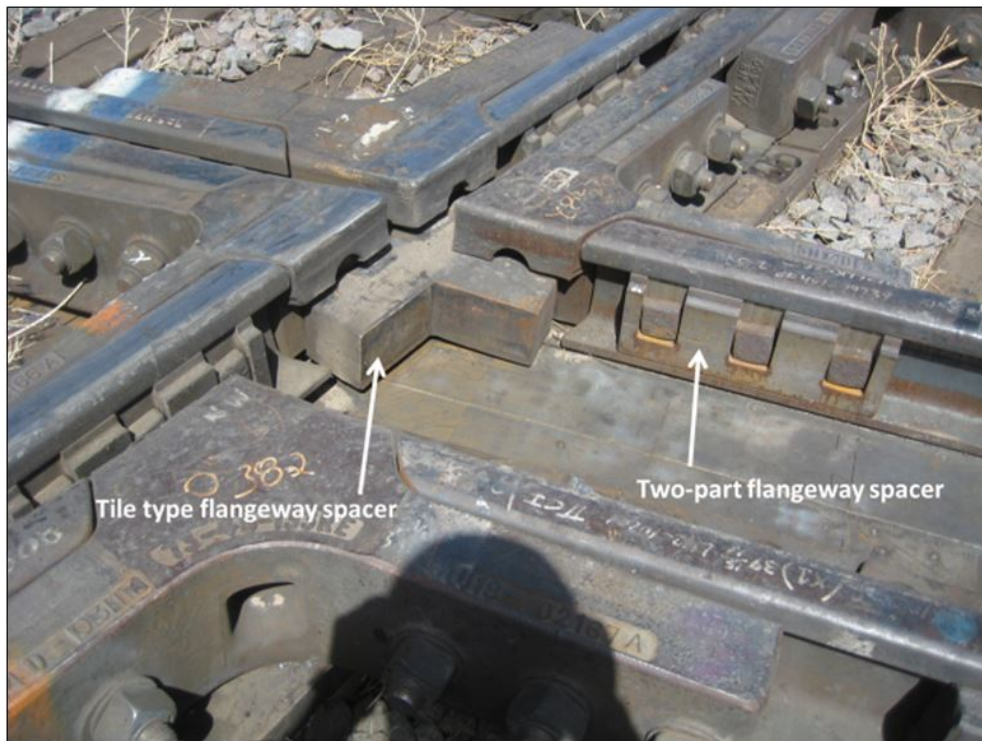
Figure 7. Tile type flangeway spacer at the casting corners and two-part (split) running rail/guardrail flangeway spacer

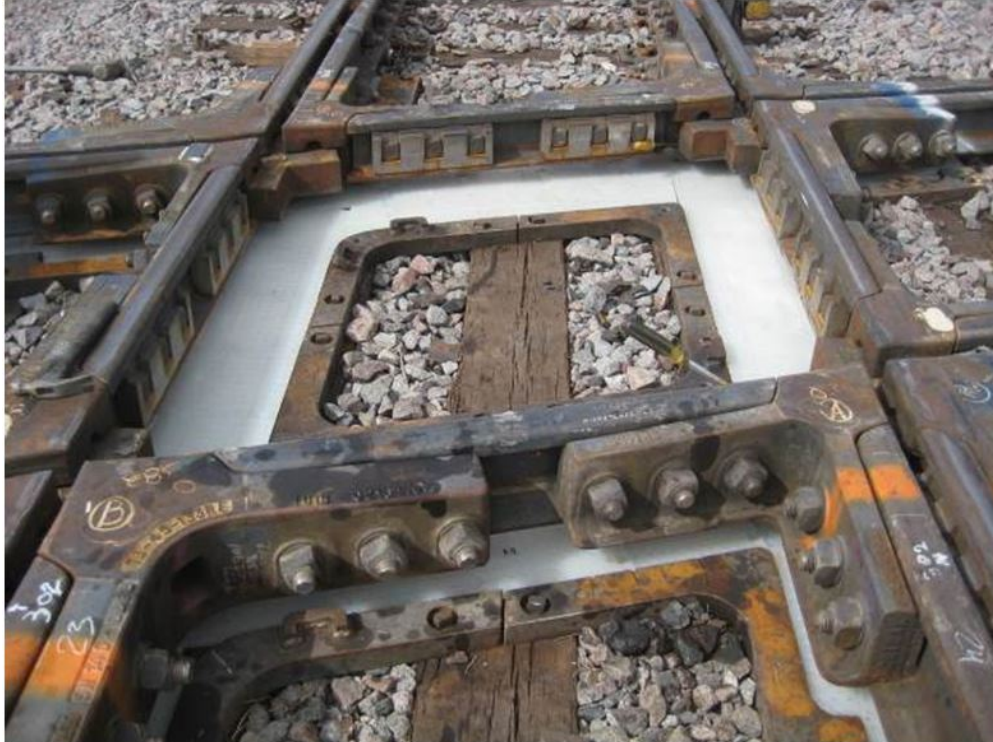
Figure 11. Nortrak-designed pad in place between the milled platework and the castings. View with the center guardrail piece removed.

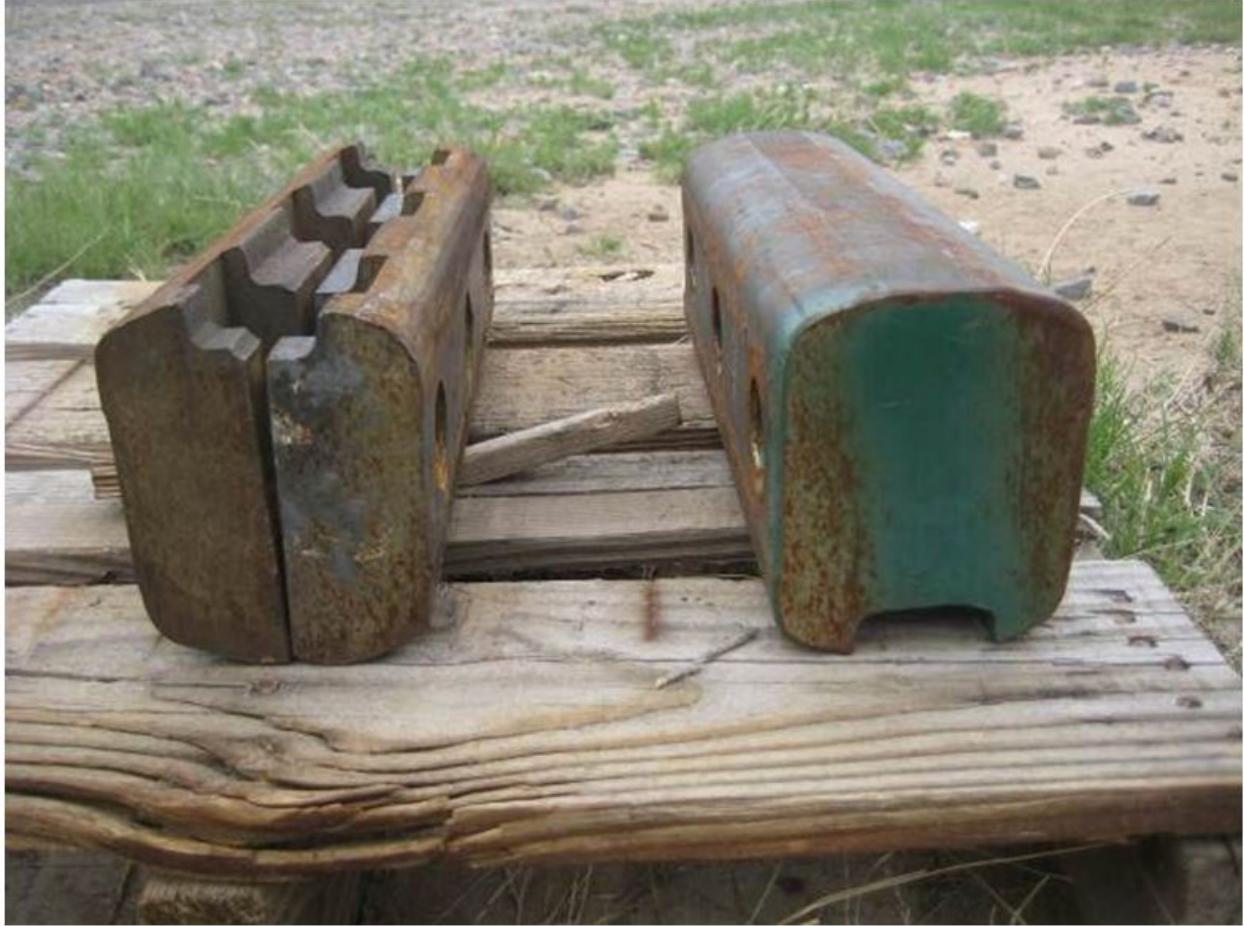
Figure 12. Split flangeway spacer on the left. Solid spacer for use with through bolts on the right (upside down in the photo)

For Test Case 3, selected split spacers were replaced with solid spacers and through bolts to evaluate the effect of reduced freedom of movement between components and reduced design flexibility on the performance of the crossing diamond. In this configuration, the common corner of the frog was isolated from the other three corners. This still allowed relative movement of the two sides of the frog on each route. But, it limited lateral and longitudinal relative movement of the frog castings. Figure 12 shows a split spacer and a solid spacer. Figure 13 shows the locations where each type of spacer was installed for Test Case 3 and kept the same through Test Case 10.

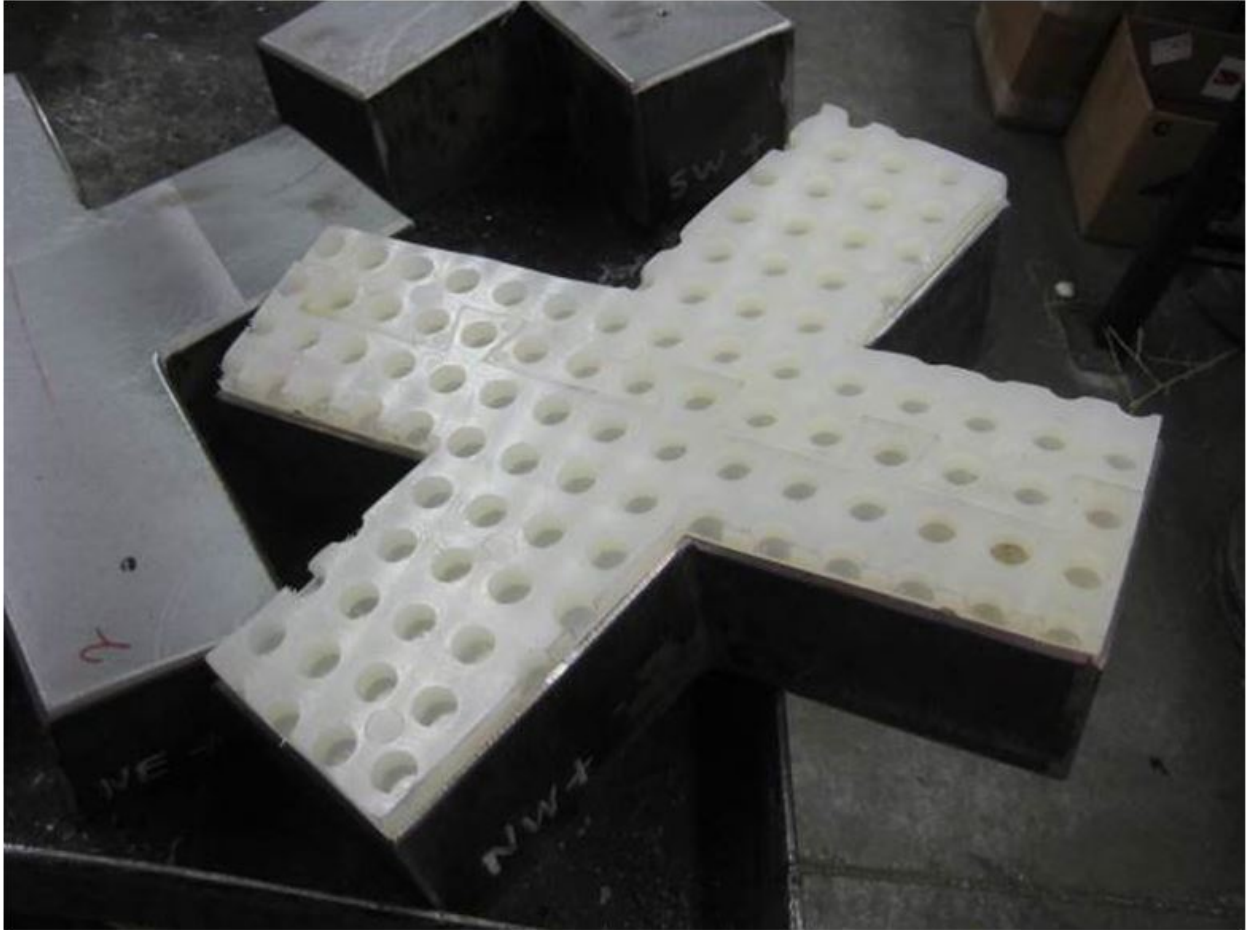
Figure 14. Nortrak pad material was cut and placed under the flangeway spacer tile to evaluate the effect of double padding

Test Case 4 was designed to evaluate the effect of doubling the Nortrak pad material directly under the flangeway spacer tile. A piece of the Nortrak pad material was cut to the shape of the tile (Figure 14) and placed above the existing full-coverage rail seat pad to evaluate the effect of double padding directly under the flangeway spacer tile.

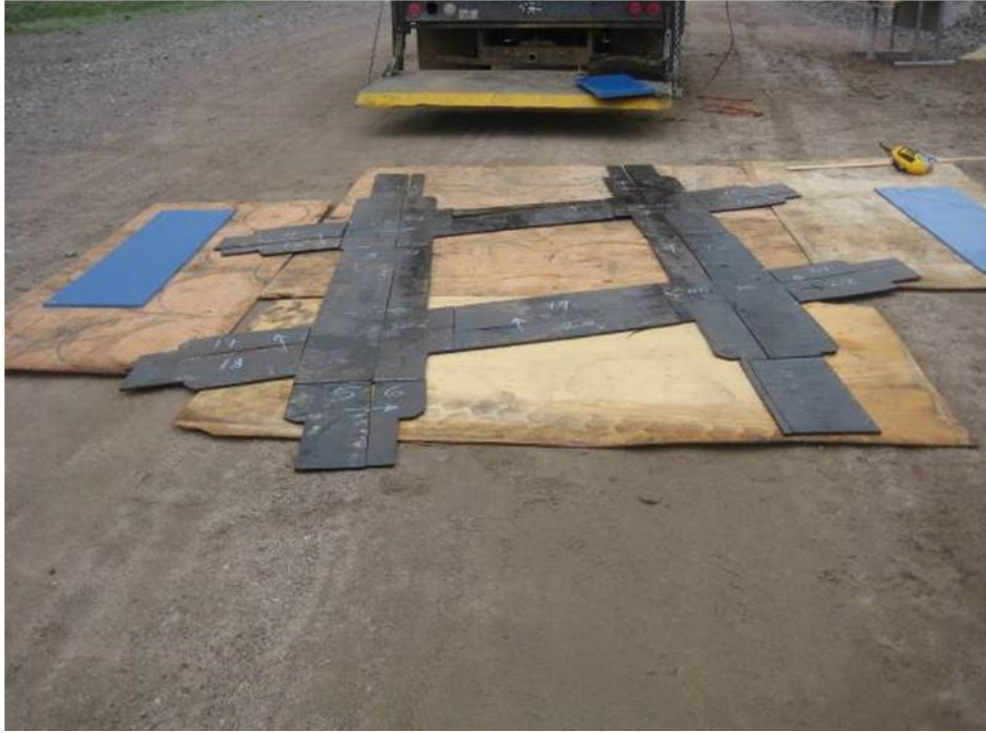
Figure 15. Getzner Type A pad intended for under-tie use was tested as a full-coverage rail seat pad

For Test Case 5, the Getzner Type A pad material is intended for under-tie use. In this case, it was used as the full-coverage rail seat pad between the platework and the castings (Figure 15). As in Test Case 4, a piece of the Getzner Type C material (Figure 16) intended for the layered tile configuration of Test Case 9 was placed above the full-coverage rail seat pad to evaluate the effect of double padding directly under the flangeway spacer tile.

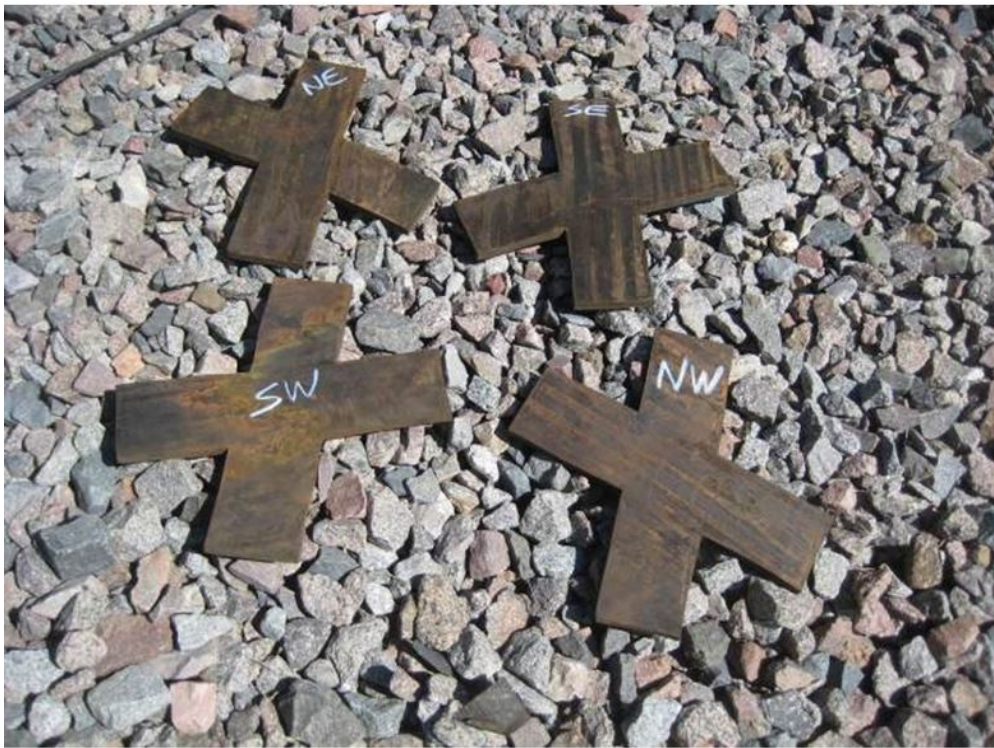
Figure 16. The Getzner Type C pad designed for the layered configuration of Test Case 9 was used to evaluate the effect of double padding under the flangeway spacer tile

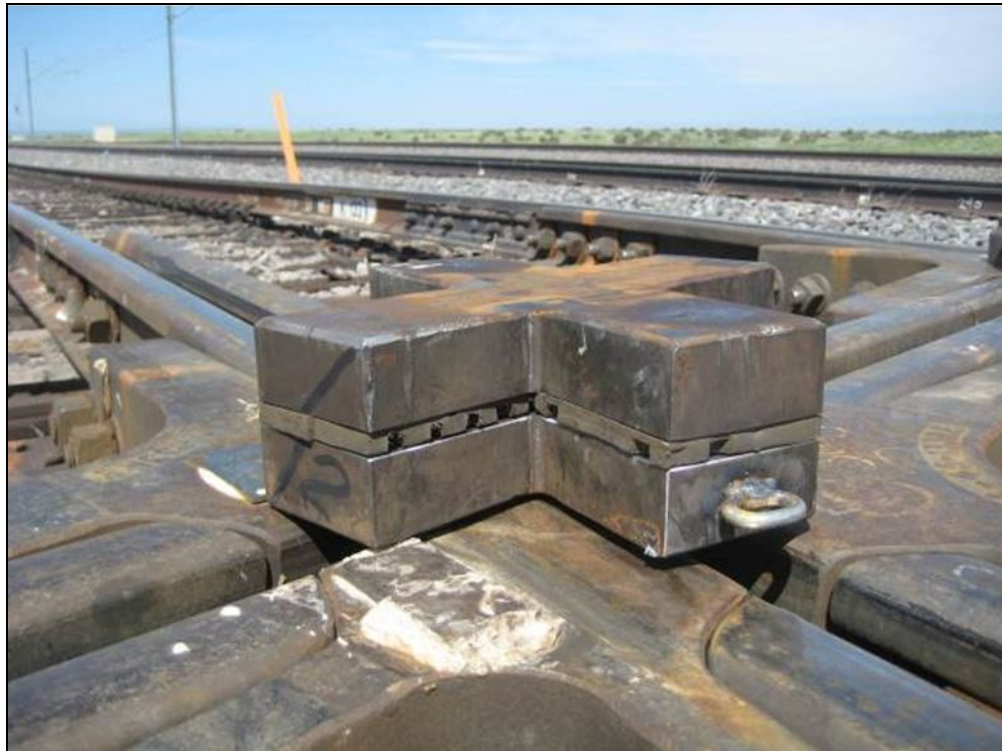
Figure 19. The steel flangeway spacer tile was cut in half and $\frac{1}{4}$ in of material was milled from each half to accommodate a layer of the $\frac{1}{2}$ -in Nortrak pad material

For Test Case 8, the full-coverage rail seat Nortrak pad tested in Test Case 4 was reinstalled and the Nortrak layered-tile configuration was introduced as a variable to determine if raising the pad material higher in the superstructure and closer to the source of impact affected the pad's performance (Figure 19).

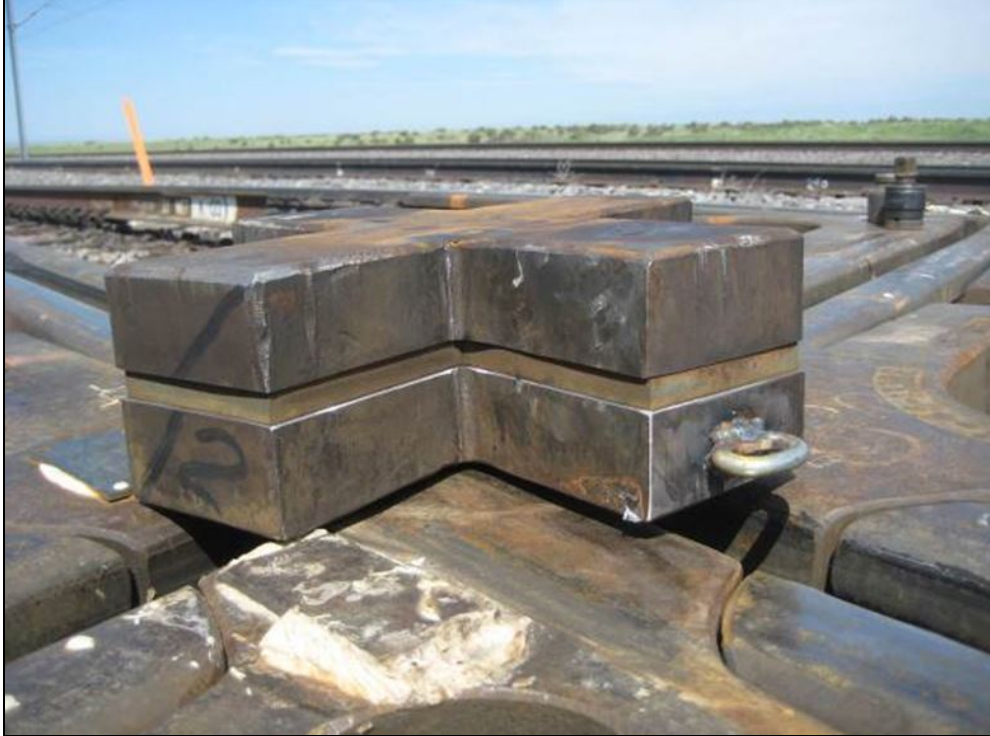
Figure 20. The steel flangeway spacer tile was cut in half and $\frac{1}{4}$ in of material was milled from each half to accommodate a layer of the $\frac{1}{2}$ -in Getzner Type C pad material

For Test Case 9, the full-coverage rail seat Getzner type B pad from Test Case 7 was reinstalled and the Getzner Type C material layered-tile configuration was introduced as a variable to determine if raising the pad material higher in the superstructure and closer to the source of impact affected its performance (Figure 20).

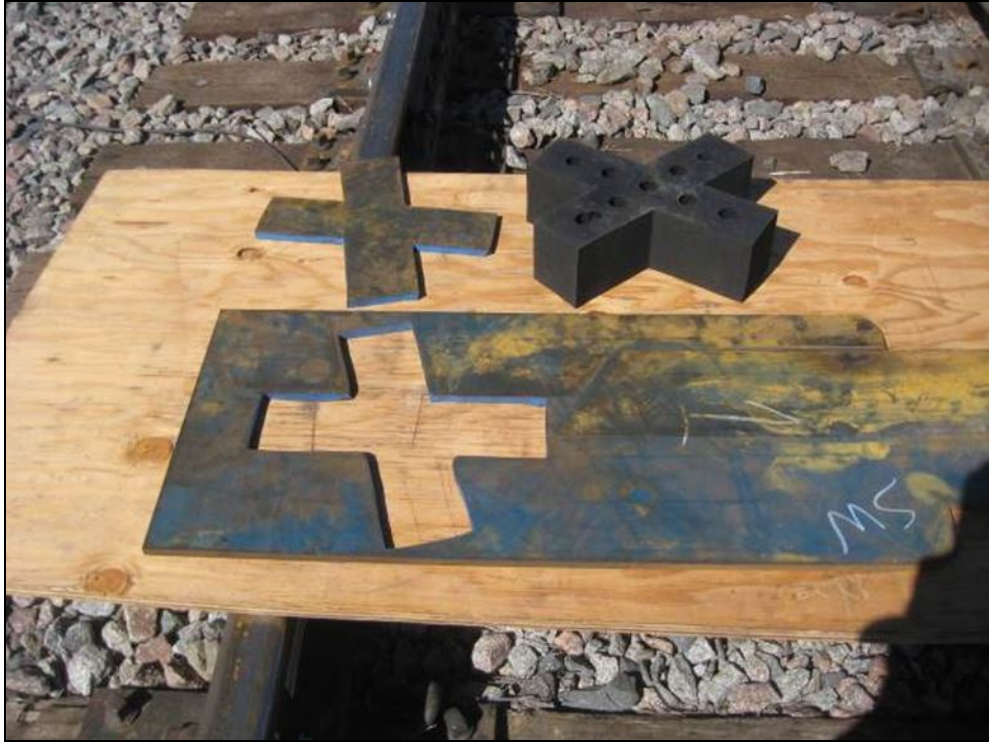
Figure 21. The solid rubber flangeway spacer tile and its shape cut out of the full-coverage rail seat section of Getzner Type B pad that fits directly under the tile

The rest of the crossing diamond remained on the full-coverage rail seat Getzner Type B pad, but the shape of the tile was cut out in order to place the rubber tile directly on the platework, as Figures 21, 22, and 23 show.

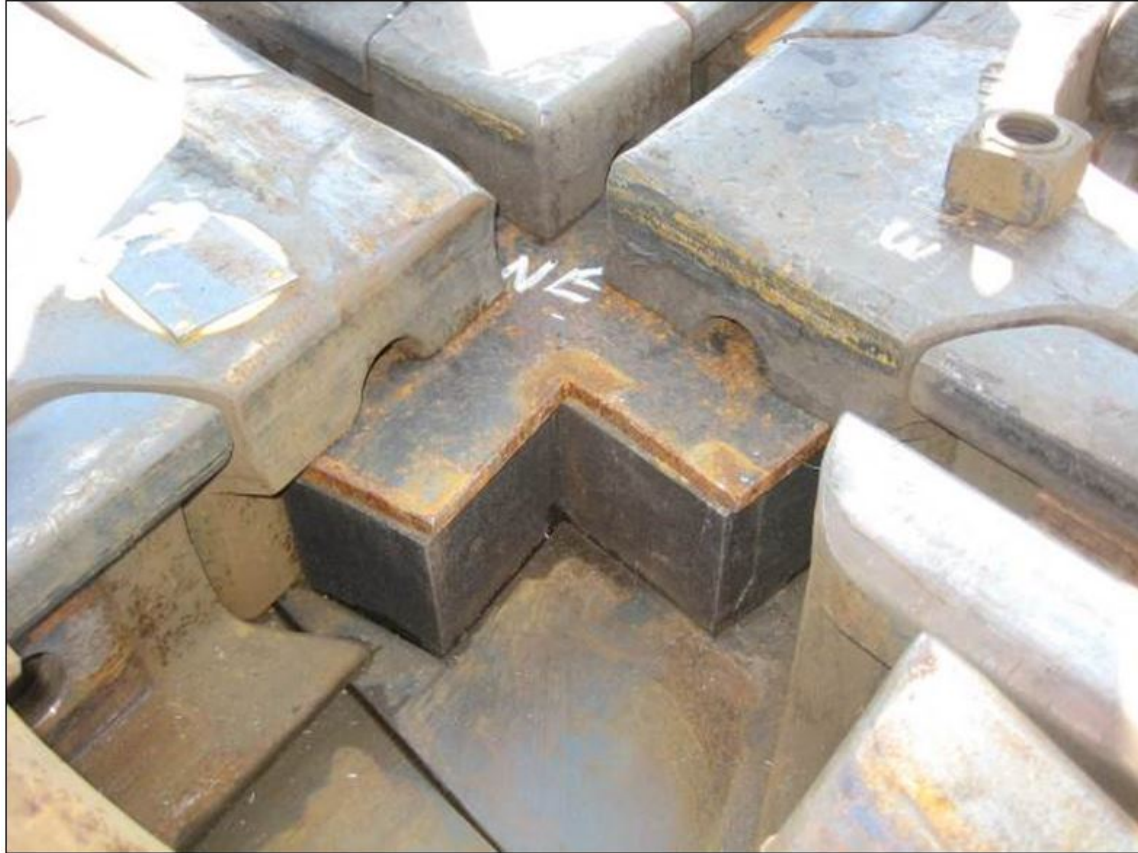
Figure 23. The solid rubber flangeway spacer tile embedded in the Getzner Type B full-coverage rail seat pad resting directly on the platework. The strike plate between the rubber tile and the bottom of the casting corners was designed to protect the rubber.

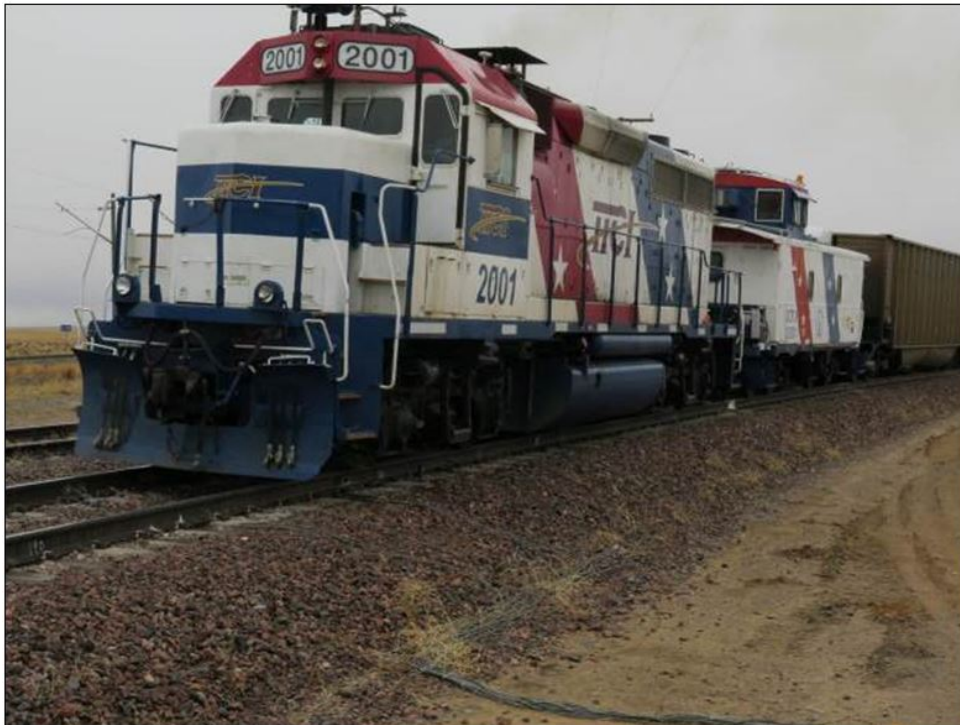
Figure 24. IWS test consist on the HTL approaching the crossing diamond in a CCW run

TTCI's two instrumented wheelsets (IWS) were installed on the leading truck of a loaded (315,000-pound GRL) high sided gondola car. This car was one of four loaded cars, along with the data collection caboose and locomotive, that made up the test train shown in Figure 24. The IWS data provided the vertical and lateral load conditions over the crossing diamond. This data was used to determine the effect that the changing variables of each test case had on the load environment.

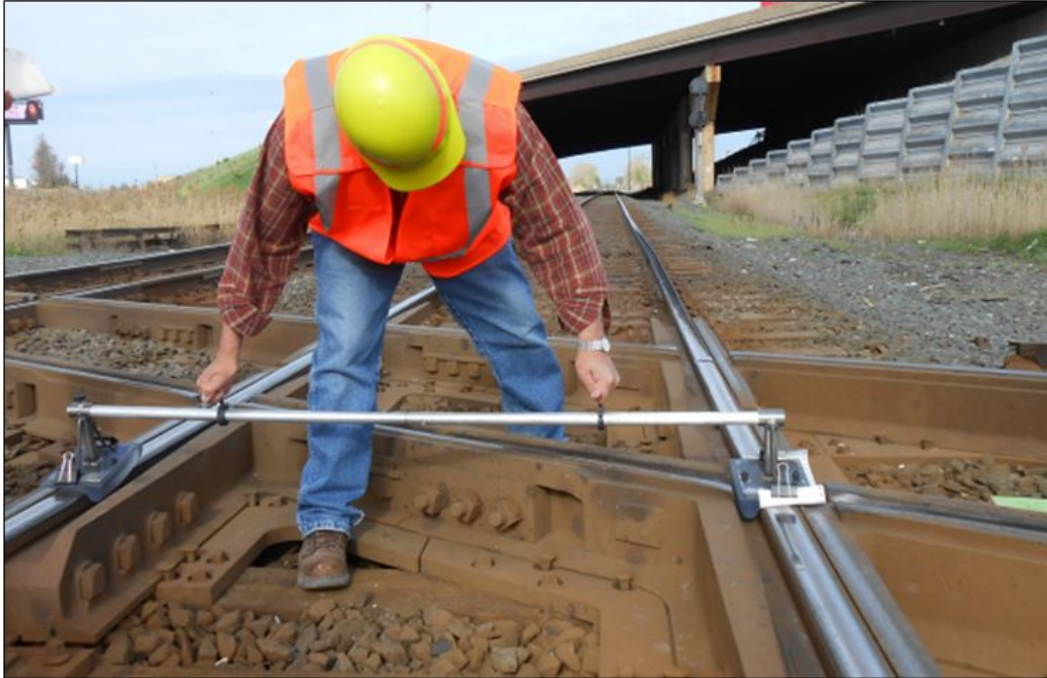
Figure 30. TTCI's prototype Effective Flangeway Gap and Wheel Drop gage in wheel gap measurement mode at a revenue service crossing diamond

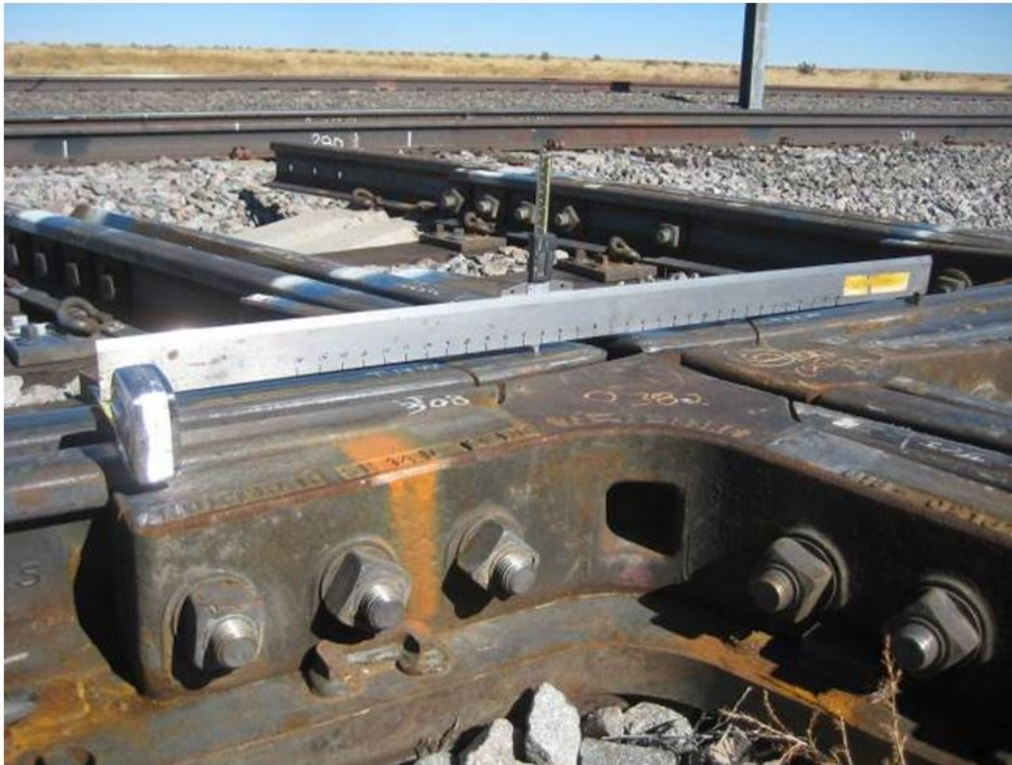
Figure 32. Longitudinal profile measurements at 1-in intervals across the casting corners using a steel straightedge and digital depth gage

The longitudinal profile along the running surface, across the casting corners, was measured at 1-in intervals to document changes early in the test. These static, unloaded measurements were taken with a straightedge to span the flangeway gap and a digital depth gage to measure down to the running surface (Figure 32).

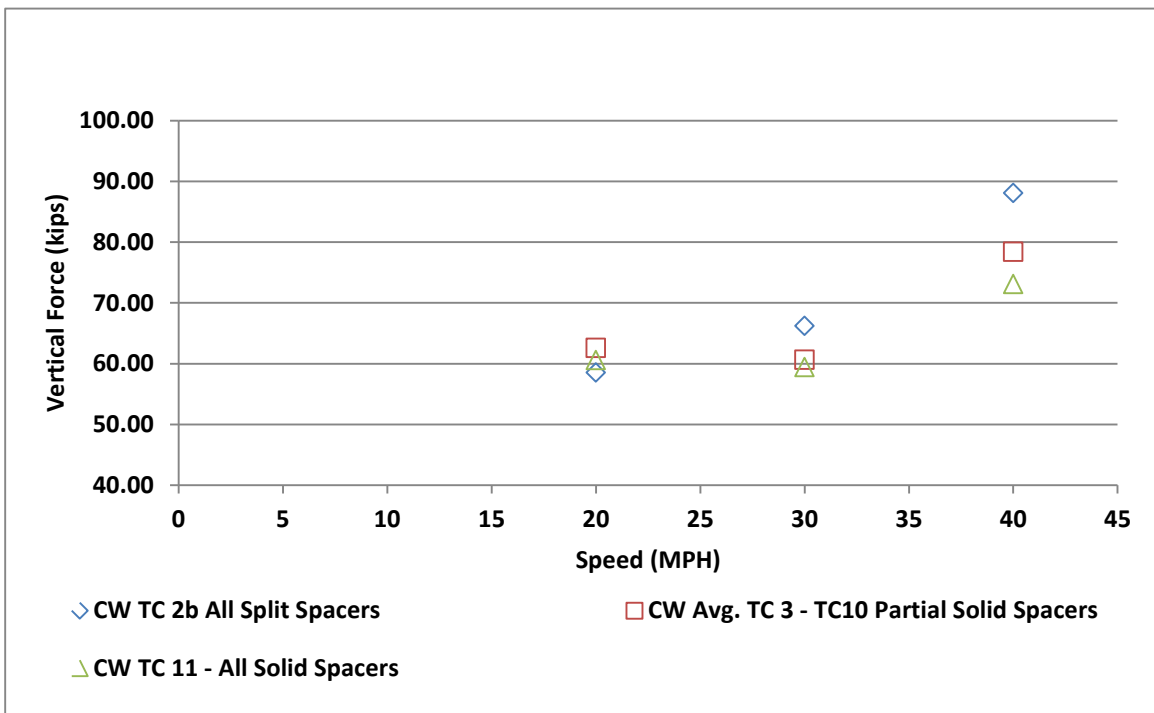
Figure 35. Maximum vertical wheel force during test cases of different design flexibility, CW traffic

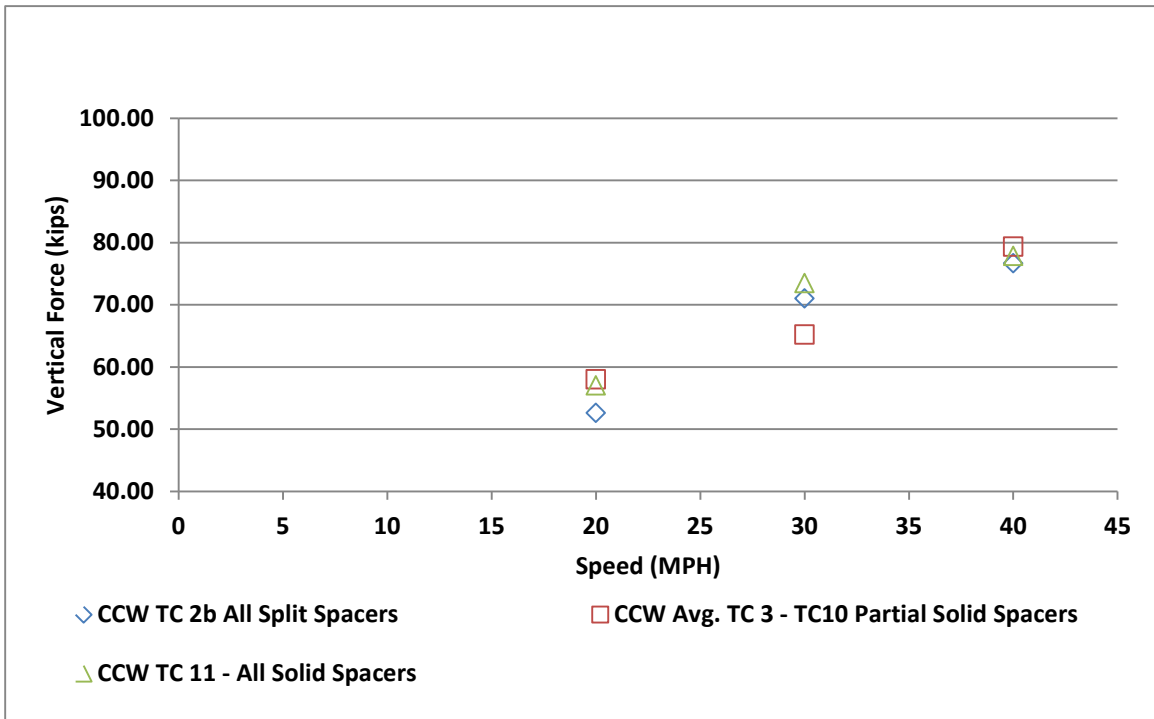
Figure 36. Maximum vertical wheel force during test cases of different design flexibility, CCW traffic

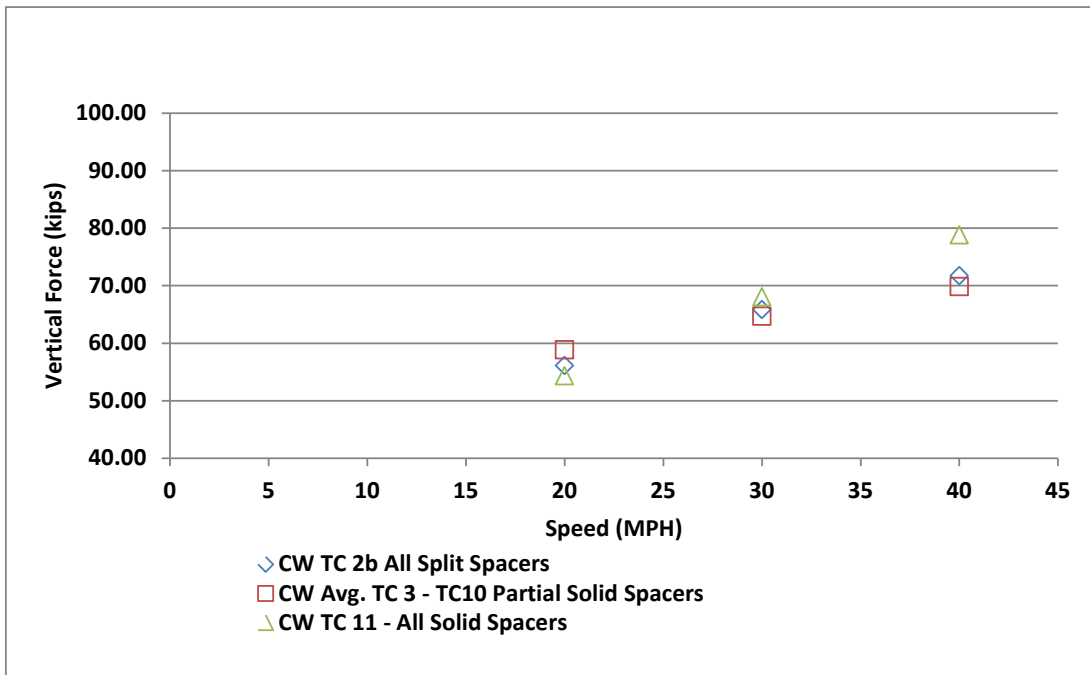
Figure 39. Maximum vertical wheel force during test cases of different design flexibility, CW traffic

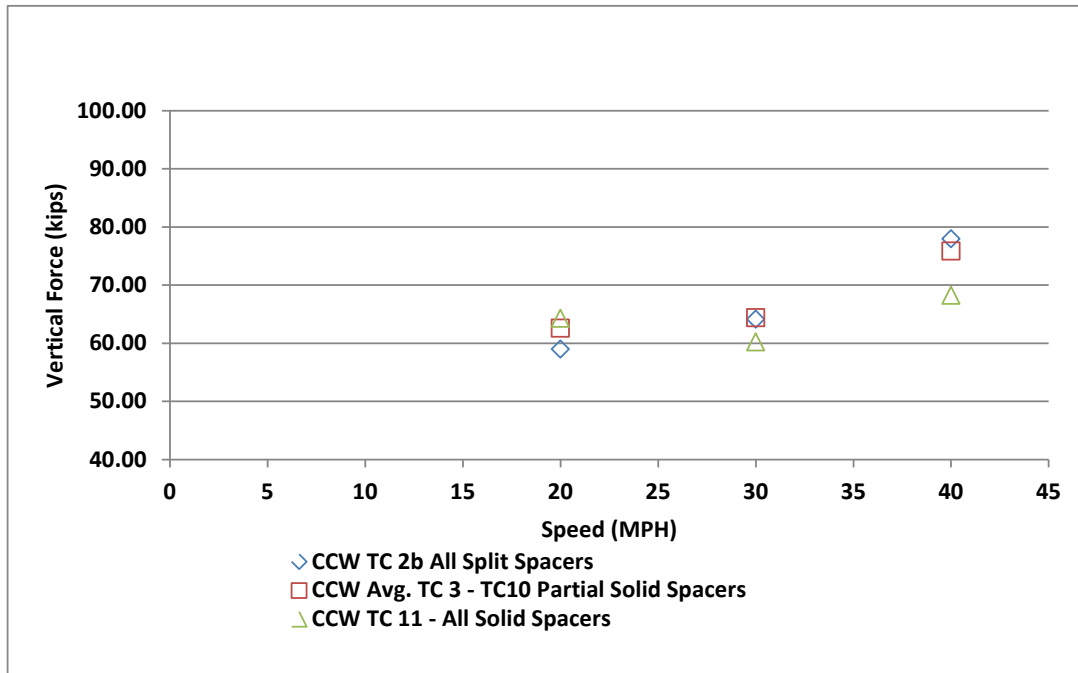
Figure 40. Maximum vertical wheel force during test cases of different design flexibility, CCW traffic

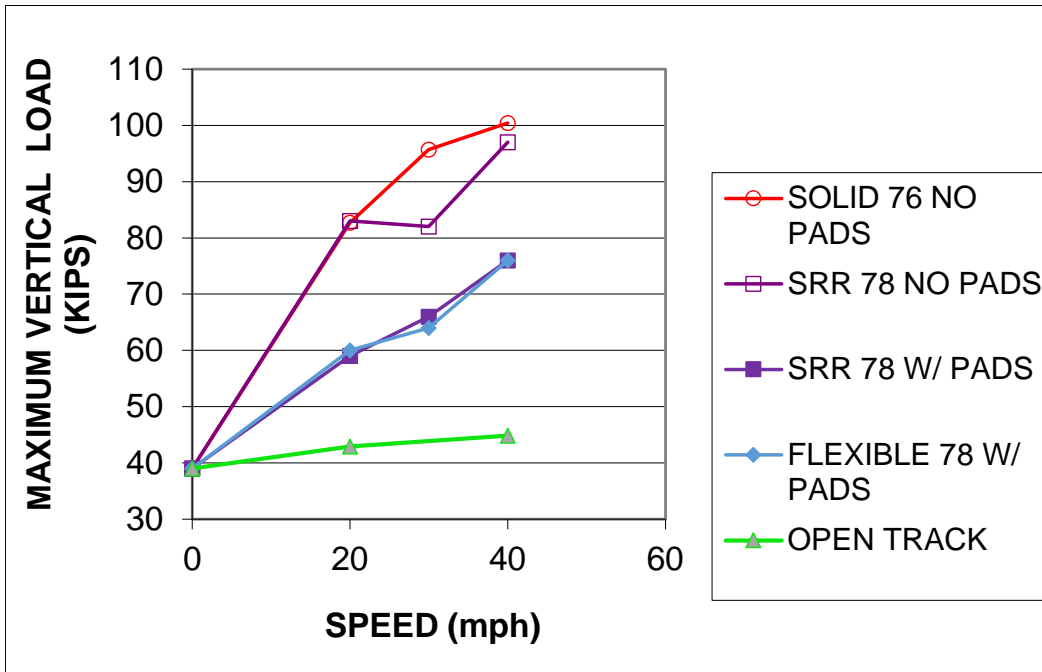
Figure 44. Maximum vertical wheel load vs. speed for various crossing diamonds foundations evaluated at FAST

Additional tests evaluated two configurations of flexible frog by using four or two split flangeway spacers per frog (i.e., all four frog corners can move vertically relative to the others versus only the common corner can move relative to the other three). Figure 45 shows 99th percentile vertical forces over the crossing diamond. A better comparison can be made using 99th percentile forces instead of maximum forces. The reduced freedom between the four frog castings resulted in less alignment degradation and maintenance. Figure 45 shows there was some small benefit of either flexible frog configuration at 20 and 30 mph, but no reduction in vertical forces at 40 mph. Also note that there was almost no performance difference between the full flexible frog and the easier-to-maintain partial split spacer flexible frog.

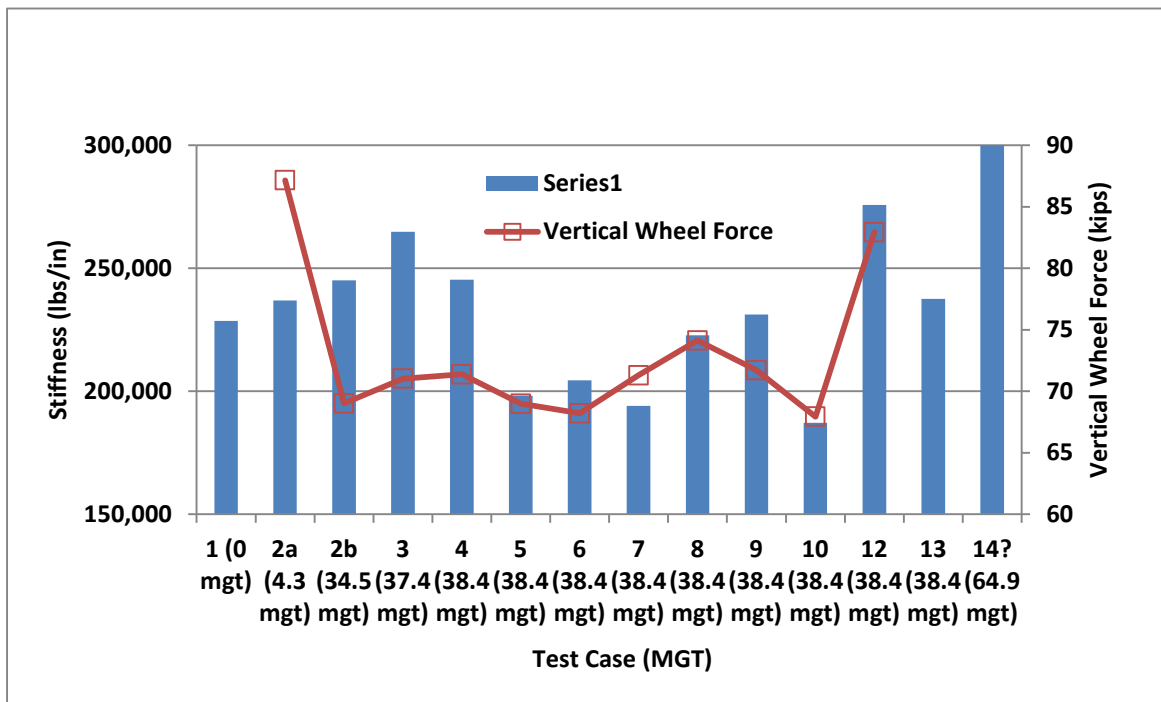
Figure 51. Relationship between vertical stiffness (bars) and vertical force for each test case

- The lowest stiffness recorded occurred under the conditions of Test Cases 5, 6, 7, and 10, when Getzner pads were in place for full coverage in the rail seat area. During Test Cases 5 and 7, Getzner pads were inserted under the flangeway spacer tile for the double-deep pad evaluation. During Test Case 10, a solid rubber spacer tile replaced the steel tile.

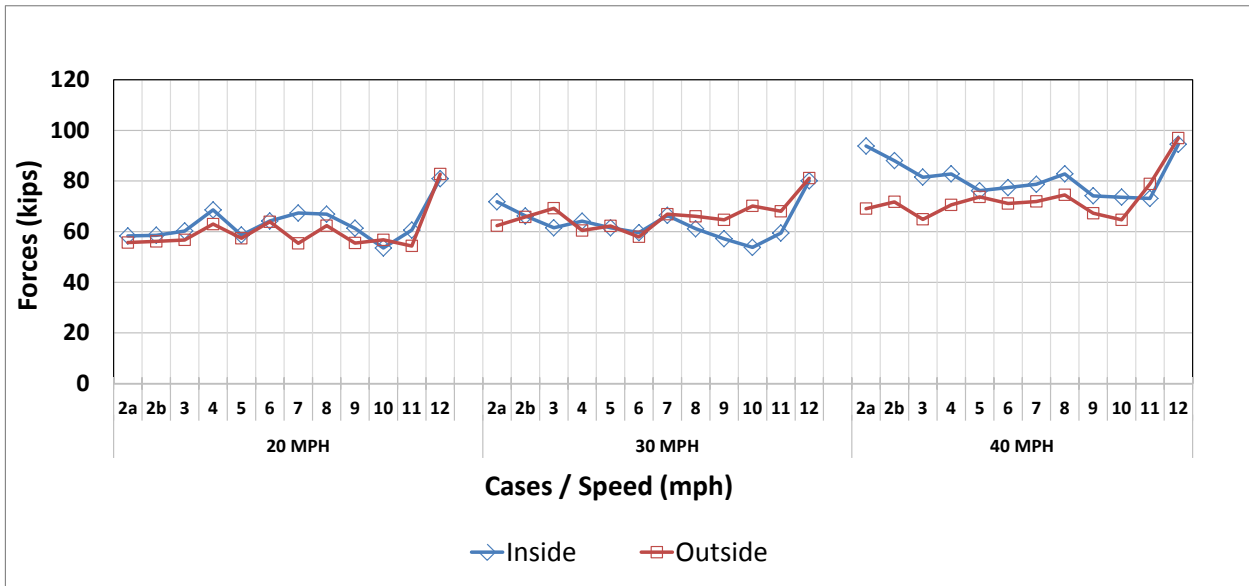
Figure 52. Maximum vertical wheel forces during all the test cases for CW train operation
