Next-Generation Foundations for Special Trackwork Phase III

| REPORT DOCUMENTATION PAGE | | | <i>Form Approved</i> <i>OMB No. 0704-0188</i> |
|--|--|---|--|
| 1. AGENCY USE ONLY (Leave blank) | 2. REPORT DATE May 2016 | 3. REPORT TYPE AND DATES COVERED Technical Report – December 2015 | |
| 4. TITLE AND SUBTITLE Next Generation Foundations for Special Trackwork - Phase III | | 5. FUNDING NUMBERS DTFR53-11-00008 Task Order 308 | |

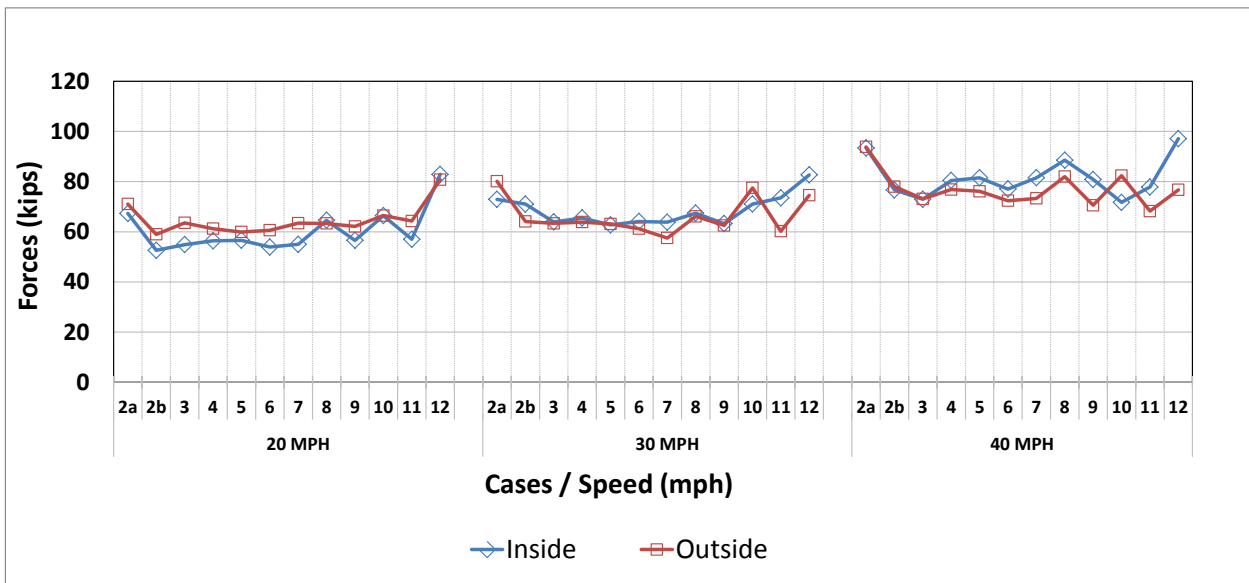
Figure 53. Maximum vertical wheel forces during all the test cases for CCW train operation

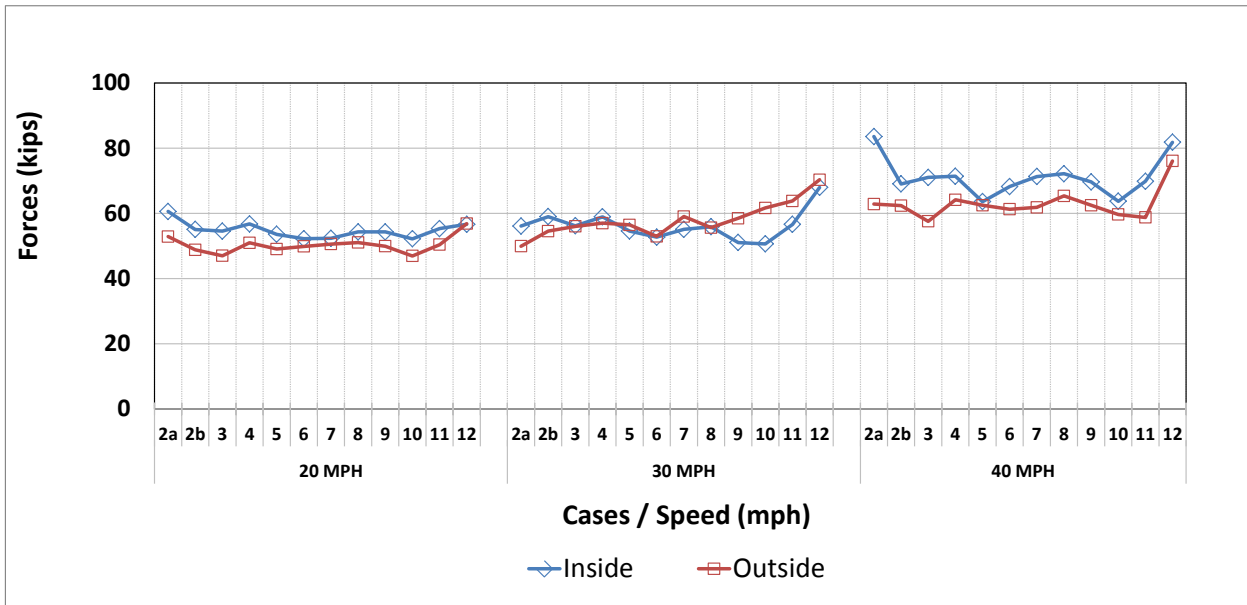
Figure 54. Ninety-ninth percentile vertical wheel forces during all the test cases for CW train operation

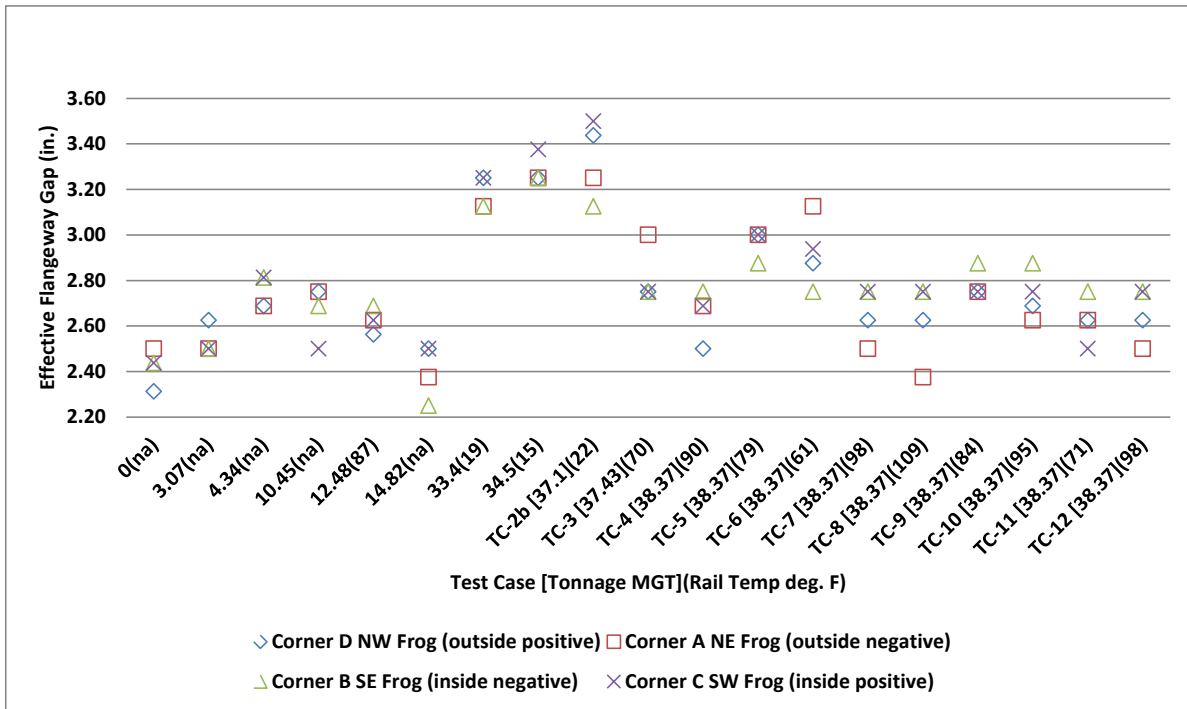
Figure 68. Effective Flangeway Gap measured over a wide range of rail temperatures

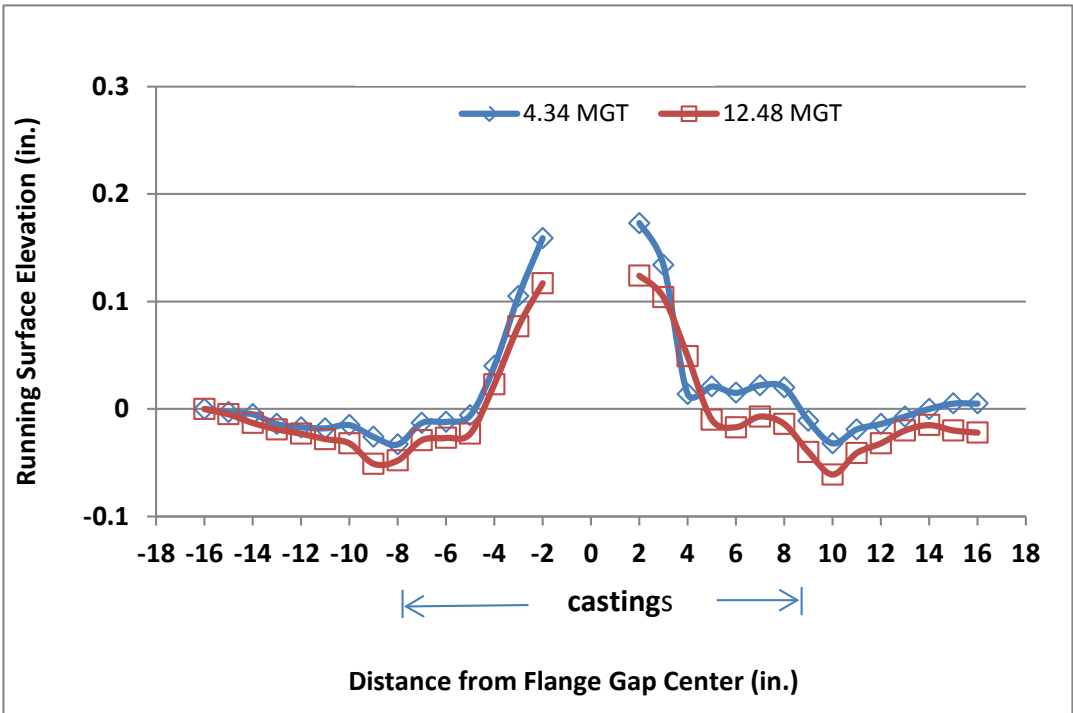
Figure 76. Longitudinal profile over the southwest frog

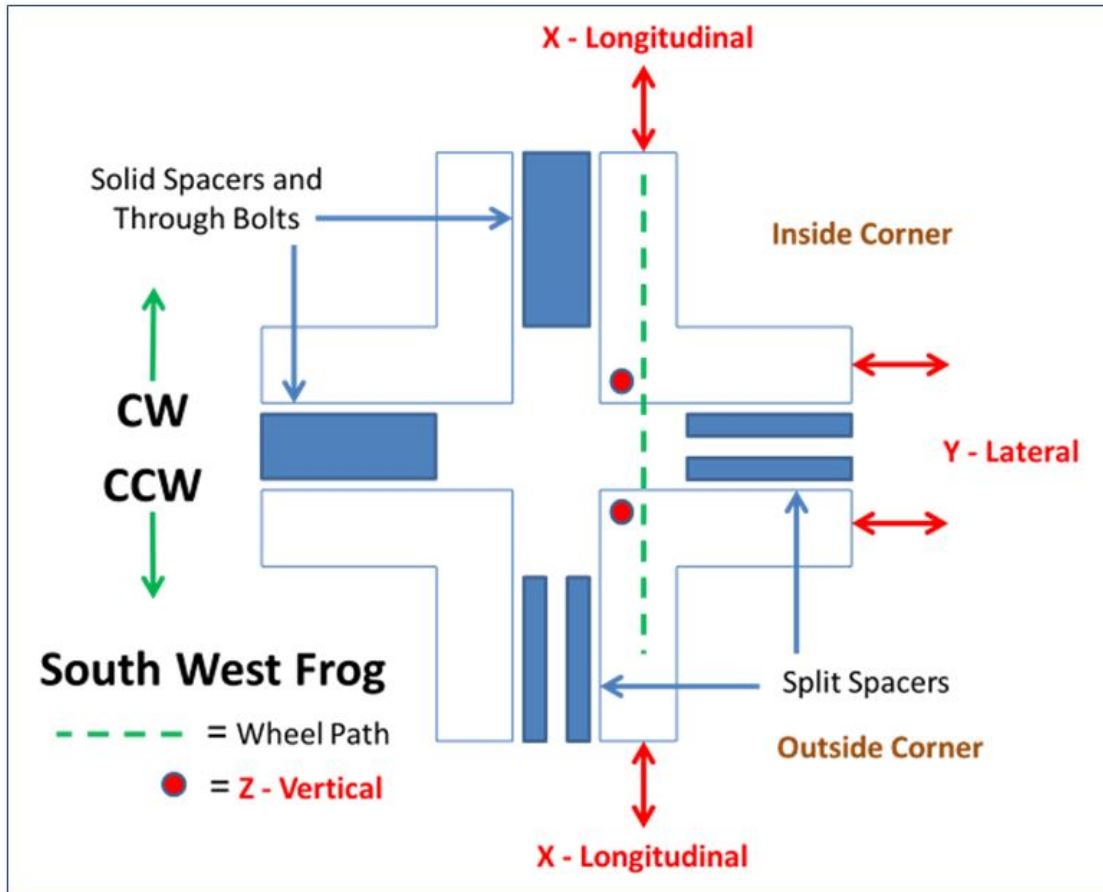
Figure 81. The inside and outside casting corners of the southwest frog were measured for longitudinal, lateral, and vertical displacement under traffic during each test case. The hybrid split spacer/solid spacer configuration shown was in place during Test Cases 3–10. All split spacers were in place during Test Cases 2a and 2b and all solid spacers were installed for Test Cases 11–13.

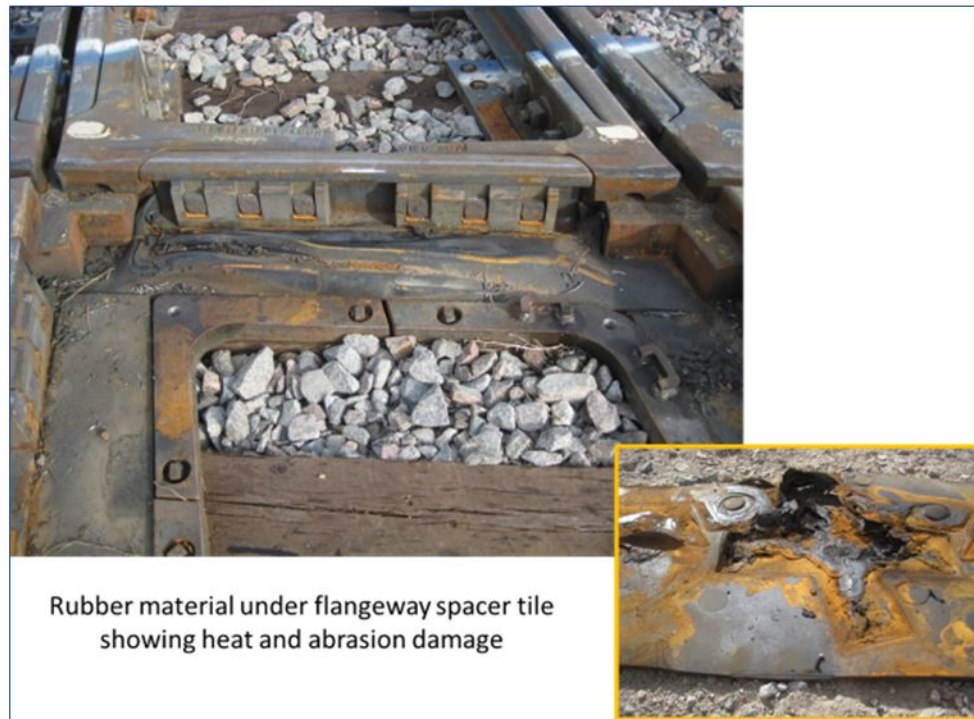
Figure 93. The full-coverage rubber pad failed to resist heat and abrasion between components. Removed after 102 laps of the HAL train

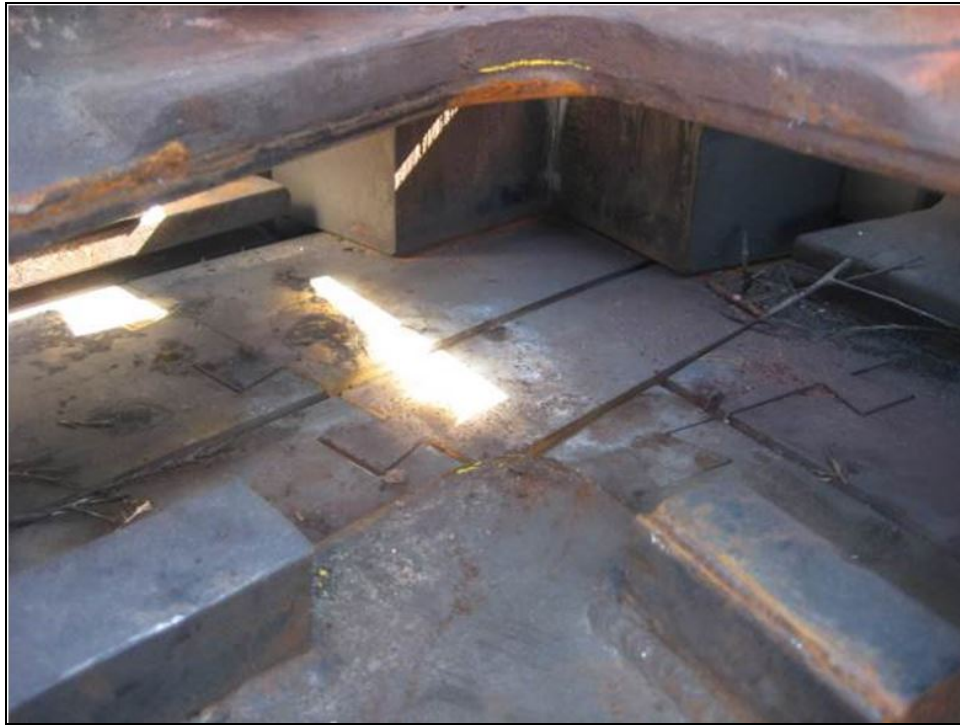
Figure 94. Nortrak pad material in good condition after 35 MGT

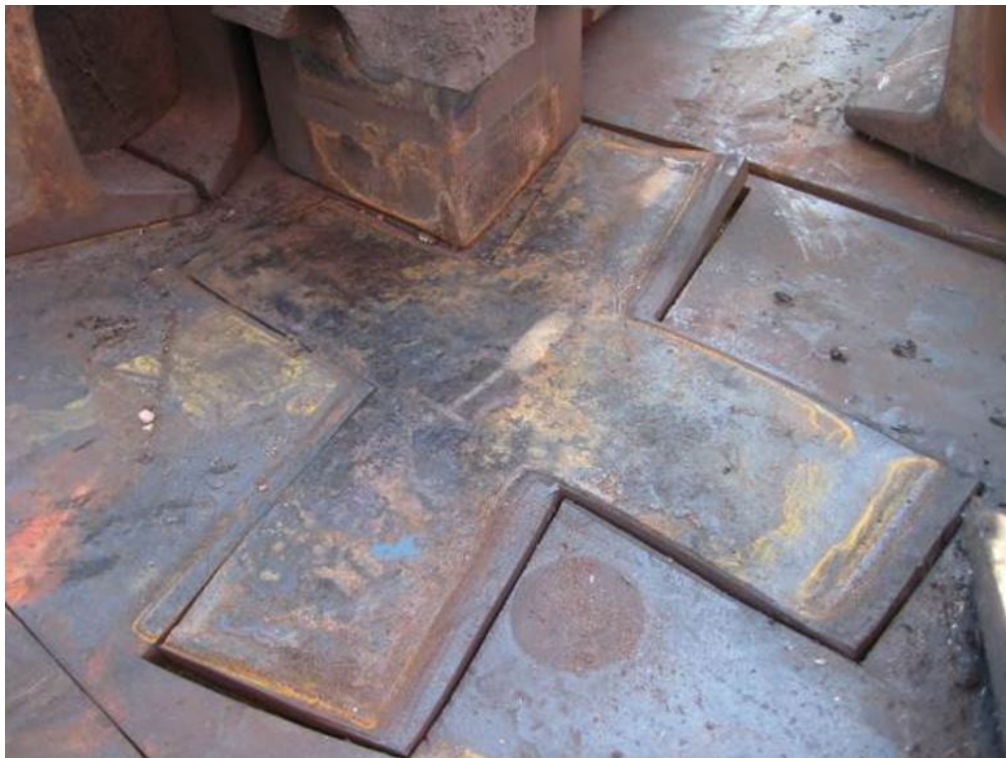
Figure 96. Getzner Type B full-coverage pad with separate under-tile piece performing well after 27 MGT

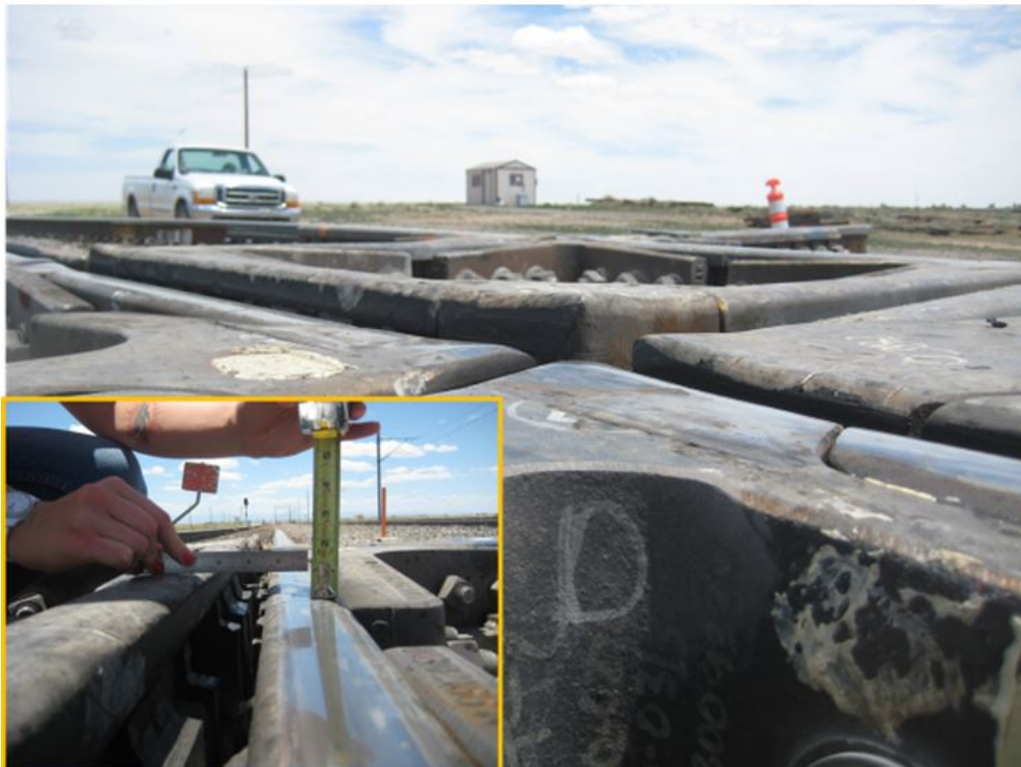
Figure 97. Differential elevation between the guardrail (left) and the running rail (right), about 1 in

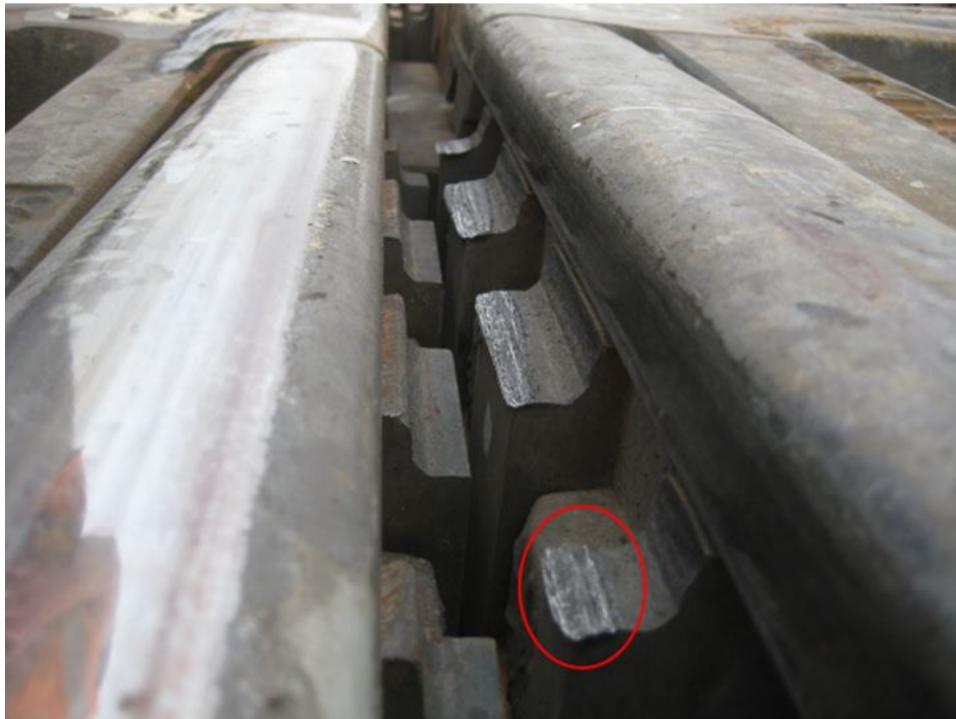
Figure 99. Wheel flange marks on the split spacer fastened to the rising guardrail

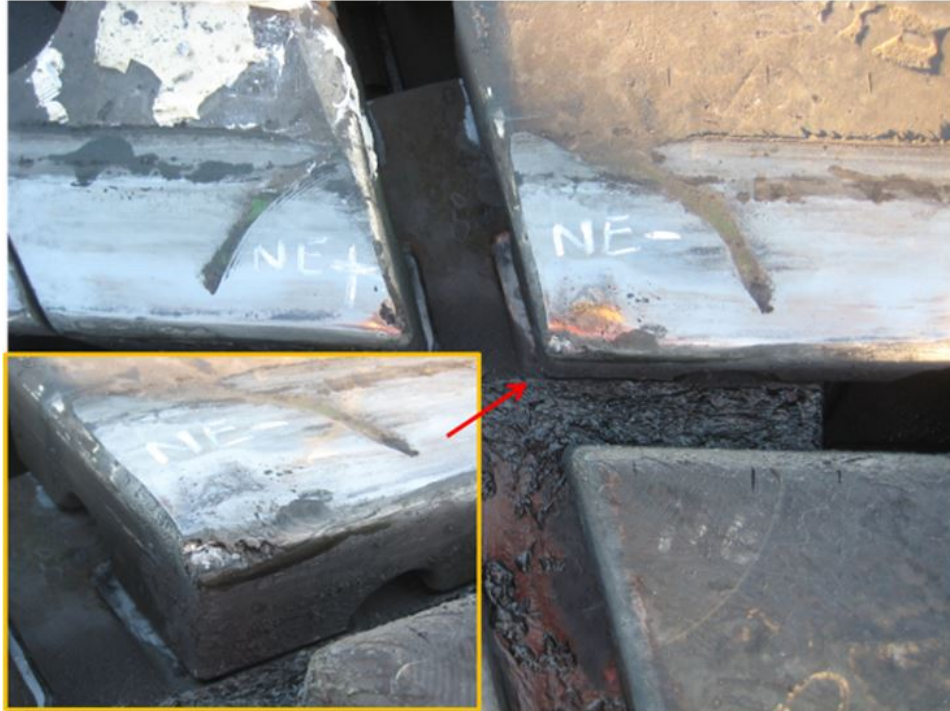
Figure 101. Casting corners were ground as required to remove metal flow

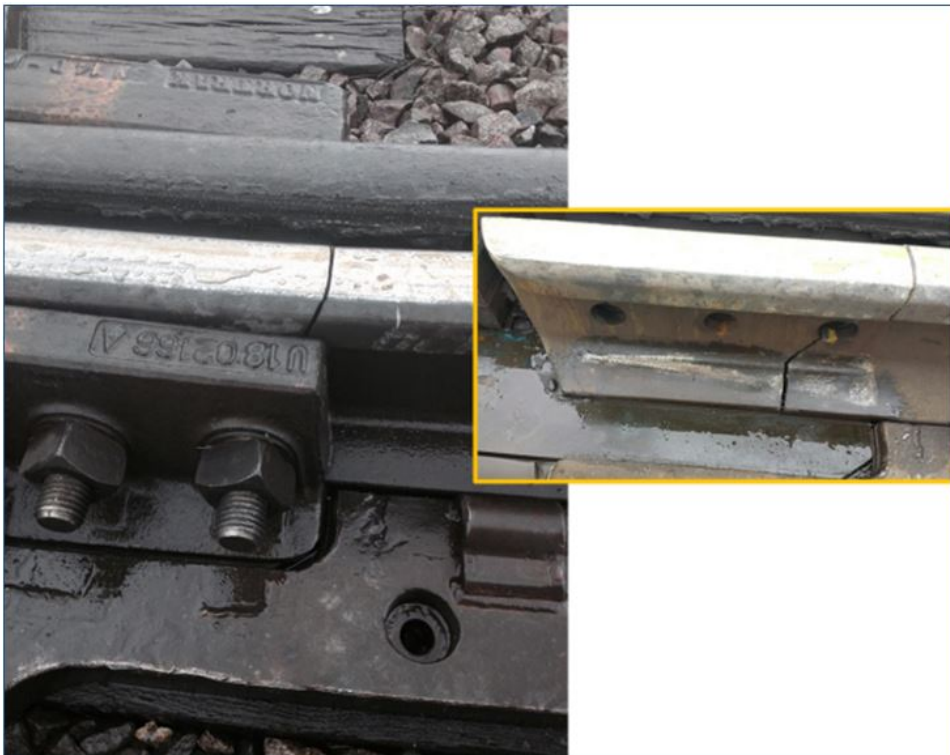
Figure 102. The leg rail on the northwest frog broke after 59 MGT

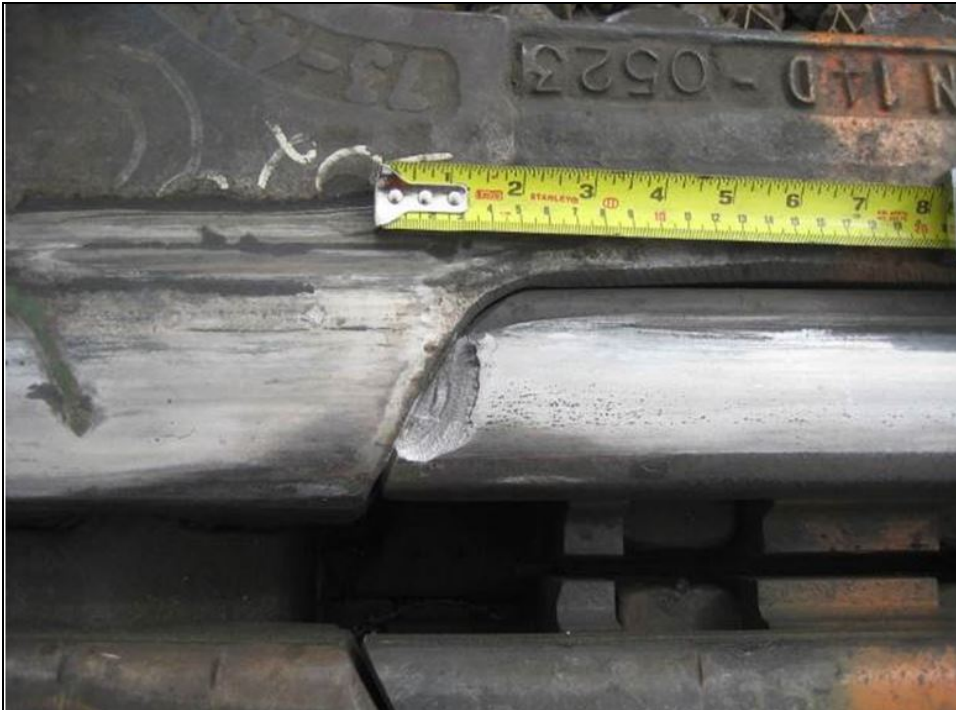
Figure 104. Chipped leg rail at the southwest frog was slotted

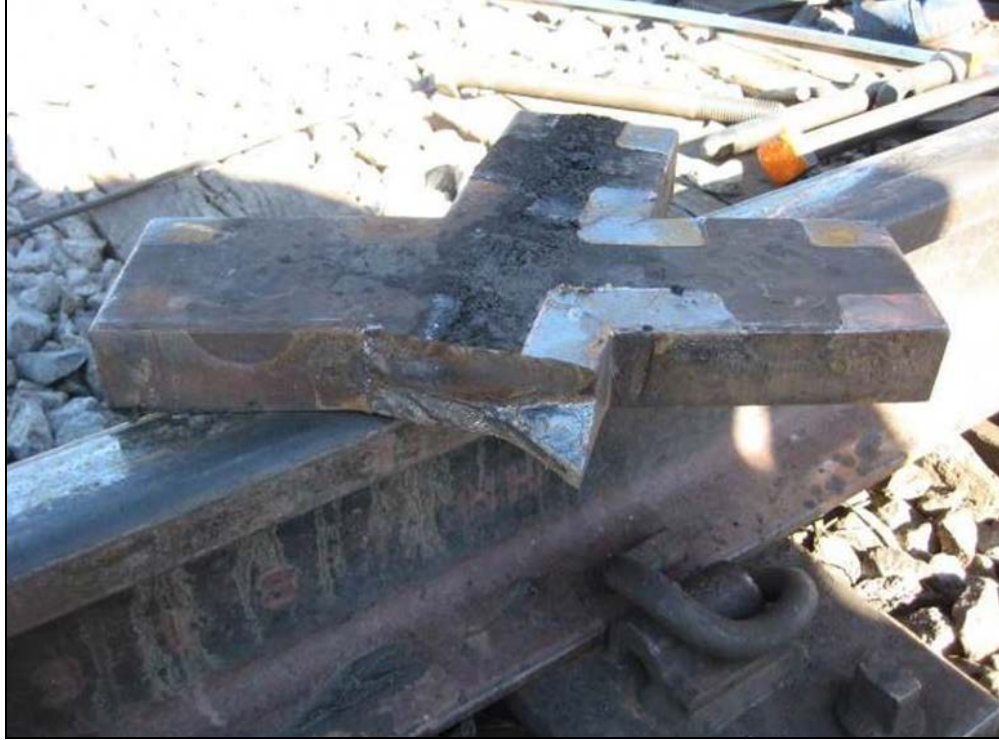
Figure 105. The top half of a layered flangeway spacer tile broke and was replaced
