REPORT NO. DOT-TSC-UMTA-74-1,I

MBTA GREEN LINE TESTS
RIVERSIDE LINE
DECEMBER 1972

VOLUME I
TEST DESCRIPTION

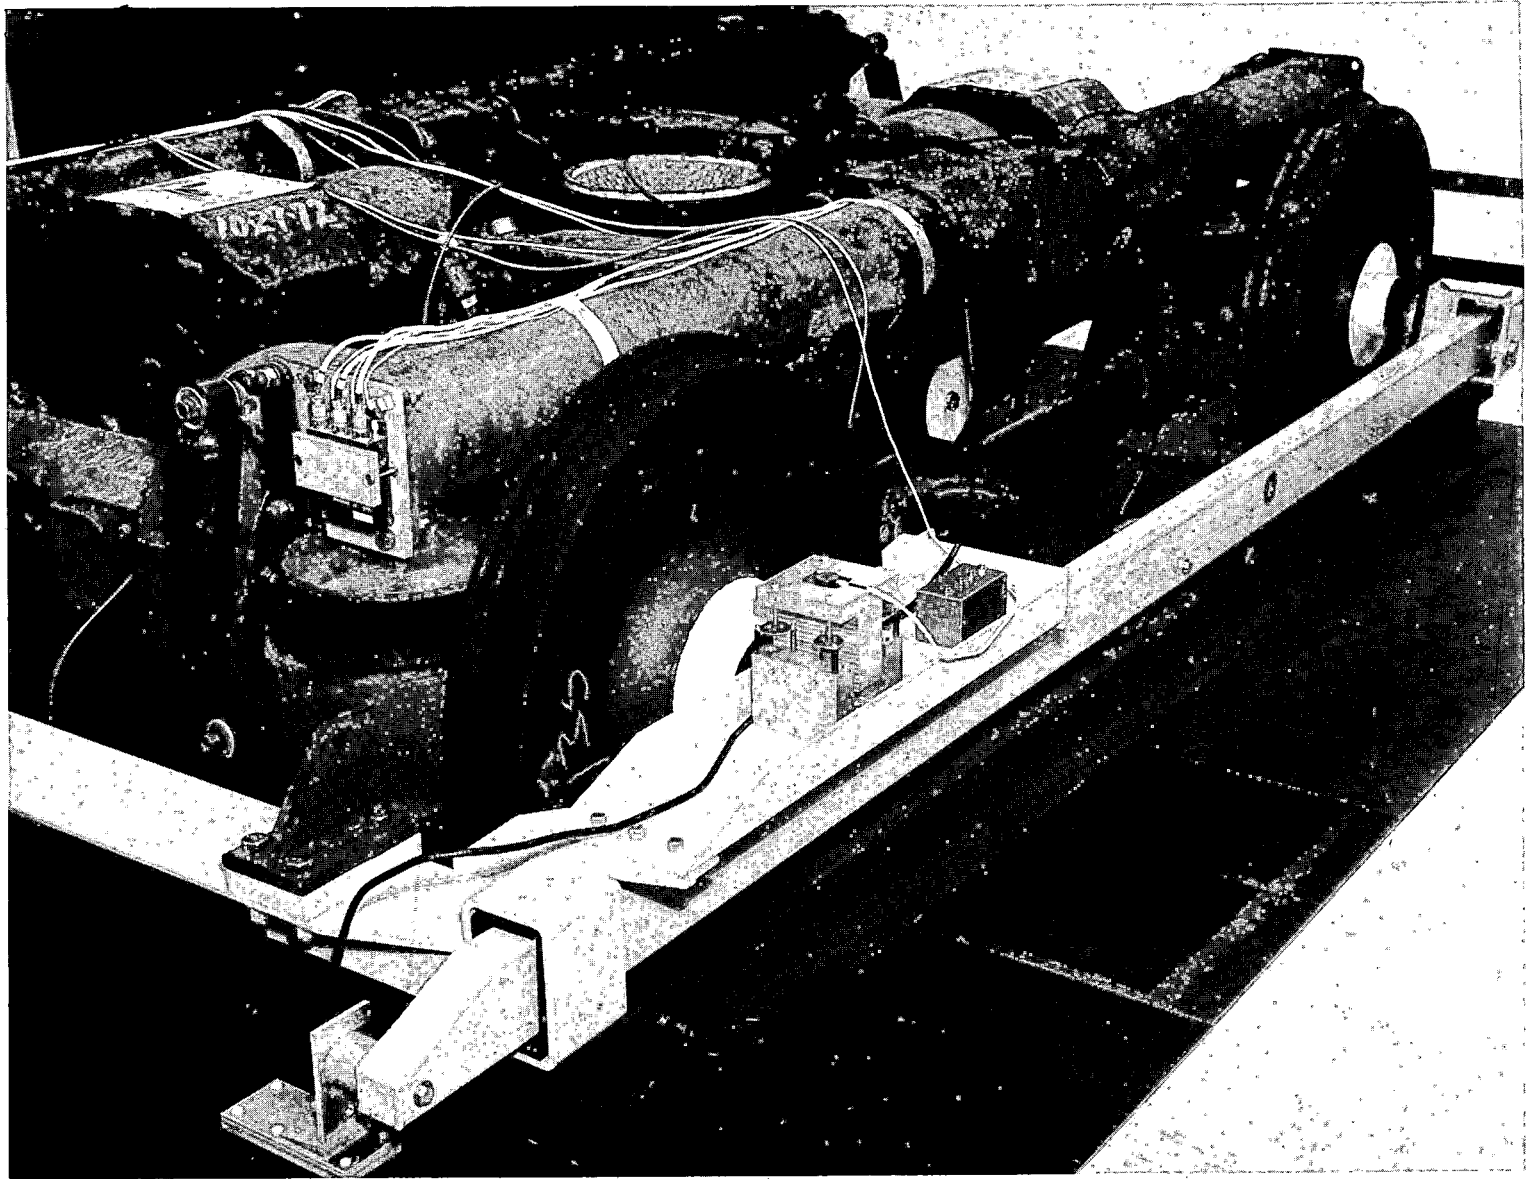
Figure 2-1 Instrumented Truck

In preparing for the tests, a reconditioned truck was delivered by the MBTA to TSC where it was carefully fitted with all of the required external sensors and a complete system checkout was performed. The instrumented truck, shown in Figure 2-1, was returned to the MBTA where it was installed on the designated PCC car for testing (see Figure 2-2 for exterior and Figures 2-3 and 2-4 for interior views of the test vehicle). Prior to this, however, another street car was fitted with a light weight breakaway

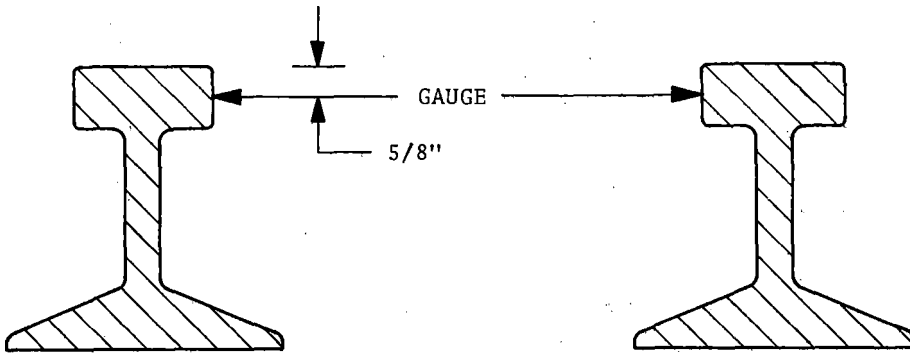
Figure 2-5 Measurement of Gage

out in the IRT publication, "Moving People Safely".* (Gage is defined as the distance between the rails measured 5/8 inch below the top of the rail - see Figure 2-5). These track classifications are used to establish allowable speeds:

In order to qualify as Class 4 track, the gage must lie between 56 and 57 inches. Class 3 track allows the gage to widen to 57.25 inches and Class 1 or 2 track must have the gage between 56 and 57.75 inches.

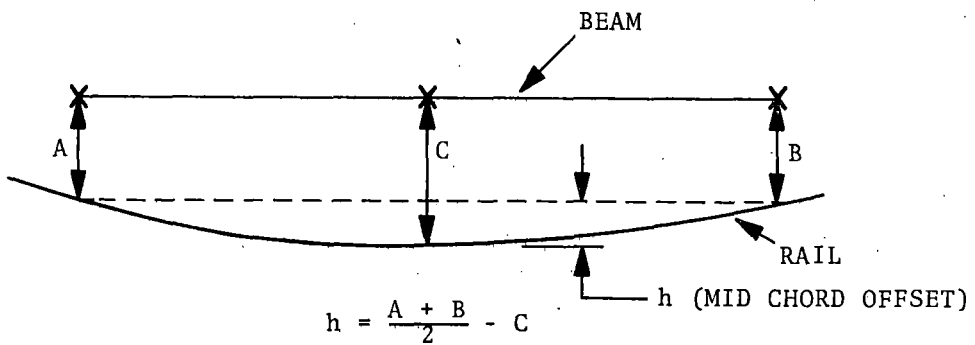
Figure 2-6 Measurement of Midchord Offset

The midchord profile measurement, 601, was made using a 10 foot (9 foot 10 inch) beam. (Profile can be defined as the vertical deviation of each rail from a given reference line.) Midchord profile is the midchord-to-ordinate distance measured in the vertical plane. The midchord definition is illustrated in Figure 2-6. Repeatable midchord data was collected and is presented in this report. The IRT track classification code uses a

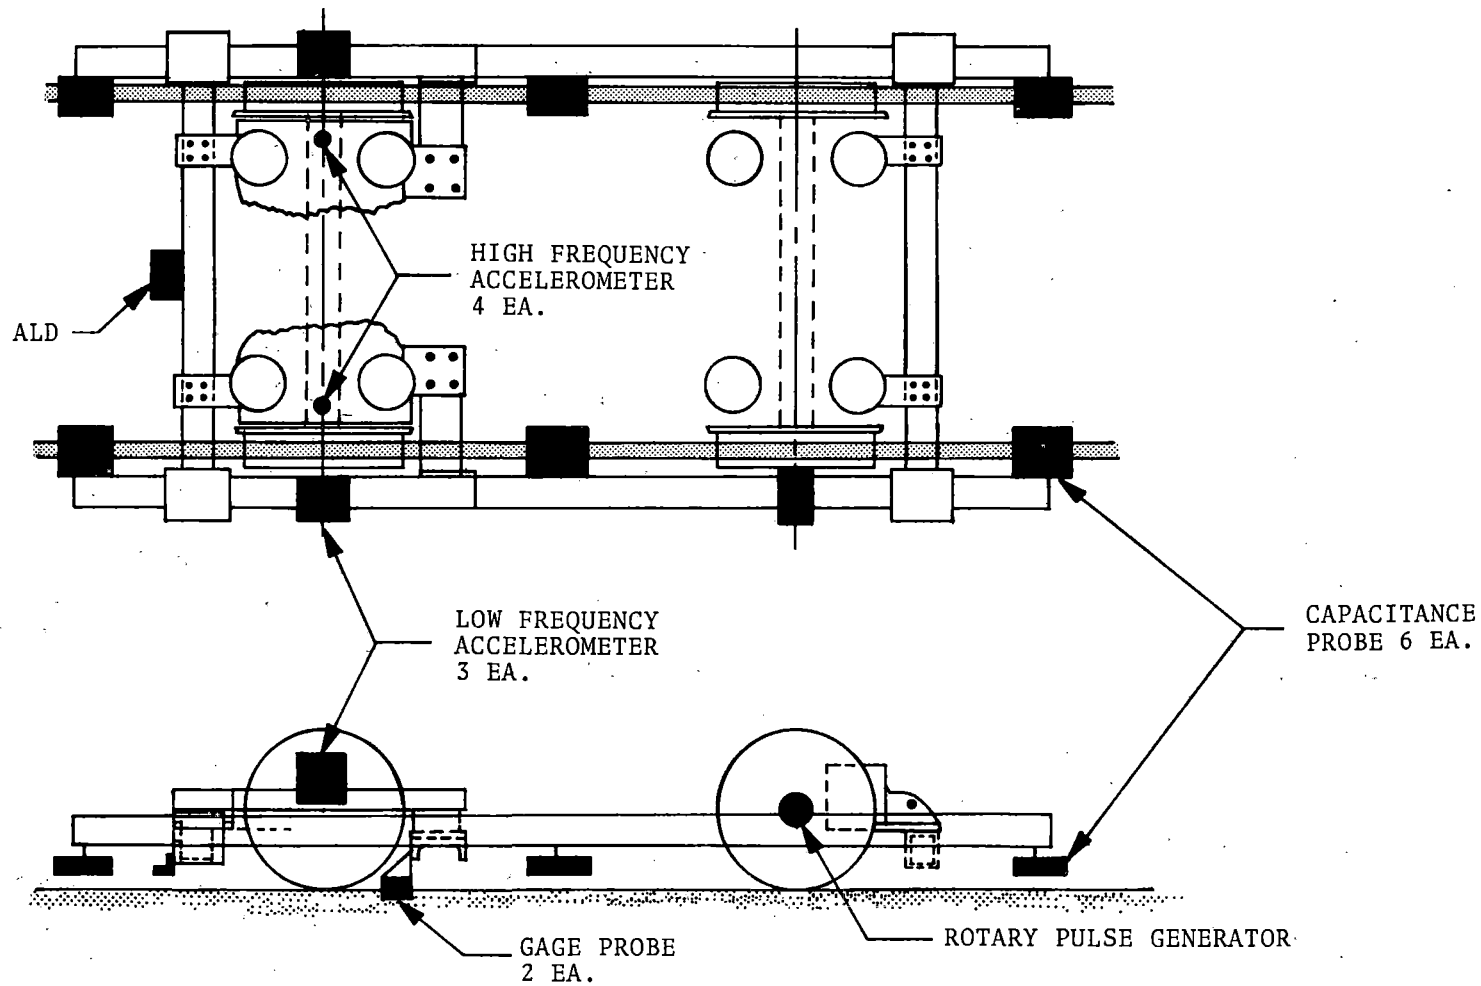
Figure A-1 Sensor Frame Configuration

To automatically provide a location reference signal, a capacitive probe is mounted on the transverse beam at the rear of the truck mid-way between the two rails. When the Automatic Location Detector (ALD) probe passes over the impedance bond associated with a signal, the rail at a turnout, or the asphalt pedestrain cross-walks at stations, sharp spikes are recorded on the magnetic tape and on the oscillograph chart.

To provide speed and distance data between ALD marks, a rotary pulse generator (RPG) is mounted on the left side profile beam and driven by the front axle of the instrumented truck. The RPG puts out 2048 pulses per revolution of the axle. This output is divided by 2 to produce 1024 pulses per revolution of the axle which is recorded on tape for future digital processing. The 2048 pulses/revolution are also divided to provide 8 pulses/foot to drive the chart recorder paper and 1 pulse/foot to drive the distance display pattern on the chart recorder.

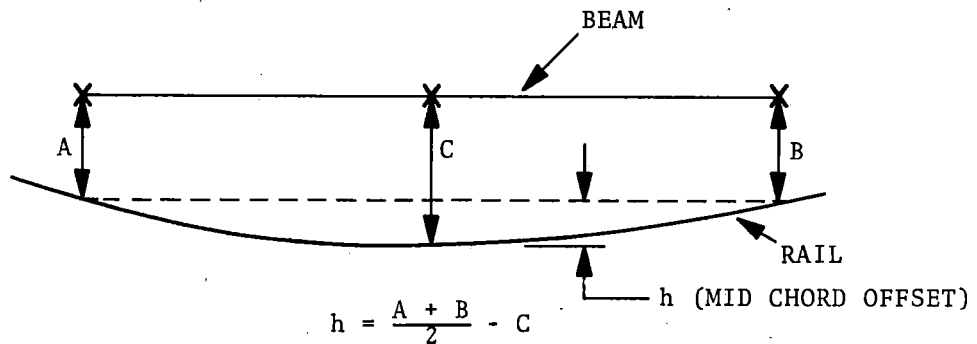
Figure B-1 Measurement of Midchord Offset

$$h = \frac{A + B}{2} - C$$

(see Figure B-1). The midchord offset is the actual output of this measurement. The beam length used in this test series was 9 ft. 10 in.

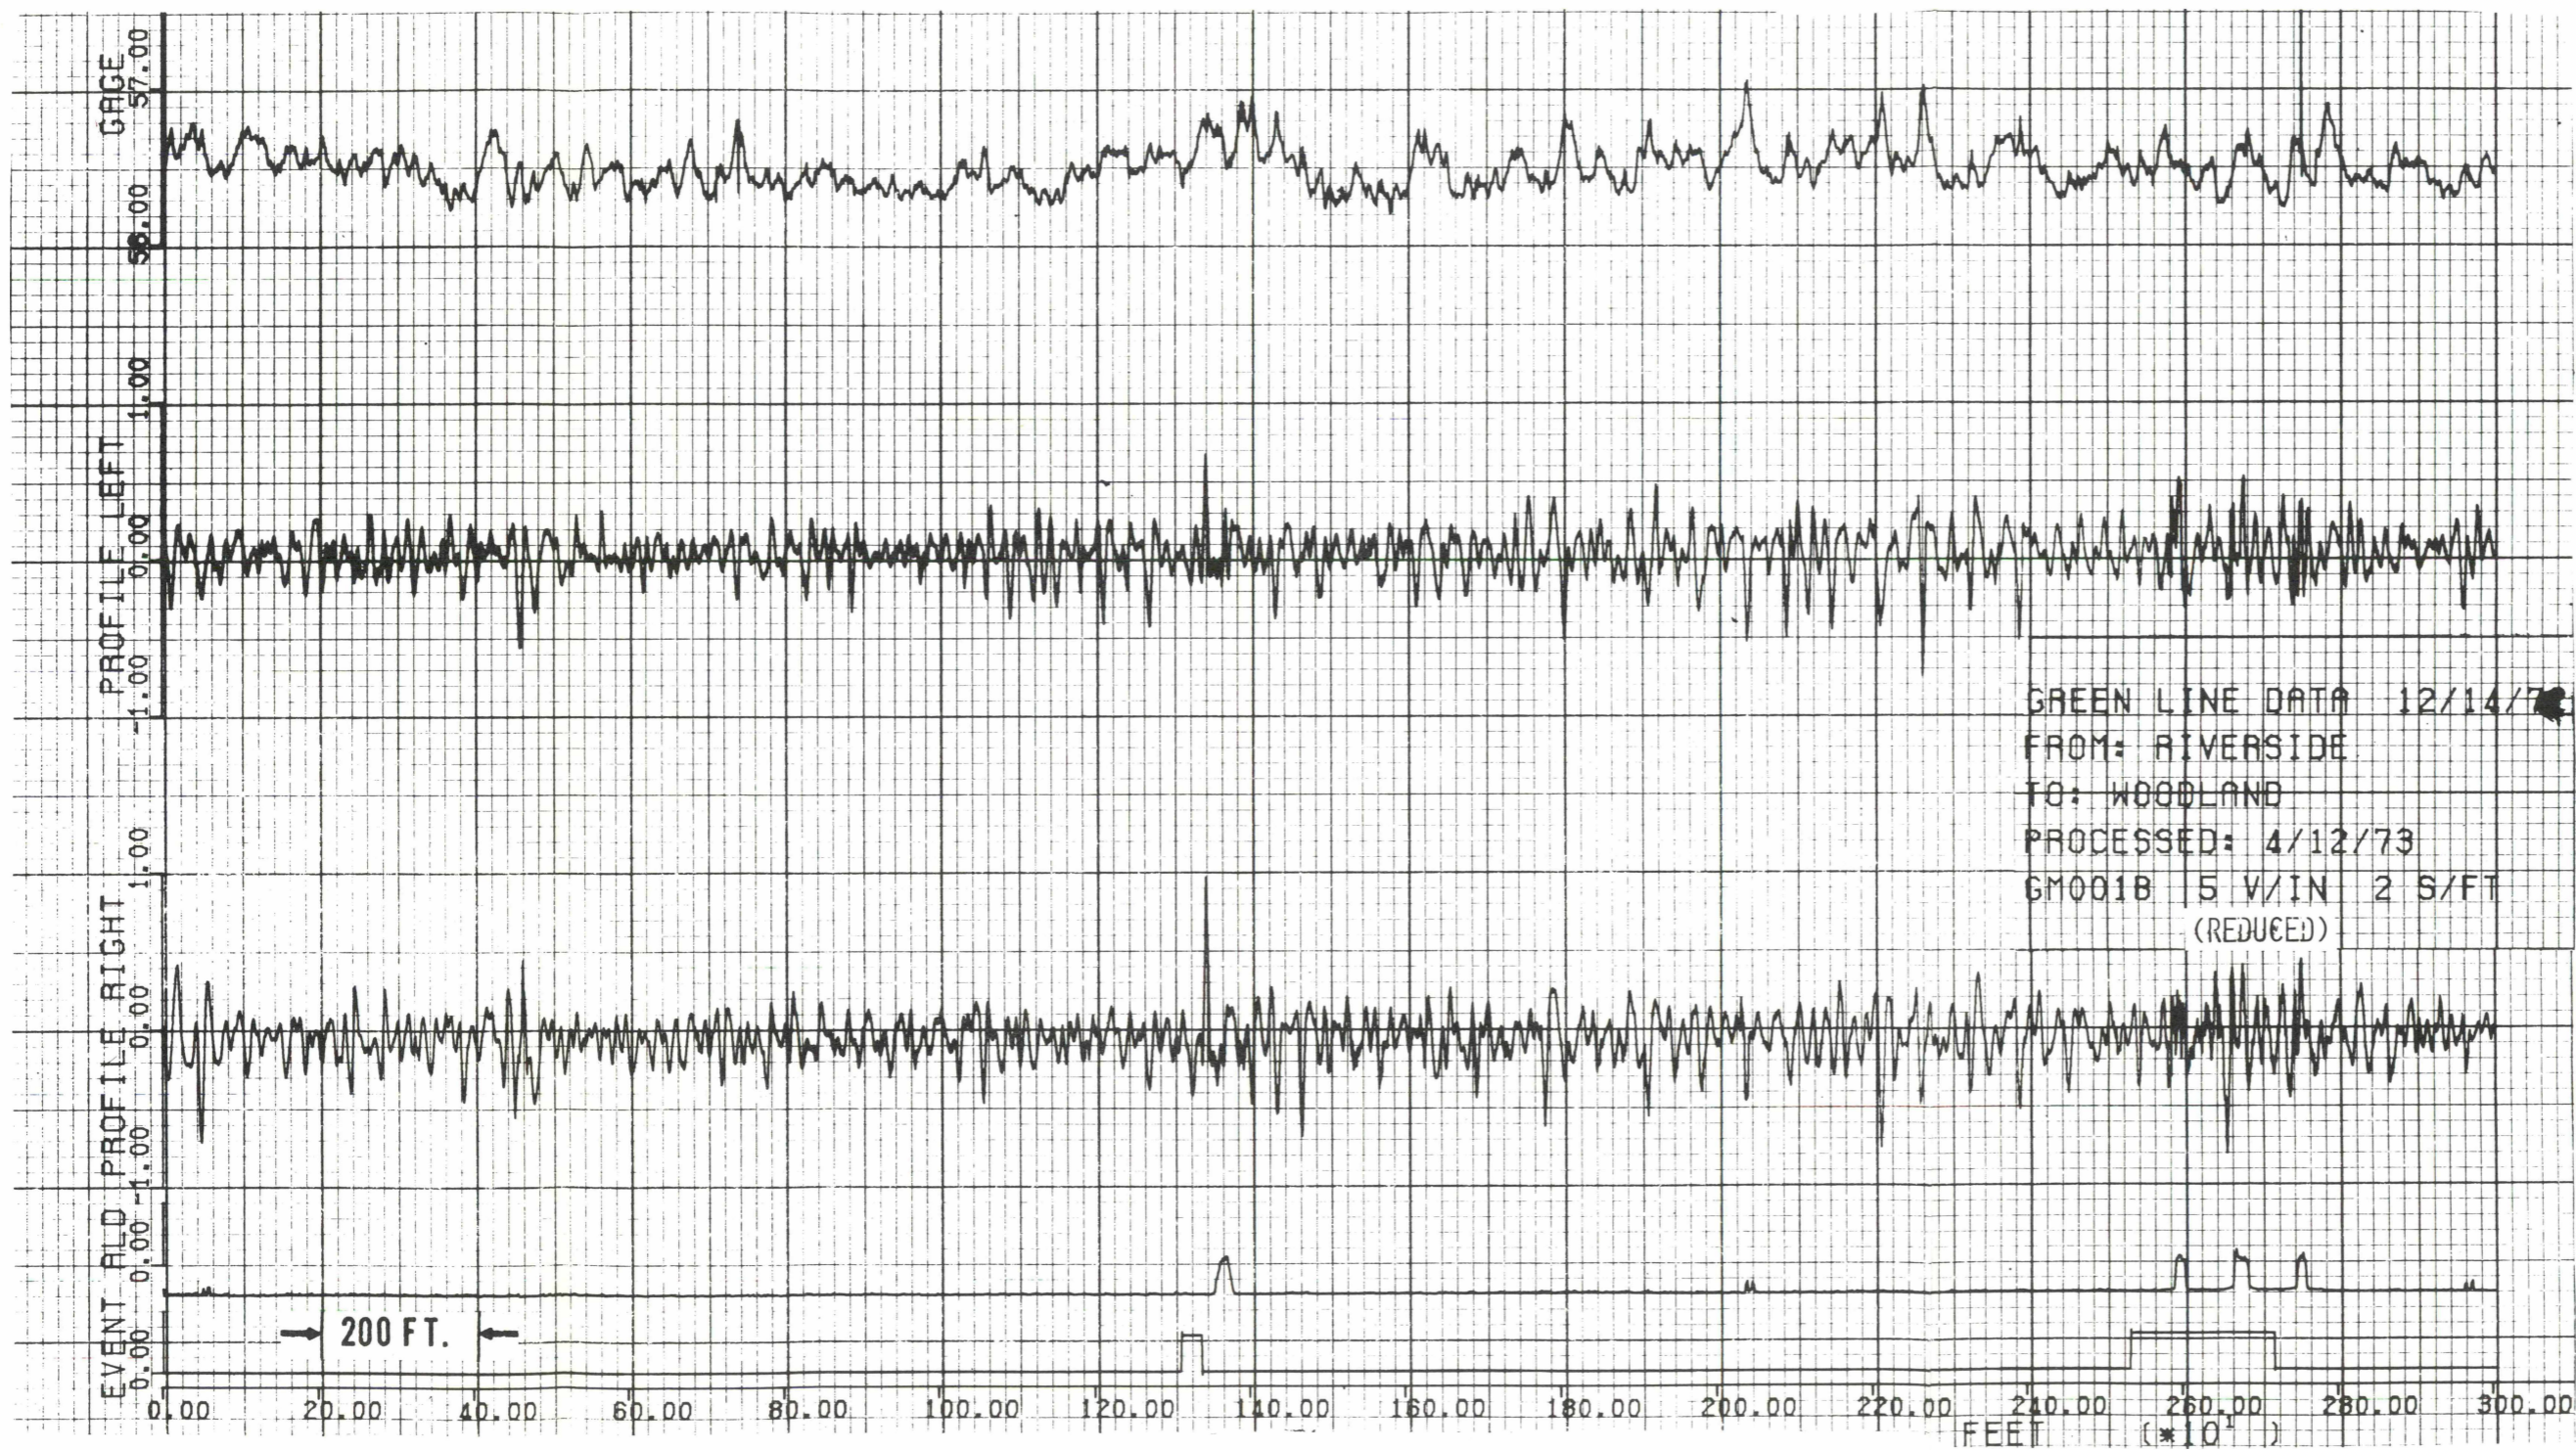
Figure B-2 Midchord Offset Data Plot, Riverside to Woodland

The summary page, C, can be used for comparison of one section of track with another. Pages B, by giving the location of the most severe perturbations, can be used for locating areas for investigation and possible repairs.

FROM - RIVERSIDE
 TO - WOODLAND
 LEFT PROFILE

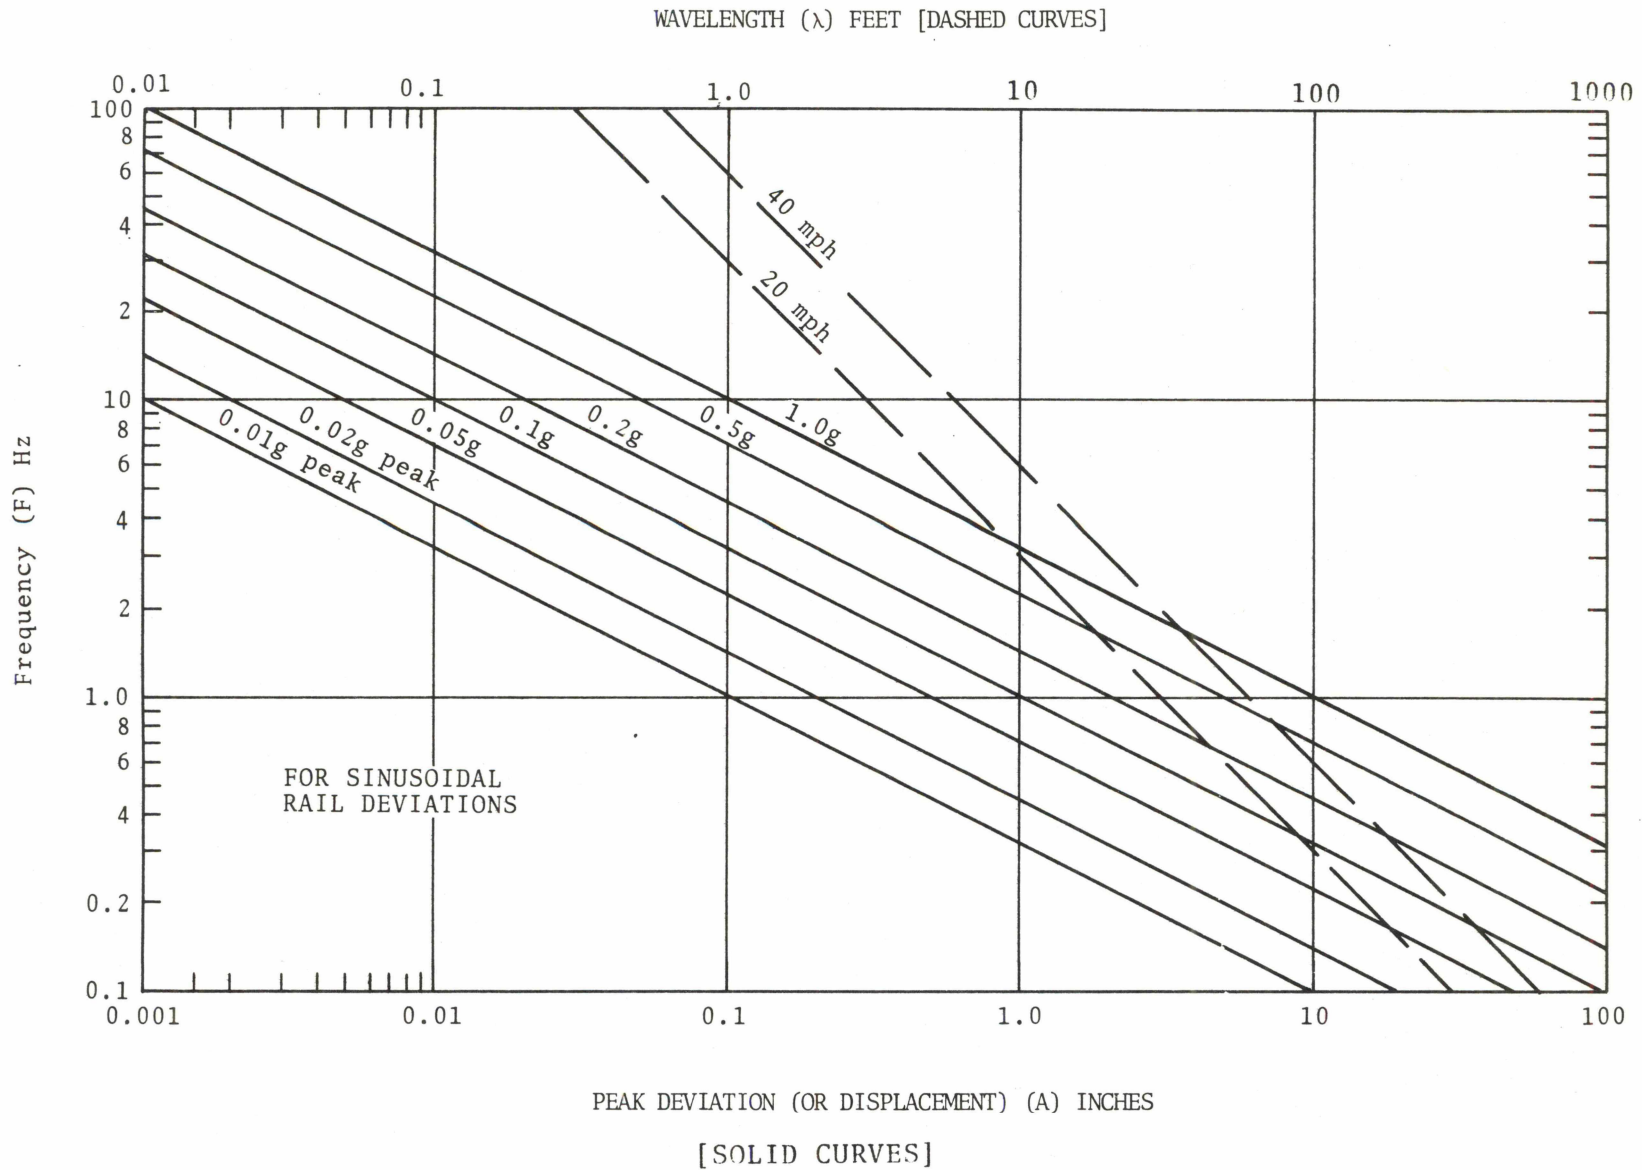
Figure D-1 Low Frequency Accelerometer Relationships

The selection of the frequency range and "g" range for the low frequency servo-accelerometers is predicated on a few simplifying assumptions. First, it is assumed that the low frequency accelerometers will be investigating rail anomalies whose wavelengths are between 3 and 150 feet. Then, for analytic simplicity, it is assumed that the perturbations in rail contour are sinusoidal in form. This permits relating wavelength, speed, frequency, acceler-

ation, and peak deviation as shown in Figure D-1. This figure shows that to sense perturbations whose wavelengths are between 3 and 150 feet, at 20 mph, the frequency range from 0.2 to 10 Hz must be covered. A 1 g peak acceleration capability would permit the observation of the effects of peak deviations from 0.1 over 100 inches, depending on wavelength.

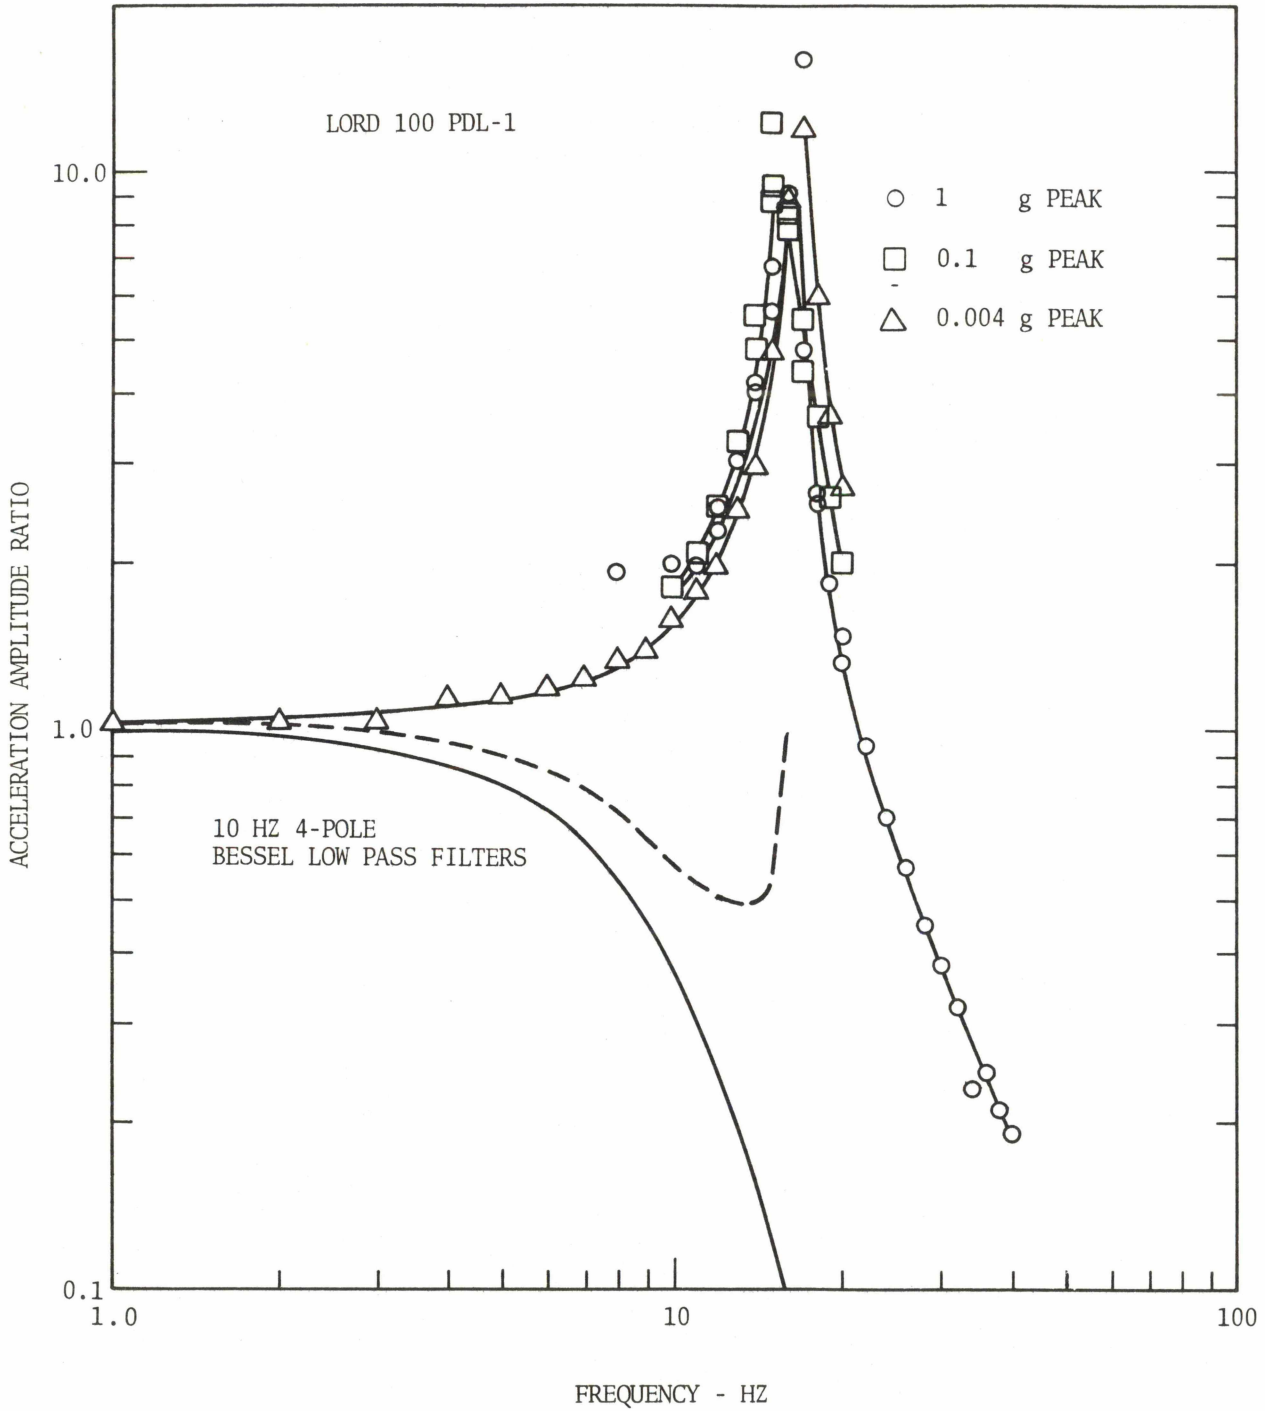
Figure D-2 Isolator Frequency Response

The low frequency accelerometers were Kistler/Endevco QA-116-15 Q-Flex servo-accelerometers. Endevco SC-116-2 "g" monitors were used as scaling amplifiers for the servoaccelerometers. During the first part of the week, Lord 100PDL-1 vibration isolators were used in the mechanical filter accelerometer mount. These isolators used a natural rubber elastomer. The acceleration frequency response for the 100 PDL-1 is shown in Figure D-2. This figure shows that the accelerometer mount, with 100 PDL-1 isolators installed, resonated at approximately 16-17 Hz and showed a resonant transmission peaking of around 10. For the December 14 (Thursday) and December 15 (Friday) runs, Lord HTO-1 vibration isolators were substituted. These use the Lord BTR elastomer which provides a higher damping coefficient than natural rubber. With the HTO-1 isolators installed, the accelerometer mounts display a

vertical acceleration resonance that varies from 40 to 85 Hz depending on amplitude. The output of each low frequency accelerometer scaling amplifier is passed through an electrical band pass filter having a pass band from 0.2 to 10 Hz. The band pass filter consists of a cascaded combination of high pass and low pass filters. The high pass filter is a Frequency Device Inc., Model 709H4L 0.2 Hz, 4-pole Bessel filter. The low pass filter is an Analog Devices, Inc., Model 730LTI 10 Hz, 4-pole Bessel filter. The frequency response for a 10 Hz 4-pole Bessel low pass filter is shown in Figure D-2. It can be seen that most, but perhaps not all, of the resonant peaking of the 100 PDL-1 isolator configuration is attenuated by the electrical filter.

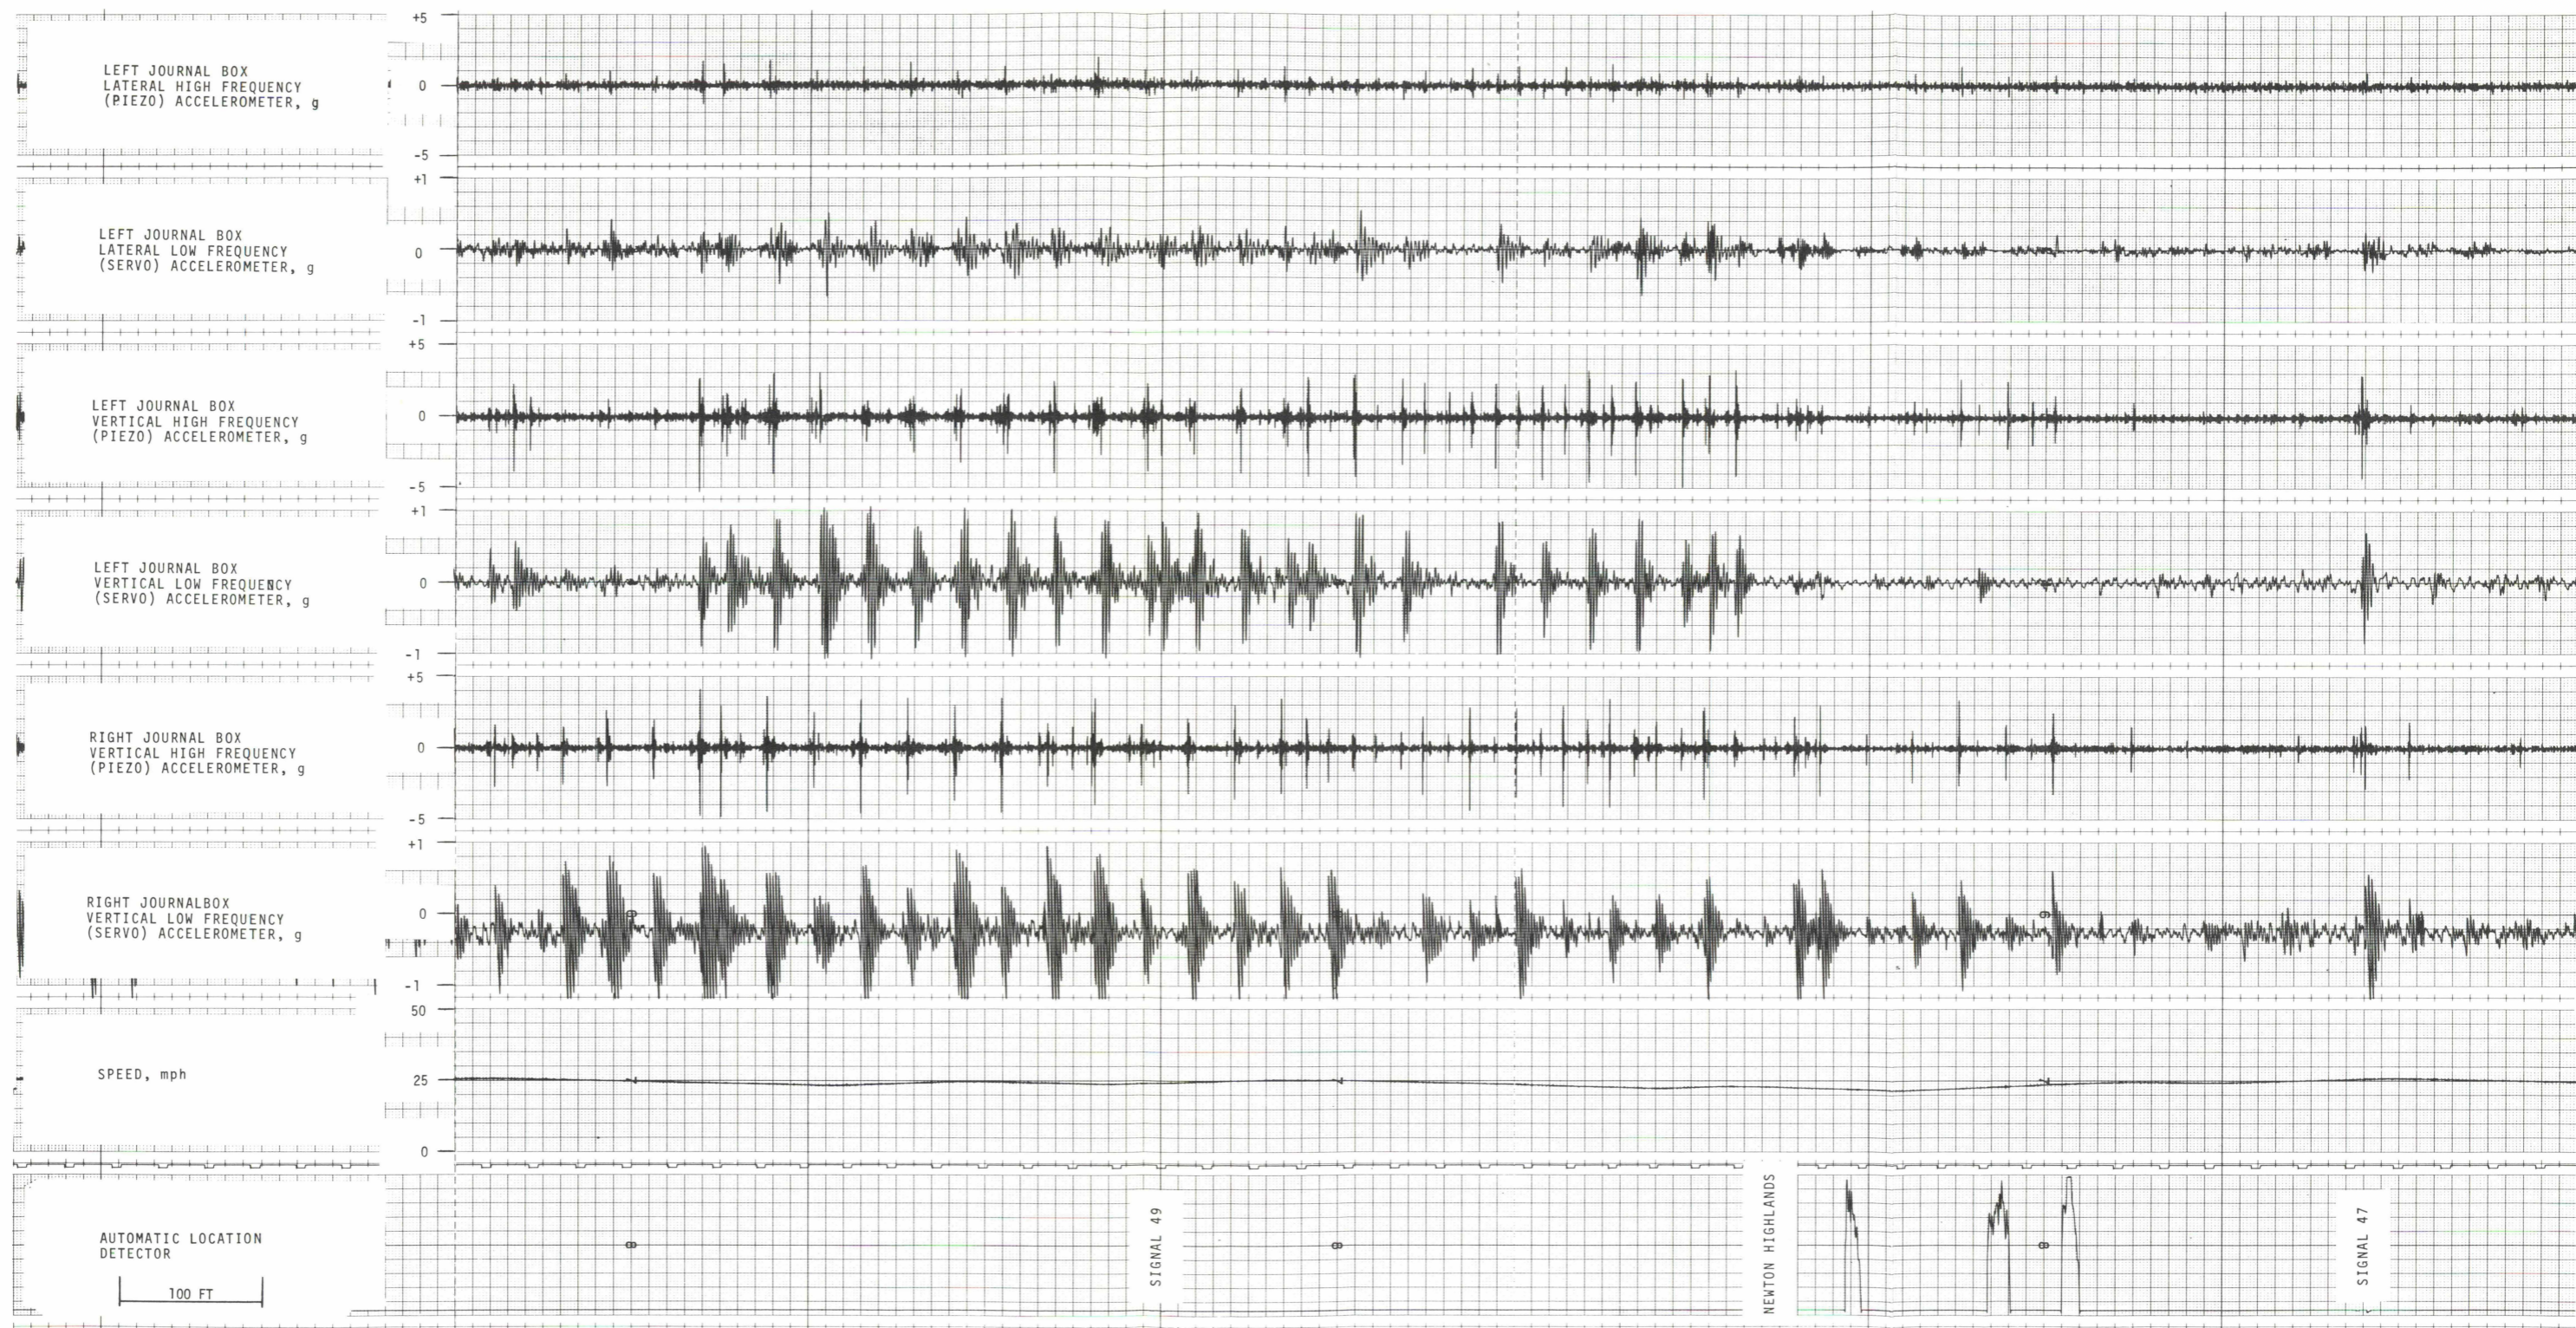
Figure D-3 Accelerometer Data

For the run from which the data of Figure D-3 was taken, the low frequency accelerometers were mounted using Lord 100PDL-1, low frequency (16 Hz), low damping ($T_{\max} = 10$), vibration isolators. What seems to predominate in the low frequency vertical accelerometer output is the transient response of the vibration isolated mount to a train of acceleration pulses. These pulses are observed to occur at spacing intervals of approximately 33 feet, and are presumed to be soft (or low) spots in the ballast at the points where the rail joints were previously welded. Since the transient response of the isolation mount obliterates much of the track accelerometer data, it is concluded that use of a low damped, low frequency vibration isolation is not appropriate for this application. The -0.25 g bias shown in the right journal box vertical low frequency accelerometer data is caused by a deteriorating oscillograph pen motor drive assembly.

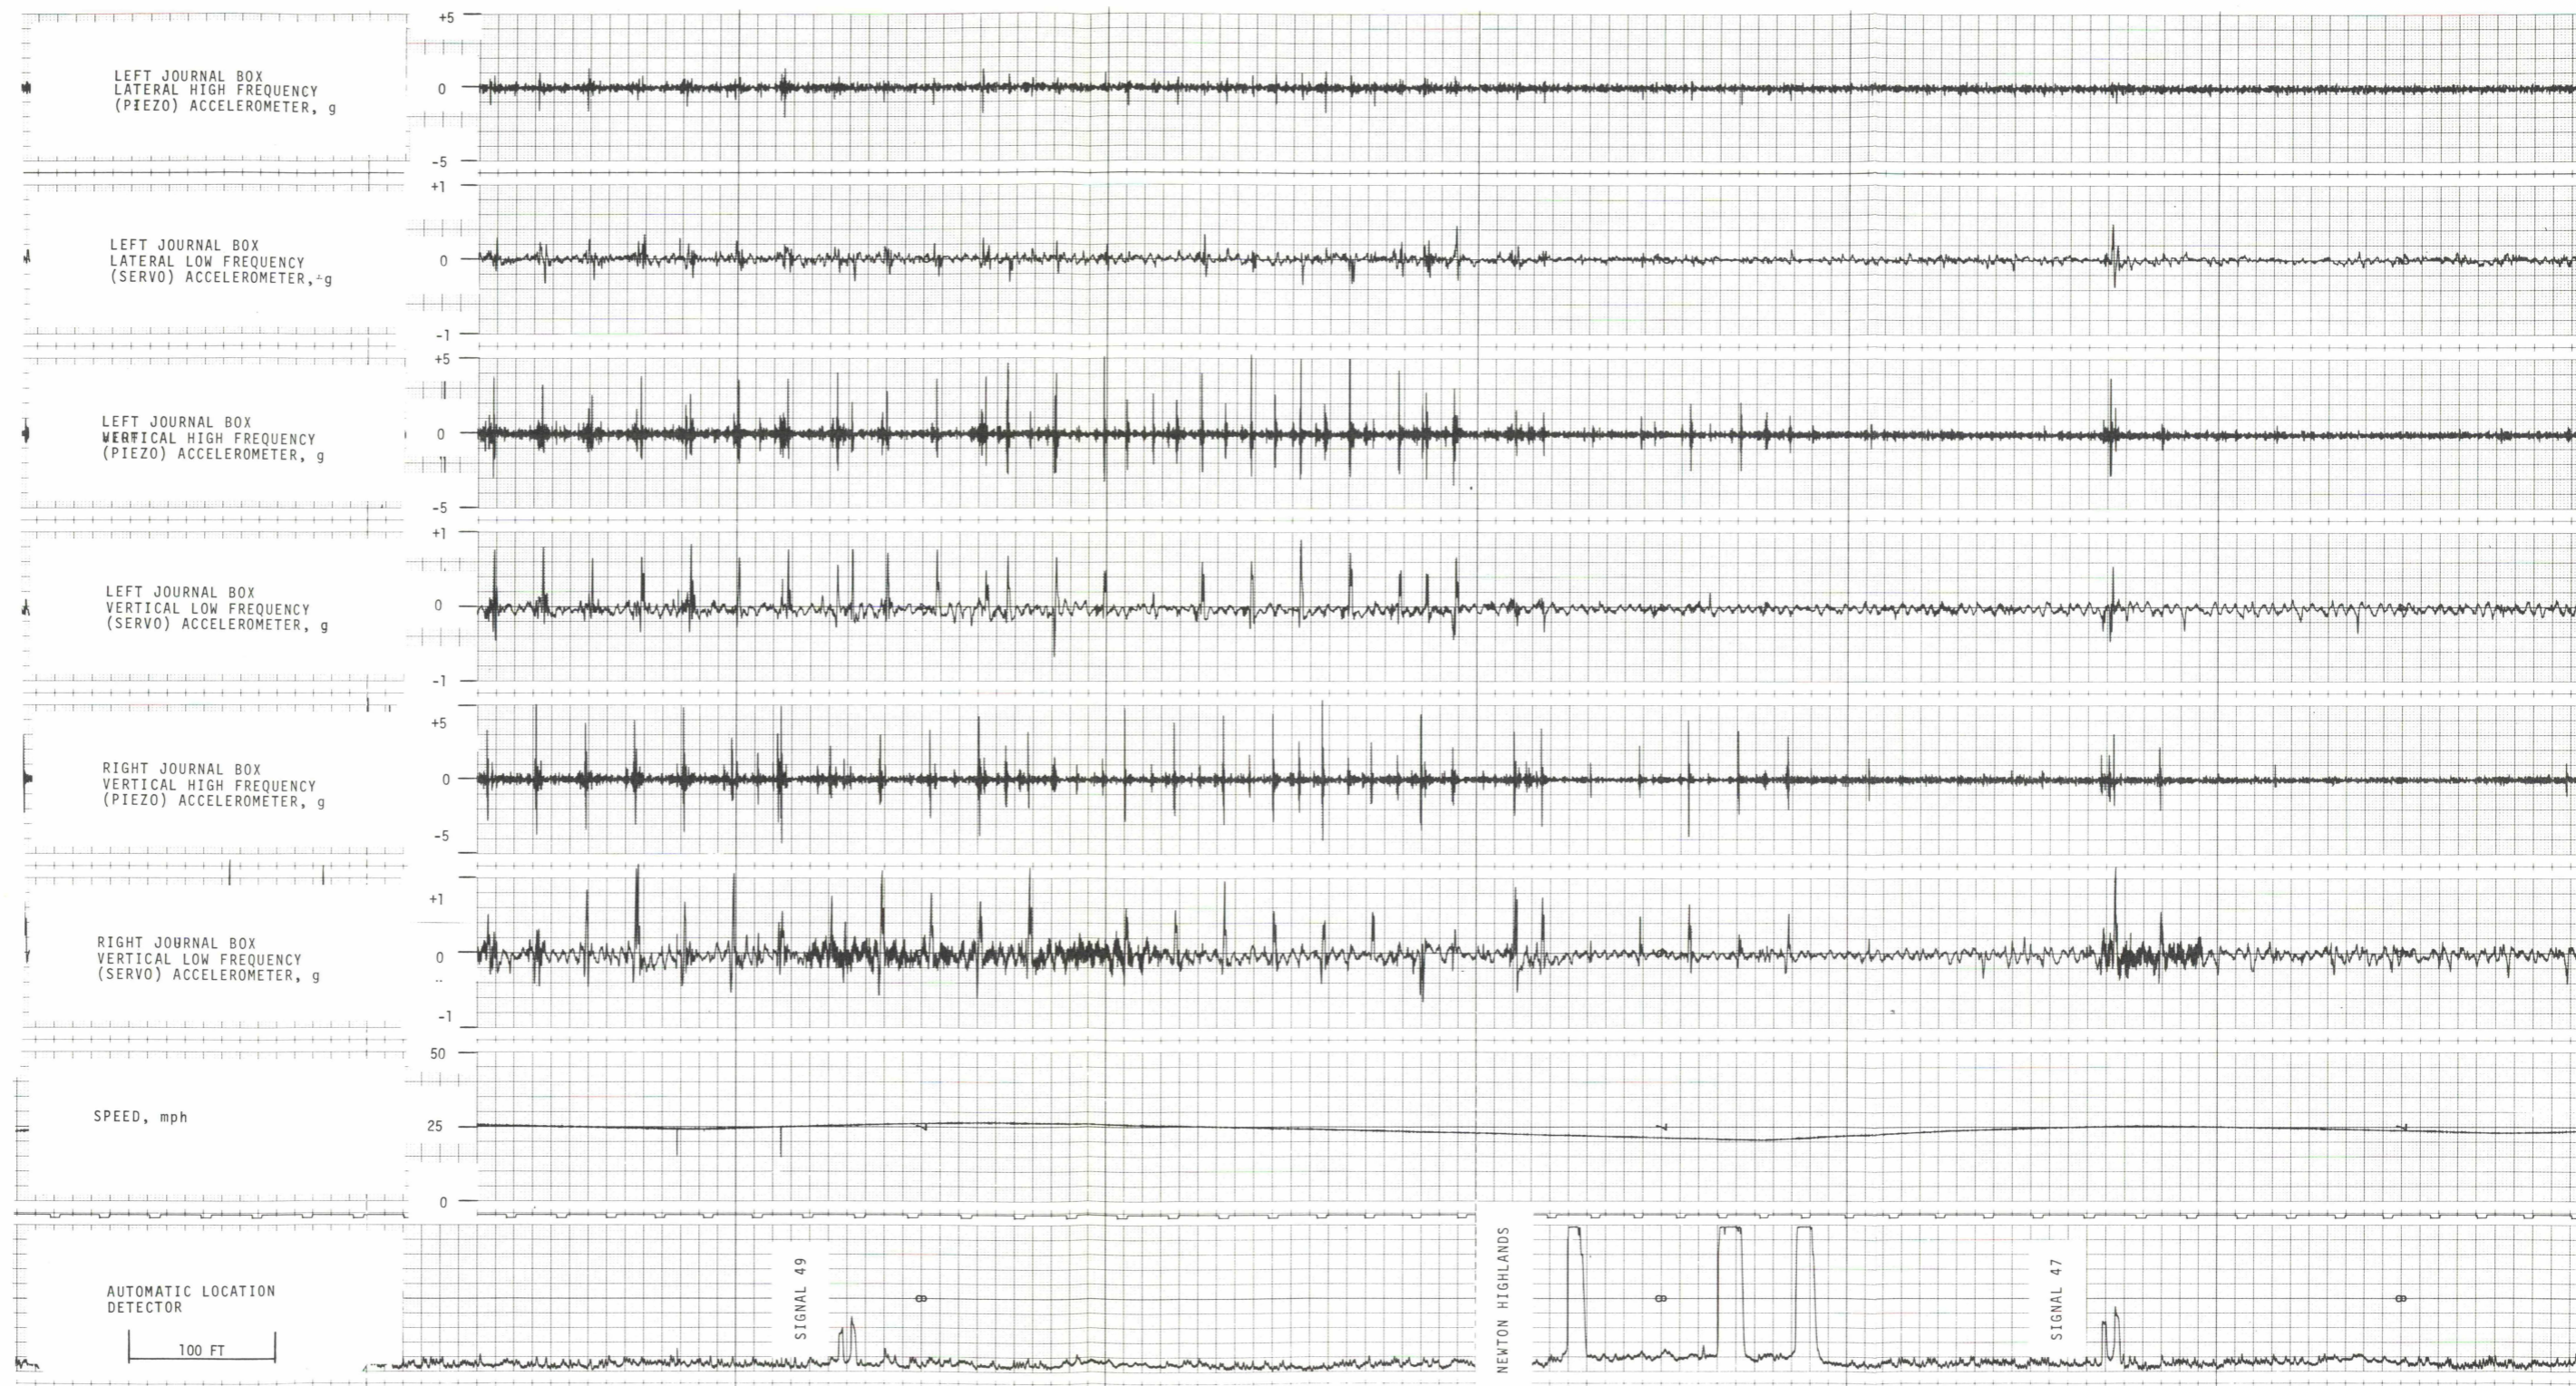
Figure D-4 Accelerometer Data

Figure D-4 shows journal box acceleration data from a run over the same section of track at approximately the same speed, 25 mph, but with Lord HTO-1 vibration isolators used in the low frequency accelerometer mounts. The HTO-1 isolators provide a resonance frequency of 40 to 85 Hz, depending on amplitude, and a

transmissability at resonance of T_{\max} from 2.8 to 8, depending on amplitude. Figure D-4 shows that the transient response of the vibration isolated mount to a pulse of acceleration damps out within one cycle. Comparison of the peaks in the piezo and servo accelerometer data for the same axis of the same journal box shows the additional attenuation achieved by the added filtering used for the low frequency accelerometers. In fact, the piezo accelerometer data is significantly attenuated by the frequency response of the oscillographic chart recorders and the 80 Hz low pass filter. Monitoring the right journal box vertical piezo accelerometer data for the same section of track and the same run depicted here indicates that the larger pulses shown here actually approach 20 g in magnitude.

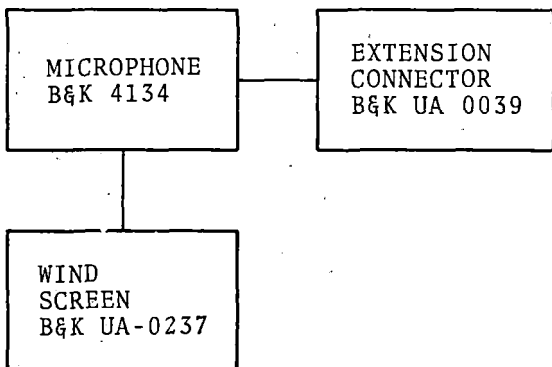
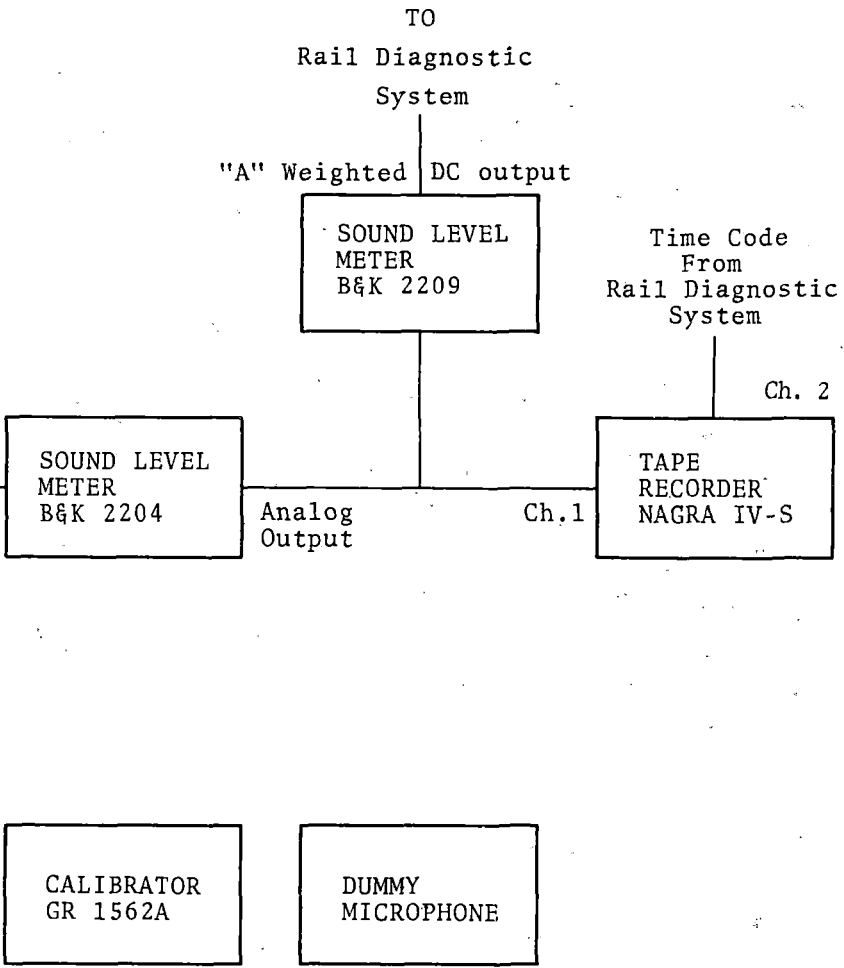
Figure F-1

The data collection and processing used in this test utilizes proven technology on the TSC noise program.

Noise Measuring System
