REPORT NO. DOT-TSC-UMTA-74-1,I

MBTA GREEN LINE TESTS
RIVERSIDE LINE
DECEMBER 1972

VOLUME I
TEST DESCRIPTION

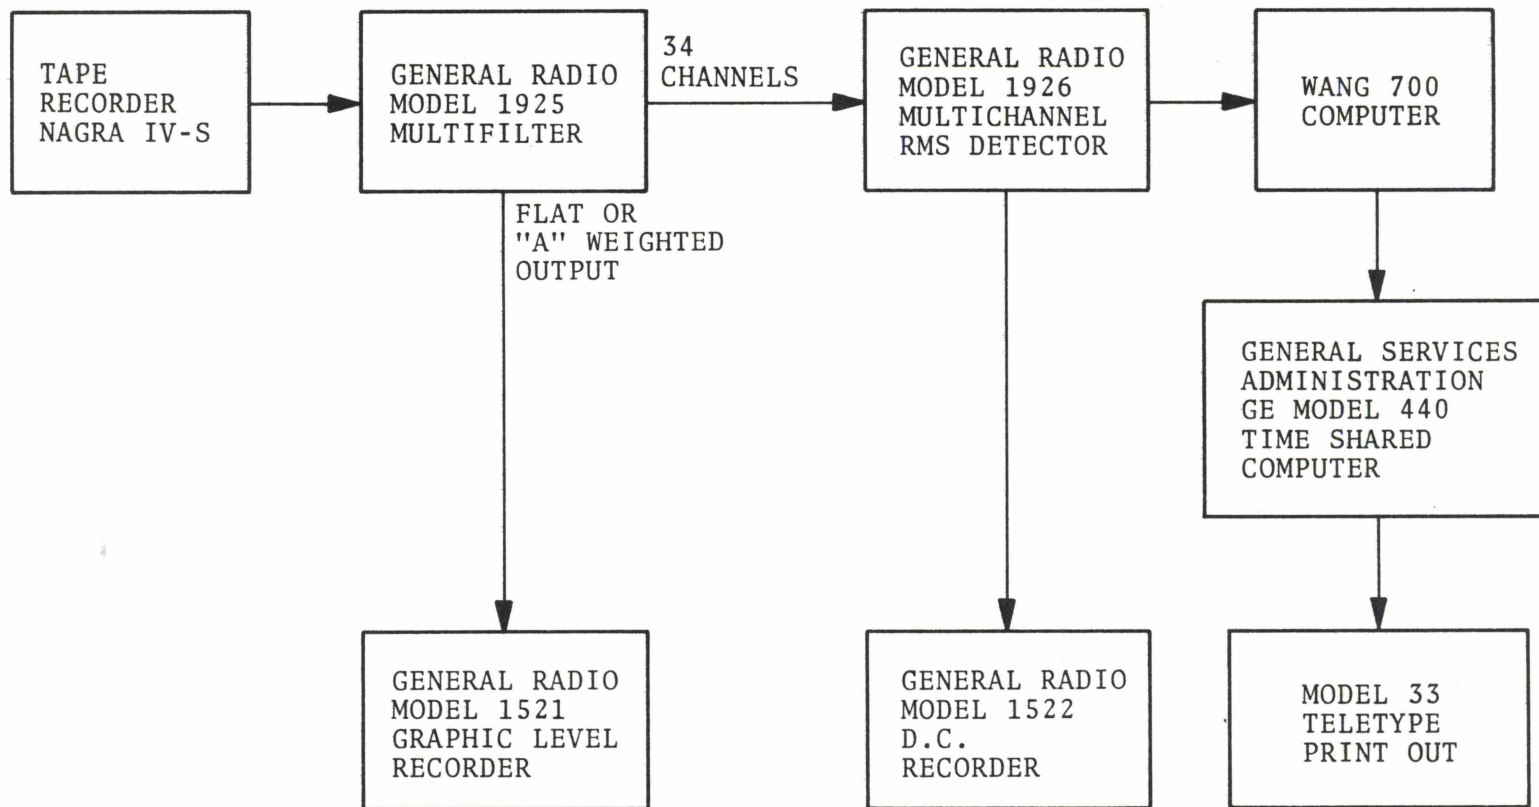
Figure F-2 Noise Data Reduction System

The GR 1925 multifilter contains a set of 30 parallel 1/3-octave band filter channels ranging from 25Hz to 20kHz, plus additional channels with standard "A", "B," and "C" sound-level meter weighting networks and an unfiltered channel with a flat frequency response "F". The output of the "A" weighted channel was selected and fed to the Graphic Level Recorder to produce a chart of noise level vs. time (time history) of all recorded data. All 34 outputs from the multifilter were fed into the multichannel detector. The multichannel detector simultaneously computes the rms (root mean square) level for each channel and converts this level to a digital output. Single integrations or measurement periods are adjustable from 1/8 to 32 seconds.

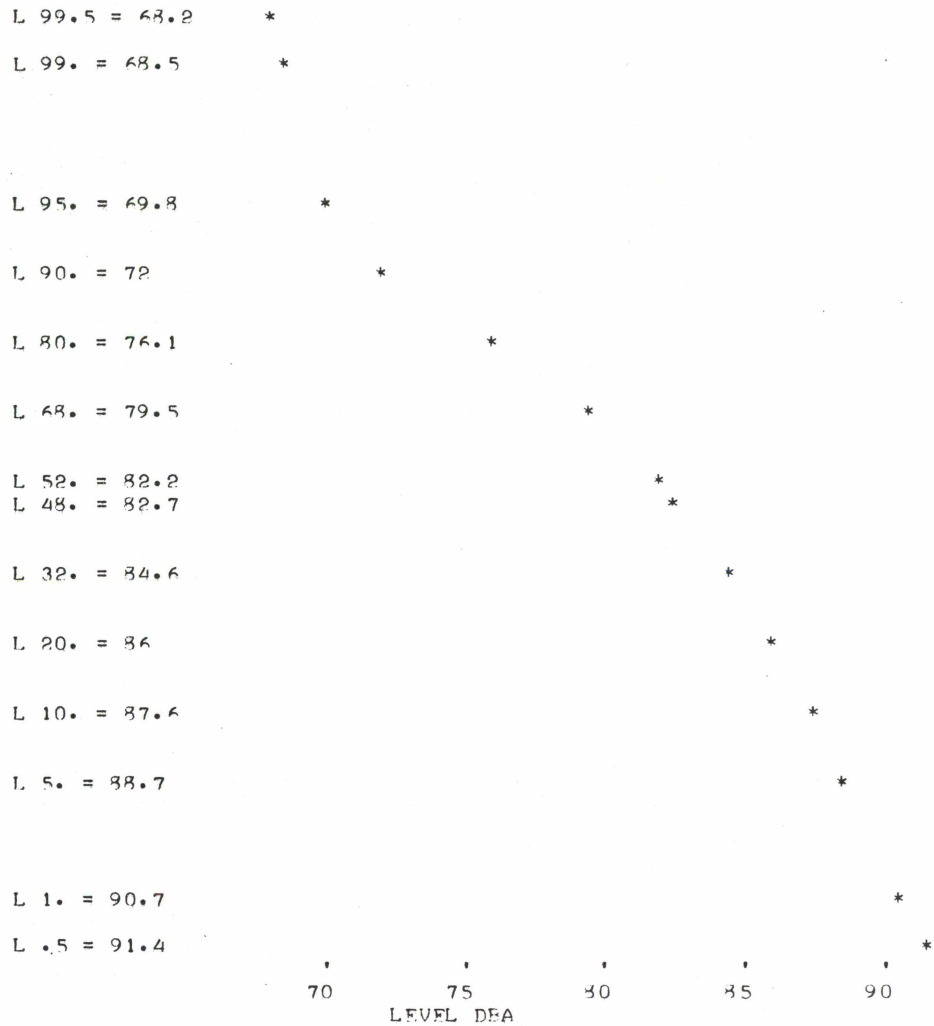
NOISE DATA FROM RUN NO 1 OF THE PORTABLE NOISE STATION ON
DEC 13 1972 FROM 10:05 TO 10:37, IN METRA GREEN LINE CAR NO 3294 FROM
NEWTON HIGHLANDS TO LECHMERE. GENERATOR ON
1/8 SECOND INTEGRATIONS, 8 PER SECOND

LEVEL (DBA) VS PERCENT OF TIME LEVEL EXCEEDED

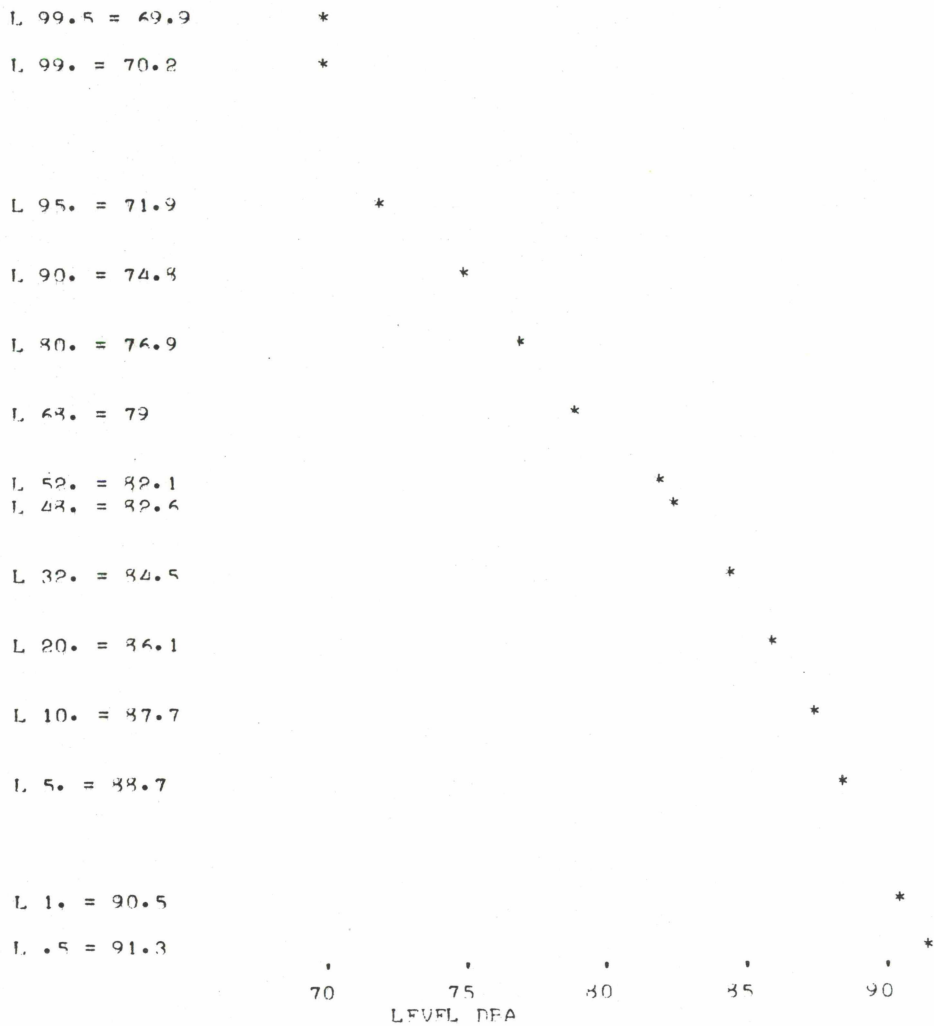
NOISE DATA FROM PIN NO 2 OF THE PORTABLE NOISE STATION ON
 DEC 13 1972 FROM 11:14 TO 12:02, IN MPTA GREEN LINE CAR NO 3294 FROM
 LECHMERE TO RIVERSIDE. GENERATOR ON
 1/8 SECOND INTEGRATIONS, 3 PER SECOND

LEVEL(DBA) VS PERCENT OF TIME LEVEL EXCEEDED

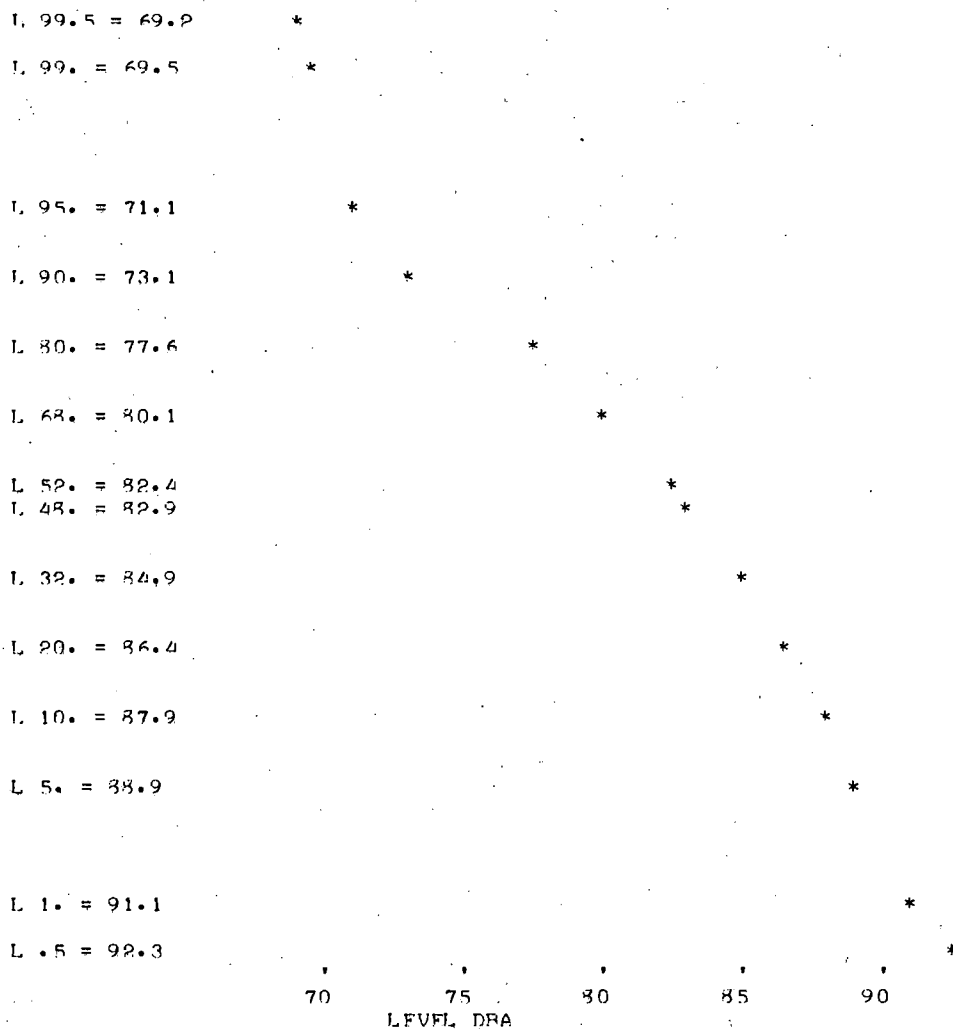
NOISE DATA FROM RUN NO. 4 OF THE PORTABLE NOISE STATION ON
 DEC 14 1972 FROM 09:57 TO 10:39, IN MRIA GREEN LINE CAR NO 3294 FROM
 N STATION (UNDER) TO RIVERSIDE. PEVENUF SPEED PROFILE (GEN OFF)
 1/8 SECOND INTEGRATIONS, 8 PER SECOND

LEVEL(DBA) VS PERCENT OF TIME LEVEL EXCEEDED

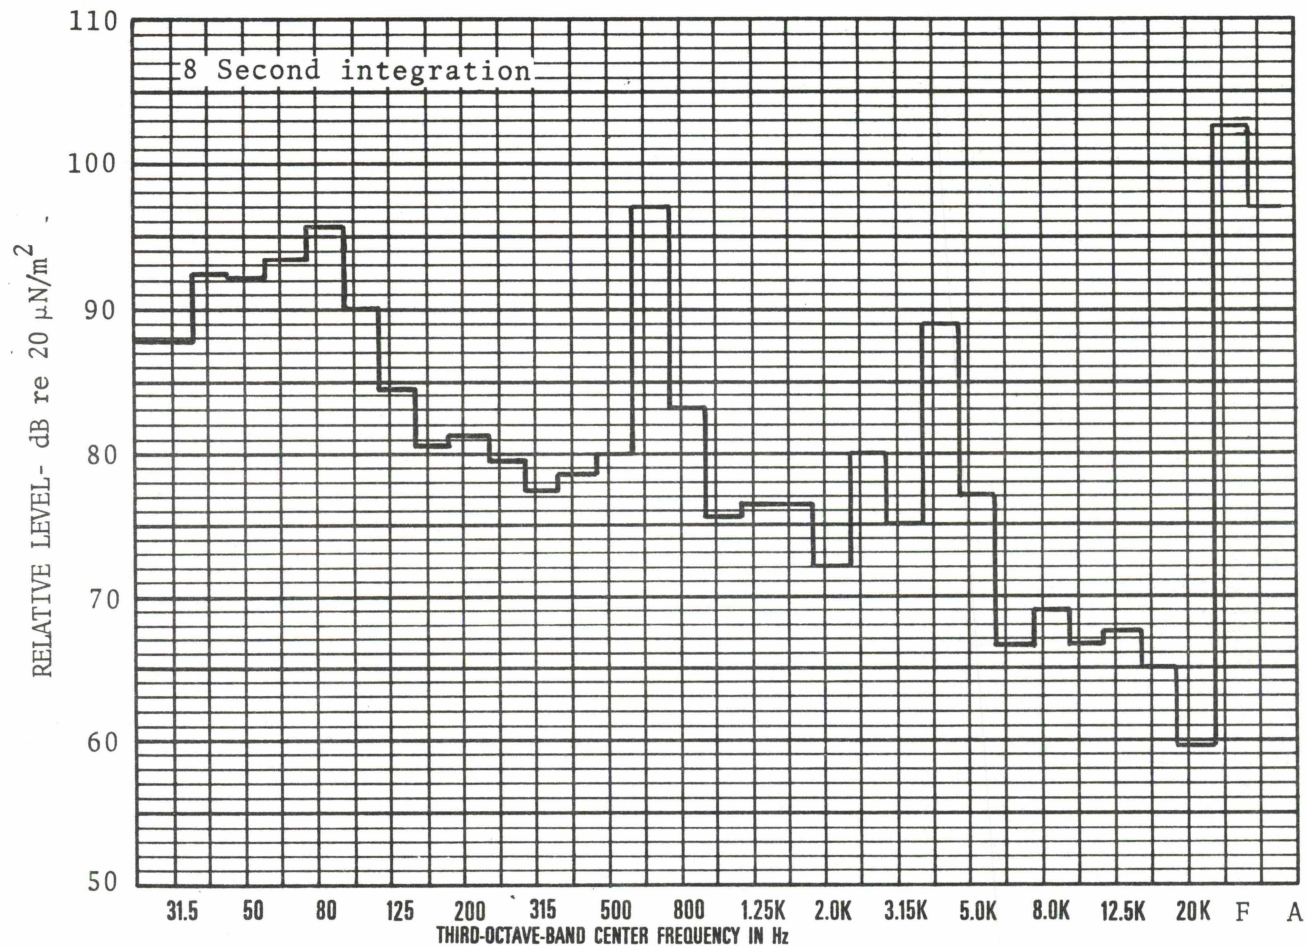
Figure F-8 Noise Spectra

Wheel Squeal - 11 mph.
12/15/72
