GENERAL VEHICLE TEST
INSTRUMENTATION EVALUATION

Prepared by
Transportation Systems Center

MARCH 1977

FINAL REPORT

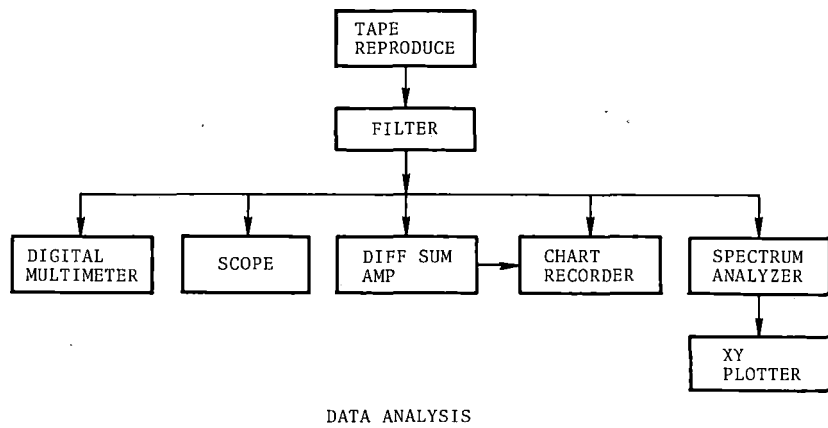
FIGURE A-1. DATA ACQUISITION AND ANALYSIS SYSTEMS GENERALIZED BLOCK DIAGRAMS

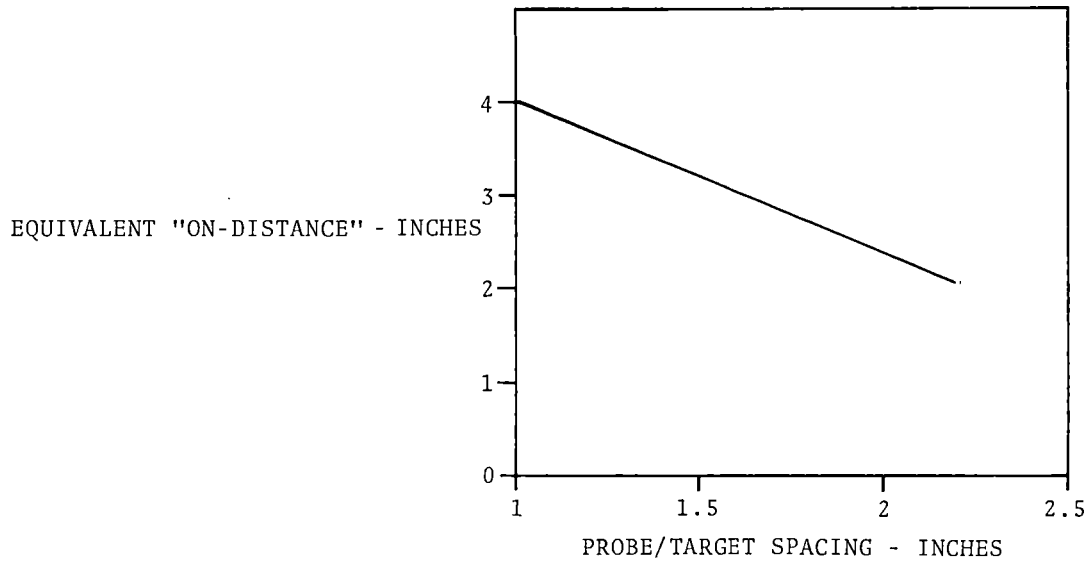
FIGURE B-15. AUTOMATIC LOCATION DETECTOR EQUIVALENT ACTUATION DISTANCE VERSUS PROBE/TARGET SPACING

During the 1.8 mph coast run, the equivalent pulse width was 4" on the level target pulse. The 2 1/8" target (#4) width was 2.31 inches versus 2.13 inches at 50 + mph.

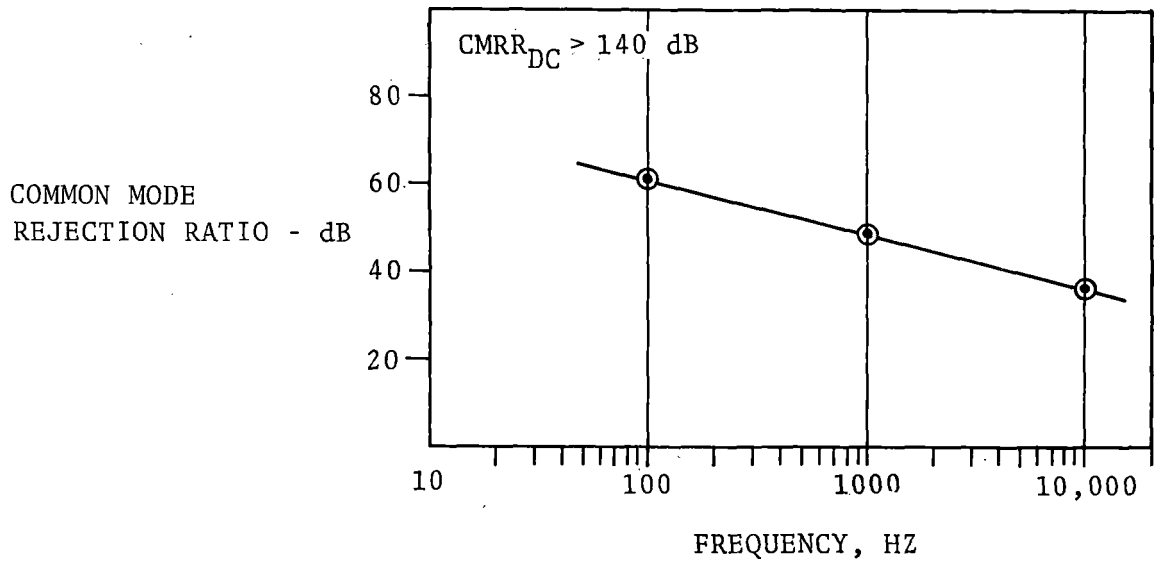
FIGURE C-20. ISOLATION AMPLIFIER COMMON MODE REJECTION RATIO VERSUS FREQUENCY
