# LATERAL RESISTANCE OF NEW AND RELAY RED OAK CROSSTIES

September, 1979

1. Report No. FRA/ORD-79/03		2. Government Accession No.		3. Recipient's Catalog No.	
4. Title and Subtitle Lateral Resistance of Some New and Relay Red Oak Crossties				5. Report Date September 1979

Joseph F. Murphy, Engineer

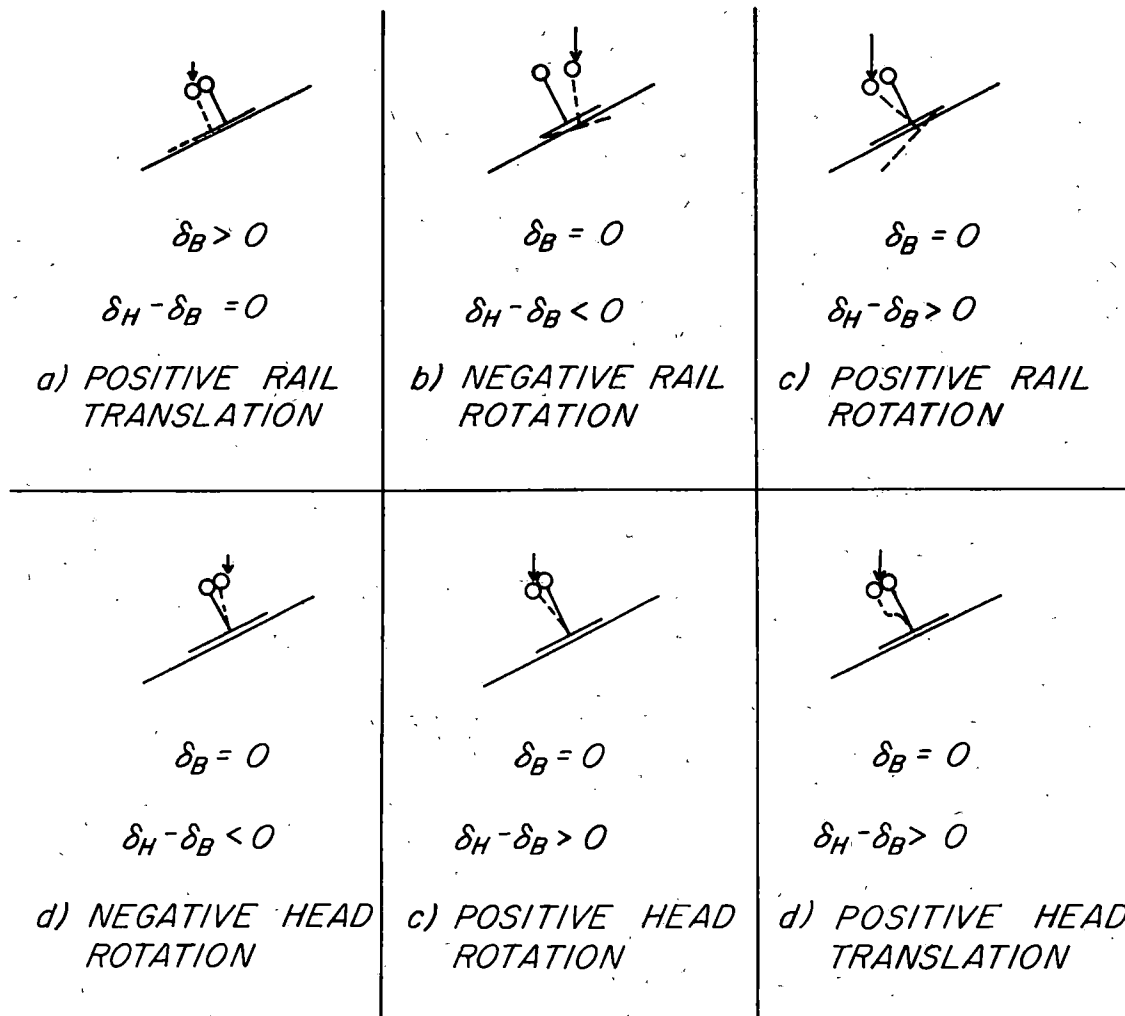
ROTATION

+ $\delta$  TRANSLATION

Figure 11.--Components of rail movement under a combined lateral and vertical load.

Nearly all individual tests had positive head-minus-base differential displacements, with the two exceptions being N6 and 61. Tie 229 had the highest differential displacement but this was less than 0.40 inch at 110,000 pounds. Figure 11 gives components of rail displacements and possible reasons for different recorded base movement and head movement. Actual rail movement would consist of one or more components.

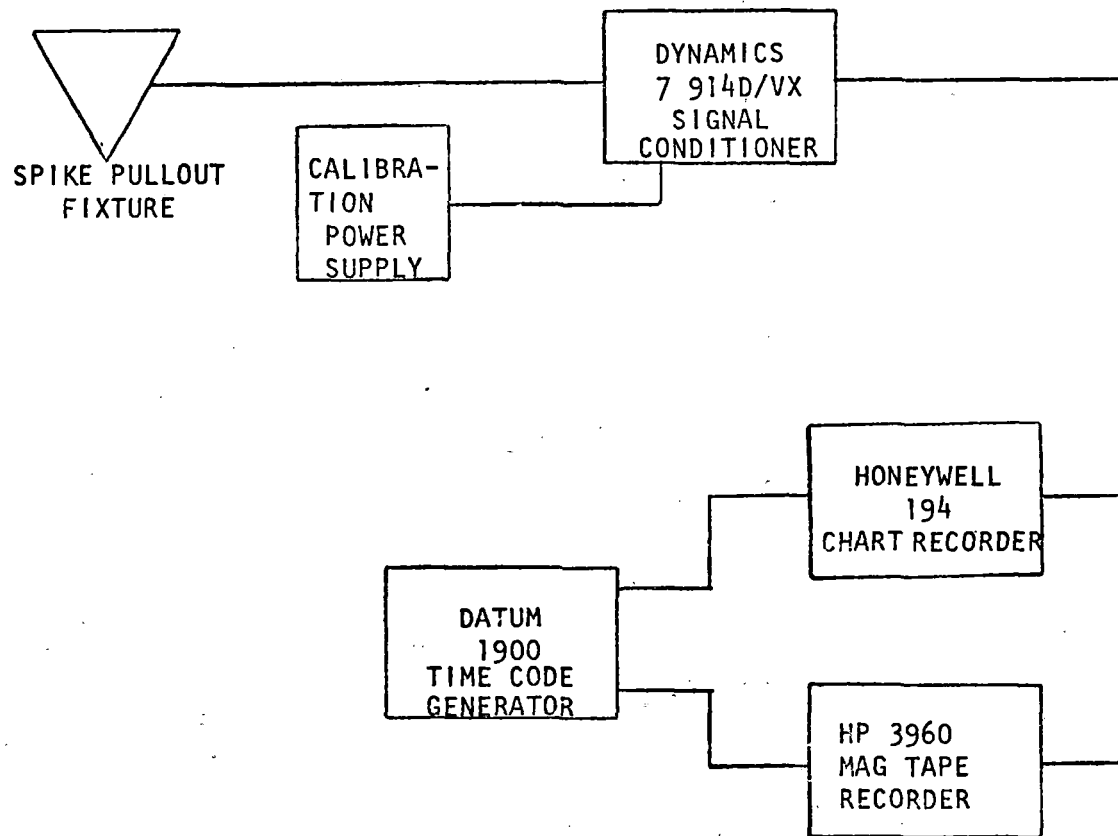
Figure D3.--Instrumentation configuration.

This signal is then conditioned, amplified, and recorded on both a pengraph recorder and a magnetic tape recorder.
