A REVIEW OF ATIP

OVERVIEW  
THE FEDERAL RAILROAD ADMINISTRATION  
AUTOMATED TRACK INSPECTION PROGRAM  
(ATIP)

September 1981

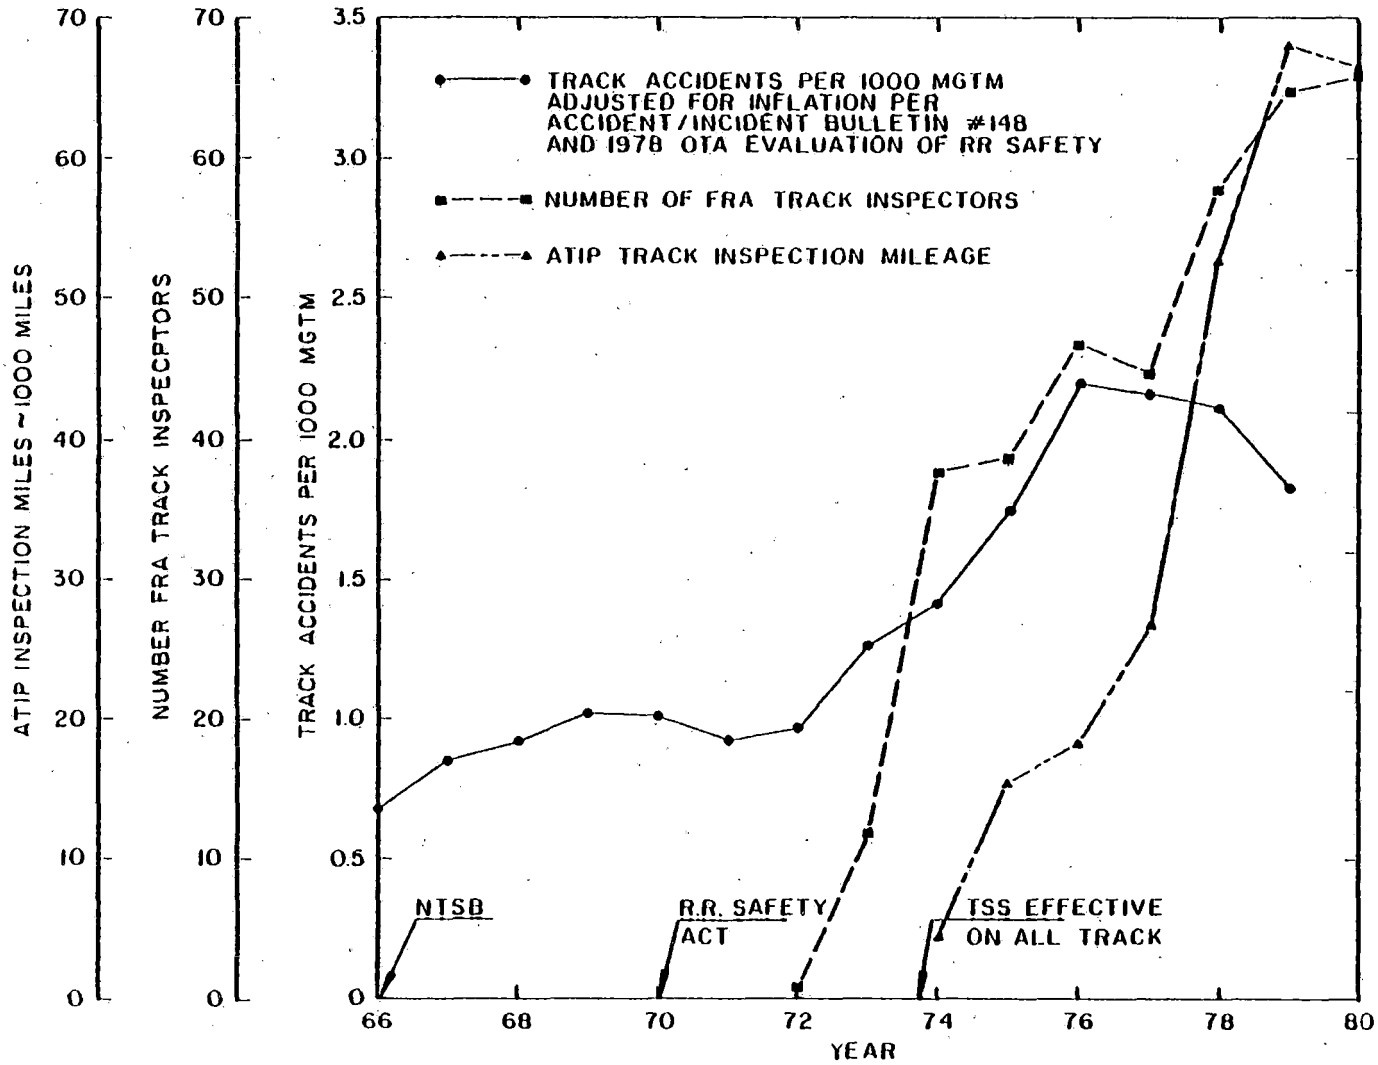
Figure 3-1. Comparison of Track Related Accidents and FRA Inspection Programs

Since the start of ATIP and the parallel increase in the number of FRA field inspectors, the previous upward trend of the track-caused accident rate has been reversed. The correlation between the increase in inspection efforts and the improvement in safety is impressive when plotted graphically on the same chart (see Figure 3-1).

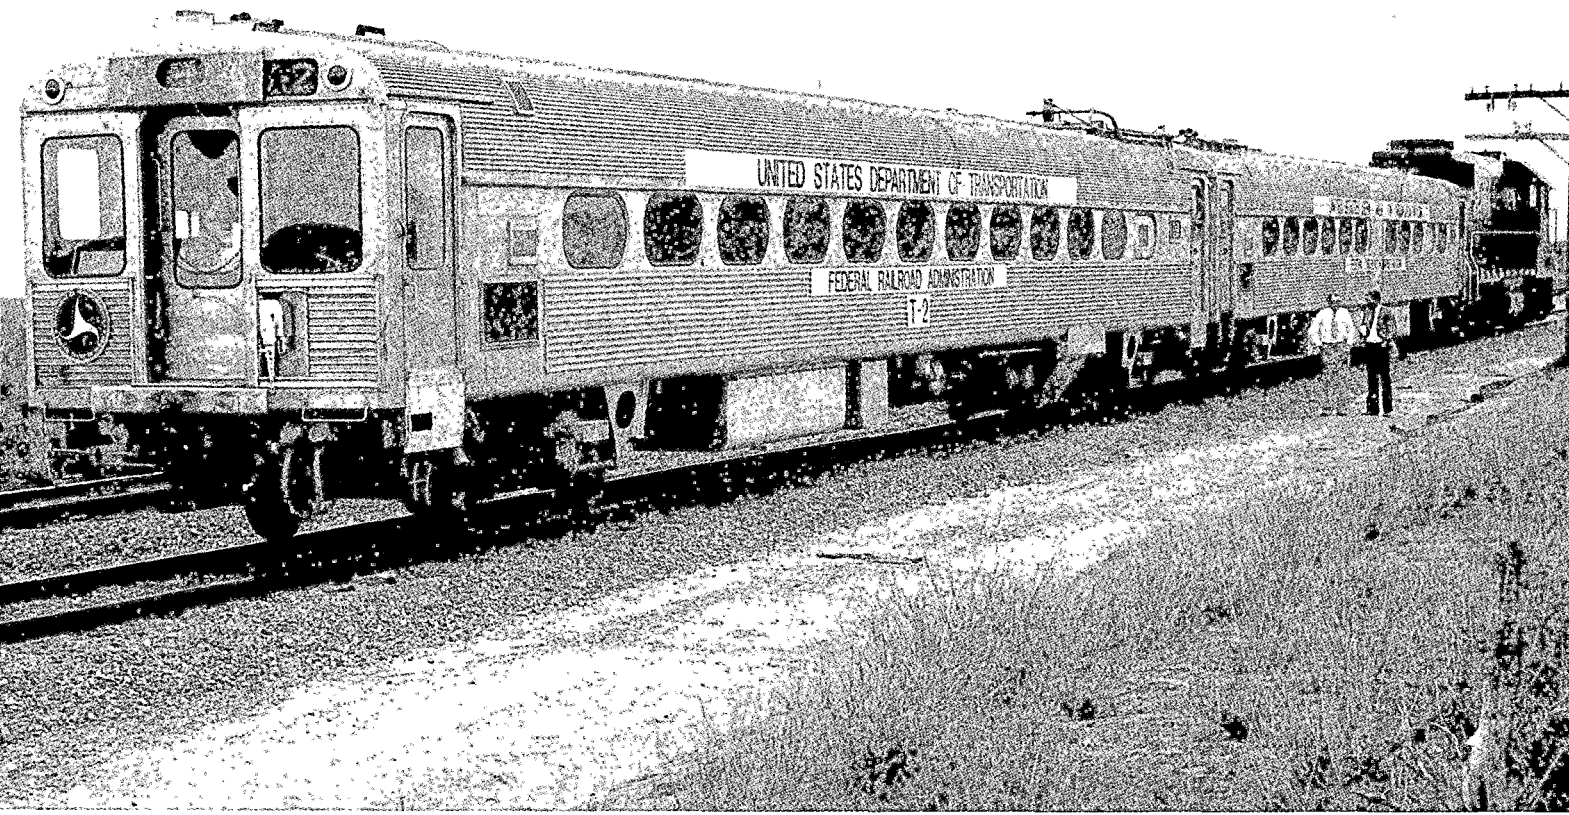
Through the use of advanced electronic sensing and data processing, the cars are able to collect track geometry data while traveling at speeds up to 120 miles per hour. In the measurement process, data are recorded on magnetic tape for computer processing, both on-line and off-line, and are simultaneously displayed on oscillographs. The oscillographs visually indicate the condition of the track being surveyed and are compared to the actual track as viewed from the rear of the survey vehicle by an FRA Track Safety Inspector and a Railroad representative.

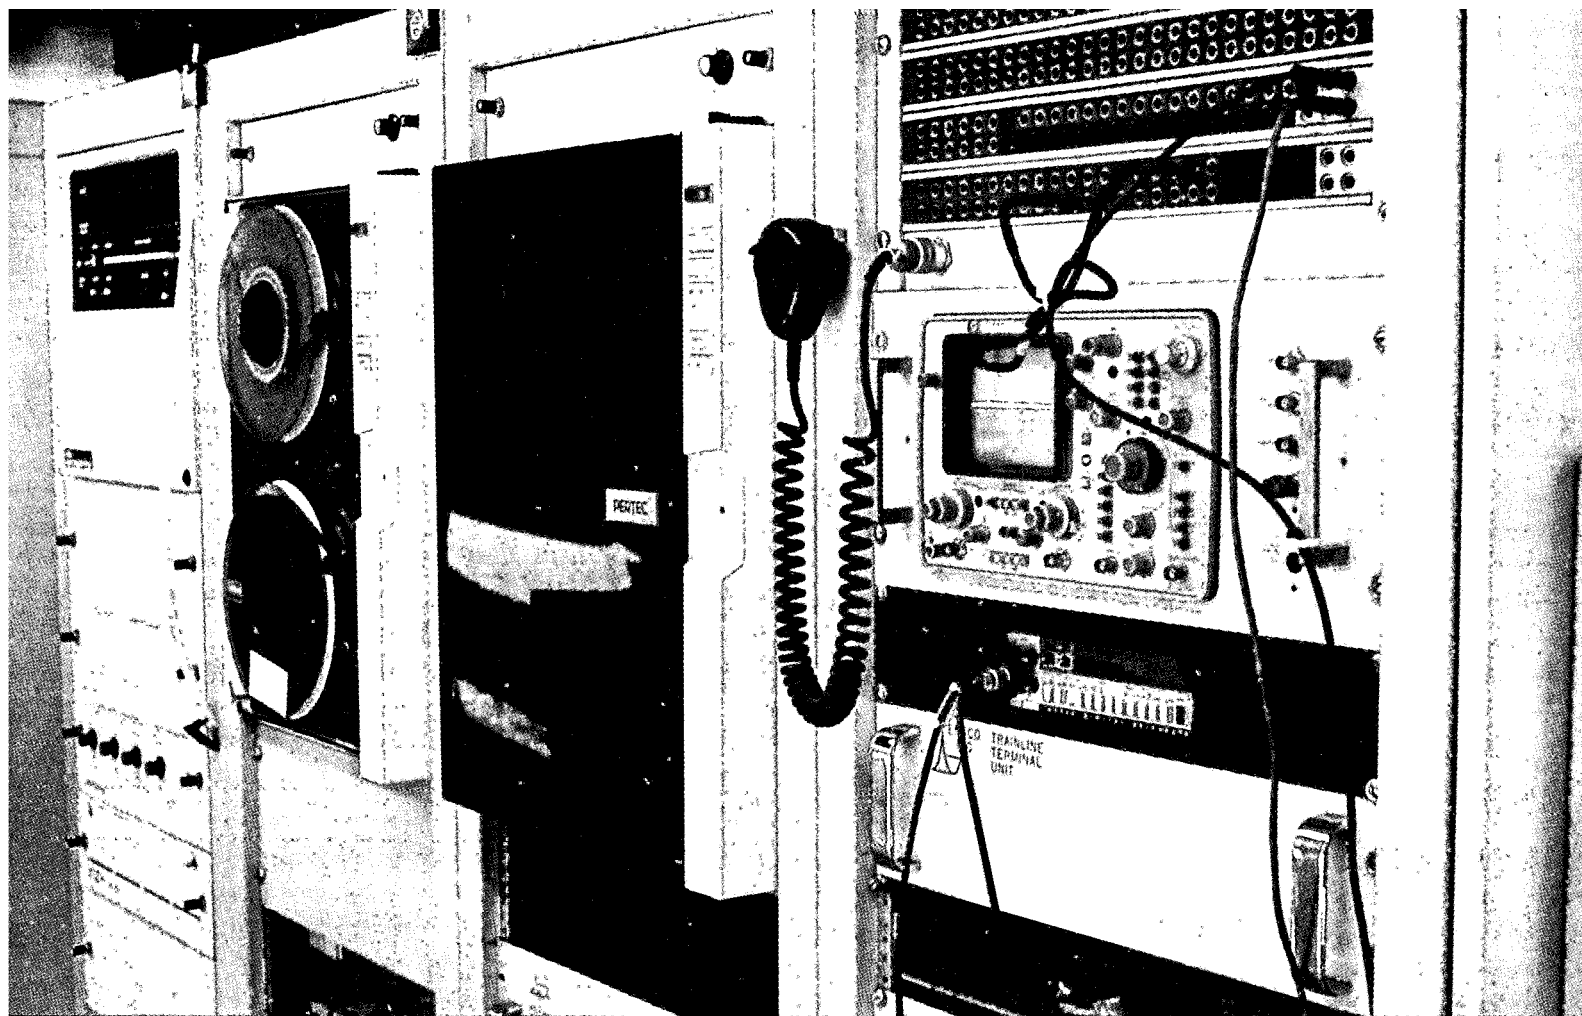
▲ DATA ACQUISITION DIGITAL COMPUTER SYSTEM

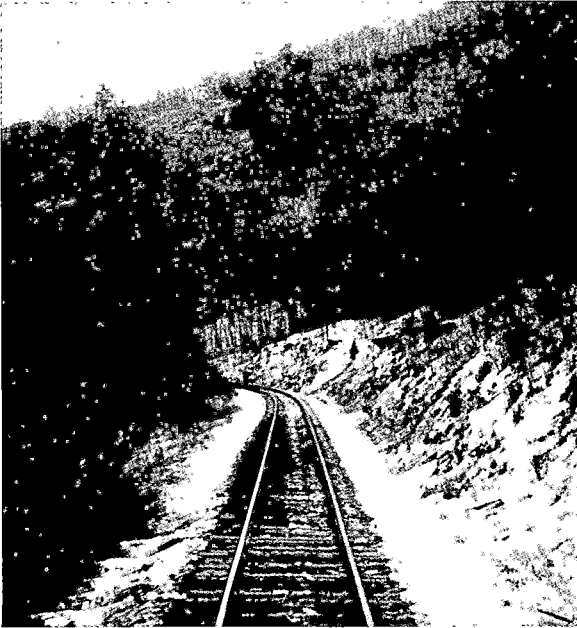
## TRACK SAFETY STANDARDS EXCEPTION REPORT LISTING EXAMPLE

This report documents the magnitude of any exceptions from the established Federal Track Safety Standards (FTSS) for profile, crosslevel, superelevation, warp, curvature, gage, and alignment. The detailed exception listings in this report provide FTSS information keyed to geographic location (i.e. distance from a milepost). The report is used as a tool by the Federal Track Safety Inspector to monitor compliance with Federal Track Safety Standards.
