REPORT NO. FRA/TTC-82/01

PROCEEDINGS

FAST Facility for
Accelerated
Service Testing
Engineering Conference 1981

**DENVER, COLORADO
NOVEMBER 4 & 5, 1981**

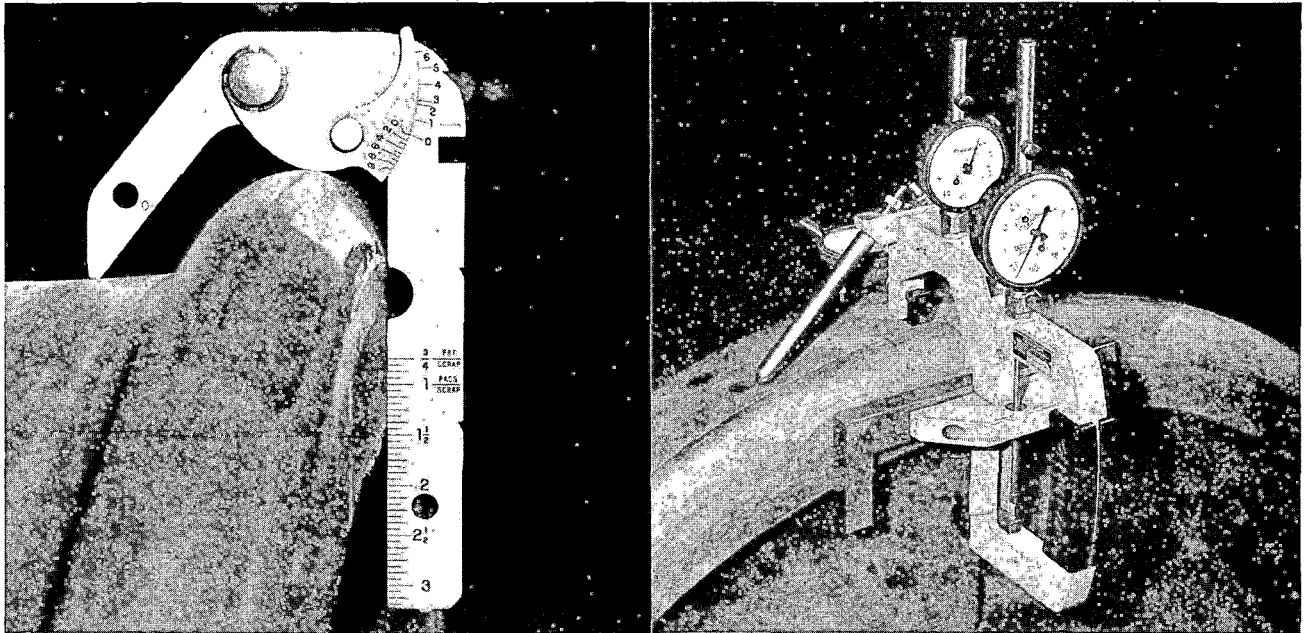
FIGURE 7. WHEEL POINT MEASUREMENTS.

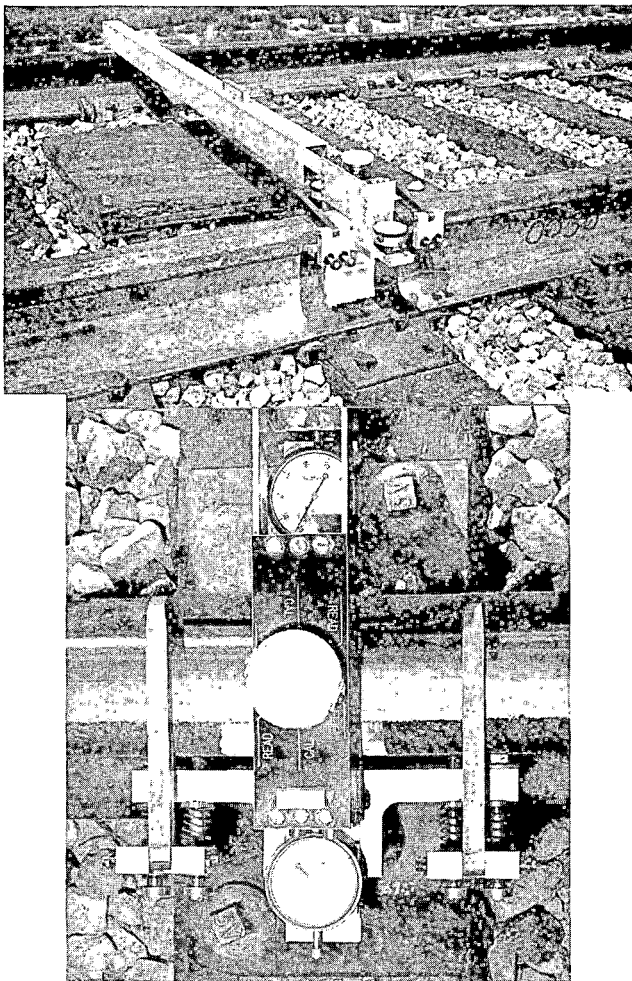
FIGURE 14a. GAGE POINT WEAR GAGE.

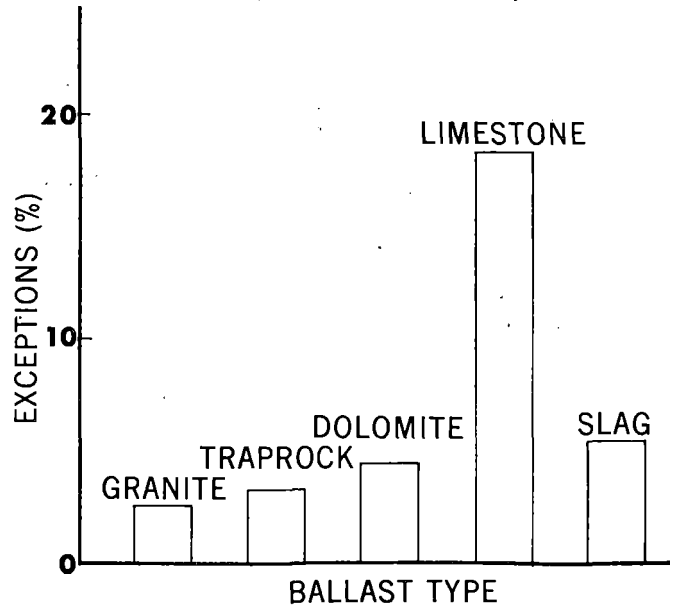
FIGURE 5b. TRACK GEOMETRY ALIGNMENT.

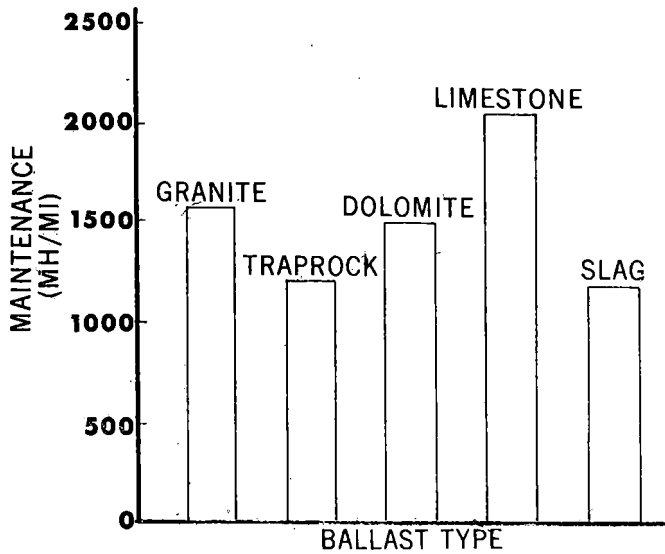
FIGURE 6. TOTAL MAINTENANCE EXPENDITURES.

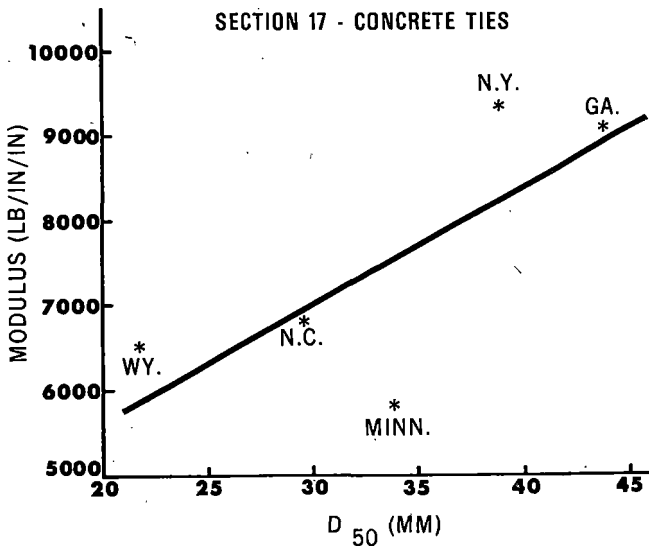
FIGURE 16. VARIATION OF TRACK MODULUS WITH PARTICLE SIZE.

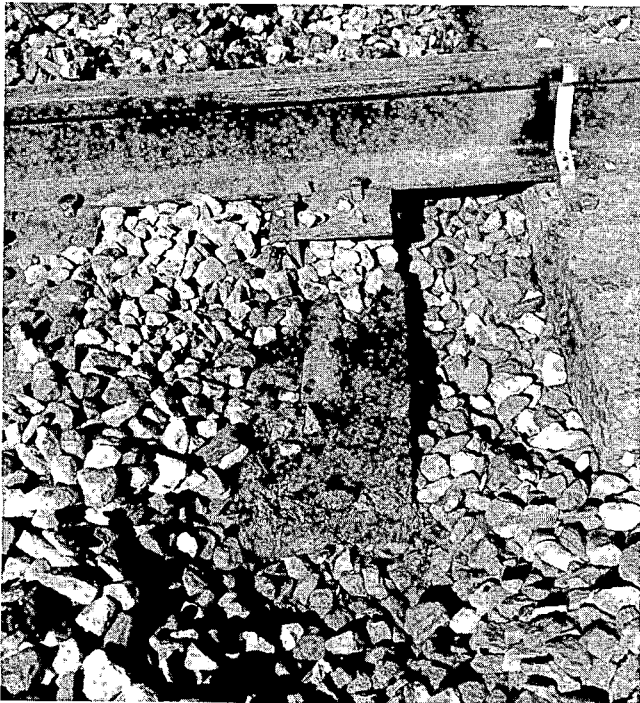
FIGURE 4. CEDRITE TIE DELAMINATIONS T-A-6.

In Section 9, nine Cedrite reconstituted ties have been removed in 610 MGT because of delaminations and breaking of the tie under the rail seat. A typical failure is shown in Figure 4. These ties, with the exception of the ties with 1/4" soft rubber tie plate pads under the rail seat, have also plate cut, seven of them severely. Figure 5 shows a plate cut tie without a tie pad and Figure 6 a tie with a tie pad. Even though these pads have protected the cedrite ties from being plate cut, early tie pad tests in Section 2, a 300' spiral into a 5° curve resulted in pad extrusion and failure after 359 MGT. An example of this type of failure is shown in Figure 7.

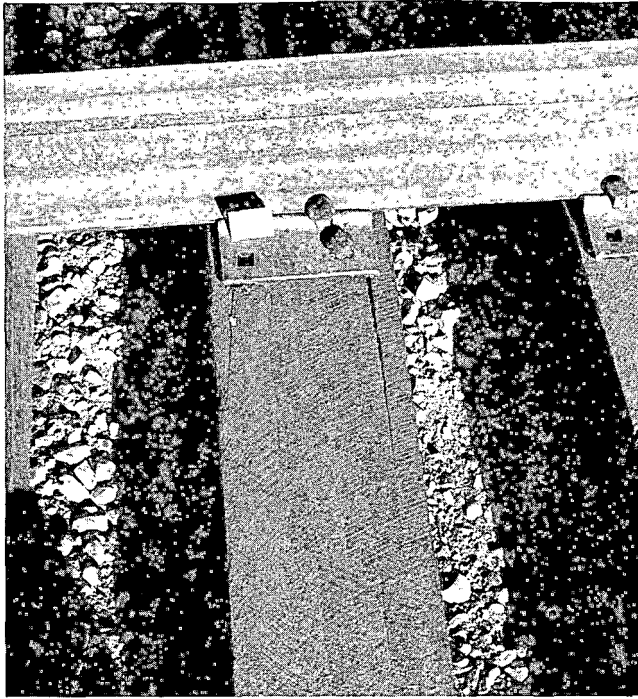
FIGURE 12. CROSS GRAIN LAMINATED TIE DELAMINATION.

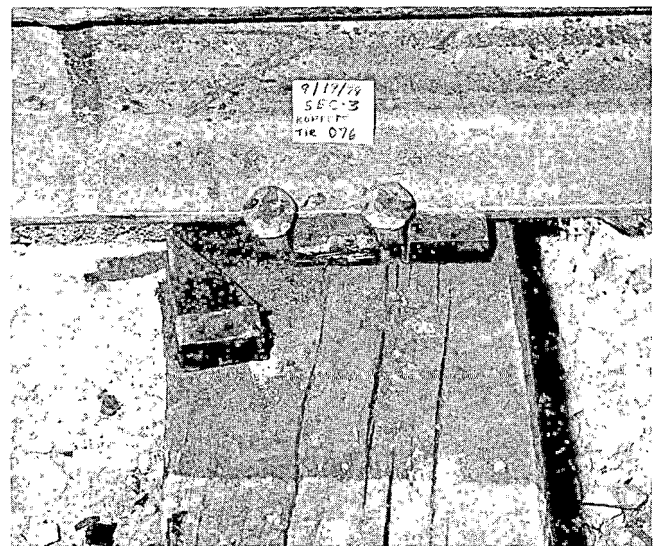
FIGURE 13. KOPPERS POLYETHYLENE TIE PLATE SHEAR FAILURE.

As a result of these failures and a subsequent dynamic wide gage of about 3/8" above static gage, the plates were removed and replaced with new ties and plates. The principal cause of the shear failures was a shallow 1/4" dap in the tie which was increased to 5/8" in subsequent tests.

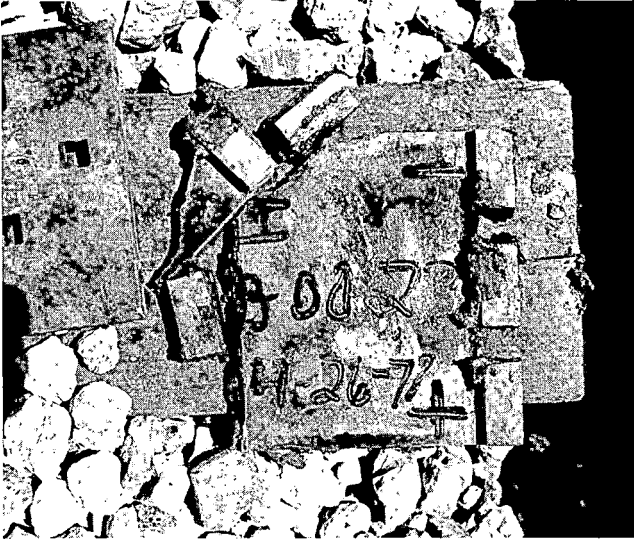
FIGURE 14. KOPPERS POLYETHYLENE TIE PLATE TRANSVERSE FAILURE.

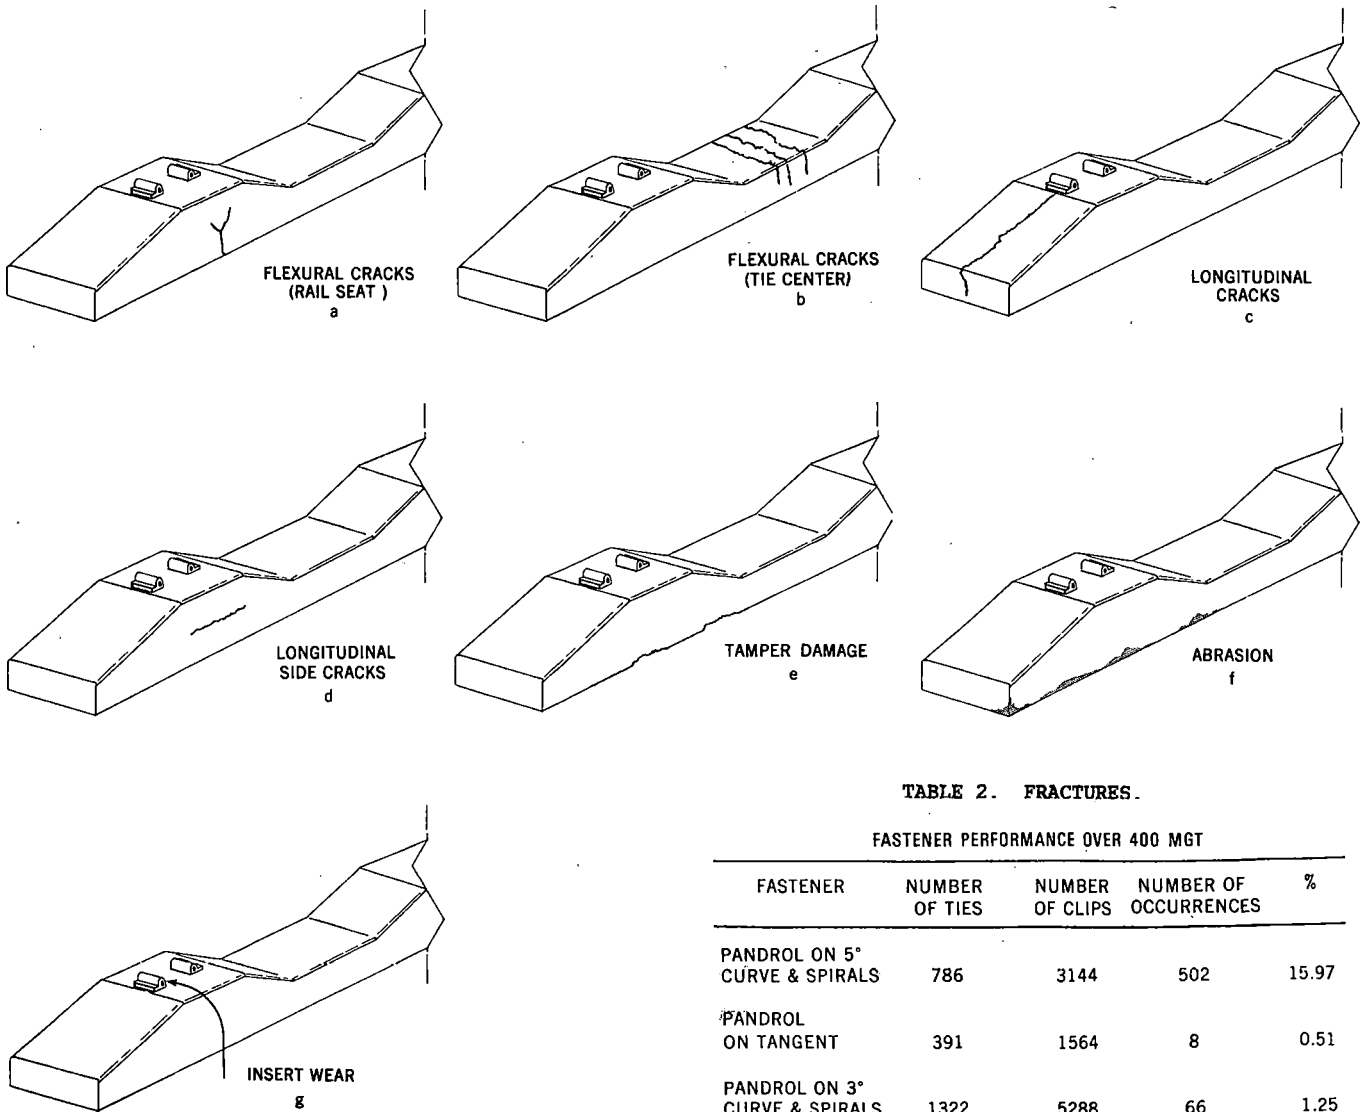
FIGURE 2. CONCRETE TIE DEFECTS.

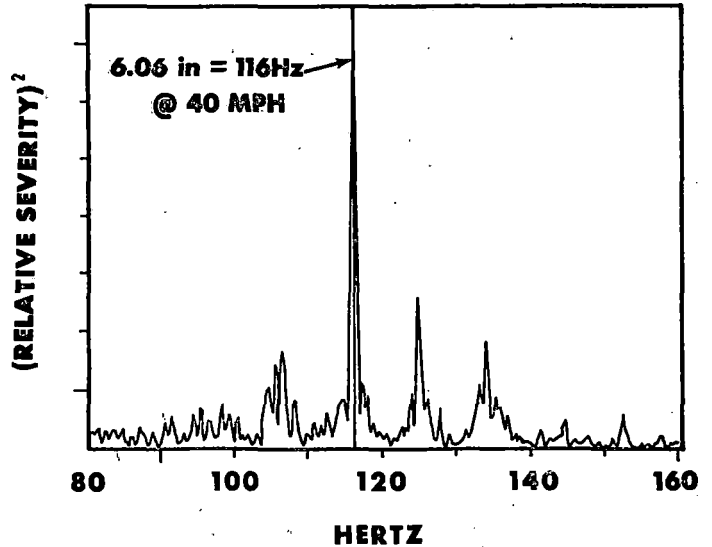
FIGURE 11. CORRUGATION WAVE LENGTH DISTRIBUTION.

the same as the fundamental frequency of the tie! A conclusion to be made is the wavelength of corrugations is defined by the vibrational frequency of the tie. Additional measurements at FAST confirm this conclusion including some preliminary work with wood ties which have a lower frequency and correspondingly longer wavelengths.

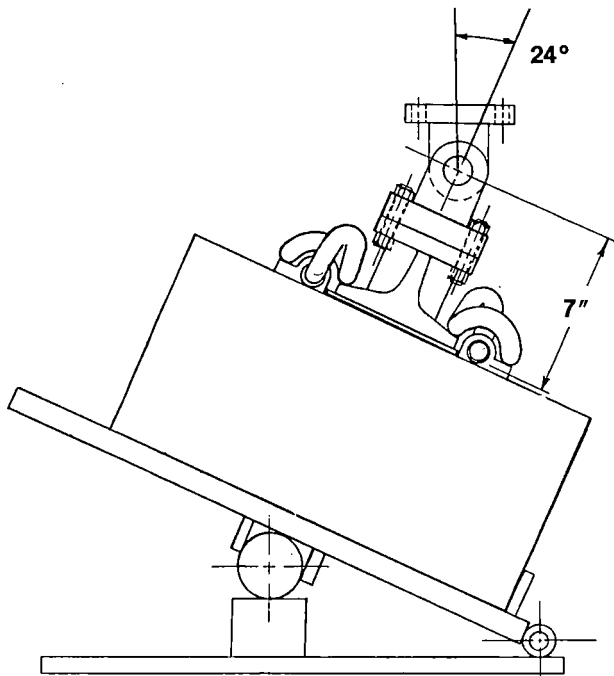
FIGURE 10. LOAD SCHEMATIC FOR CONCRETE TIE FASTENER FATIGUE TEST.

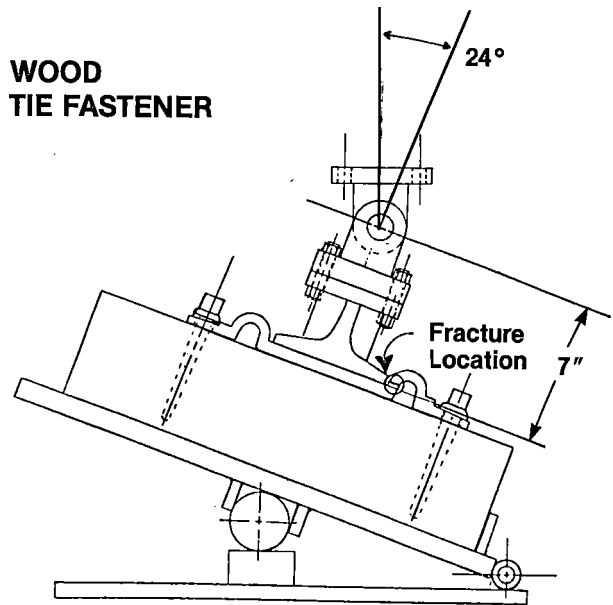
FIGURE 12. LOAD SCHEMATIC FOR WOOD TIE FASTENER FATIGUE TEST.

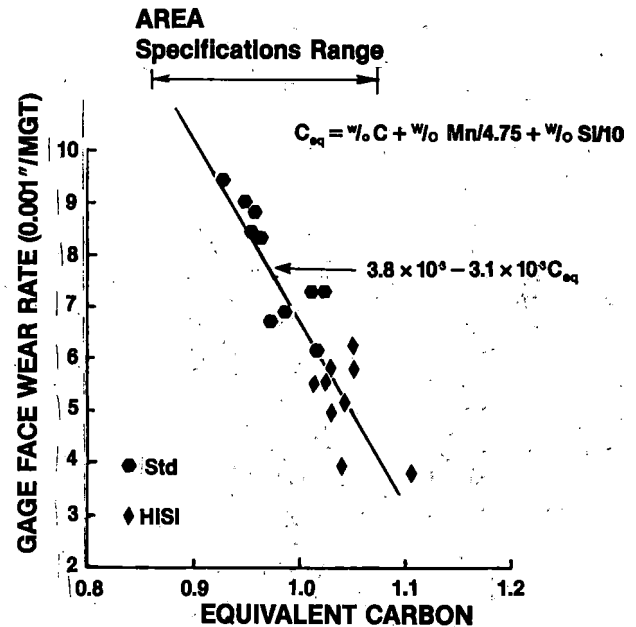
FIGURE 11. EFFECT OF EQUIVALENT CARBON LEVEL ON GAGE FACE WEAR RATE: RME I.

Figure 11 is a plot of gage face wear rate in the dry regime versus equivalent carbon calculated from ladle analyses after corrections have been applied for position-in-curve effects. Within the range of chemistry of the standard carbon rails tested, there was an approximate 50% variation in gage face wear rate. Within the range of equivalent carbon calculated from the extremes of C, Mn, and Si, content allowed by the AREA specifications* on rail, there could be as much as a 3:1 variation in wear rate. This behavior suggests that there may be some merit in segregating rails at the high end of the equivalent carbon range for more severe usage (in the fashion of "blue" rails some years ago). Also perhaps a very low cost premium rail could be developed near or just above the upper end of the current allowable AREA range.

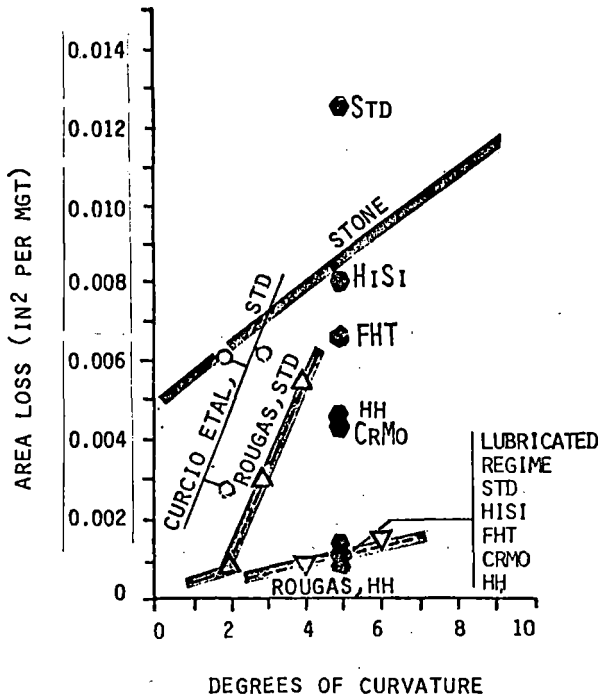
FIGURE 12b. FIELD COMPARED TO FAST DATA (COMPARING STONE, CURCIO, ROUGAS).

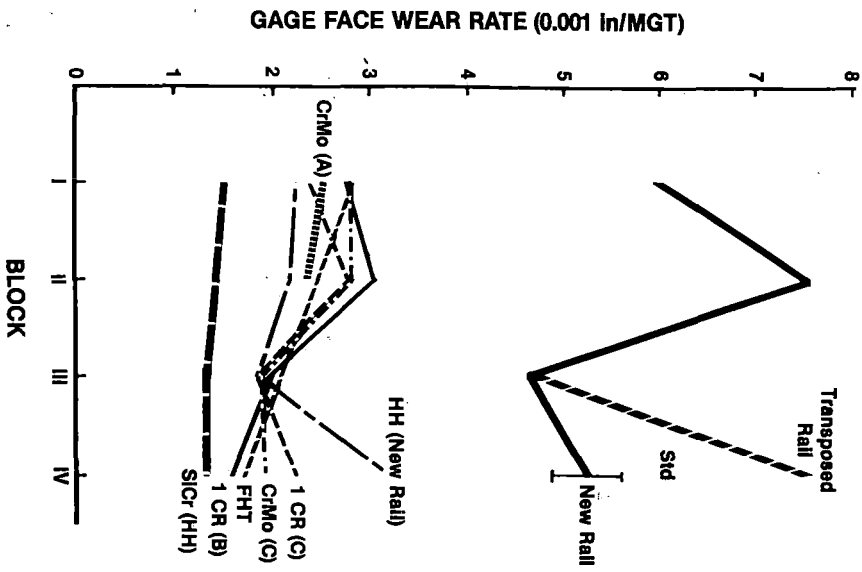
FIGURE 16b. GAGE FACE WEAR RATES; SECTION 17; DRY.

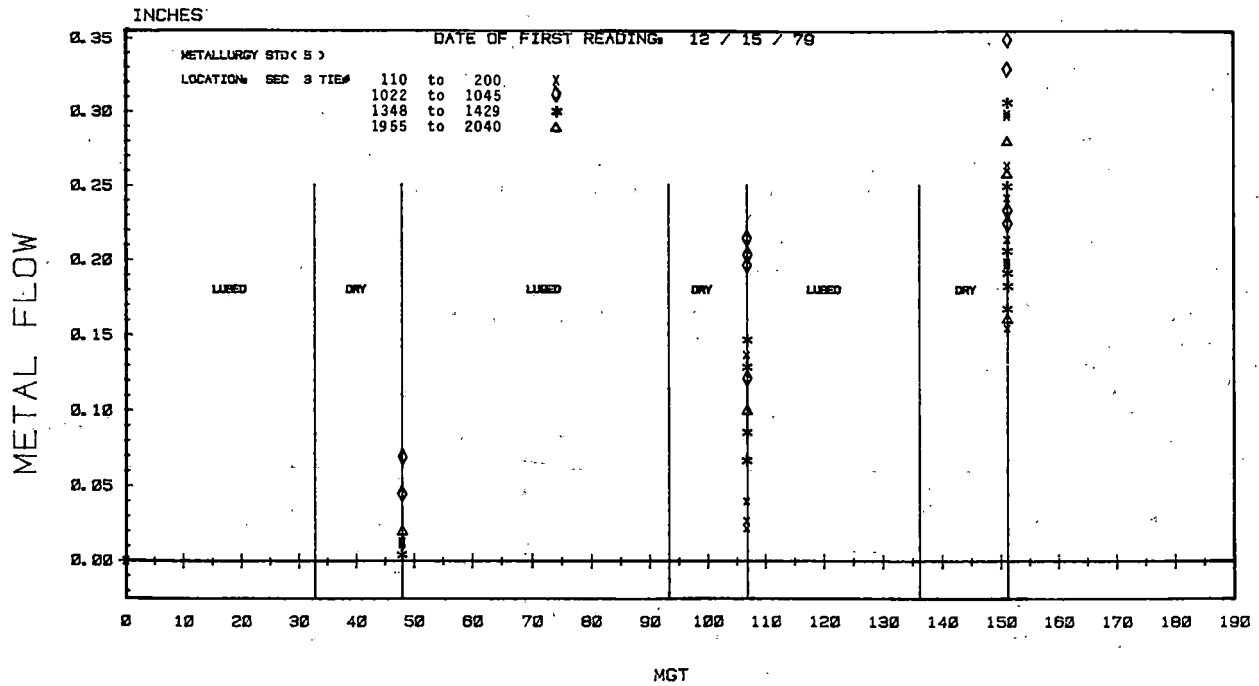
FIGURE 17a. METAL FLOW LOW RAIL FIELD MEASUREMENT
SNAP GAGE: RME III.

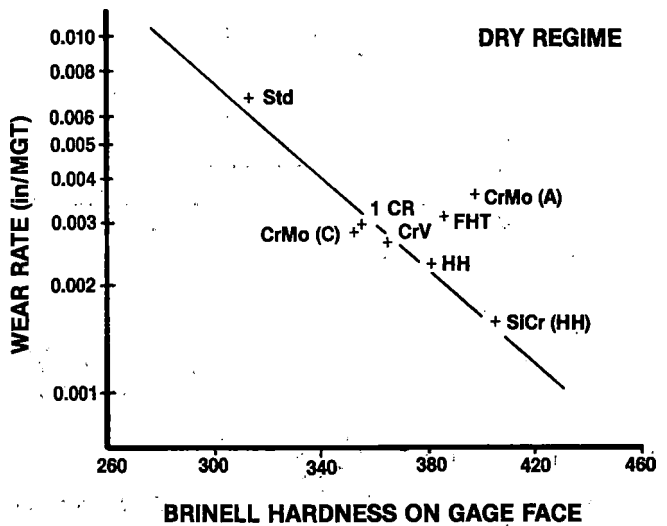
FIGURE 19a. WEAR RATES AS A FUNCTION OF HARDNESS: RME III.

Although hardnesses are available for the gage face of each of the different rail metallurgies (see Figure 19a), flange face hardnesses of wheels are not readily obtained with the instrumentation available at FAST. Therefore, to estimate flange face hardness, the microhardness data taken from near the flange surface to a depth of about 5½ mm as shown in Figure 74²⁷ for a FAST U wheel, have been used to determine that the flange metal near the surface is about 20 BHN harder than the base metal. Thus, the estimated flange hardness is taken as the measured rim Brinell hardness plus 20 BHN.

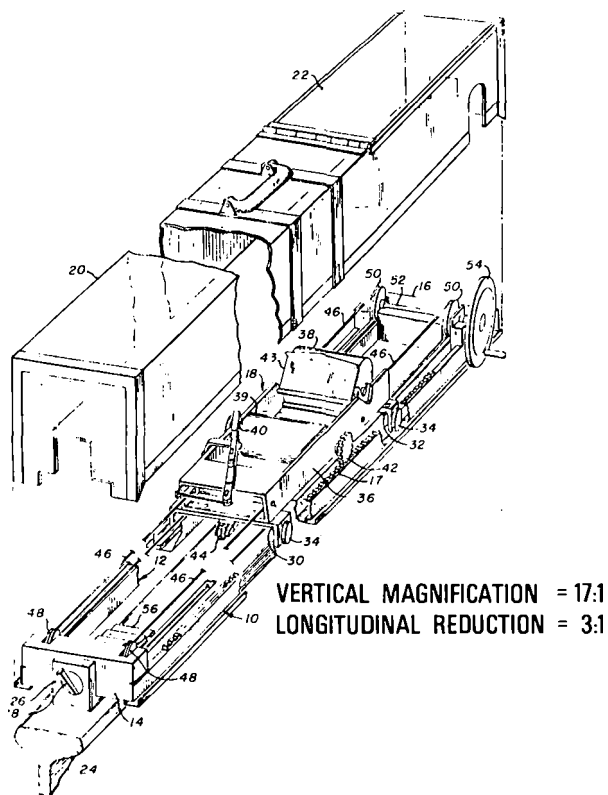
FIGURE 22. LONGITUDINAL RAIL PROFILOMETER.

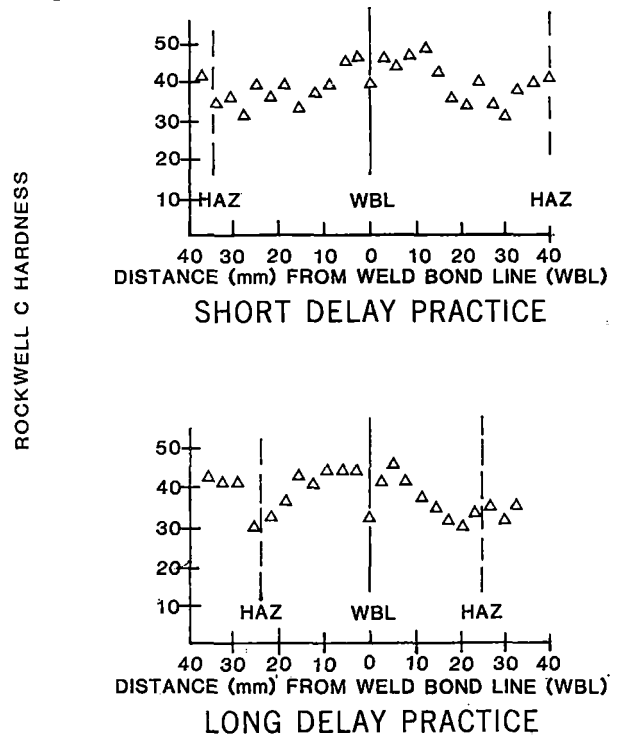
FIGURE 37a. HARDNESS AS A FUNCTION OF DISTANCE FROM WELD BOND LINE CrMo RAIL.

Figure 36a and 36b illustrate the fact that the short delay practice can cause the distance between the HAZ boundaries at the running surface to be about twice as large as that produced by the long delay practice--at least for CrMo(A) weldments on the 60 kA welder. The hardness profile in each of these welds just below the running surface is shown in Figures 37a and 37b.

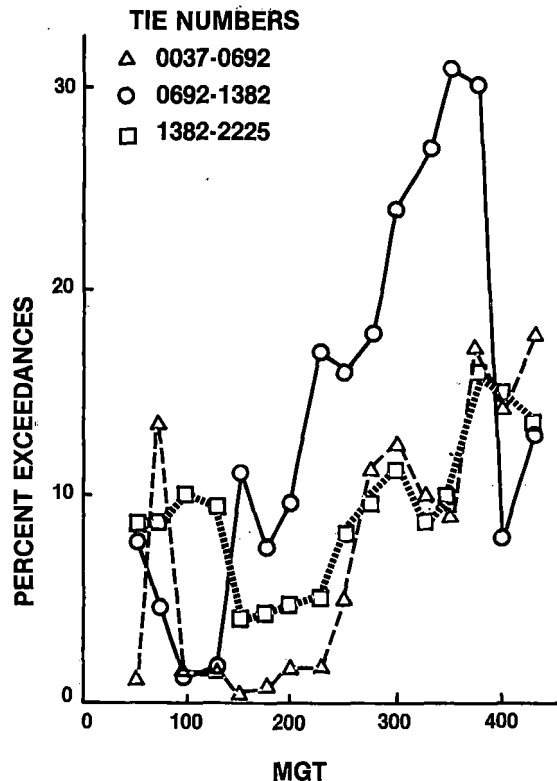
FIGURE 44. LOSS OF ALIGNMENTS BY TIE POSITION.

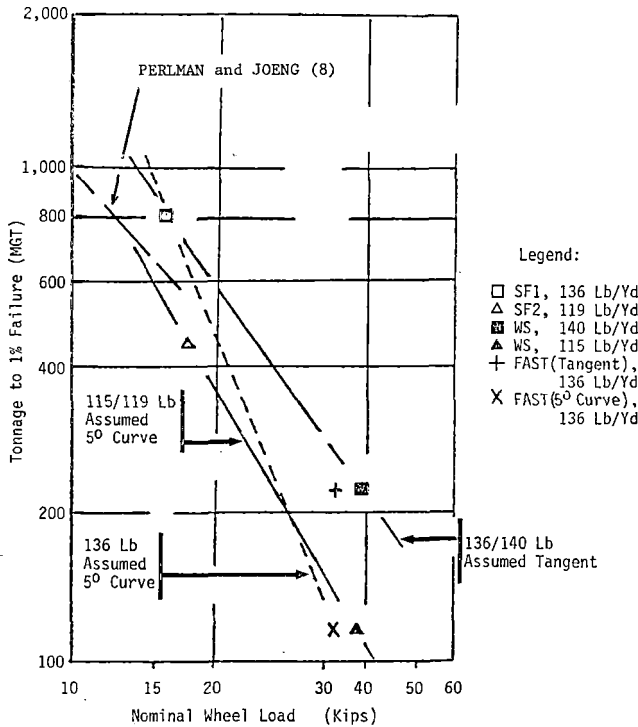
FIGURE 46. WHEEL LOADS VS RAIL FAILURES.

The effect of wheel load can be seen by using the FAST rail failure data in conjunction with the defect data of the Waynesburg Southern and two sites (SF1, SF2) of the AAR/AREA/AISI survey where wheel loads are known. The one percentile tonnages have been taken from the Weibull plot (Figure 45) and plotted on a log-log basis (Figure 46). Typically, the slope of the plots was near -1.5. A theoretical prediction by Perlman et. al.,⁷ (estimated at the five percentile life) using an amplified and attenuated Union Pacific load spectra is shown to have a just slightly lower wheel load dependency than that observed for service information. Laboratory tests for contact fatigue performed by British Rail⁹ and Nippon Steel¹⁰ exhibited slopes of -1.5 and -0.7 respectively.

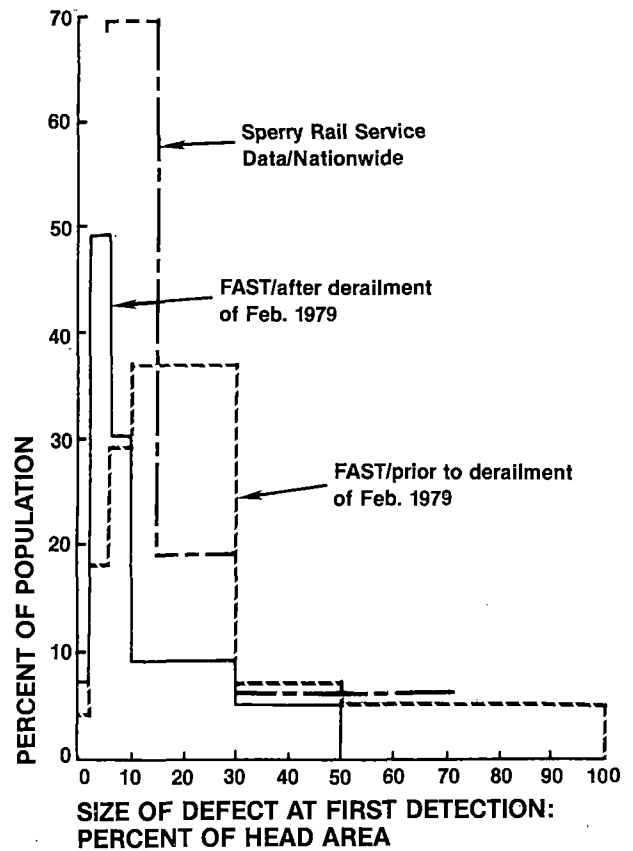
FIGURE 47. TRANSVERSE DEFECT SIZE DISTRIBUTION.

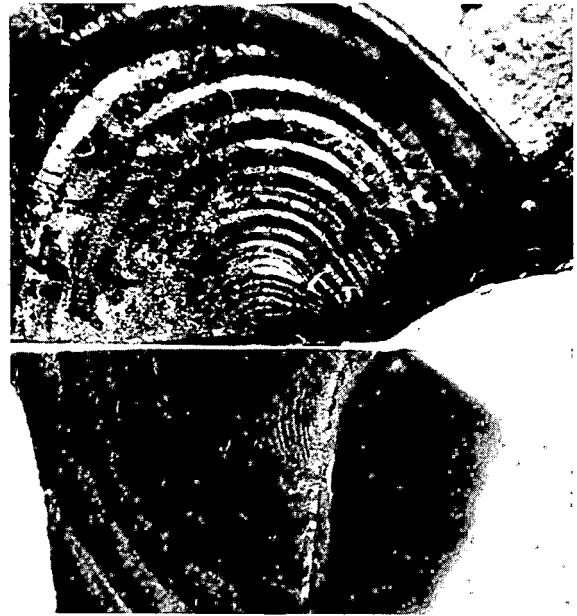
FIGURE 49. PLANT WELD FAILURE TRANSVERSE VIEW.

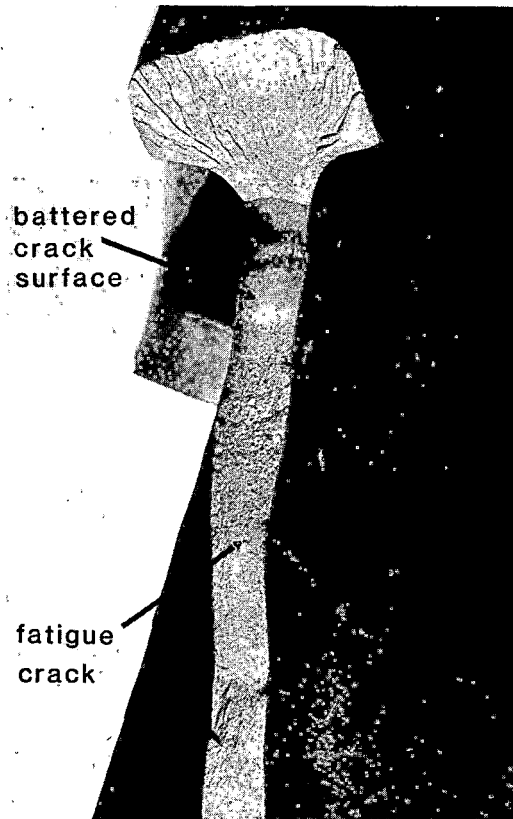
FIGURE 51. THERMITE WELD FAILURE.

Figure 51 shows a typical 'long' life failure of a thermite weld. The failure was somewhat unique because a clear cut indication of a fatigue crack can be seen at the edge of the cast region. In addition, a shiny battered region on the opposite side of the weld suggests that the crack traversed this region slowly enough to allow the surfaces to come together and develop the battered pattern. The circular shape of the battered region suggests that the possibility that it may also have been an origin. Many thermite weld failures fall into the 'infant mortality' category. Such a failure is shown in Figure 52. Although the weld was made in accordance with 'proper' procedure, shrinkage cracks developed in the head-web fillet region. Subsequent examination of the cracks revealed finger-like dendrites protruding from what was the liquid-solid interface (Figure 53). The solidification process had been starved of liquid metal. The likely cause was insufficient preheat or insufficient superheat of the liquid metal prior to pouring. Though the procedure may have been 'proper', it clearly was not adequate for the cold, windy day on which the weld was made.

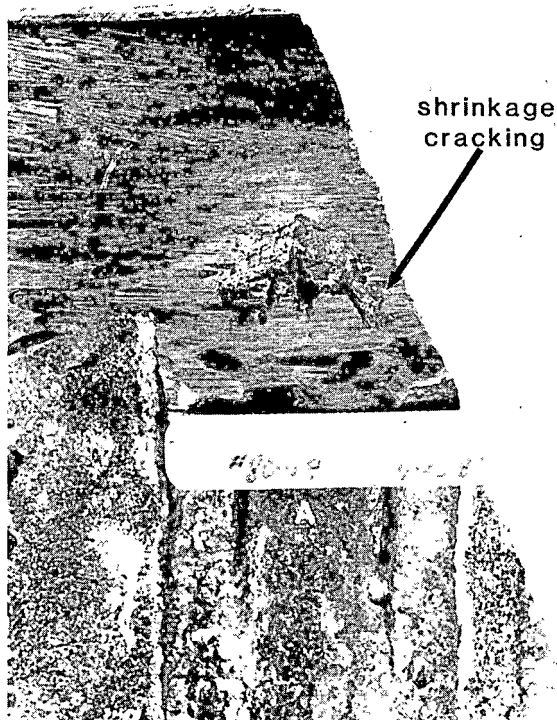
FIGURE 52. WELD FAILURE DUE TO COOLING SHRINKAGE.

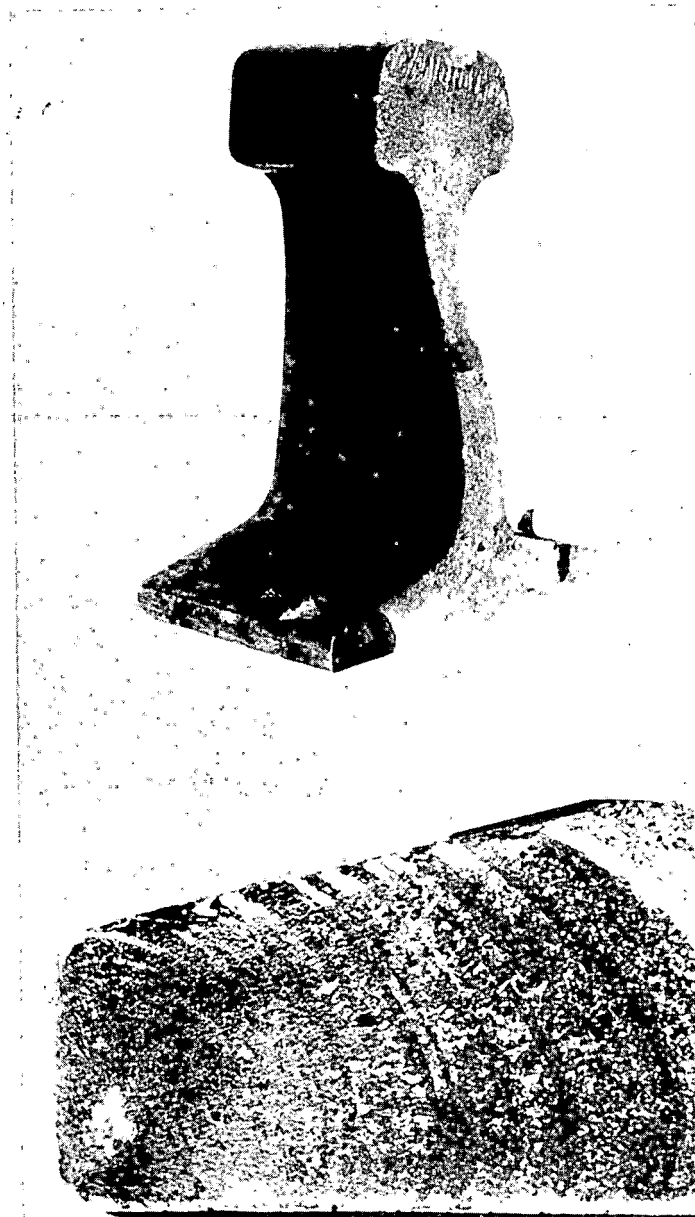
CLOSE UP VIEW OF FATIGUE CRACK
SURFACE AT THE END OF BASE

FIGURE 56. OVERALL AND CLOSE-UP VIEWS OF FATIGUE CRACK
SURFACE AT THE END OF BASE.

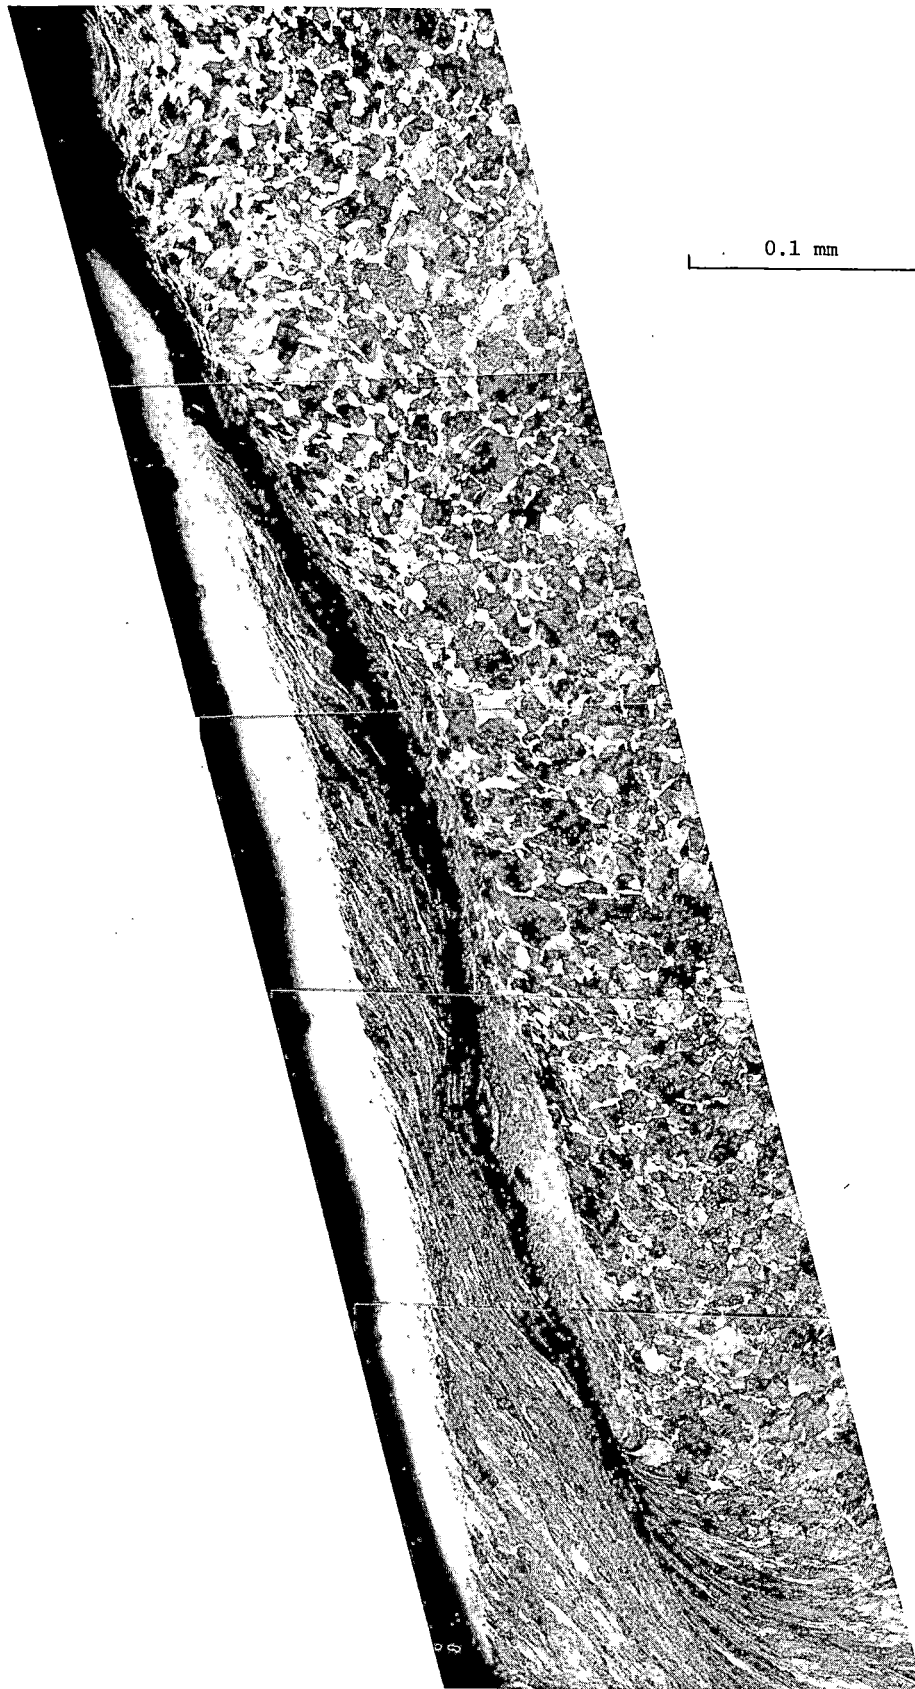
FIGURE 57. MICROGRAPH OF TRANSVERSE SECTION SHOWING
WHITE ETCHING LAYER AND DECARBURIZATION
AT EDGE OF RAIL BASE.

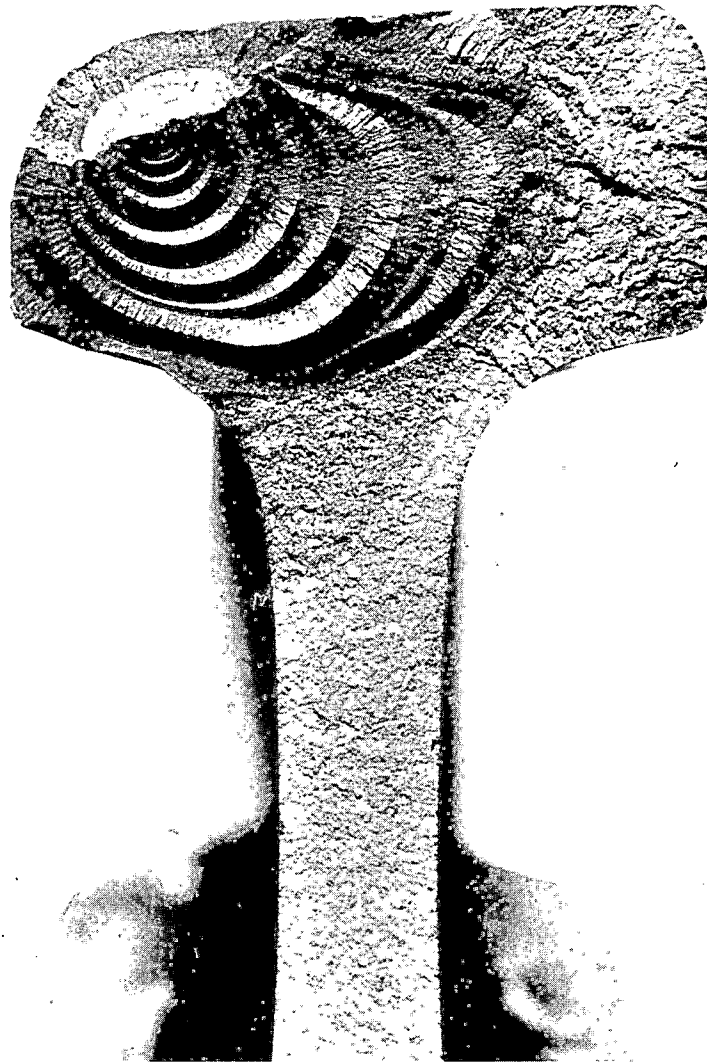
FIGURE 60. DETAIL FRACTURE FROM SHELL.

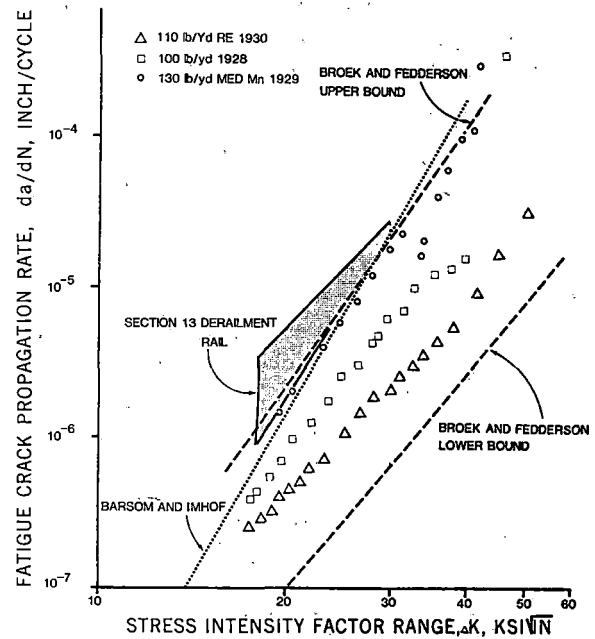
FIGURE 65. VARIABILITY OF FATIGUE CRACK PROPAGATION RATE BEHAVIOR.

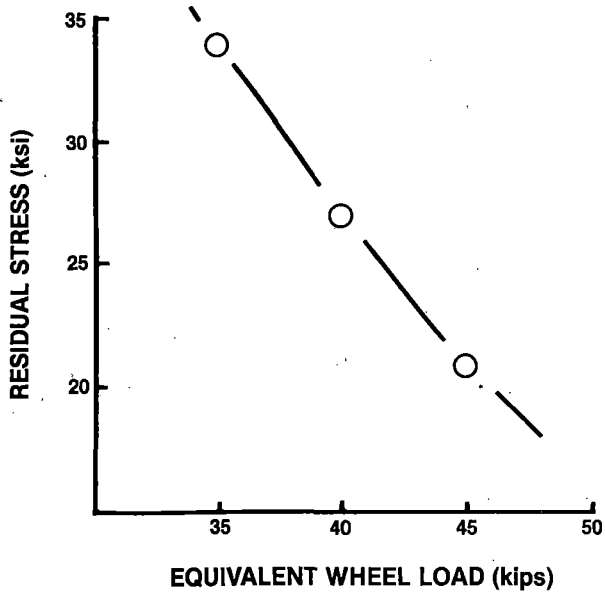
FIGURE 67. WHEEL LOAD/RESIDUAL STRESS COMBINATIONS FOR OBSERVED CRACK GROWTH.

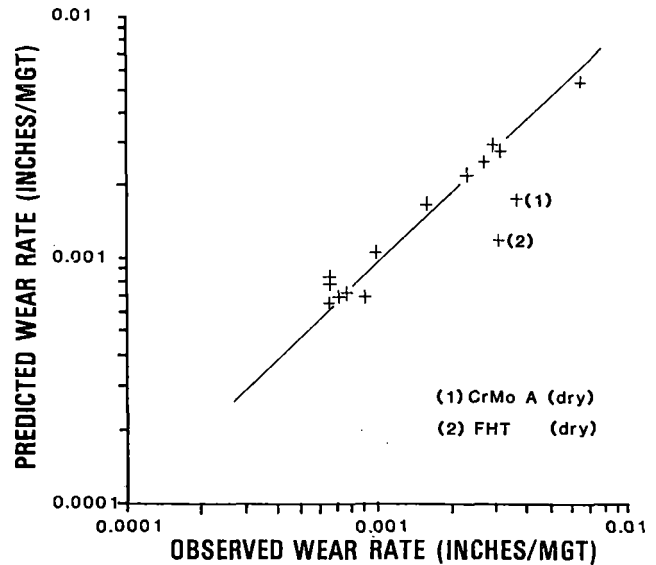
FIGURE 70. PREDICTED VS. OBSERVED GAGE FACE WEAR RATES.

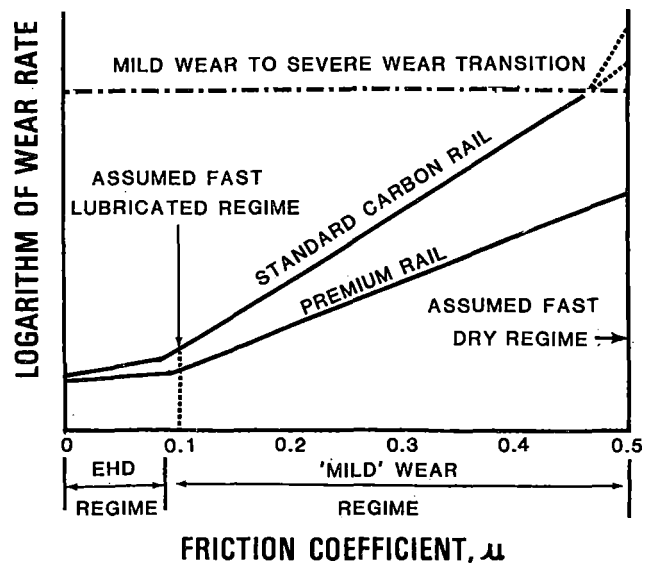
FIGURE 71. CONCEPTUAL VIEW OF CHANGE IN WEAR MECHANISM WITH INCREASING FRICTION COEFFICIENT.

The transition in modes is shown conceptually in Figure 71 as the friction coefficient changes. A variant on the model is a transition to severe wear

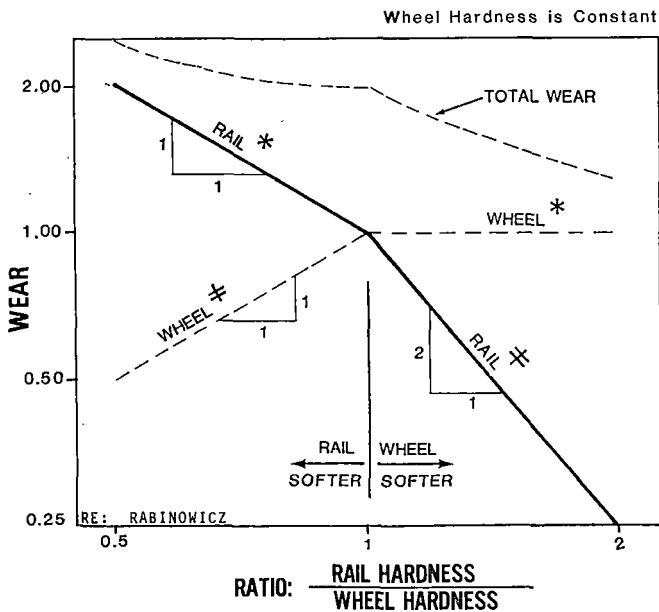
FIGURE 73. COMBINED PRESENTATION OF RAIL/WHEEL WEAR INFORMATION.

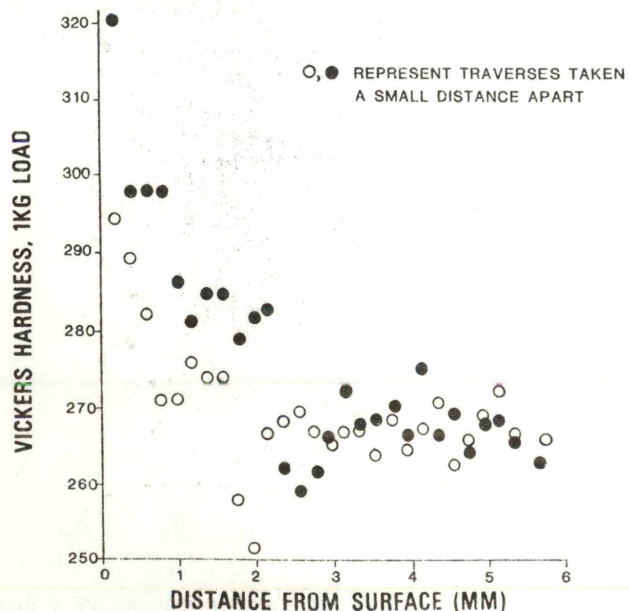
FIGURE 74. HARDNESS PROFILE IN A WHEEL FLANGE.

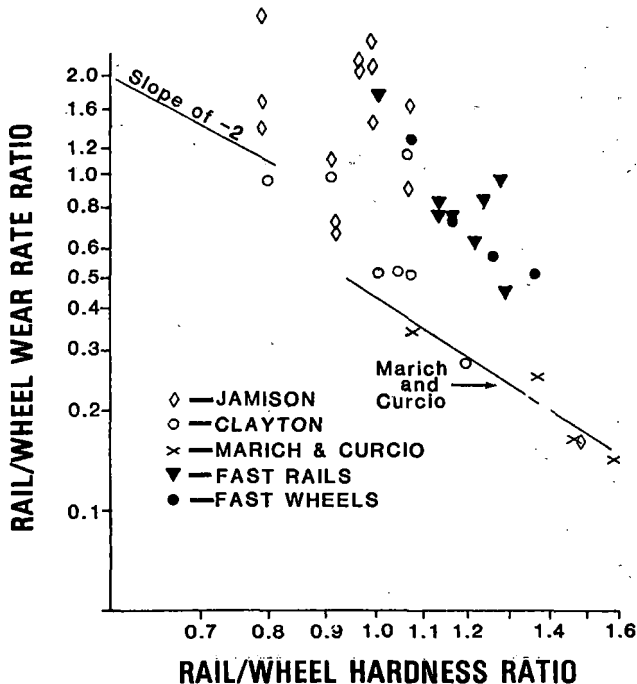
FIGURE 77. RAIL/WHEEL WEAR RATE RATIO AS A FUNCTION OF RAIL/WHEEL HARDNESS RATIO.

By using a somewhat different format, i.e., wear rate ratio* vs hardness ratio, the FAST wheel and rail wear rate data can be compared with that of other investigators. The FAST data for wheels and rails is shown in Figure 77 to be very close to that of Clayton²³ for field observations and Jamison²⁴ for laboratory tests, all three of which have disposition inclined more steeply than that for adhesive wear. Only the information of Marich & Curcio²⁴ approaches a slope of -2. However, before leaving this topic the data of Jamison should be examined more closely. Some specific data has been plotted in Figure 78. It appears that when the relative humidity is low, the slope of the wear rate ratio vs hardness ratio plot becomes quite steep. However, when the relative humidity is high, the disposition of the data is far less steeply inclined. This leads one to wonder if the FAST data would appear differently disposed if it were determined in a more humid area (although the Clayton field data was determined in the UK -- certainly a more humid environment than that of Pueblo, Colorado).

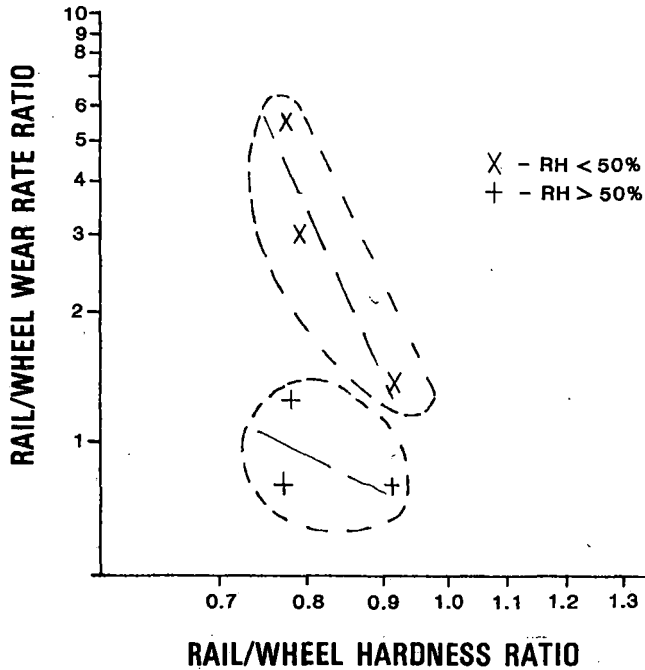
FIGURE 78. JAMISON DATA.

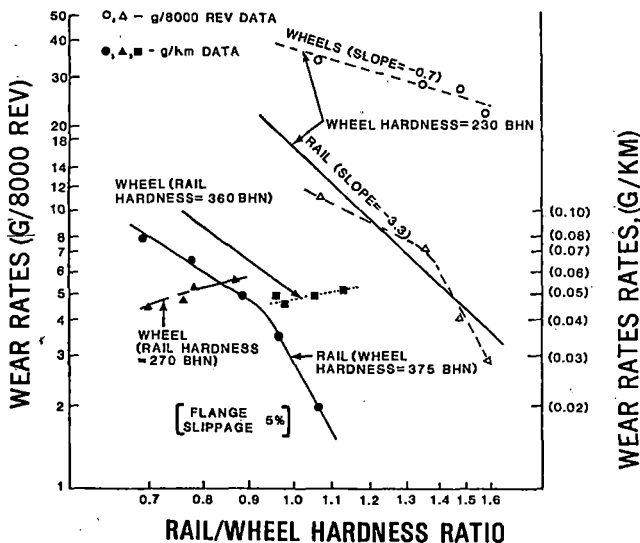
FIGURE 79. LABORATORY RAIL: WHEEL DATA OF 'MARICH AND CURCIO' AND 'MARICH AND MUTTON'.

Some additional insight can be gained by plotting the individual wheel and rail specimen wear rates of Marich and Curcio²⁵ and Marich and Mutton²⁶ in the fashion proposed by Rabinowicz. This is done in Figure 79. The wheel data tended to show two different behavior patterns; in one case (upper right) the wheel wear rate decreased as the rail hardness increased while in the other case (lower left) the wheel wear rate increased very slightly as the rail hardness increased over a limited range. Strangely, when 360 BHN rail was substituted for 270 BHN rail the wheel wear rate diminished for a given rail to wheel hardness ratio. The rail behavior in each case (each investigation) behaved somewhat similarly

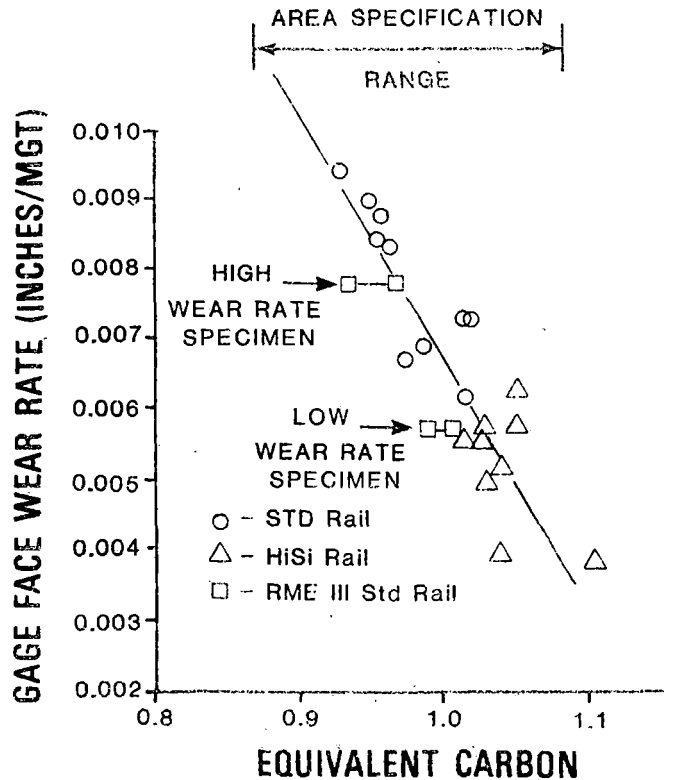
FIGURE 82. EFFECT OF EQUIVALENT CARBON LEVEL ON GAGE FACE WEAR RATE.

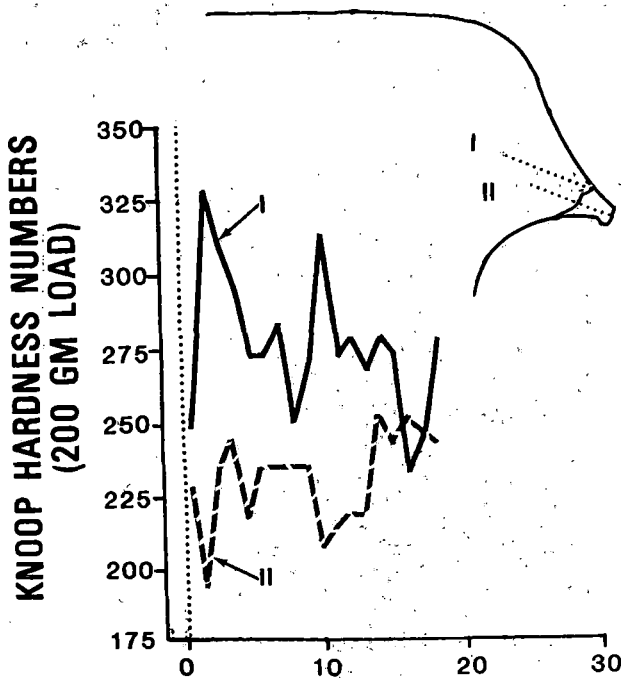
FIGURE 86. HARDNESS VARIATION WITH DEPTH.
