REPORT NO. FRA/TTC-82/01

PROCEEDINGS

FAST Facility for
Accelerated
Service Testing
Engineering Conference 1981

**DENVER, COLORADO
NOVEMBER 4 & 5, 1981**

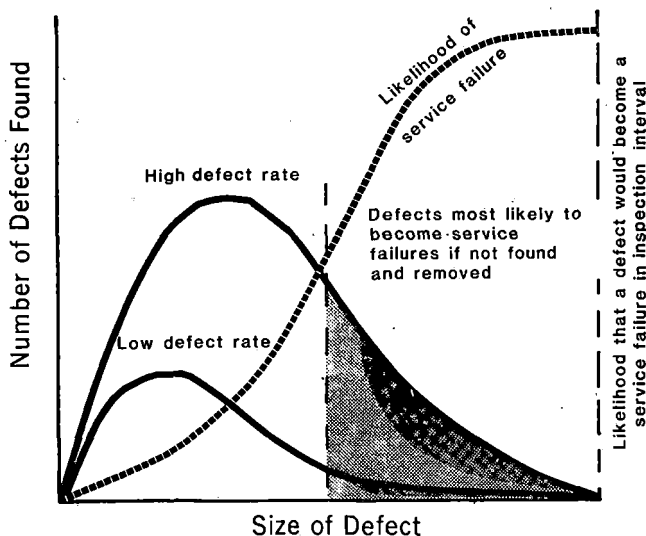
FIGURE 90. SIZE OF DEFECT.

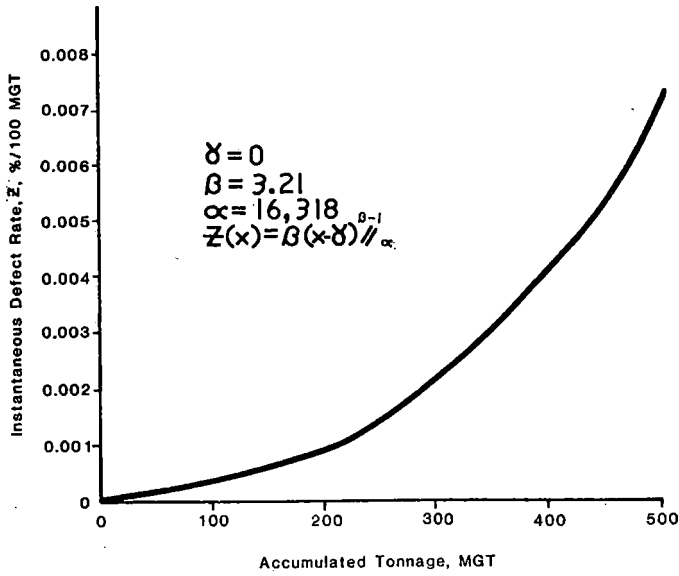
FIGURE 91. INSTANTANEOUS DEFECT RATE AS A FUNCTION OF SERVICE EXPOSURE.

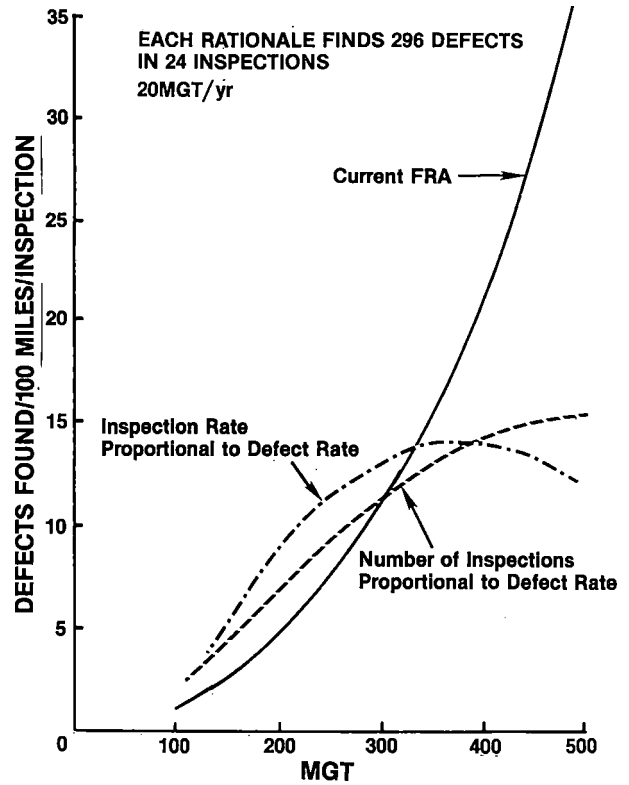
FIGURE 94. DEFECTS FOUND AS A FUNCTION OF TONNAGE.

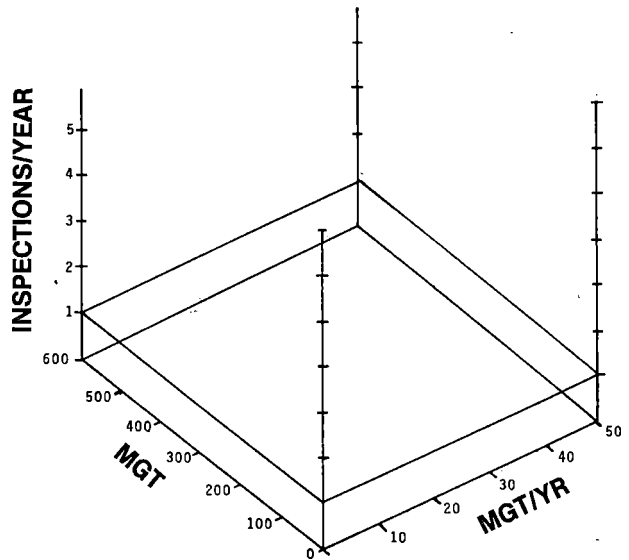
FIGURE 95a. CURRENT FRA INSPECTION REQUIREMENTS.

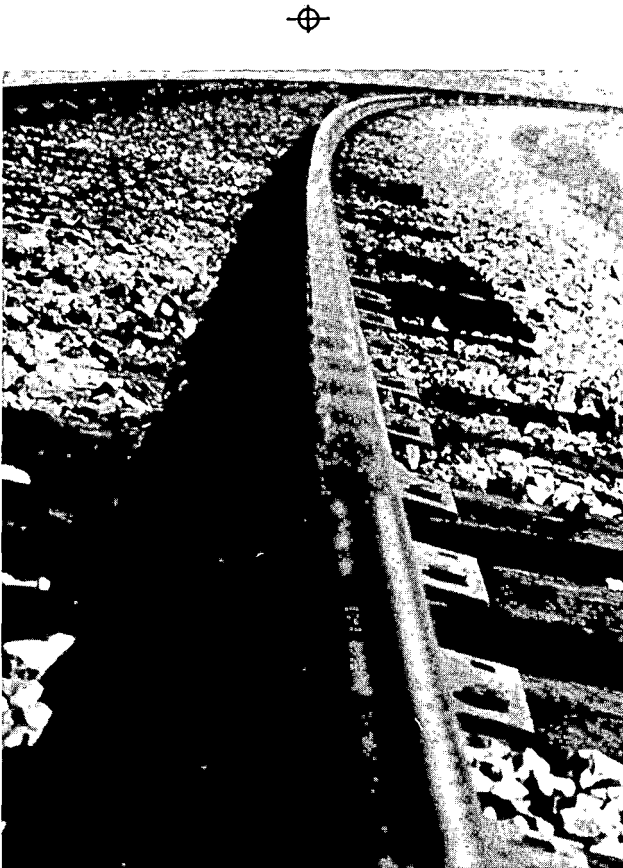
FIGURE 1. LOW RAIL CORRUGATIONS AT SECTION 3, 5°
CURVE, 73 MGT.

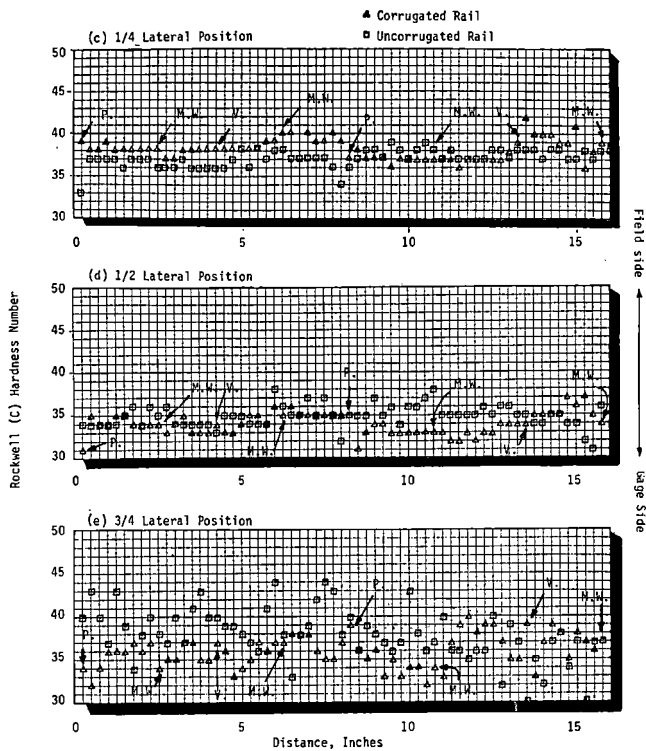
FIGURE 9. ROCKWELL (C) HARDNESS NUMBER VARIATIONS ALONG 16 INCHES OF CORRUGATED AND UNCORRUGATED RAIL.

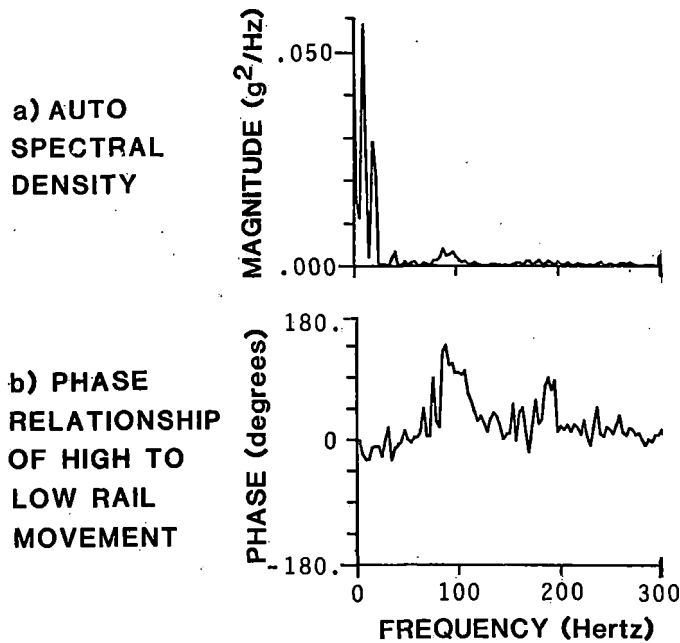
FIGURE 13. RESULTS OF RAIL WEB LONGITUDINAL ACCELERATION MEASUREMENTS, SECTION 3, 5° CURVE, NEAR TIE 825, SPEED = 43 MPH.

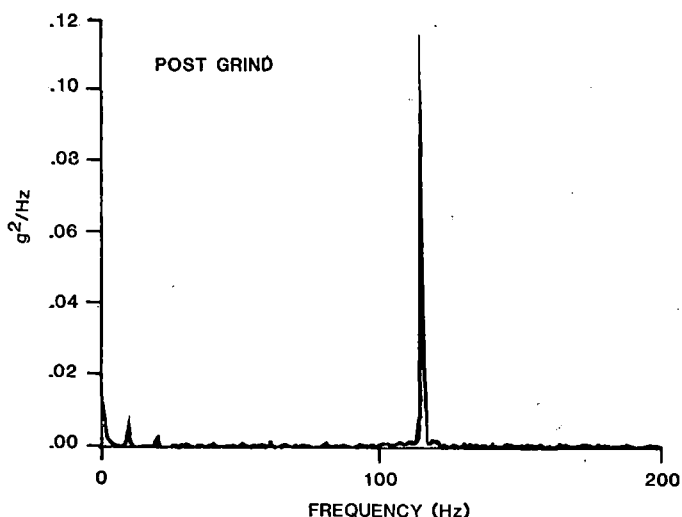
FIGURE 14. AUTO SPECTRUM - SECTION 17, TIE 400-500, AVERAGE CONSIST SPEED = 40 MPH.

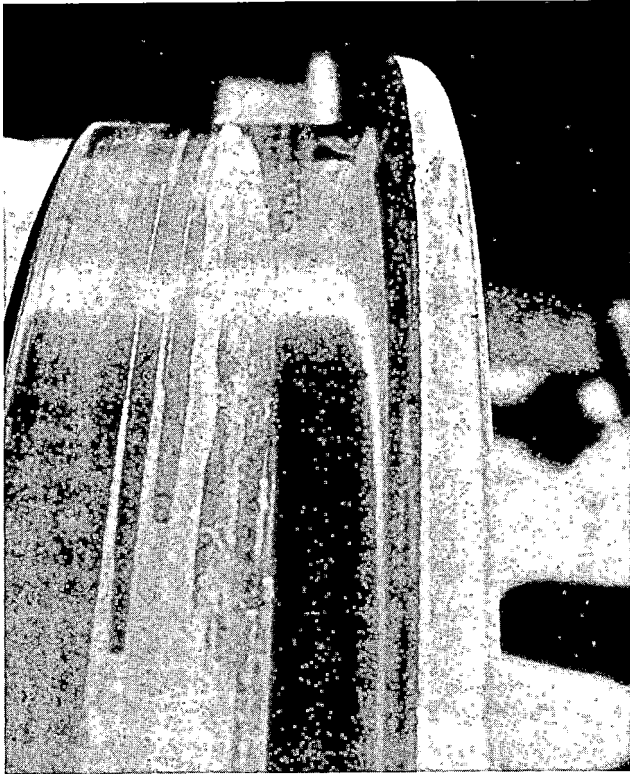
FIGURE 1. TYPICAL WHEEL WEAR PATTERN SHOWING EXCESSIVE FLANGE WEAR.

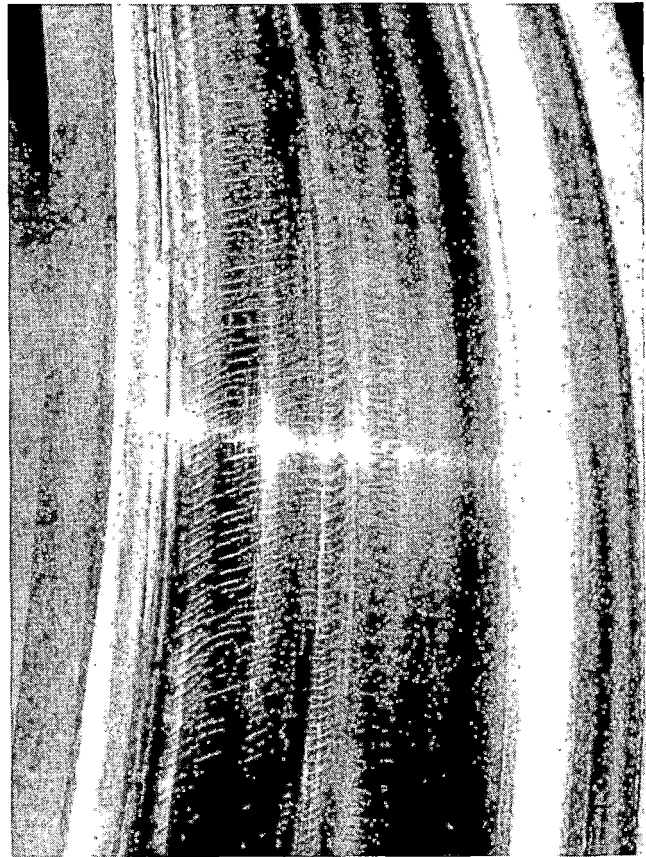
FIGURE 6. OBLIQUE TREAD CRACKS

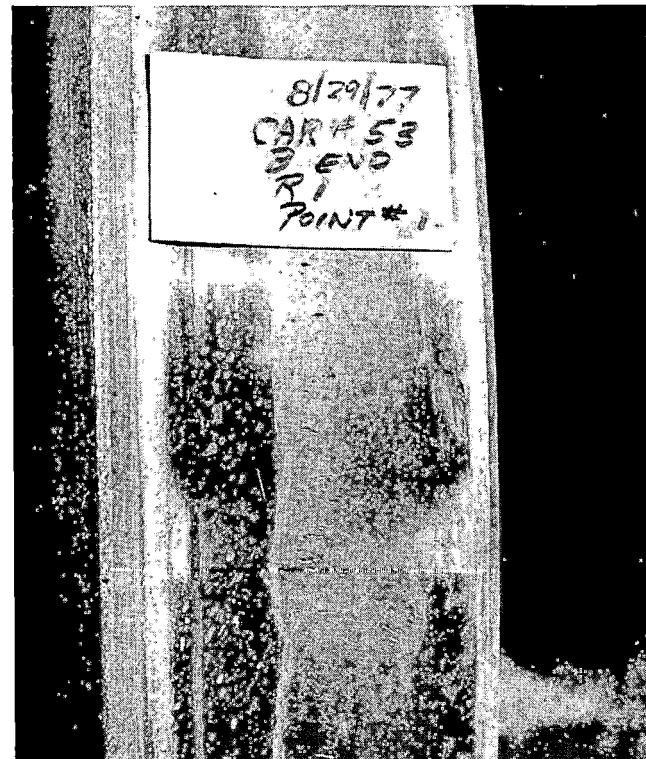
FIGURE 7. INITIAL TREAD SHELLING

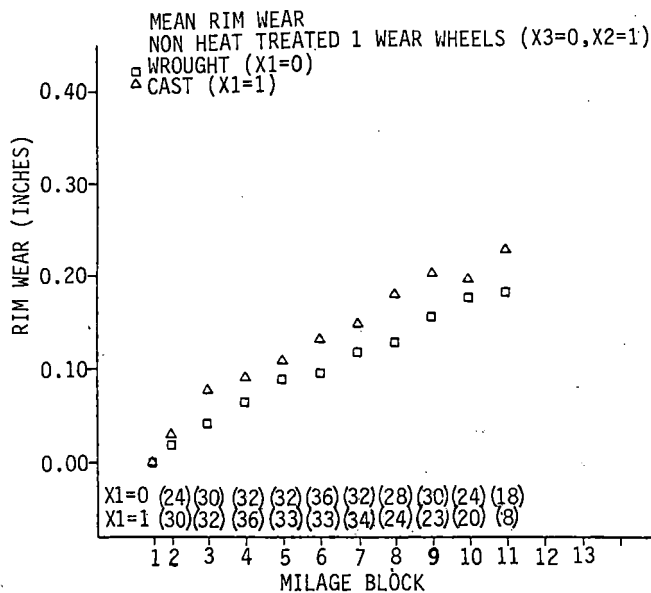
FIGURE 19. MEAN RIM WEAR VERSUS MILEAGE BLOCK PLOTS OF WROUGHT AND CAST NONHEAT-TREATED 1-WEAR WHEELS (AAR STANDARD PROFILE).

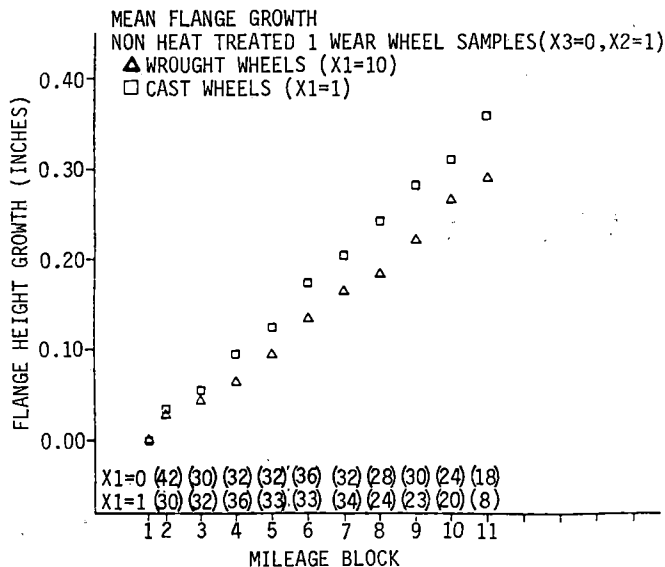
FIGURE 20. MEAN FLANGE HEIGHT GROWTH VERSUS MILEAGE BLOCK PLOTS OF WROUGHT AND CAST NONHEAT-TREATED 1-WEAR WHEELS (AAR STANDARD PROFILE).

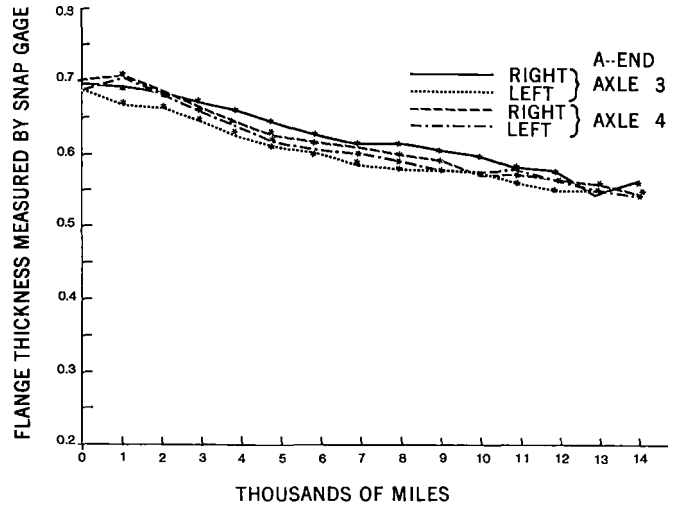
FIGURE 24. AVERAGE FLANGE THICKNESS WEAR PATTERN FOR EMPTY CAR #48.

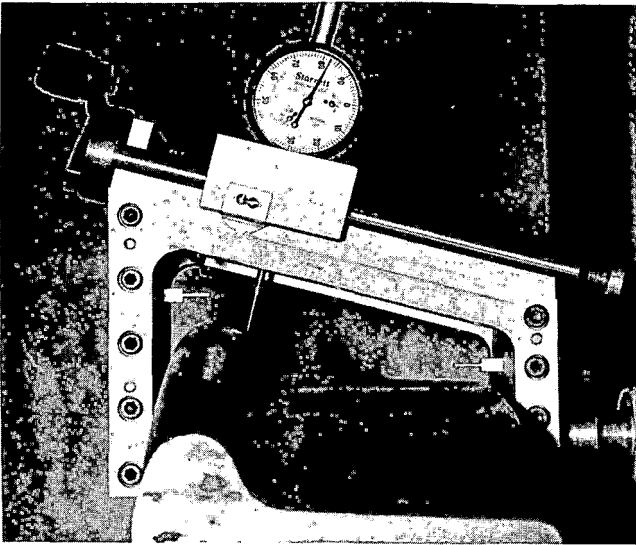
FIGURE 7. PHOTOGRAPH OF PROFILOMETER.

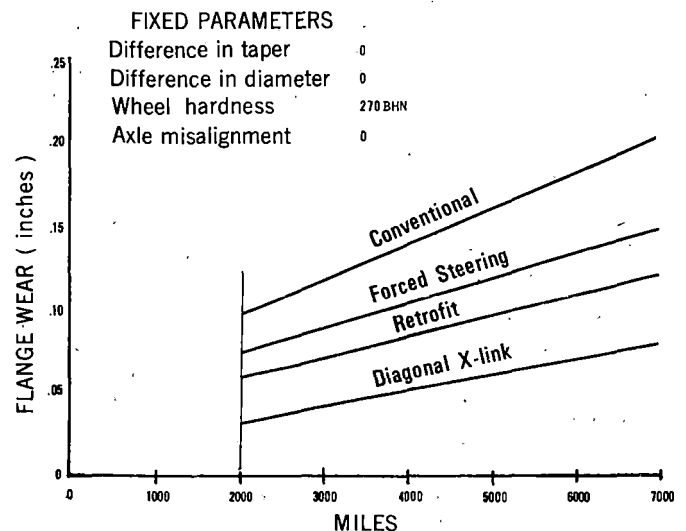
FIGURE 11. STATISTICAL MODEL PREDICTION FOR EFFECT OF MILES.

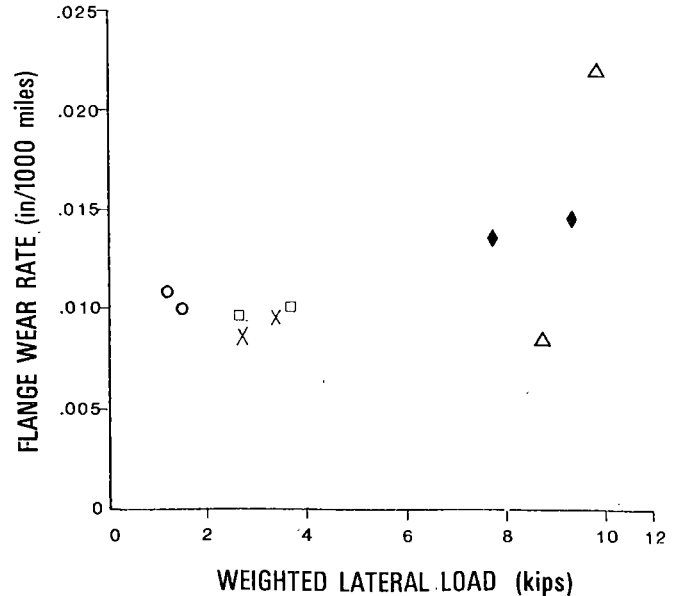
Figure 16 Flange Wear Comparison - Lateral Load

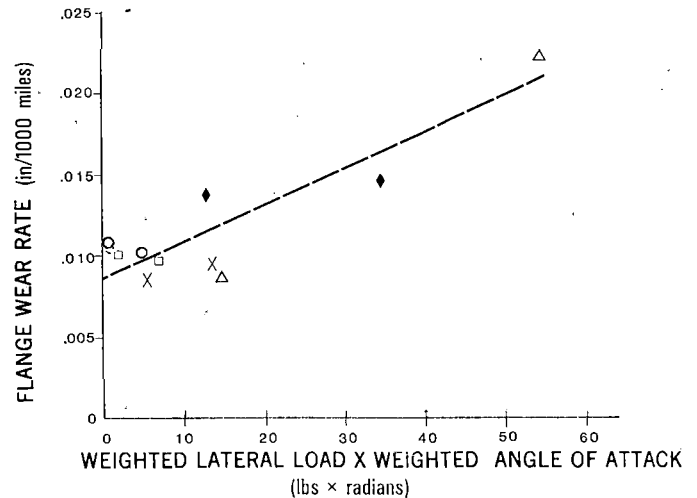
Figure 17 Flange Wear Comparison - Weighted Product

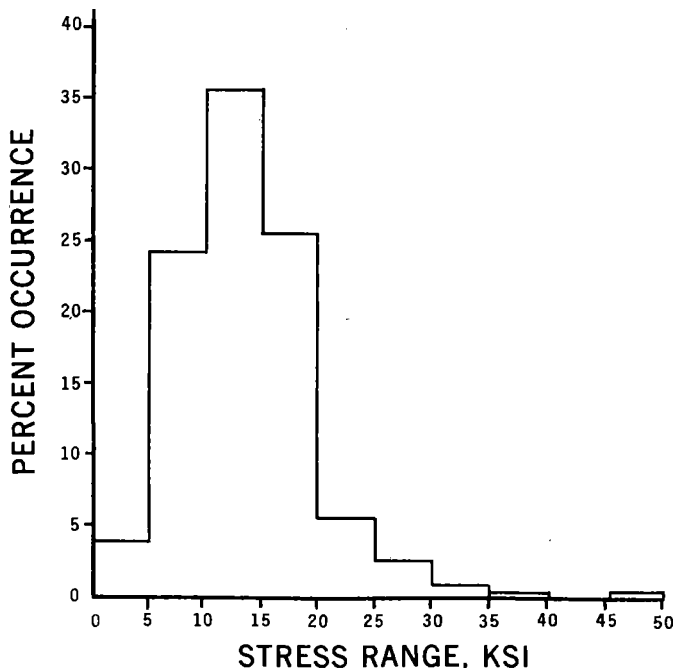
FIGURE 19. STRESS RANGE PERCENT OCCURRENCE HISTOGRAM

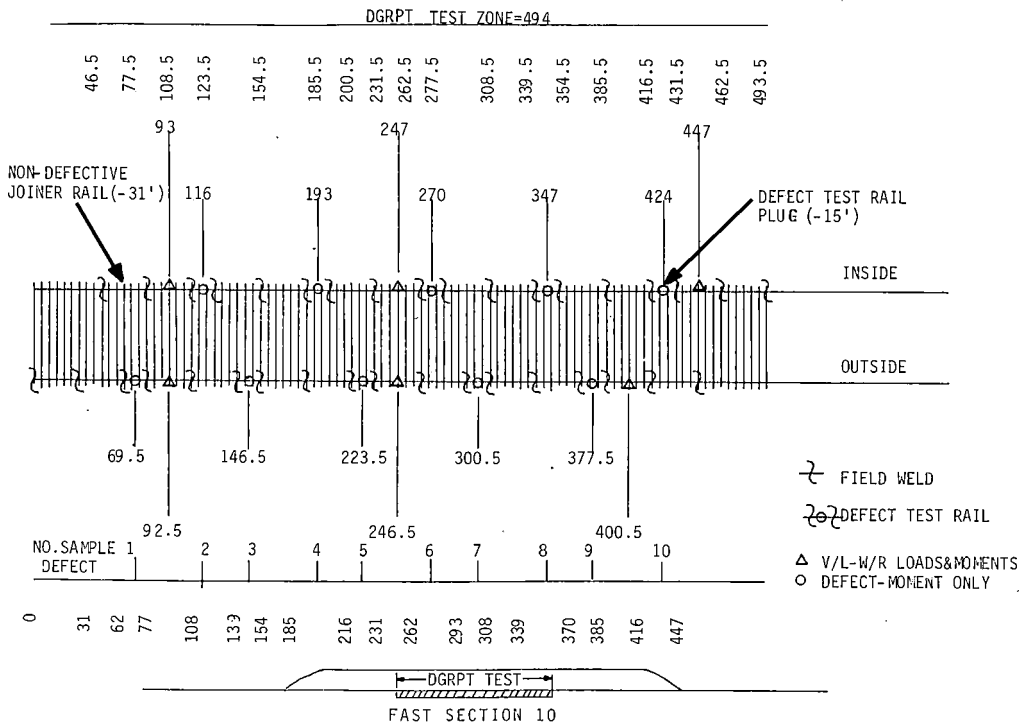
FIGURE 3. DEFECT GROWTH RATE PILOT TEST (DGRPT) ZONE.
