RADIAL AXLE TRUCK TEST RESULTS REPORT

**U.S. DEPARTMENT OF TRANSPORTATION
FEDERAL RAILROAD ADMINISTRATION
OFFICE OF FREIGHT & PASSENGER SYSTEMS
400 SEVENTH STREET, S.W.
WASHINGTON, D.C. 20590**

**TRANSPORTATION TECHNOLOGY ENGINEERING DIVISION
ENSCO, INC.
5400 PORT ROYAL ROAD
SPRINGFIELD, VA 22151**

1. Report No. FRA/ORD-82/25		2. Government Accession No.		3. Recipient's Catalog No.	
4. Title and Subtitle RADIAL AXLE TRUCK TEST RESULTS REPORT				5. Report Date March 1982

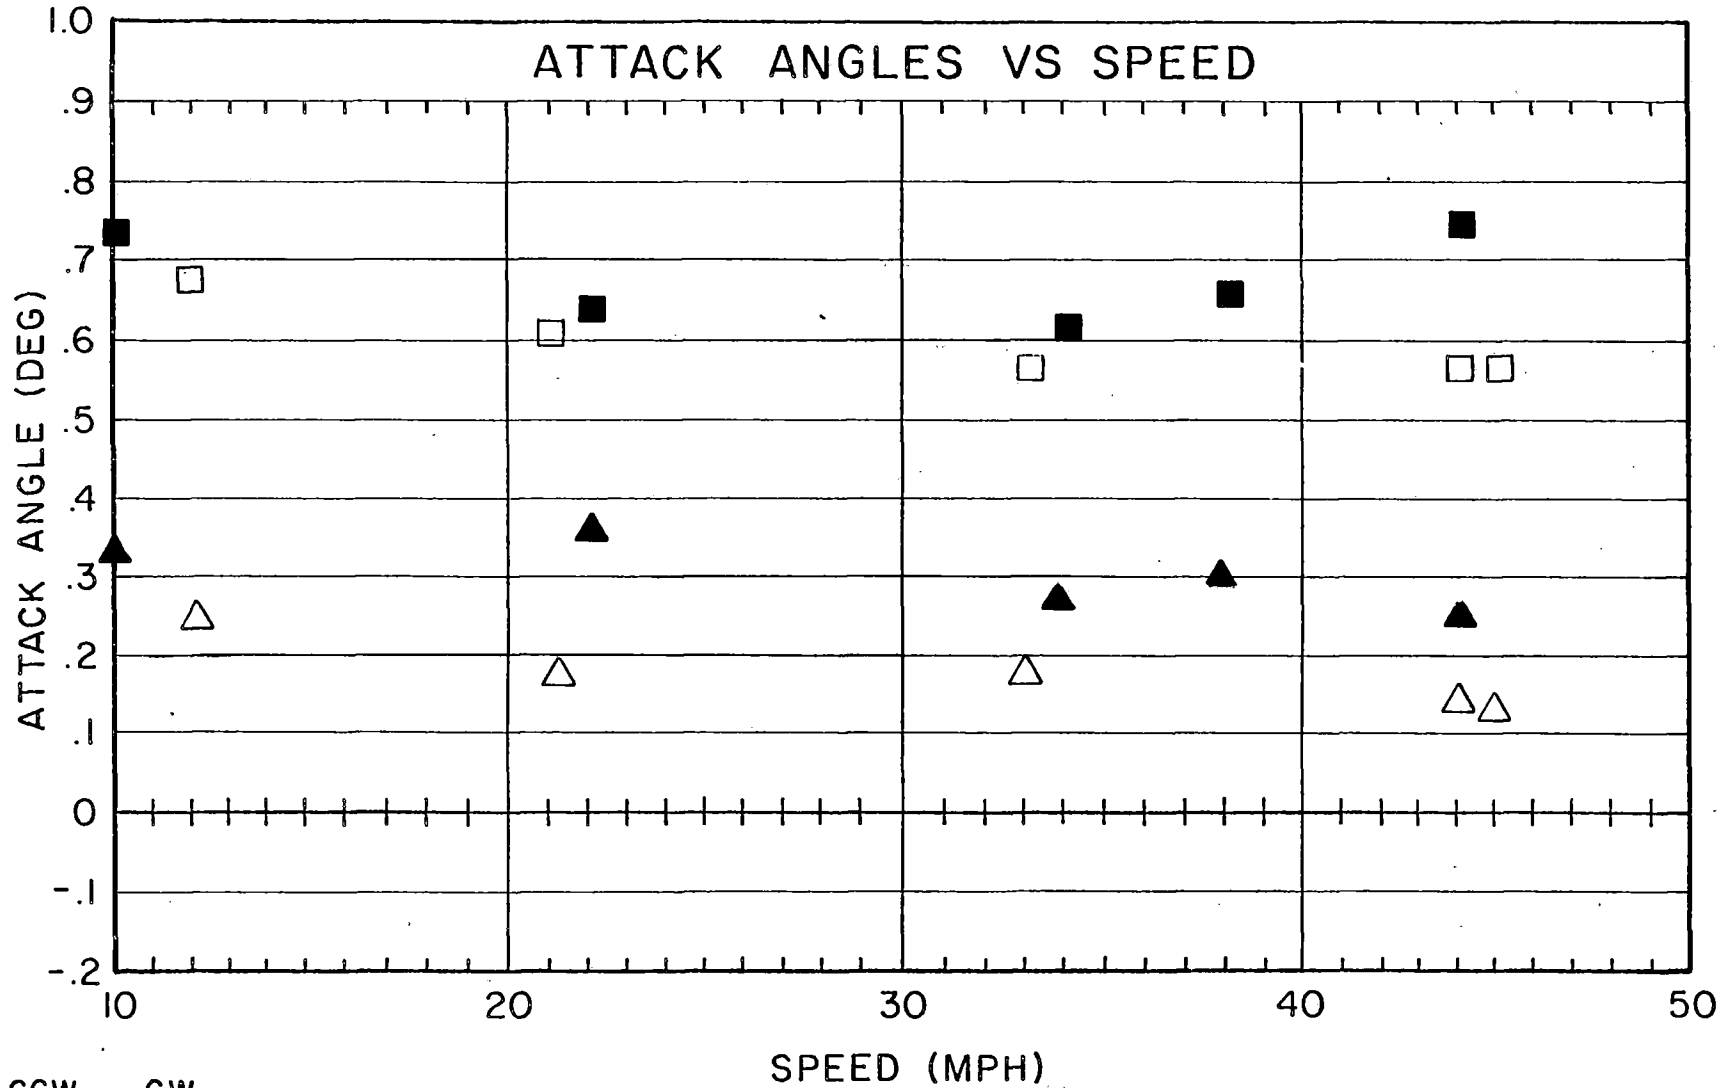
Figure 4-16. Angle-of-Attack Results from the Leading Axle of the Radial and Reference Truck from the 5 Degree Right Hand and 5 Degree Left Hand FAST Curves

CCW CW
 ■ □ REF TRUCK
 ▲ △ RADIAL TRUCK

Figure 4-16 and 4-17 shows similar data to Figure 4-15. In these figures, the data from the CCW and CW operations are presented. The figures show that the radial truck displays minor differences in angle-of-attack for the clockwise and counterclockwise tests. To account for this difference, the strip chart of the data was reviewed. The difference developed because of a local disturbance which repeatedly occurred as the truck negotiated the particular section of the curve used for this analysis.

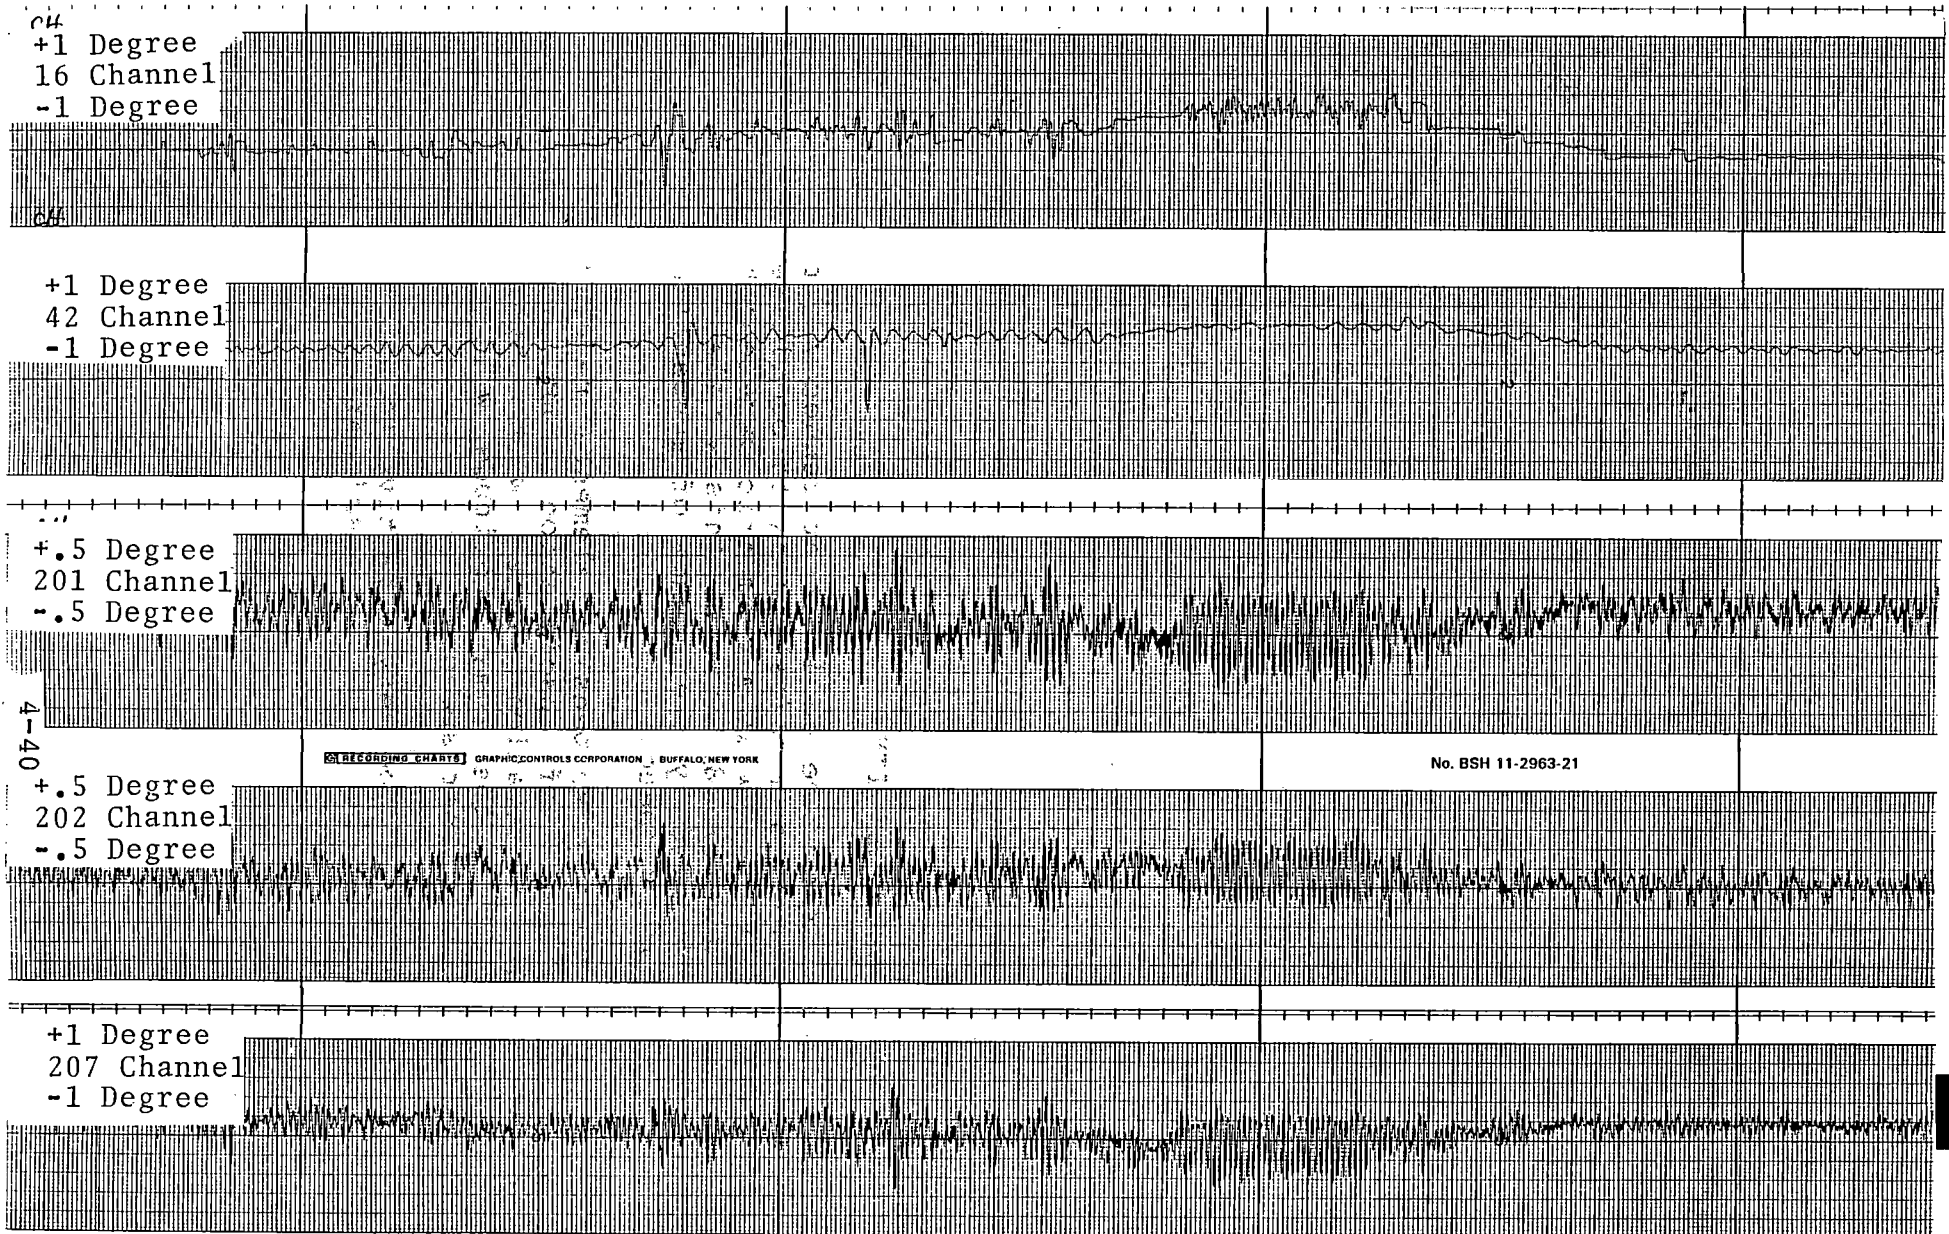
Figure 4-28. Selected Data Channels for Firm (Stiffness "C") Suspension
 Clockwise on RTT, Location 450 to 550, 108 mph

Axle yaw, which was the primary oscillatory mode observed, reached peak-to-peak amplitudes of greater than 1° above 110 mph for the firm "C" suspension without damping (the configuration used initially in life testing). At this yaw rate, assuming that each of the two axles is producing half of the amplitude, the equivalent longitudinal displacement is approximately 0.25 inch peak-to-peak at each wheel-rail contact point. Since a complete cycle of oscillation is accomplished in 38 feet, the total longitudinal slip would be approximately 0.5 inch over a 38-foot distance of travel. Such slip would be producing oscillatory longitudinal adhesive forces which would not be normally present.

Combined with the longitudinal slippage, the lateral position oscillation was typically measured at 1 inch peak-to-peak somewhat independent of suspension configurations or speed. Even through the position change (measured relative to the rail by a single AOA position transducer) may be partially due to rolling with changing axle heading, there will be a contribution due to lateral creep. The creep force will be added vectorially to the longitudinal shear load on the contact patch.
