DEMONSTRATION OF
THE BUDD COMPANY AMCOACH
TILT BODY SYSTEM

U.S. DEPARTMENT OF TRANSPORTATION
FEDERAL RAILROAD ADMINISTRATION
OFFICE OF PASSENGER AND FREIGHT SERVICE

April, 1983

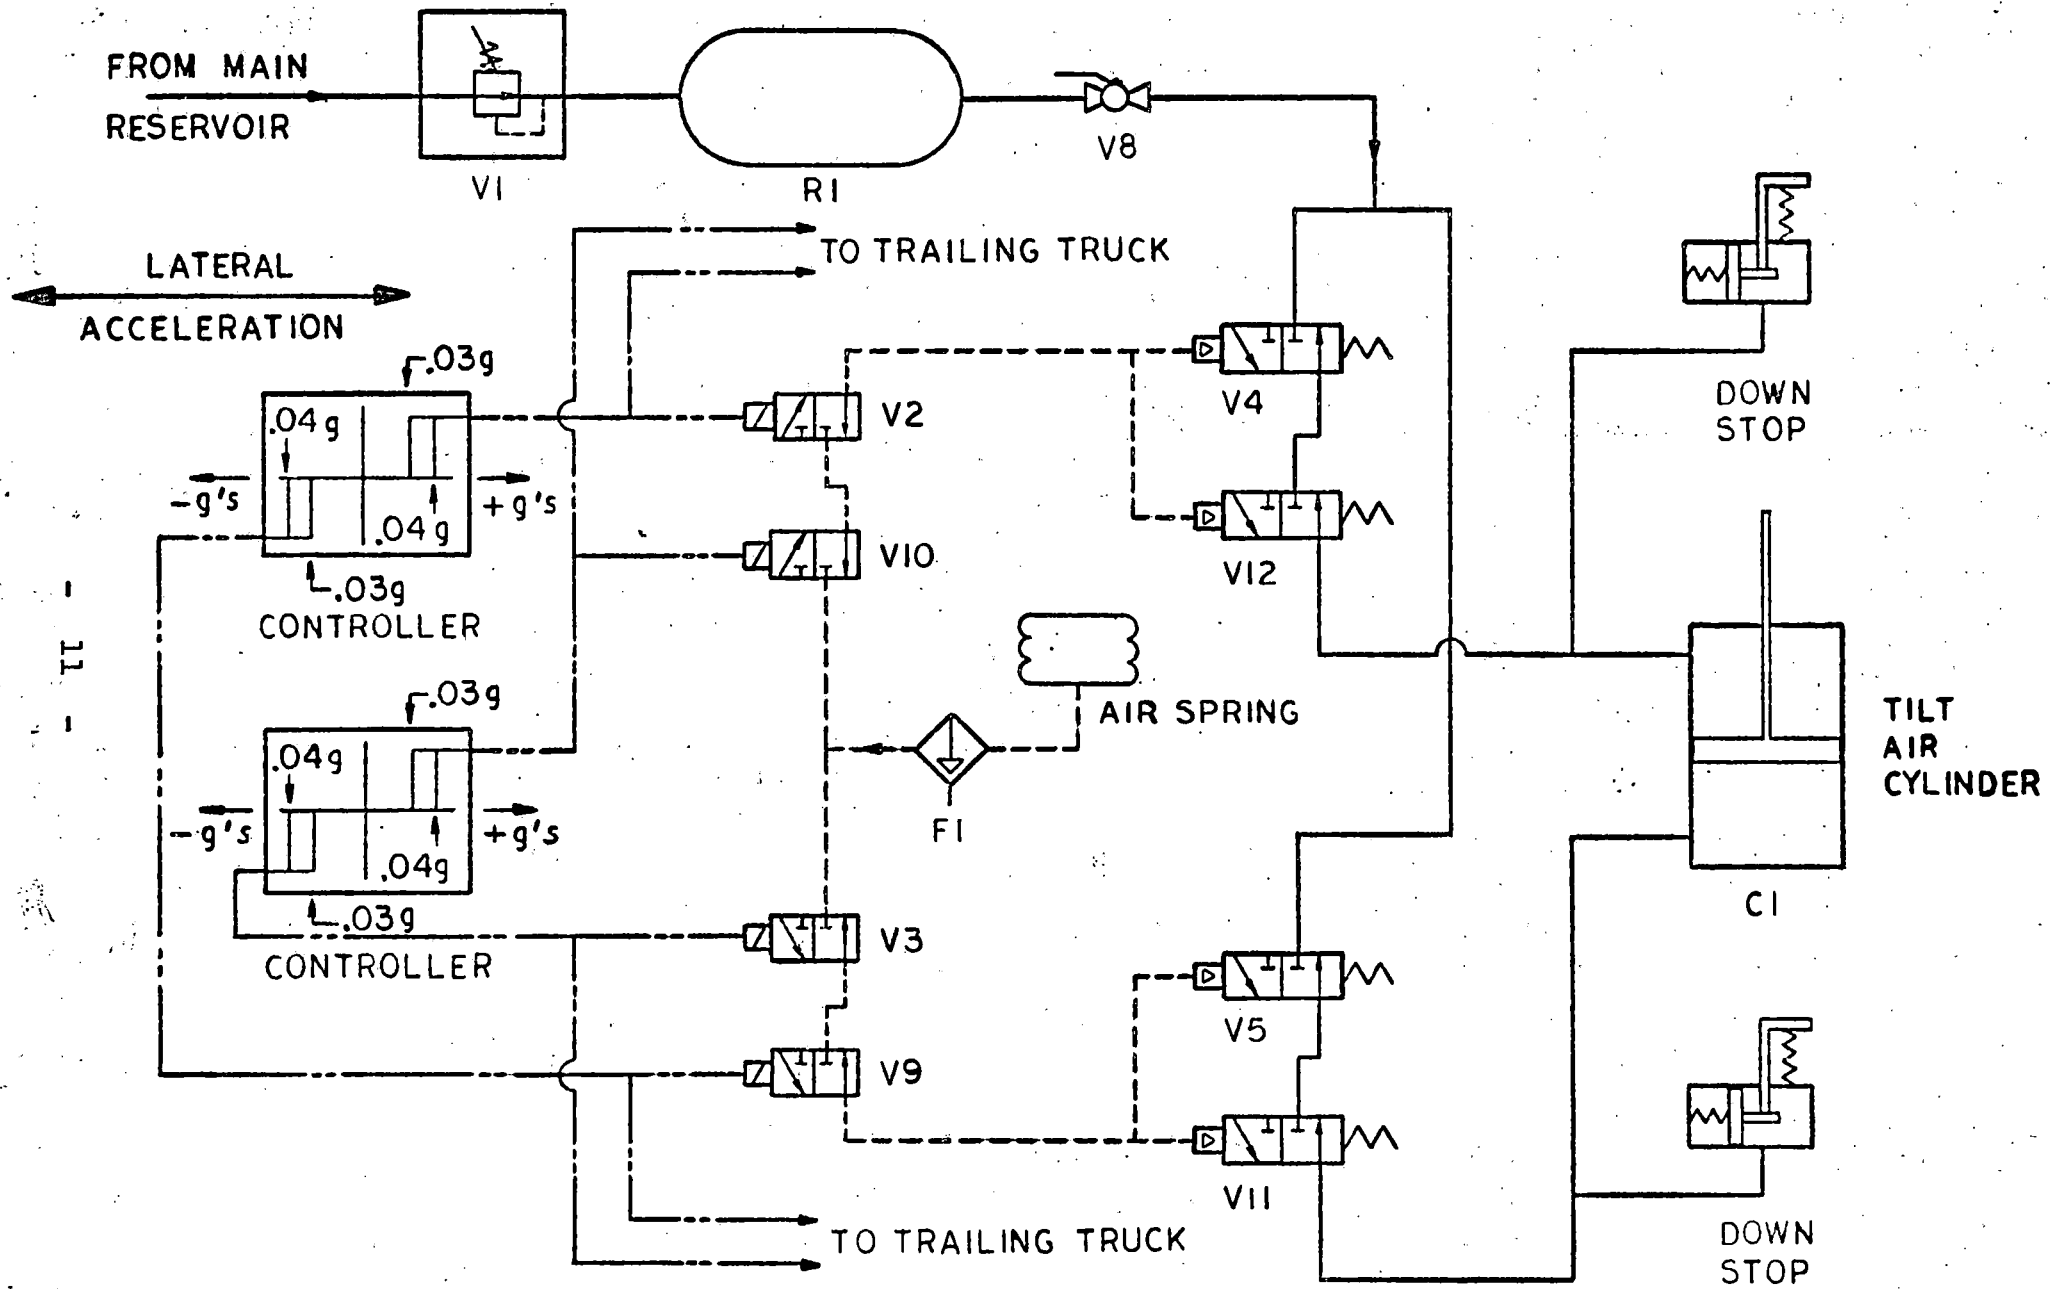
FIGURE 4-1

Figure 4-1 shows a mechanical schematic of the system.

MECHANICAL SCHEMATIC

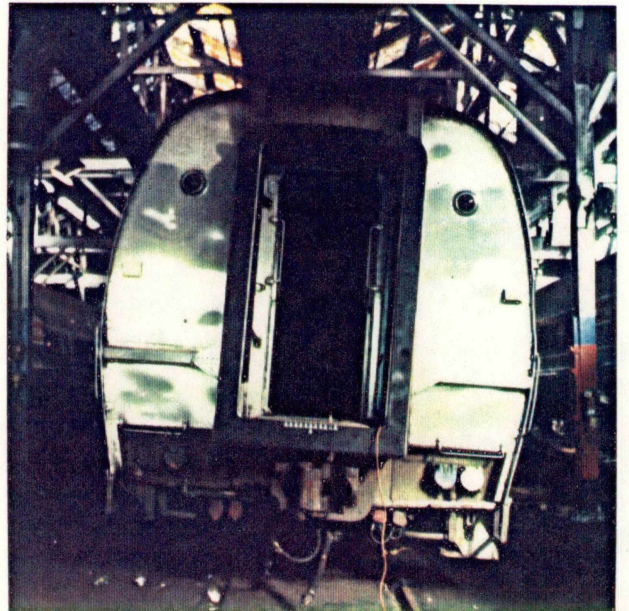
A. TILT LEFT

B. CENTERED

C. TILT RIGHT

FIGURE 5-1: TILT CHECKOUT

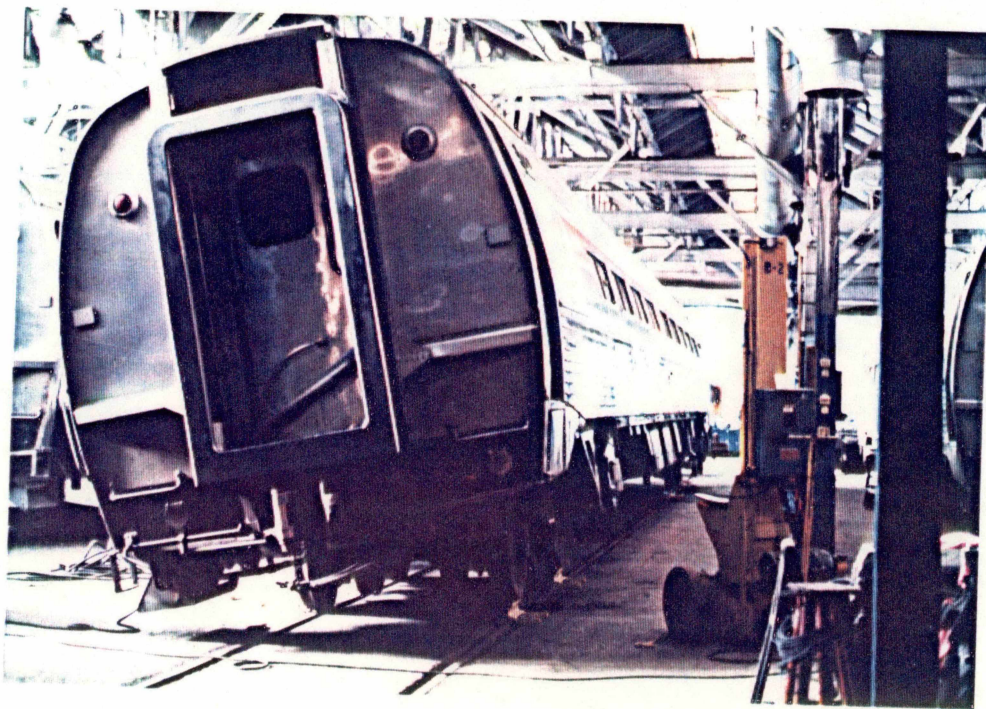
FIGURE 5-7: LEAN TEST - MEASUREMENT-PLUMP BOBS

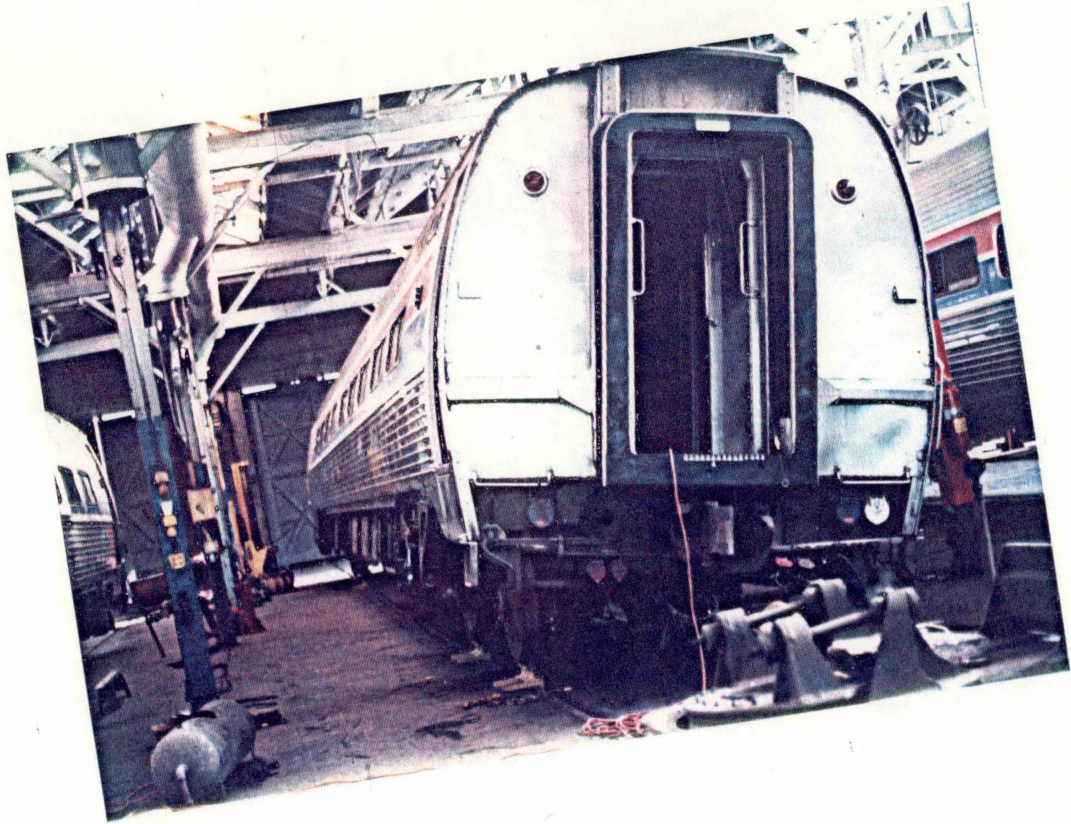
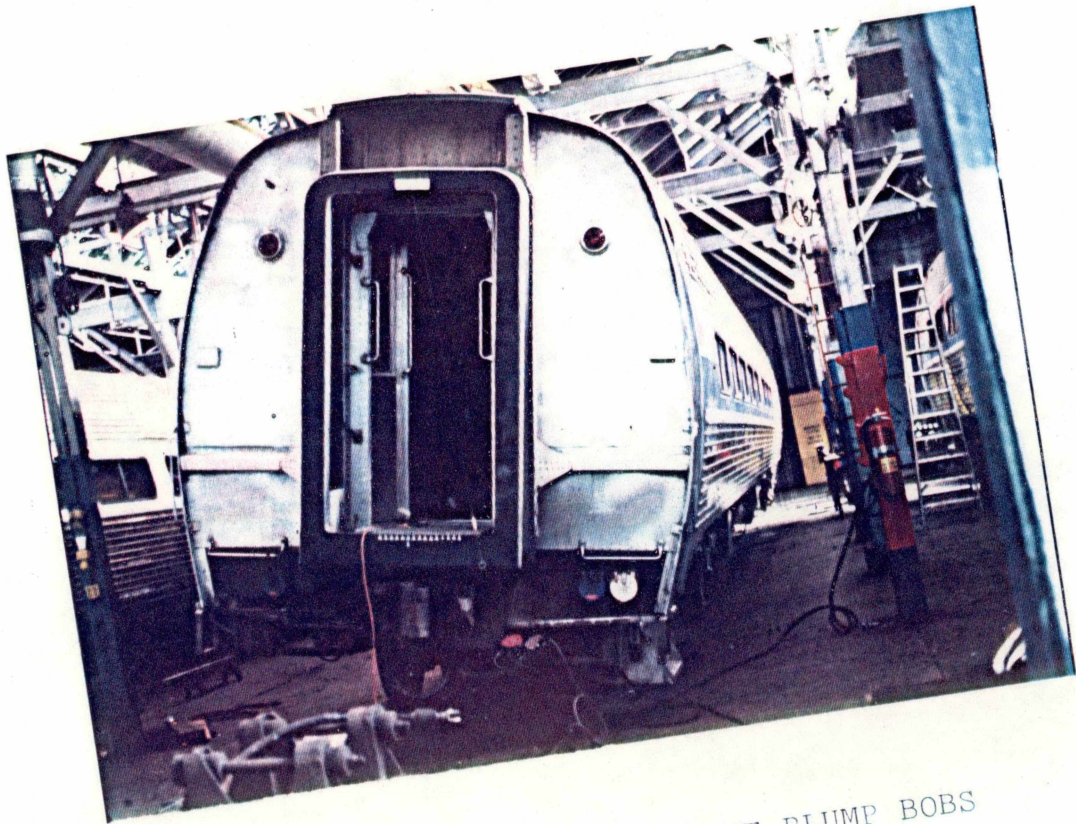
FIGURE 5-8: LEAN TEST - MEASUREMENT-PLUMP BOBS

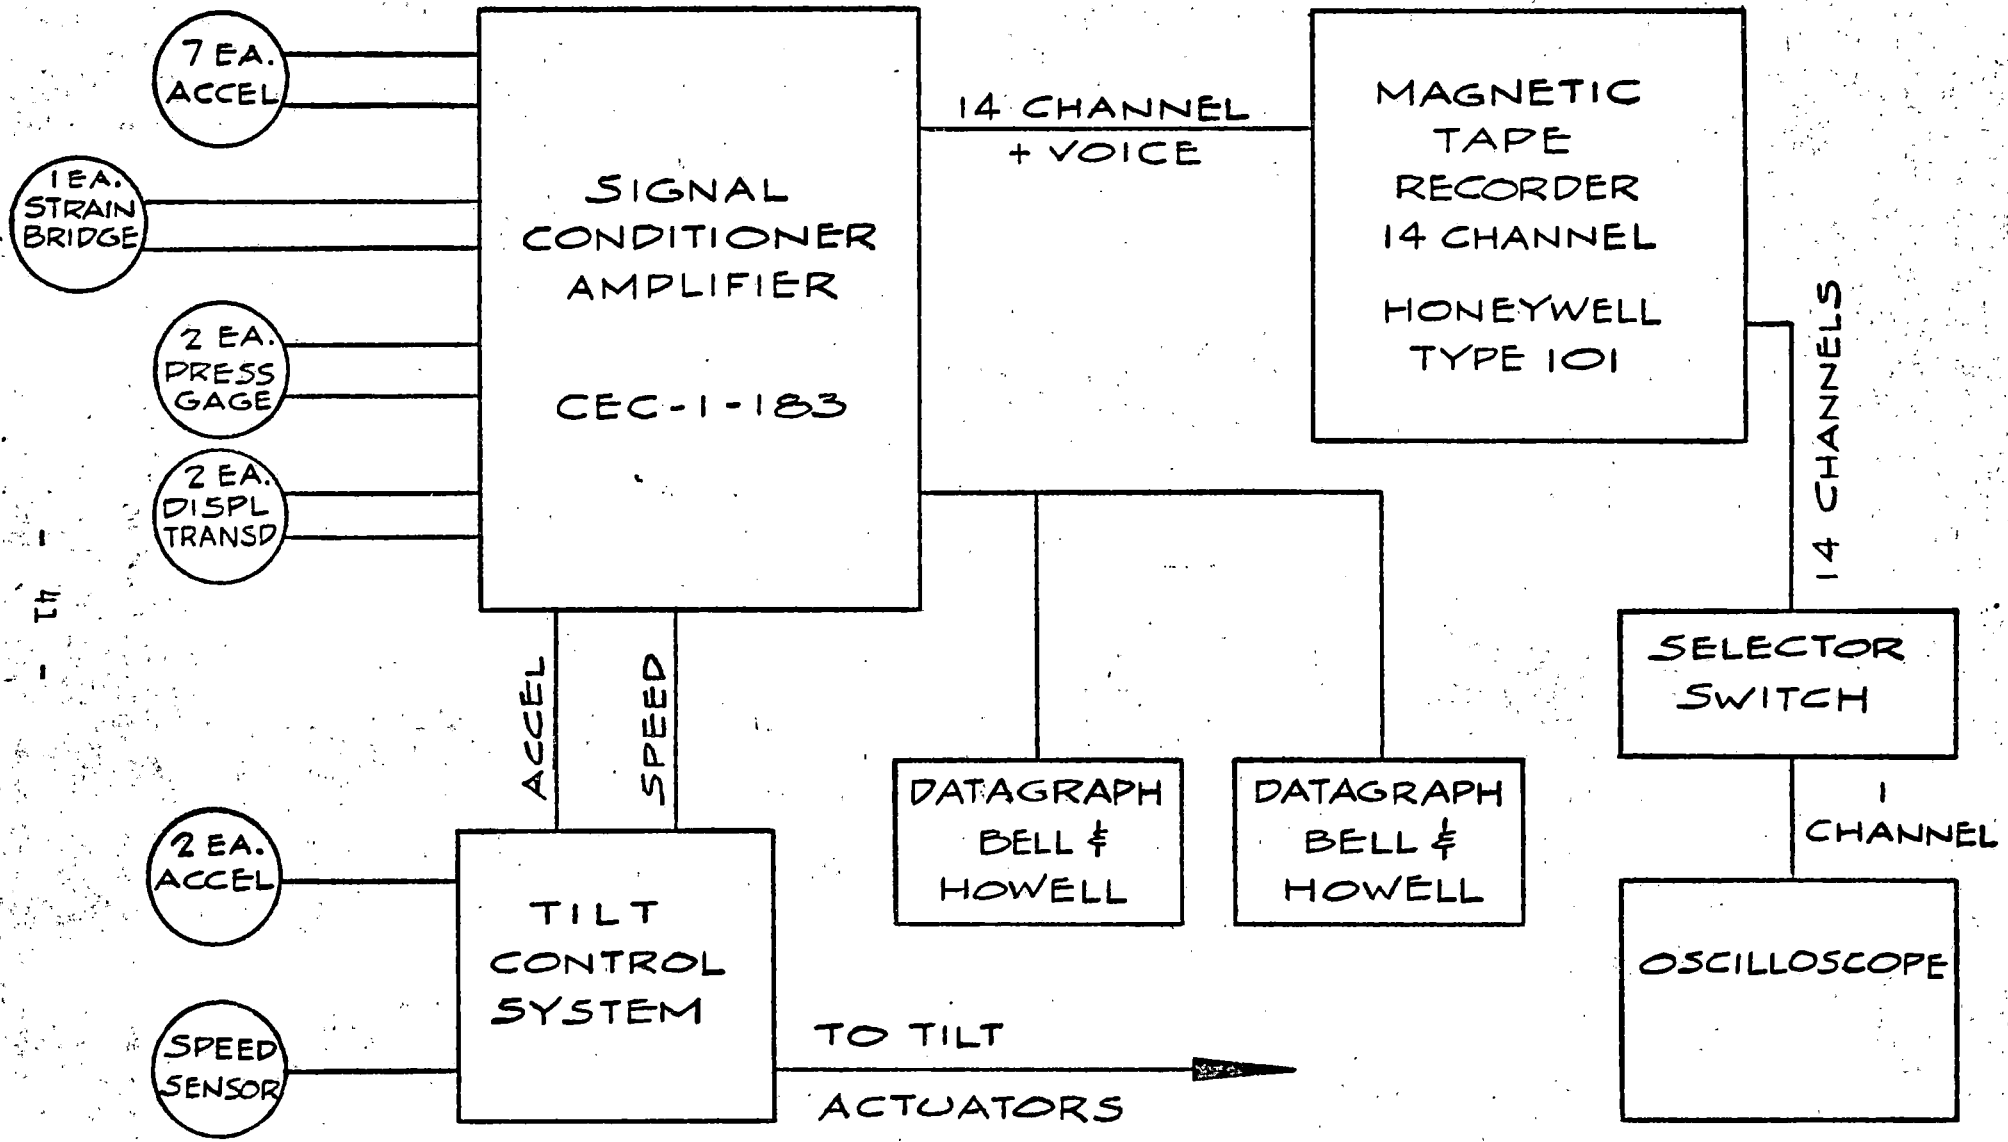
FIGURE 5-9

INSTRUMENTATION SCHEMATIC

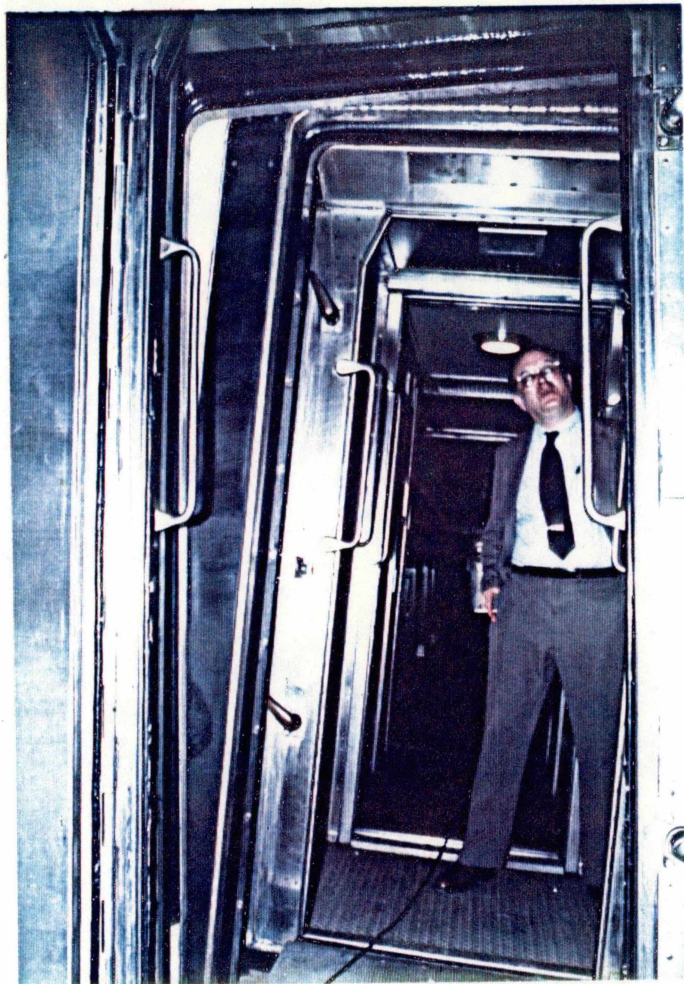
FIGURE 5-17: DIAPHRAM GAP BETWEEN TILTED AND STANDARD AMFLEET COACH .

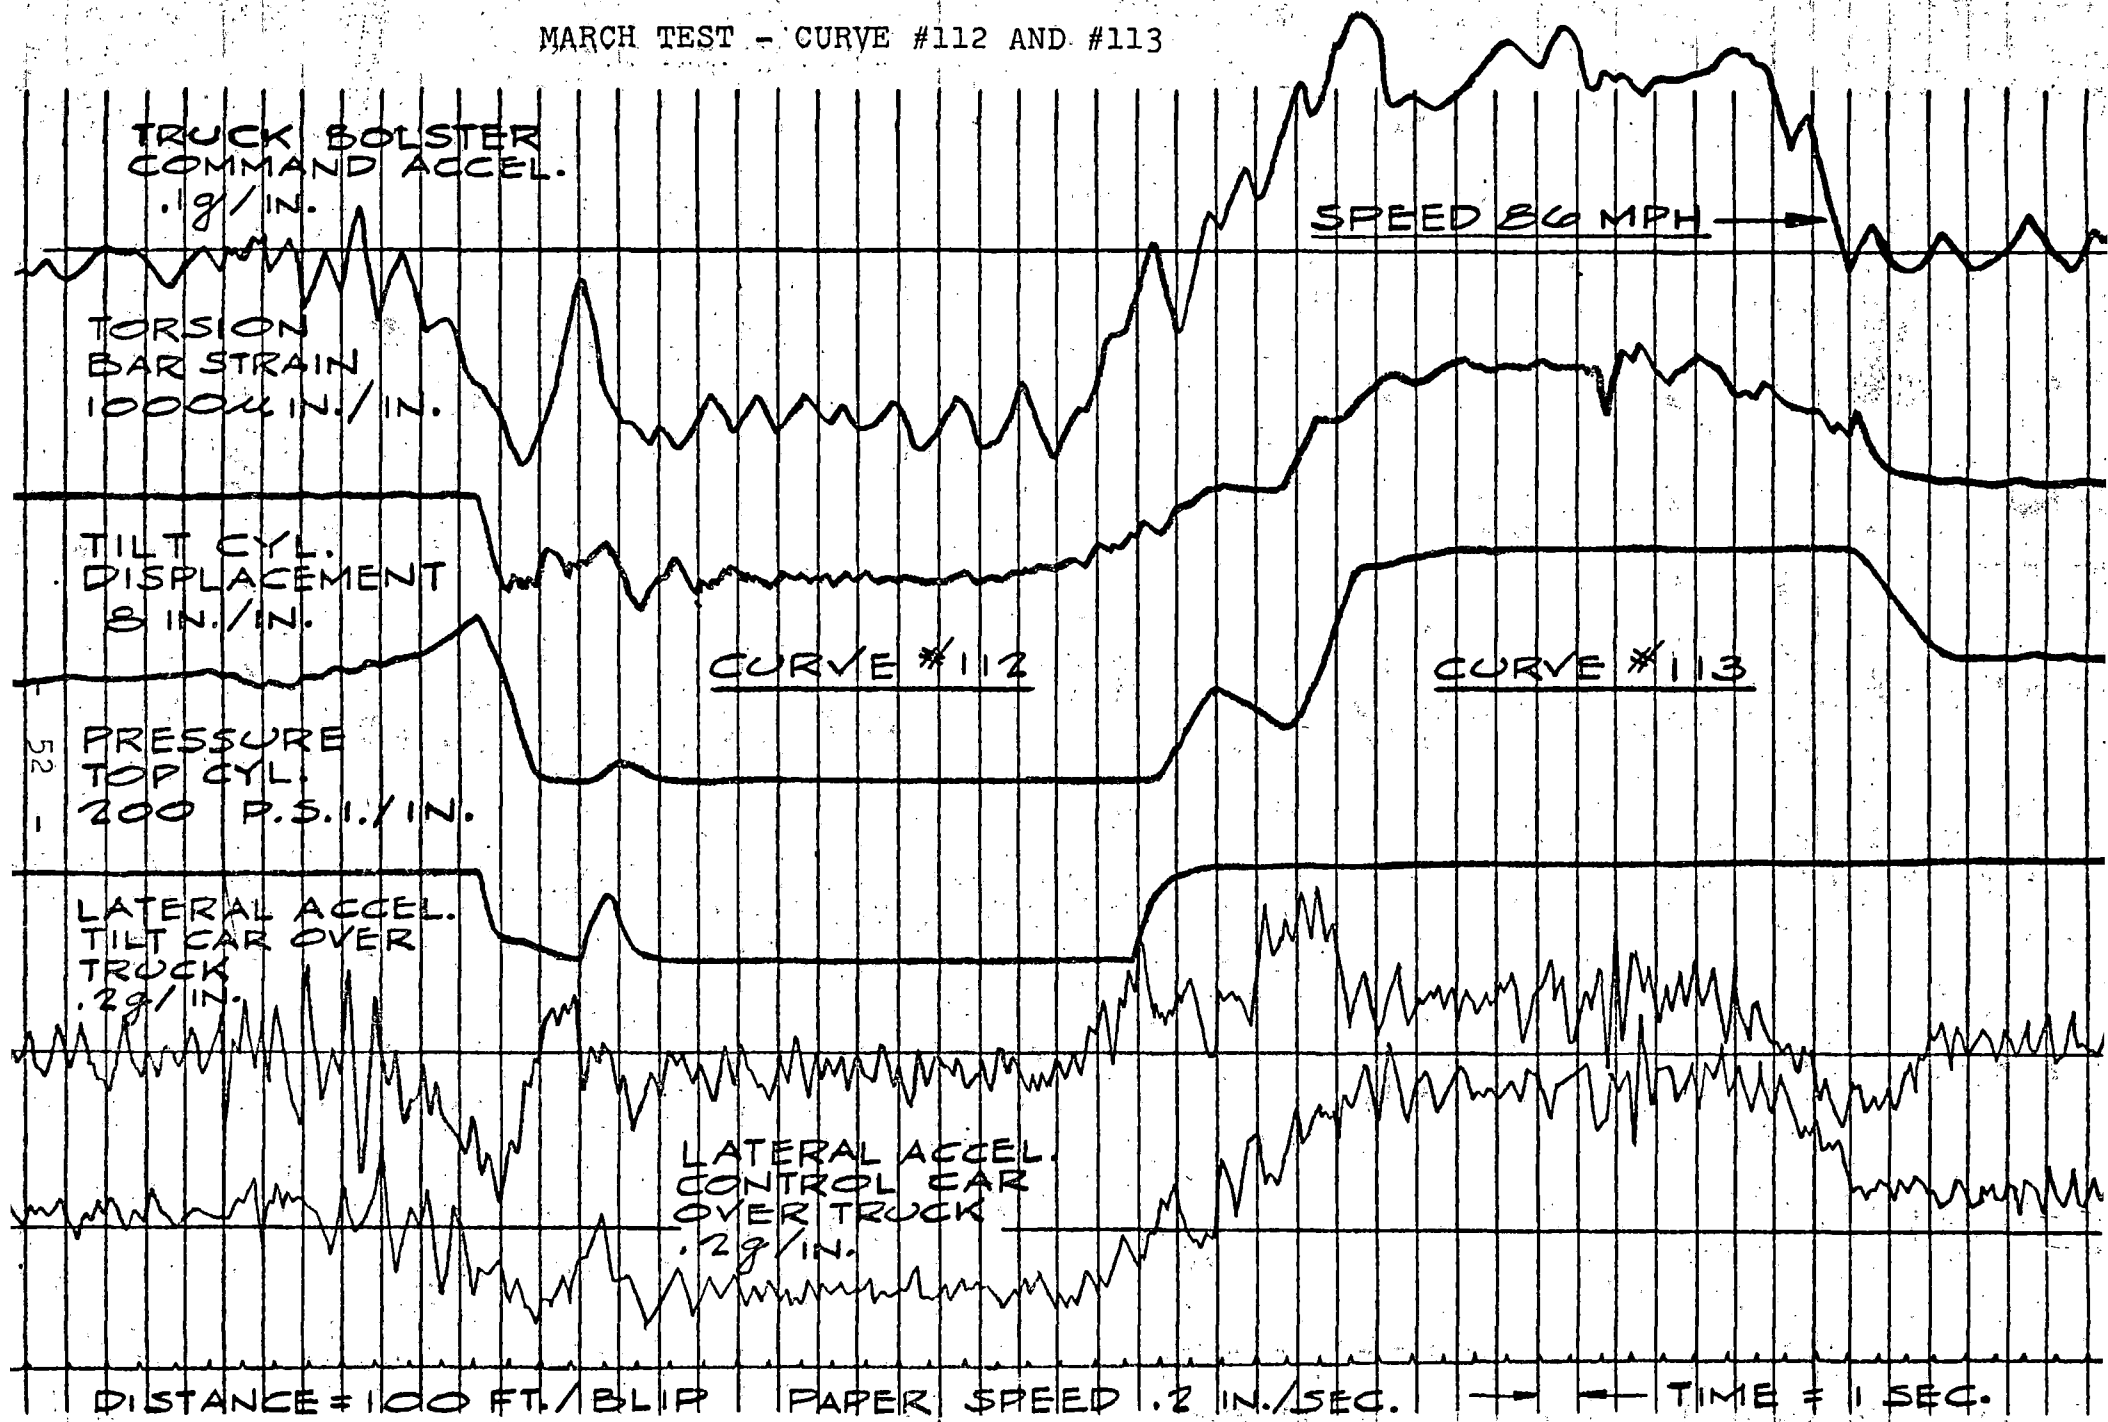
FIGURE 5-19

MARCH TEST - CURVE #112 AND #113

Figure 5-19 shows the performance of the consist on a set of reverse curves, #112 and #113, where the truck experiences a lateral acceleration of approximately .09g's and .1g's respectively. (5.4" cant deficiency and 6" cant deficiency). As the car enters the spiral of Curve #112, the performance is typical of that experienced in Curve #62, except that there is a large deviation in the spiral which momentarily deactivates the tilt system. In the transition between the two curves, the system recovers and again behaves similar to Curve #62 as it enters Curve #113. The steady lateral accelerations experienced by the passengers are reduced from .09g's to .04g's on Curve #112 and from .12g's to .06g's on Curve #113.
