1. Report No.	2. Government Accession No.	3. Recipient's Catalog No.	
4. Title and Subtitle IN-SERVICE WHEELFAX CONCEPT EVALUATION		5. Report Date January 1983	6. Performing Organization Code

12. Sponsoring Agency Name and Address Federal Railroad Administration Office of Rail Safety Research 400 7th Street, S.W. Washington, D.C. 20590		13. Type of Report and Period Covered FINAL REPORT January 1983

16. Abstract Work performed on this task include the evaluation of the WheelFax concept; problems, difficulties and modifications made by purchasers of WheelFax systems; effectiveness of this detection concept with respect to the wheel inspection process defined in the Field Manual of the AAR Interchange Rules 1983; an analysis of total accidents attributed to wheel failures versus the number of these accidents where the WheelFax may have detected the faulty wheels; and finally recommendations on future research with respect to the WheelFax and other related wheel failure projects that are anticipated in the near future.

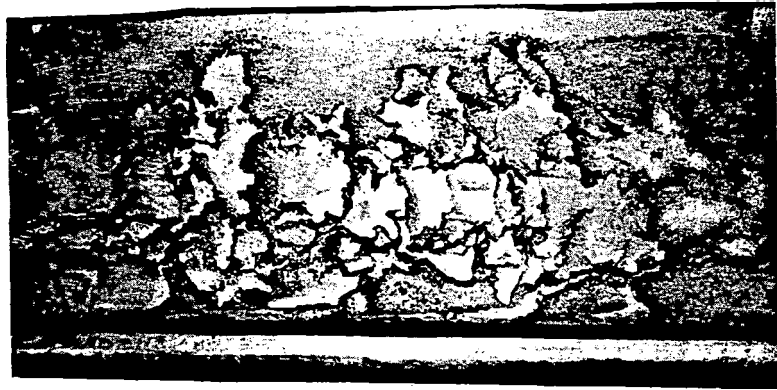
FIGURE 9. BUILT-UP TREAD

The WheelFax system can detect built-up tread. As in wheel shelling, it cannot measure the severity of this tread defect and therefore could alarm on serviceable wheels.

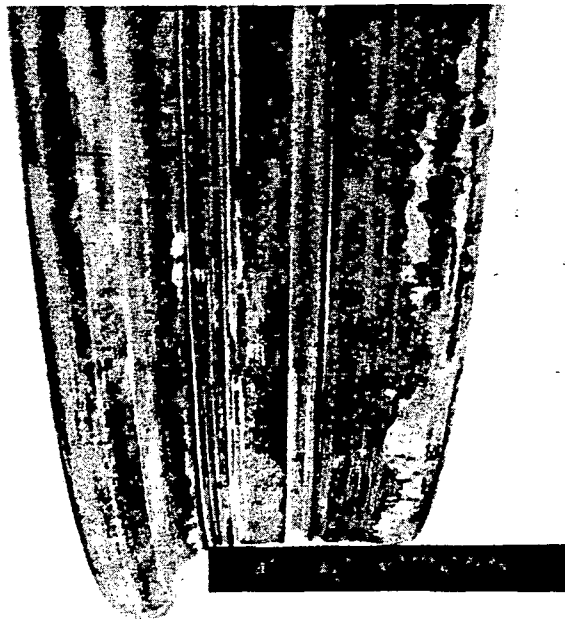
FIGURE 10. GROOVED TREAD

11. Grooved Tread: One or more grooves worn to a depth of  $\frac{1}{8}$  inch or more (See Figure 10).

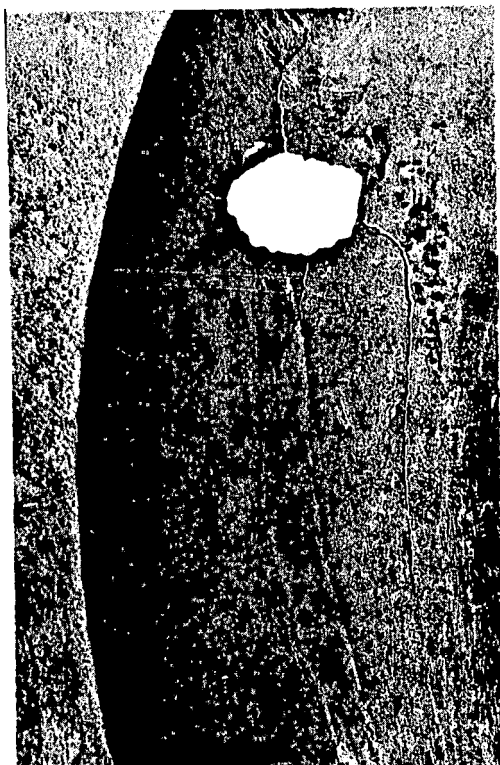
FIGURE 13. HOLE IN PLATE

14. Holes in Plate: (See Figure 13)

The WheelFax system will not detect any defects in the wheel plate area.
