U.S. Department
of Transportation

Federal Railroad
Administration

Laboratory Tests of Two 100-Ton Covered Hopper Cars

1. Report No. FRA/ORD-85/13		2. Government Accession No.		3. Recipient's Catalog No.	
4. Title and Subtitle LABORATORY TESTS OF TWO 100-TON COVERED HOPPER CARS				5. Report Date December 1985

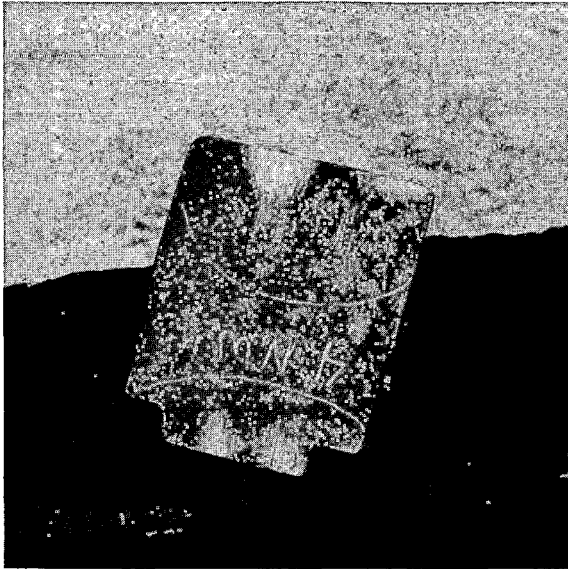
**FIGURE 3-5
FRICTION CASTINGS FROM THE A-END TRUCK OF BASE VEHICLE NO. 1
SHOWING UNEVEN WEAR AND GOUGING**

1. Friction snubbers binding in A end truck. The truck had apparently been refurbished with new column wear plates, in the side frames, with the plates welded in place and positioned so that the edge of the plate would gouge the friction face of the friction casting. This resulted in very noisy operations and very high effective friction forces.
2. Center plate on the body bolster, A end, rotated 90° so that tapered edges were at the front and back edges. There was no measurable affect on car characteristics due to this error. Its only likely impact would be on the wear life of the center bowl.
3. No vertical wear liner in the B center bowl. No noticeable effects.

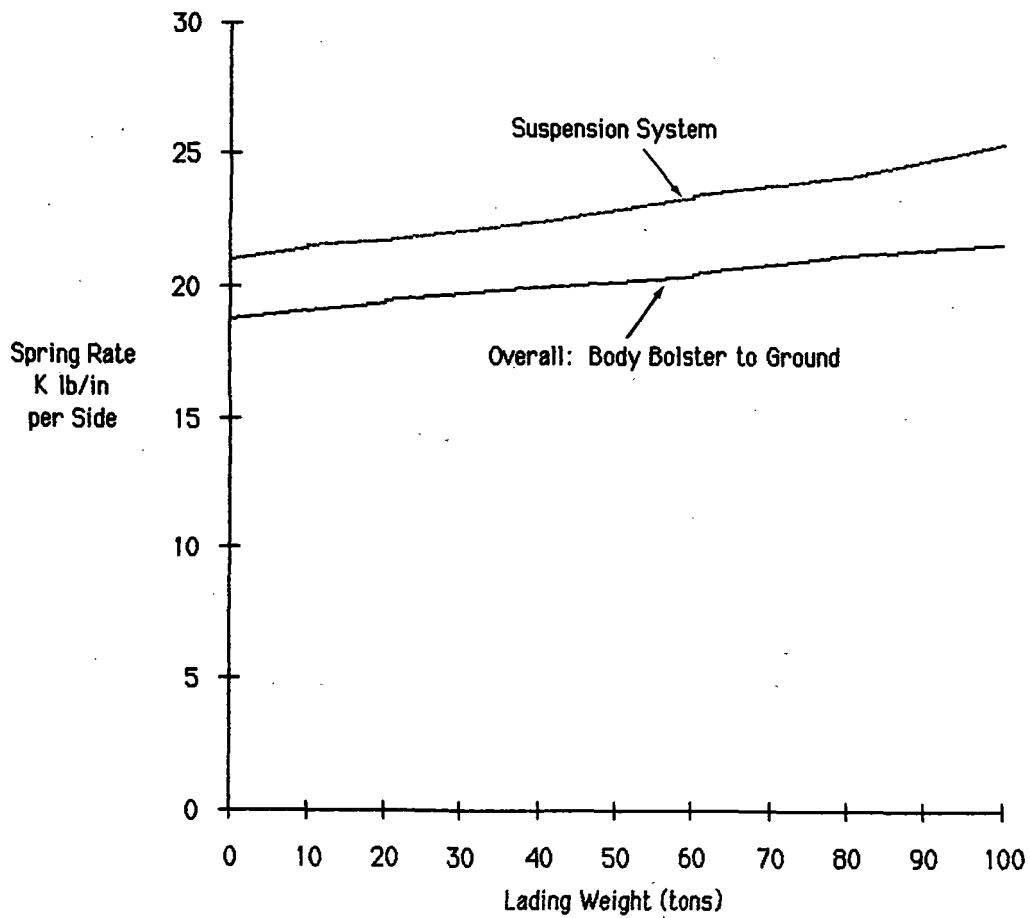
Based on data from B truck tests.

FIGURE 3-8
BARBER S-2-C TRUCKS
VERTICAL SPRING CONSTANTS, PER SIDE, FROM NO-SNUBBER TESTS

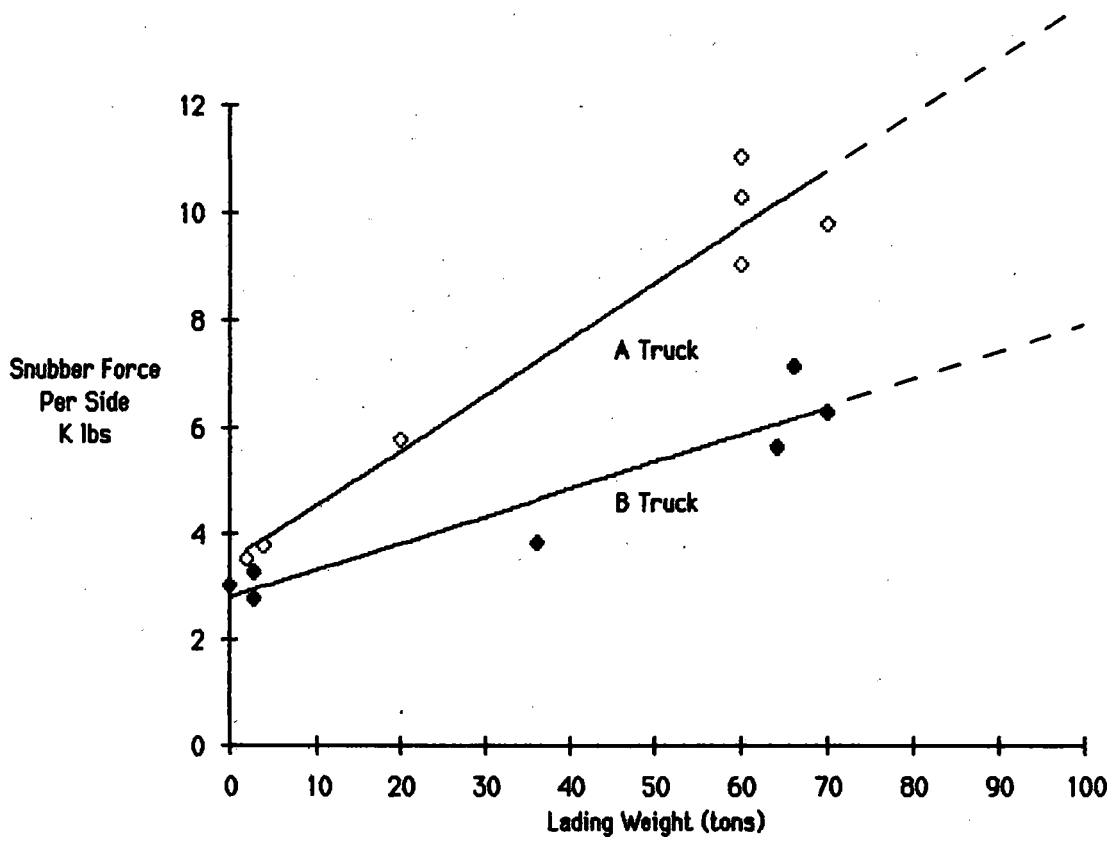
FIGURE 3-10
EFFECT OF BINDING FRICTION CASTINGS
BARBER S-2-C TRUCK WITH DOUBLE SIDE SPRINGS

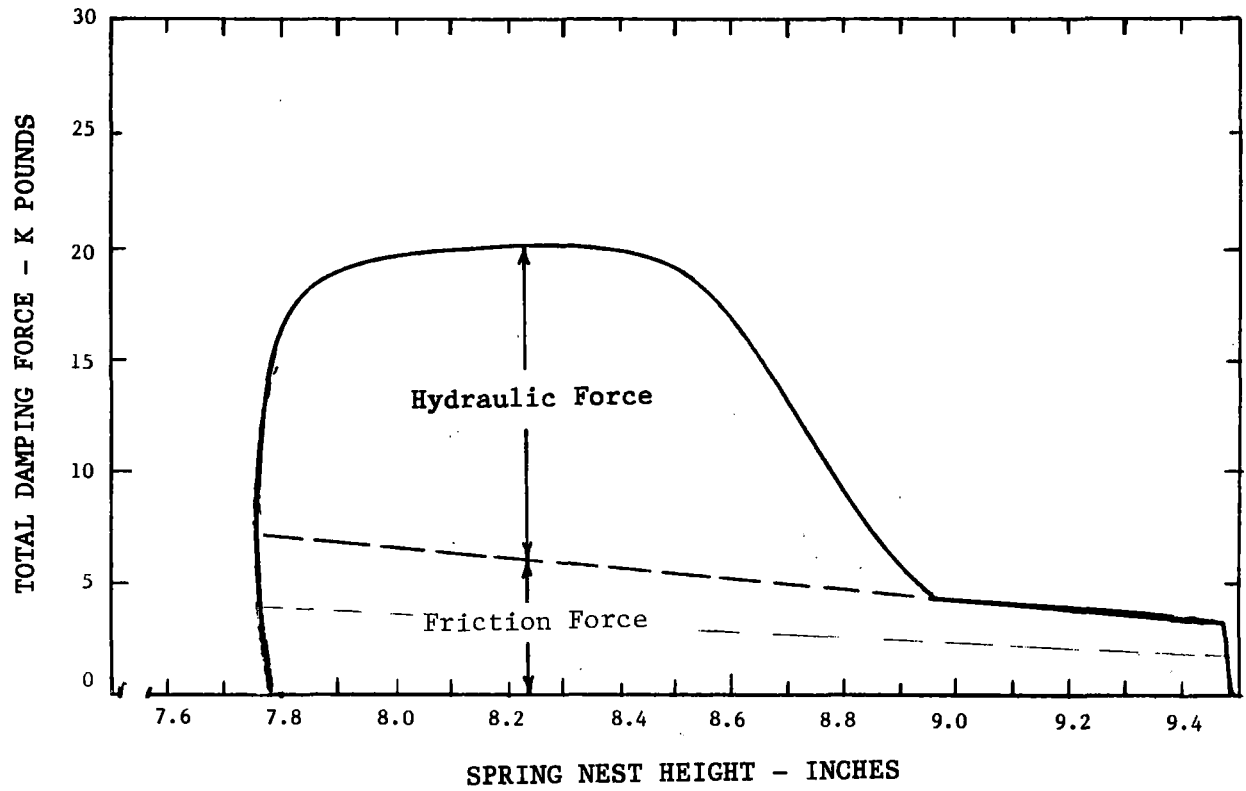
From vertical test with 0.5 Hertz input motion

FIGURE 3-11
DAMPING FORCE OF HYDRAULIC SNUBBER, TRUCK B
WITH REDUCED FRICTION SNUBBER

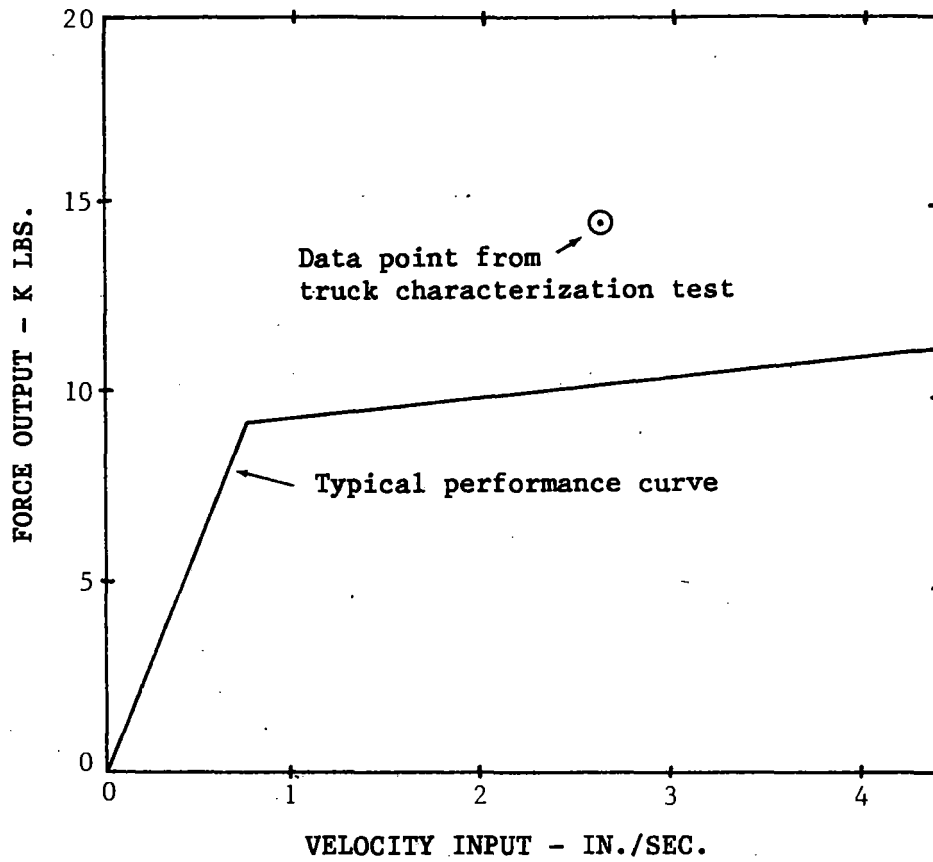
FIGURE 3-12
FORCE OUTPUT OF HYDRAULIC SNUBBER

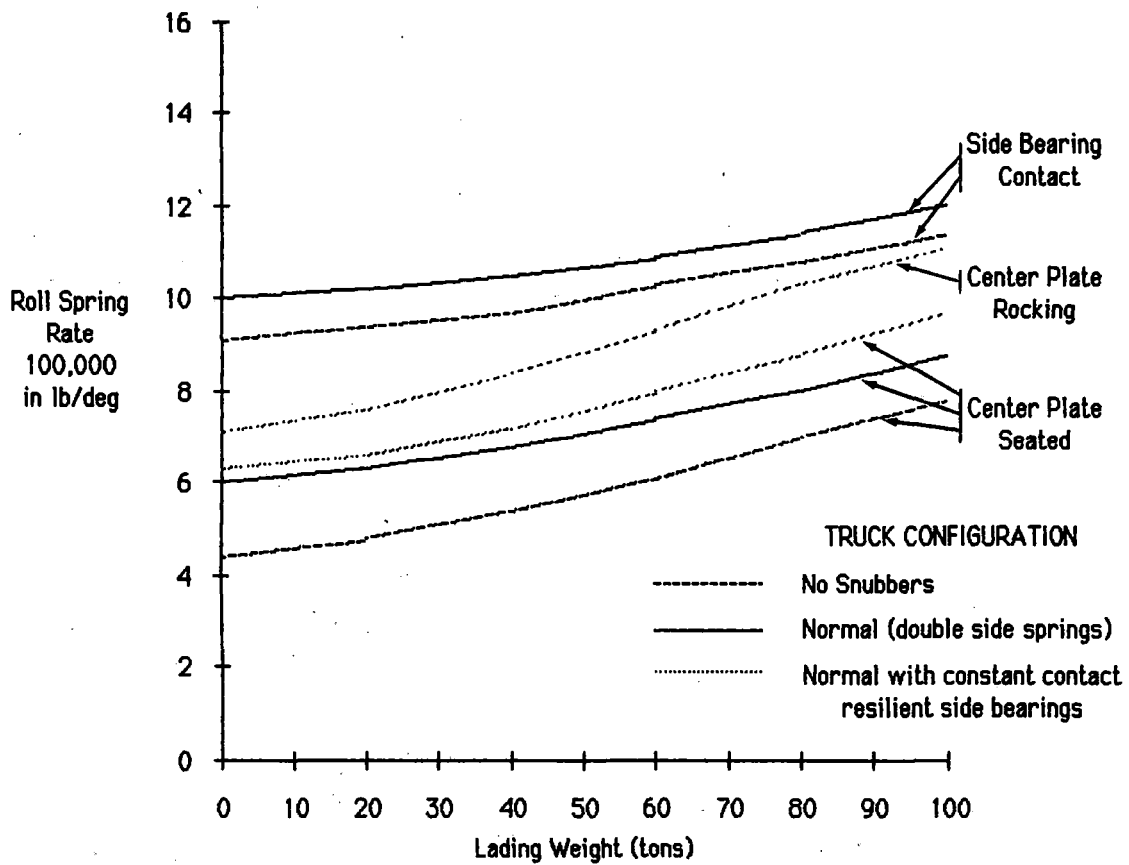
FIGURE 3-18
OVERALL TRUCK ROLL SPRING RATES, PER TRUCK
BARBER S-2-C

The Barber truck roll test results are summarized for both with roller and constant contact resilient side bearings in Figure 3-18 for the overall truck and Figure 3-19 for the secondary suspension. The secondary suspension data is also given in Table 3-7 for empty and 90% load conditions.

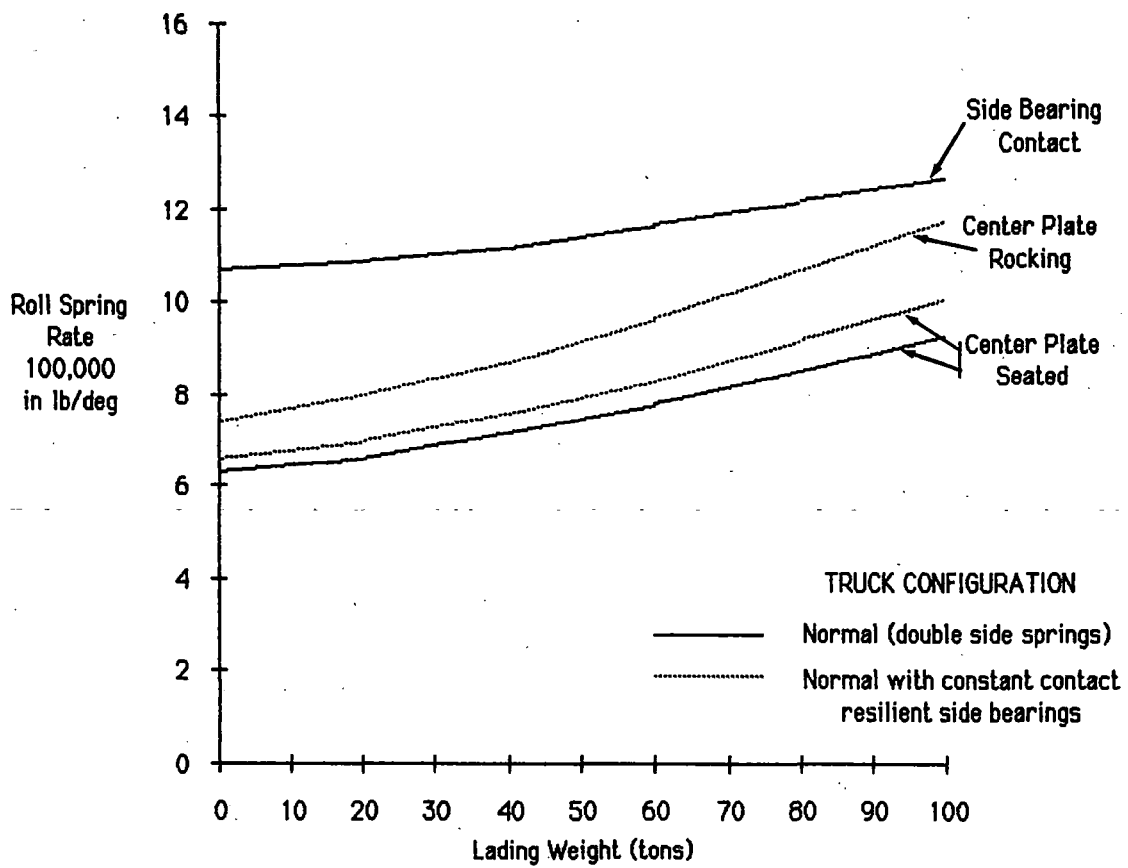
FIGURE 3-19
SUSPENSION SYSTEM ROLL SPRING RATES, PER TRUCK
BARBER S-2-C TRUCK

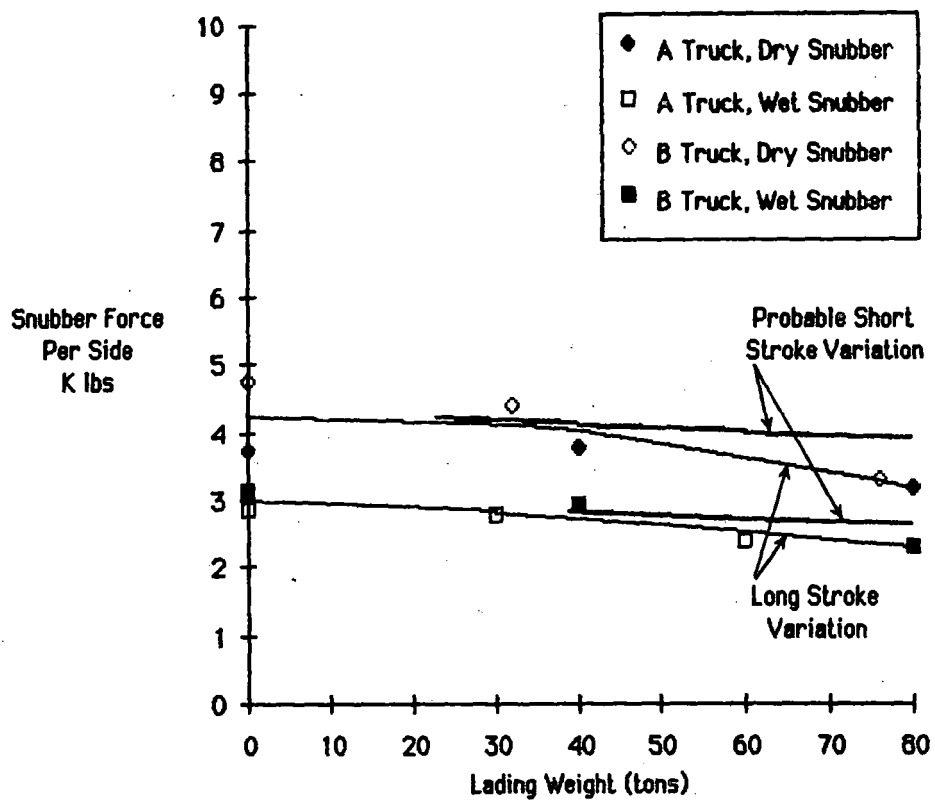
FIGURE 4-4
RIDE CONTROL TRUCK SNUBBER FORCE

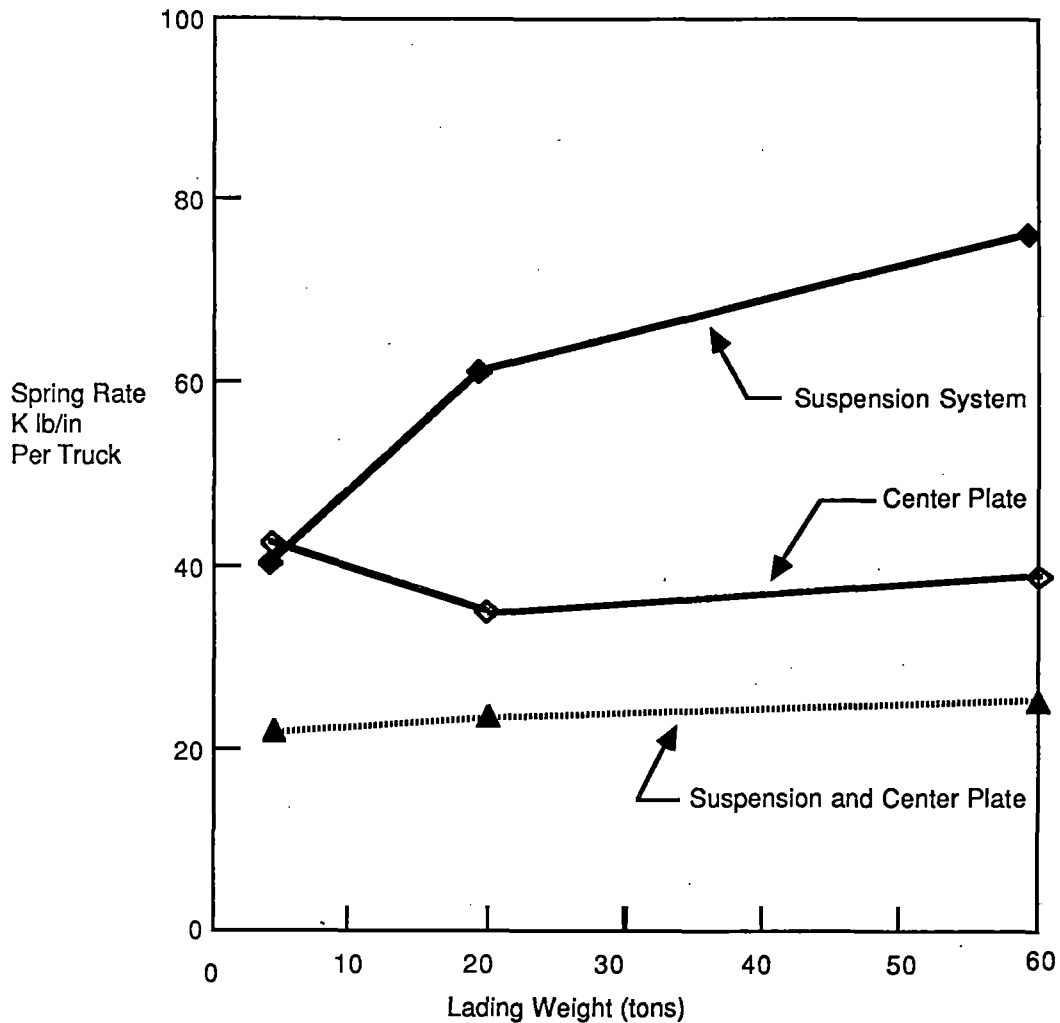
FIGURE 4-6
RIDE CONTROL TRUCK SUSPENSION SYSTEM
LATERAL SPRING RATES, PER TRUCK
