**Freight Car Fatigue -
Coal Car Simuloader Demonstration Test**

Report No. R-747

Association of American Railroads
Research and Test Department

December, 1990

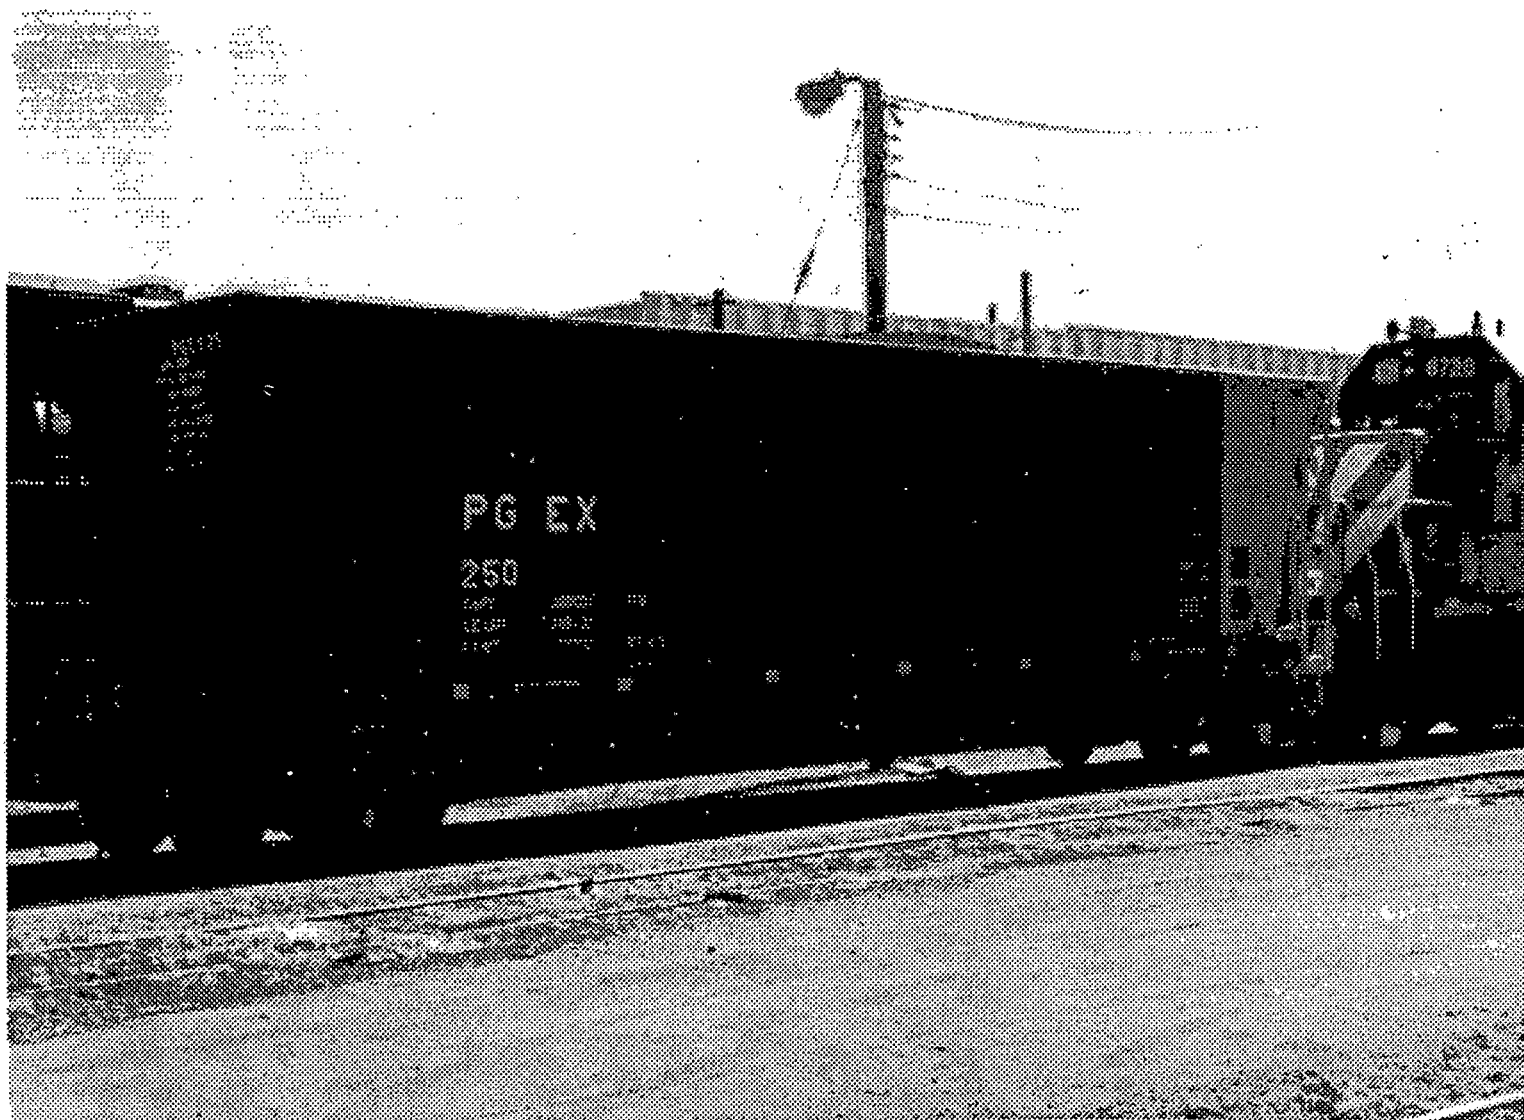
Exhibit 2.1 Photograph Of The Test Car.

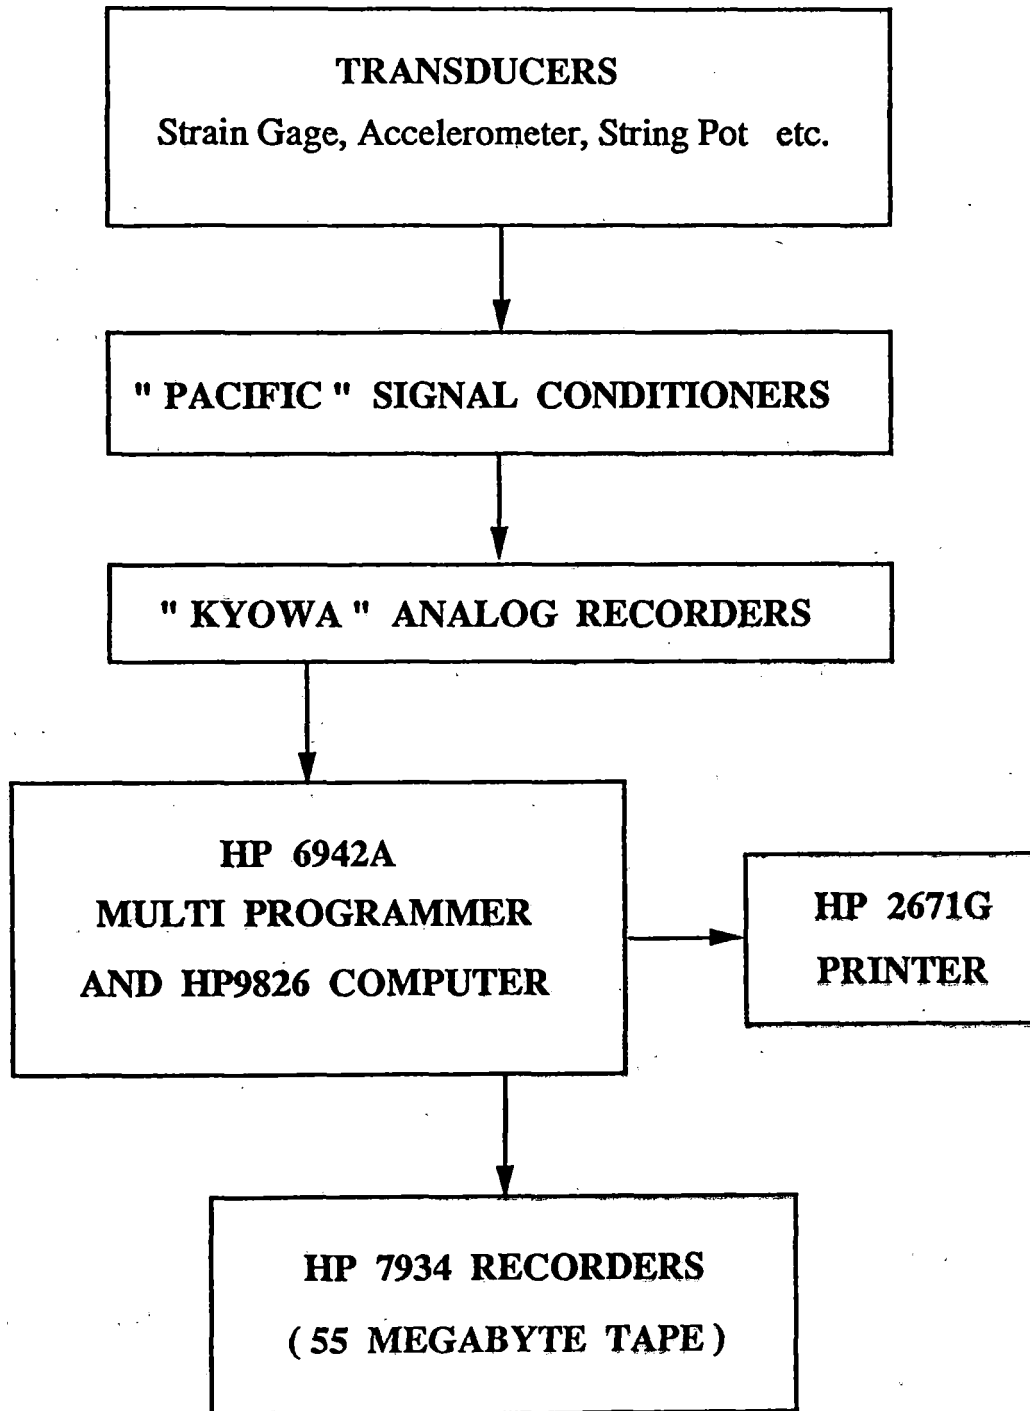
Exhibit 4.3 Data Acquisition System Flow Chart.

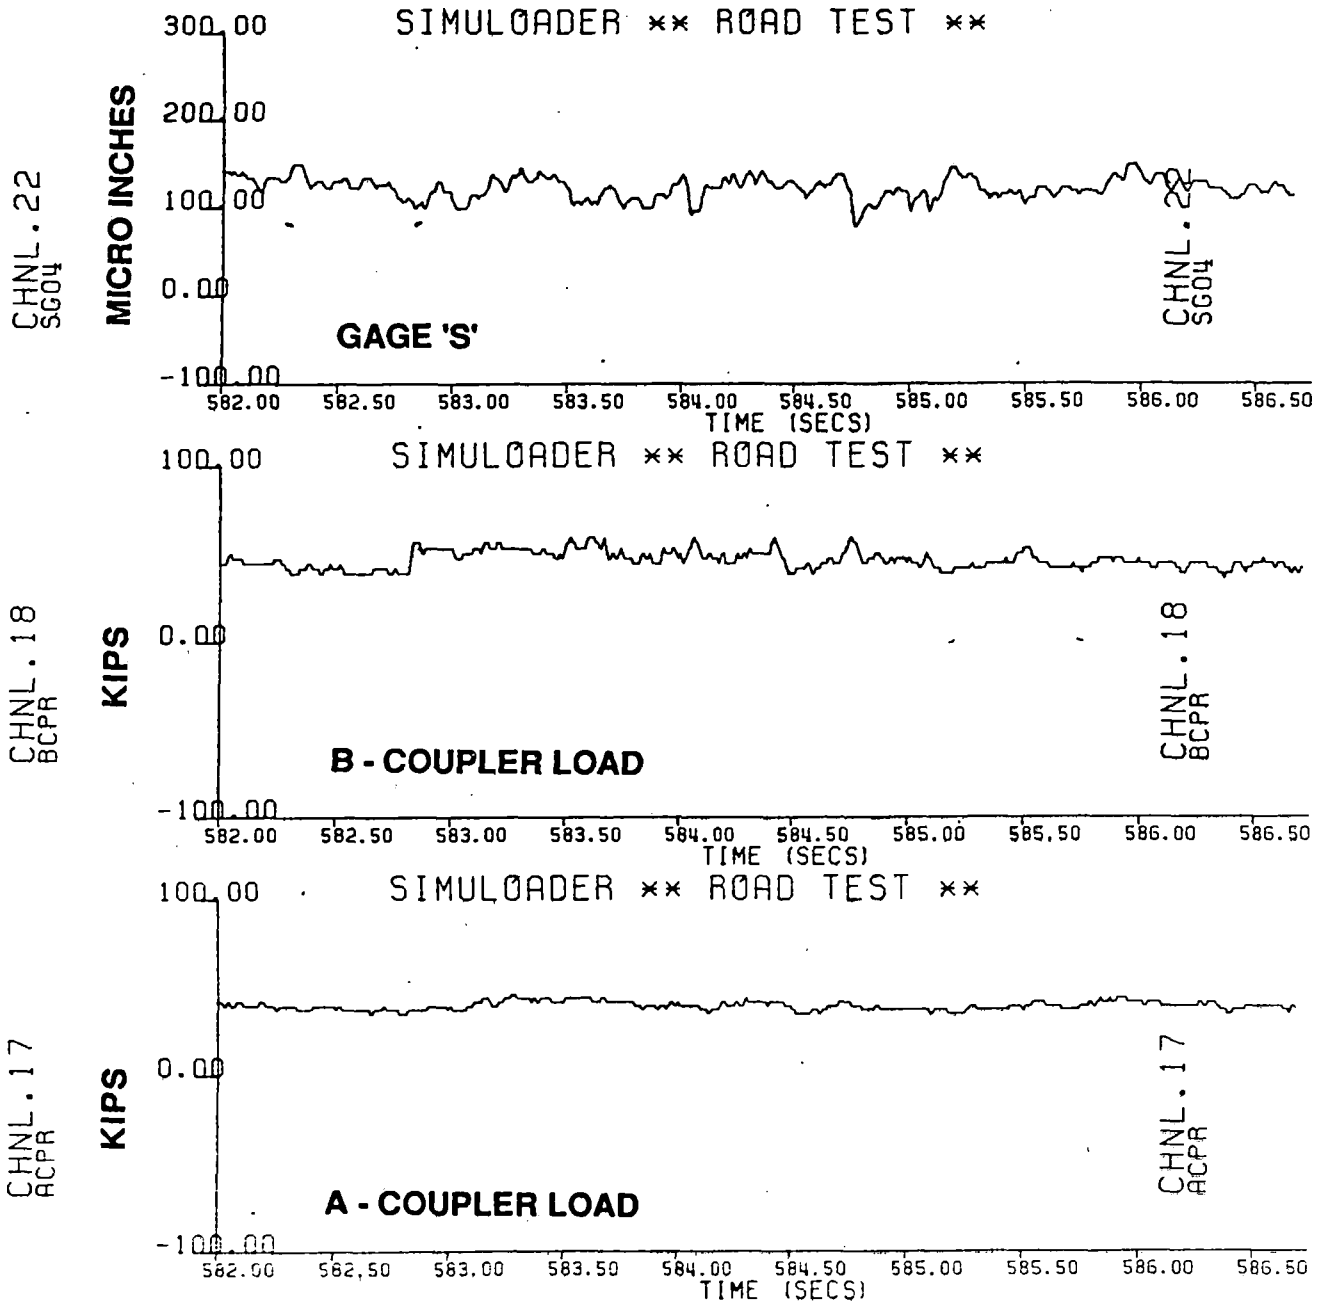
Exhibit 6.1B shows A and B-end coupler loads and the strain response of gage 'S'.

Exhibit 6.1B Road Test Data - Time Histories for Pitch & Bounce Case (Continued).

The two coupler loads are in the 45 to 50,000 lbs. range and the side sill gage also shows little activity. This leads us to believe that this incident of high vertical bolster loads was due to bounce and some accompanied pitching.

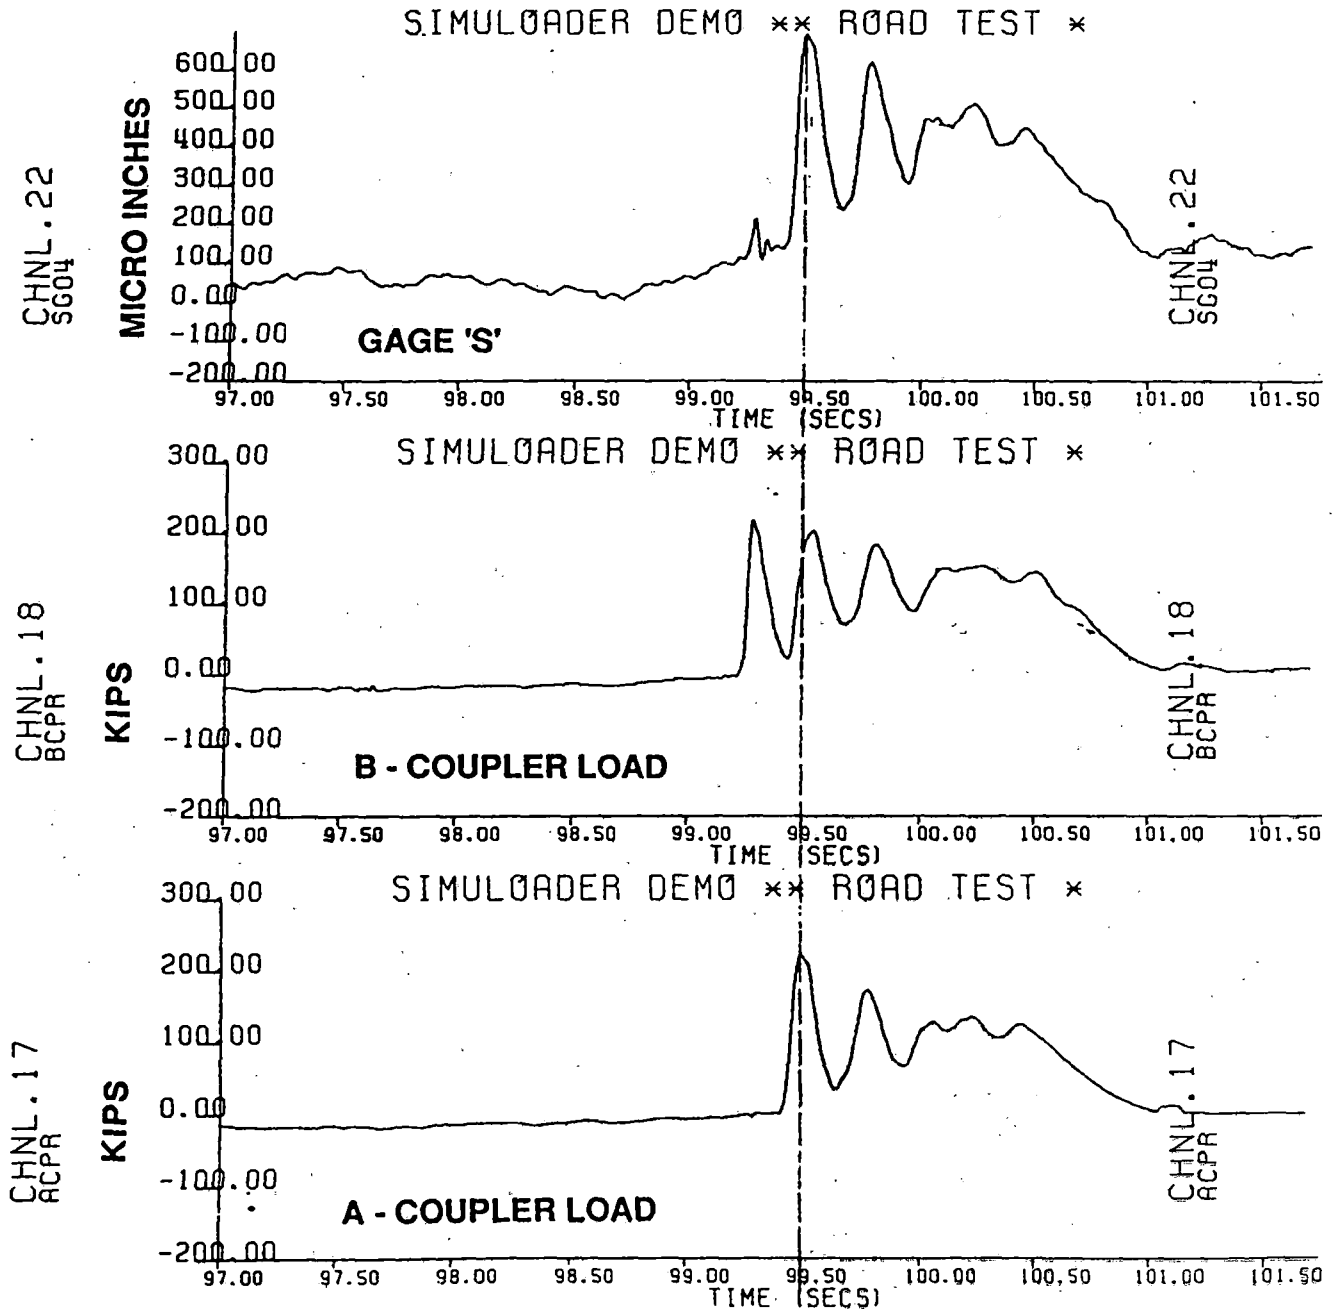
Exhibits 6.3A and 6.3B show the A and B-end coupler loads and truck bolster strains ('V') and strains at gages S and R. The run-in is observed at the B coupler at approximately 99.25 seconds and the A coupler experiences the run-in at 99.4 seconds. At about the same time the strain gage 'S' shows a strain plot very similar to the A-end coupler load plot. The speed plot shows a speed increase beginning at 99.25 seconds. Truck bolster strains ('V') indicate a slight unloading at 99.5 seconds followed

Exhibit 6.3A Road Test Data - Time Histories For Sustained Run-In With Sustained Bounce Case.

by a bounce of approximately 0.7g dynamic load. Strain gage R' responses slightly to this bounce event. Cyclic behavior of gage 'R' before and after this event indicates slight rocking motion, also seen by the truck bolster gage before and after the event.

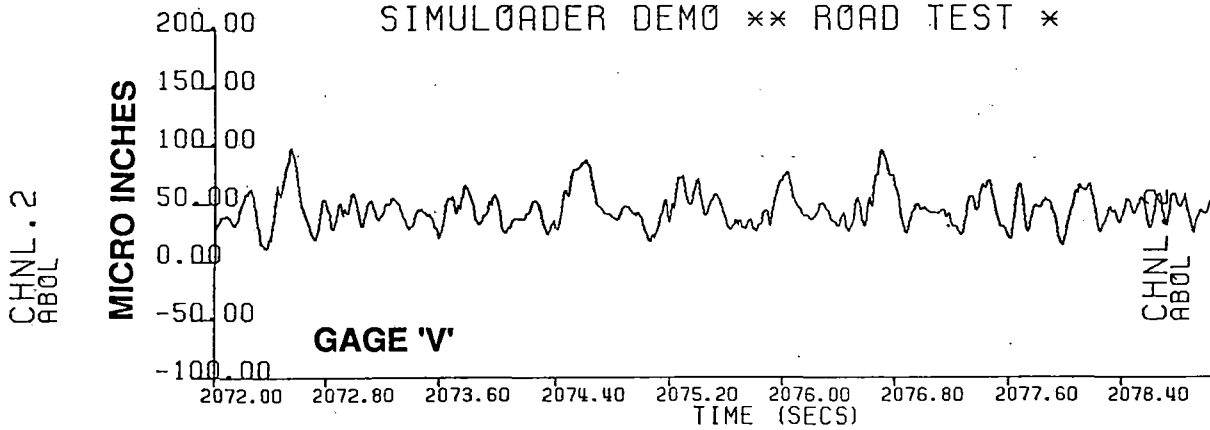
Exhibits 6.4A and 6.4B show the car body bolster strain gage "R" response to what apparently is rock and roll motion of the car body as also seen in the cyclic response of the truck bolster vertical gage "V" at a speed of 30 MPH. This action takes place during moderate sustained draft load of 100 KPS as shown in Exhibit 6.4B. There is some modest response of side sill gage "S" to this motion.

Exhibit 6.4A Road Test Data - Time Histories for Rock and Roll Case.

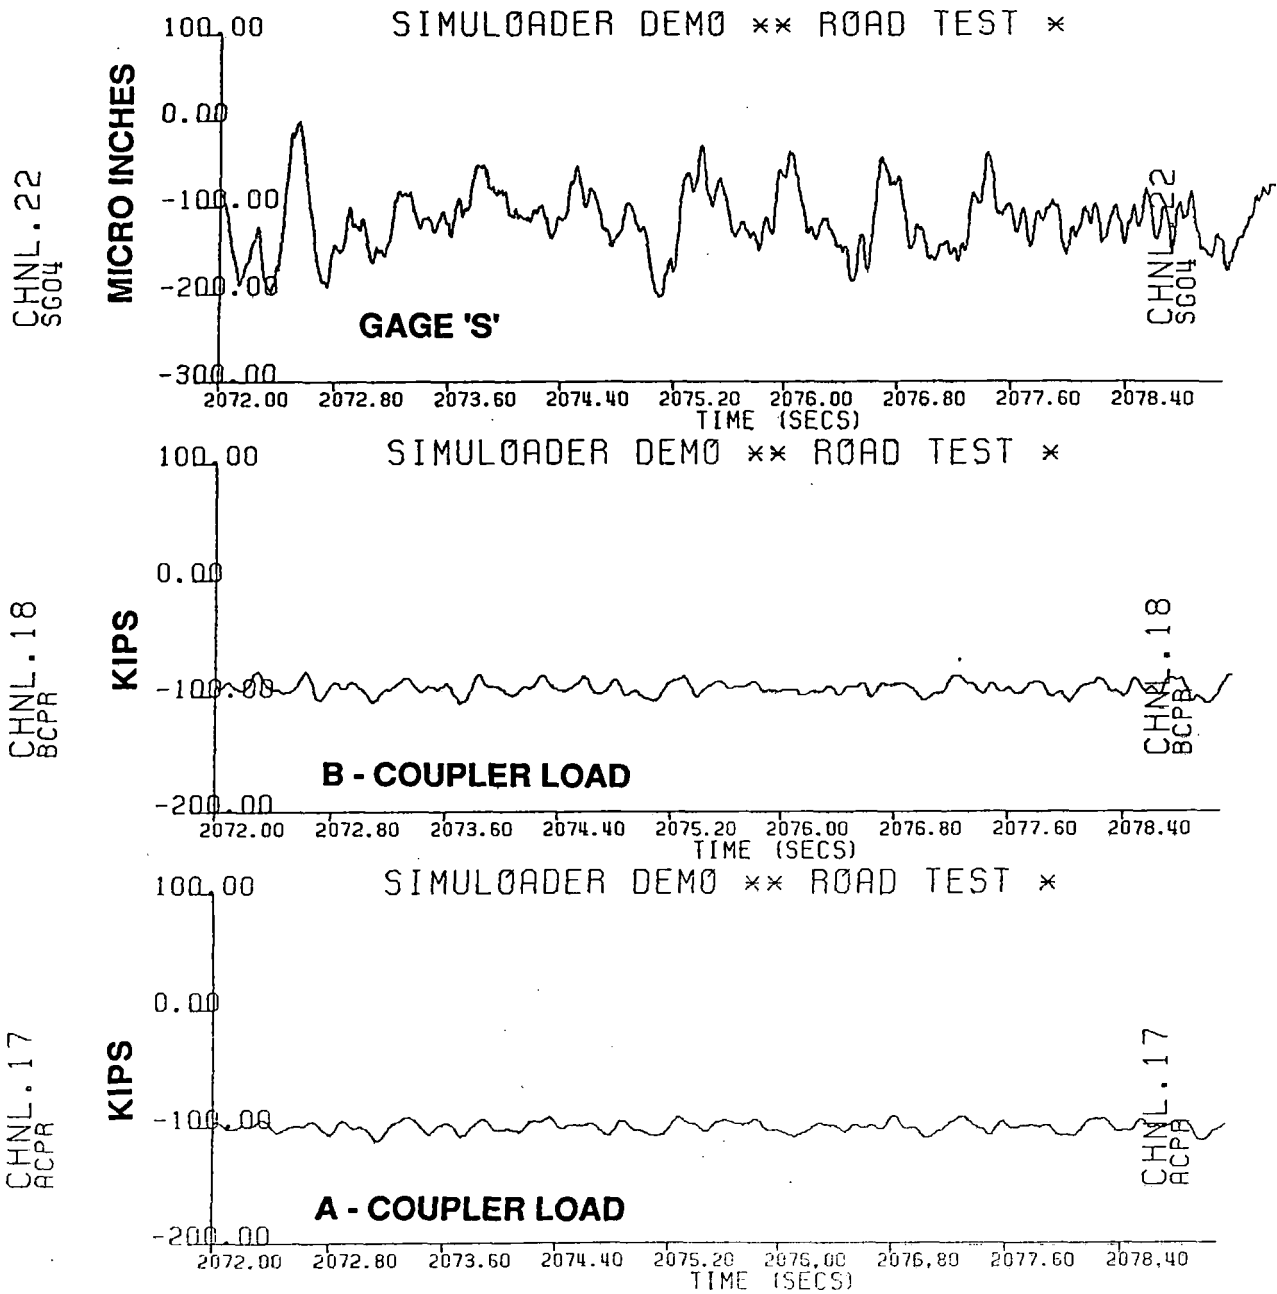
Exhibit 6.4B Road Test Data - Time Histories For Rock and Roll Case (Continued).

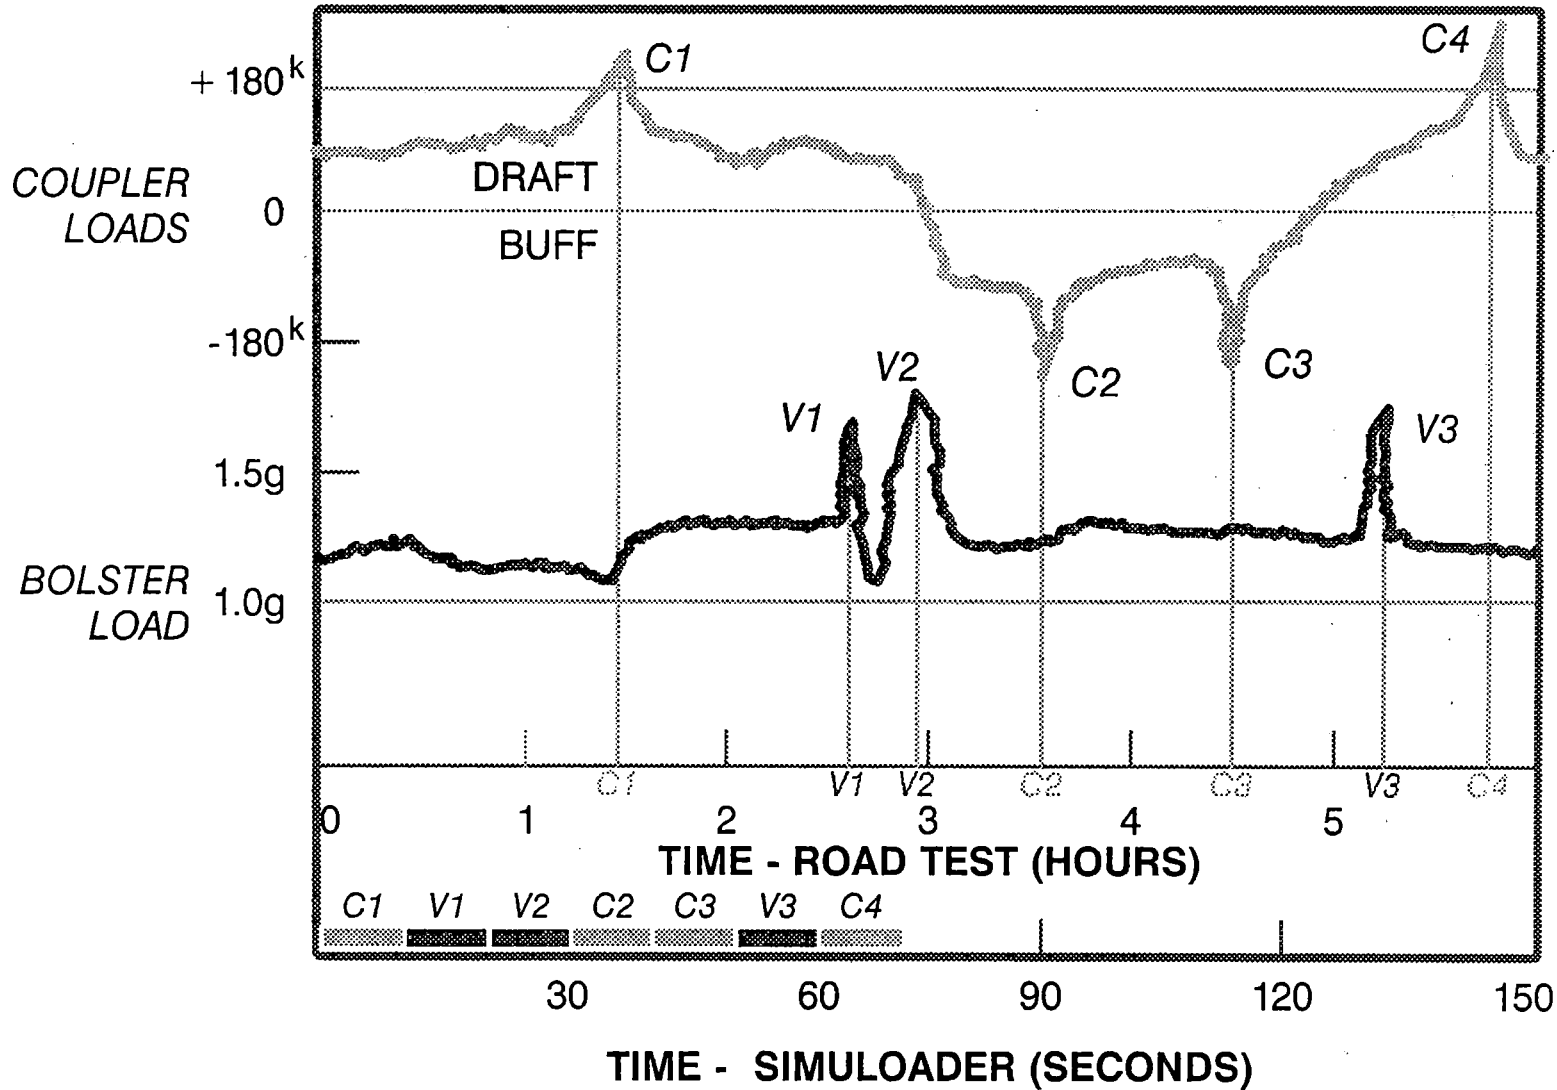
Exhibit 8.1 Methodology for Condensation - The Time Slice Approach.

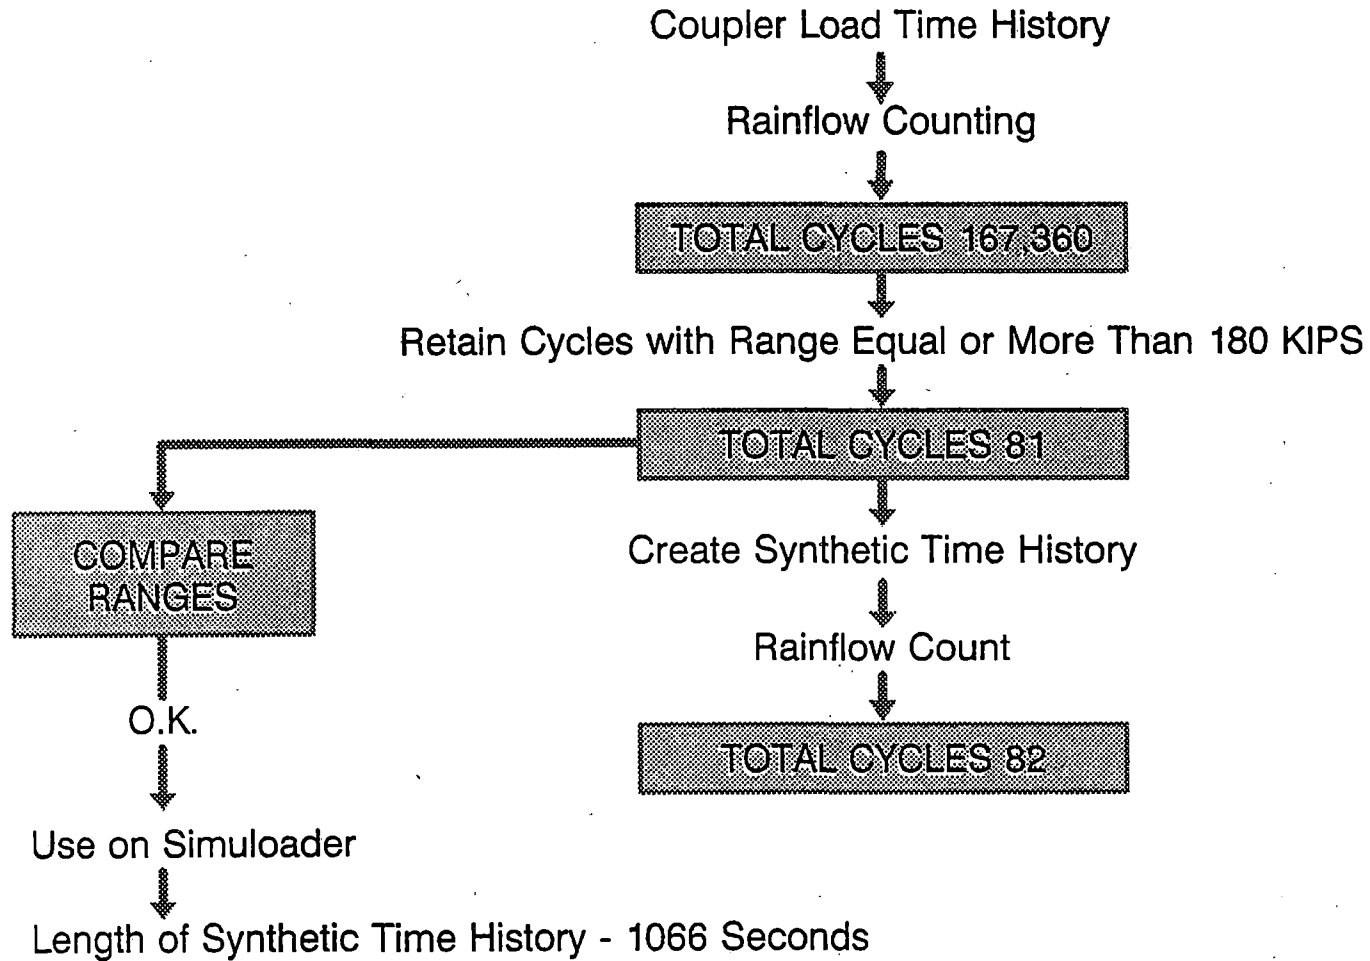
Exhibit 8.3 Selection Scheme for Long Duration Coupler Load Cycles.

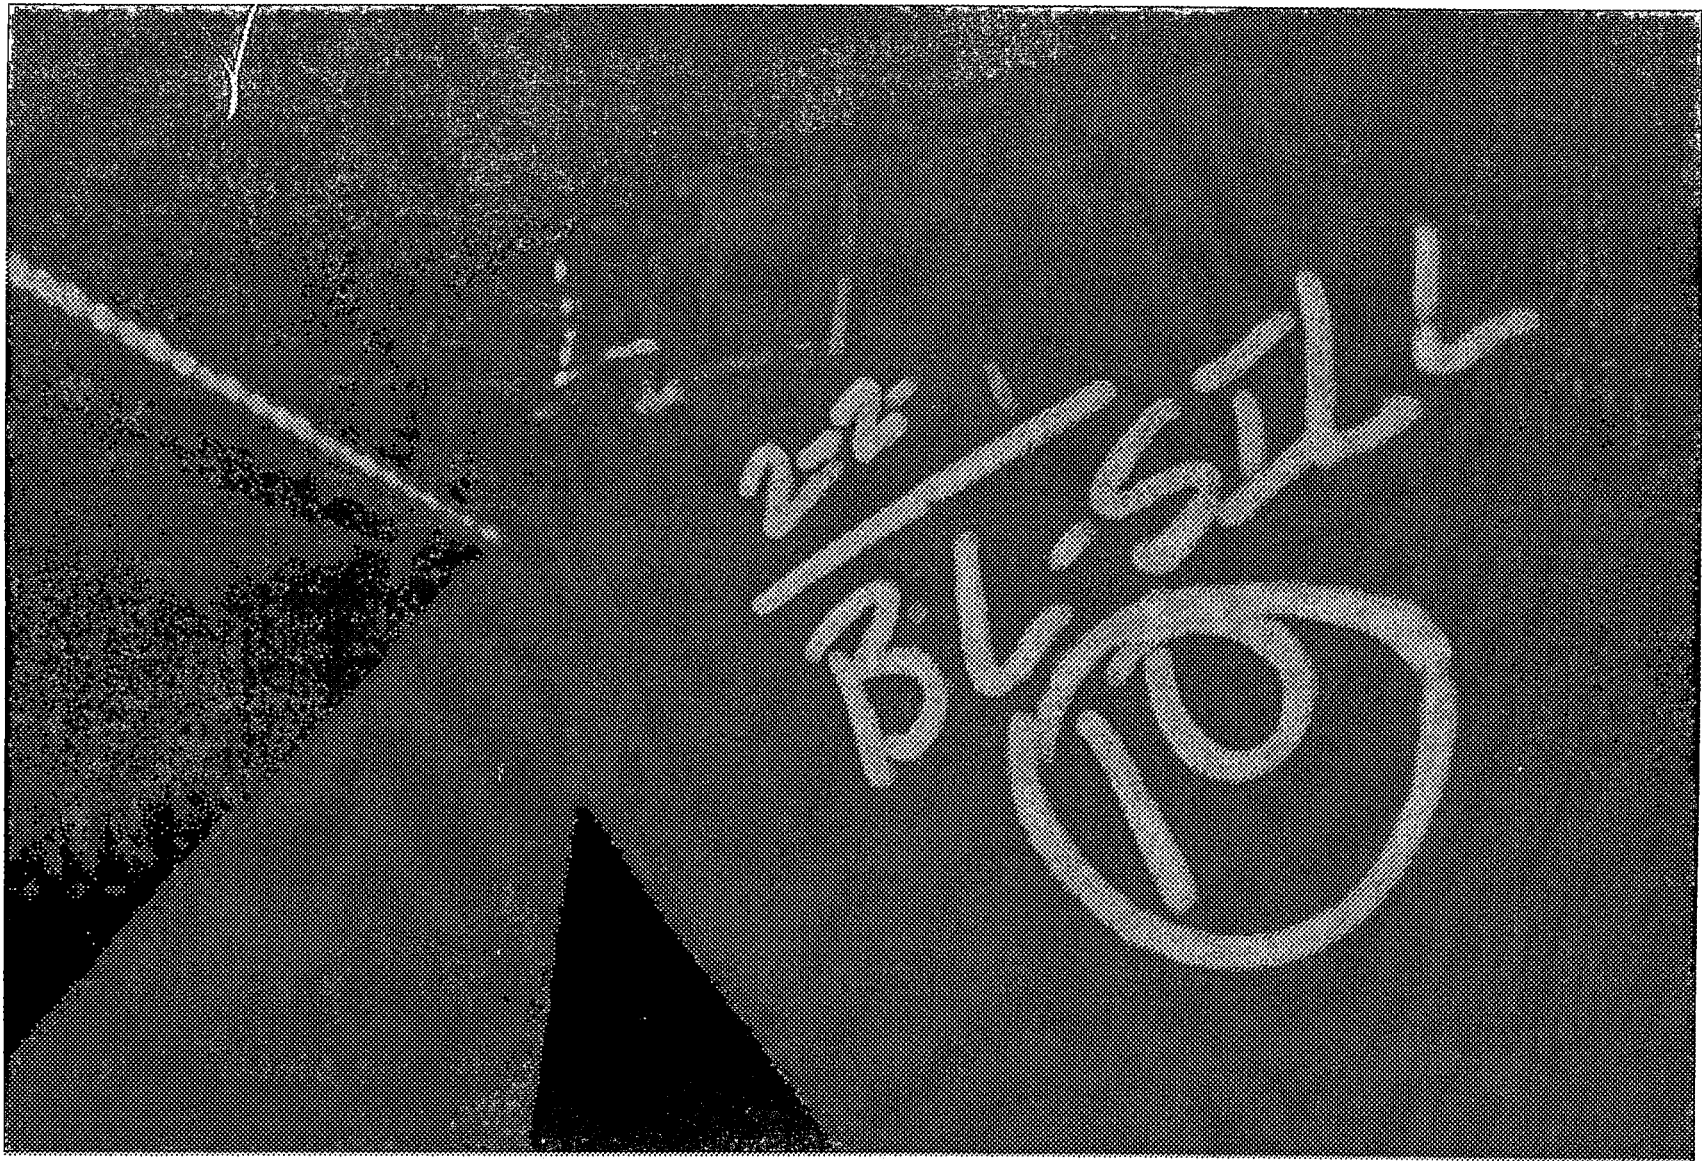
Also in the left B-end of the car an inch long crack was observed in the horizontal weld between the inboard end of the stub sill and the shear plate near the tub end enclosure. See Exhibit 10.3 again for location. This crack, which was first observed after about 200 hours of testing, grew to 3 inches at 260 hours. See Exhibit 10.5 for a photograph of this crack.

Exhibit 10.5 Photograph of Stub Sill Crack..

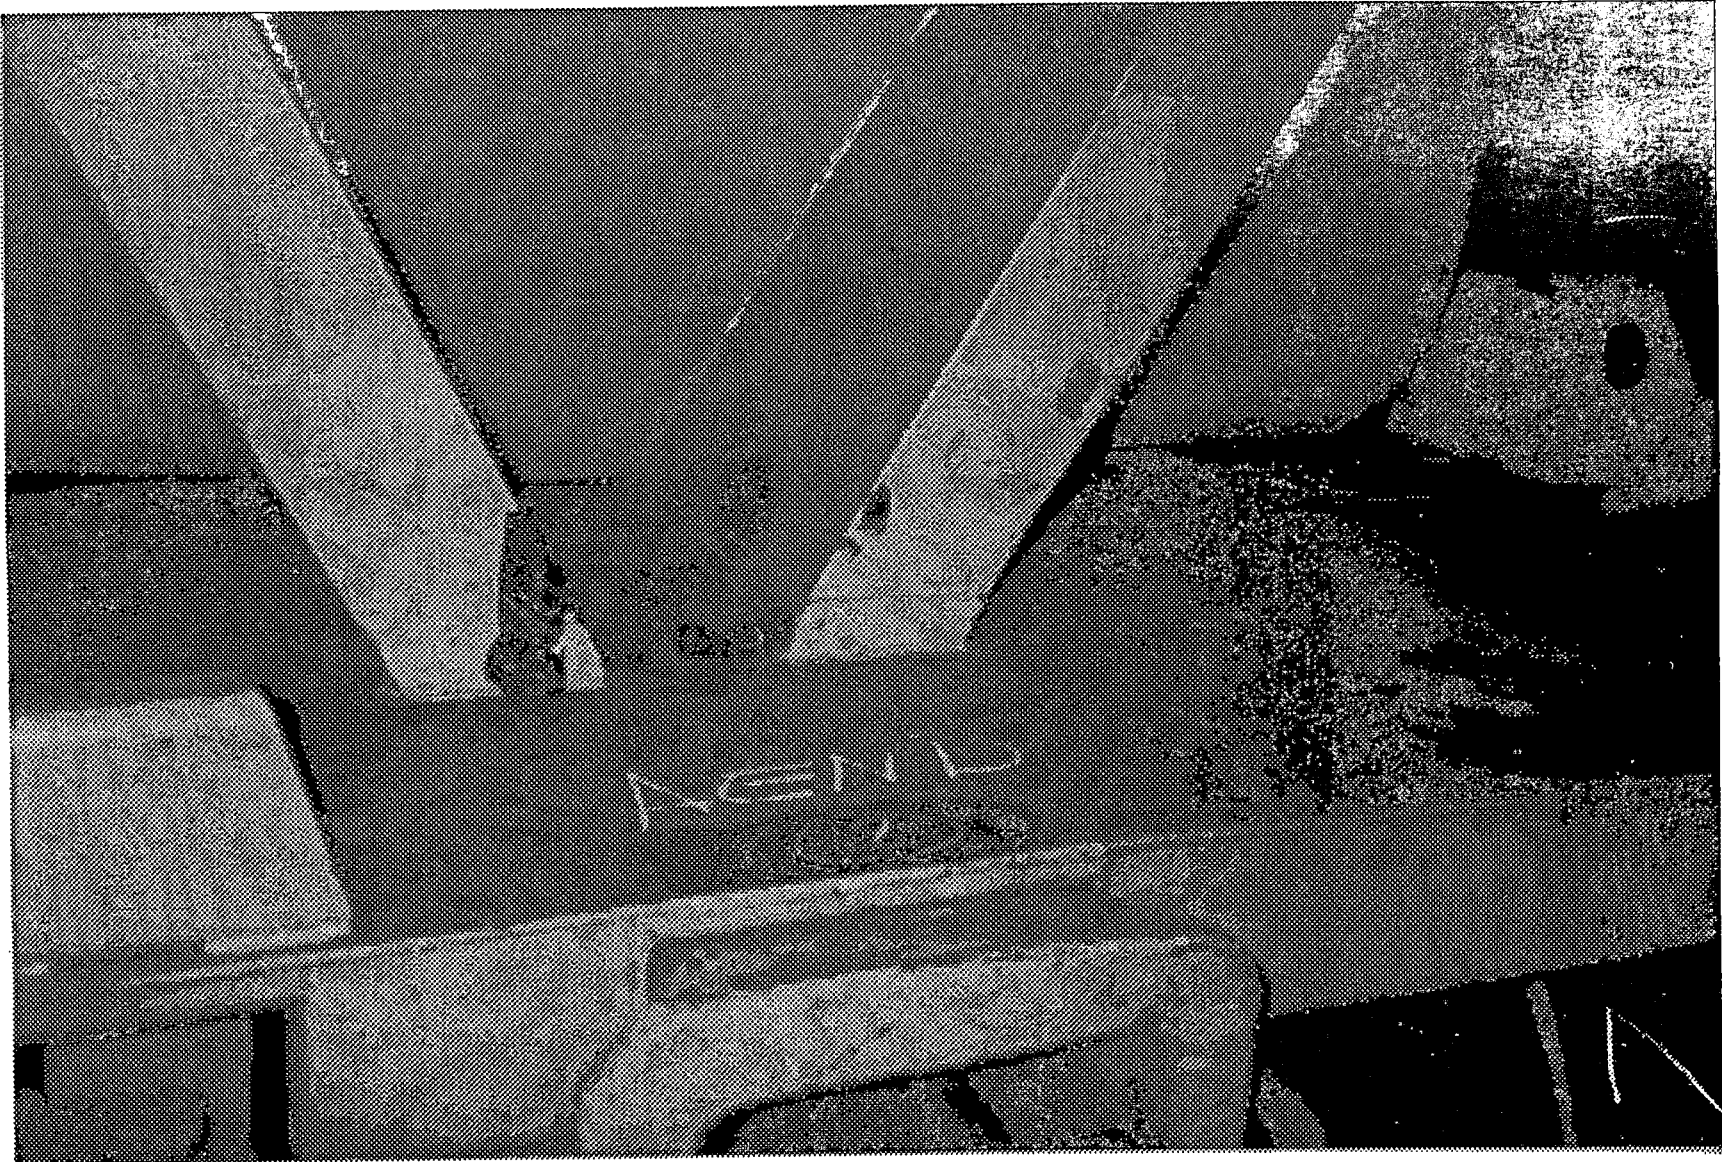
Finally, some small deformation or buckling of the shear plate was seen on the A-end of the car near the coupler carrier. This is shown in the photograph of Exhibit 10.8.

Exhibit 10.8 Photograph of Shear Plate Deformation Near A-End Coupler Carrier.
