INTERIM REPORT ON  
MAGNETIC FIELD TESTING OF  
TR07 MAGLEV VEHICLE AND SYSTEM,  
CONDUCTED AUGUST 1990

**FEDERAL RAILROAD ADMINISTRATION**

**ELECTRIC RESEARCH AND MANAGEMENT, INC.**

**MAY 1991**

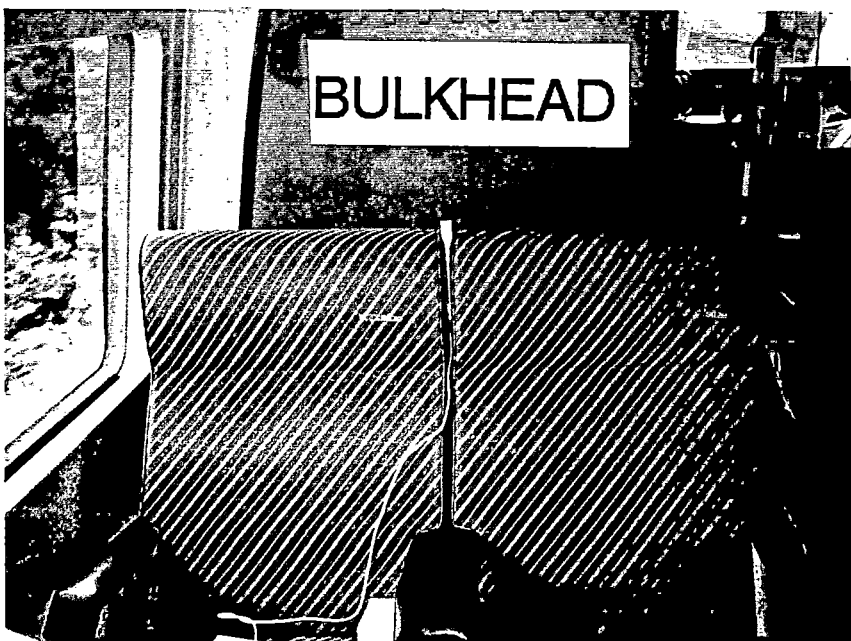
**FIGURE 3B**  
**REAR BULKHEAD**  
**REFERENCE PROBES, V,**  
**STARBOARD SIDE.**  
**V-DC/AC → HEADREST**

V-AC → SEAT

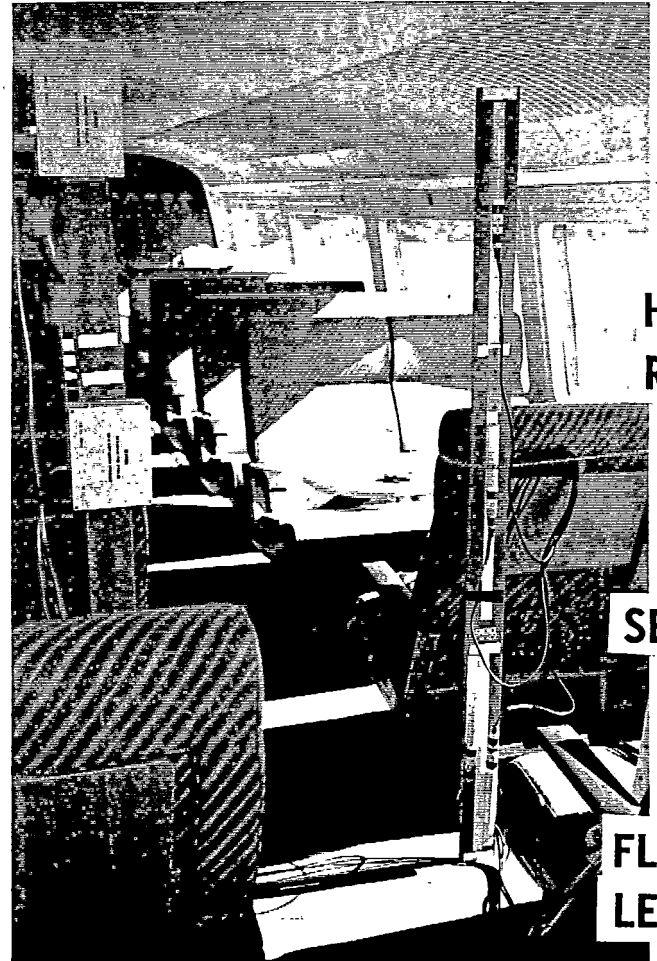
**AC (LEFT) DC (RIGHT)  
@ MIDDLE AISLE SEAT**

**FIGURES 4A AND 4B  
AC AND DC  
VERTICAL PROFILE PROBE  
CONFIGURATION (LOC. #2,1,  
RESPECTIVELY; PROBES  
90° ROTATED FR. 1',2')**

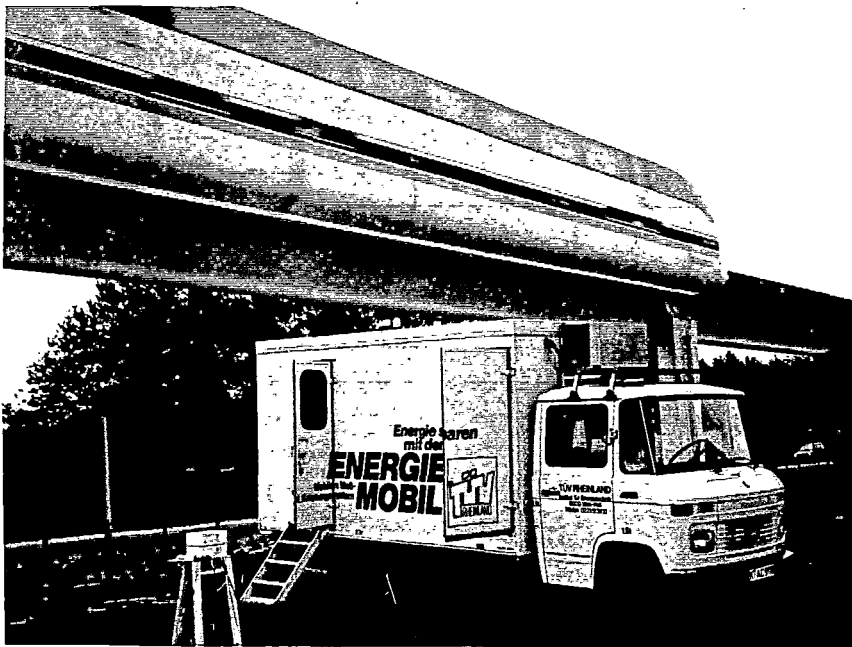
**FIGURE 14B**  
**SETUP 18 (WED. AM)**  
**REVISED SETUP AT HIGH**  
**STEEL G/W WITH COMPUTER**  
**IN TEST TRUCK. SAME**  
**PROBE LOCATIONS AS ABOVE.**  
**-10M OFFSET PROBE IN**  
**FOREGROUND. RIGHT SIDE**  
**REFERENCE PROBE AT -3M**  
**OFFSET AT PILLAR 2422**  
**BEHIND TRUCK.**

The setup was redeployed Wednesday morning using the TÜV Mobile Lab truck to contain the computer and multiplexers (Setup 18'). The probes were at the same locations as before but the lab truck was used to house the computer and was positioned about 10 m south of the 10 m offset probe. It is believed (but not proven) that the truck had negligible effect on the data.

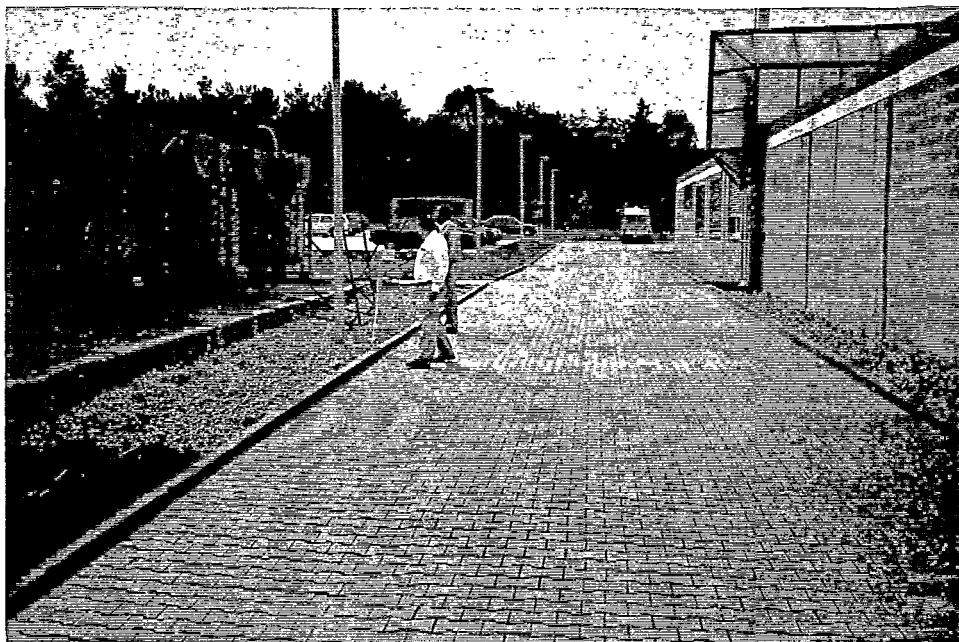
**FIGURE 14C SETUP 19  
(SAME AS #18 EXCEPT  
RIGHT SIDE REFERENCE  
PROBE AT LOCATION  
BETWEEN OUTPUT  
TRANSFORMER BANK AND  
INVERTER BLDG.)  
(TR7017, 018)**

Later Wednesday morning, the high steel guideway setup was modified by moving the right side reference probe set to the vicinity of the output transformer yard, across a driveway from the inverter building (Setup 19). The very audible whine of the transformers gave a good indication of the TR07 operating conditions (speed, acceleration or deceleration) and it was felt that the fields of the inverter output transformer would convey this same information. The transformer yard right side reference was available for data sets TR7017 and TR7018.

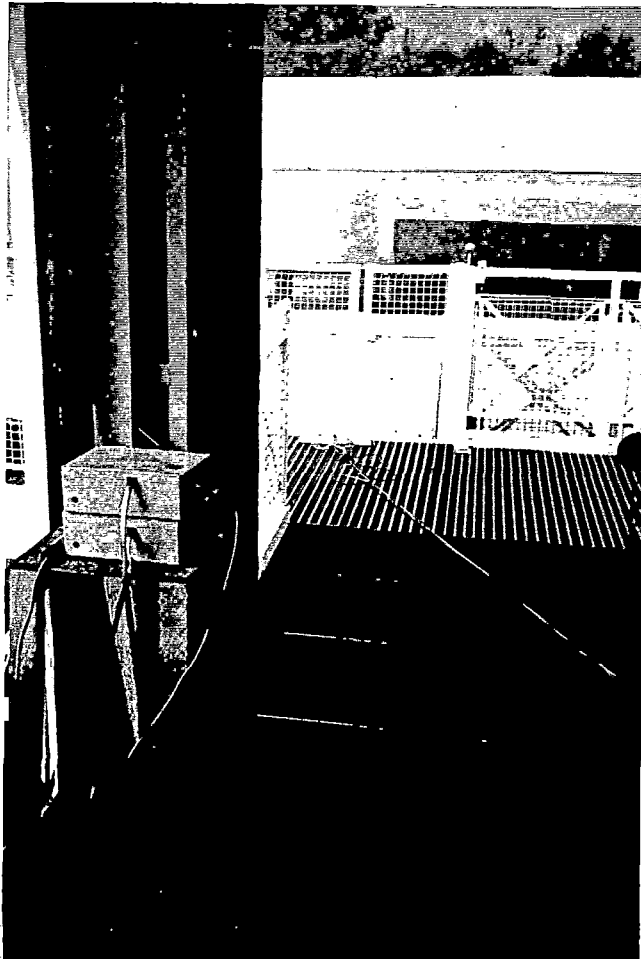
**FIGURE 16 SETUP #20  
AT PASSENGER STATION**

**PASSENGER STATION  
LOADING AREA  
(PARKED TR07 IN  
BACKGROUND)**

**(FLOOR ONLY USED  
SECURELY TIED)**

Extensive data were taken at the passenger station. The passenger terminal platform was at a high concrete section of guideway ( $\approx 5$  m above ground level). Two probe sets were placed at the elevated terminal platform area. One was just inside the waiting area door, 1 meter off the floor and about 8 m from the guideway edge. A second probe set was placed (tied securely) on the floor of the passenger loading gate, behind an aluminum flip-down bridge treadway (Figure 16). The majority of the framing members on the platform were steel and may have affected the measurements to some degree. The "background" fields (without the TR07 nearby) were measured and can be subtracted from the net field with the TR07 present. This is best done with the time domain data and has not yet been performed. The platform floor was an aluminum grid-like structure with anti-skid material

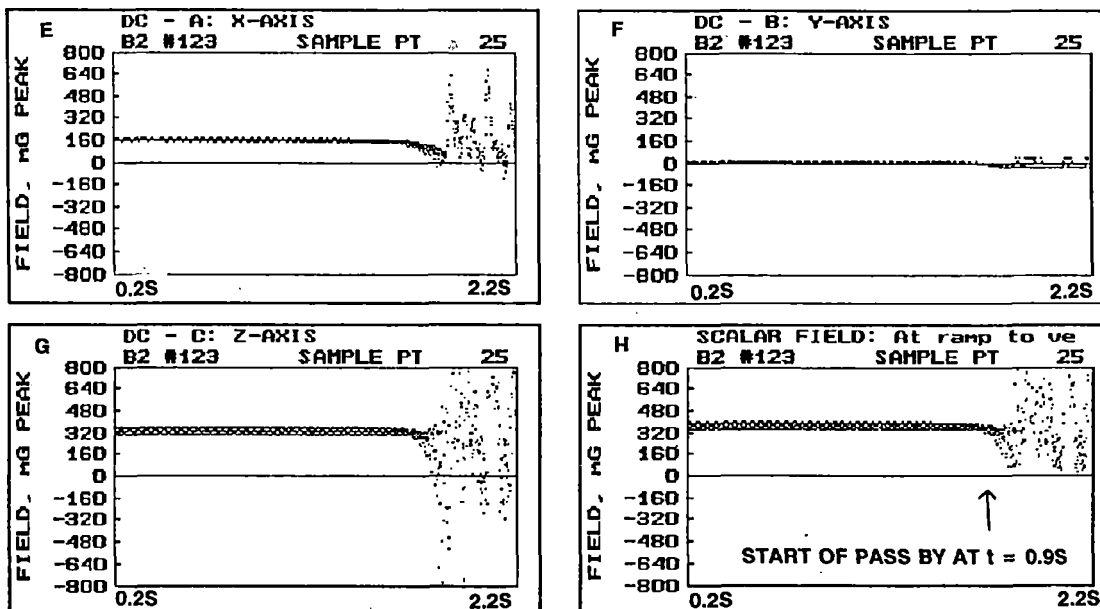
Figure 19 LOADING AREA OF PASSENGER STATION, TR07 PASS BY N - S, V = 330 KM/HR & SLOWING

SITE: TR7020 DC PROBE, LOAD FLOOR, ALIASED

The waveforms at the outdoor loading platform floor have rather large amplitude swings (several hundred mG peak to peak) since these sensors are quite close to the vehicle levitation/propulsion magnets. It should be pointed out that this test point is off limits to passengers when the TR07 passes by. Further, the wind gust created by the wake of a 300 km/hr (180 mph) TR07 pass by definitely encourages people to stay clear. Even the passenger terminal platform buffeted sharply when the TR07 passed by. A 1 meter height probe was originally planned at the loading area but was simply not practical. The loading area floor level probe set was tied securely in place and withstood the buffeting of over 30 pass bys of the TR07.

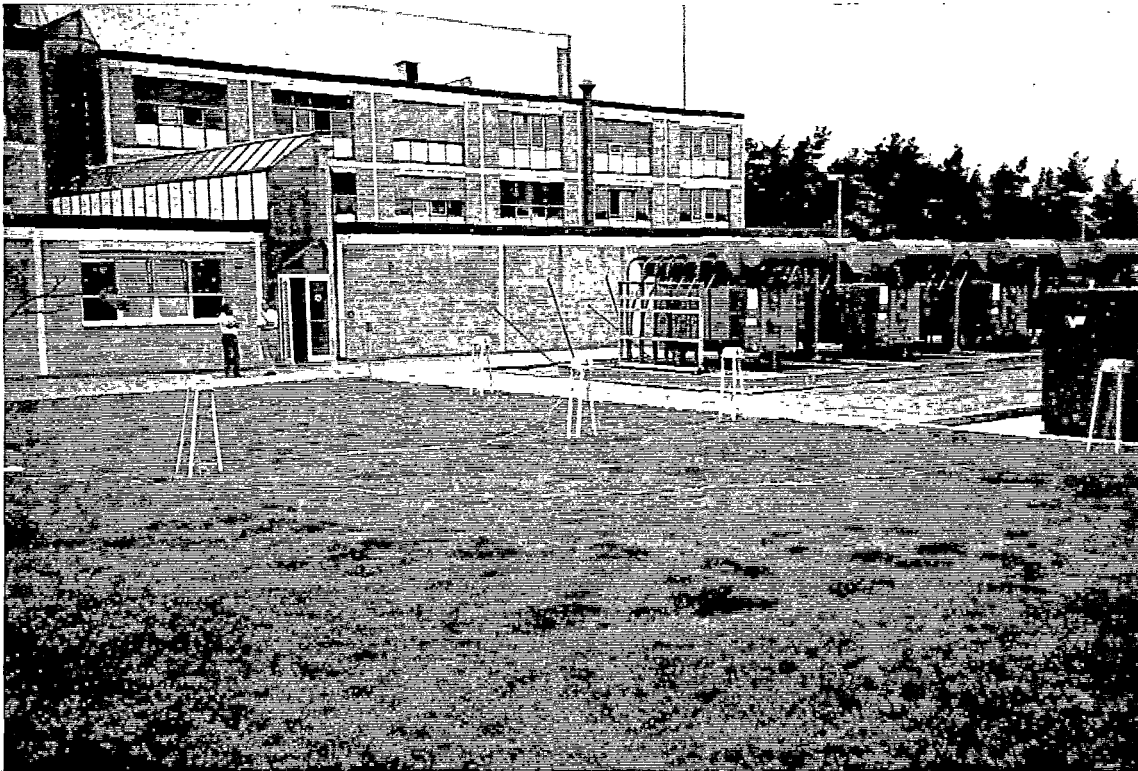
**FIGURE 25A  
TRANSFORMER  
YARD PROFILE  
LOOKING NW  
(INVERTER  
BLDG. AND  
CONTROL CENTER  
IN BACKGROUND)**

A field profile was done south of the output transformer yard, as shown in Figure 25. The 20 kV stepdown transformers are located on the east side of the yard, farther from the control center than the inverter output transformers. The magnetic flux density at this location was  $\approx 10$  mG and was dominated by the 50 Hz ac primary power rather than the variable inverter output excitation frequency (dc to 215 Hz). The operating conditions of the TR07 were readily discernable from the audible "whine" of the output transformers which should also be reflected in

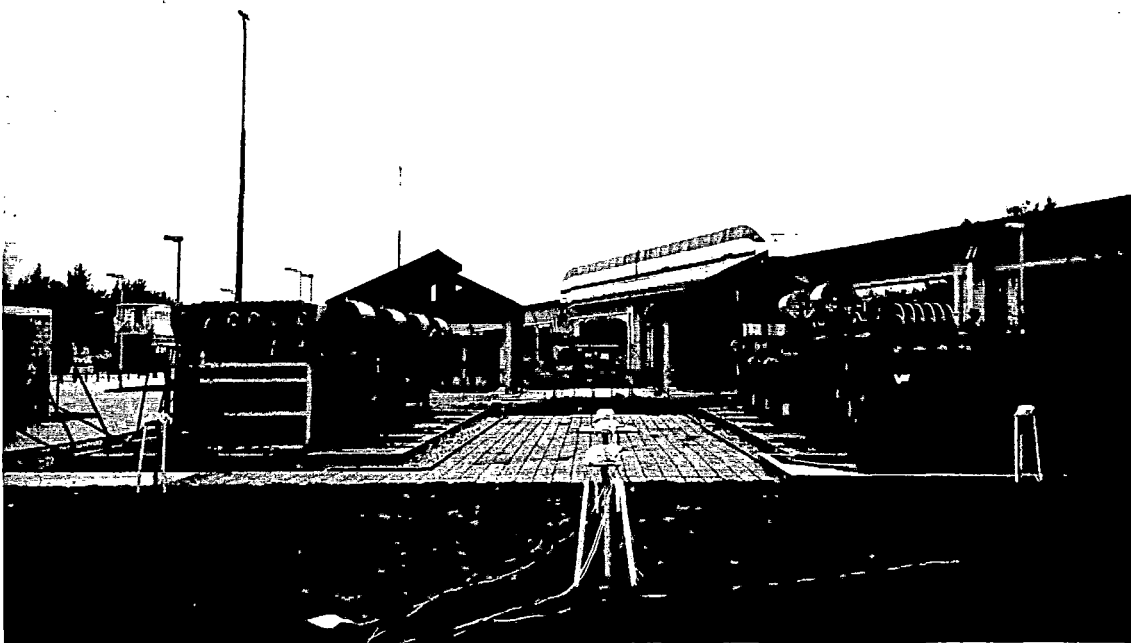
**FIGURE 25B TRANSFORMER YARD, LOOKING NORTH.  
BRAKING RESISTOR BANKS IN SHELTERS  
BEHIND TRX YARD**
