X2000 U.S. DEMONSTRATION VEHICLE DYNAMICS TESTS FINAL TEST REPORT

DOT/FRA/ORD-94/15

November 1993
Final Report

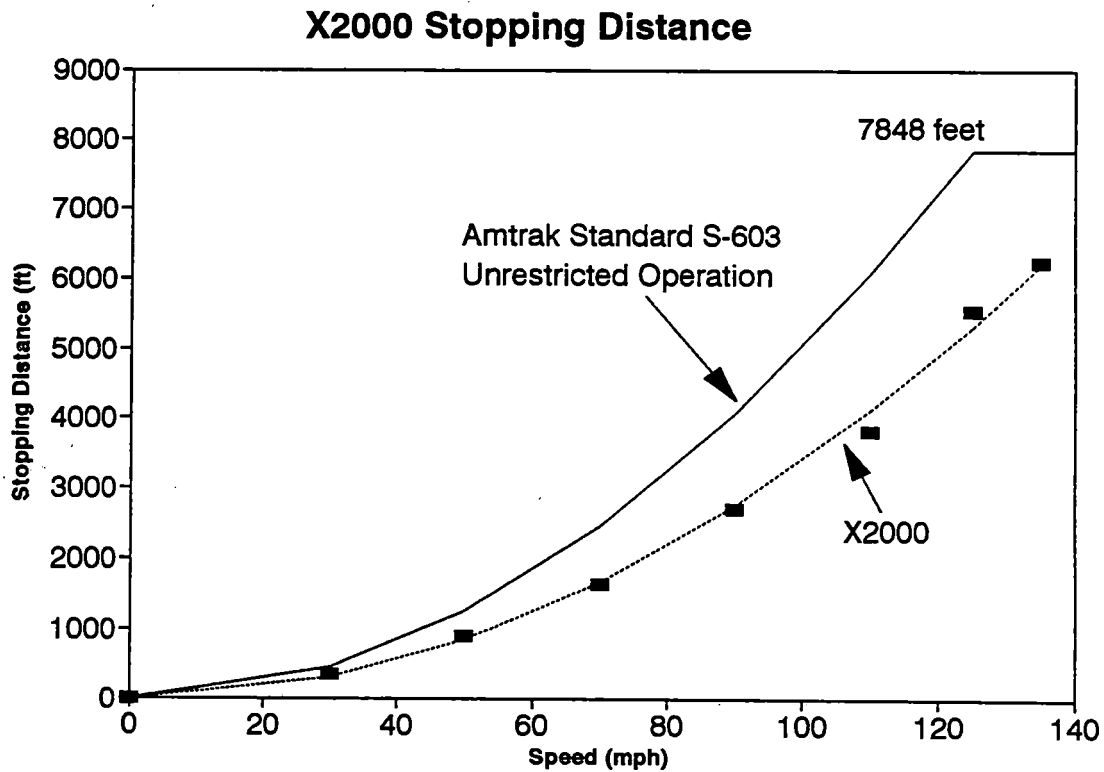
Figure 2.1: X2000 Stopping Distances, Air (Disc) Brakes Only

Results of these tests are included in Table 2.1. A plot of the braking distances is shown in Figure 2.1, together with Amtrak's maximum braking distance specification, Amtrak Standard S-603. The maximum acceptable braking distance for unrestricted operation throughout the NEC signaling system is 7848 feet. The plot indicates the X2000 braking performance is well within the acceptable envelope for speeds up to 135 mph.

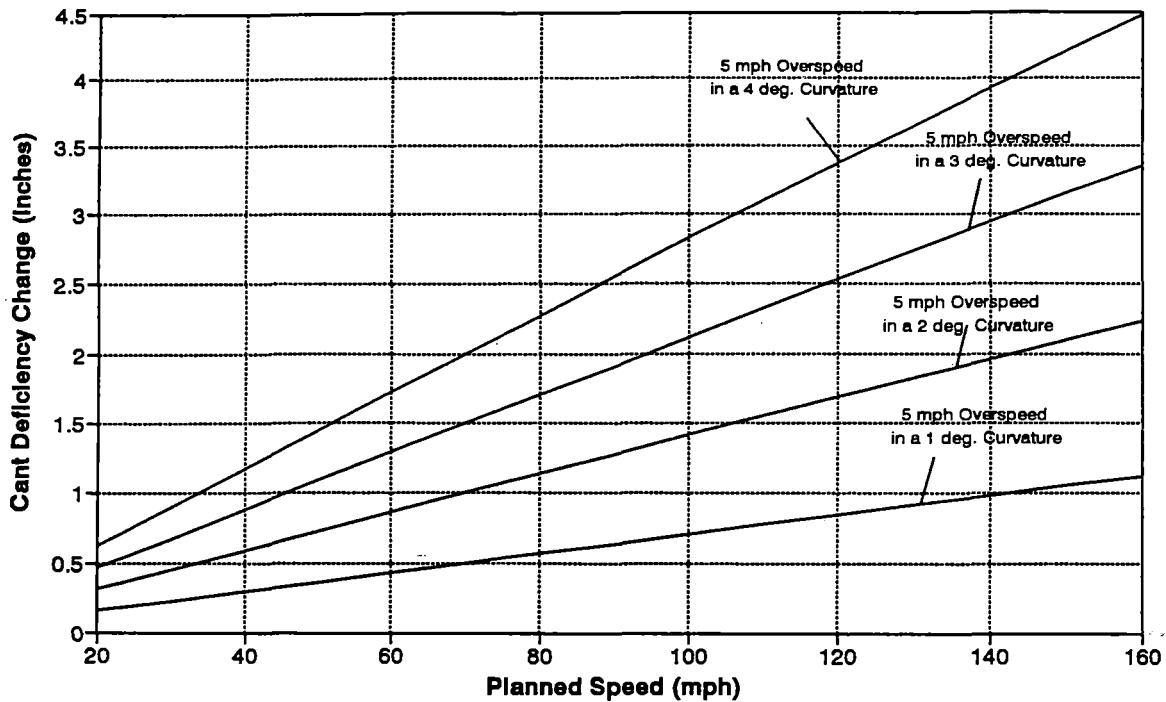
Figure 6.3: Effect of 5 mph Overspeed on Cant Deficiency

CHANGE IN CANT DEFICIENCY FOR A 5 MPH OVERSPEED

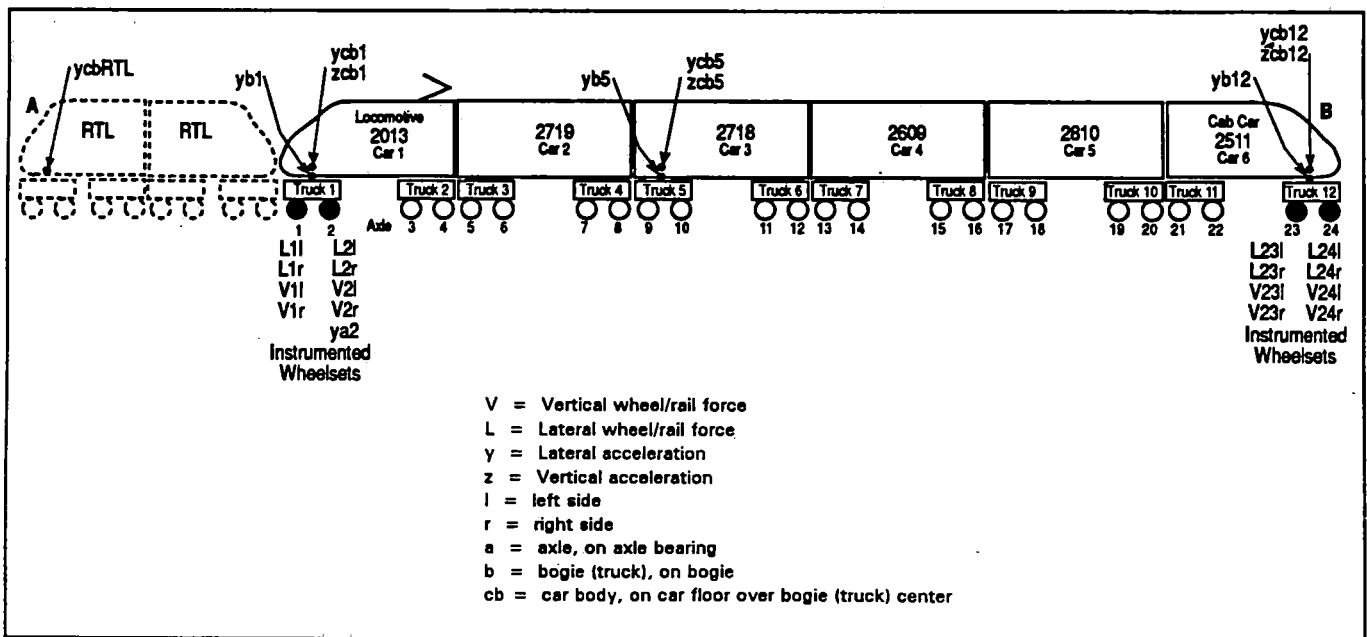
Figure B.1: Transducer Configuration, X2000 Tests USA

- V = Vertical wheel/rail force
- L = Lateral wheel/rail force
- y = Lateral acceleration
- z = Vertical acceleration
- l = left side
- r = right side
- a = axle, on axle bearing
- b = bogie (truck), on bogie
- cb = car body, on car floor over bogie (truck) center
