## **ACOUSTIC DETECTION OF RAIL CAR ROLLER BEARING DEFECTS**

DOT/FRA/ORD-00/66

May 1, 2001  
Final Report

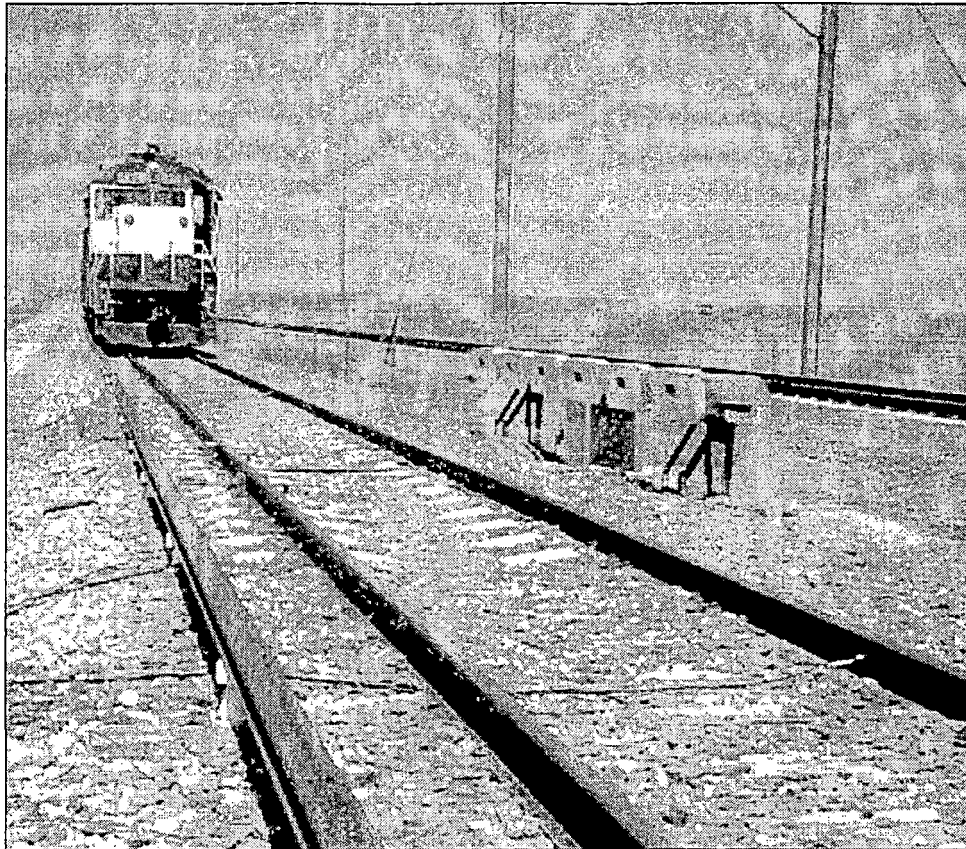
**Figure 1. Test Train and TTCI Microphone Array**

Figure 1 shows the trackside microphone enclosure, and Figure 2 shows the track mounted wheel sensors. In addition to the wheel detectors clamped to the rail, a traditional island track circuit was used to alert the system for train presence. The wheel detectors, typically used in hot bearing detection systems, were used to calculate vehicle speed, wheel (bearing) position relative to the microphones, and to estimate bearing class from axle spacing. These wheel detectors are magnetic probes that respond to the proximity of the wheel flanges passing over the sensor element.

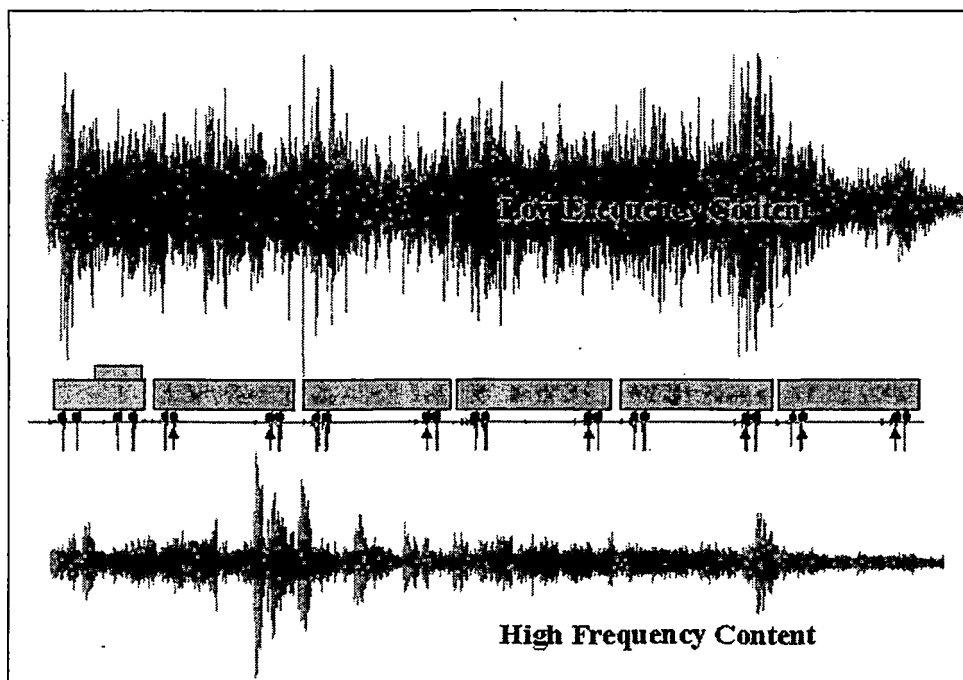
Figure 4. Typical Microphone Time History

A typical raw microphone time history for a passing train is given in Figure 4. Data has been broken down into the low-frequency content of the signal (above) and the high frequency (below). The graphic depicting the consist properly positions the wheelsets with respect to the signal, and the small vertical arrows give the position of defective bearings in this particular consist.

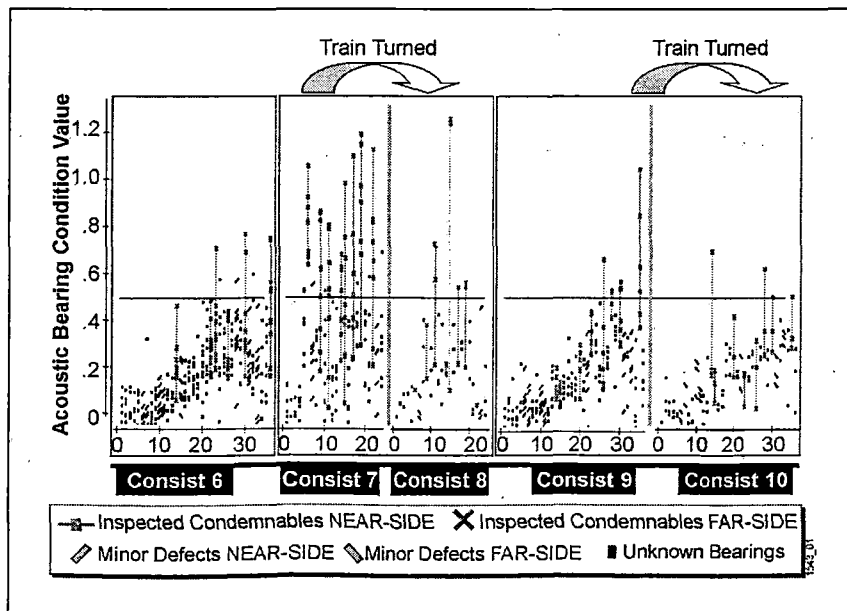
Figure 6. Graphical Output for Expert Model Results

The expert system model output shown in Figure 6 contains the entire result from the detector for all test runs with all five consists. It shows that consists 8 and 10 were run with the train direction reversed and defective bearings on the opposite side from the detector. Few defects were detected from those two consists compared to the previous consist before the train was reversed. The figure also illustrates that this expert system does select only defective bearings with a few exceptions.

Figure 6 also illustrates that not all defects will be "heard" or recognized each time they pass the detector. Observe the numerous defects that have low ABC values, mixing with the good bearings. This analysis, complicated by the extraneous noise, mixes the defects with many of the unknown but assumed good bearings. A given threshold, shown by the dashed line here at an ABC value of 0.5, would not identify some defects. Besides illustrating a variation in detectable acoustic emissions between passes, it can also be assumed that this expert system is not fully developed and may produce better results with additional data points (meaning more in quantity and variety of defective bearings and car types).

The expert system model developed from this data is a complex one. In spite of the noise issues, this model is almost accurate enough to be useful in revenue service, as Figure 6 shows. It is expected that further training with more and varied bearing defects would improve this performance.

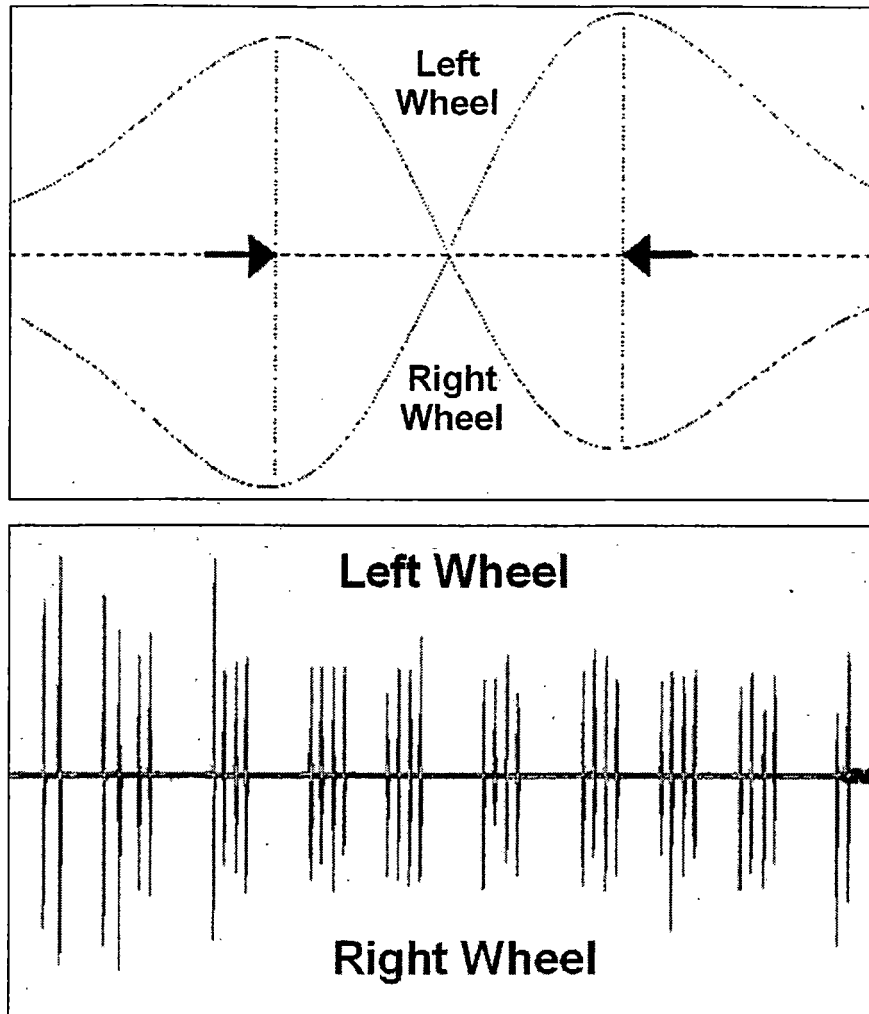
Figure 8. Encore Wheel Sensor Response

The Encore wheel monitor provides a signal, which is close to a “half-sine-wave” for every wheel that passes (see Figure 8 for a detailed view of responses from a single wheel and test train). The peak response (changing slope & height) of the monitor’s signature is related to a passing wheel’s diameter. The monitor’s output is a measure of wheel curvature because the detector is sensitive to the proximity of a wheel’s outer flange. The monitor is typically fixed to the gage side of the rail. The output waveform of the monitor is also speed dependent because the waveform is proportionally compressed along the time-based axis as passing wheels run faster. This means that most applications require these monitors to set up in pairs.

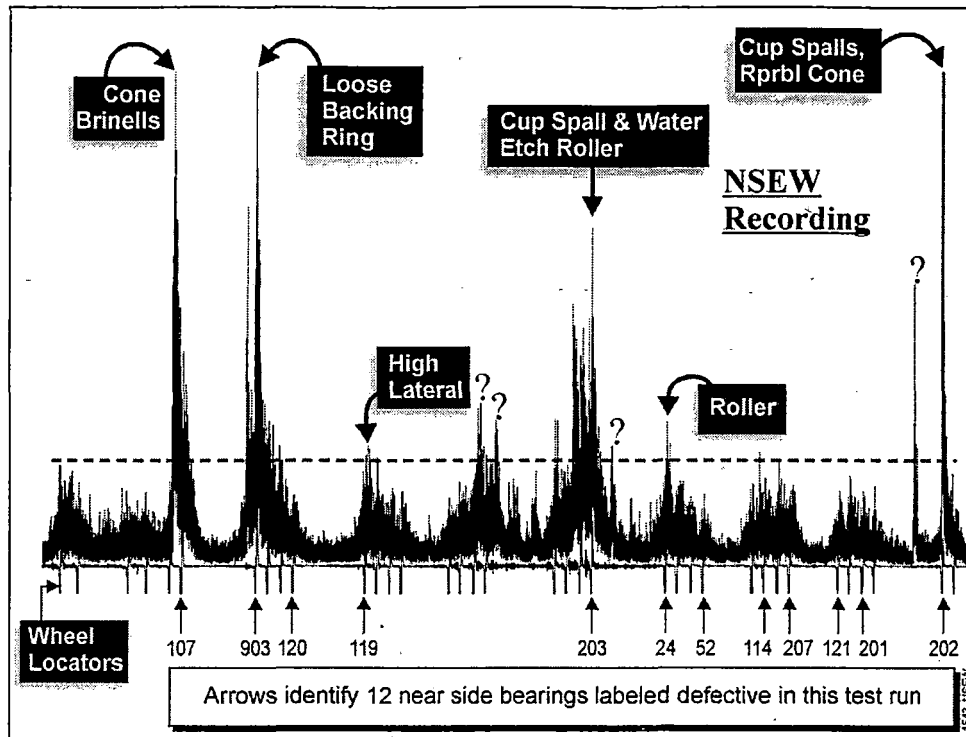
Figure 10. NSEW Recording of Passing Train

Figure 10 illustrates one of the NSEW recordings of a passing test train. The figure was derived from post processing one of the deployed microphones. Several specific bearings with known degraded components in the test consist can be identified from this simple graphic (i.e., 6 of the 14 total defects present, if wheel flats are ignored). Flags have been attached to the top of the defective passing bearings with the highest peaks in the figure. The arrows at the base of the display confirm that bearings were in the consist at the locations indicated by the flagged bearings. This simple diagnostic display is instructive because it uses only the peak rankings of the passing bearing’s processed acoustic output to accurately locate several defective bearings.

However, note that some defect types will not be found with this type of analysis because they may generate small amounts of acoustic output even though they contain defects. This can be seen from the graphic where arrows are pointing to bearings – yet they have small amplitude acoustic peaks above them.

the post-process chosen to generate the acoustic curves displayed. If a higher cut-off level is used to cull-out defective bearings, it tends to provide greater accuracy in defect identification — but fewer bearings are culled for inspection. Likewise, if the detection level is lowered with this scheme, many called-out bearings would contain no defects at all because even the best bearings generate some sound.

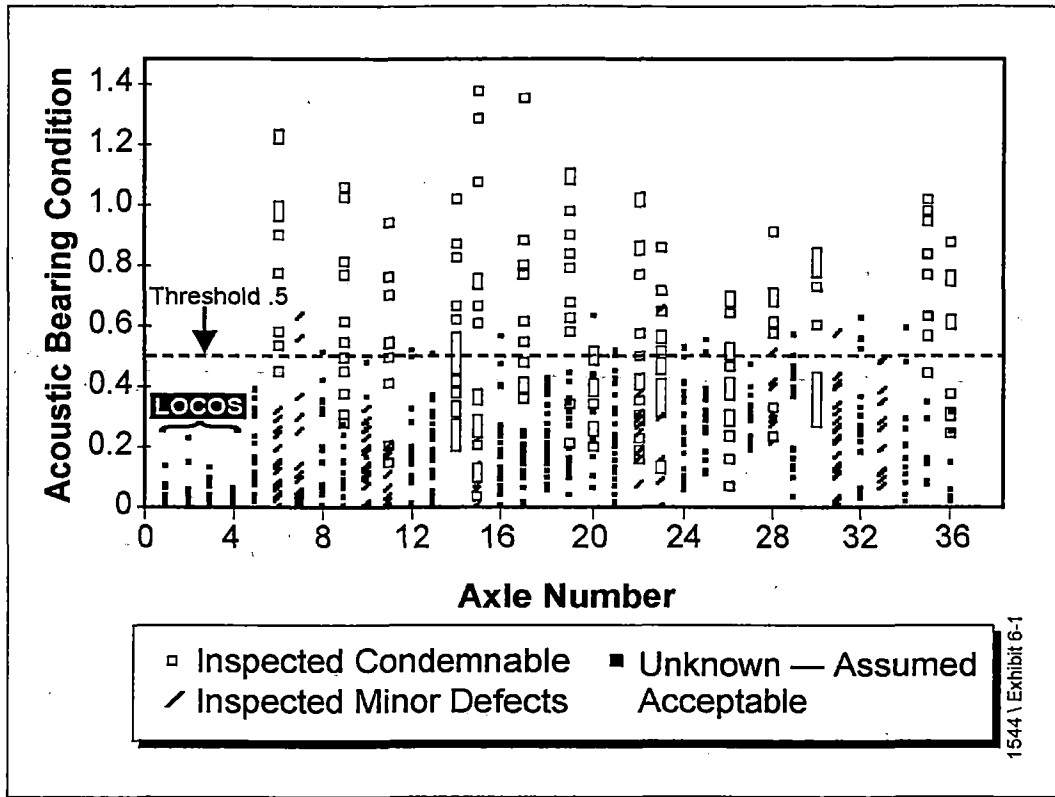
Figure 11. ABC Value versus Axle Number

The large "squares" are from shop-confirmed inspected defective bearings with at least one or more condemnable mounted component(s). Right slanted "slash-marks" are

from bearings with one or more, non-condemnable, yet visually detectable component defect(s). The small "lightly-shaded" dots are from bearings that were not inspected but were assumed to be acceptable by AAR standards.

There are 54 "condemnable" defects that have ABC values greater than 0.80 in the displayed plot. There were no non-condemnable bearings that produced ABC outputs above this arbitrary cut-off level.
