**Locomotive Crashworthiness Impact
Test No.3: Test Procedures,
Instrumentation and Data**

February 2003
Draft Report

6. AUTHOR(S) Russell Walker				
7. PERFORMING ORGANIZATION NAME(S) AND ADDRESS(ES) Transportation Technology Center, Inc. P.O. Box 11130 Pueblo, CO 81001			8. PERFORMING ORGANIZATION REPORT NUMBERS

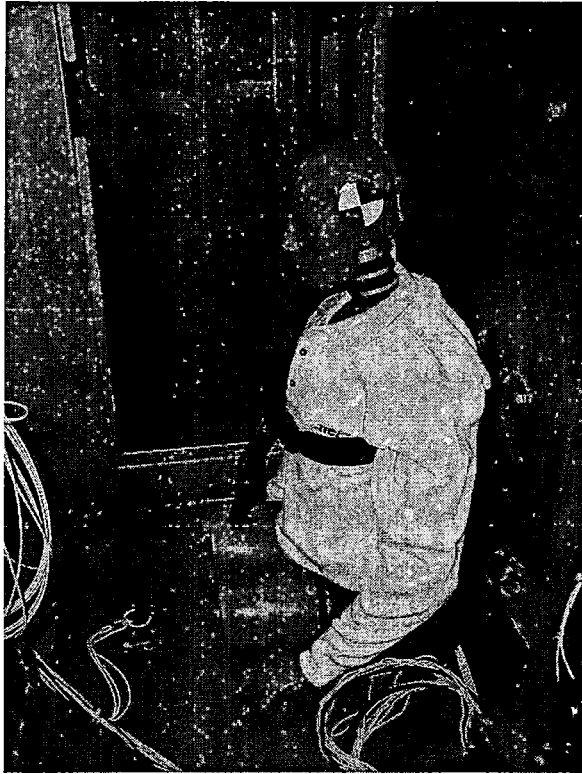
The first two tests in this series (References 1 and 2) utilized an ATD in the engineer's seat of the locomotive. It was recognized at the time of these tests that in the event of an impending accident the locomotive engineer may choose to take up a different position in the cab that would offer more protection than is available in the engineer's seat. At the suggestion of the Brotherhood of Locomotive Engineers, the ATD was placed in a seating position on the floor facing rearward in the nose of the locomotive with its back against the interior door. There was no room for its legs in the nose because its pelvis is fixed in a normal seated position. Figure 2 shows the ATD in place in the cab.

Figure 2. ATD in the Nose of the Locomotive

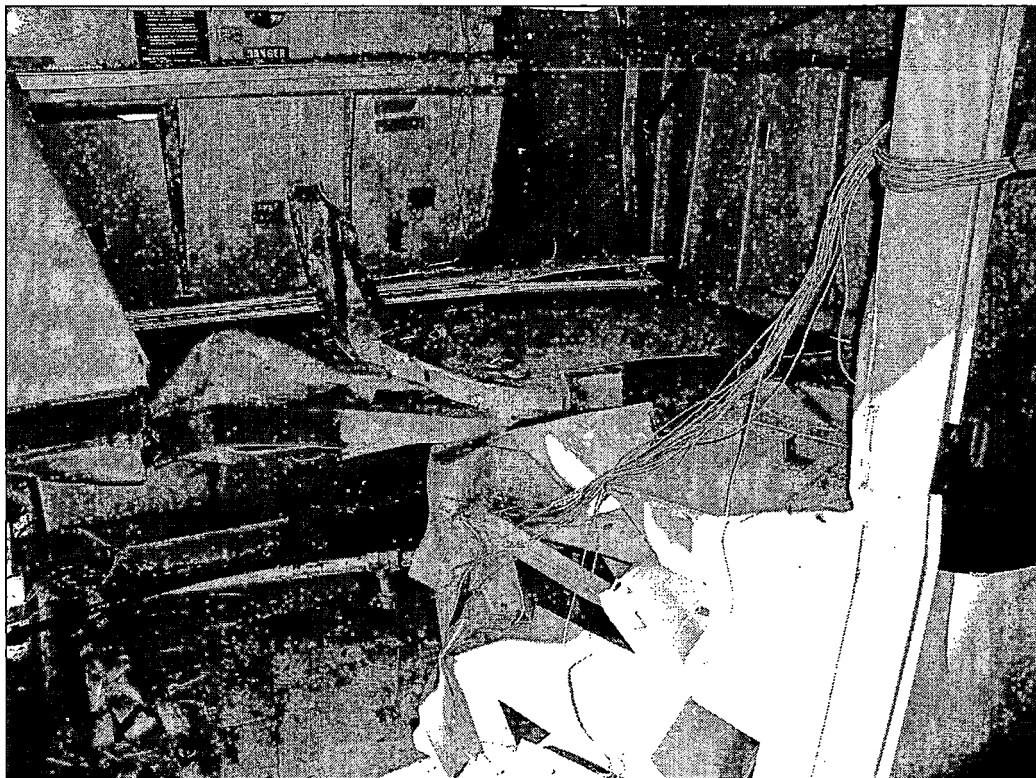
The interior of the cab also suffered extensive damage. Both sections of the windshield were broken out. The cab floor was buckled on the right side and torn apart on the left side. The control console was destroyed and the remains were pushed back into the engineer's seat. Figures 20 and 21 show the interior of the locomotive cab after impact.

Figure 21. Left Side of the Cab after Impact
