**Federal Railroad
Administration**

Geothermal Switch Heater Installation, Testing and Monitoring – Phases 1 & 2

1. AGENCY USE ONLY (Leave blank)		2. REPORT DATE July 2016	3. REPORT TYPE AND DATES COVERED Technical Report
4. TITLE AND SUBTITLE Geothermal Switch Heater Installation, Testing and Monitoring – Phases 1 & 2			5. FUNDING NUMBERS DTFR53-11-D-00008 Task Order 303

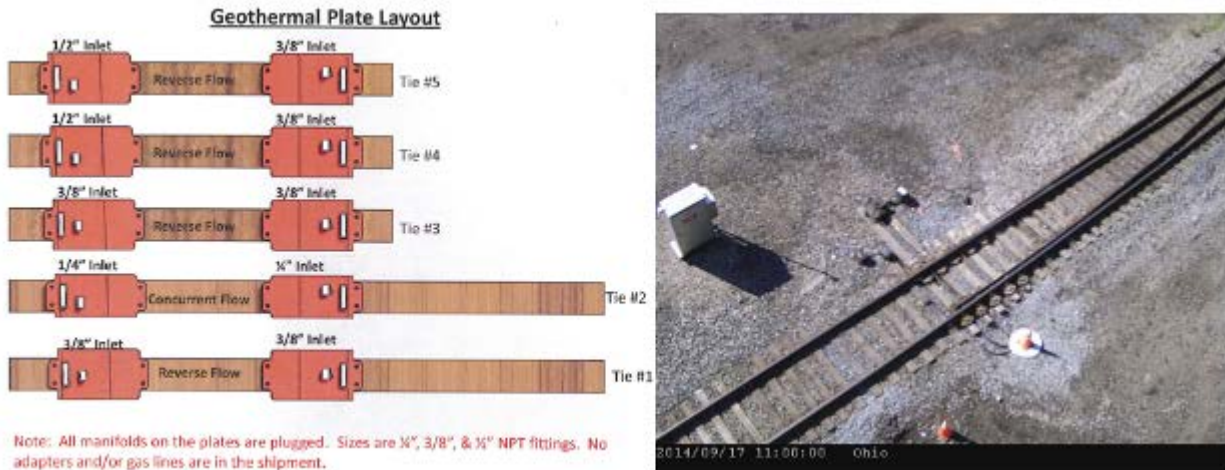
Figure 4. Switch Configuration and Tie Plate Layout

Voestalpine Nortrak tie plates were installed in the switch during the week of August 31–September 6, 2014. The old switch plates were removed and 10 specially designed tie plates were installed before initiation of other system installations. The tie plates were designed for a left hand turnout that switches from the right side, which was the configuration at a previous location choice. The 55th Street location has a left hand turnout with switch stand on the left side, whose different layout was successfully accommodated by the switch plate installation gang during preliminary site activities. However, there were some problems matching the tubing to the switch plates as a result of the different head block configurations. Figure 4 shows the switch configuration and tie plate layout. The left graphic is Nortrak's left hand turnout design showing the switch head blocks on the right and the right graphic shows the left hand turnout installed at the test site.

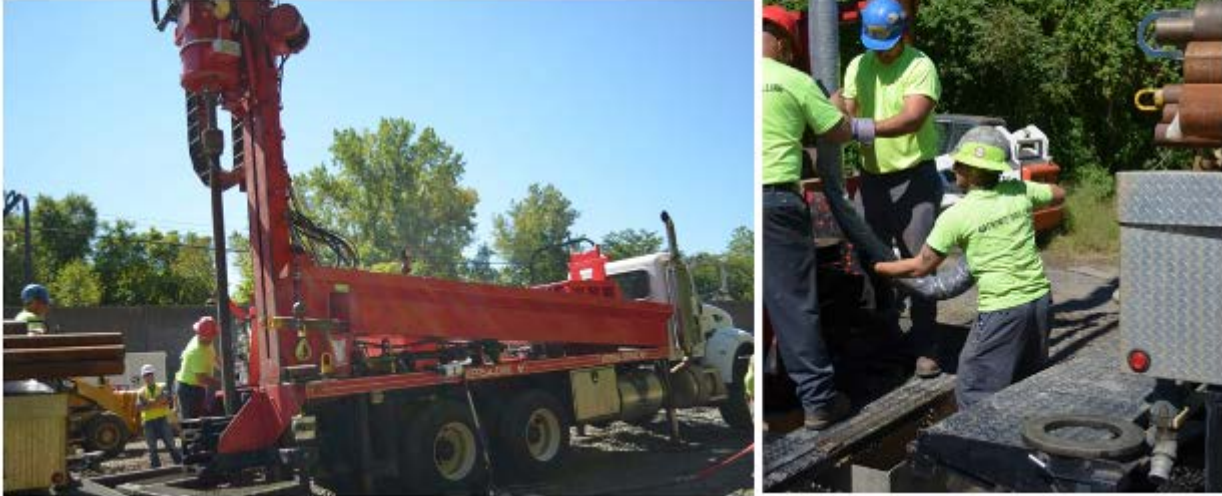
Figure 5. Drilling and Sampling Well 1

Fronz Drilling drilled two boreholes to 175 feet according to the work plan, using a sonic drill rig. Continuous coring methods were used, producing a 4-inch diameter core in unconsolidated soils to 150 feet below ground level, and a 2-inch core in consolidated sediments from 150 to 175 feet below ground level. Golder Associates logged the boreholes and produced a drilling log of the results. Geothermal wells were drilled in predetermined locations; one on either side of the track. Figure 5 shows the sonic drill rig in operation and a 4-inch diameter sample extraction of soil.

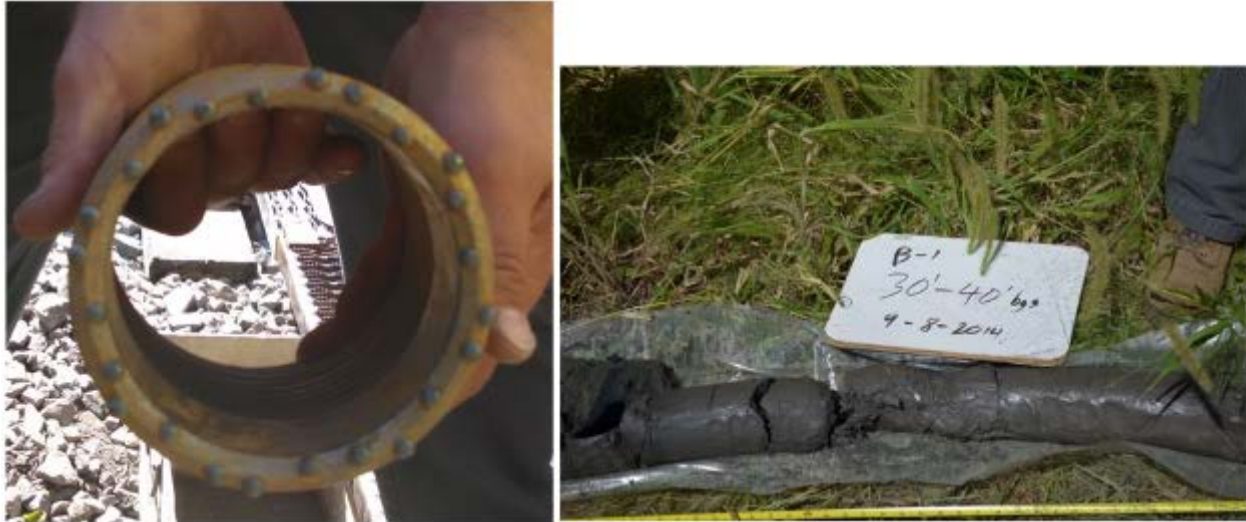
Figure 6. Coring and Sampling Well 1

Surficial soils were initially penetrated with a large diameter (12-inch) bit and surface casing during the setup phase of the drilling operation. The purpose of the surface casing is to provide a stable platform for drilling and to provide a conduit for drilling fluids to exit the borehole without washing out surficial soils. Drill cuttings and cores were logged by Golder Associates and were assessed in the field for engineering and hydraulic characteristics such as grain size, moisture content, stiffness, classification, and sample depth. This was followed by a 5-inch diameter soil coring bit that obtained the 4-inch diameter soil samples. Then the 2-inch diameter rock sampling bit was used to obtain 2-inch diameter rock samples. Figure 6 shows a 4-inch coring bit with carbide buttons and a borehole sample taken 30–40 feet below ground level, which contained very stiff, moist silt.

(left) 4-inch Coring Bit and (right) Borehole Sample at 30–40 feet below ground level

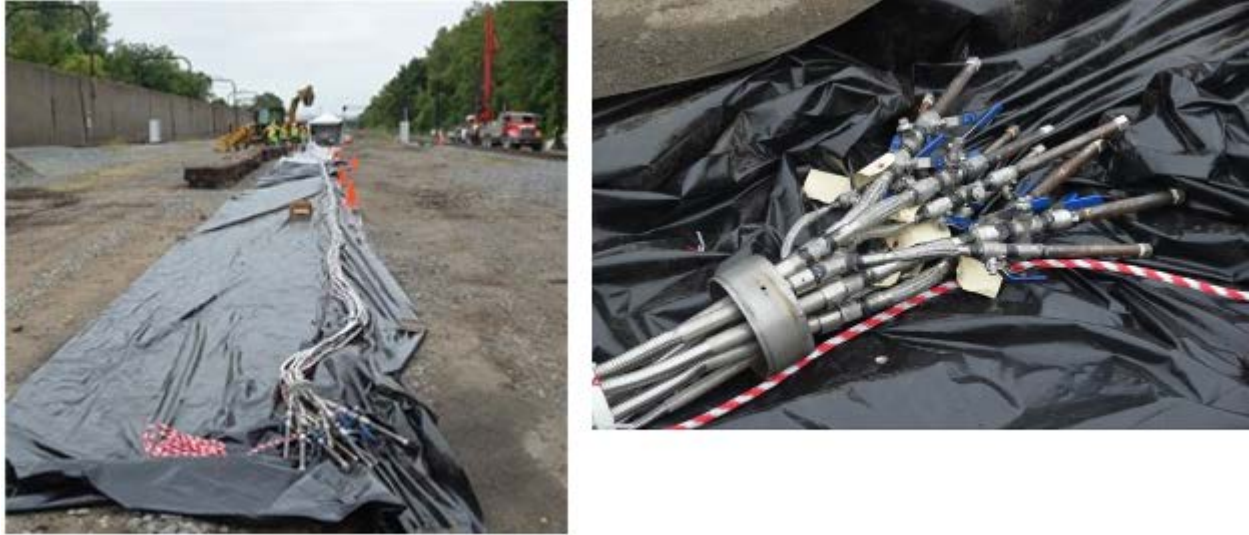
Figure 8. Tubing Layout and Assembly

Well 1 onsite tubing preparation began by laying 8 tubing pieces parallel to the track on several lengths of polyethylene plastic sheeting to protect it (Figure 8 (left)). Tubing preparation continued by inserting tubing pieces through the stainless steel well cap, placing and securing the PVC spacer rings to the tubing with zip ties, placing the black foam stop on the tubing bundle, epoxying the tubing bundle into the steel ballast bottom weight, tying the pull rope onto the ballast weight, and epoxying thermocouples onto the tubing at 20-foot intervals. Figure 8 (right) shows the tubing array in the well cap and pull rope attached.

Four pieces of the tubing were damaged by contact with a backhoe onsite during site activities. However, pressure and vacuum testing of the damaged tubing revealed no leaks, so the project proceeded as planned.

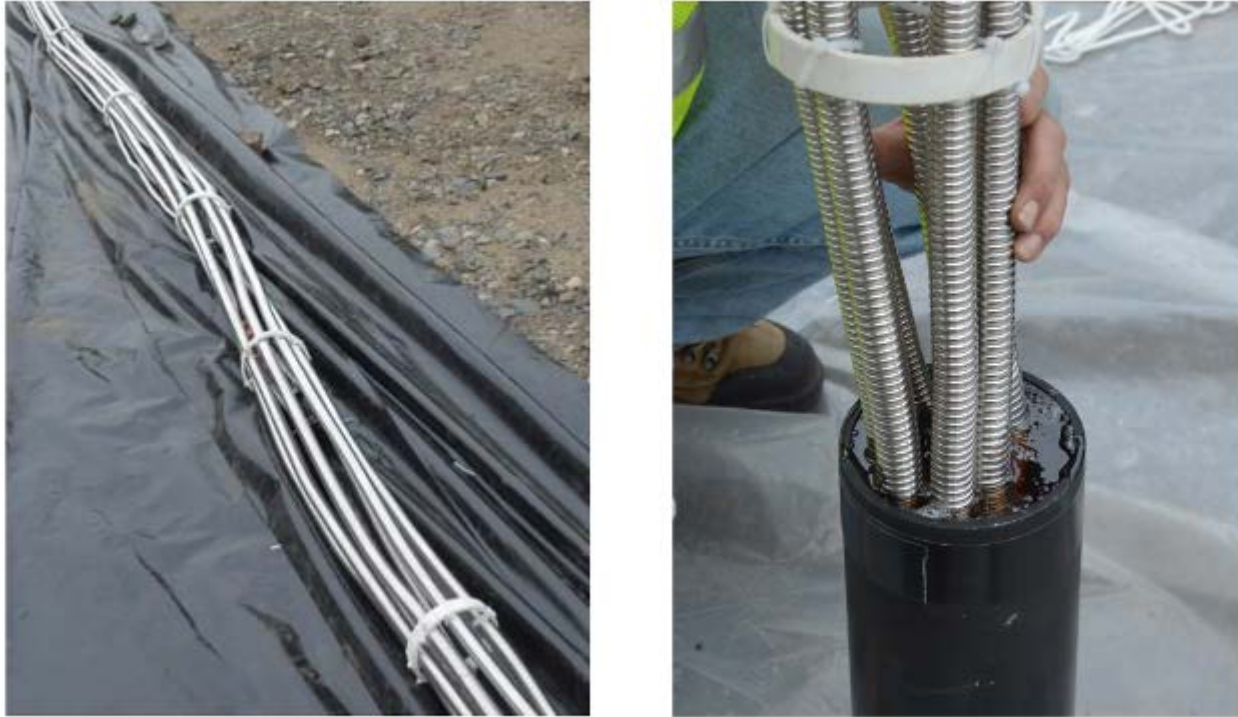
Figure 9. Tubing Preparation
(left) tubing with spacers (right) epoxying the tubing

Spacers and zip ties were initially used to hold tubing apart down-hole, maximize tubing contact with groundwater. The cluster was to be 5-inch diameter, and the 6-inch PVC inside diameter was 5.5 inches, resulting in a clearance of $\frac{1}{2}$ inch between the tubing cluster and the well inner diameter. It was found during tubing insertion that this did not allow enough room for sidewall frictional forces, buoyancy effects, and zip tie thickness. Figure 9 shows the tubing with the spacers attached and epoxying the tubing into the 85-pound steel ballast weight.

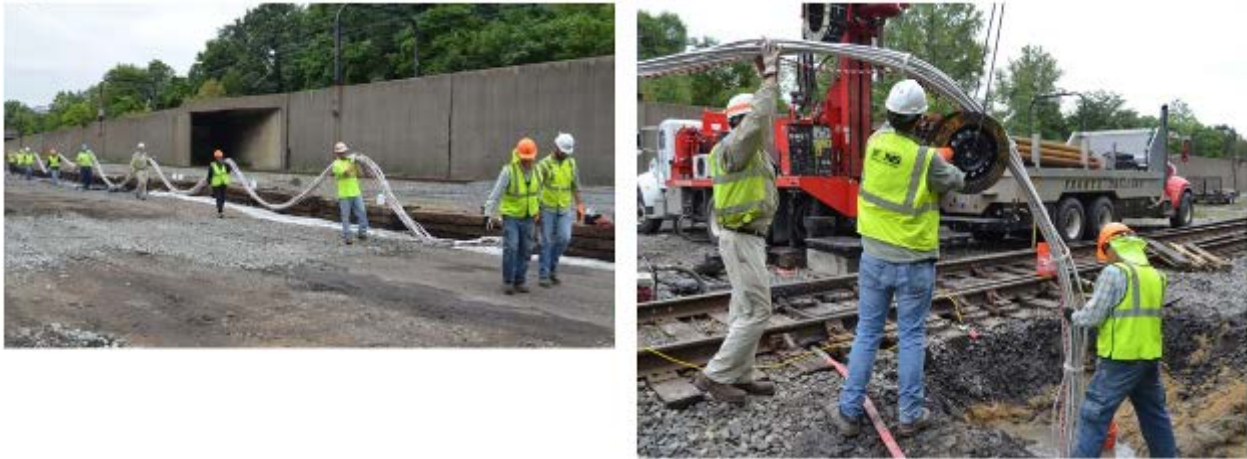
**Figure 10. Tubing Placement into Well 1 (first attempt)
(Note the 5-inch diameter white spacers)**

Figure 10 shows the initial unsuccessful attempt at placing the tubing in the well, because the tubing was only able to be inserted to a depth of 110 feet below ground level. The combination of large (5-inch) diameter spacer rings, buoyant forces, and sidewall frictional forces from the zip ties on the spacers made complete insertion impossible with the available manpower. Ballast weight for Well 1 was 85 pounds, but should have been approximately 105 pounds.

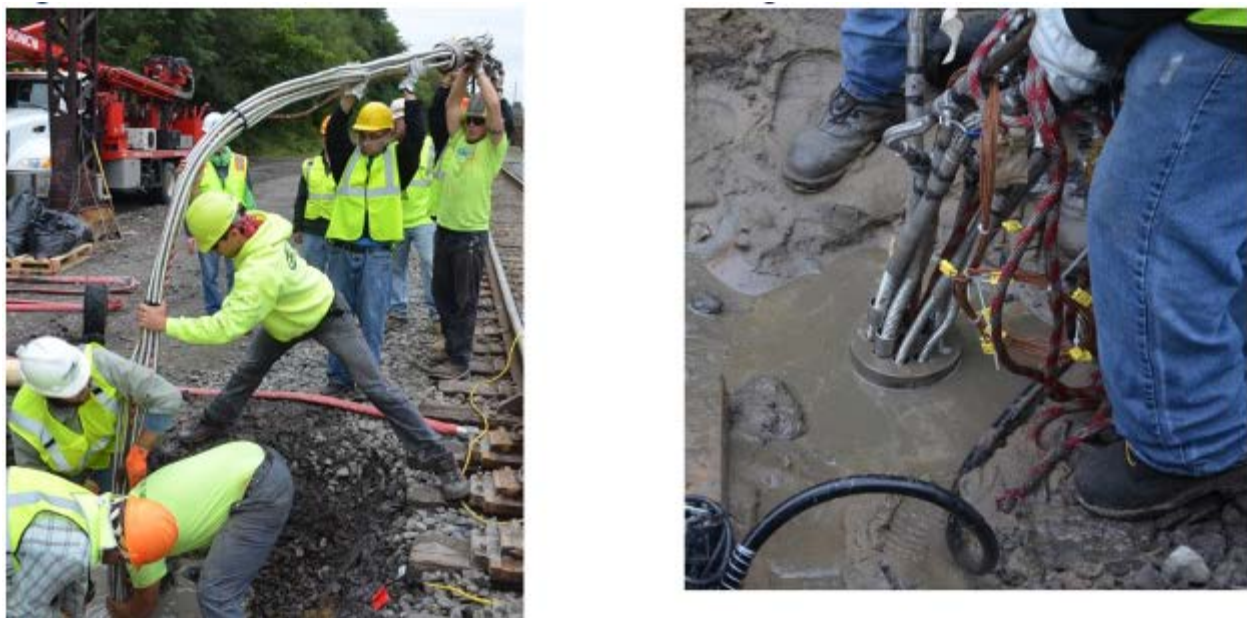
Figure 11. Insertion of Tubing into Well 1 (second successful attempt)

The tubing was then removed, laid back out on the plastic sheeting, and the spacers were removed. The tubing was then configured into a smaller radius bundle and re-inserted into the well (Figure 11 (left)). The second attempt was successful. Figure 11 (right) shows the well cap being tightened onto the well casing.

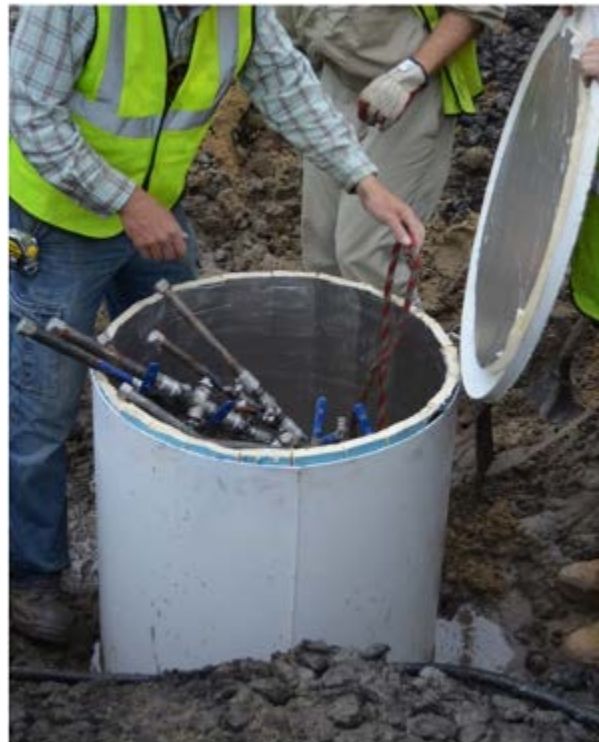
Figure 13. Instrumentation Vault

The well vaults were placed over the wellhead and wellhead tubing cluster, in addition to the pull rope and topside thermocouple leads (Figure 13). Although the well vaults were 30 inches in diameter, rigid insulation placed on the inside of the vaults reduced the effective inside diameter to 28 inches, which proved to be a tight working space. The refrigeration contractor began the installation of the crossover tubing, but found that the threads on the valve bodies, nipple ends, flexible tubing, and refrigeration tubing ends had all been damaged (Figure 14). It appears that the threads did not match on the pieces, and were damaged during assembly. The contractor was able to salvage two of the tubing sets to provide a “proof of concept” test, but all tubing sets will need to be repaired before a meaningful test can be accomplished.

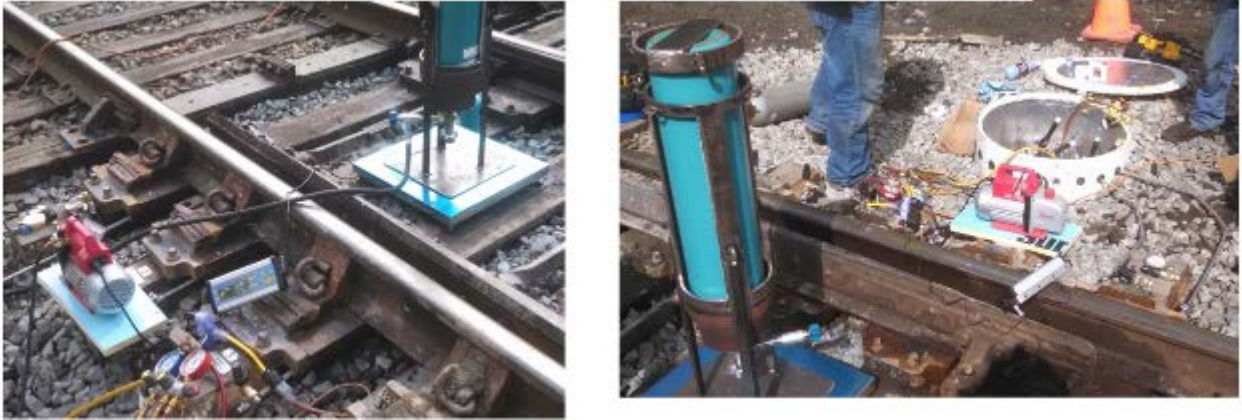
Figure 16. Filling the Refrigeration Systems

Anhydrous ammonia was used as the refrigerant for this system test. To prepare for the “proof of concept” test, the refrigeration contractor purged the two usable tubings three times with nitrogen gas to be sure any non-condensable gas was completely removed from the system. After purging, one pound of refrigerant was released into the two usable evacuated tubings by weighing out the refrigerant on a highly accurate scale on an inverted tank frame (Figure 16). The ammonia gas had a working pressure of 70 to 75 pounds. A steel frame had been manufactured to provide a safe dispensing environment for the inverted anhydrous ammonia tank. The tank holds about 15 pounds of liquid ammonia.

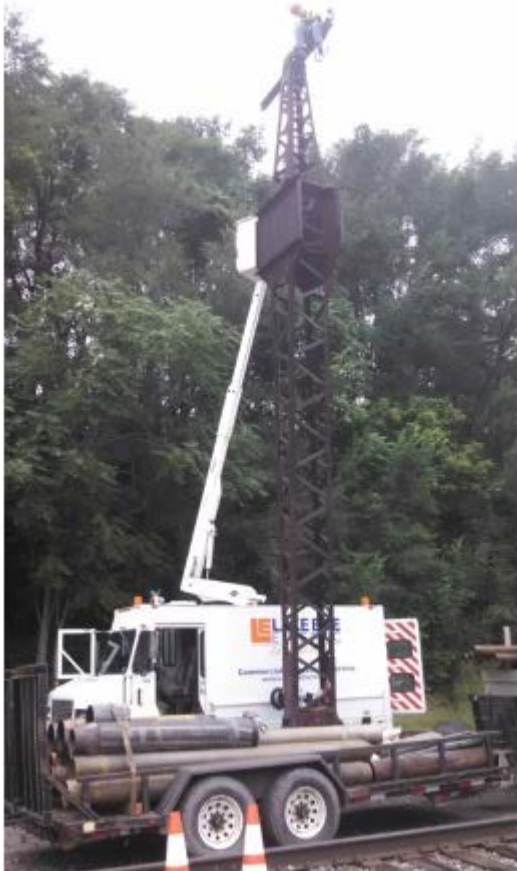
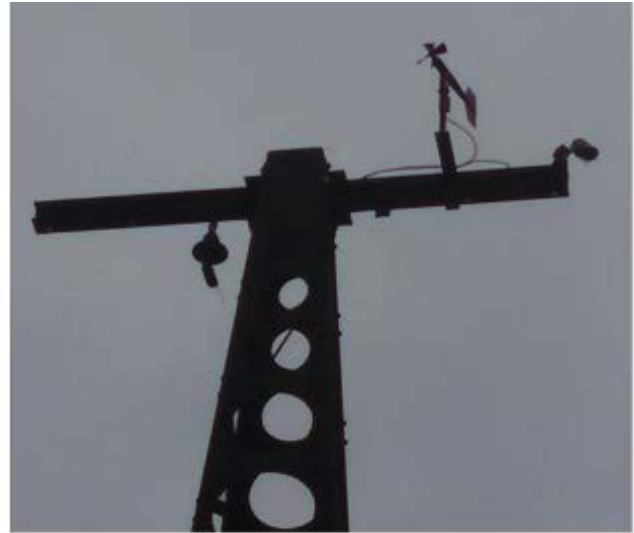
Figure 17. Anemometer and Camera System

The metal tower located near the switch was used to mount the camera and anemometer for the system (Figure 17).

The camera and anemometer logged photos of the switch heater from above every 10 minutes, and provided wind speed information.

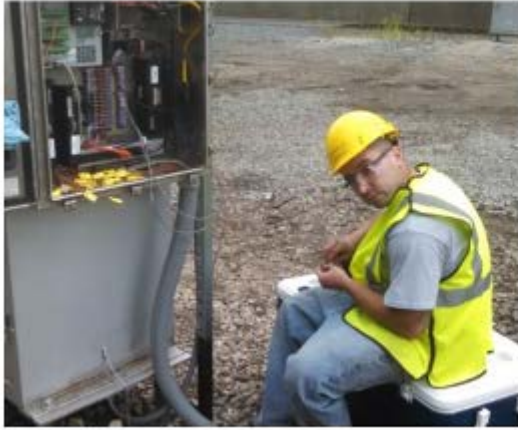
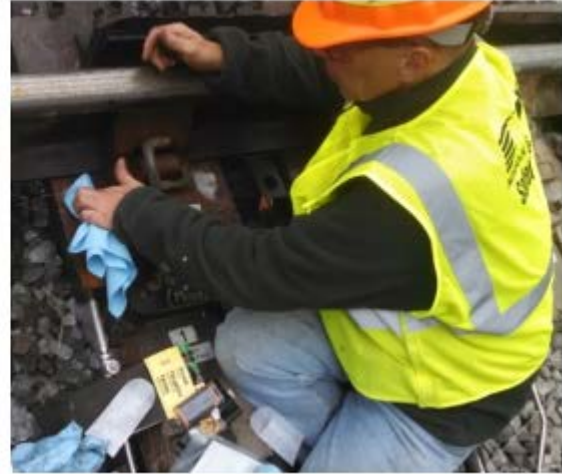
Figure 18. Preparation of Signal Wire and Installation of Switch Plate Thermocouples

Signal wiring was used to connect down-hole, track, switch plate, and ambient thermocouples to the instrumentation logging box (Figure 18). Trenches were dug and 2-inch diameter flexible conduit was placed in the trenches at a depth of at least 12 inches to minimize the potential for cable damage during the testing and logging of the systems.

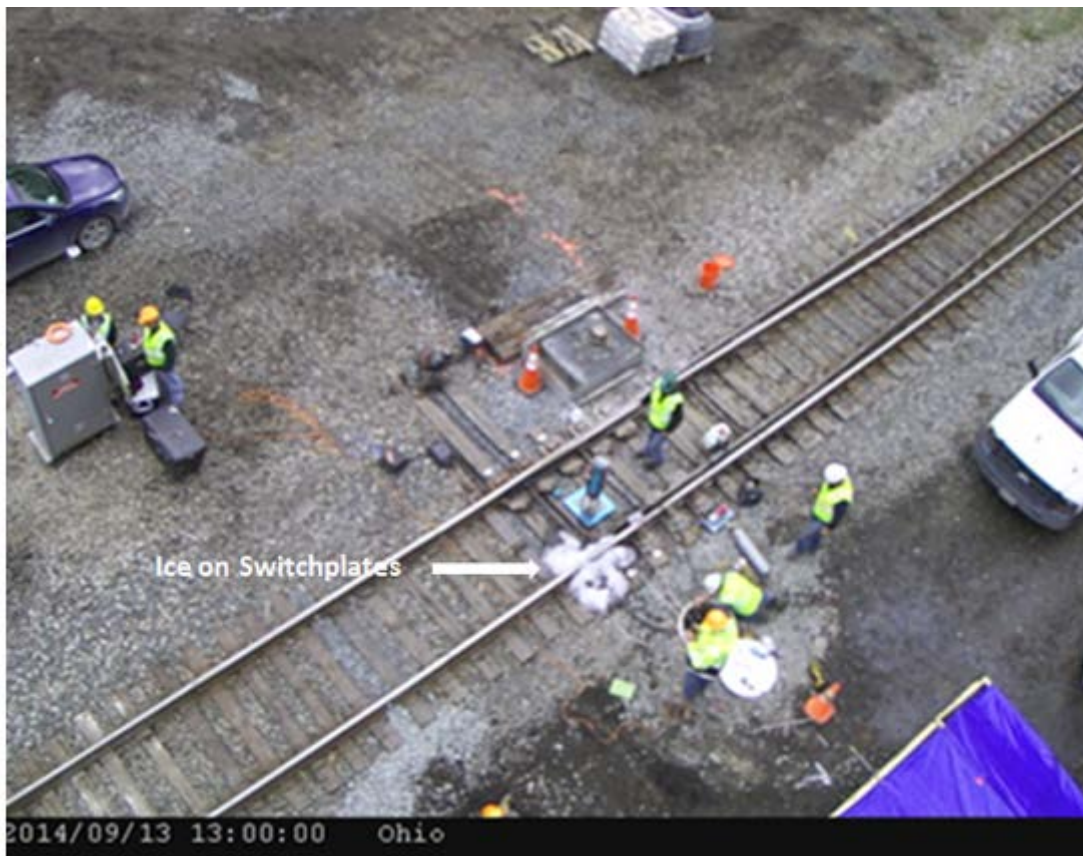
The ice melt test produced visual and instrumentation results, which indicated that the conceptual principles of the technology are sound, but additional work needs to be accomplished to complete the working system. Figure 19 and Figure 20 show the ice test and results.

Figure 19. Overhead View of Initial Ice Melt Test

Figure 20. Ice Test at Conclusion of First Installation Phase

The refrigeration contractor charged two of the down-hole refrigeration systems successfully, corresponding to Switch plate 1 (right side “R”) and Switch plate 2 (right side “R”). The tubing associated with the left sides of the two switch plates, “L”, did not hold pressure, so were “dead” and not charged with gas. As soon as they were pressurized, an ice test was immediately performed on the two charged systems, using approximately 240 pounds of ice which had been ordered for system testing. The ice was placed directly on Switch plates 1 and 2. It was observed that within 30 seconds of placing the ice on the two switch plates, the associated “R” crossover tubing was noticeably cold, which meant that liquid ammonia was passing through the down-hole tubing as it condensed and released heat into the switch plates. The “L” side tubings were at ambient temperature, with no condensate passing through them. The test continued for approximately 1 ½ hours, after which the ice was melted.

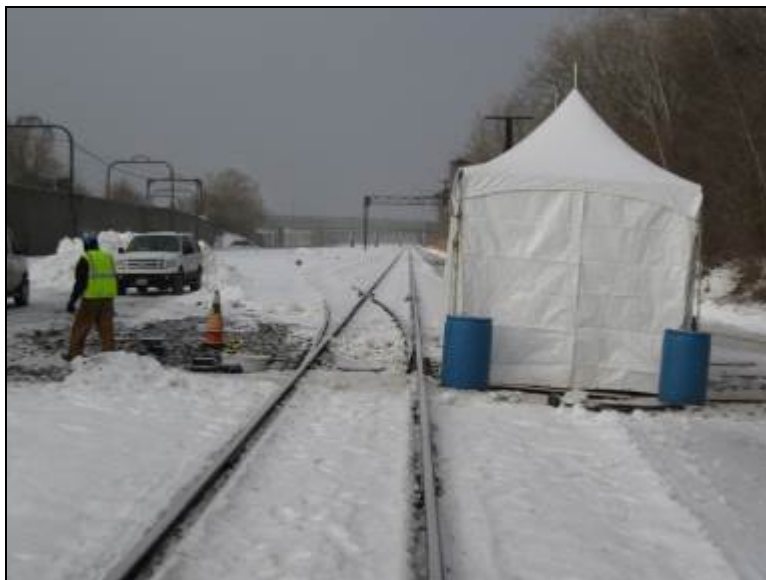
Figure 21. Phase 2 Installation of Geothermal Switch Heater

The final installation of the geothermal switch heater system was completed in February 2015 (Figure 21). Geothermal Wells 1 and 2 had already been completed and were ready to receive the refrigerant tubing. A local refrigerant contractor had removed damaged wellhead fittings from the refrigerant tubing cluster and replaced them with higher quality fittings. In addition, the crossover tubing connection to the switch plates were redesigned to receive a 2-foot-long flexible connector to provide dynamic damping and fatigue reducing properties to the wellhead tubing pieces.

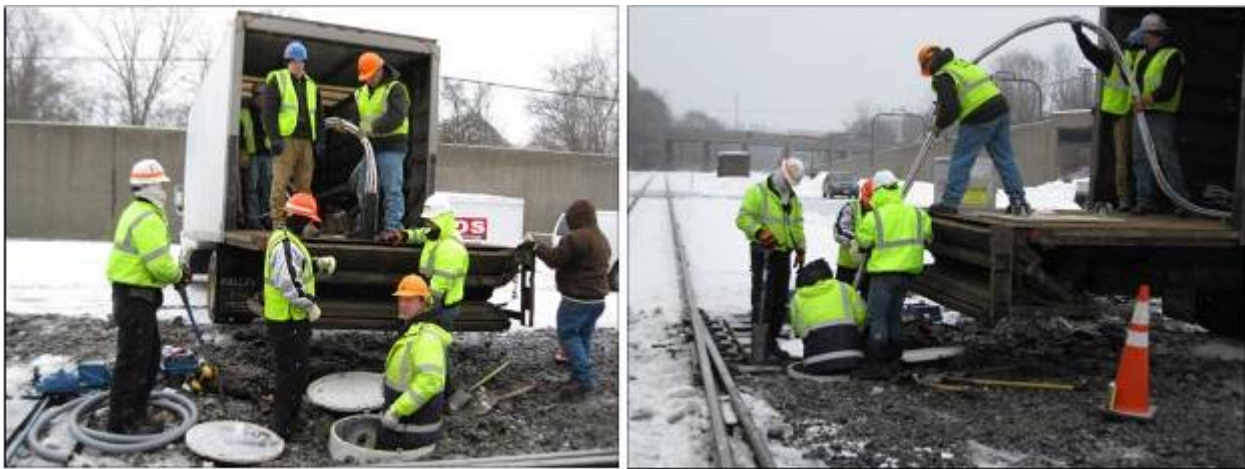
Figure 22. Installing Refrigerant Tubing into Well 2

Snow was cleared away from the work area at the site, and the refrigeration contractor backed up a delivery truck to Well 2, which had been prepared with an instrumentation vault at ground level, identical to the vault that had been positioned over Well 1. The tubing was coiled up in a large roll for transport from the shop, and the ballast weight was positioned to go down the well first (Figure 22). The tubing was uncoiled down into the well by hand, and the tubing insertion process took less than 10 minutes. The insertion proceeded smoothly and the well cap was tightened into place. The total process was streamlined using lessons learned from Phase 1 work.

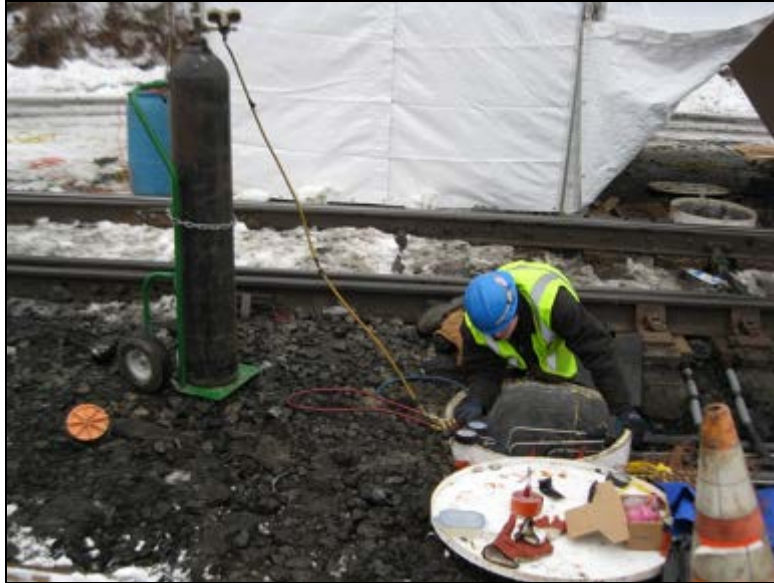
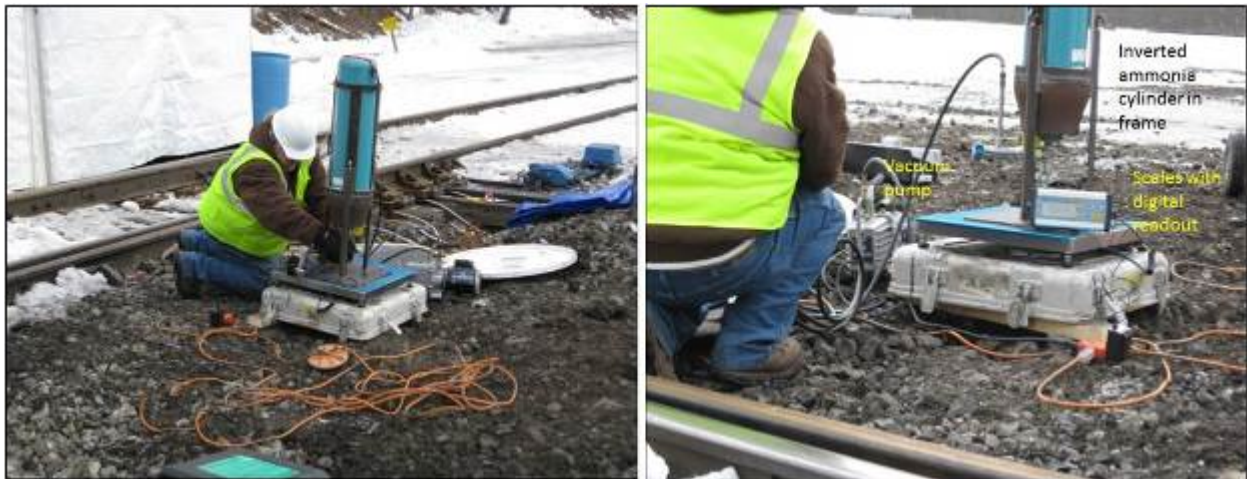
After the tubing was in place, each system was pressure and vacuum tested with nitrogen overnight before filling with ammonia (Figure 26 and Figure 27). The nitrogen also served to capture and displace any air and water vapor that might be present before the systems were charged with ammonia. Nitrogen purging was performed three times, then ammonia was introduced to the evacuated system.

Figure 26. Purging the Systems with Nitrogen

Figure 27. Charging the Heating Systems with Ammonia

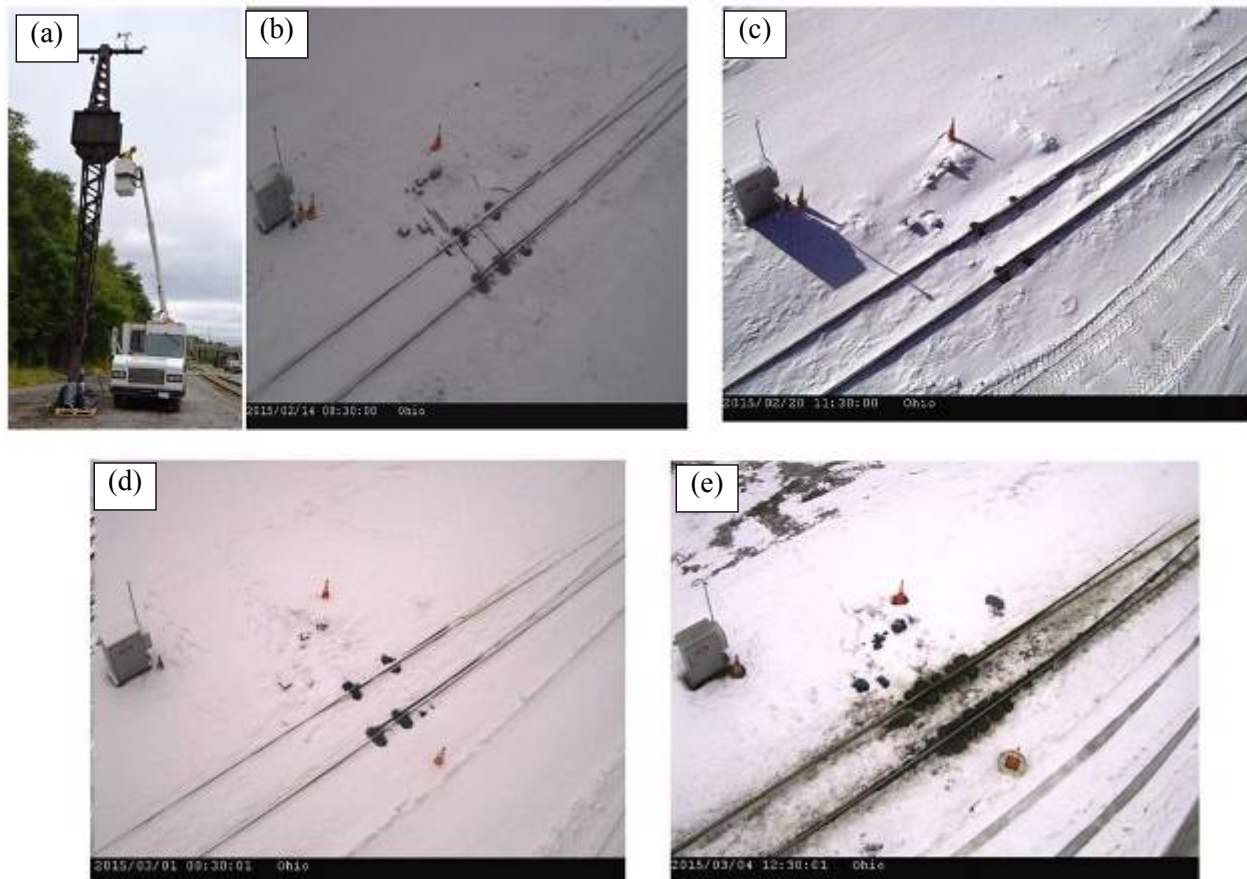
A video camera was mounted on a nearby abandoned catenary support tower with a full view of the switch. The camera was configured to communicate with the data logger over a serial communications link, and an external SD card was provided for image storage. Remote access to the data logger was provided by a wireless 4G modem. The video camera showed that four of the switch plates worked well during the entire test period of approximately 3 months; one switch plate appeared to have one side working and one side working marginally. Figure 30 shows photographs of the overhead camera setup and several overhead photographs taken during the test.

**Figure 30. (a) Overhead Camera and Anemometer Setup on Old Catenary Tower
(b) Feb. 14, Initial Overhead Photos show five Switch Plate Heating Systems Working
(c) Feb. 20 after heavier snow (d) Mar. 1 system still working
(e) Mar. 4, switch plates are clear**

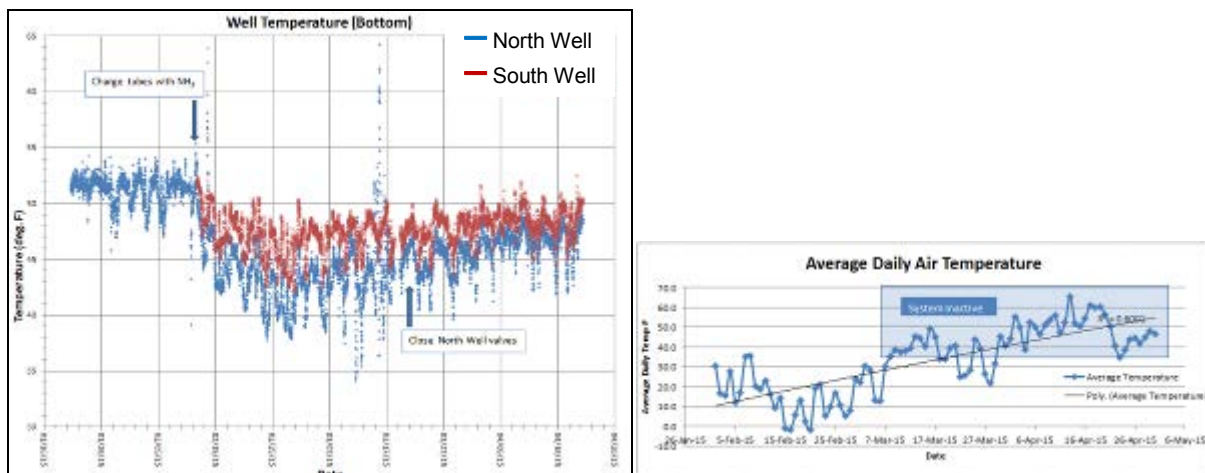
Down-hole temperatures were monitored and recorded every 20 feet vertically, starting at the wellhead (Figure 31). For each date, an array of temperatures was recorded, which shows a more tightly clustered variation before the geothermal heating systems were started (Feb. 8, 2015), and becoming more spread out over time. Initial down-hole temperature range for the north well varied from approximately 54°F to 47°F before the systems started. After the track had been warmed for 3 weeks, temperatures appeared to reach minimum temperatures ranging from 44°F to 38°F; then began a slow warming trend.

Figure 31. (left) Well Bottom Temperatures (right) Average Daily Air Temperatures

The south well temperatures averaged approximately 46°F to 48°F near the bottom during operation, and the north well temperatures averaged 41°F to 46°F, with 2 to 5 degrees temperature difference between the two well systems. There were more working heating loops functioning in the north track, which may have contributed to the difference, but a more efficient heating system may have caused the difference. Temperature differences between the two wells seemed to merge slowly after the north well valves were shut down on March 20, 2015.
