U.S. Department of  
Transportation  
**Federal Railroad  
Administration**

## Weld Repair of Manganese Frogs for Enhanced Performance

1. AGENCY USE ONLY (Leave blank)	2. REPORT DATE January 2017	3. REPORT TYPE AND DATES COVERED Final	
4. TITLE AND SUBTITLE Weld Repair of Manganese Frogs for Enhanced Performance		5. FUNDING NUMBERS Contract No. DTFR53-13-C-00037

6. AUTHOR(S) Marc Alan Purslow		8. PERFORMING ORGANIZATION REPORT NUMBER 53744GTH	
7. PERFORMING ORGANIZATION NAME(S) AND ADDRESS(ES) EWI 1250 Arthur E. Adams Drive Columbus, OH 43221		10. SPONSORING/MONITORING AGENCY REPORT NUMBER DOT/FRA/ORD-17/01

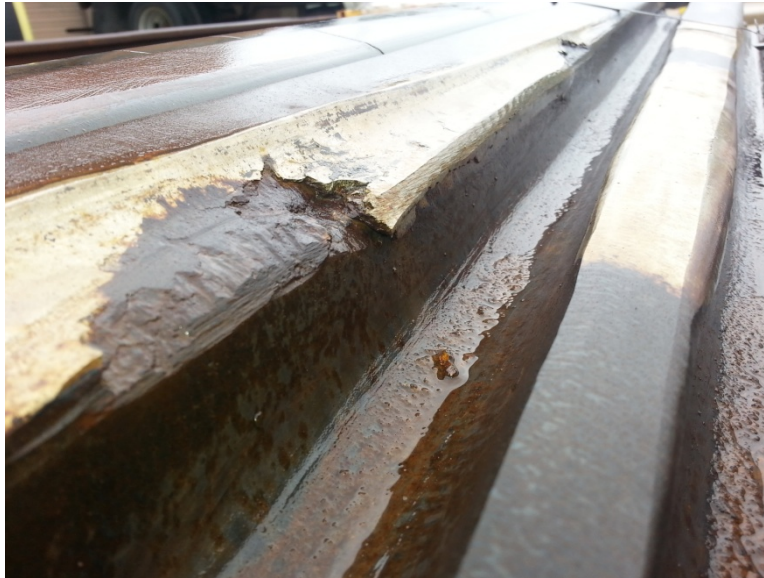
**Figure 1: Breakout of Weld Repair**

Both studies show that the majority of required repairs are caused by “breakouts” or cracks. Breakouts occur when the frog casting has not been sufficiently work-hardened and plastically deforms during the beginning of its service life. The damaged material often acts as the initiation point for cracks, and can lead to the break off of large areas of material during wheel contact. Breakouts occur in new frogs as well as weld-repaired frogs; however, the reduced initial hardness of repaired frogs results in more plastic deformation, making breakouts more prevalent. Examples of breakouts are provided in Figure 1 and Figure 2.

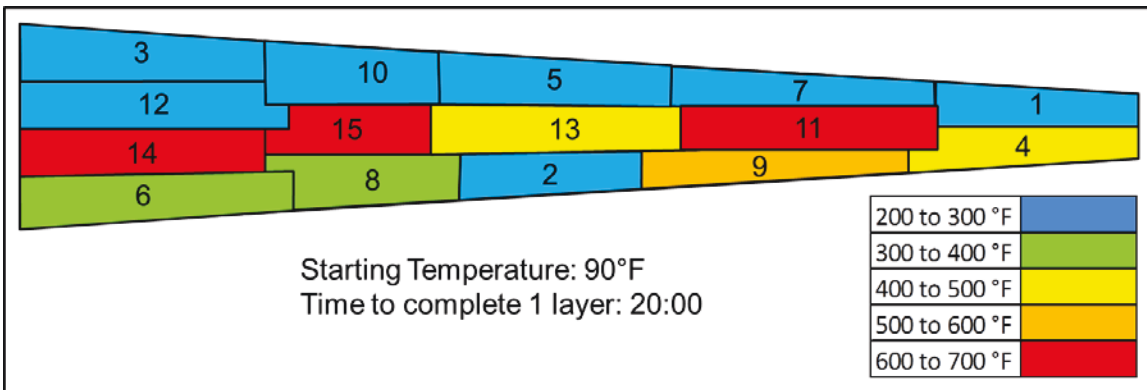
**Figure 14: Alternate Weld Sequence 2**

EWI evaluated a second weld sequence which used an alternate intermittent welding sequence in an attempt to avoid heat build-up; however, the temperature exceeded 500°F in four of the fifteen deposited weld beads, and in three of these beads, exceeded 600°F (Figure 14).

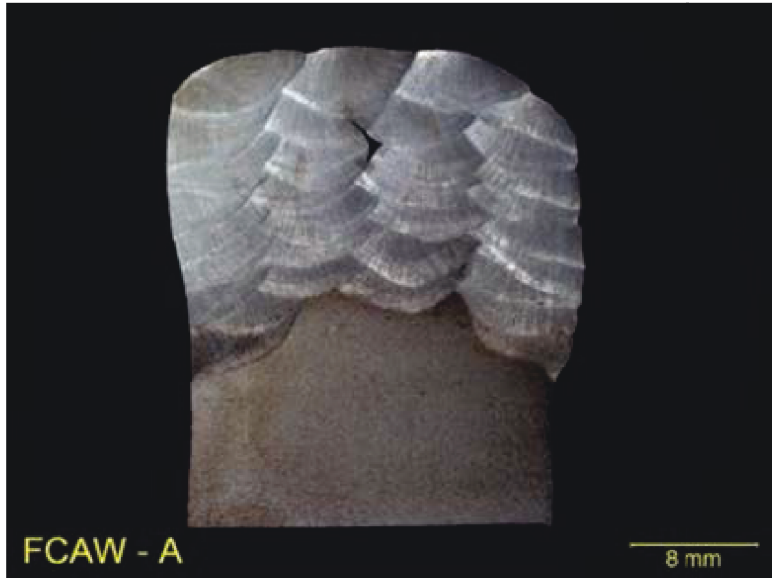
EWI evaluated the build-up using RT. Linear slag inclusions were found throughout, which indicated a need for interpass cleaning. The photo-macrograph of a cross section (provided in Figure 18) shows adequate penetration and fusion with the base material and previously deposited weld beads; however, a large slag inclusion is visible in the center of the build-up. The hardness matrix provided in Figure 19 indicates that the hardness of the weld metal ranged from 230 to 300 Brinell, and hardness data from the base metal indicates that the heat from welding resulted in hardening well below the visible HAZ. Due to the number of slag inclusions found, EWI did not perform tensile testing.

**Figure 18: Cross Section of Automated FCAW Build-up Without Interpass Cleaning**

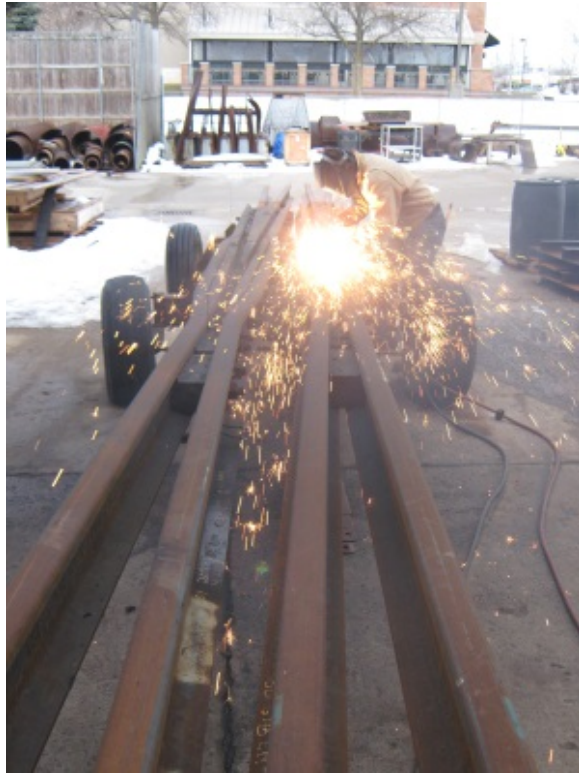
As with the partial frog, EWI used carbon arc gouging to complete the bulk of the required material removal. Figure 36 shows the carbon arc gouging process, while Figure 37 shows Frog #1 after the completion of carbon arc gouging. EWI then ground both frogs smooth to prepare for weld repair (Figure 38 and Figure 39).

**Figure 36: Carbon Arc Gouging Process**

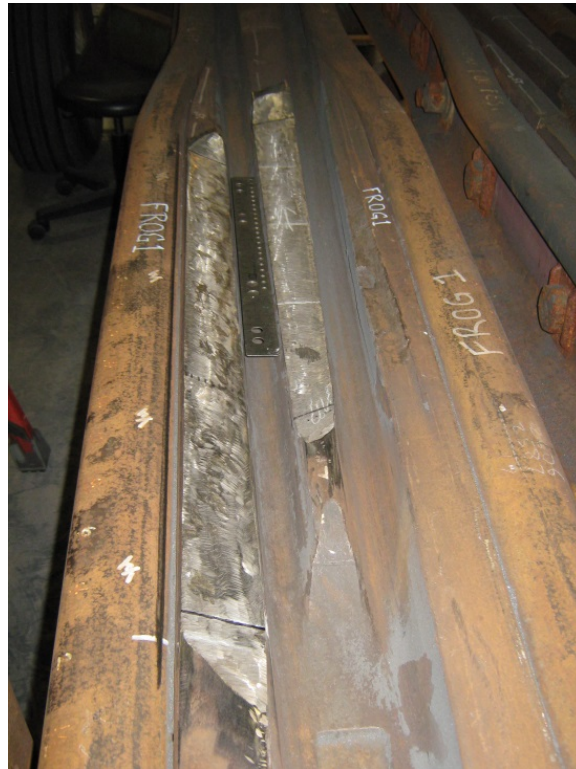
**Figure 39: Frog #1 After Grinding**

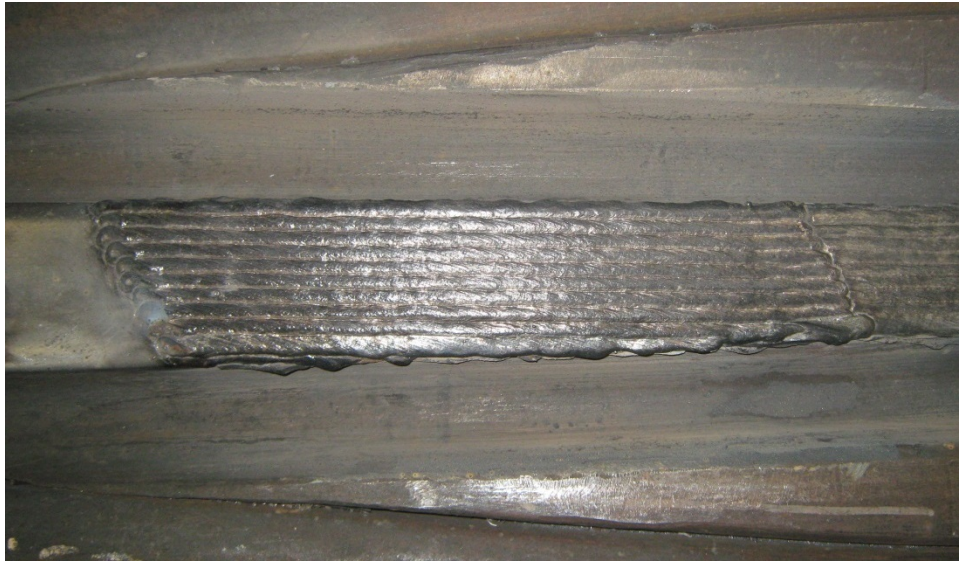
**Figure 42: Frog #1 After Additional “Taper” Weld Build-up**

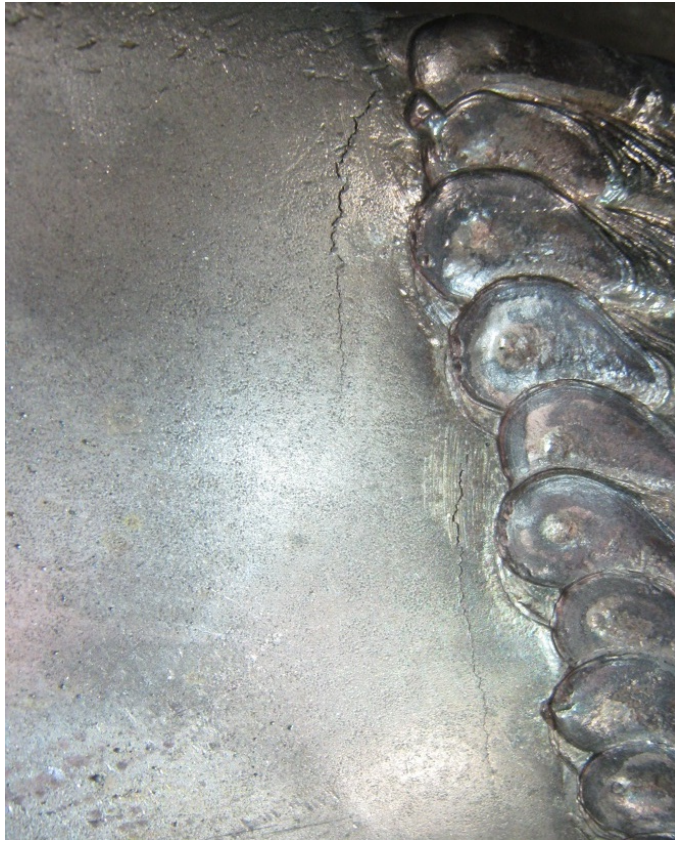
EWI observed cracks oriented transverse to the welding direction in the base material during welding of the transition area (Figure 43). EWI ground these cracks out and removed 0.125 in of material from the adjacent area to avoid welding on work-hardened material (Figure 44). Since the cracks extended 0.25 in deep, EWI filled these areas and ground the surface smooth before depositing subsequent layers (Figure 45 and Figure 46). EWI extended the grinding into the previously welded area to determine if cracks extended into the weld; however, no additional cracks were found using dye-penetrant testing.

**Figure 43: Base Material Cracking in Frog #1 at Interface with “Transition” Build-up**

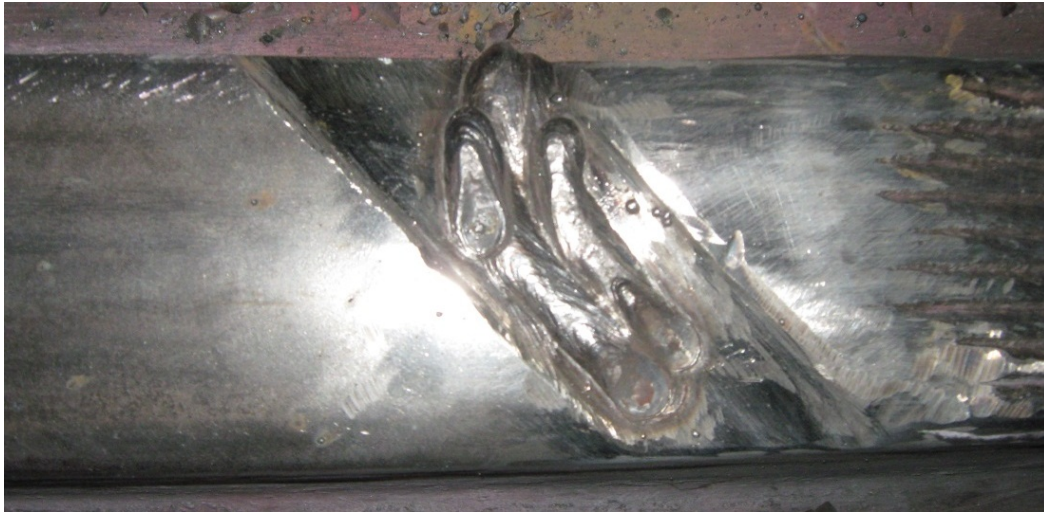
**Figure 45: Filling of Cracks in Frog #1**

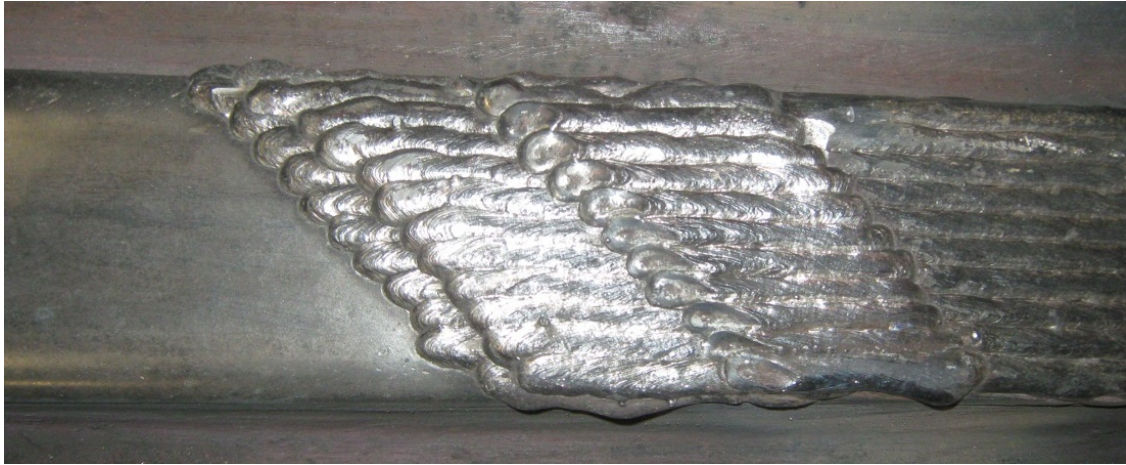
EWI deposited a third layer in the original welding direction to even out the build-up and ensure the proper height; however, this layer did not extend to the interface between the weld repair and the work-hardened base material (Figure 47).

**Figure 47: Weld Build-up to Complete Frog #1 Crack Repair**

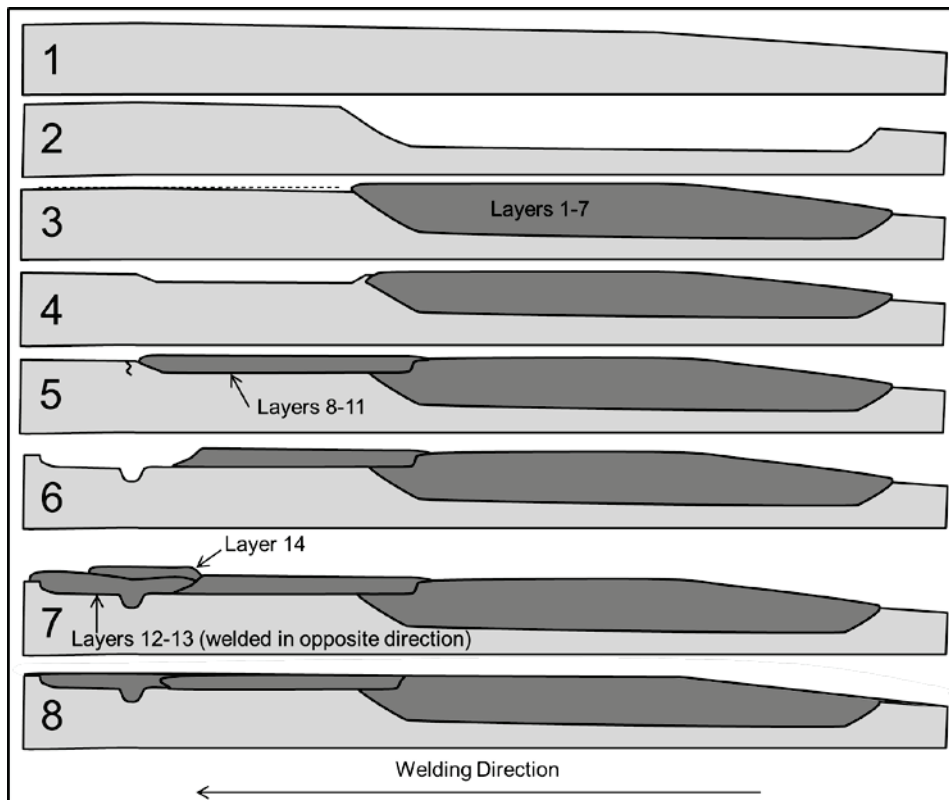
- (8) TTCI ground the frog to final shape.

**Figure 48: Illustration of Frog #1 Point Repair Sequence**

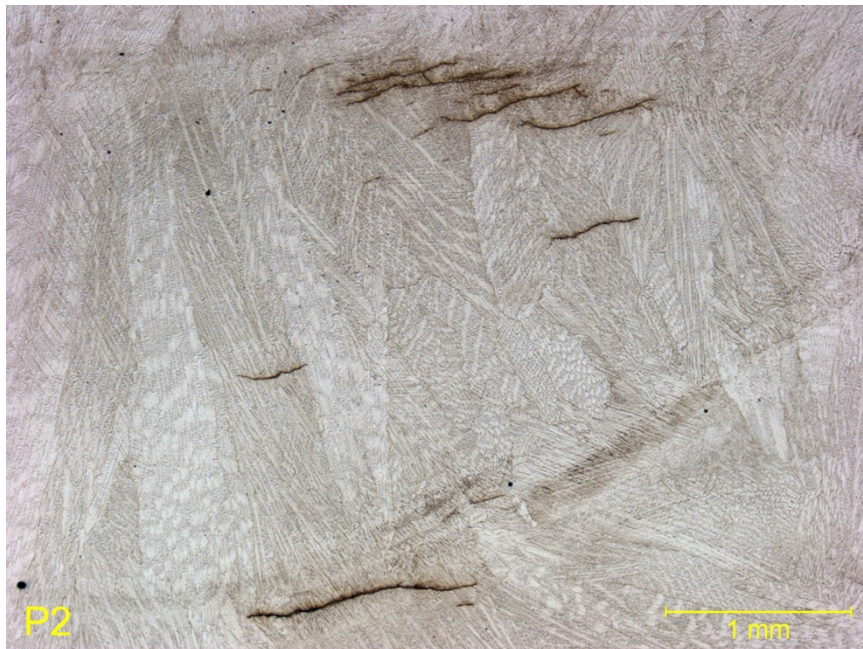
**Figure 71: Horizontal Cracks Likely Due to Shear Loading<sup>(1)</sup>**

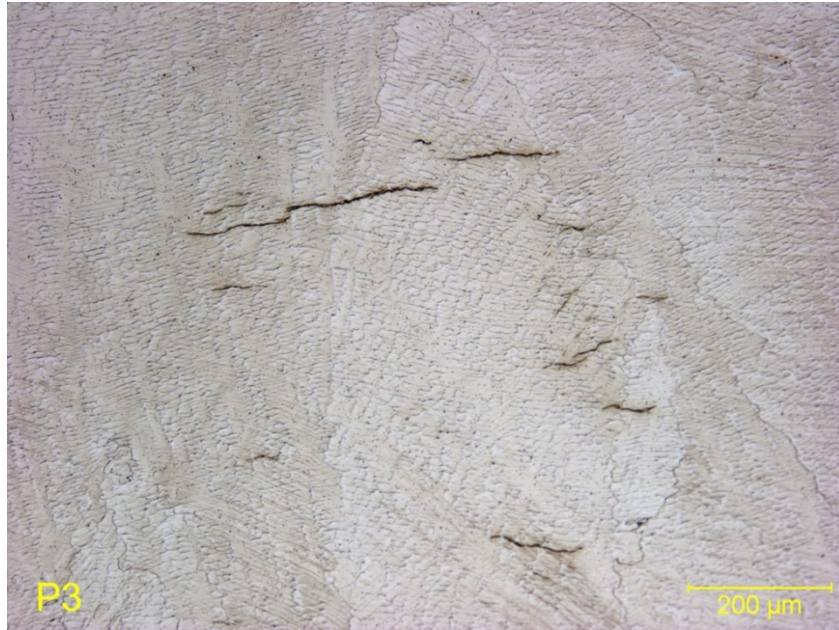
**Figure 72: Horizontal Cracks Likely Due to Shear Loading** <sup>(2)</sup>

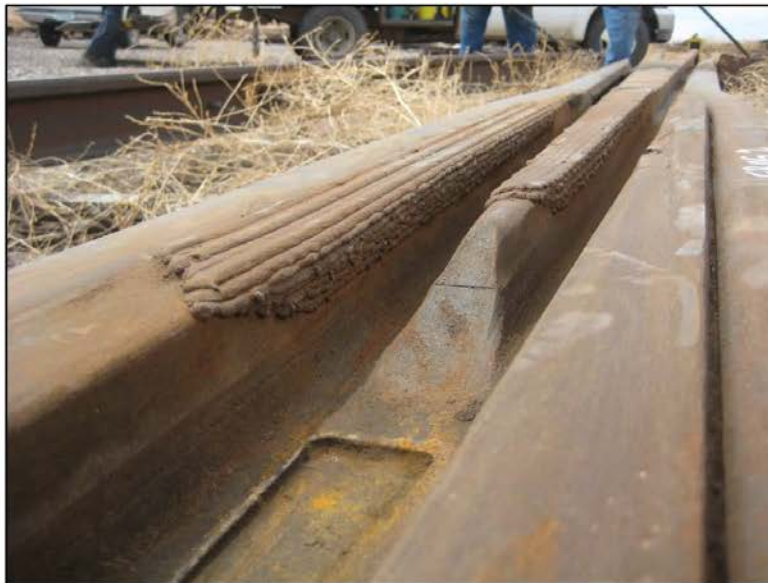
Figure 1. Frog 1: Wing rail repair about 36 inches long; point repair about 48 inches long

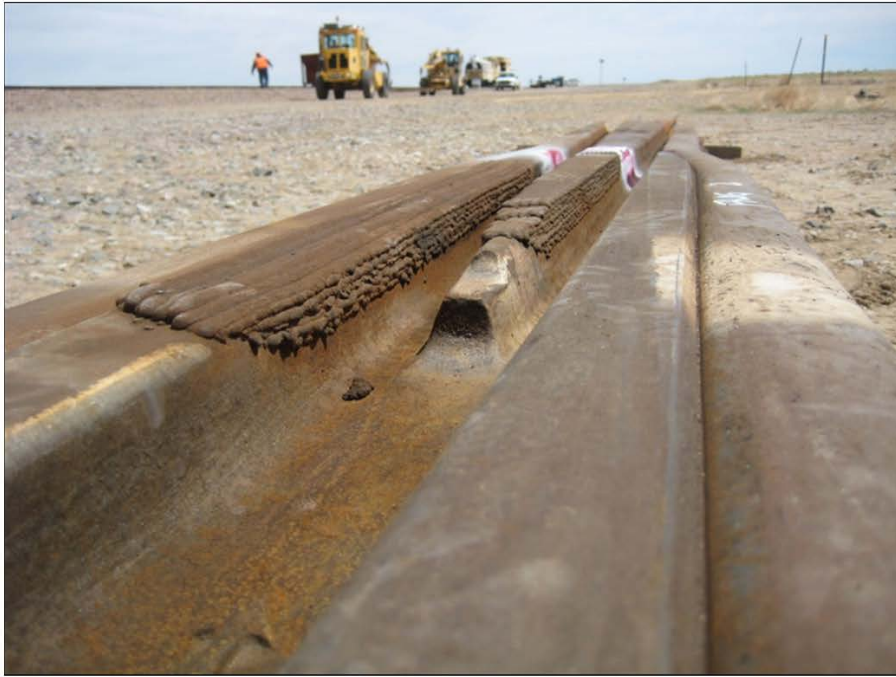
Figure 2. Frog 2: Wing rail repair about 36 inches long; point repair about 43 inches long

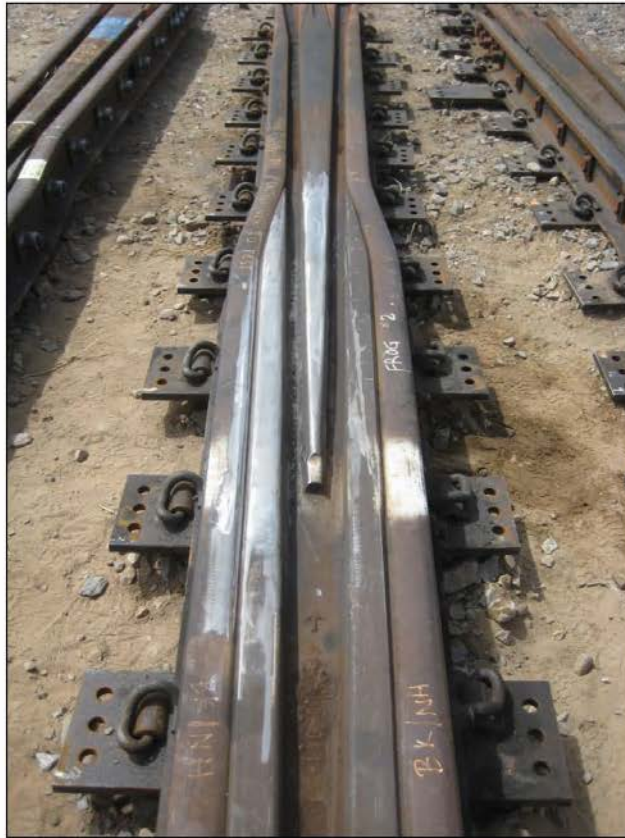
**Figure 3. Weld repaired Frog 2 after grinding excess weld material**

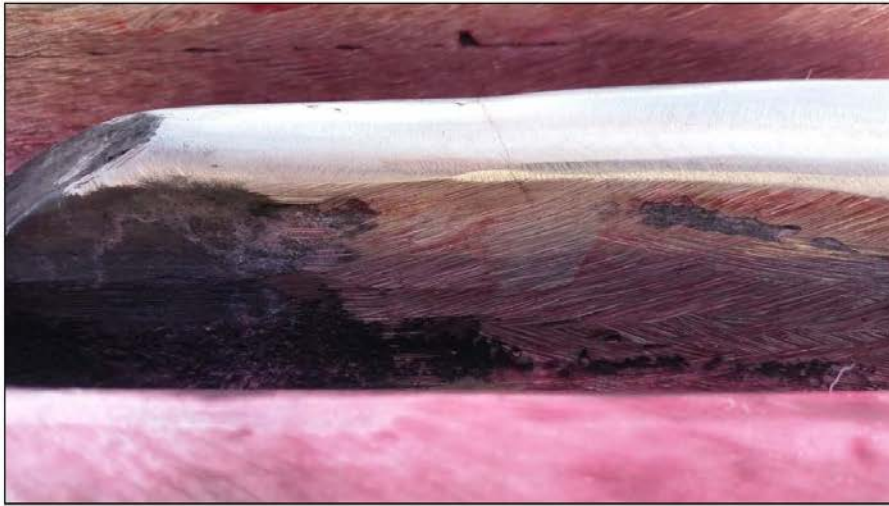
Figure 4. Frog 1: Transverse crack near the point of the frog visible with dye penetrant

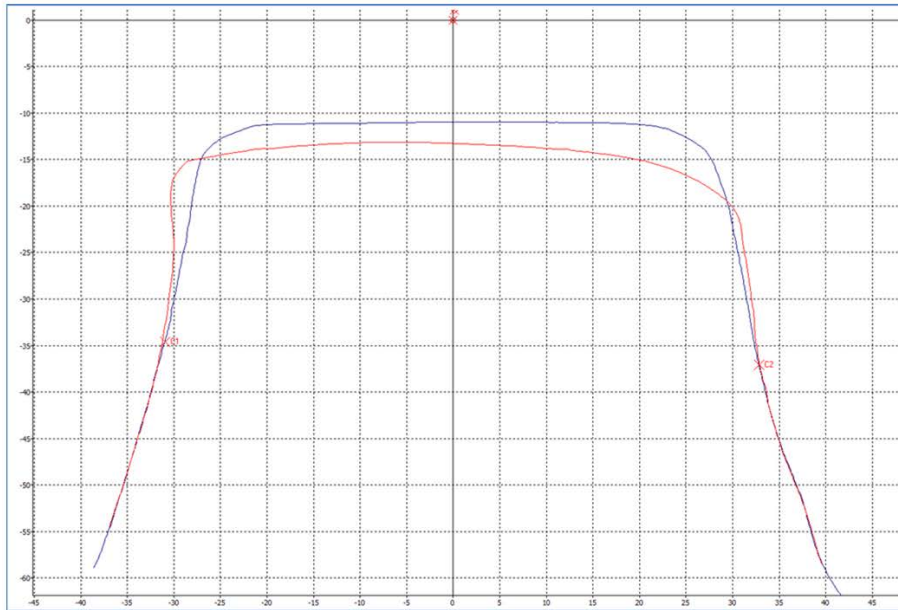
Figure 6. Frog Point: Measurement location 16, 32 inches past the POF — overlay of the newly ground (0 MGT) weld repaired frog point profile and the final profile (100 MGT)

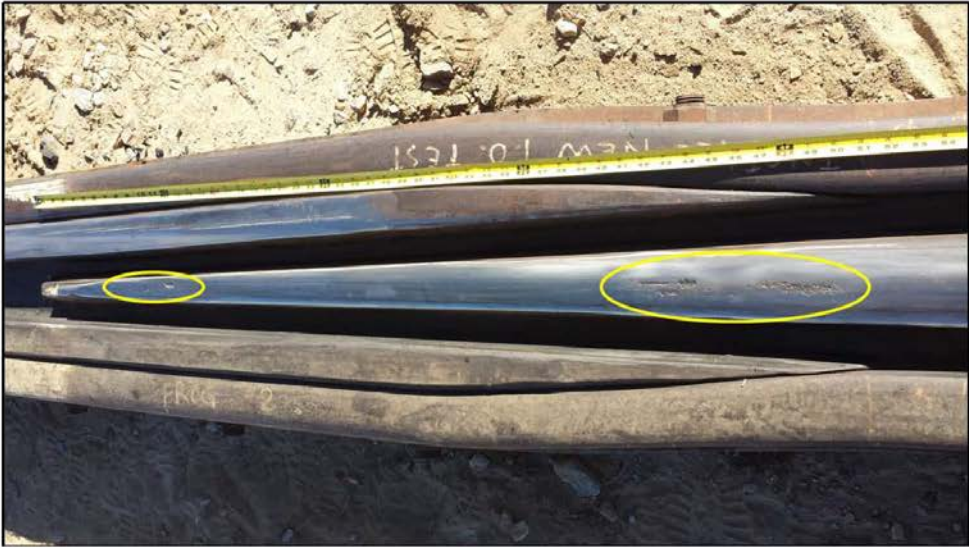
Figure 18. Final inspection: Running surface spalls developing on the frog point

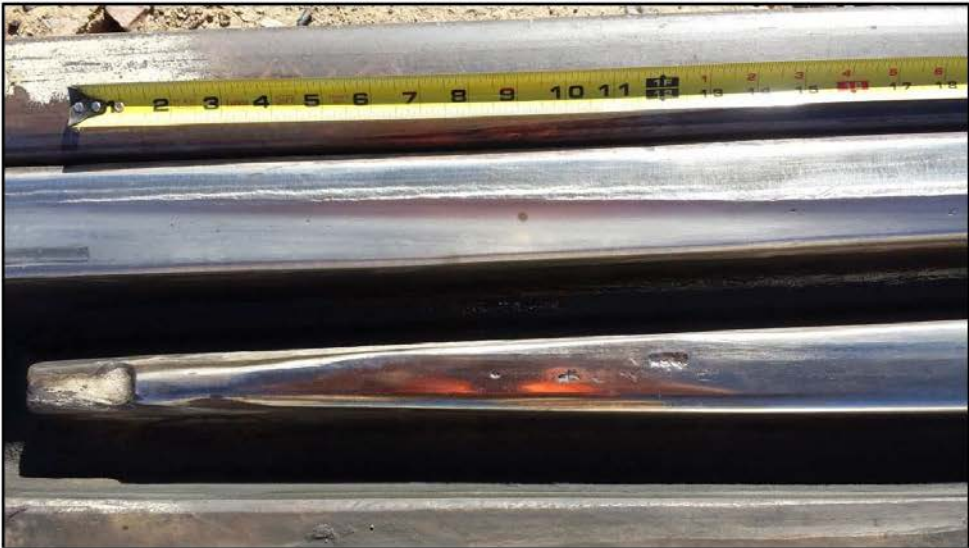
Figure 19. Final inspection: Close-up of running surface spalls developing on the frog point

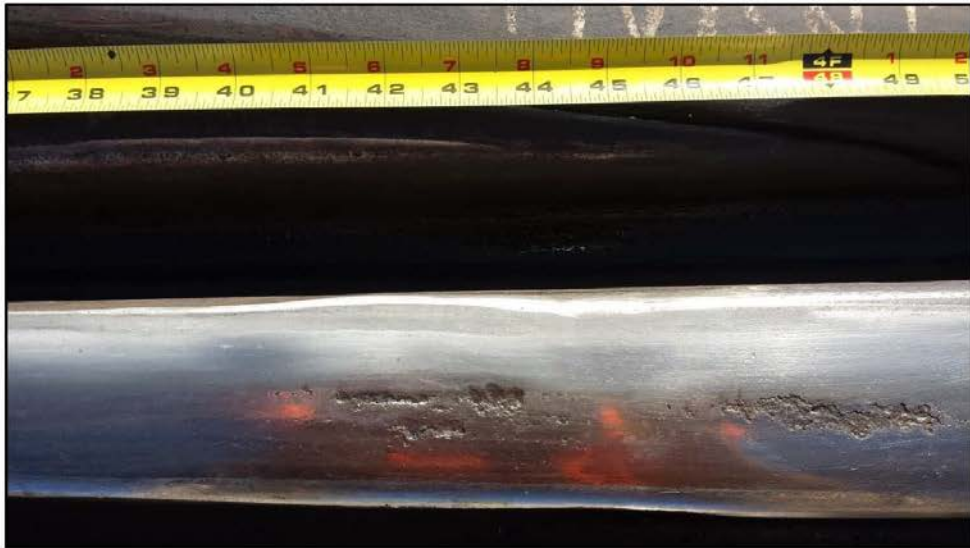
Figure 20. Final inspection: Close-up running surface spalls developing on the frog point

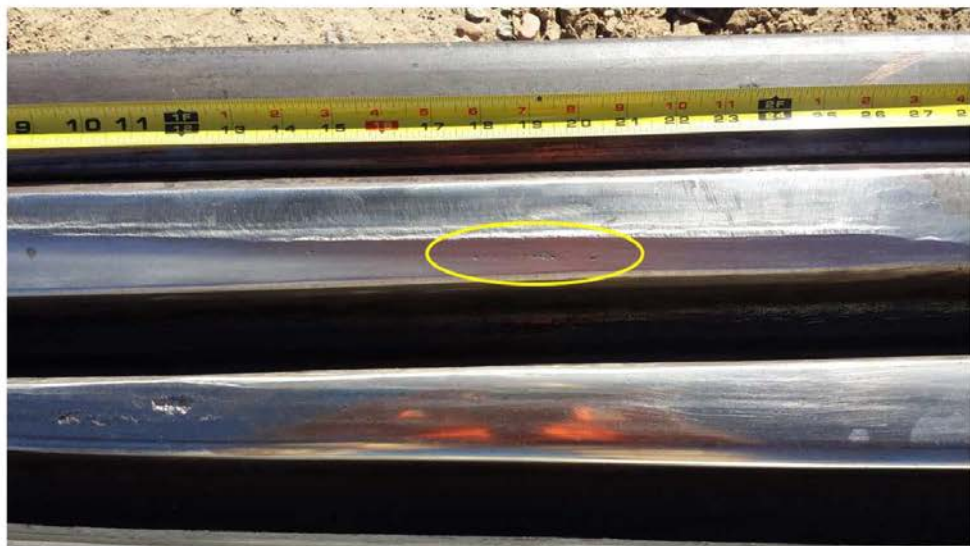
Figure 21. Final inspection: Minor running surface pitting on the wing rail
