**Federal Railroad
Administration**

Sled Tests Using the Hybrid III Rail Safety ATD and Workstation Tables for Passenger Trains

1. AGENCY USE ONLY (Leave blank)	2. REPORT DATE August 2017	3. REPORT TYPE AND DATES COVERED Technical Report	
4. TITLE AND SUBTITLE Sled Tests Using the Hybrid III Rail Safety ATD and Workstation Tables for Passenger Trains		5. FUNDING NUMBERS

6. AUTHOR(S) David Hynd and Claire Willis			
7. PERFORMING ORGANIZATION NAME(S) AND ADDRESS(ES) Transport Research Laboratory (TRL) Crowthorne House, Nine Mile Ride Wokingham, Berkshire, UK, RG40 3GA		8. PERFORMING ORGANIZATION REPORT NUMBER

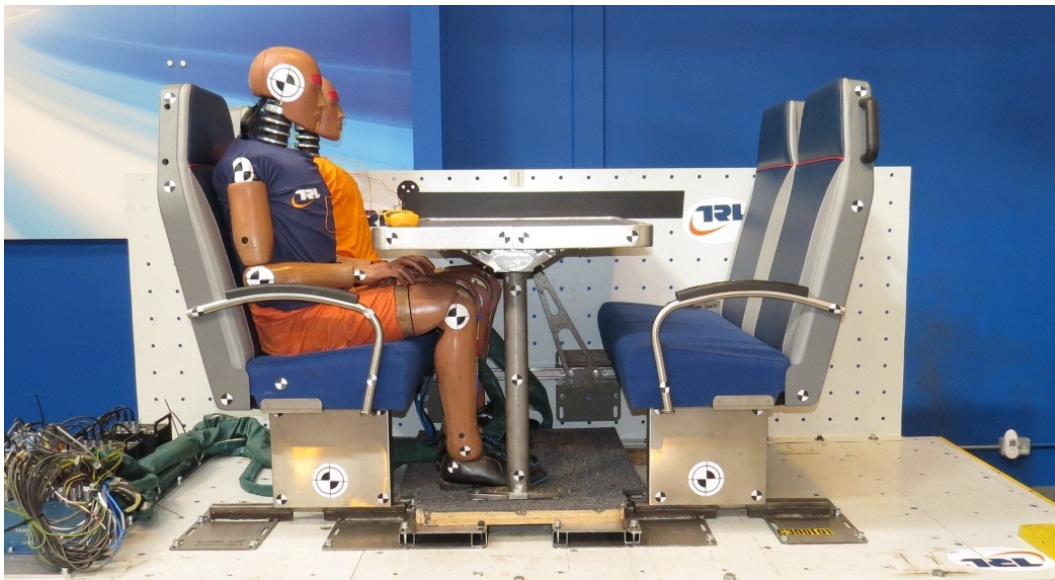
Figure 4. Pre-test view of Test 1 – seat 1, table design 1

The pre-test and post-test ATD and table positions are depicted in Figure 4 and Figure 5. The test pulse is plotted in Figure 6 and the calibration run pulse obtained prior to testing is plotted in Figure 1, which demonstrates that the test conforms as far as possible to the requirements of the standard.

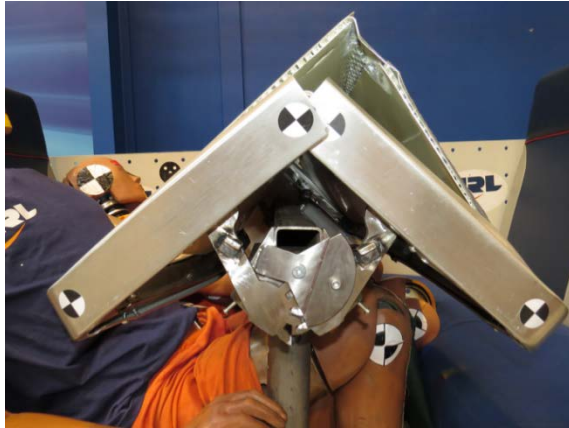
The table folded as it was designed to do, leaving clear survival space

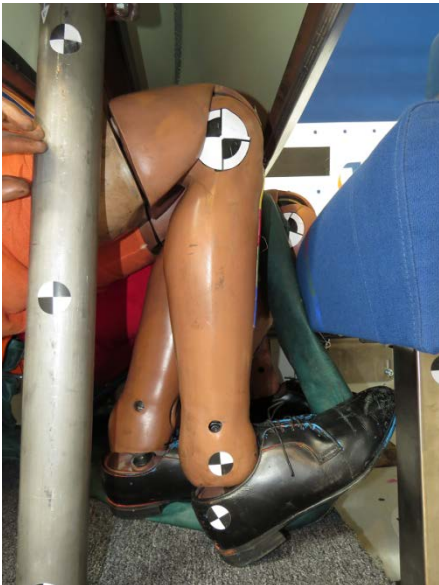
The table deformation allowed the occupants to slide forward, resulting in leg contact with the opposing seats. This result is primarily a function of the initial seat pitch. Leg contact with opposing seats can help to limit the load on the thorax and abdomen.

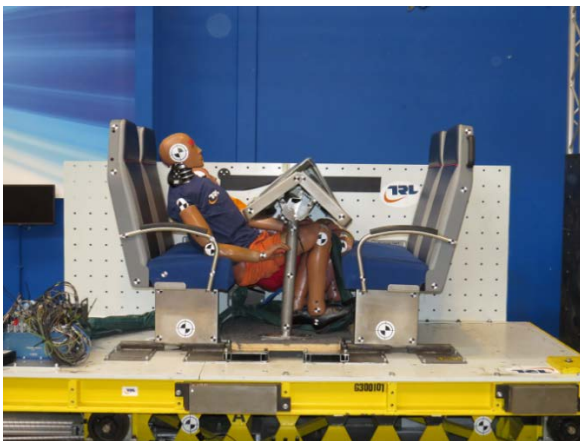
The table and seats all remained securely attached to the sled and no parts (e.g. parts of the table/arm rests) became detached during the impact

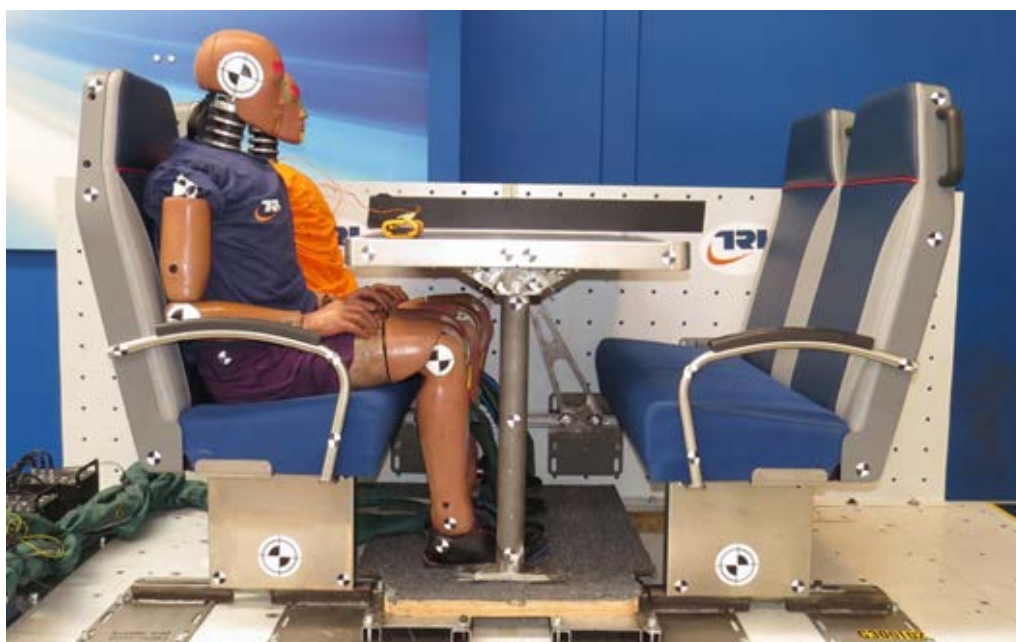
Figure 7. Pre-test view of Test 2 – seat 1, table design 2

The pre- and post-test ATD and table positions are depicted in Figure 7 and Figure 8. The test pulse is plotted in Figure 9 and the calibration run pulse obtained prior to testing is plotted in Figure 1, which demonstrated that the test conforms as far as possible to the requirements of the standard.

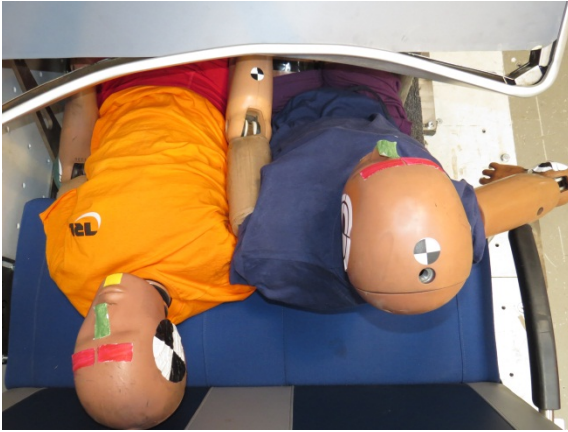
The table side deformed less at the corners and least at the wall.

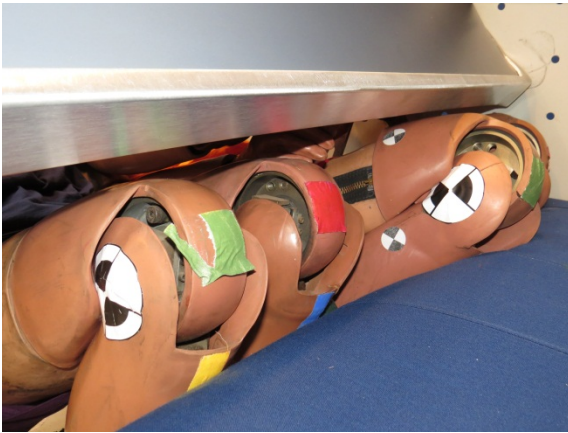
There was more significant impact of the occupant legs with the facing seat compared to the previous test. Had this test been assessed for GM/RT2100 lower leg injury criteria such as Tibial Index and knee deflection it would have failed. It should be noted that this crash pulse had a higher velocity than the minimum prescribed by GM/RT 2100.

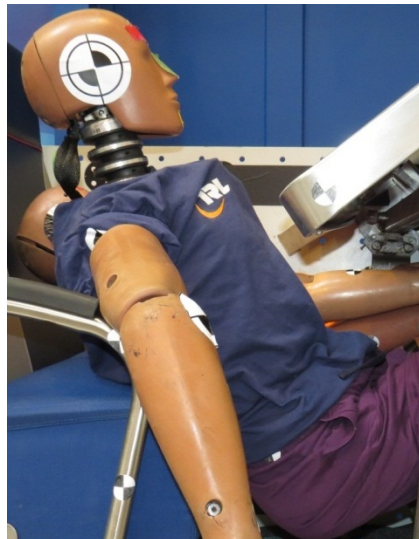
The energy associated with the mass of the moving occupants deformed the table as intended, causing the occupants to move forward to the point where their posterior was no longer supported by the launch seat.

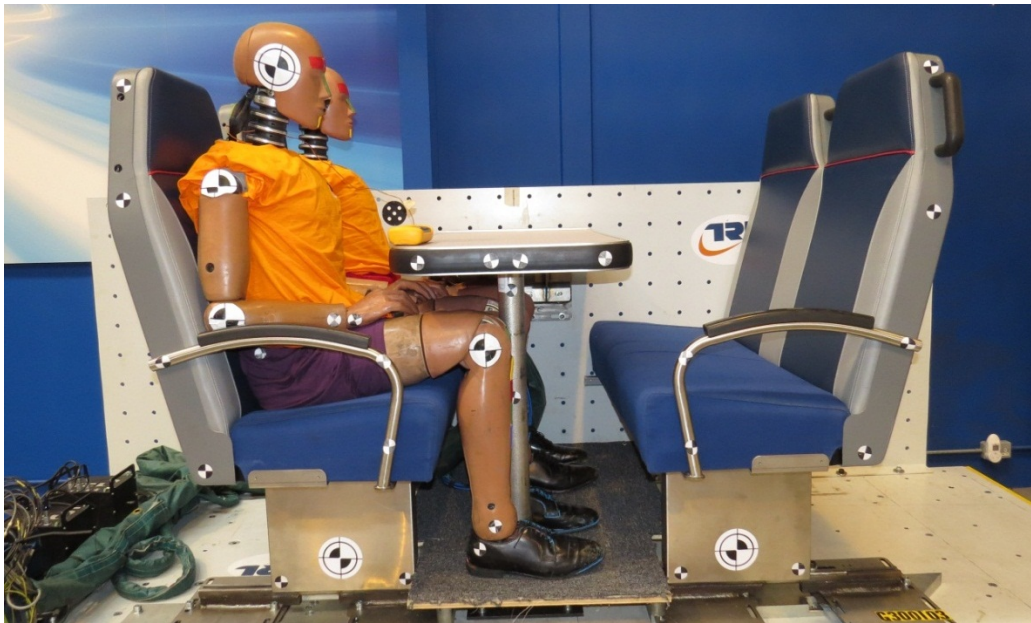
Figure 10. Pre-test view of Test 3 – seat 1, table design 3

The pre- and post-test ATD and table positions are depicted in Figure 10 and Figure 11. The test pulse is plotted in Figure 12, and the calibration run pulse obtained prior to testing is plotted in Figure 1, which demonstrated that the test conforms as far as possible to the requirements of the standard.

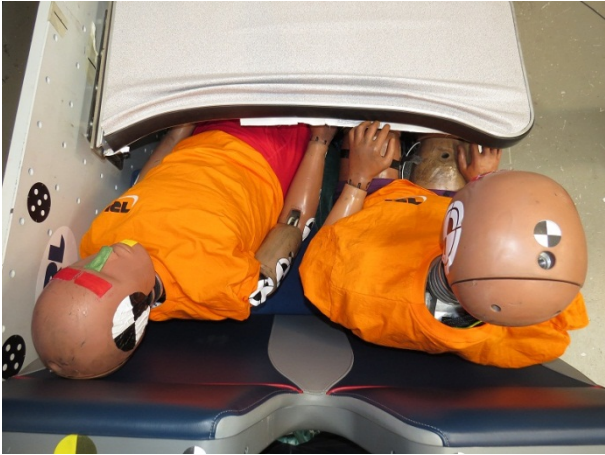
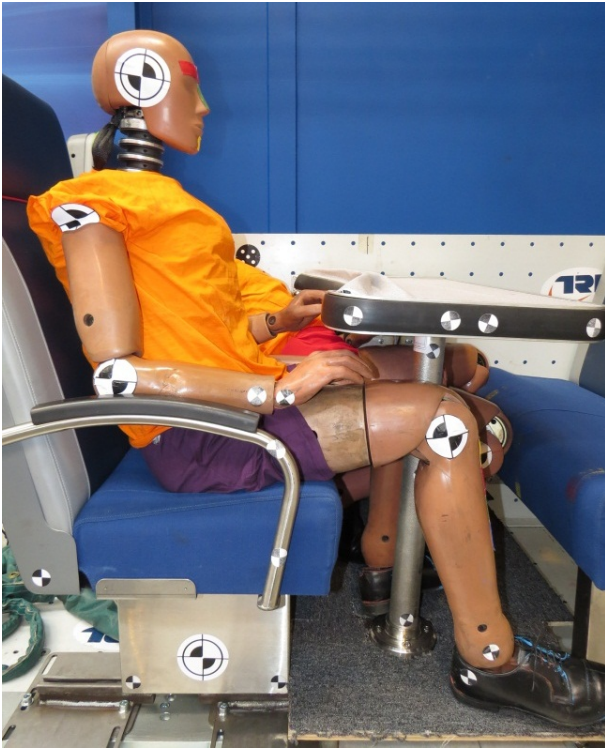
The Hybrid III-RS slid under the table such that its knees contacted the seat opposite.

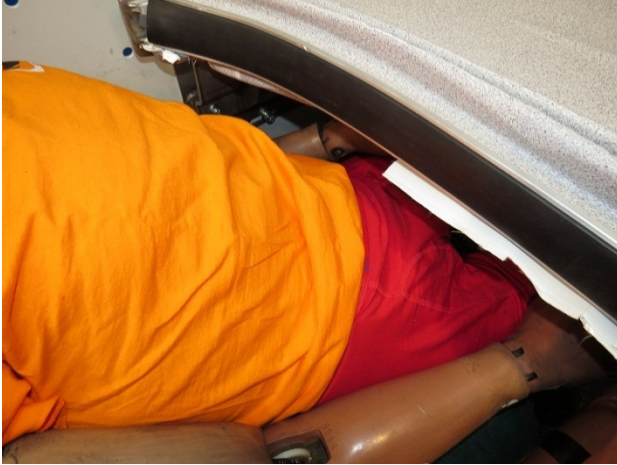
The Hybrid III-RS was able to slide under the table so its resting position was with its knees against the opposing seat and its buttocks off the edge of its seat.

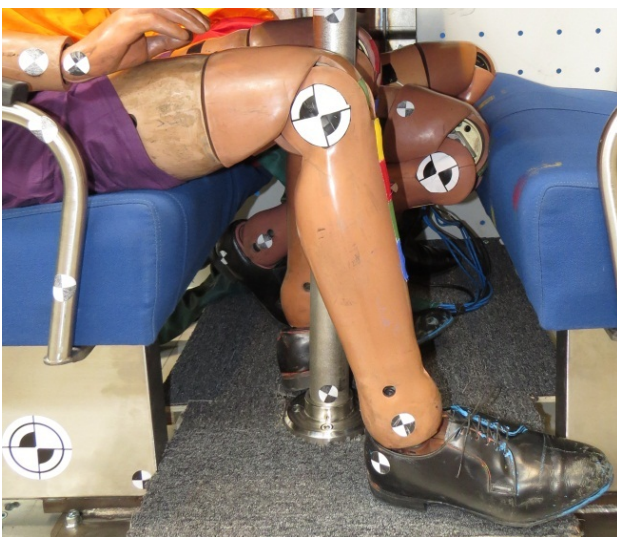
The Hybrid III did not have any leg contact against the table leg.

The table and seats all remained securely attached to the sled and no parts (e.g. parts of the table/ arm rests) became detached during the impact.

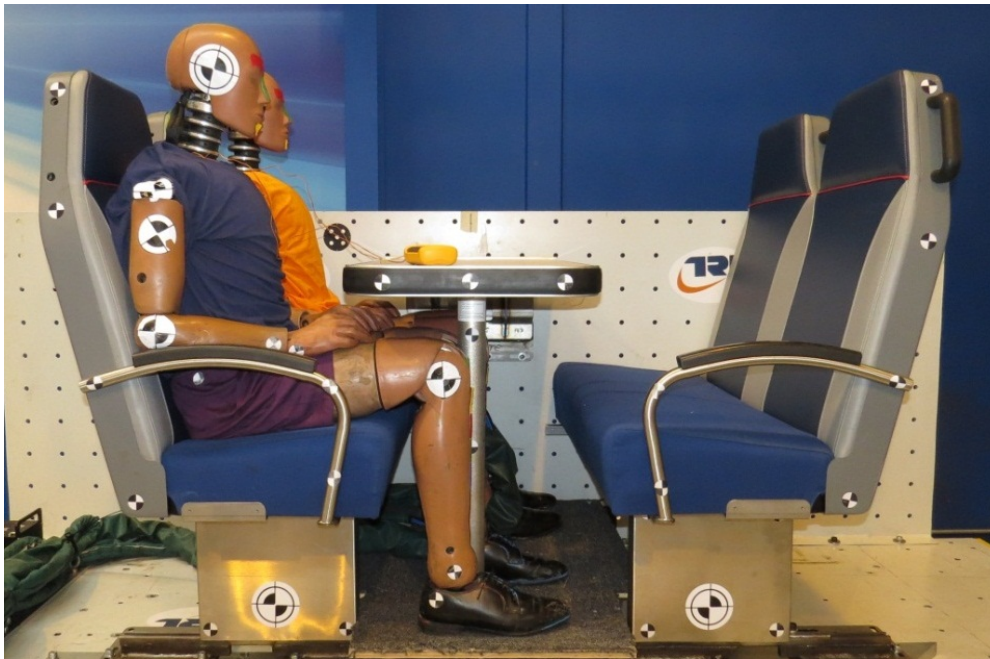
Figure 13. Pre-test view of Test 4 – seat 1, table design 3

The pre- and post-test ATD and table positions are depicted in Figure 13 and Figure 14. The test pulse is plotted in Figure 15, and the calibration run pulse obtained prior to testing is plotted in Figure 1, which demonstrated that the test conforms as far as possible to the requirements of the standard.

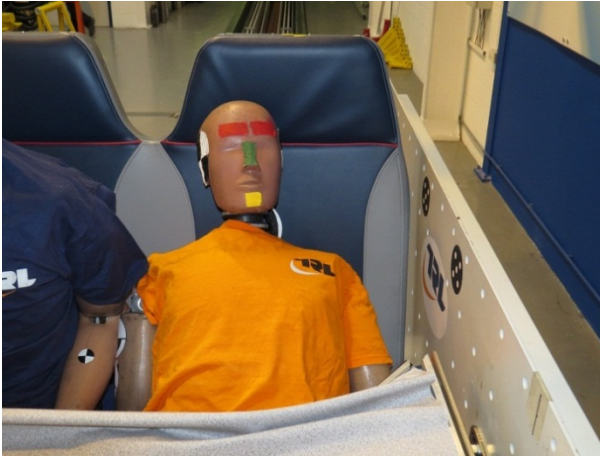
The table deformation allowed the ATDs to slide forward, resulting in leg contact with the opposing seats. This result is primarily a function of the initial seat pitch.

The final position of the standard Hybrid III was near its original position on the launch seat.

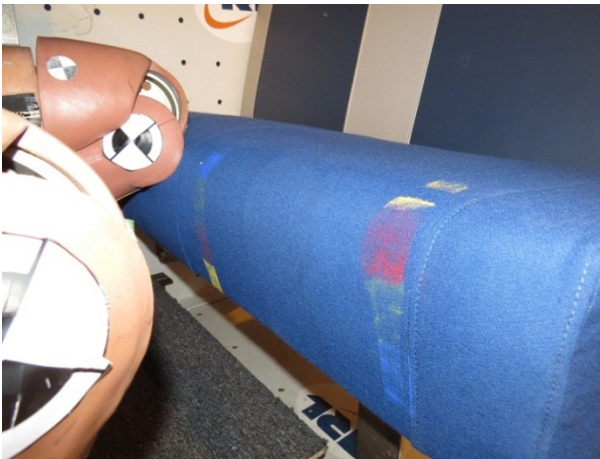
Both ATDs experienced contact with the opposing seat. This contact can serve to limit to load on the abdomen, although this may be dependent on the seat pitch.

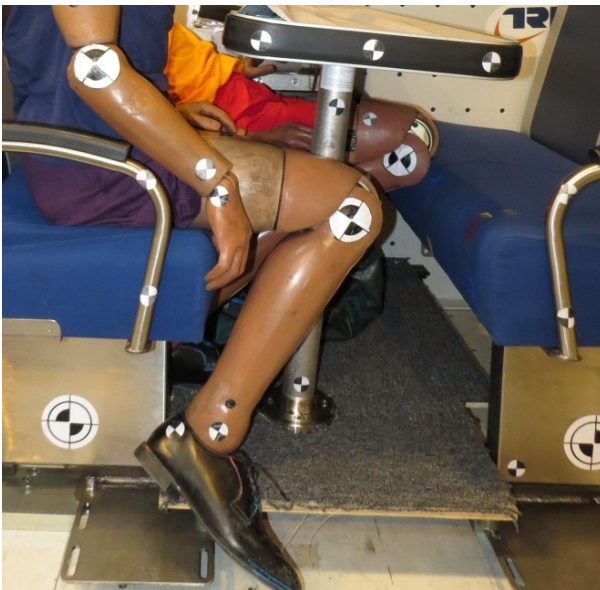
The table and seats all remained securely attached to the sled and no parts (e.g. parts of the table/ arm rests) became detached during the impact.

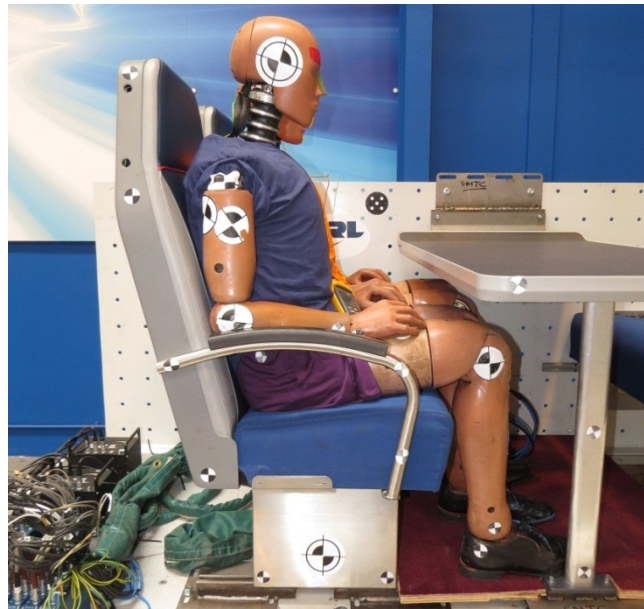
Figure 16. Pre-test view of Test 5 – seat 1, table design 4

The pre- and post-test ATD and table positions are depicted in Figure 16 and Figure 17. The test pulse is plotted in Figure 18, and the calibration run pulse obtained prior to testing is plotted in Figure 1, which demonstrates that the test conforms as far as possible to the requirements of the standard.

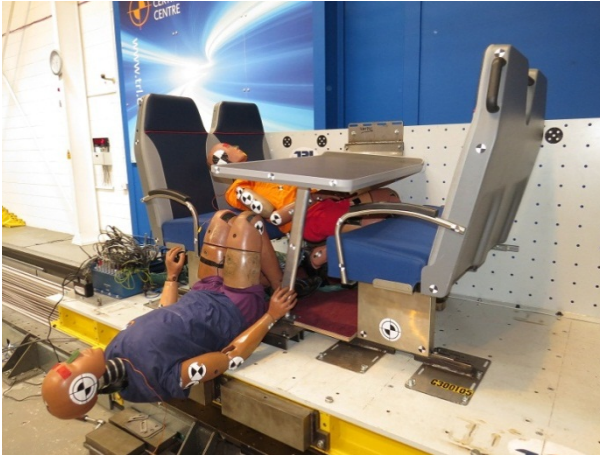
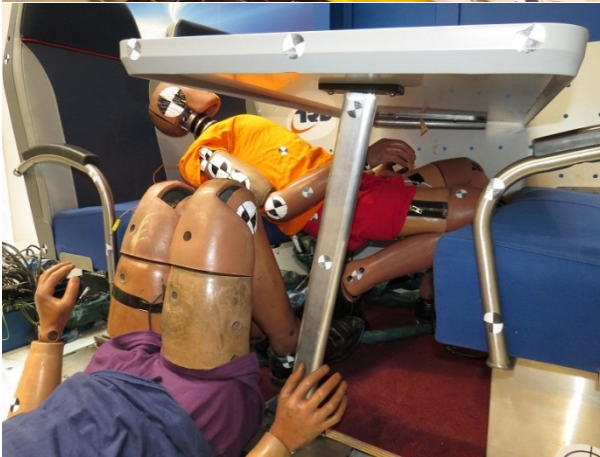
The deformation of the table caused the ATD in the aisle seat to fall into the aisle after impact with the table, but compartmentalization was achieved as defined by the APTA standard.

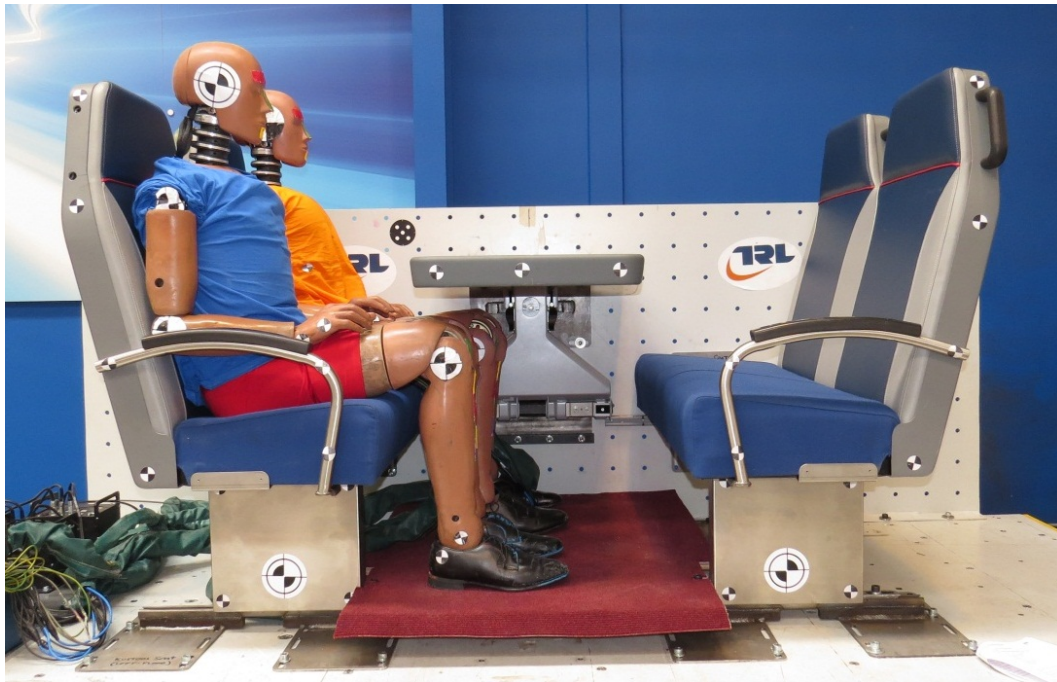
Figure 19. Pre-test view of Test 6 – seat 1, table design 5

The pre- and post-test ATD and table positions are depicted in Figure 19 and Figure 20. The test pulse is plotted in Figure 21; the calibration run pulse obtained prior to testing is plotted in Figure 1, demonstrating that the test conforms as far as possible to the requirements of the standard.

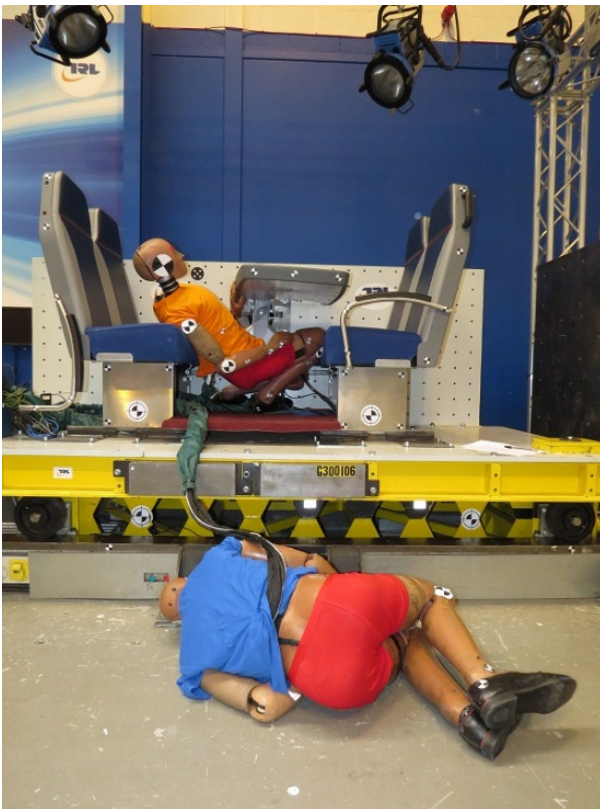
The wall-side occupant slid under the table and was contained by contact with the opposing seat.

The aisle-side occupant fell into the aisle during the rebound phase.

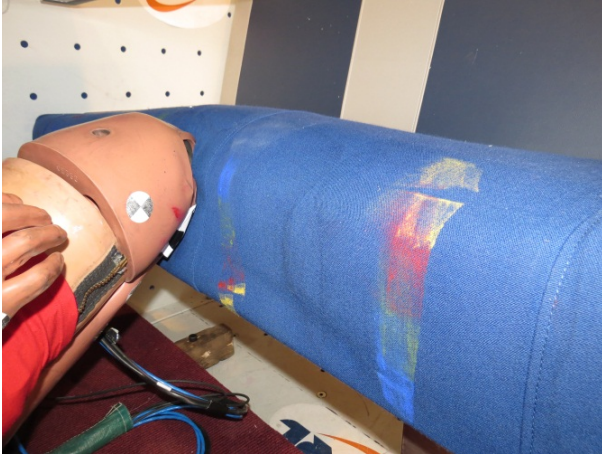
View of opposing (rear facing) seat pan cushion and witness marks from knee contacts.

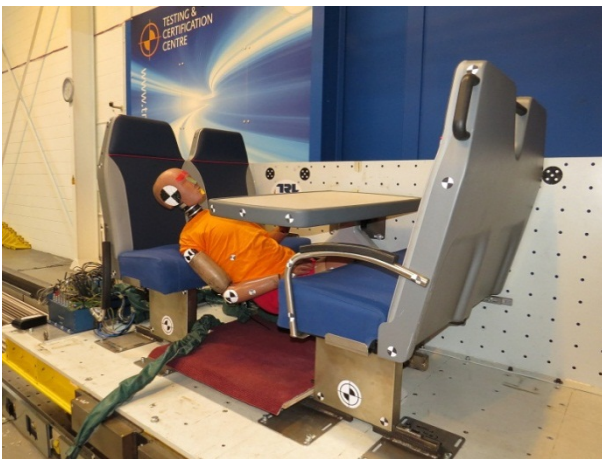
Post-test position of wall-side ATD depicting angle of occupant.

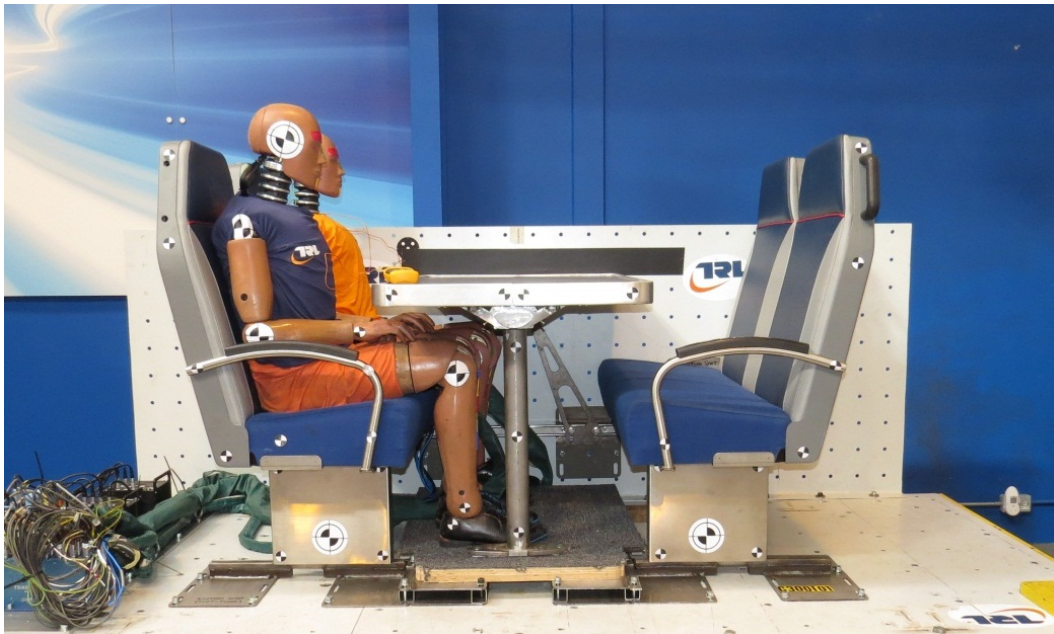
Figure A.1.1: Pre-Test

This injury test was for the seat configuration depicted above. The seat design was ‘Seat 1’ and the table design was ‘Table 1.’ The installation of seats and table was carried out by TRL test staff; all mountings and interface plates were designed and fabricated by TRL.

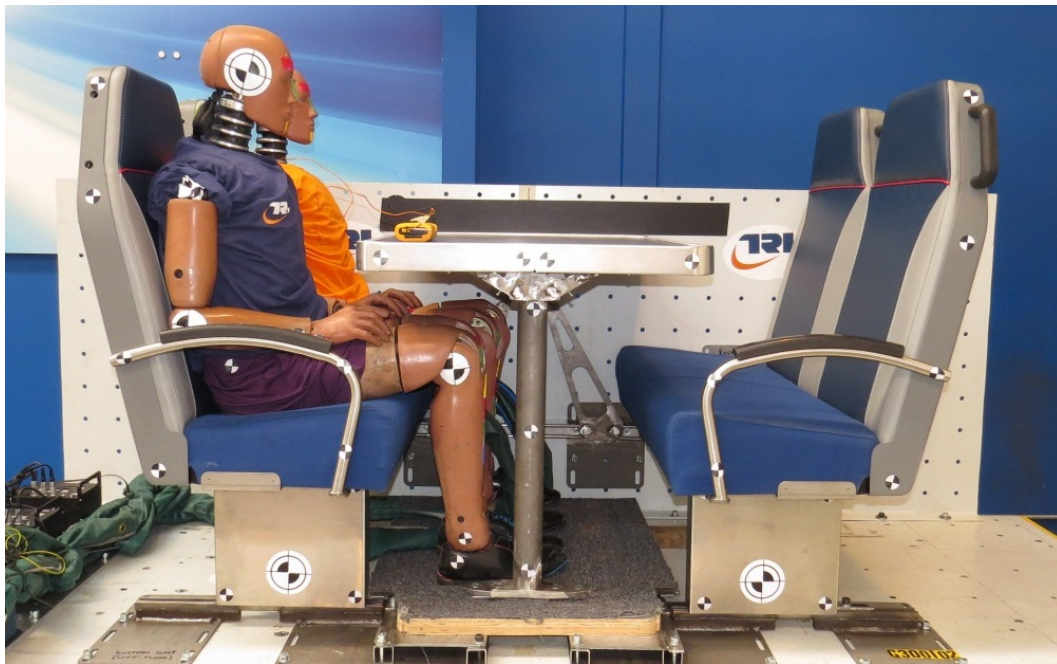
Figure A.2.1: Pre-Test

This injury test was for the seat configuration depicted above. The seat design was ‘Seat 1’ and the table design was ‘Table 2’. The installation of seats and table was carried out by TRL test staff; all mountings and interface plates were designed and fabricated by TRL.

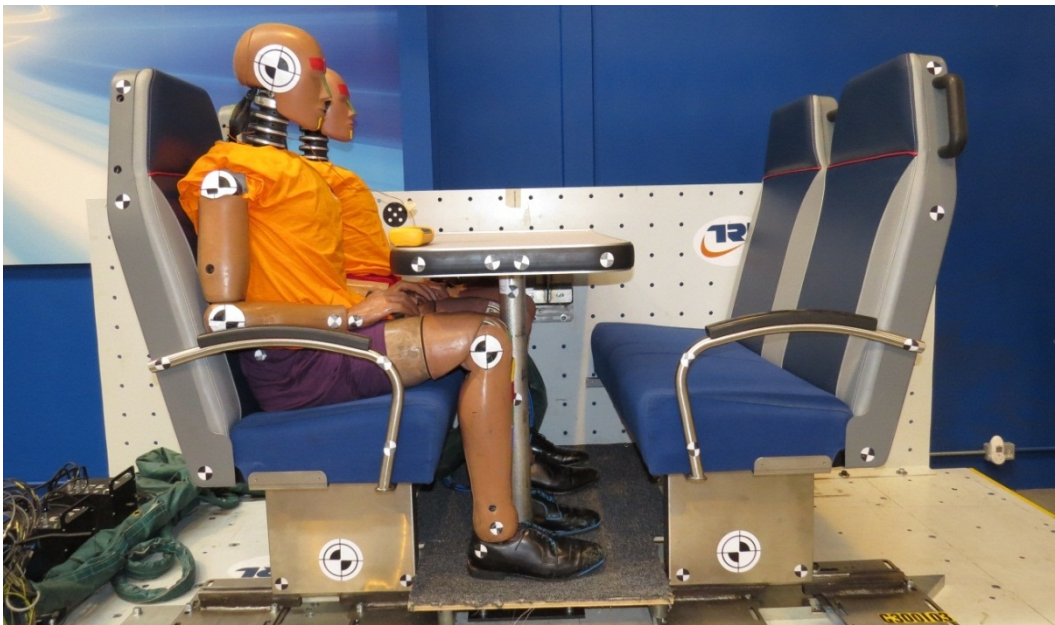
Figure A.3.1: Pre-Test

This injury test was for the seat configuration depicted above. The seat design was ‘Seat 1’ and the table design was ‘Table 3.’ Since the table was not designed to be used with these seats, it was placed asymmetrically (per the installation drawing) to give a representative distance from the ATD chest to the table edge and from the ATD knees to the opposing seats. The installation of seats and table was carried out by TRL test staff, and all mountings and interface plates were designed and fabricated by TRL.

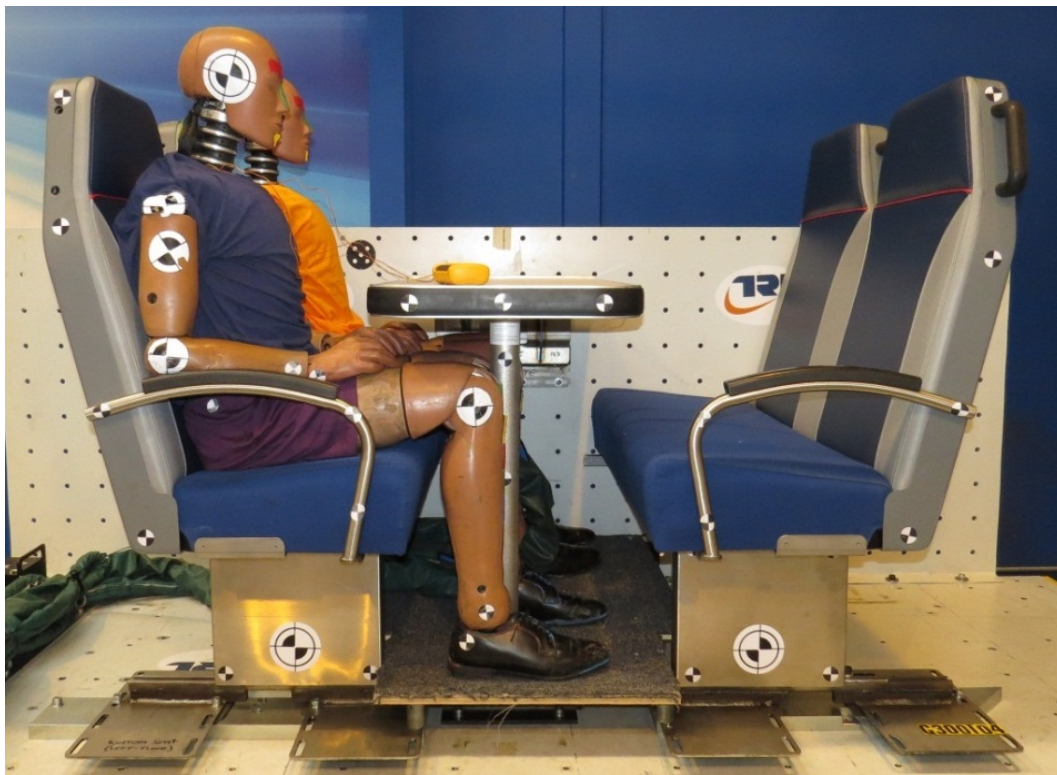
Figure A.4.1: Pre-Test

This injury test was for the seat configuration depicted above. The seat design was ‘Seat 1’ and the table design was ‘Table 3.’ As the seats and table were not intended to be installed together, the table was installed asymmetrically (per the installation drawing) in order to give a representative distance between the seat back and table edge, and between the ATD knees and opposing seats. The installation of seats and table was carried out by TRL test staff, and all mountings and interface plates were designed and fabricated by TRL.

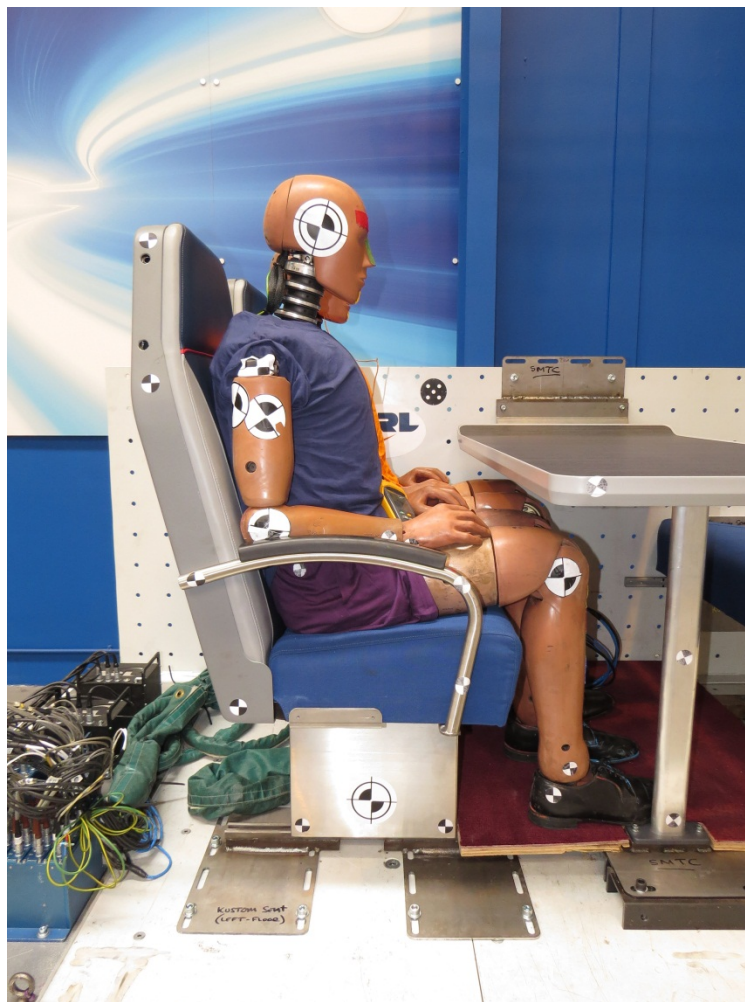
Figure A.5.1: Pre-Test

This injury test was for the seat configuration depicted above. The seat design was ‘Seat 1’ and the table design was ‘Table 4.’ The installation of seats and table was carried out by TRL test staff, and all mountings and interface plates were designed and fabricated by TRL.

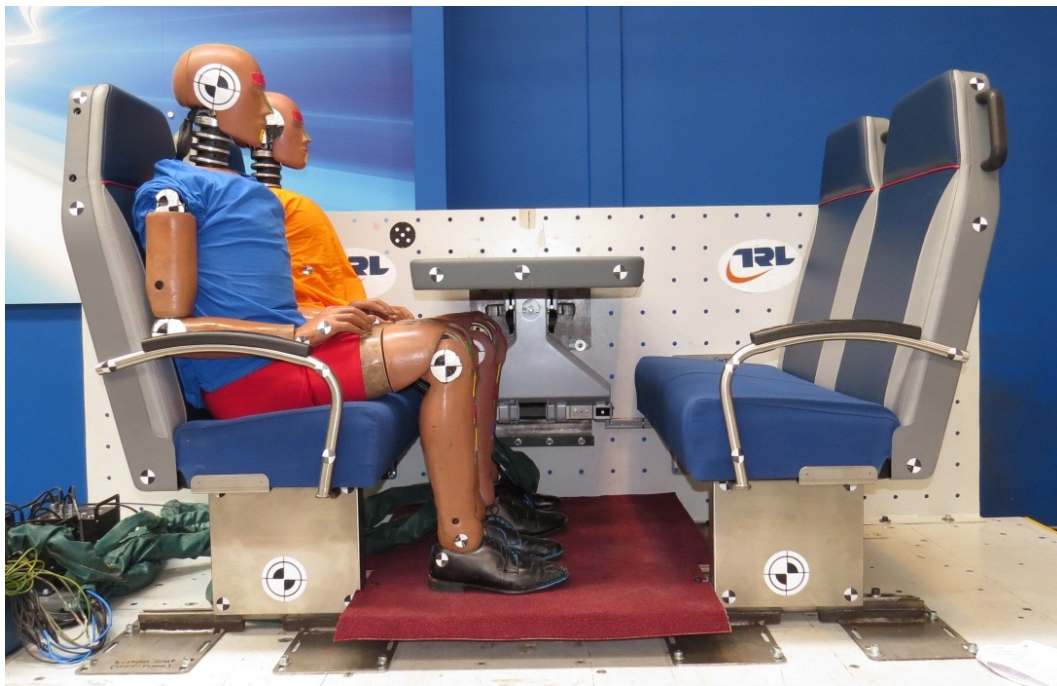
Figure A.6.1: Pre-Test

This injury criteria test was for a pair of double seats facing each other across a cantilever mounted table, as depicted above. The seat design was ‘Seat 1’ and the table design was ‘Table 5.’ The installation of seats and table was carried out by TRL test staff; all mountings and interface plates were designed and fabricated by TRL to be representative, as far as reasonable, real-world installation.

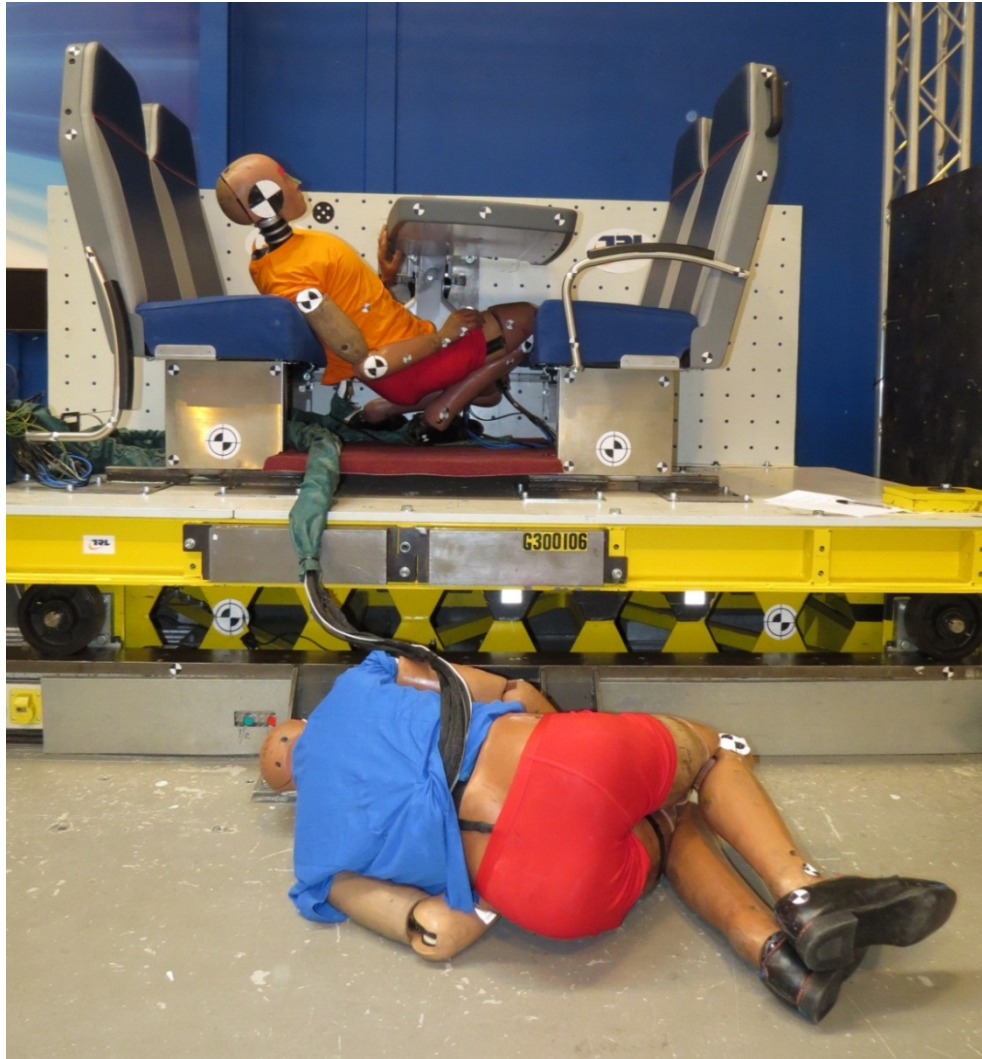
Figure A.6.2: Post-Test

During the impact both ATDs' knees became wedged beneath the table and the opposite seat pan cushion. Both motions would have severely compromised the occupant survival space of any occupant on the opposing seat.
