U.S. Department of
Transportation

**Federal Railroad
Administration**

Passenger Car Crippling End-Load Test and Analyses

1. AGENCY USE ONLY (Leave blank)		2. REPORT DATE September 2017	3. REPORT TYPE AND DATES COVERED Technical Report	
4. TITLE AND SUBTITLE Passenger Car Crippling End-Load Test and Analyses			5. FUNDING NUMBERS DTFR53-11-D-00008 Task Order 323

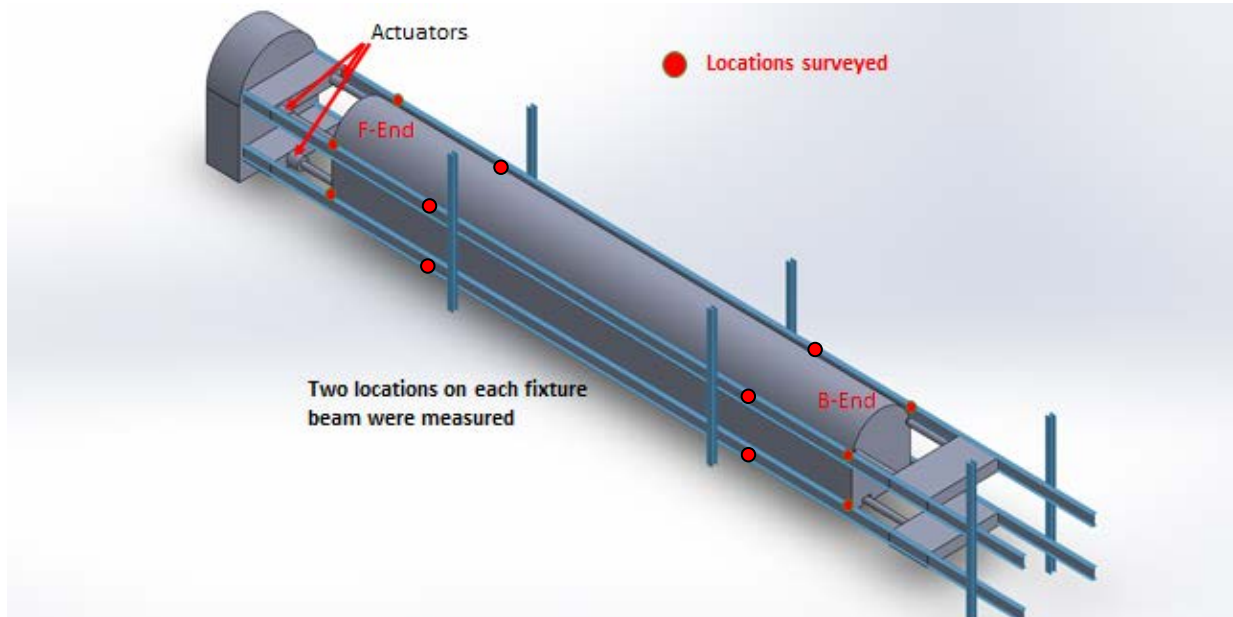
Figure 5. Locations Surveyed — Fixture

Before the crippling load test, survey measurements were taken to assess the squareness of Car 9614 in the test fixture. Thirty-two locations were measured on the fixture and the car, as Figure 5, Figure 6, and Figure 7 show. All the locations were surveyed twice under the following conditions:

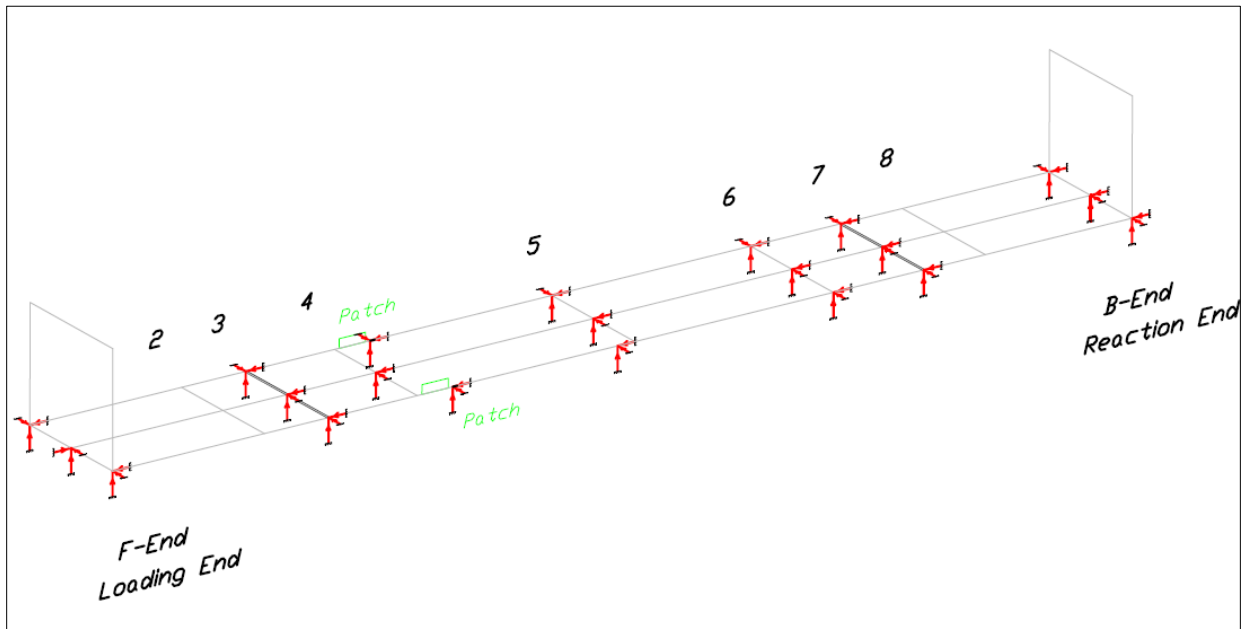
Figure 15. 800,000-pound Load Test Layout of VLL String Potentiometer Arrays

Vertical, lateral, and longitudinal (VLL) string potentiometer arrays were installed along the center sill and side sills at each cross-section, with the exceptions of Cross-Sections 2 and 8. These sections coincided with the bolster locations, which complicated the placement of the VLL arrays. Figure 15 shows the map of VLL string potentiometer arrays for the 800,000-lb load test. Table A3 in Appendix A contains details of the load measuring channels used in the 800,000-lb load test.

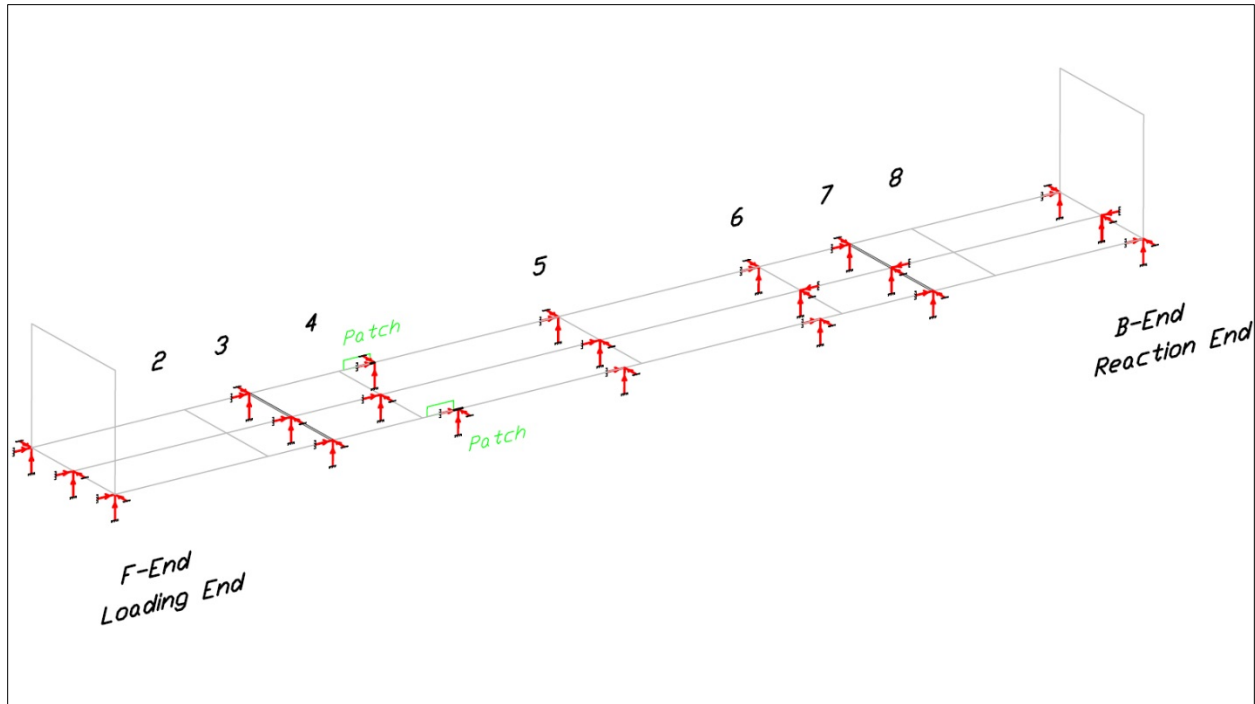
Figure 16. Crippling Load Test Layout of VLL String Potentiometer Arrays

During the crippling test, some of the VLL arrays were moved to avoid damaged or vulnerable areas and the orientations of some arrays were changed. Figure 16 shows the string potentiometer map for the crippling load test. Table A4 in Appendix A contains details of the string potentiometer locations used in the crippling load test. The positions and orientations of the sensors in both tests were consistent with the previously described coordinate system.

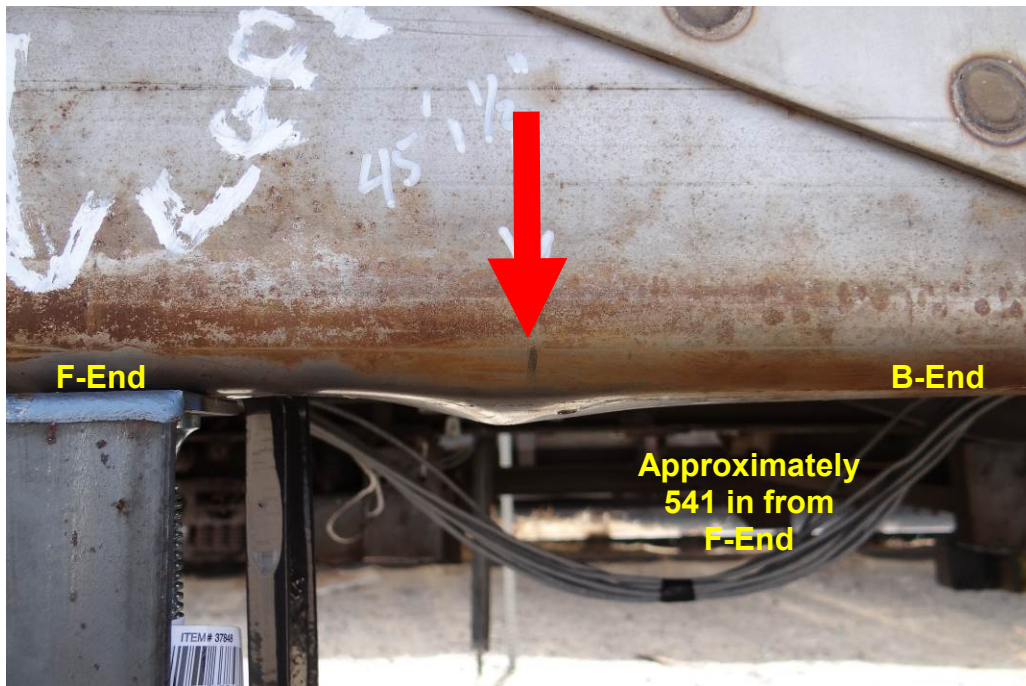
Figure 25. Damage on Left Side Sill Following 800,000-pound Load Test

Figure 24 and Figure 25 show that the car incurred minor damage during the 800,000-lb load test. Both side sills had deformations at Cross-Section 6.

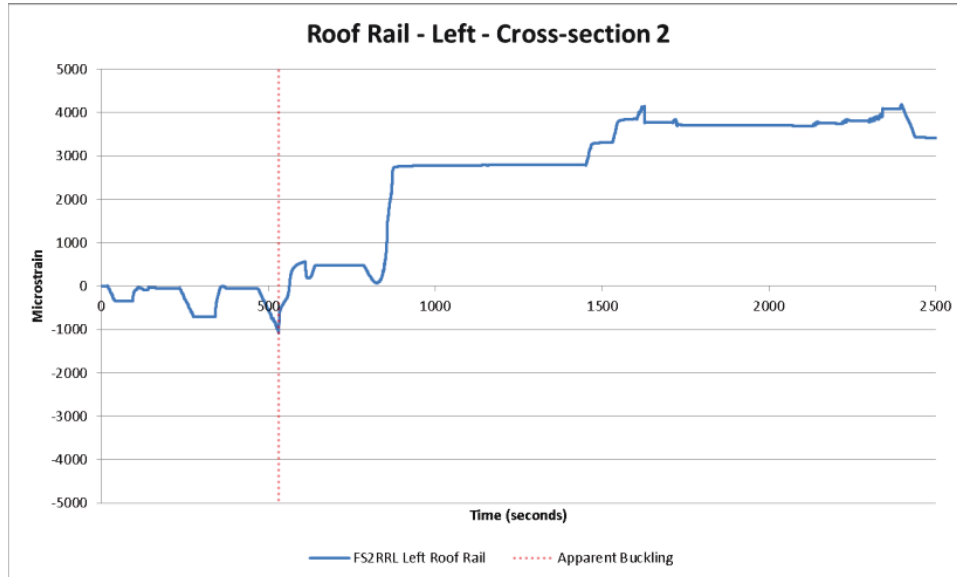
Figure 30. Strain versus Time for Strain Gage on Left Roof Rail, Cross-Section 2

Through examination of the strain gage data, it appears the roof rail at Cross-Section 2 (closest to the F-end) began to buckle locally just as the total load reached 600,000 pounds. Because the load was held at 600,000 pounds, no reduction in force is apparent due to this buckling. However, the strains experience a near-instantaneous transition from compression to tension, as seen in Figure 29.

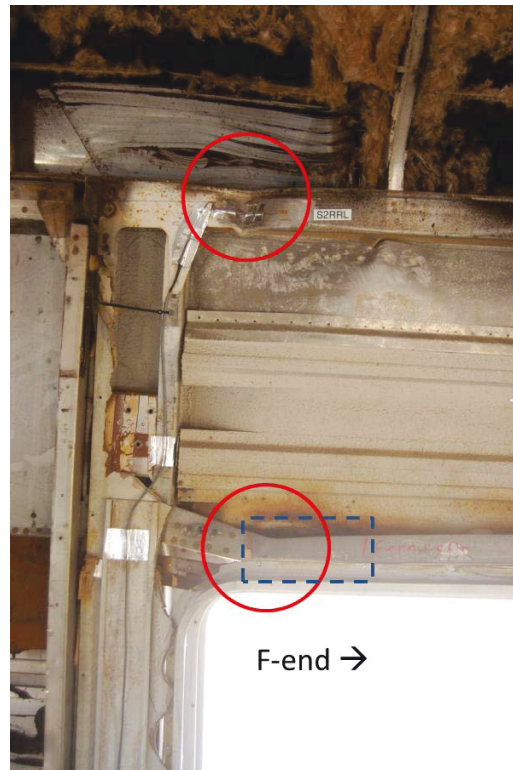
Figure 31. Buckled Areas of Left Roof Rail and Window Rail at Cross-Section 2

Post-test examination of this area revealed buckling occurred in both the window and roof rails at this location. Prior to the crippling test, an area of pre-existing damage was noted on the window rail in the approximate area that buckled during the test. The two buckled areas are circled in Figure 30. The area of pre-existing damage is outlined with a dashed rectangle in this figure.

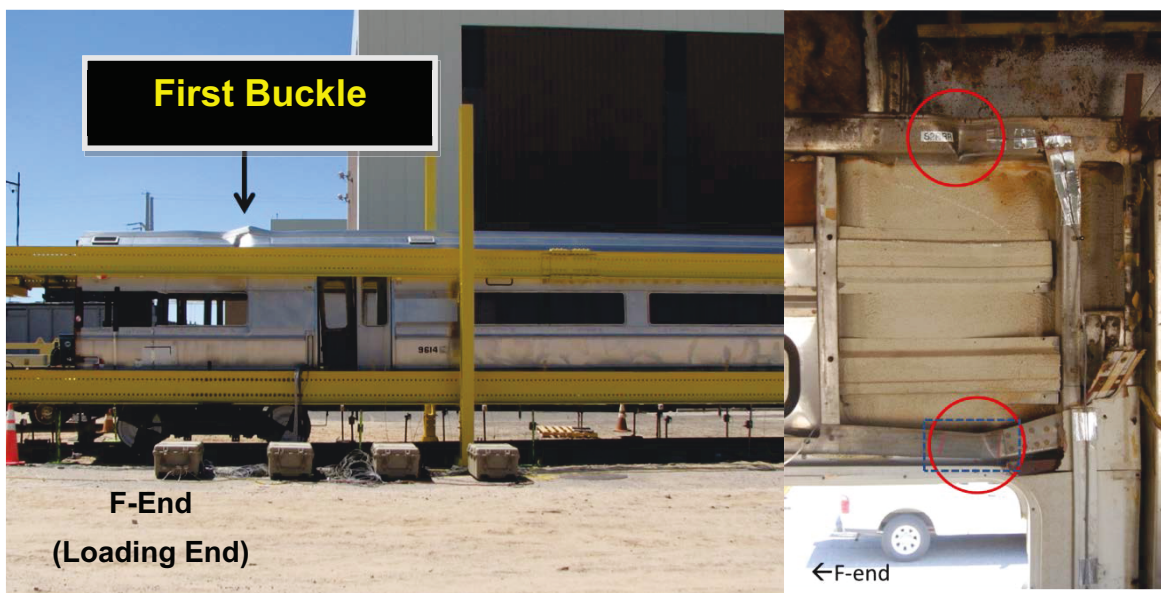
Figure 32. First Buckle at Approximately 700,000 lbs Exterior (left) and Interior (right)

During the 800,000-lb load cycle, the car began to buckle on the roof near the F-end doors, as Figure 31 shows. Buckling began at approximately 700,000 pounds. The left side of this figure shows the exterior of the car and the right side of this figure shows the interior right-side wall at Cross-Section 2. The damage to the window rail and roof rail are circled, and an area of pre-test damage to the window rail is outlined with a dashed rectangle.

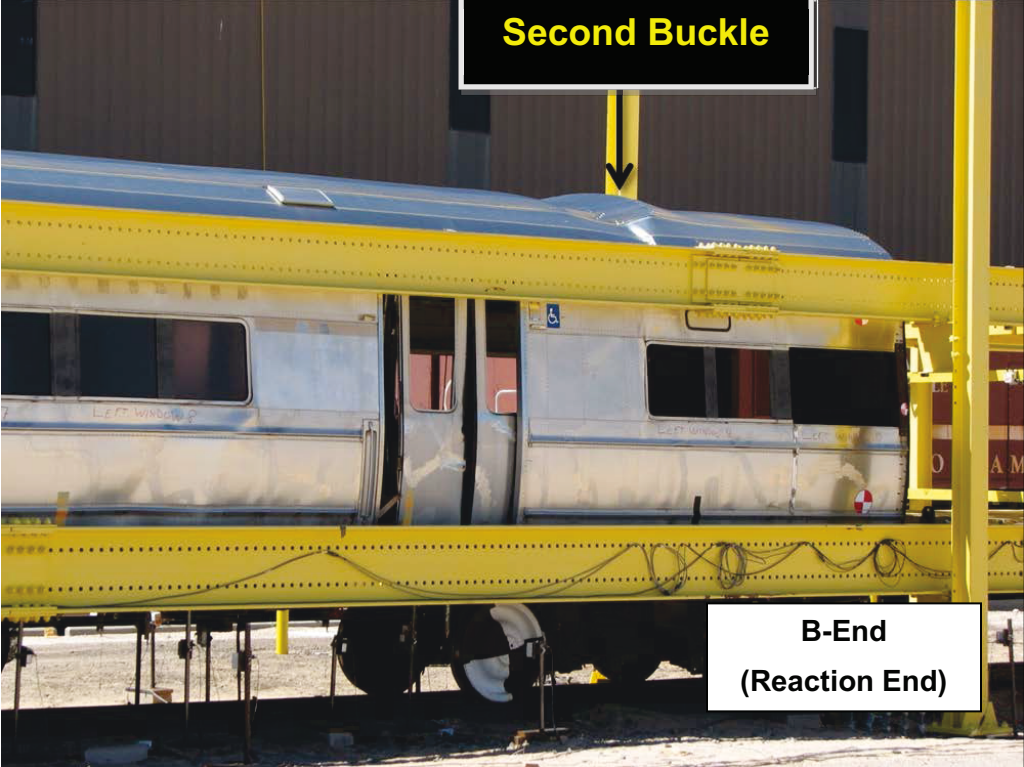
Figure 33. Second Buckle at 1,000,000 lb

After the first buckle, loads were increased using 0.25-inch displacement increments rather than increments of applied load. The second buckle occurred on the roof near the B-end doors at approximately 1,000,000 pounds and it was similar to the first buckle. Figure 32 shows the damage resulting from the second buckle. The first two buckling locations were outside of the doors near the ends of the car. The second buckle was located close to the instrumentation Cross-Section 8.

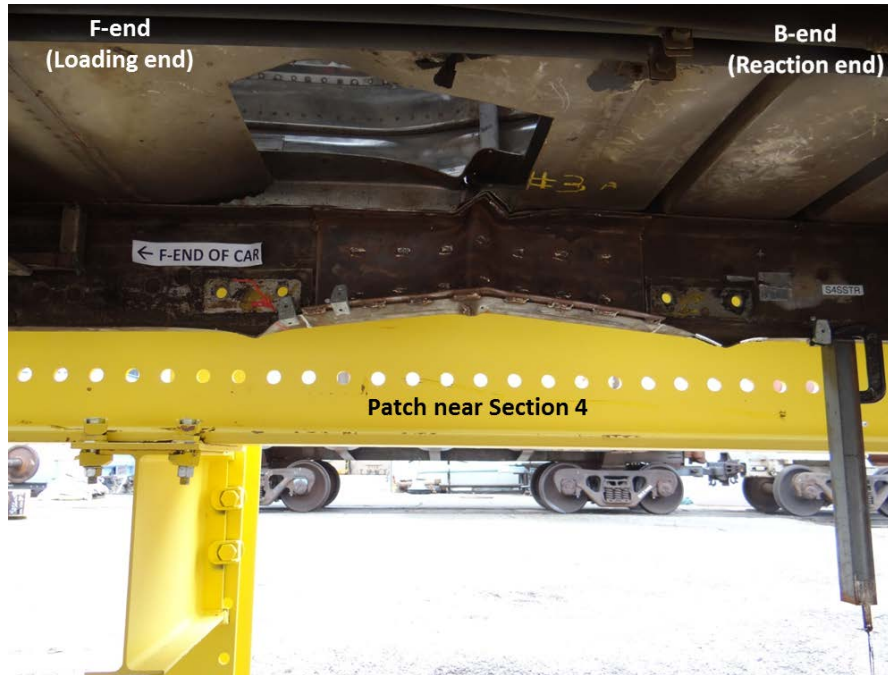
Figure 34. Section 4 Right Side Sill Buckle

During the fourth quarter-inch increment, buckling was observed on the right-side sill near Cross-Section 4 and on the left side sill near Cross-Section 6. Figure 33 shows the buckle on the right-side sill near Cross-Section 4, and Figure 34 shows the buckle on the left side sill near Cross-Section 6. After the 800,000-lb load test, the left side sill was slightly bent at Cross-Section 6. The string potentiometer VLL near the defect was moved 19-inches toward the F-end to avoid losing data at this location. The left side still buckled at that location during the crippling test.

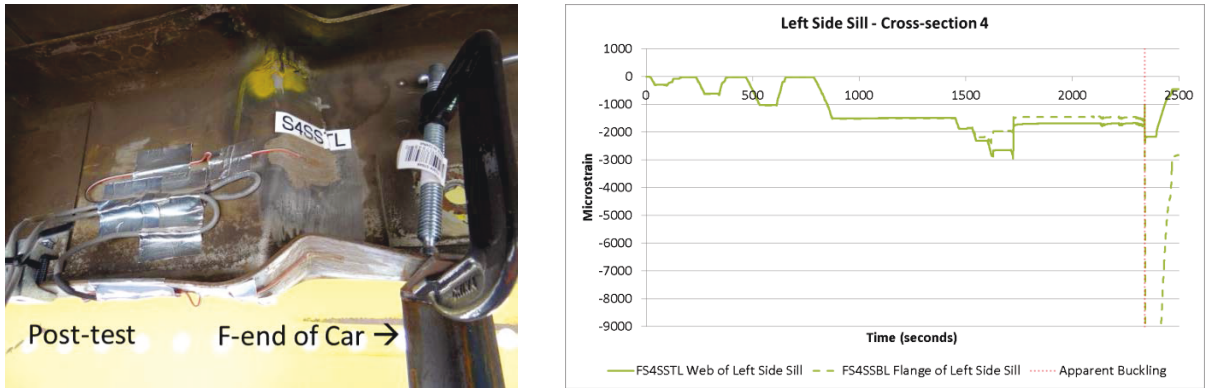
Figure 36. Buckled Left Side Sill at Cross-Section 4 (left) and Strain-time History (right)

After six quarter-inch increments, the applied load on the test car was increased until the car could sustain no further load. At approximately 1,100,000 pounds of total load, the car experienced crippling of the center and side sills. The post-test damage to the side sill and the strain-time history from the buckled location at Cross-Section 4 are both shown in Figure 35. The post-test damage to the center sill and the strain-time history from the buckled location at Cross-Section 4 are both shown in Figure 36.

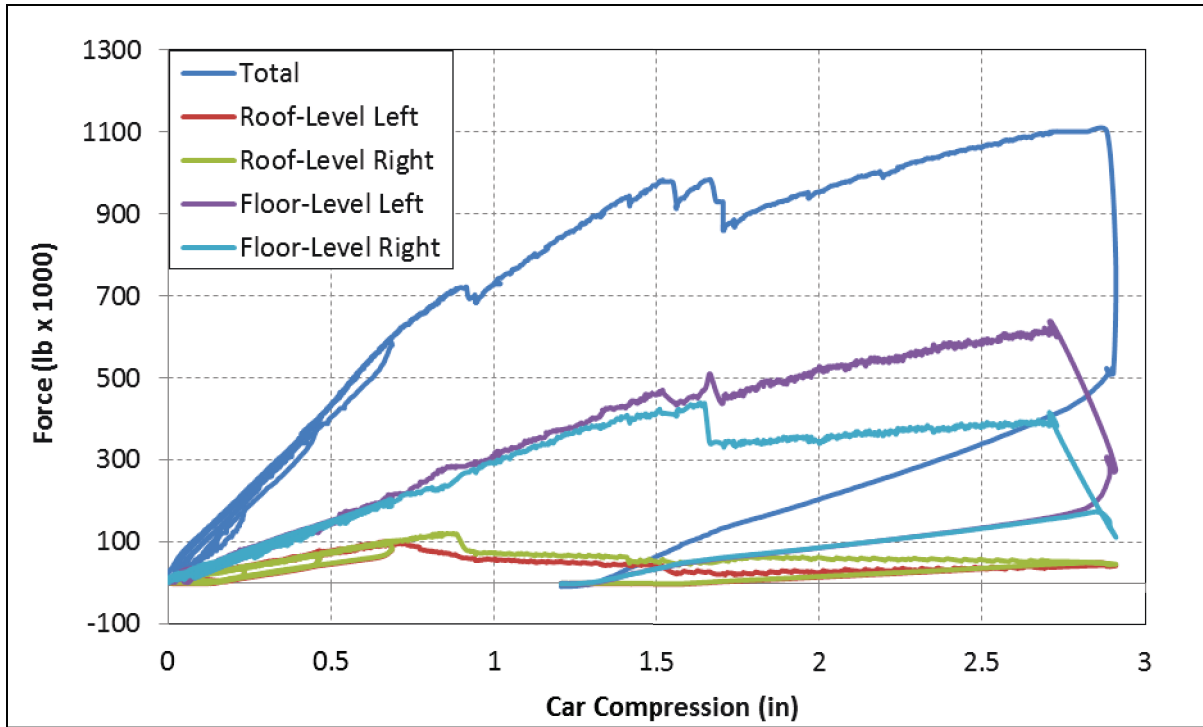
Figure 38. Crippling Load Test – Load Deflection Curves

Figure 37 and Figure 38 show load-deflection curves for the crippling test. Figures B7 through B23 in Appendix B depict more of the damage incurred by the car during the crippling load test.

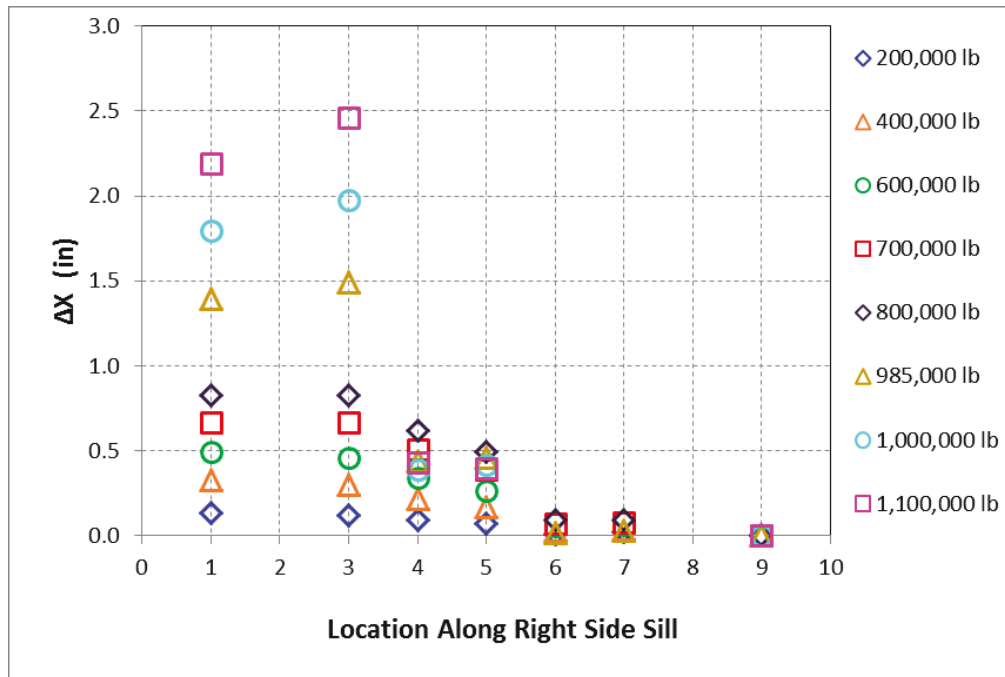
Figure 42. Crippling Load Test Right Side Sill Longitudinal Compression

Similarly, right side sill displacements at Sections 1 and 3 increased drastically at loads above 800,000 pounds, as seen in Figure 41. Displacements elsewhere on the side sill increased considerably less under the same loads, suggesting there was buckling between Sections 3 and 4. Figure 33 shows the resulting buckle.

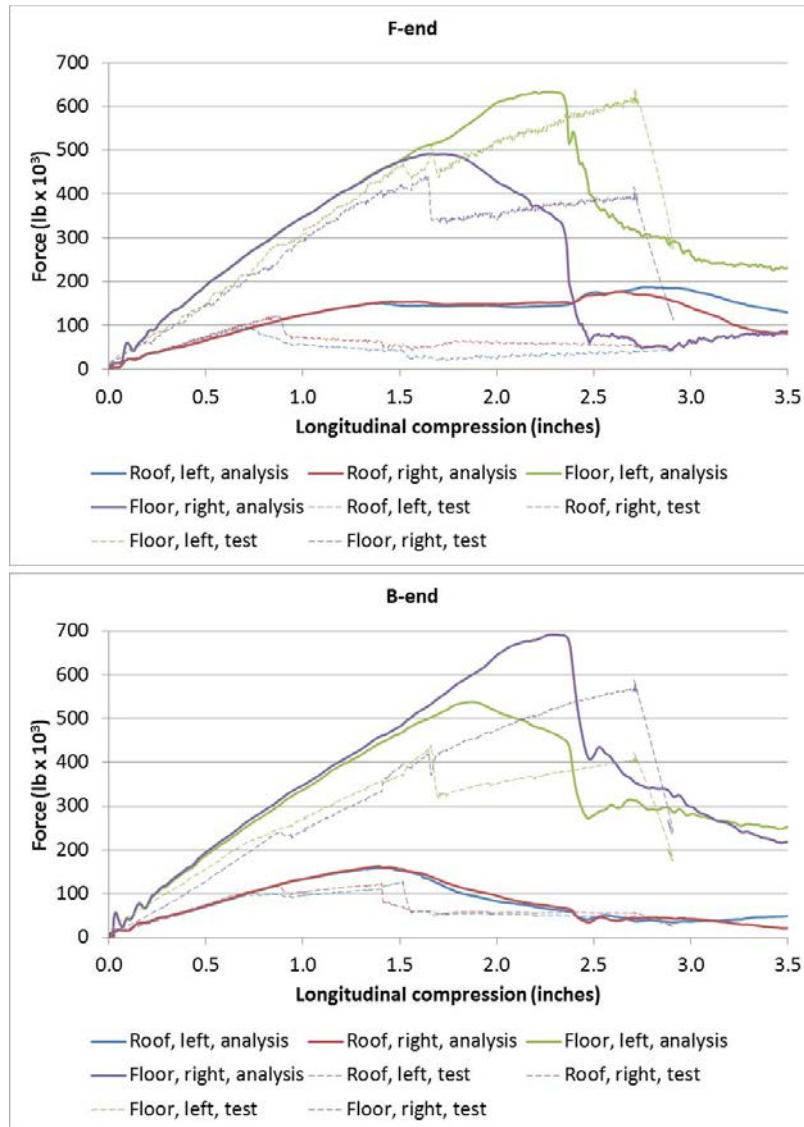
Figure 48. Force-Displacement Curves for the Crippling Analysis and Crippling Load Test Results at Roof and Floor, Left and Right

By comparing the crippling load analysis results (solid lines) to the crippling load test results (dashed lines), Figure 47 shows that reasonable correlation was achieved up to the first failure point (in the roof at about 0.8-inch displacement). During this phase, the analysis generally overstates the stiffness of the car floor; whereas, at roof level, the analysis and the crippling load test results match very closely.

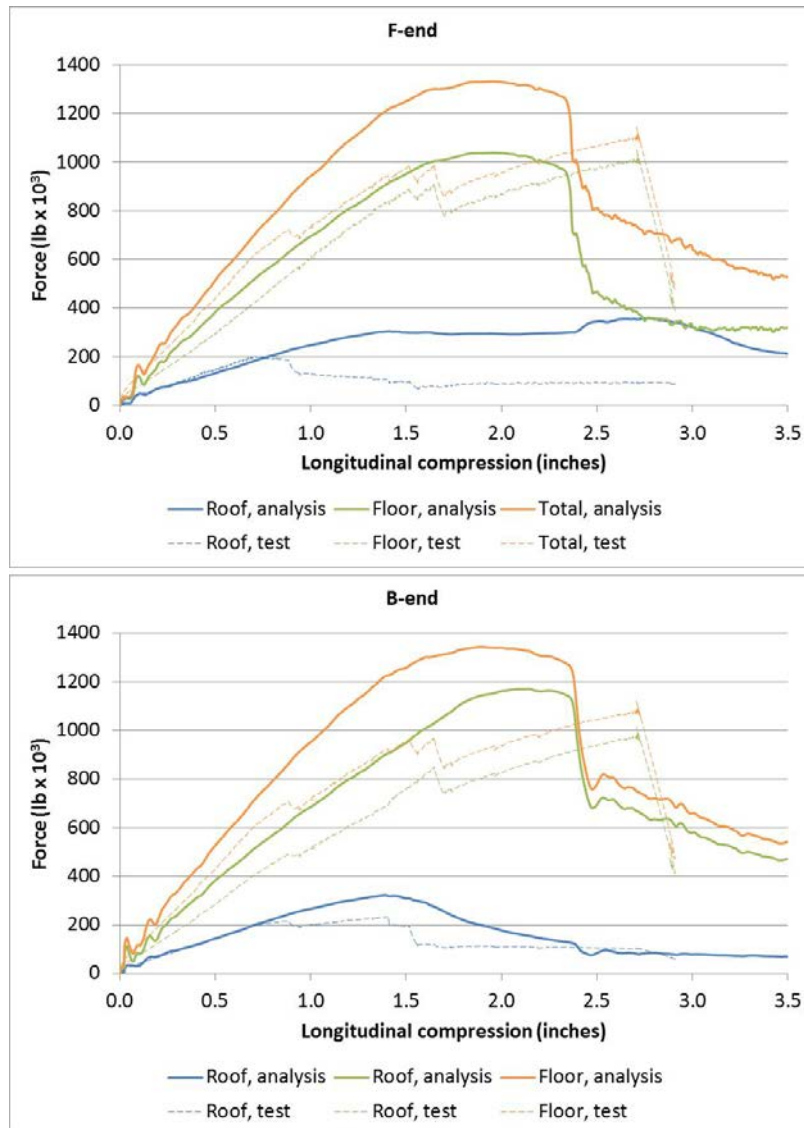
Figure 49. Force-displacement for the Crippling Load Analysis and Test Results at Roof and Floor, and for Total Overall Load

Figure 48 shows that there is a marked difference in the resulting overall strength of the railcars in the test and the analysis. The physical railcar lost a large percentage of the resistance from each component as it failed, while the simulated railcar tended to have a more gradual decline in resistance. As a result, each local buckle had a much larger impact on the overall resistance of the physical railcar than the simulated railcar, and the prediction for overall maximum load was around 21 percent larger than that recorded in the crippling load test.

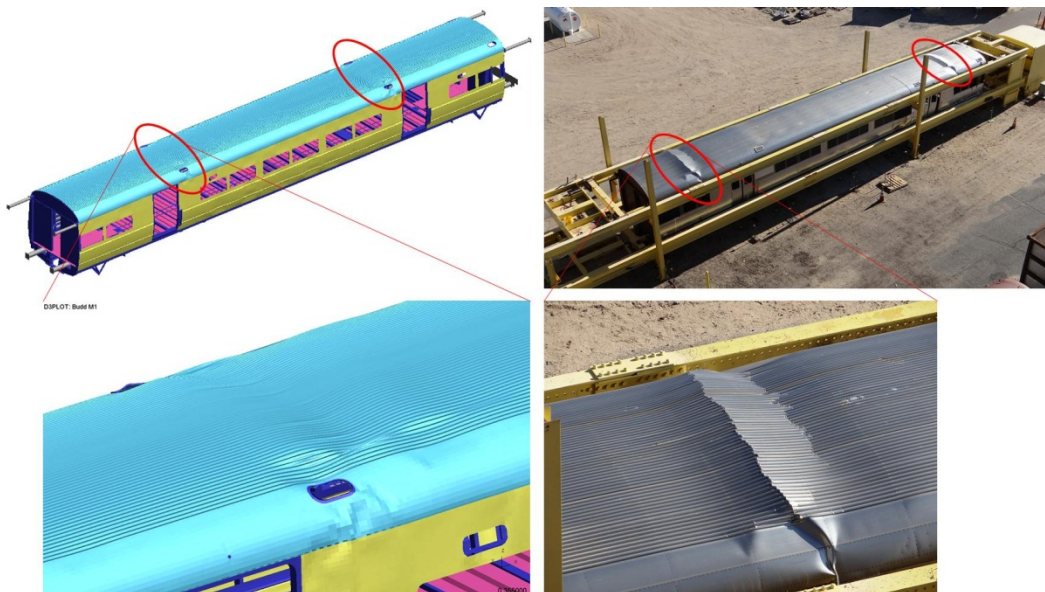
Figure 50. Roof Failure in the Simulated and Physical Railcars

Figure 49 shows the predicted and actual locations of the roof buckling failures. The simulation predicted that the roof would fail just inboard of the doorways (locations A1 and A5 in Figure 46). This is a location which would have an abrupt change in stiffness due to the reinforcement around the doorway, and reduced strength because of the vents penetrating the roof structure.

In the crippling load test, the failure occurred outboard of the doors (locations P1a and P1b in Figure 46). The difference in the location is may be due to additional structural elements (longitudinal stringers and duct work) within the roof structure that were not in the available drawings, but were revealed during asbestos abatement when some of the ceiling panels were removed. The additional structures may have prevented the buckling deformation of the roof that was predicted by the analysis. Instead, the buckling occurred in an unstiffened area that was outboard of the doors.

There was also a difference in the nature of the failure in the analysis and the test. The failure was ductile in the analysis, with the wave-like deformations increasing gradually without significant loss of resistance. The physical crippling test, by contrast, showed a sudden failure of the roof as the corrugations folded abruptly with significant loss of resistance.

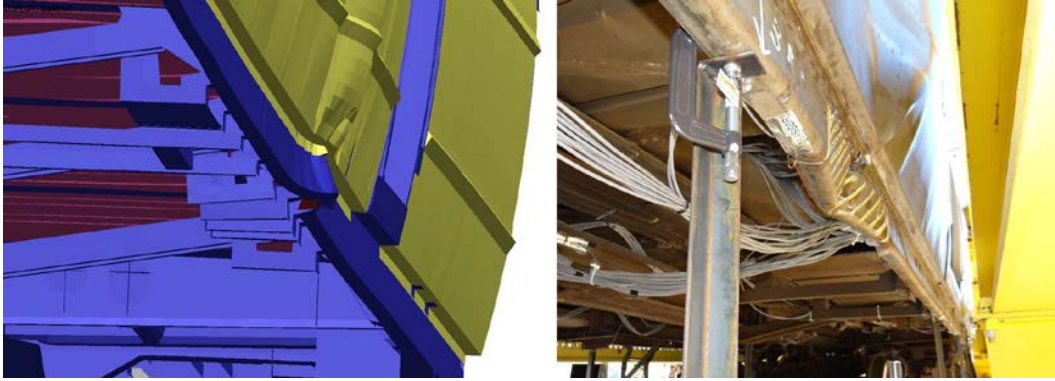
Figure 51. Buckling at the Repair Location in the Crippling Load Analysis (left) and Test (right)

Figure 50 shows that in the crippling load test and the analysis, the side sill underwent buckling at the repaired location (locations A2b and P2b).

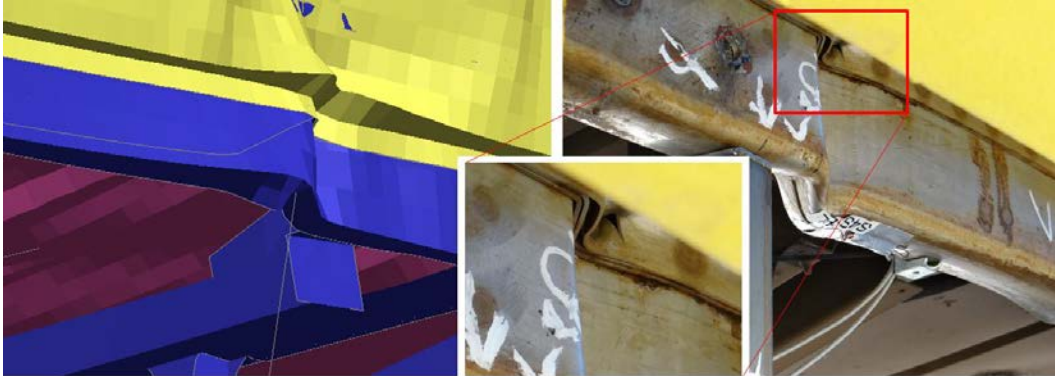
Figure 52. Similar Side Sill Buckles in the Crippling Load Analysis (left) and Test (right)

In the test, the side sill also buckled on the opposite side of the repair, in the same longitudinal location (P3a in Figure). This buckle included a folding of the side sill in conjunction with delamination of the layered components and tearing at a spot weld.

In the diagonally opposite location, the analysis model underwent a similar failure (A4 in Figure). The side sill folded in the same way and delamination started to occur. However, because the spot weld definitions in the analysis did not include failure, the tearing was not simulated and the delamination was limited. Figure 51 compares these buckles on the model and the physical railcar.

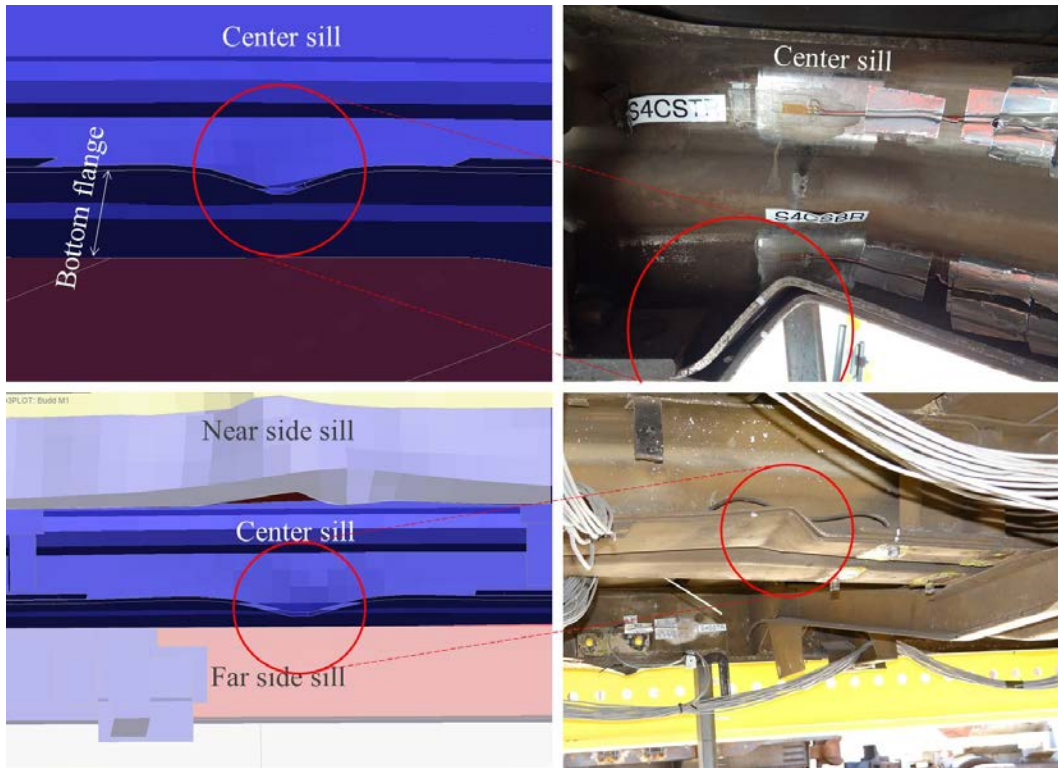
Figure 53. Comparison of Buckles in the Center Sill (top — A3, P3b)

This same phenomenon occurred in other locations on the side sills and center sill. In the analysis, ductile failure occurred as the buckles gradually increased in magnitude. During the crippling load test, the failure was more sudden and the tearing of the parent material near spot welds may have been a factor in this. Figure 52 shows two examples.

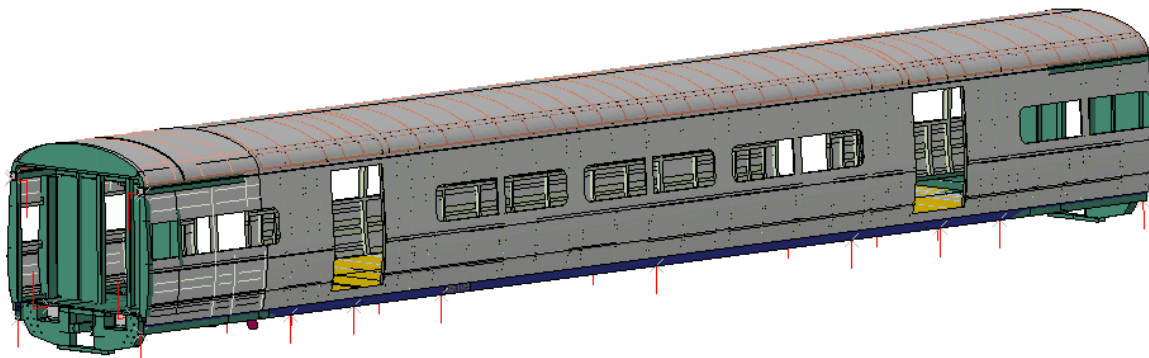
Figure 54. Volpe FE Model of M1 Passenger Car

Volpe's FE model is shown in Figure 53. This model is based on a half-symmetric FE model of a CEM-equipped Budd M-1 car used in the CEM train-to-train test [3]. That model featured a highly-refined representation of the crush zone at the F-end of the car with a more coarsely-meshed occupant volume. To make the previous model a better fit for current occupant volume integrity research, Volpe removed the CEM elements from the ends of the model, replaced many beam elements throughout the occupant volume with shell element representations of the structural members, and modeled the left- and right-sides of the car. The final FE model featured approximately 750,000 nodes and approximately 760,000 elements.

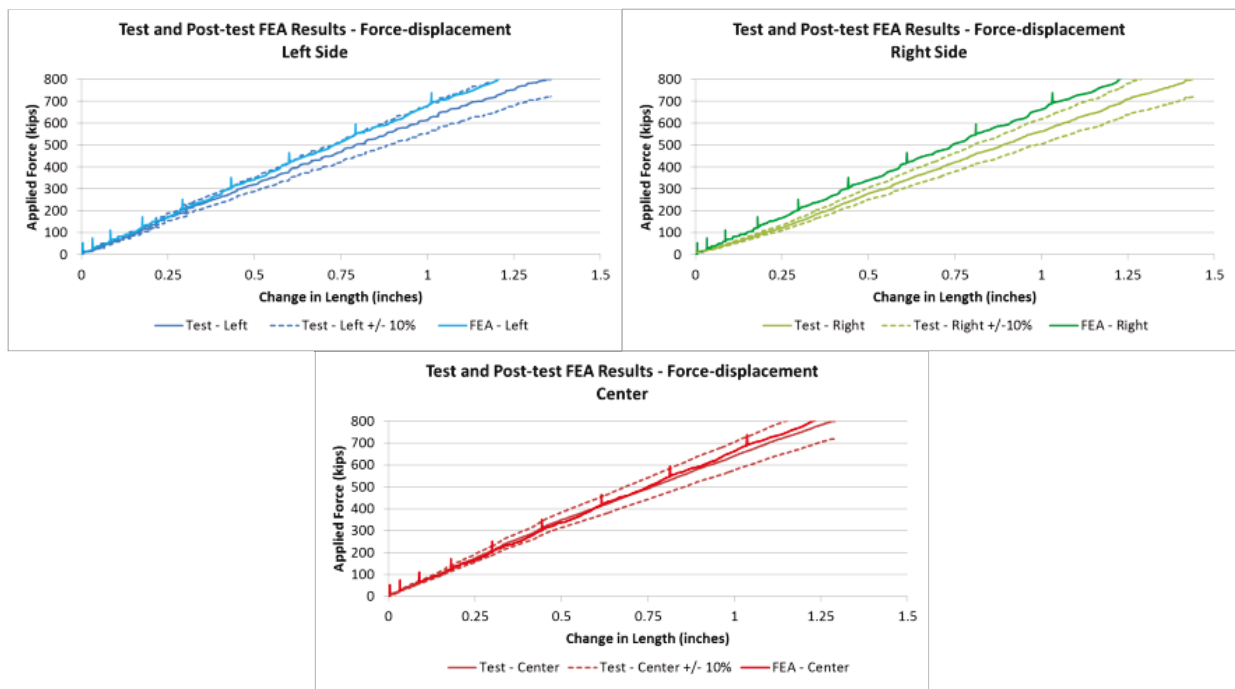
Figure 55. 800,000-pound Test and Volpe FE Force-displacement Results

To determine the overall shortening of the M1 car during the 800,000-lb test, the rigid body displacement associated with lengthening of the test frame must first be subtracted from the live end displacements. As shown in Figure 15, longitudinal string potentiometers were installed between the car and the ground at the left, center, and right side of both the F-end (Cross-Section 1) and the B-end of the car (Cross-Section 9). The differences between the F-end and B-end measurements were calculated for both test and FE model using the displacements at these locations. Figure 54 shows the force-displacement behavior from both the test and the FEA on the left side sill, center, and right side sill. These figures also feature a $\pm 10\%$ envelope on the test measurements. This envelope is consistent with the ETF's criteria for demonstrating model validation.

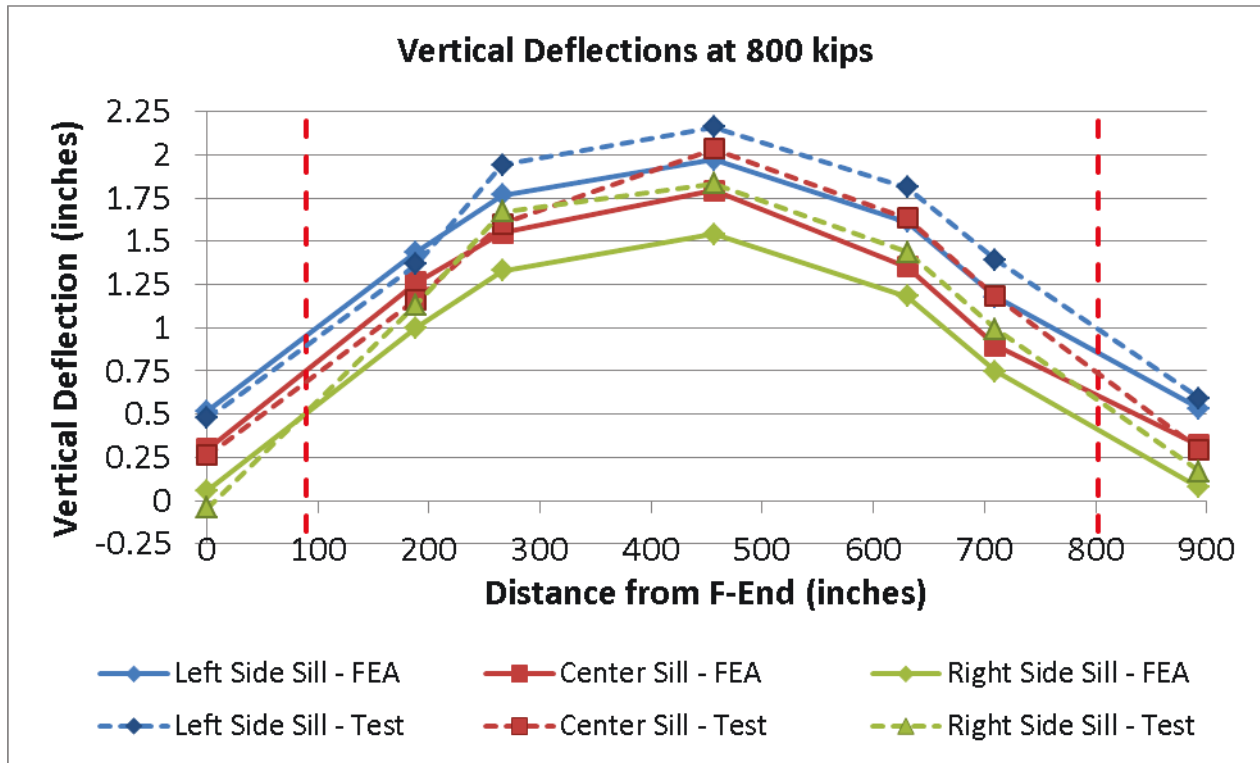
Figure 56. 800,000-pound test and Volpe FE Vertical Displacement Results

The second global behavior that Volpe compared with the FEA was the vertical deflection of the carbody. After examining the results of the 800,000-lb test, it appeared the carbody exhibited a tendency to roll during the test. At the center of the car, the left side of the carbody lifted up more than either the center or the right side. An attempt was made to replicate this behavior in the post-test FE model by applying vertical and longitudinal displacement of the loading plates (see Appendix J for a description of the loading conditions in the 800,000-lb simulation). Figure 55 shows the vertical displacement profiles of the car on the left side sill, center sill, and right side sill for both the test and the model under an axial load of 800,000 pounds. The horizontal axis represents distance from the F-end of the car (Cross-Section 1).

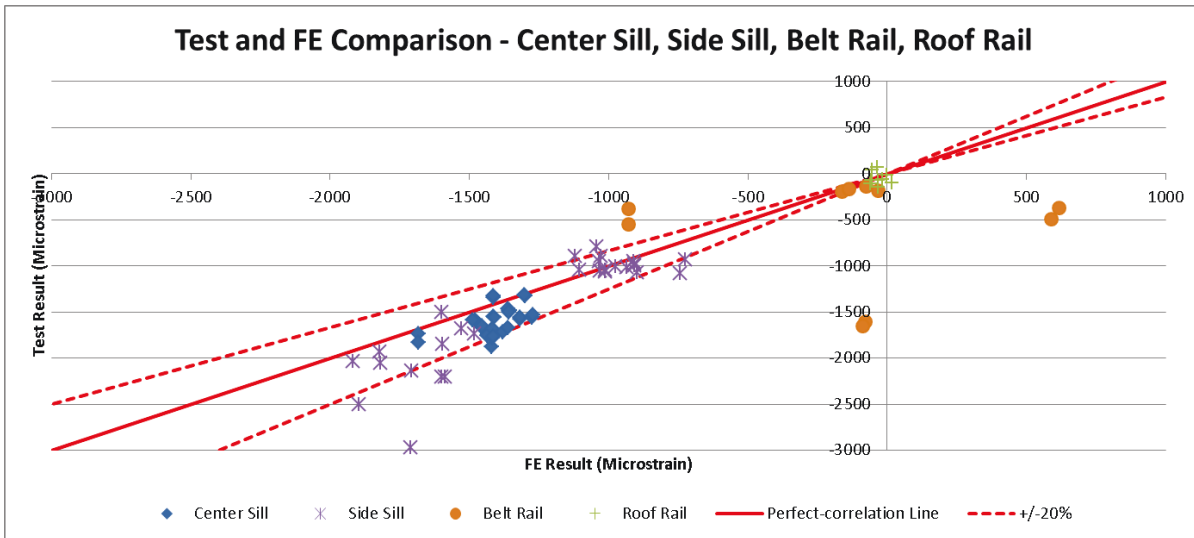
Figure 57. 800,000-pound test and Volpe FE Strain Comparison

Figure 56 features a cross-plot of the strains measured in the test (vertical axis) with the strains calculated at the corresponding locations in the FE model (horizontal axis). This type of plot provides an overall indication of the quality of the correlation between the test and Volpe's post-test FE model. The perfect-correlation line, shown in this figure as a solid line, has a slope of 1. This line indicates the condition where the strain measurement from the test is exactly equal to the strain calculated by the FE model. Additionally, two dashed lines are shown, indicating a $\pm 20\%$ envelope on this perfect-correlation line. This $\pm 20\%$ envelope is consistent with the target correlation value provided by the ETF [2].

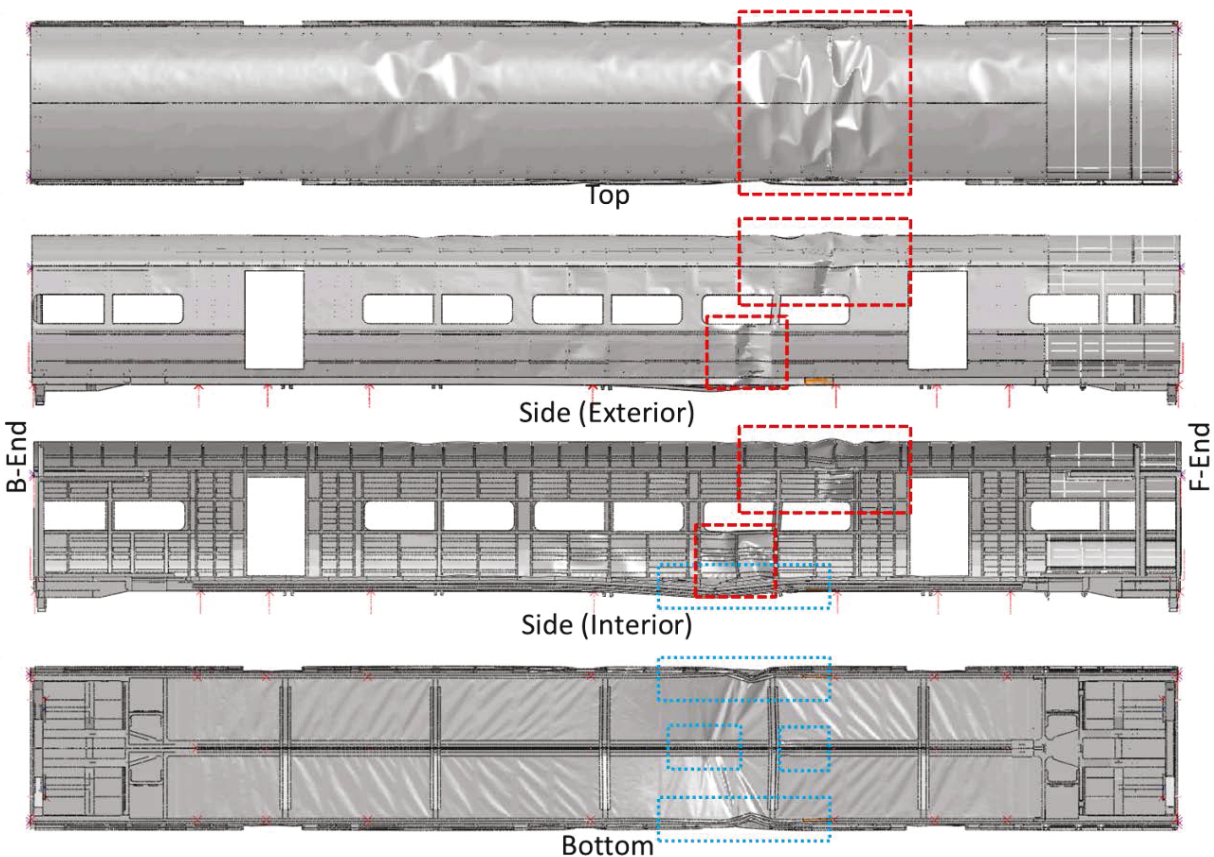
Figure 58. Crippling Load Damage in Volpe FE Model

Figure 57 shows a top, side (exterior and interior), and bottom view of Volpe’s FE model in its post-crippling condition. Damage to the roof, sidewall, and underframe (center and side sills) is highlighted in this figure. For comparison, damage to the tested M1 car is mapped out in the bottom half of Figure 46.
