**Federal Railroad
Administration**

Measurement of Wheel Load Environment of AAR M-976 Approved Truck

9. SPONSORING/MONITORING AGENCY NAME(S) AND ADDRESS(ES) U.S. Department of Transportation Federal Railroad Administration Office of Research, Development, and Technology 1200 New Jersey Avenue, SE Washington, DC 20590			10. SPONSORING/MONITORING AGENCY REPORT NUMBER DOT/FRA/ORD-17/22

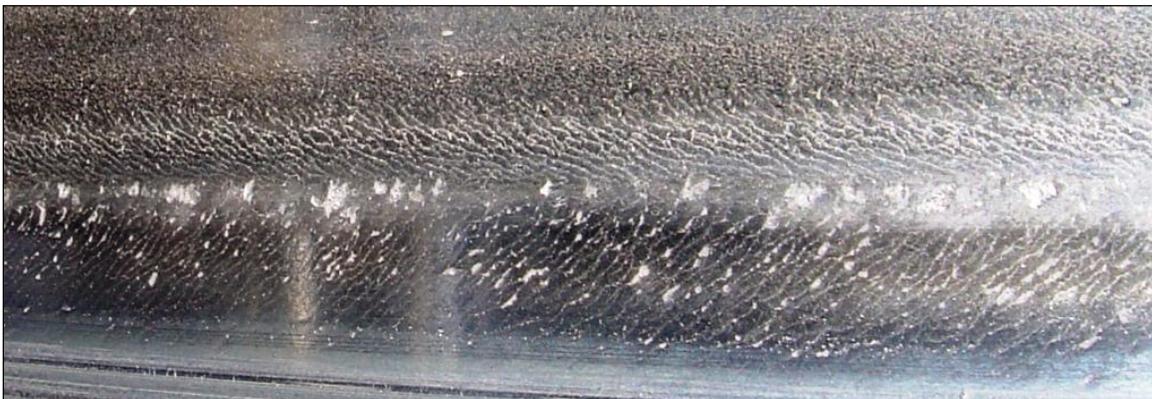
Figure 1. Wheel Tread Surface with RCF Cracks

Shelling is a fatigue-based process and one mechanism by which large voids can be left in the running surface of a wheel. Many cycles of high stress create surface cracks in the wheel tread through the process of RCF. Frequently, bands of these cracks will form on the wheel tread surface. Figure 1 shows a wheel with a band of RCF cracks. As the cracks propagate and grow, they can connect and dislodge a patch of wheel tread, creating a void in the process.

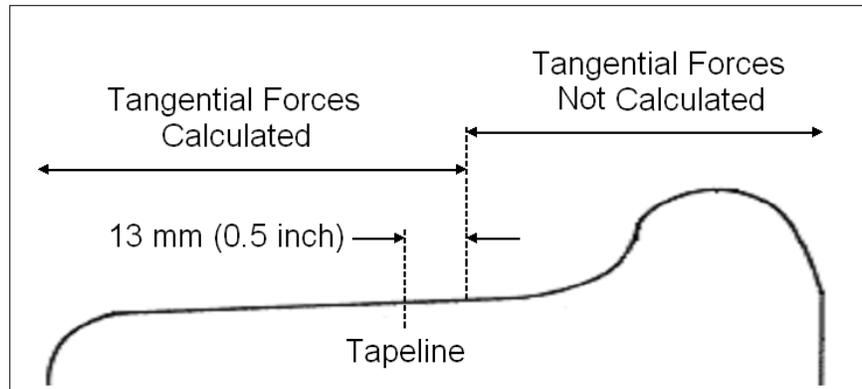
Figure 2. Wheel Profile Showing Contact Zone Considered in the Analysis

From the available IWS measurements, the tangential force was calculated whenever the lateral contact position was no more than 0.5 inch inboard from the tapeline, effectively excluding any less accurate tangential force calculations because of wheel flange contact with the rail. Figure 2 shows the contact positions considered in the analysis. The exclusion of tangential forces near the flange should be an acceptable simplification, based on the fact that RCF damage on wheels

is most intense outboard of the tapeline [4]. This simplification also means that all shakedown exceedances in curves described in this report are related to the low-rail wheel, because the contact patch of the high-rail wheel is located in the flange root where tangential forces are not calculated.

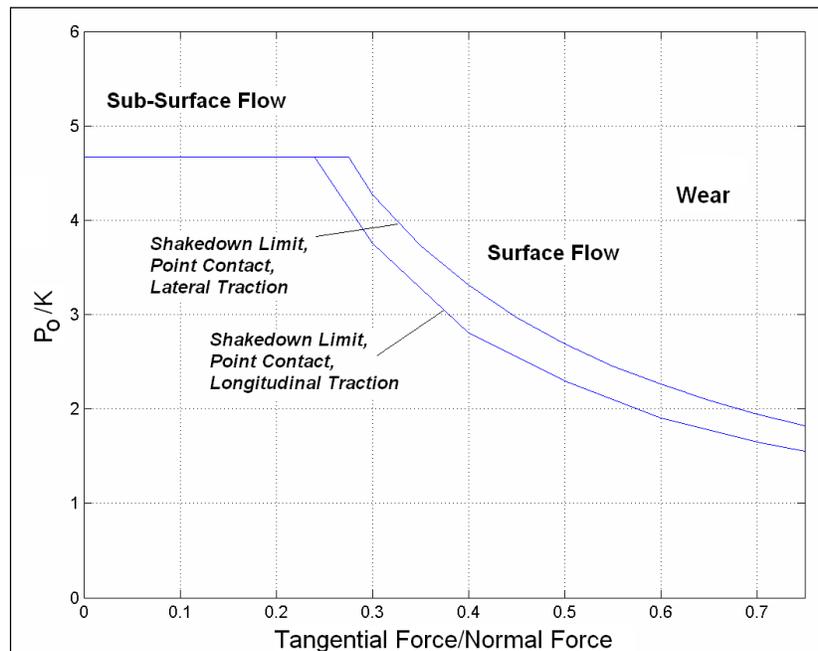
Figure 3. Shakedown Diagram

Figure 3 shows the shakedown diagram. The contact stress for the rolling contact (P_0) is divided by the material's shear yield stress (K) and plotted against the traction coefficient (ratio of tangential force (T) and normal force (N)). Traction coefficient values can range from zero to the wheel-rail coefficient of friction. The shakedown limit is the limit for continuous deformation under repeated loading. This limit is calculated to be slightly different, depending upon assumptions made regarding the contact conditions. The shakedown limits under full-slip conditions for pure lateral and pure longitudinal loading are plotted on the axes [5]. The exact location of the shakedown limit line is a subject of some debate. In fact, it may be more accurate to identify it as a shakedown limit zone, rather than a line. The area below this zone represents conditions when only elastic deformation is likely to take place. The area above this zone represents conditions where plastic deformation is likely to take place. Regions where the plastic deformation occurs below the surface or on the surface are labeled. Contact conditions far beyond shakedown may result in wear instead of RCF damage.

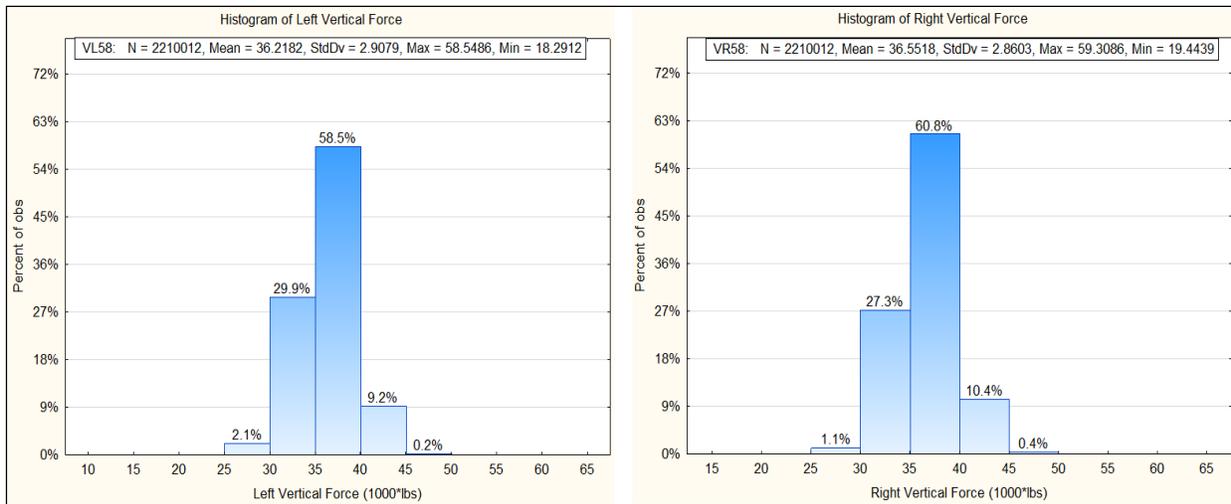
Figure 4. Histogram of Vertical Wheel-Rail Loads

The first loaded trip began May 25, 2013, at the mine and concluded May 29, 2013, at the power plant. A total of 1,325 miles of data were recorded with the car in the loaded condition between the mine and the power plant. Figures 4 through 6 contain histograms of the vertical, lateral, and longitudinal wheel-rail forces, respectively. Figure 7 contains a histogram of the train speed, and Figure 8 is a histogram of the left and right traction ratios.

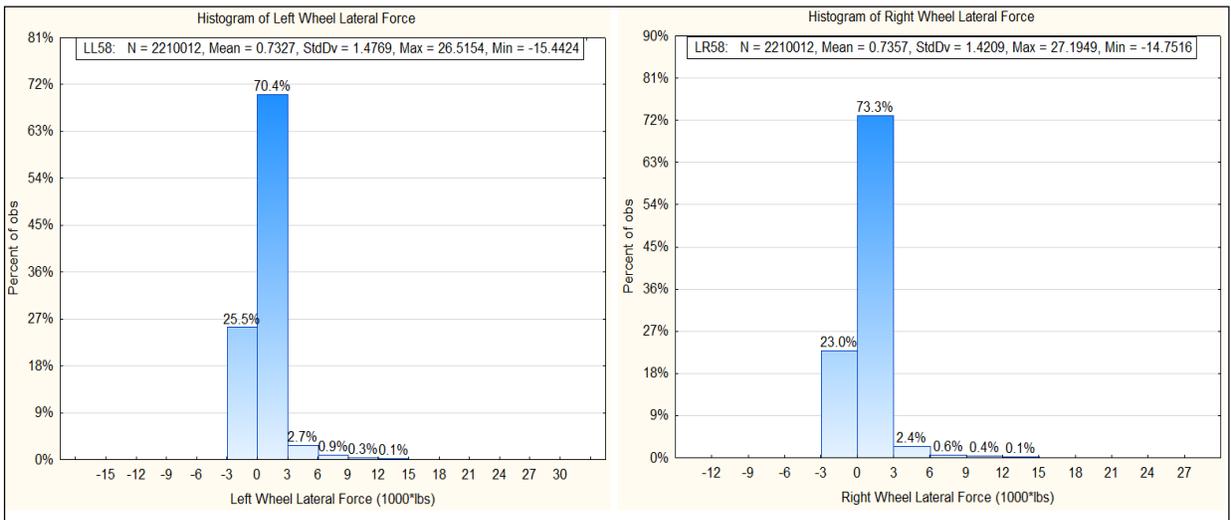
Figure 5. Histogram of Lateral Wheel-Rail Loads

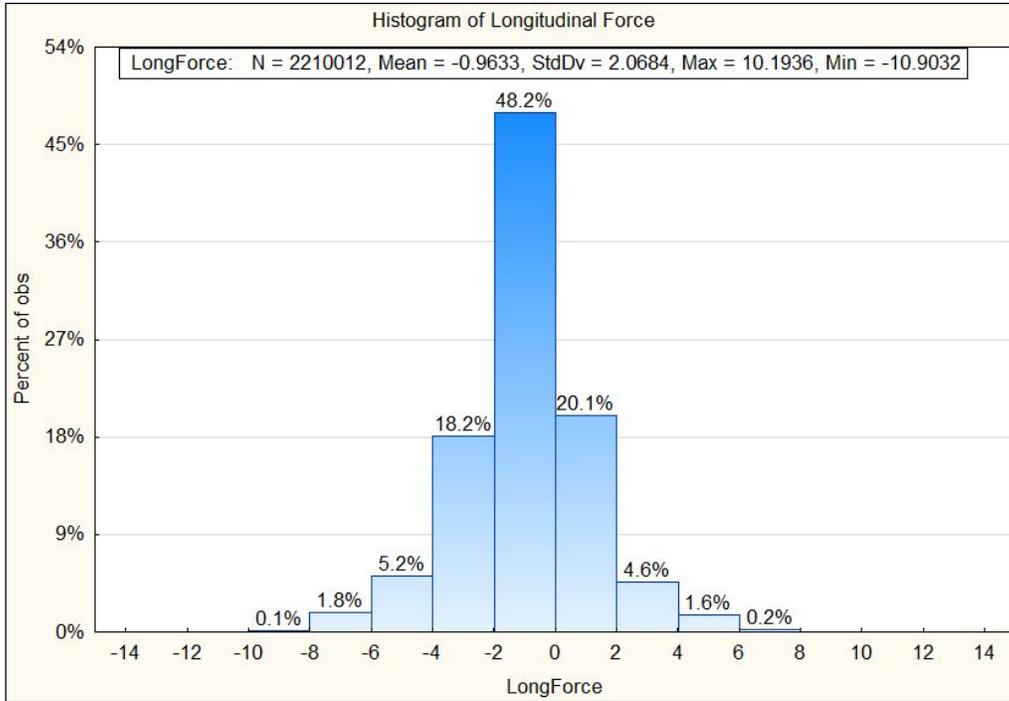
Figure 6. Histogram of Longitudinal Wheel-Rail Loads (1000*lb)

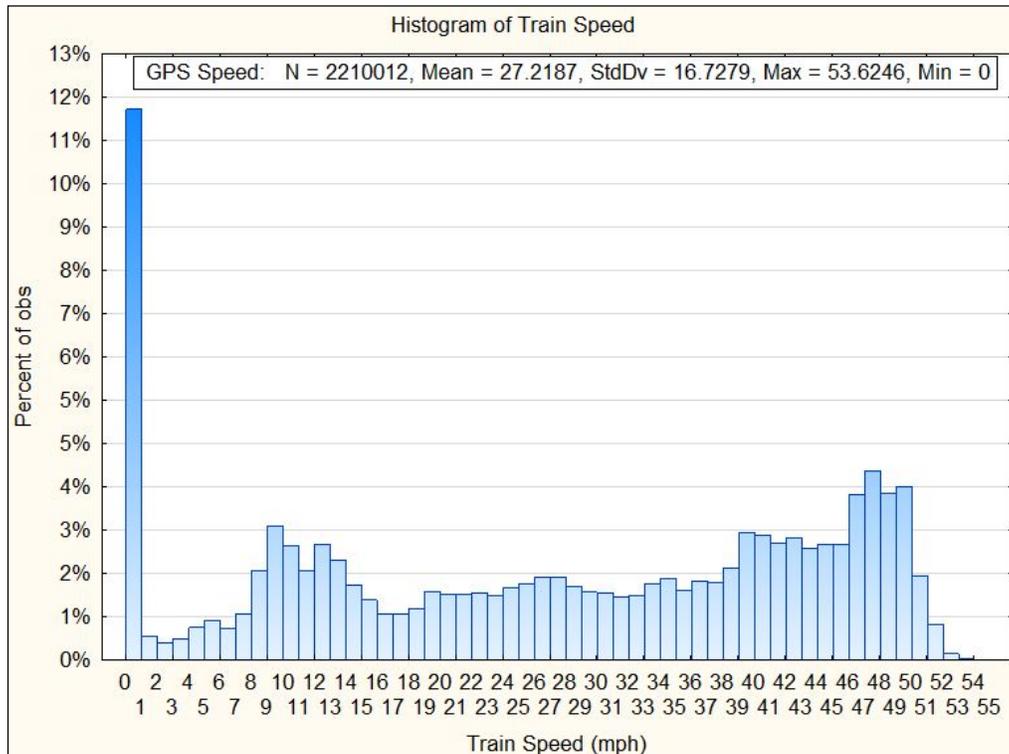
Figure 7. Histogram of Train Speed

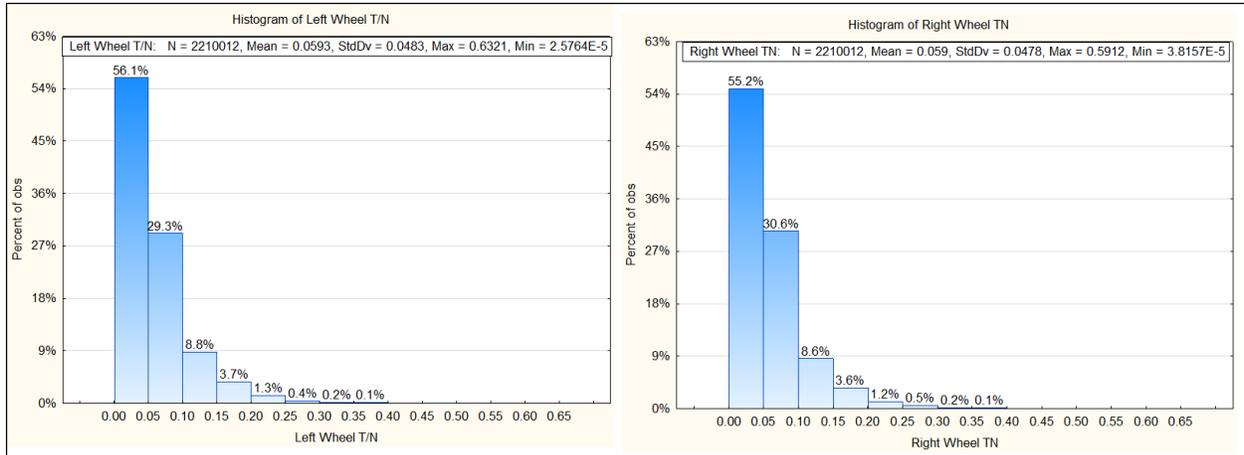
Figure 8. Histogram of Left and Right Traction Ratio

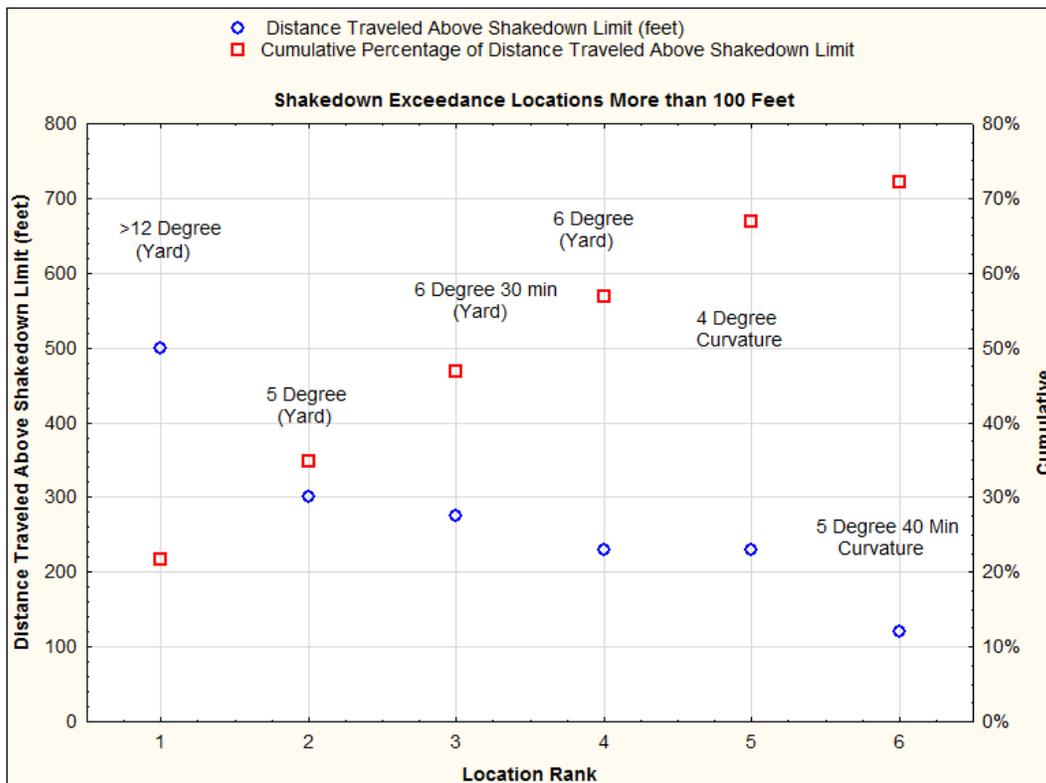
Figure 9. Distance Traveled per Top Shakedown Exceedance Location

Figure 9 shows the six specific track locations ranked in descending order by distance traveled above the shakedown limit and curvature information. The shakedown limit was exceeded at a total of 64 specific track locations. In the previous study, nonsteering trucks exceeded the shakedown limit at 157 specific locations.

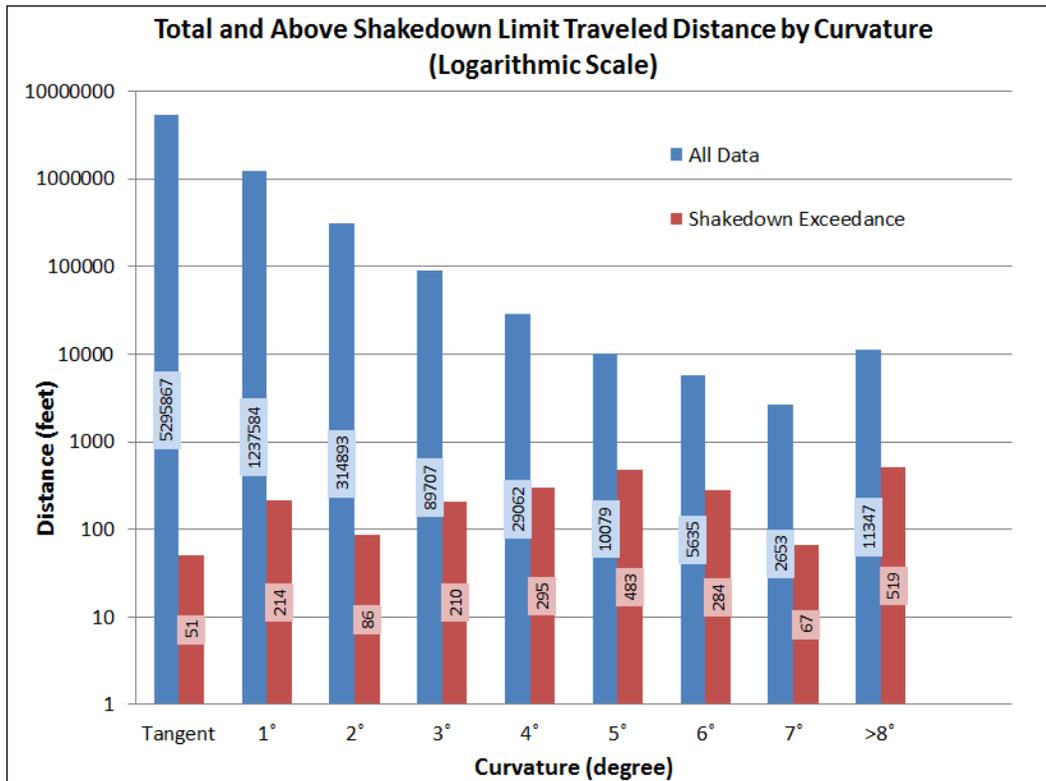
Figure 10. Distance Traveled by Track Curvature

Figure 10 shows the distance traveled at each curvature, as well as the distance traveled at that curvature exceeding the shakedown limit. While the route consists mainly of tangent track (75 percent of all trip) and shallow curves (total length of 4-degree and greater curvatures is about 1 percent of all trip), the majority of the distance traveled in excess of the shakedown limit occurred where the track curvature was 5 degrees or greater (60 percent of shakedown exceedance that occurred). In fact, 5-degree curves alone accounted for 21 percent of the total distance traveled above the shakedown limit. Figure 11 shows the percent of the total distance traveled at conditions exceeding the shakedown limit for each degree of curvature. Figure 12 shows the percent of distance traveled at each degree of curvature that exceeded the shakedown limit. Figure 12 shows that on 5-degree and tighter curves, approximately 5 percent of the distance traveled exceeds the shakedown limit. Note that some curvature information needed to

be calculated via GPS data due to unavailability of track charts; for example, in yards. While +/-1 degree calculation error bands are accounted for these cases, the 7-degree column may belong to one lower or higher category. In the previous study, non-steering trucks showed a significant RCF probability at 4 and greater degrees of curvatures. Also, non-steering trucks showed more than 20 percent shakedown exceedance probability, whereas the AAR M-976 truck showed approximately 5 percent.

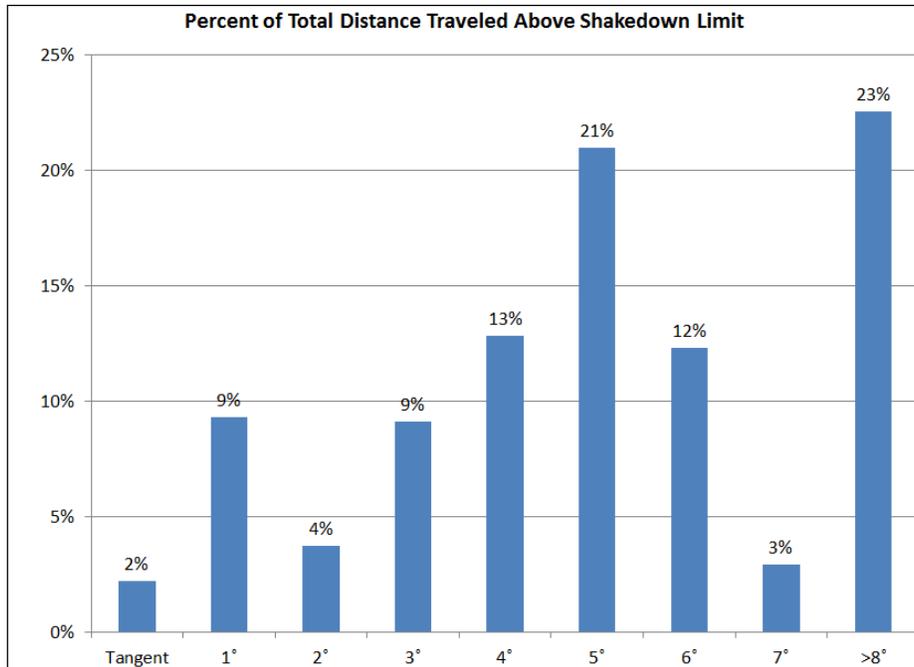
Figure 11. Relative Distribution of Track Curvature at Shakedown Exceedance Locations

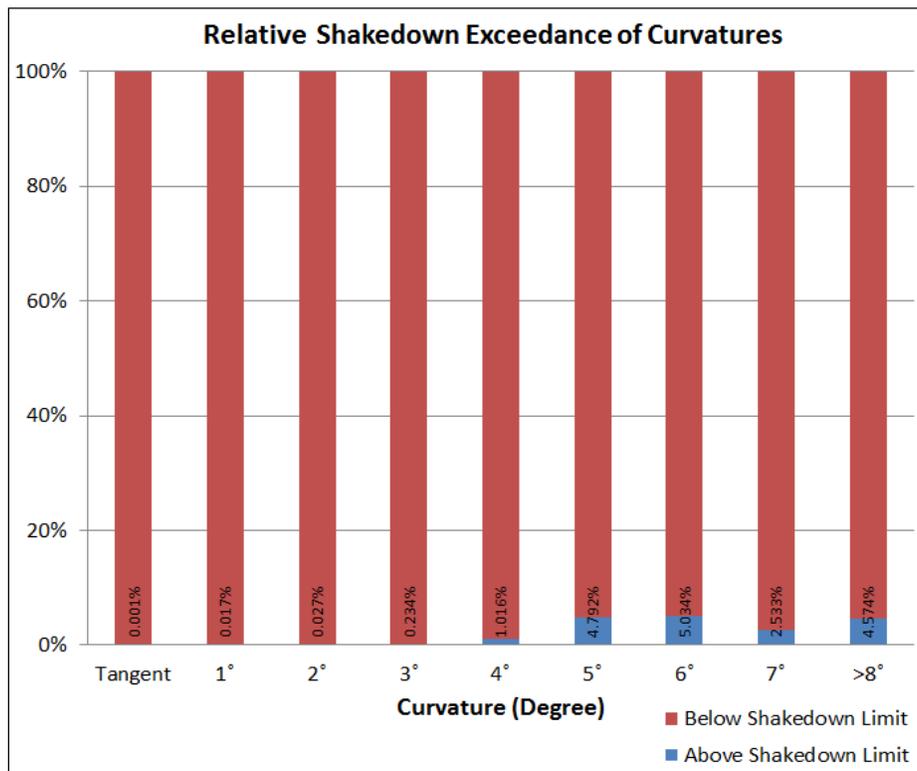
Figure 12. Percentage of Distance Traveled Above Shakedown Limit by Curvature

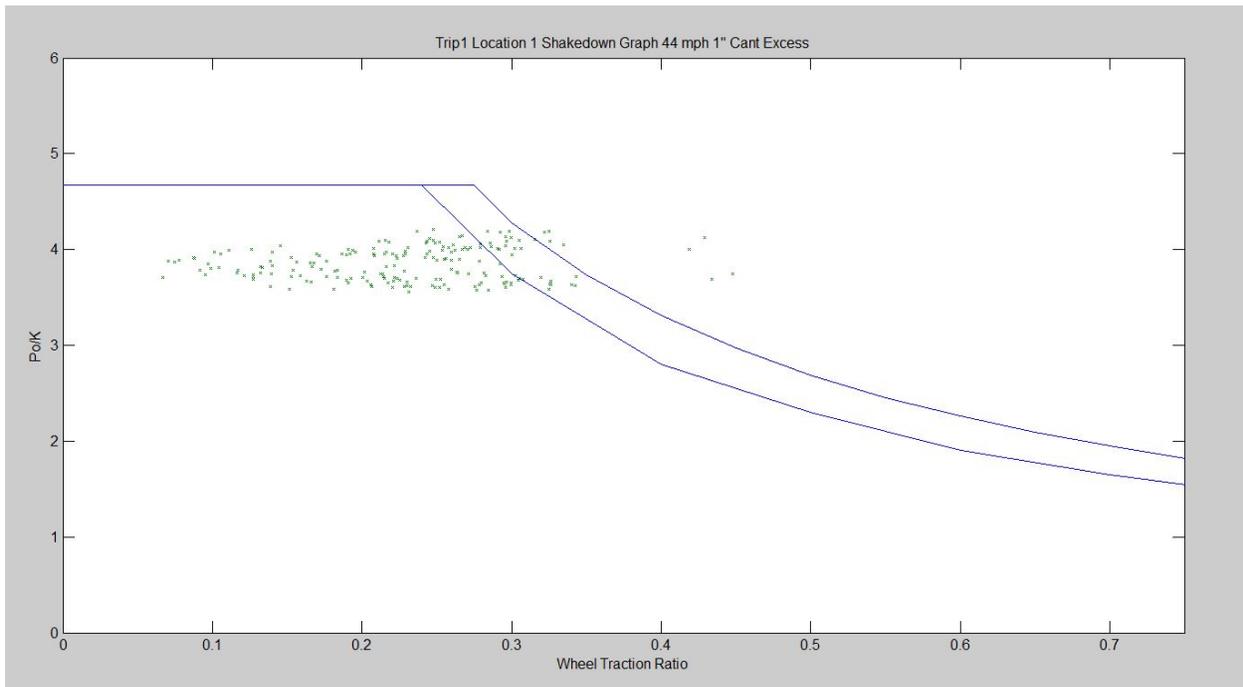
Figure 13. Shakedown Data at a 4-Degree-30-Minute Curve, Trip 1, 1-Inch Excess Cant

In Trip 1, the test car traveled through a 4-degree-30-minute curve with 4 inches superelevation and 35 mph balance speed at 44 mph (Figure 13). No RCF was predicted.

The data in the 4-degree-30-minute curve provides an example of the potential influence of train speed and track superelevation. Superelevating the outside rail in a curve is done to counteract some of the centripetal forces generated by the fastest train allowed on a particular curve. Many times, the fastest train on a curve will be a passenger train. Freight trains typically operate at lower speeds and thus do not need as much superelevation in curves to balance the smaller centripetal curving forces. Excess superelevation results in increased AOA and higher lateral wheel-rail forces. Larger AOA values produce higher tangential wheel-rail forces, which can produce conditions exceeding the shakedown limit and accumulate RCF damage.

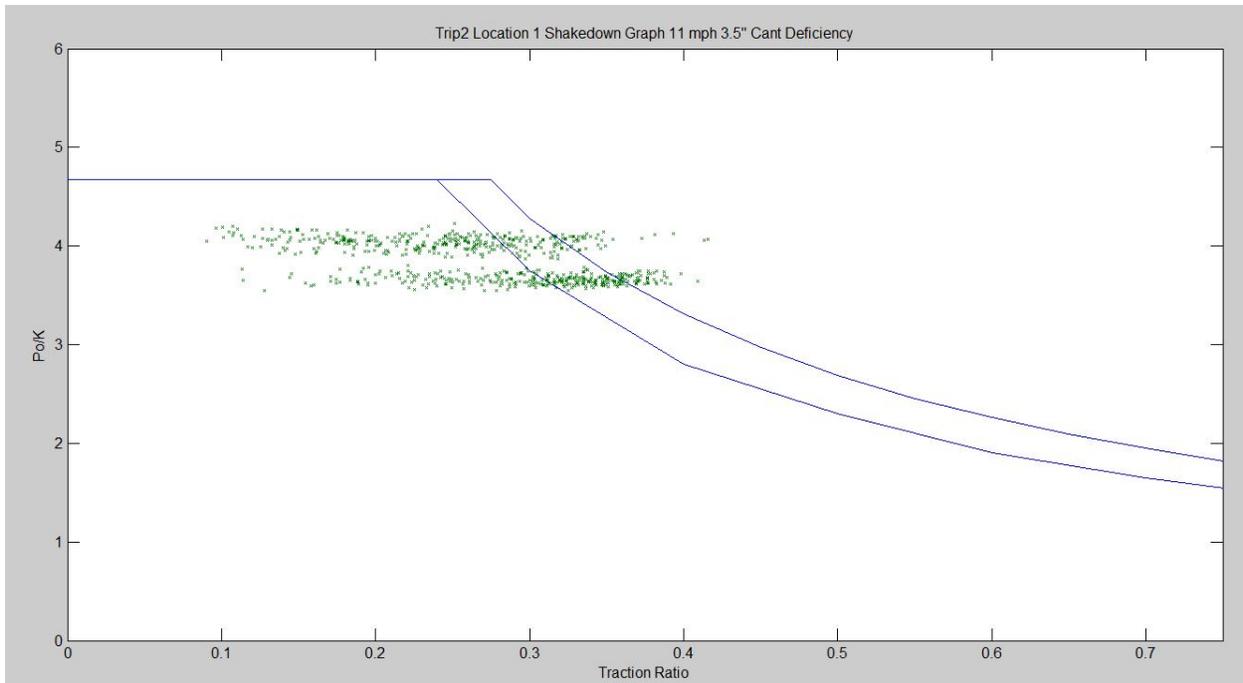
Figure 14. Shakedown Data at the Same 4-Degree-30-Minute Curve, Trip 2, 3.6 Inches Cant Deficiency

In Trip 2, the test car traveled through the same curve at 11 mph with 3.6 inches cant deficiency and the shakedown limit was exceeded (Figure 14). The Figure 14 shakedown plot shows greater exceedances than the one in Figure 13.
