Port Bienville Railroad

Hancock and Pearl River Counties, Mississippi

**DRAFT WETLANDS AND
THREATENED AND ENDANGERED SPECIES
REPORT**

December 2016

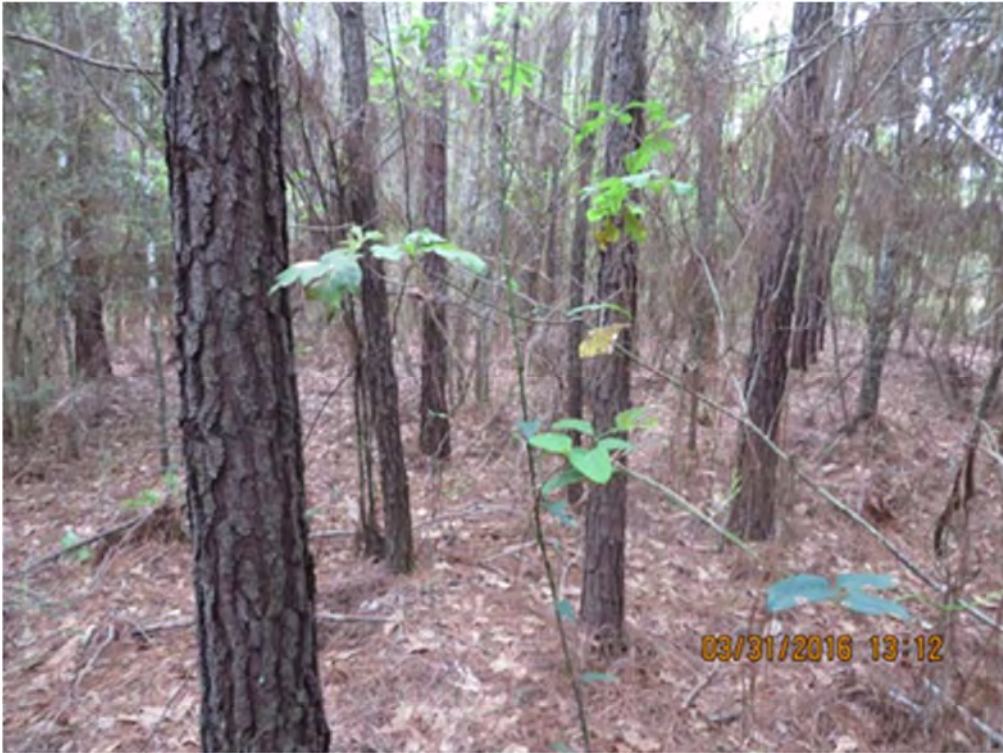
Photo 1 - Representative photo of upland pine plantation. Note the lack of hydrology and hydrophytic vegetation.

During the survey, these areas were identified among intermediate-aged and mature upland pine plantations. Dominant species observed during field surveys include loblolly pine saplings and gallberry, interspersed with broomsedge bluestem (*Andropogon virginicus*). Even after a rainfall of approximately 2 inches the day prior to the survey of these areas, no surface water or saturation was observed. This is due to the well-drained sandy soils identified during the survey, which are characteristic of upland areas.

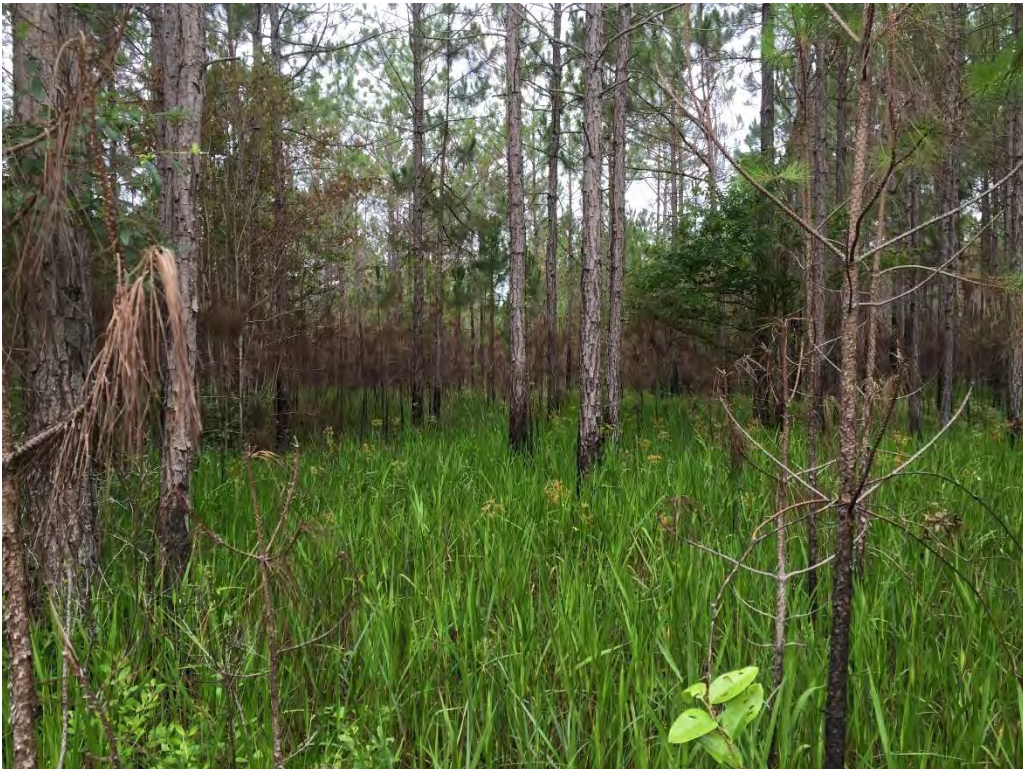
Photo 2 – Representative photo of Pine Savannah/Pine Flatwoods

Pine savannah/pine flatwoods is the most common habitat type found throughout the survey corridor. Many of these areas are maintained for silviculture and are constantly changing due to harvesting, planting or thinning. This habitat is essentially flat or rolling topography with a canopy of pines along with a well-developed subcanopy of several tall shrub or understory species. The soils are usually sandy with a high-water table.

Similar to the upland pine plantations observed, the pine flatwoods contain a variety of planted pine species with the majority being loblolly and slash pine. Longleaf pine may be present but has mostly been removed in favor of the faster growing previously mentioned species. This habitat was previously fire dependent but now is typically man-altered through the use of thinning, selective harvesting and/or ditching. In contrast to the upland pine plantation, here a clear herbaceous understory is present, and where not maintained, it is dominated by one or two species throughout. These were generally swamp titi (*Cyprilla racemiflora*) and fetterbush. Other species observed include inkberry (*Ilex glabra*), wax myrtle (*Morella cerifera*), sweetbay (*Magnolia virginiana*), and redbay (*Persea borbonia*). The groundcover contains a variety of panic grasses (*Panicum* spp.), blazing-stars (*Liatris* spp.), St. John's worts (*Hypericum* spp.), and broom sedges (*Andropogon* spp.). Some of the less-common but ecologically important herbs observed included pitcher plants (*Sarracenia* spp.), sundews (*Drosera* spp.), and club mosses (*Lycopodium* spp.).

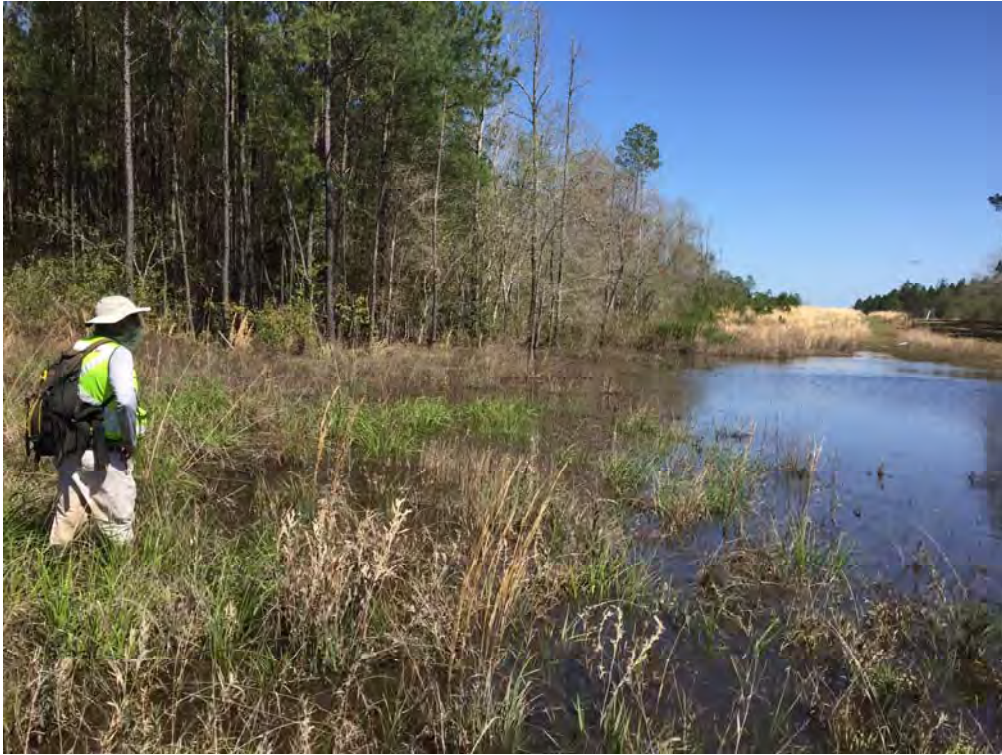
Photo 7 - Turtleskin Creek flooded out of its banks (March 2016)

In the days prior to the first field survey, Louisiana and parts of Southwest Mississippi experienced record rainfall and flooding with totals of over 26 inches of rain between March 8 and March 11, 2016.² The project survey corridor is situated within the Pearl River Basin. Due to flooding, the Pearl River experienced its second highest crest in history of 20.35 ft on March 14, 2016, the day fieldwork began.³ Flood stage for the Pearl River is 14 ft.⁴ The recent heavy rainfall and flood stage of the Pearl River caused flooding throughout the extent of the area and conditions may have been wetter than normal. During a second field visit for the southern alignment in June 2016 under normal conditions, portions of the proposed corridor were still heavily saturated or ponded with standing water varying between 3 to 12 inches.

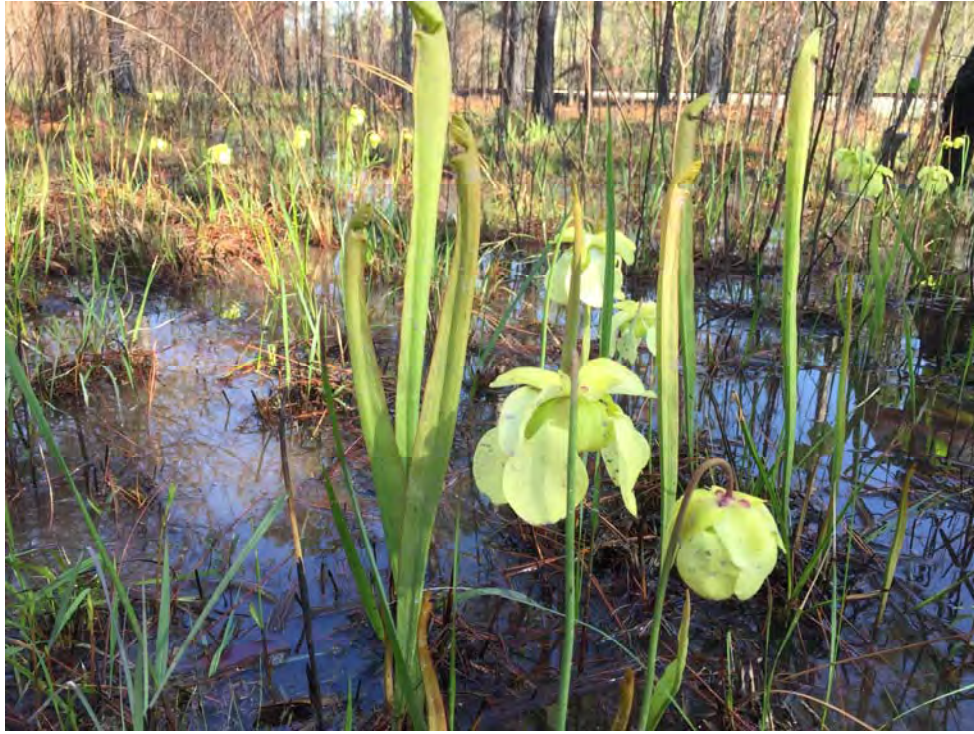
Photo 11 - Pitcher plants found within pine flatwoods
