Evaluation of the Degradation of Concrete Ties Using Machine Vision Technology on High-Speed Rail Corridors

1. AGENCY USE ONLY (Leave blank)		2. REPORT DATE July 2018	3. REPORT TYPE AND DATES COVERED Technical Report – 2011	
4. TITLE AND SUBTITLE Evaluation of the Degradation of Concrete Ties Using Machine Vision Technology on High-Speed Rail Corridors			5. FUNDING NUMBERS DTFR53-12-C-00003

6. AUTHOR(S) Herbert J. Henderson; Eric T. Sherrock				
7. PERFORMING ORGANIZATION NAME(S) AND ADDRESS(ES) ENSCO, Inc. 5400 Port Royal Road Springfield, VA 22151			8. PERFORMING ORGANIZATION REPORT NUMBER SERV-REPT-0000479 Rev B

9. SPONSORING/MONITORING AGENCY NAME(S) AND ADDRESS(ES) U.S. Department of Transportation Federal Railroad Administration Office of Railroad Policy and Development Office of Research, Development and Technology Washington, DC 20590			10. SPONSORING/MONITORING AGENCY REPORT NUMBER DOT/FRA/ORD-18/26

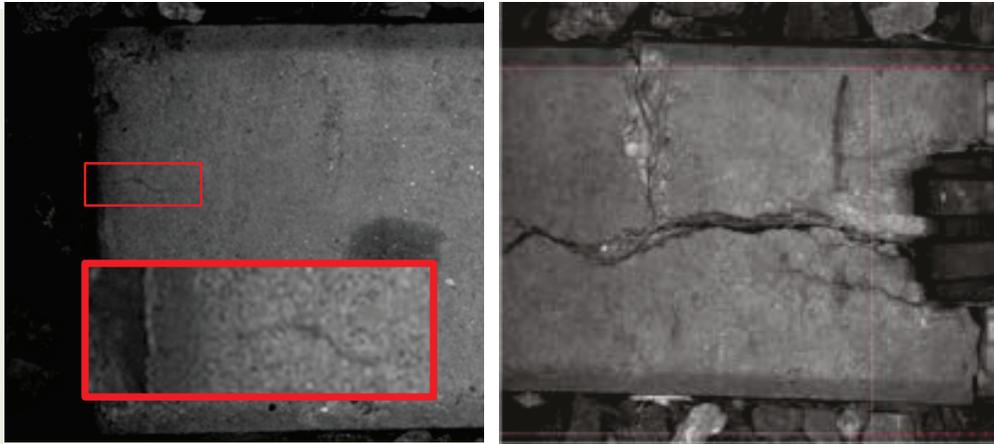
nonconformance (left side of Figure 1-1) to progress to a Grade 5 state (right side of Figure 1-1). Similarly, data needed to estimate the time required for a benign, early-stage crack (left side of Figure 1-1) to progress to a later-stage crack of concern (right side of Figure 1-1) is also not readily available.

Figure 1-1. Examples of Early and Late Stage Cracking on Two Concrete Ties

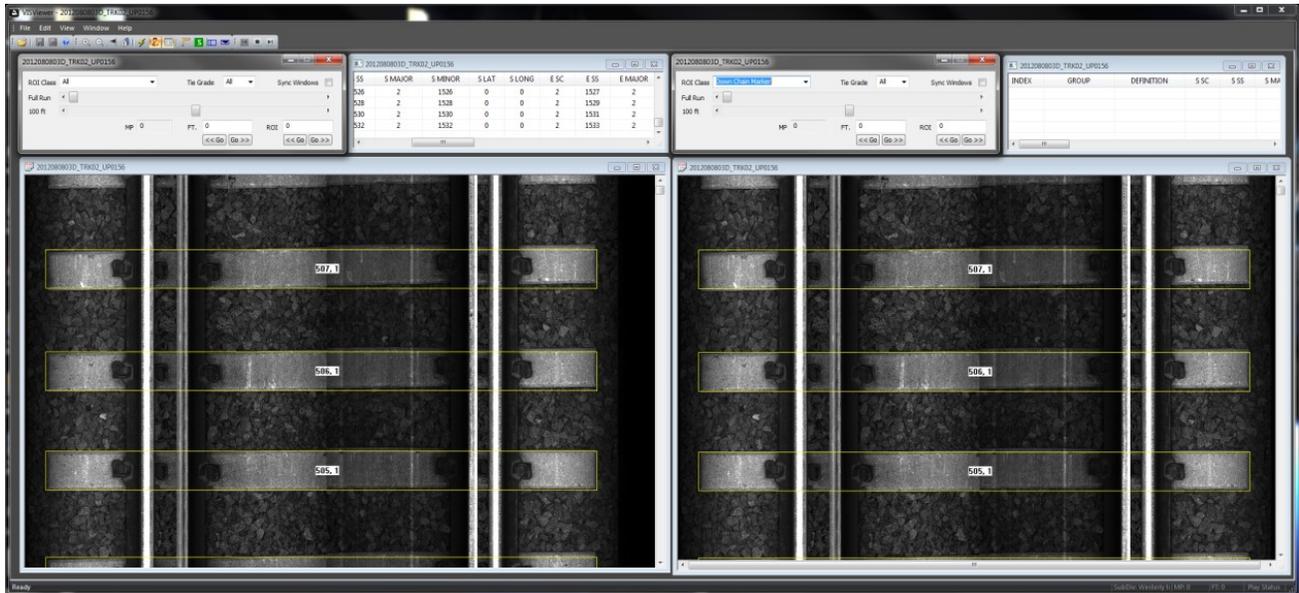
To assess crack growth rates, image files from consecutive surveys were aligned on a tie-by-tie basis. To facilitate the process of aligning track bed images, automatic tie detection software located each tie in the image sets for each survey and each detected tie was assigned a set of GPS coordinates that were recorded during the imaging process. Next, ties at the beginning and end of each mile of image data were aligned based on minimizing the distance between the assigned GPS coordinates. This approach typically resulted in ± 20 feet of registration error. Finally, optimal tie-to-tie registration was achieved by manually aligning the starting and ending points for each one-mile section of track. Manual alignments were made using a side-by-side track bed viewing application, as shown in Figure 2-2.

Figure 2-2. Track Bed Viewing Software Configured for Side-By-Side Track Bed Viewing

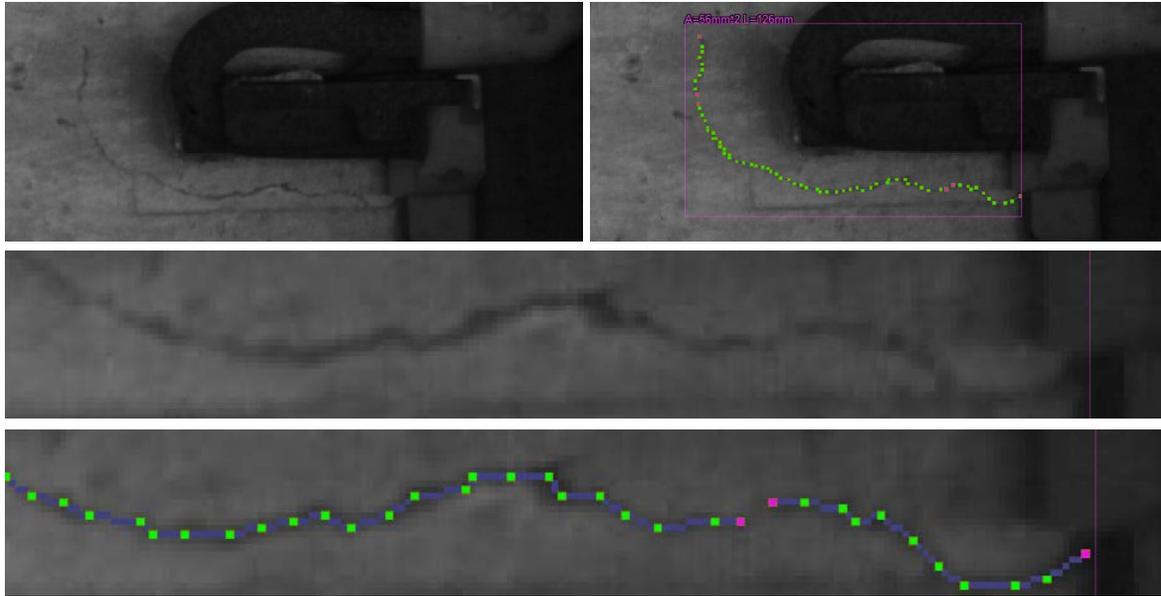
Next, the area of each crack was computed automatically by counting the number of pixels enclosed within (or along) an annotation and multiplying this total by the nominal area of a single pixel.

Figure 2-3. Example of an Annotated “Thin” Crack (Width Less Than or Equal to 5 Pixels)

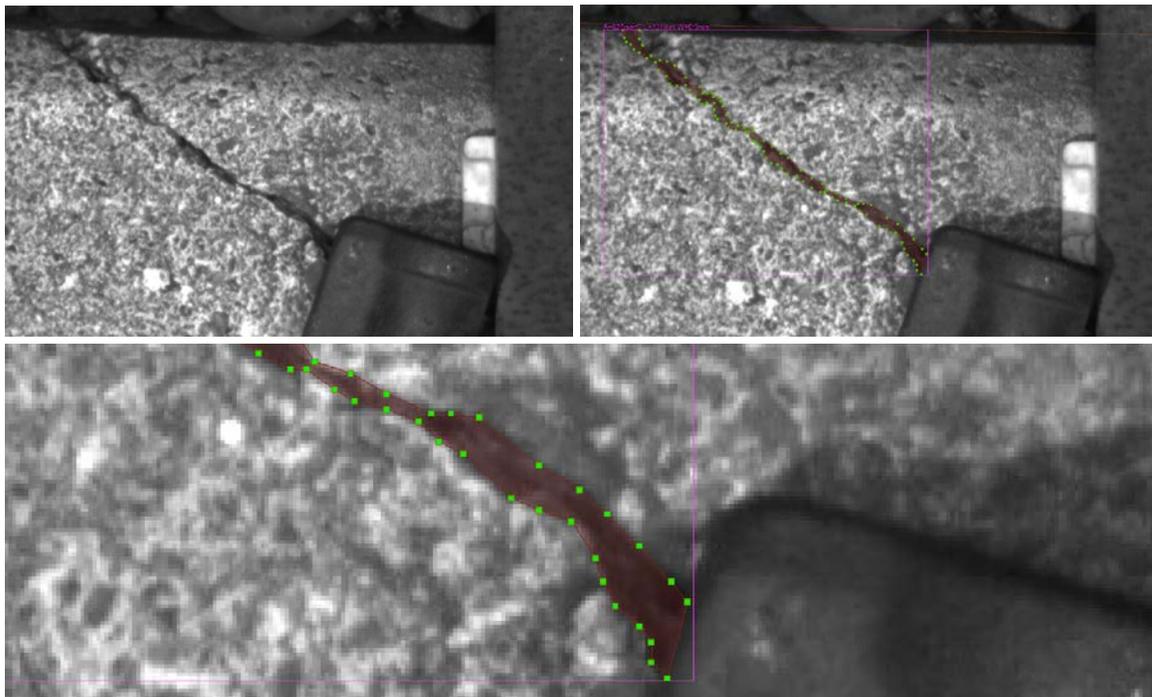
Figure 2-4. Example of an Annotated “Thick” Crack (Width Greater Than 5 Pixels)

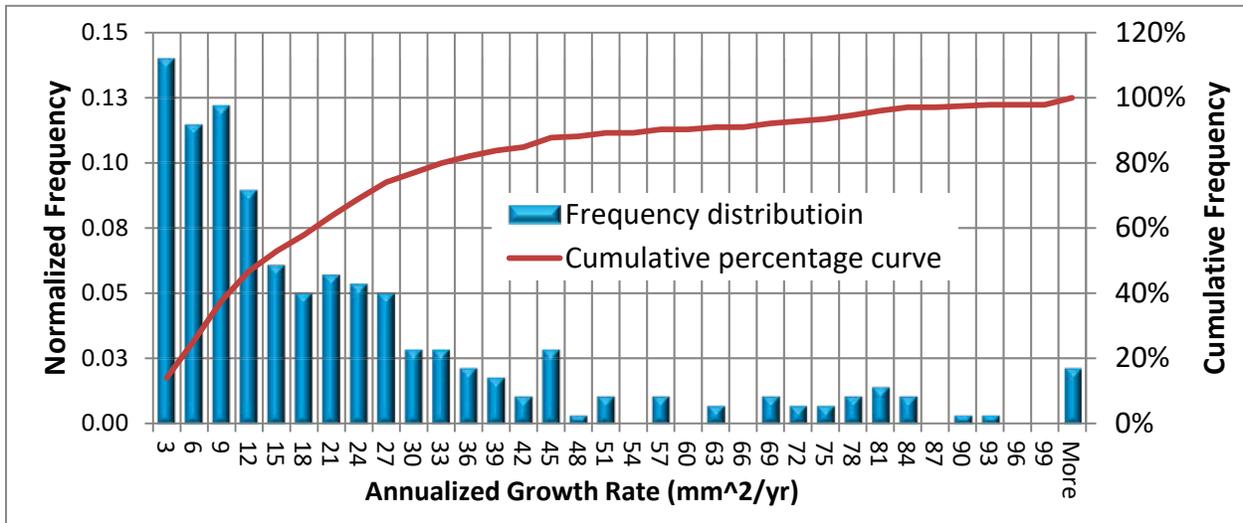
The first of two primary formats used in this report to present crack growth rate data is a normalized frequency distribution. The figure below (Figure 2-5) shows a typical normalized frequency distribution for a sub-population of crack growth rate data. In Figure 2-5, the left-most vertical bar indicates that about 14 percent (read from the left vertical axis, which shows percentages in decimal form) of the cracks in this sub-population grew at an annualized rate greater than zero but not more than 3 mm²/year (read from the horizontal axis). Similarly, each remaining bar in the graph indicates the relative percentage (or normalized frequency) of cracks that grew by the corresponding rate shown under the bar along the horizontal axis. A normalized frequency distribution like Figure 2-5 is an intermediate format needed to produce the second format that is used to compare crack growth rates between two or more crack populations.

Figure 2-5. Example Frequency Distribution Based on Percentage Growth Rate

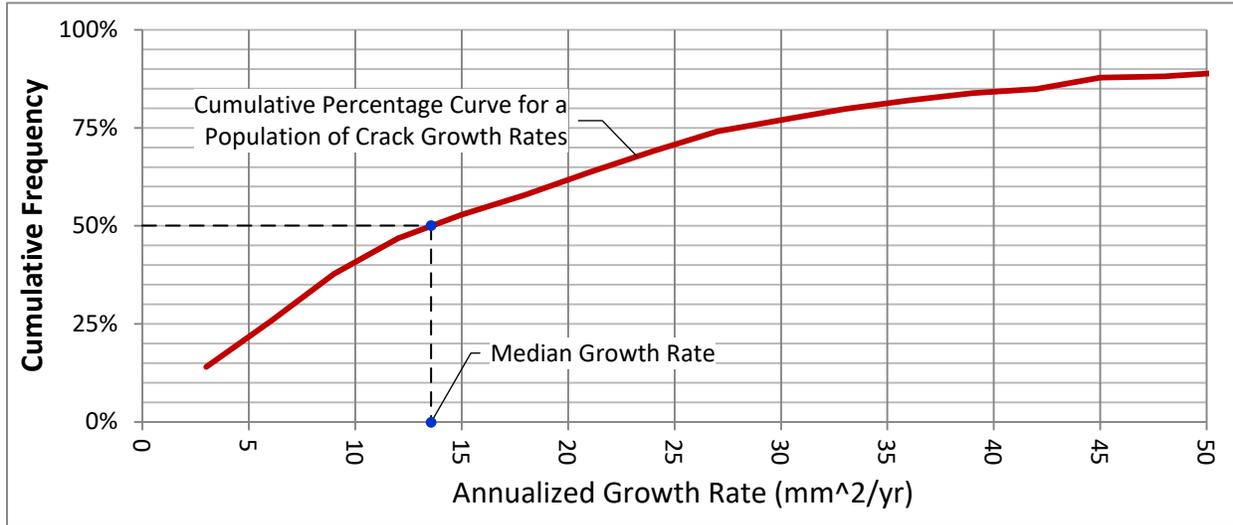
represented by a hypothetical “typical crack.” In this report, a “typical crack” for a given sub-population is one that grows at the sub-population’s median growth rate.

Figure 2-6. Relationship Between Median Growth Rate and Cumulative Percentage Curve

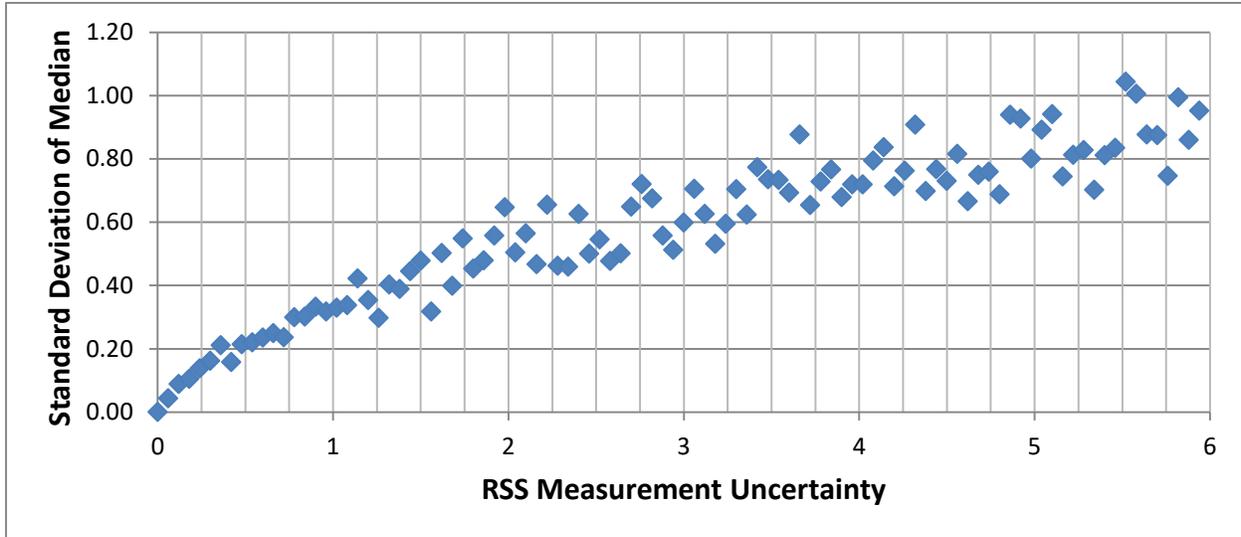
As described earlier in Section 2.3.4, this study compares the growth rate behavior of two or more crack populations by assigning each population a single parameter (the median crack growth rate within a given sub-population, also referred to herein as the “growth rate for a typical crack”). In order to properly account for measurement uncertainty, the uncertainty in growth rate corresponding to a single crack must be translated to a corresponding uncertainty in the median crack growth rate. To accomplish this, a conventional Monte Carlo simulation was conducted to establish a relationship between the measurement error in the growth rate for a single crack (the x-axis of Figure 2-7) and the standard deviation of the median (the y-axis of Figure 2-7).

Figure 2-7. Relationship Between RSS Measurement Uncertainty and the Standard Deviation of the Median

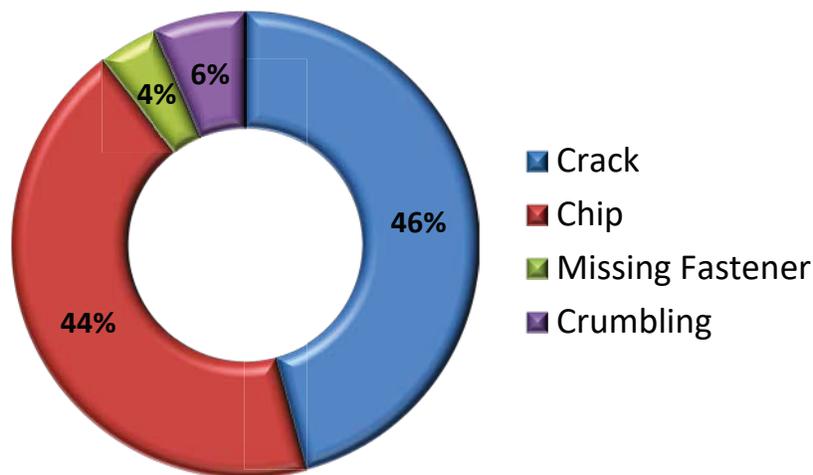
The graph in Figure 3-1 presents the distribution of four nonconformance types (e.g., cracks, chips, missing fasteners, and crumbling) within 10 miles of track in the study's test zone. There was a total population of 2,232 nonconformances dispersed across approximately 26,000 ties in the zone.

Figure 3-1. Observed Distribution of Nonconformance Types

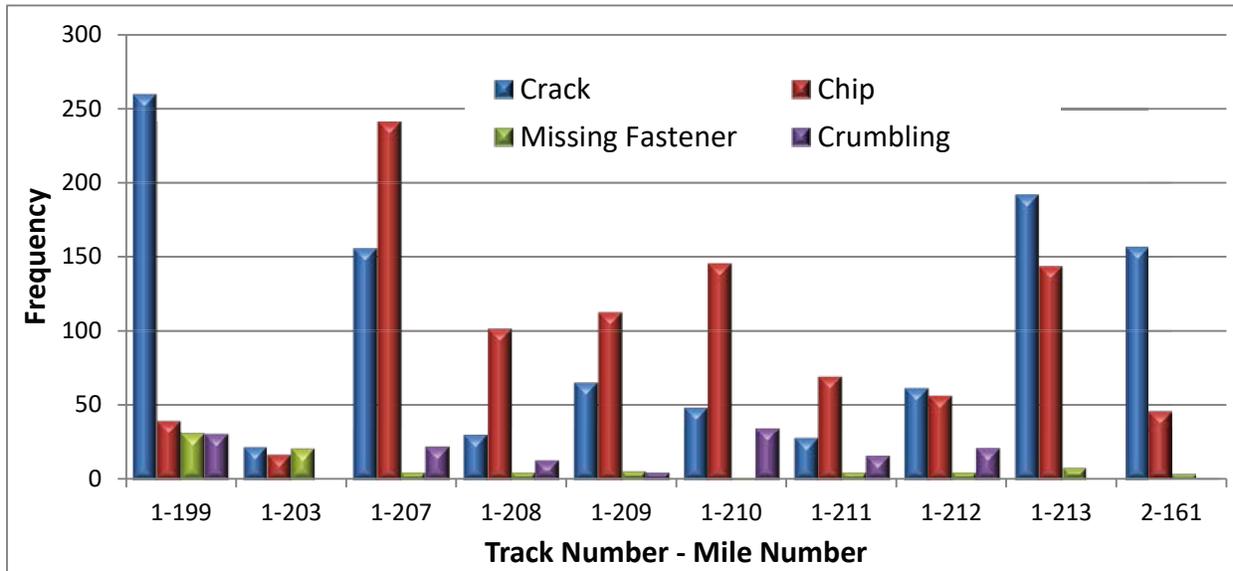
Figure 3-2 shows the number of nonconformances by type on a per-mile basis within 10 miles of track bed image data. The results of Figure 3-2 are derived from the same 10 miles of track bed image data used in Figure 3-1.

Figure 3-2. Observed Distribution of Nonconformance Types by Mile

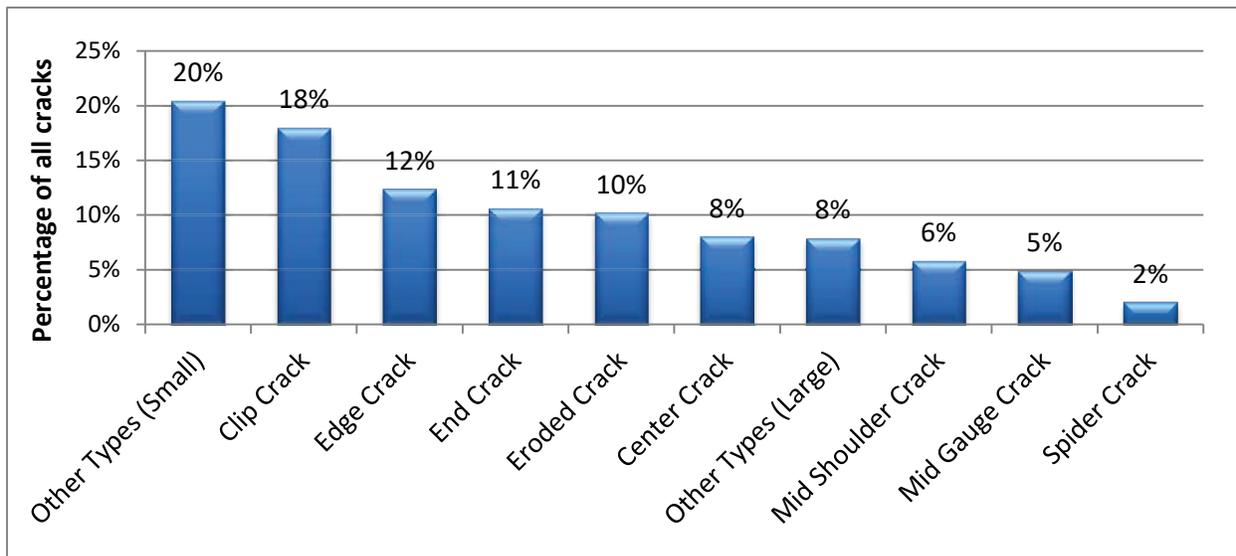
Figure 3-3’s graph classifies approximately 1,000 cracks within the study’s test zone into 1 of 10 categories. An image showing a typical crack from each category is provided in Appendix A.

Figure 3-3. Observed Distribution of Crack Types

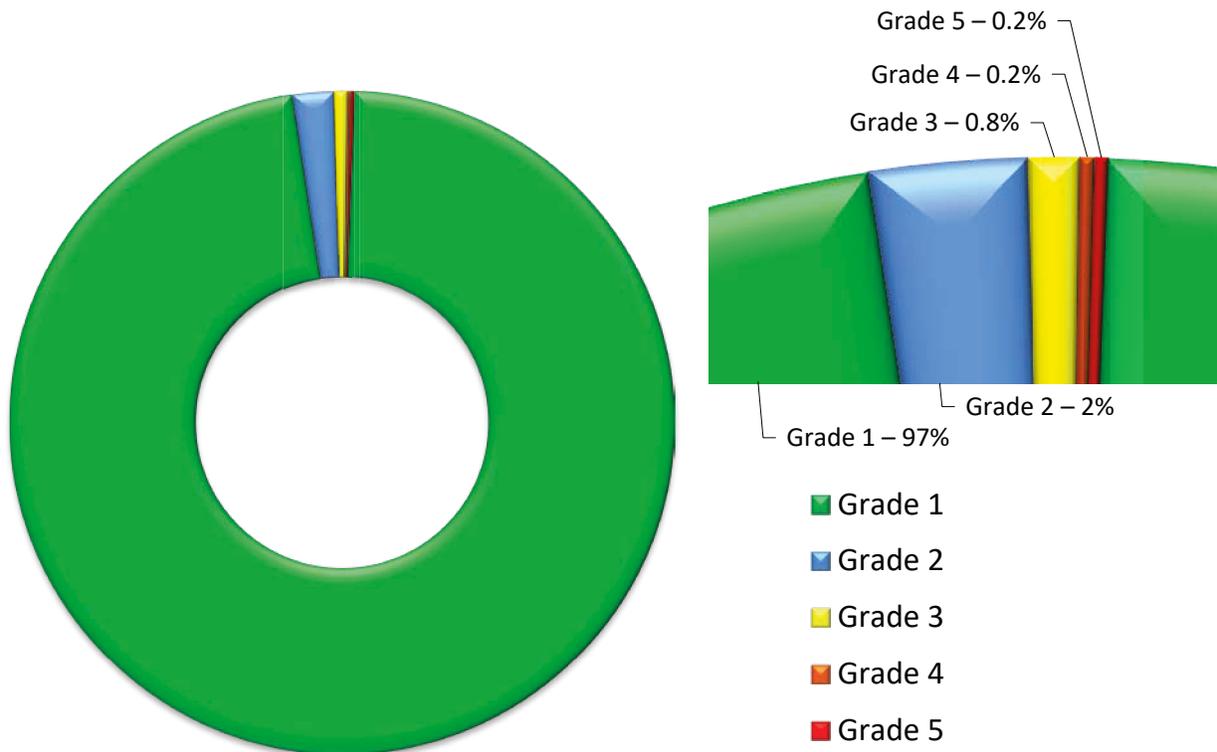
represented in Figure 3-4. The results of Figure 3-4 correspond to the ten miles of track listed earlier in Table 2-3.

Figure 3-4. Distribution of Tie Grades Assessed Over 10 Miles of Track Bed Image Data

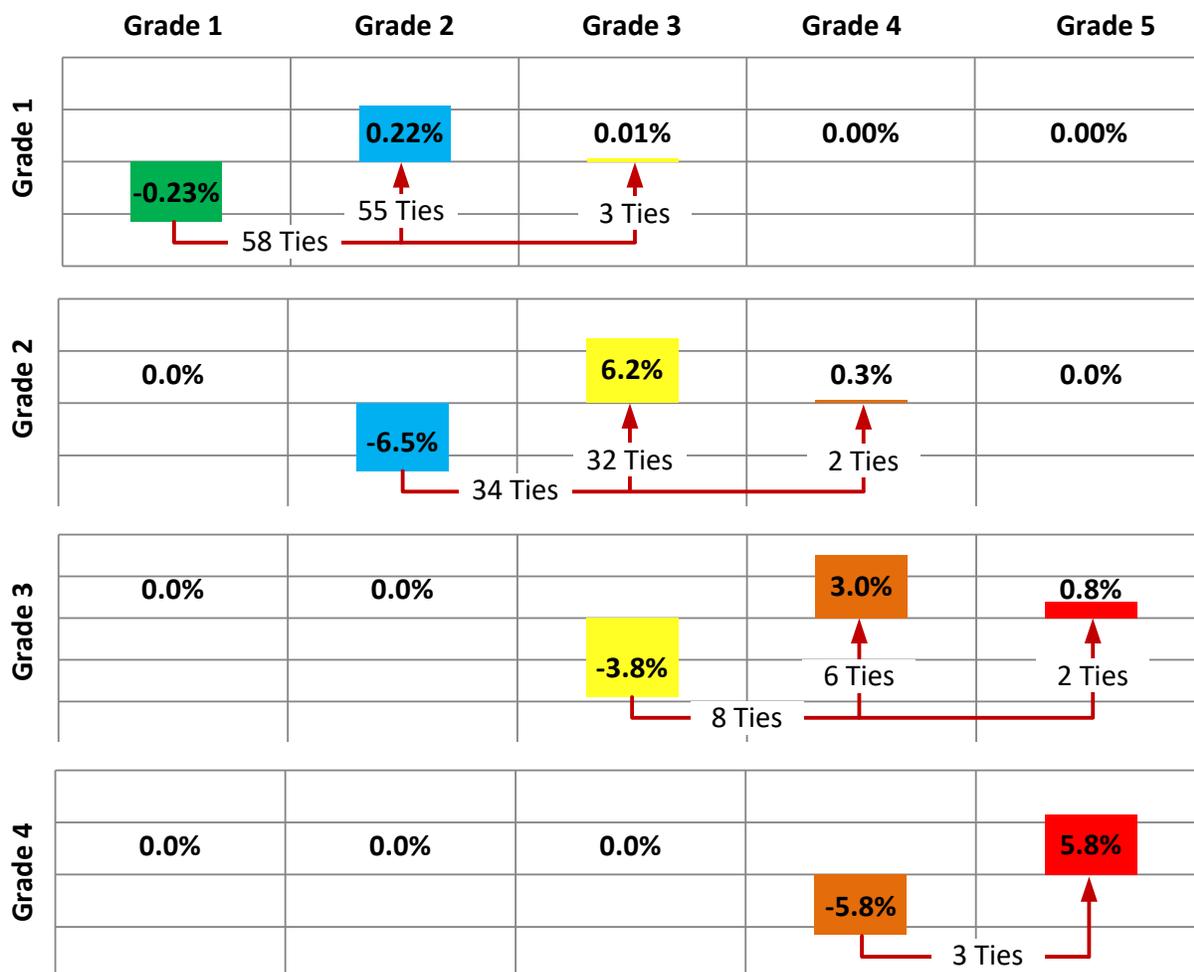
The last bar graph in Figure 3-5 indicates that 5.8 percent of the pre-existing Grade 4 ties (3 out of 52 ties) advanced to become Grade 5 ties. In Figure 3-5 no bar graph is shown to indicate advancing Grade 5 ties because the grading scale ends at Grade 5, however, in principle, Grade 5 ties are ultimately replaced and, therefore, cycle back to Grade 1 ties.

Figure 3-5. Percent Change in the Number of Ties of Each Grade Over a 1-Year Period

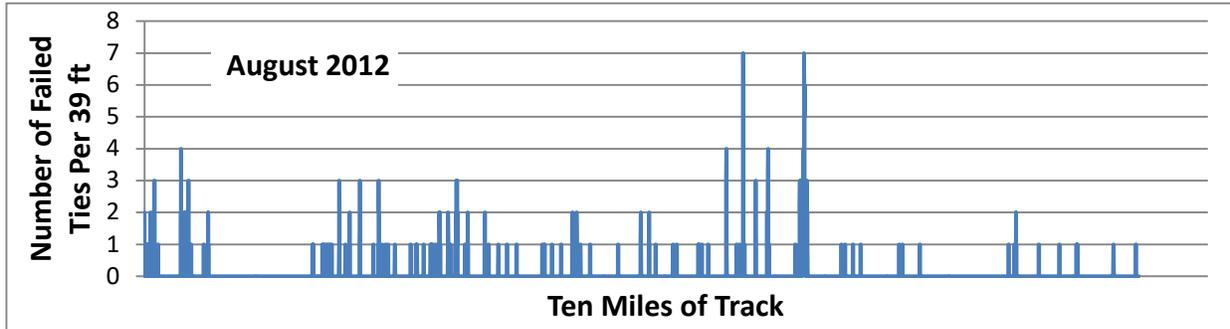
Figure 3-7 show the number of ties with a grade of either 4 or 5 per 39 feet over the ten miles of track listed in Table 2-3. The results in Figure 3-6 correspond to the status of the ties during the first imaging survey conducted in August 2012. The results of Figure 3-7 correspond to the status of the ties following the third imaging survey conducted in September 2013. In Figure 3-6 and Figure 3-7 the horizontal axis represents the location along the track over ten non-contiguous miles; the vertical axis then indicates the number of Grade 4 or 5 ties per 39 feet at each location.

Figure 3-6. Number of Grade 4 or 5 Ties per 39 Feet Versus Tie Location - August 2012

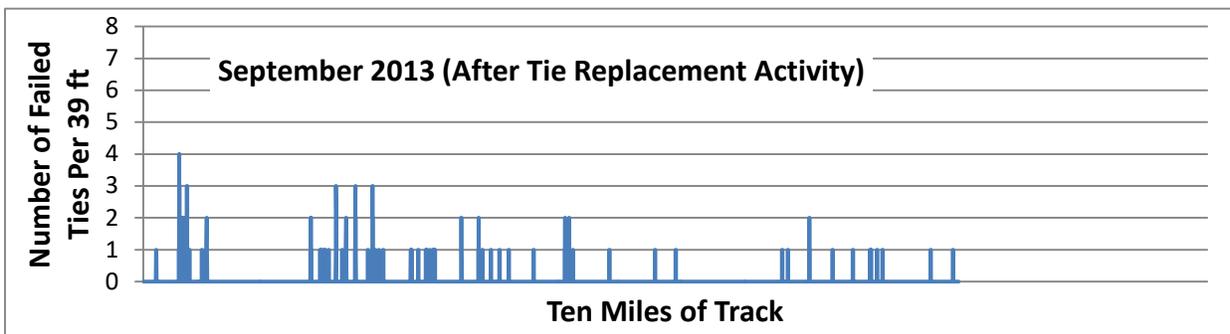
Figure 3-7. Number of Grade 4 or 5 Ties per 39 Feet Versus Tie Location—September 2013

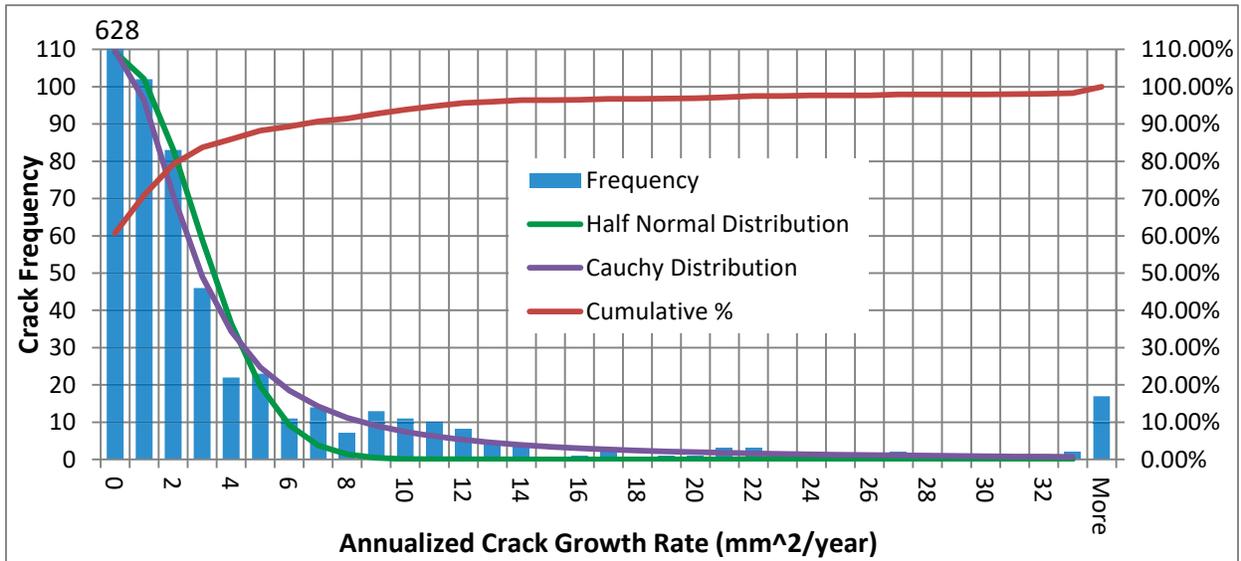
Figure 3-8. Crack Growth Rate Data for All Cracks Studied Between August 2012 and April 2013 (1,022 Cracks)

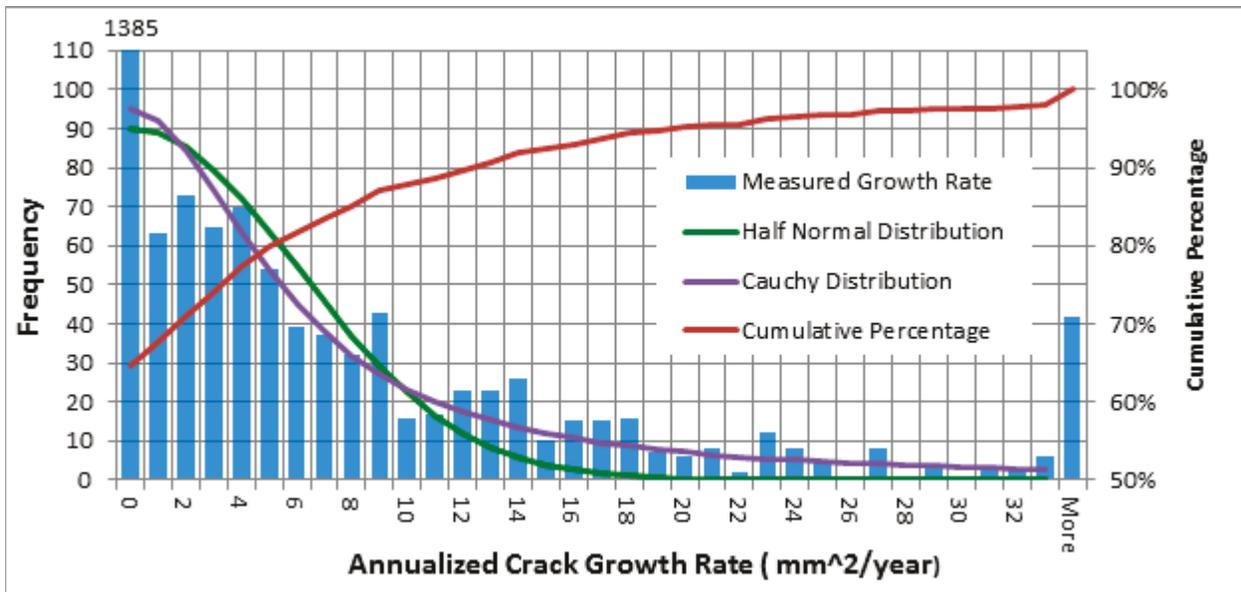
Figure 3-9. Crack Growth Rate Data for All Cracks Studied Between August 2012 and September 2013 (2,139 Cracks)

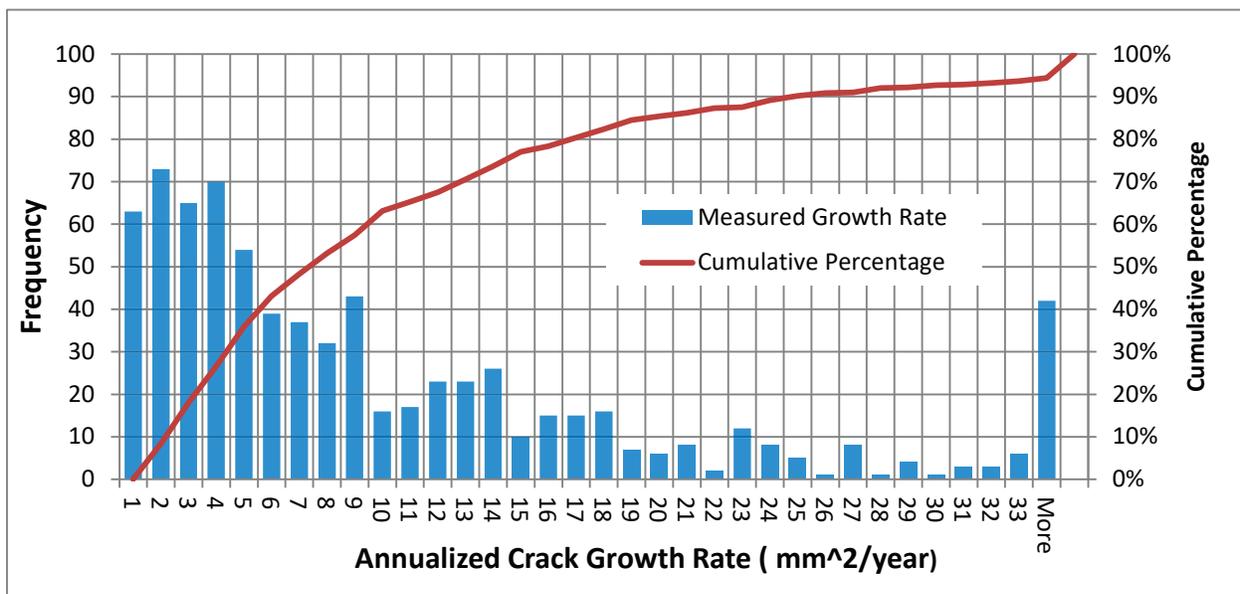
Figure 3-10 shows the distribution of crack growth rates among the cracks that showed measurable growth between August 2012 and September 2013. The cumulative percentage curve shown in Figure 3-10 provides a basis for defining typical slow, medium, and fast growth rates among the studied cracks. Specifically, a typical slow growth rate (10th percentile) would be 2.7 mm²/year, a typical medium growth rate (50th percentile) would be 7.5 mm²/year, and a typical fast growth rate corresponding to the 90th percentile point would be 25.5 mm²/year.

Figure 3-10. Distribution of Crack Growth Rates Among Cracks That Grew

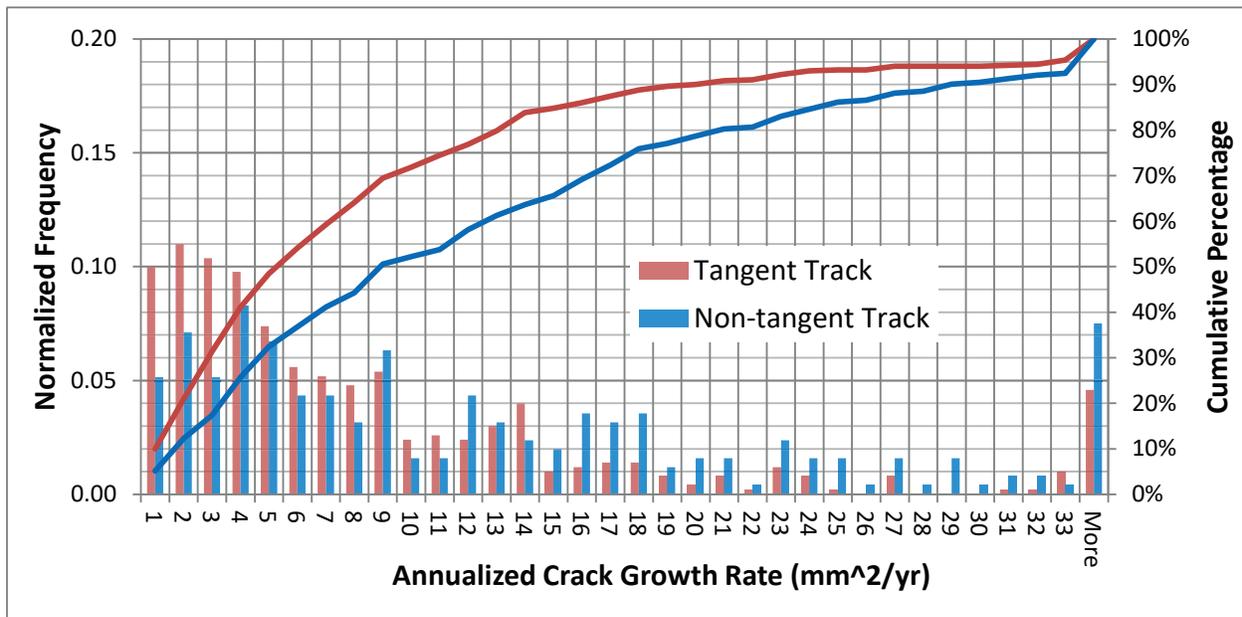
Figure 3-11. Crack Growth Rate Versus Curvature

This section presents Figure 3-11, Figure 3-12, and Figure 3-13 used to evaluate whether or not the following parameters related to operating conditions tend to impact crack growth rate.

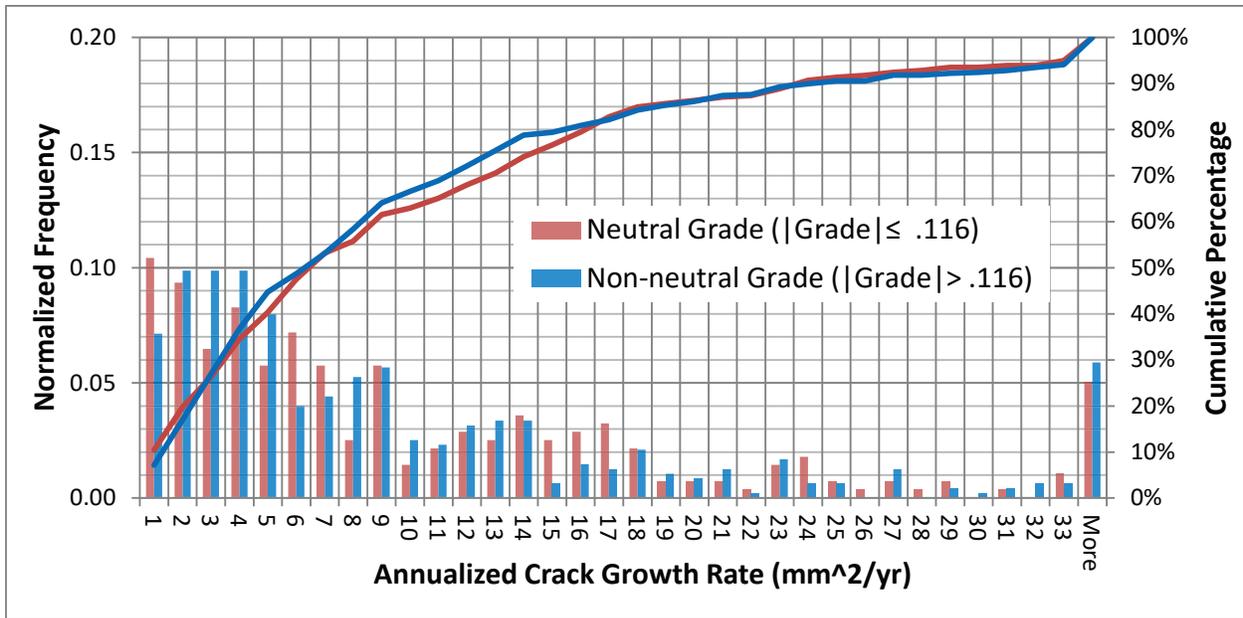
Figure 3-12. Crack Growth Rate Versus Track Grade

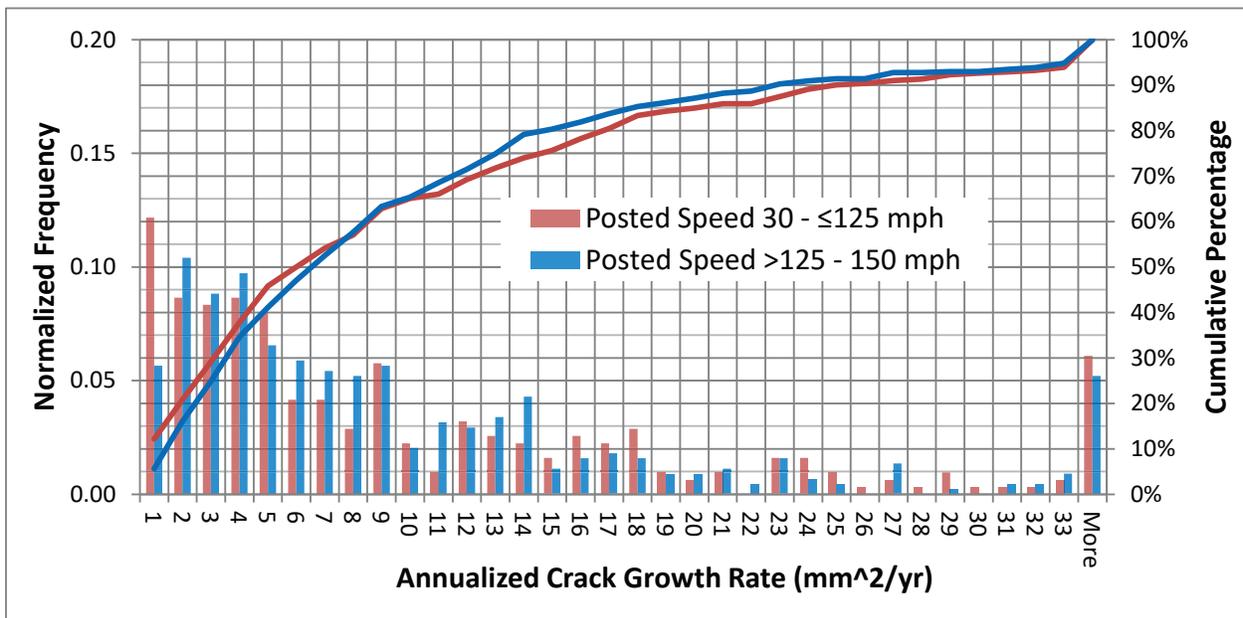
Figure 3-13. Crack Growth Rate Versus Posted Speed

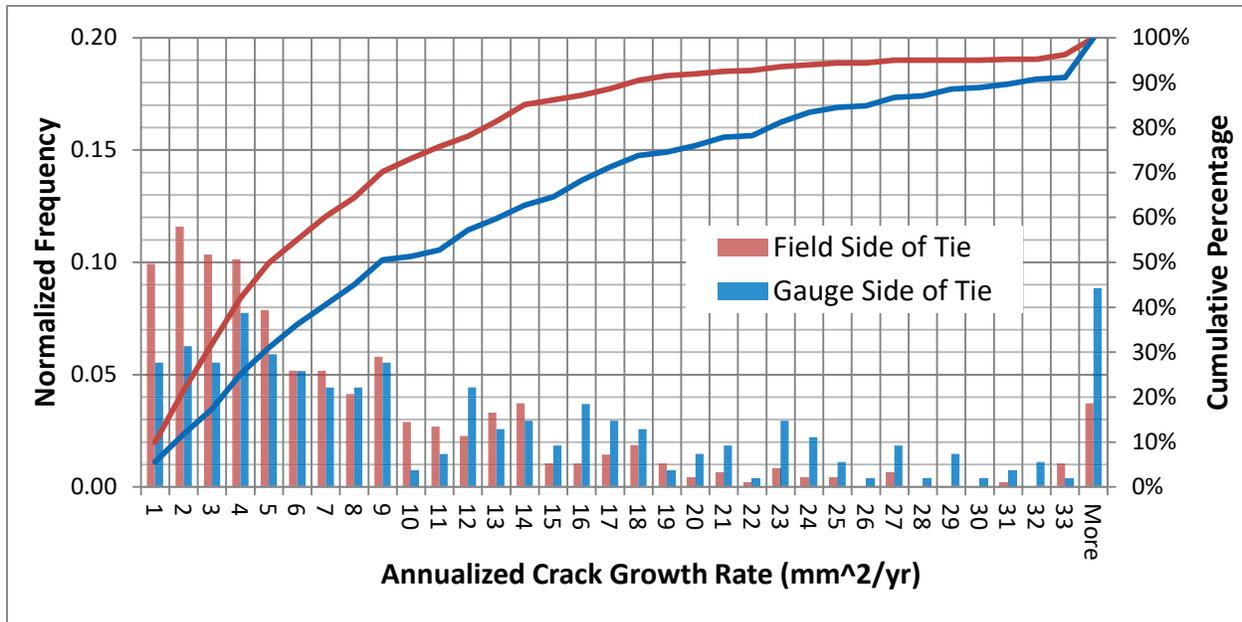
This section presents evidence which may indicate that crack growth rates are influenced by whether a crack is located on the field or gauge side of a tie. Specifically, Figure 3-14, compares measured crack growth rates on the field side of the tie to those on the gauge side of the tie.

Figure 3-14. Crack Growth Versus Crack Location (Field Versus Gauge Side of Tie)

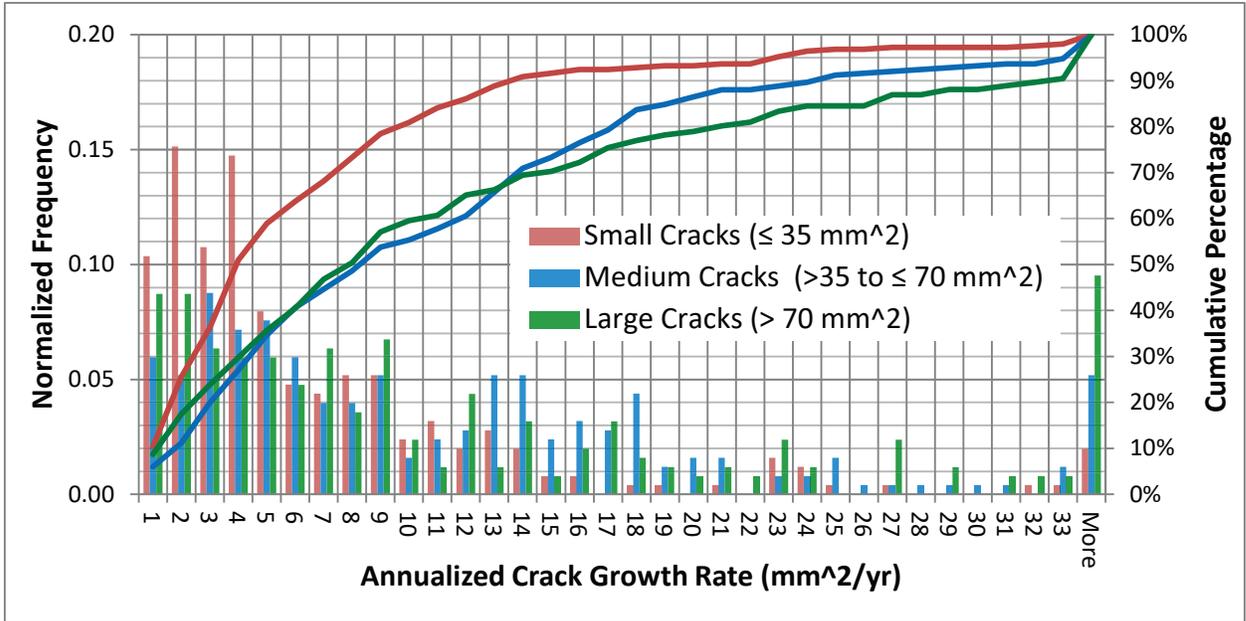
- Small cracks - $\leq 35 \text{ mm}^2$ (typical length ≈ 3 in)
- Medium cracks - $> 35 \text{ mm}^2$ to $\leq 70 \text{ mm}^2$ (typical length ≈ 3 to 6 in)
- Large cracks - $> 70 \text{ mm}^2$ (typical length greater than ≈ 6 in)

Figure 3-15. Comparison of Crack Growth Rate Versus Crack Size

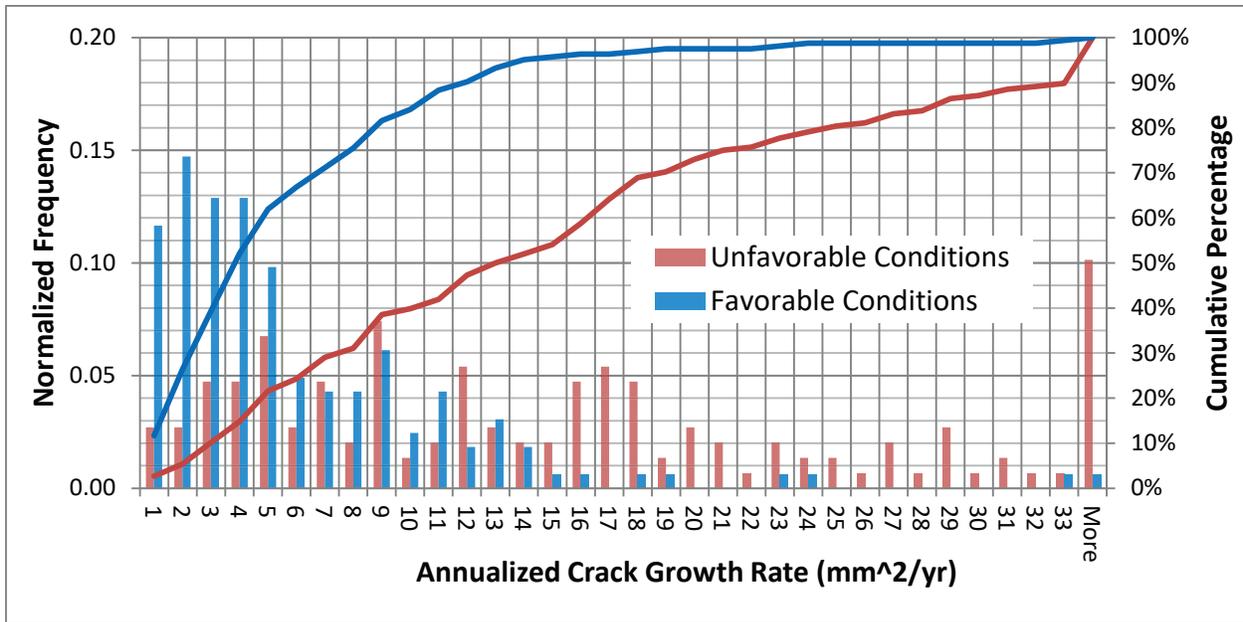
Favorable Conditions	Unfavorable Conditions
Tangent Track	Curving Track
Tie Manufacturer "A" Only	Tie Manufacturers "A" and "B"
Small Cracks Only	Medium and Large Cracks
Field Side of Tie	Gauge Side of Tie

Figure 3-16. Crack Growth Rate Versus Favorable and Unfavorable Conditions

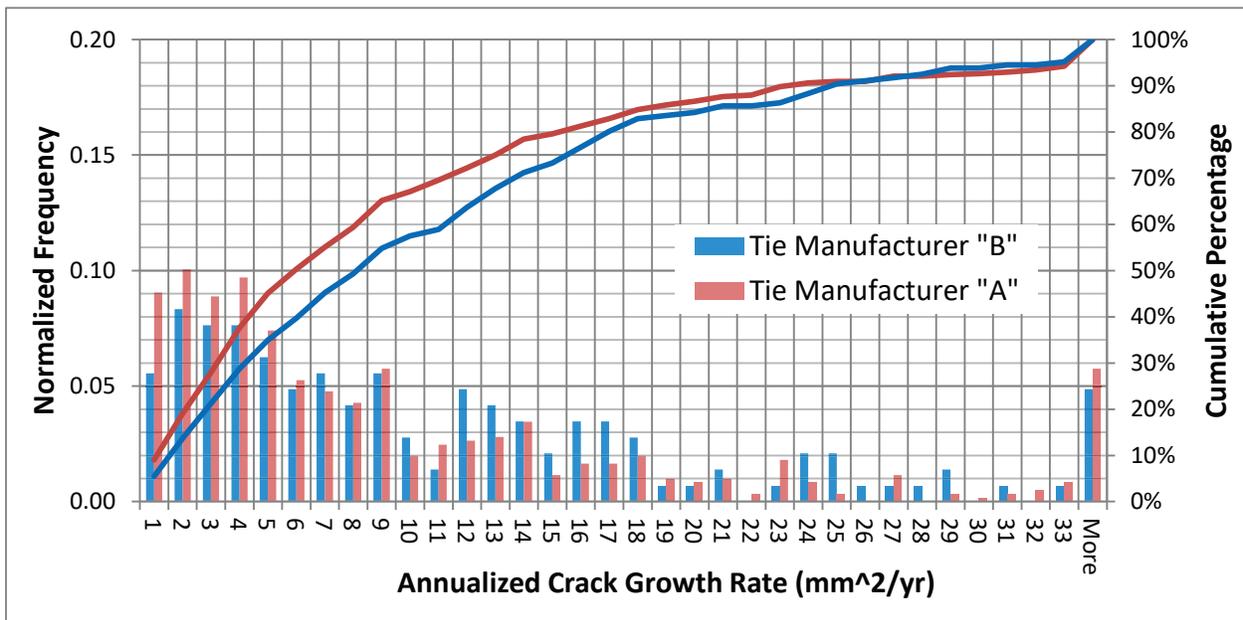
This section presents data that assesses whether or not the tie manufacturer has a material impact on crack growth rate. The data presented in Figure 3-17 compares crack growth rates for a population of cracks found on ties manufactured by Tie Manufacturer “A” with growth rates corresponding to a population of cracks found on ties manufactured by Tie Manufacturer “B.”

Figure 3-17. Crack Growth Rate Versus Tie Manufacturer

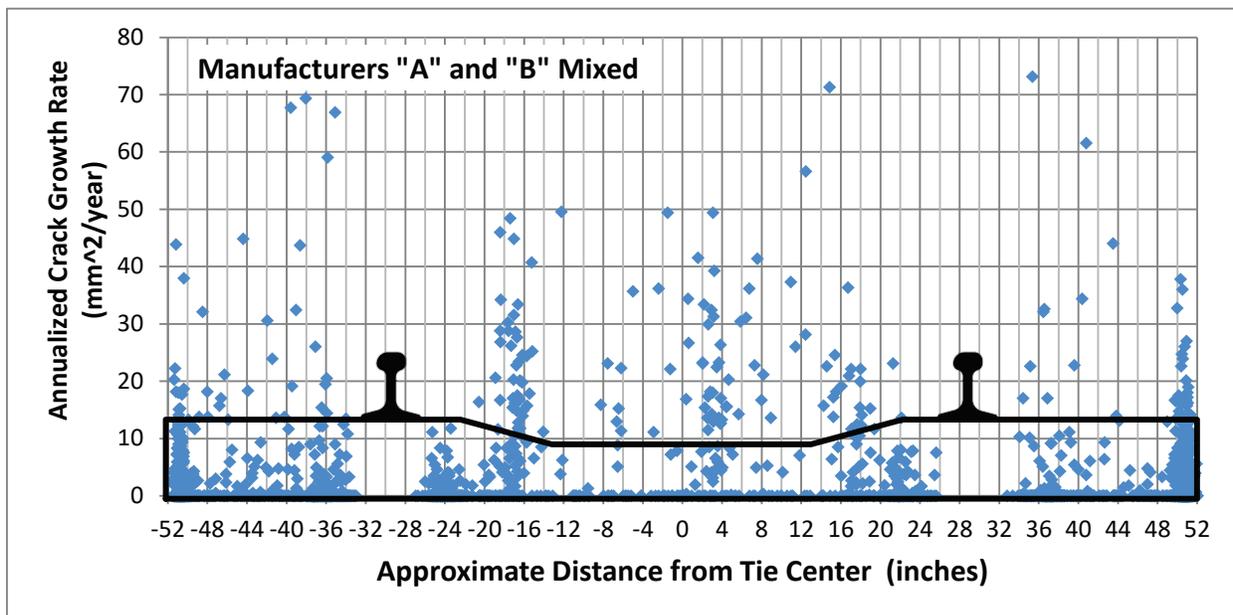
The data presented in Figure 3-18 includes ties manufactured by both Tie Manufacturer "A" and Tie Manufacturer "B." Figure 3-19 and Figure 3-20 are in the same format as Figure 3-18 but only include data corresponding to either Tie Manufacturer "A" or Tie Manufacturer "B," respectively. These latter two plots support a heuristic assessment of any crack growth rate trends that might depend on differences in the respective tie manufacturing processes.

Figure 3-18. Crack Growth Rate Versus Position Along the Tie (Tie Manufacturers "A" and "B")

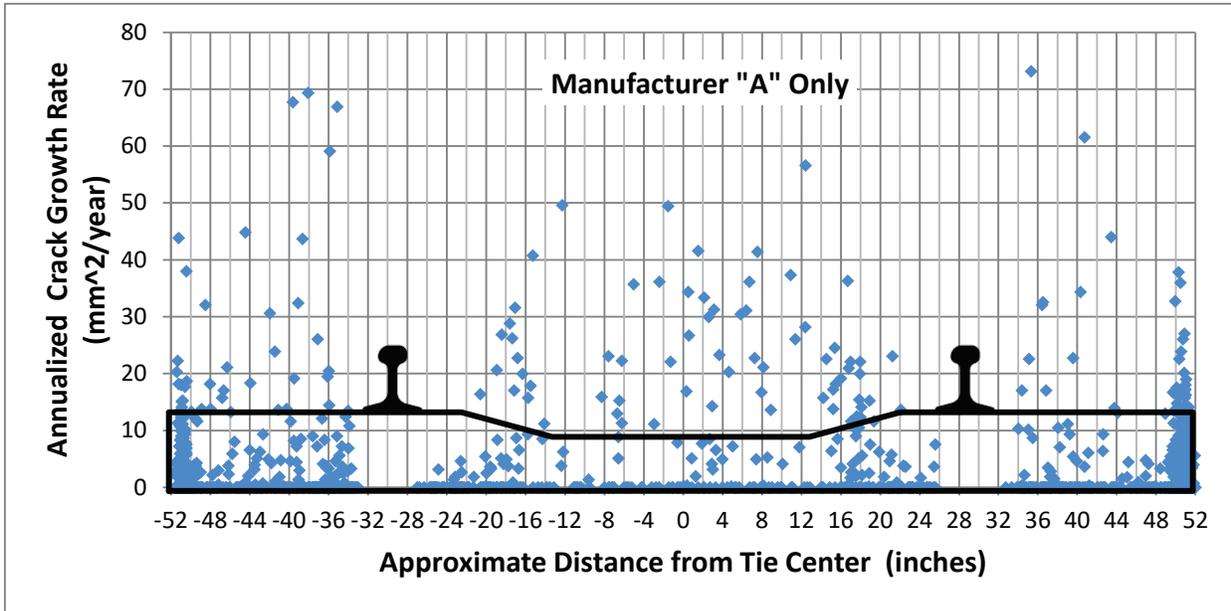
Figure 3-19. Crack Growth Rate Versus Position Along the Tie (Tie Manufacturer “A” Only)

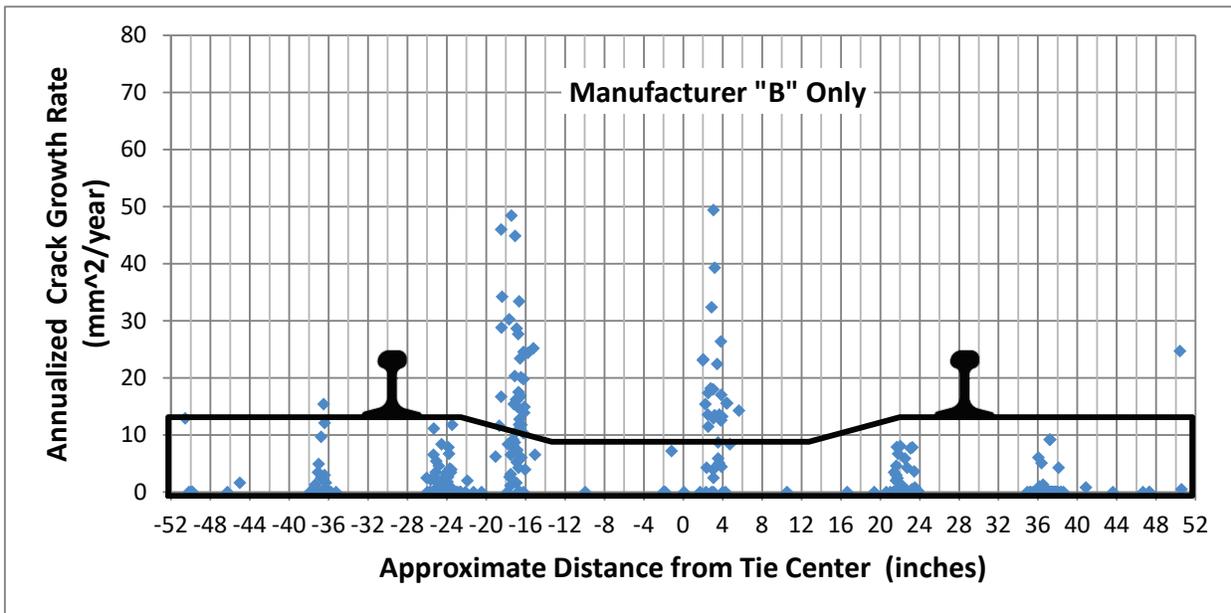
Figure 3-20. Crack Growth Rate Versus Position Along the Tie (Tie Manufacturer “B” Only)

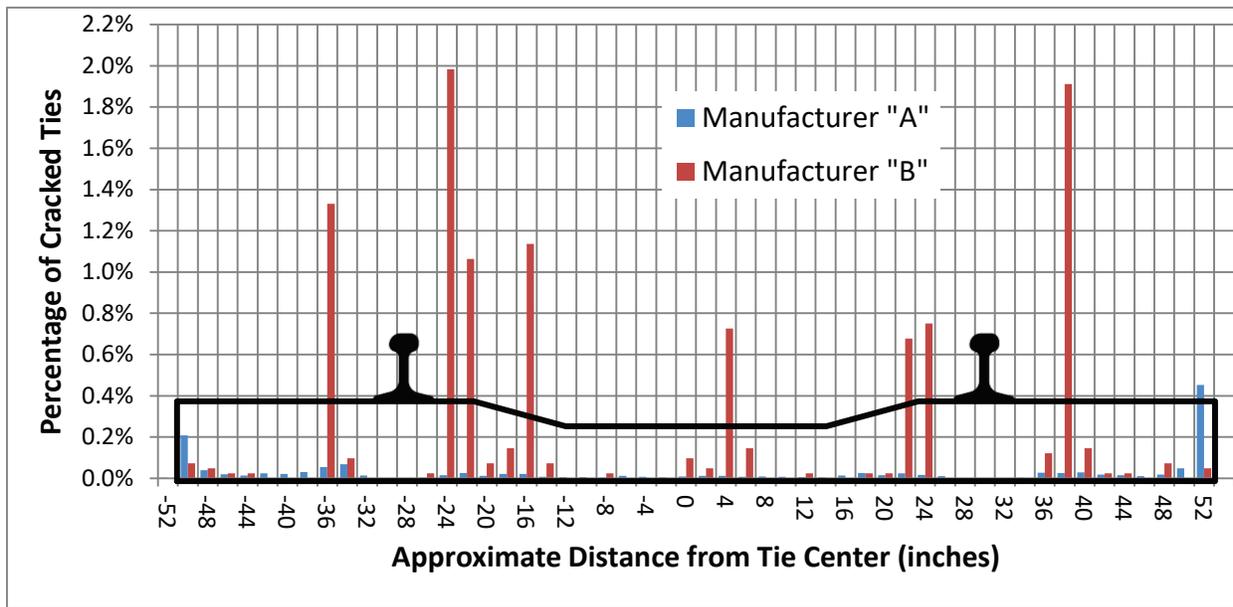
Each graph in this section is a frequency histogram that indicates the prevalence of cracks at each position across the length of a tie. Figure 3-21 presents normalized crack frequency as a function of position along the tie for both Tie Manufacturers “A” and “B.” Effectively, each vertical bar in Figure 3-21 indicates the percentage of a given manufacturer’s ties that have a crack at the bar’s approximate position along the tie. Thus, Figure 3-21 compares the prevalence of cracks as functions of both location and tie manufacturer. Figure 3-22 and Figure 3-23 present the same data shown in Figure 3-21, except the results for Tie Manufacturers “A” and “B” are shown on separate graphs so that the vertical scale for each tie manufacturer better matches the data for each tie manufacturer. The crack prevalence data presented in this section was derived from track bed images recorded during the first imaging survey in August 2012.

Figure 3-21. Normalized Crack Frequency Versus Position Along the Tie (Tie Manufacturers “A” and “B”)
