Evaluation of the Degradation of Concrete Ties Using Machine Vision Technology on High-Speed Rail Corridors

1. AGENCY USE ONLY (Leave blank)		2. REPORT DATE July 2018	3. REPORT TYPE AND DATES COVERED Technical Report – 2011	
4. TITLE AND SUBTITLE Evaluation of the Degradation of Concrete Ties Using Machine Vision Technology on High-Speed Rail Corridors			5. FUNDING NUMBERS DTFR53-12-C-00003

6. AUTHOR(S) Herbert J. Henderson; Eric T. Sherrock				
7. PERFORMING ORGANIZATION NAME(S) AND ADDRESS(ES) ENSCO, Inc. 5400 Port Royal Road Springfield, VA 22151			8. PERFORMING ORGANIZATION REPORT NUMBER SERV-REPT-0000479 Rev B

9. SPONSORING/MONITORING AGENCY NAME(S) AND ADDRESS(ES) U.S. Department of Transportation Federal Railroad Administration Office of Railroad Policy and Development Office of Research, Development and Technology Washington, DC 20590			10. SPONSORING/MONITORING AGENCY REPORT NUMBER DOT/FRA/ORD-18/26

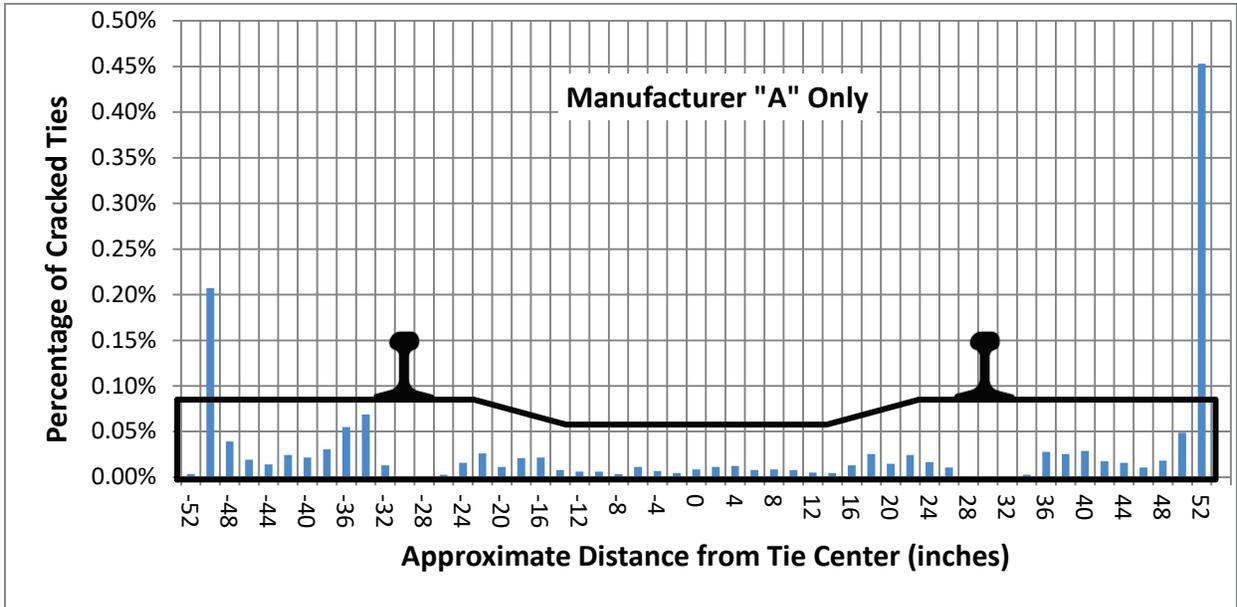
Figure 3-22. Crack Frequency Versus Position Along the Tie (Tie Manufacturer "A" Only)

Each graph in this section is a frequency histogram that indicates the prevalence of cracks at each position across the length of a tie. Figure 3-21 presents normalized crack frequency as a function of position along the tie for both Tie Manufacturers “A” and “B.” Effectively, each vertical bar in Figure 3-21 indicates the percentage of a given manufacturer’s ties that have a crack at the bar’s approximate position along the tie. Thus, Figure 3-21 compares the prevalence of cracks as functions of both location and tie manufacturer. Figure 3-22 and Figure 3-23 present the same data shown in Figure 3-21, except the results for Tie Manufacturers “A” and “B” are shown on separate graphs so that the vertical scale for each tie manufacturer better matches the data for each tie manufacturer. The crack prevalence data presented in this section was derived from track bed images recorded during the first imaging survey in August 2012.

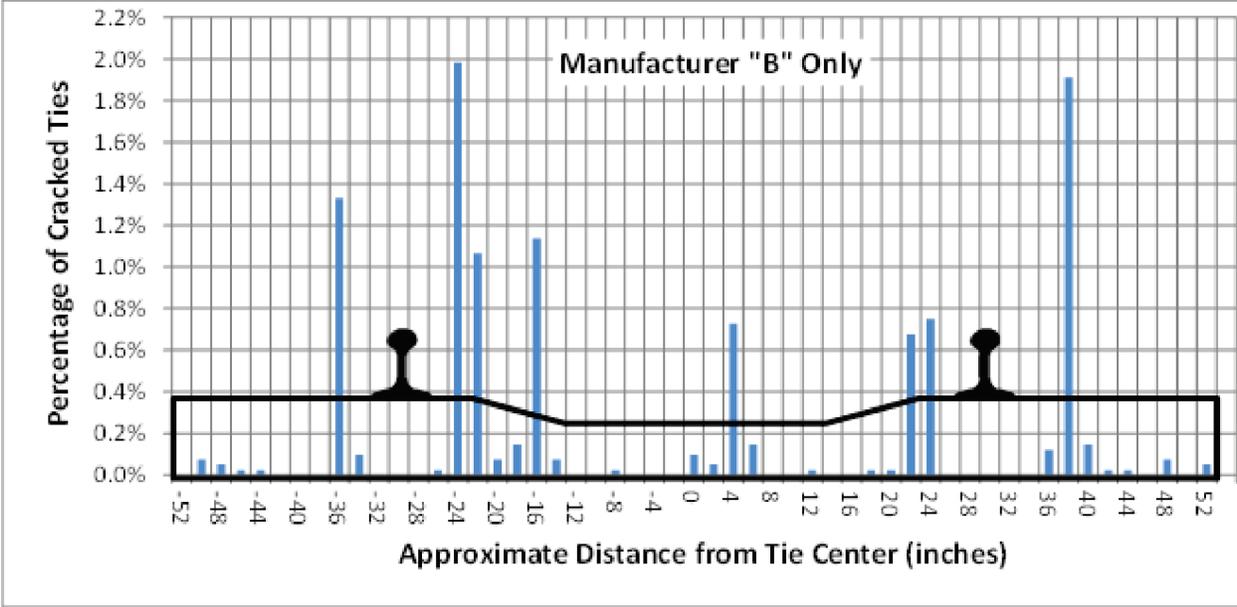
Figure 3-23. Crack Frequency Versus Position Along the Tie (Tie Manufacturer "B" Only)

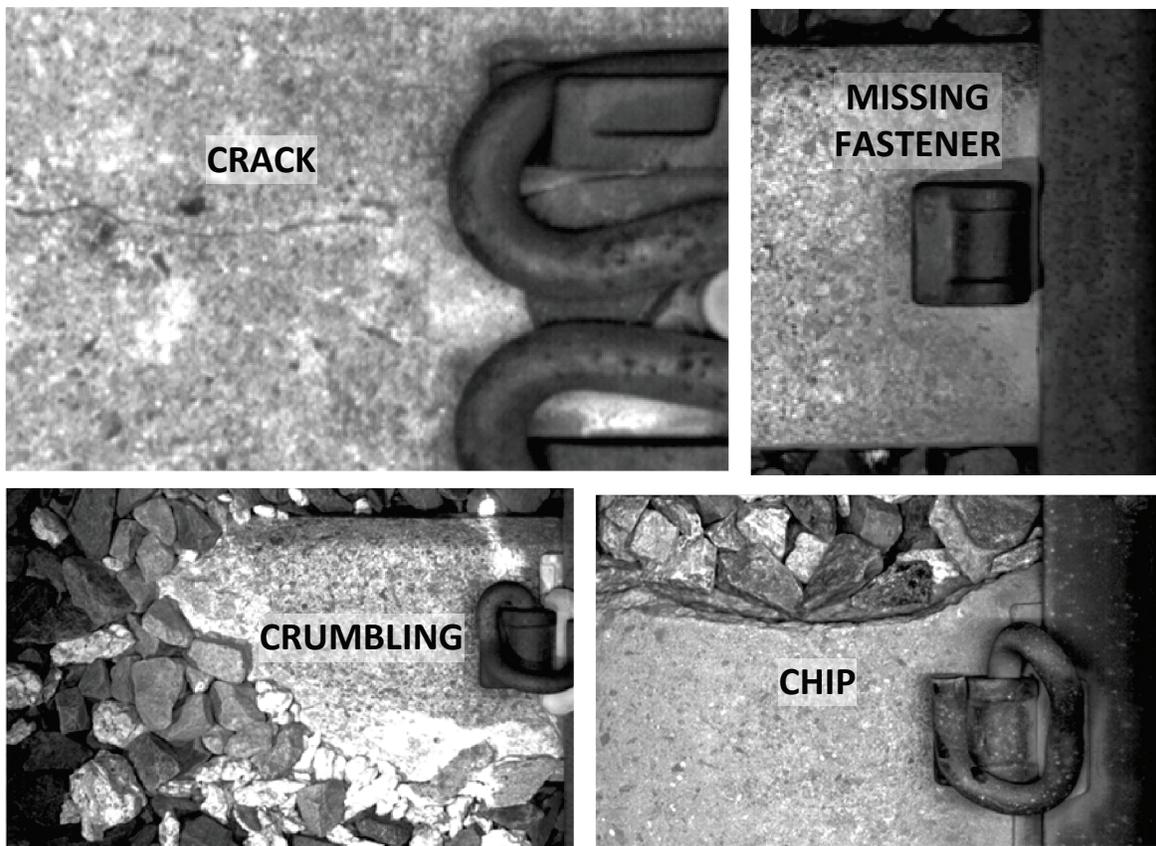
Figure 4-1 shows a typical example of each of the nonconformance types listed above.

Figure 4-1. Typical Examples of the Nonconformance Types Assessed

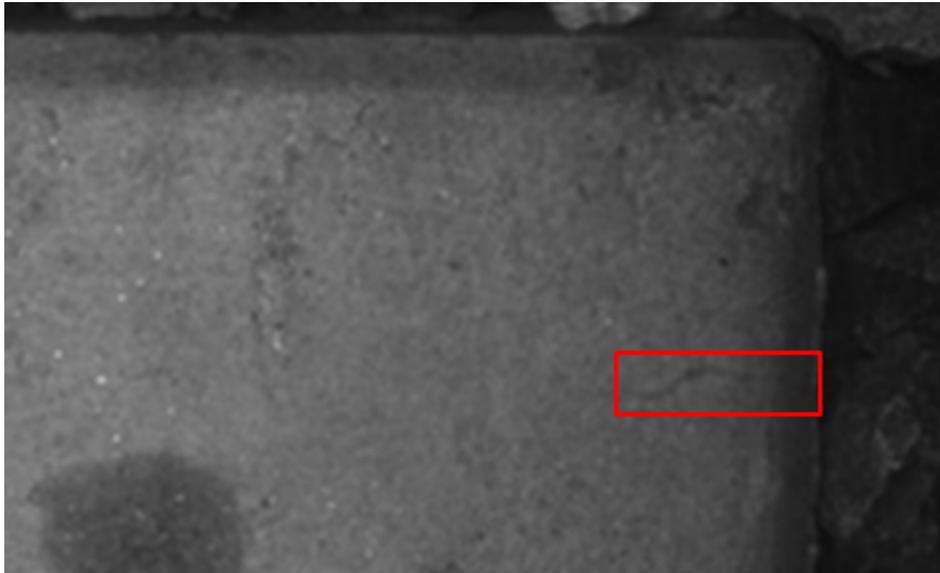
Figure A-1. Example of a Typical Other Crack Type (Small)

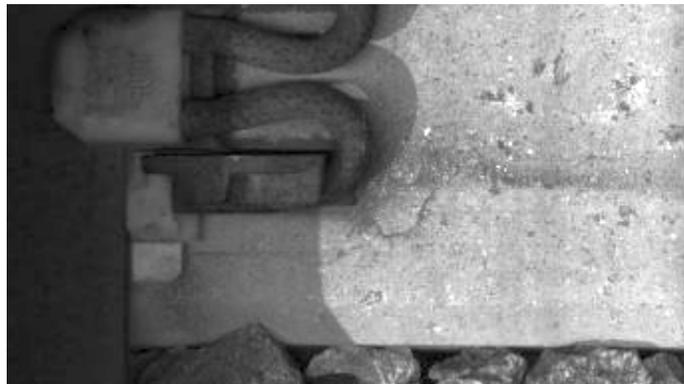
Figure A-2. Example of a Typical Clip Crack

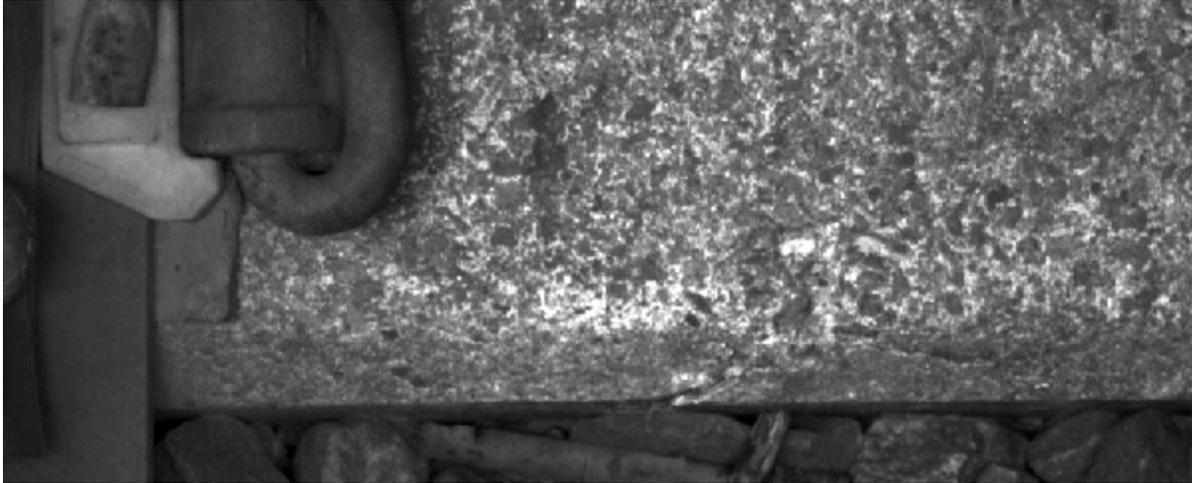
Figure A-3. Example of a Typical Edge Crack

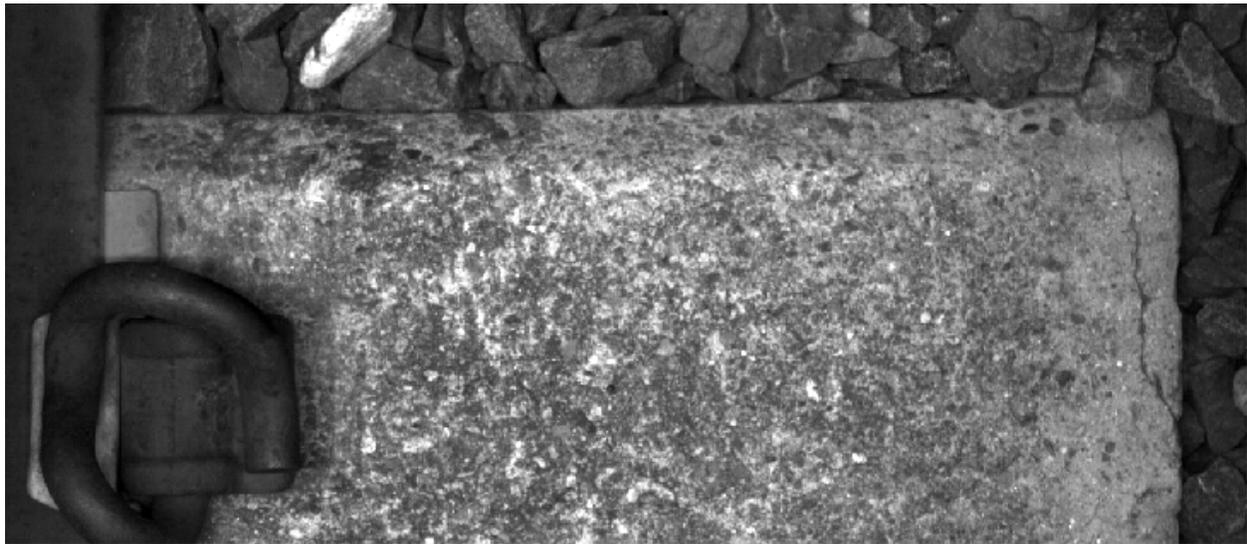
Figure A-4. Example of a Typical End Crack

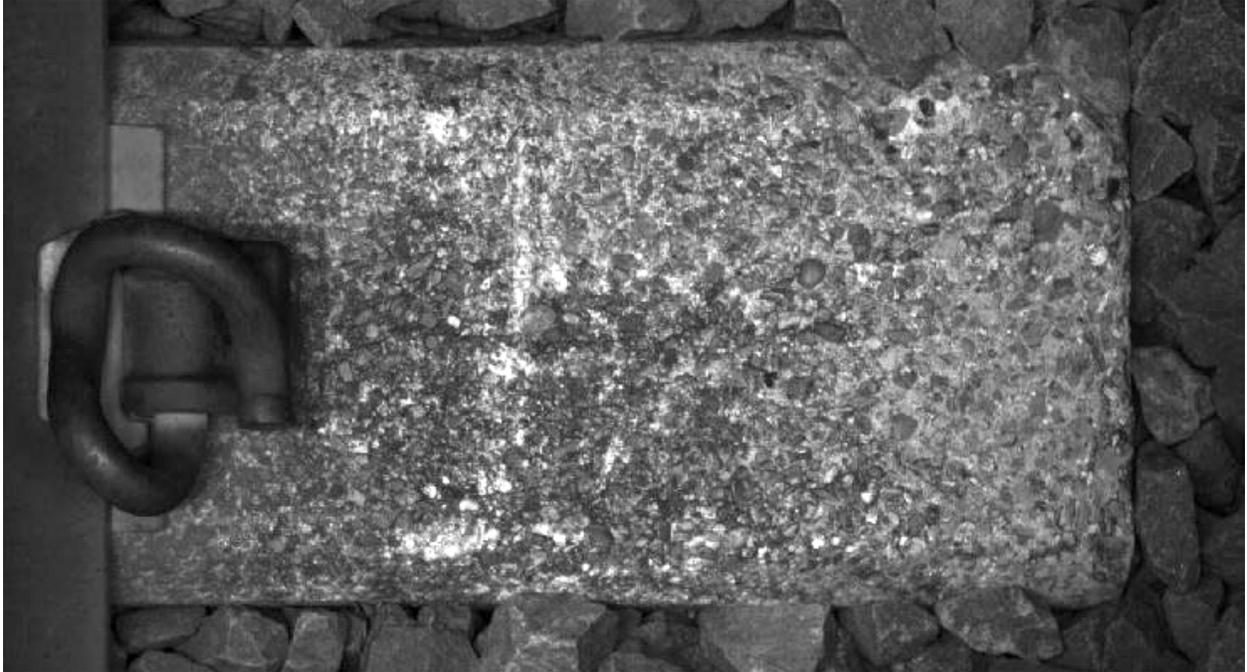
Figure A-5. Example of a Typical Eroded Crack

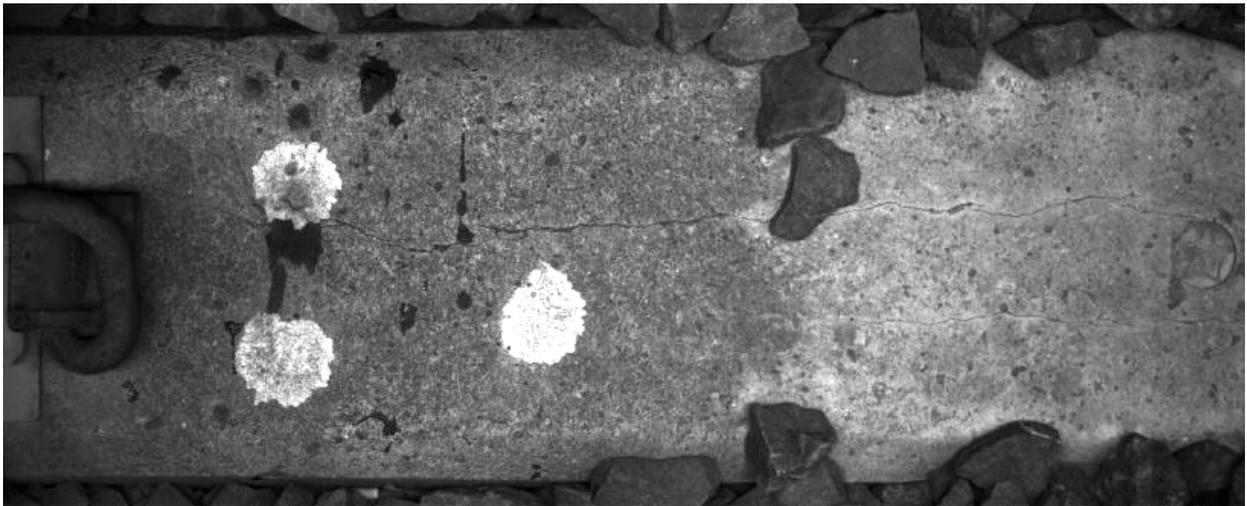
Figure A-6. Example of a Typical Center Crack

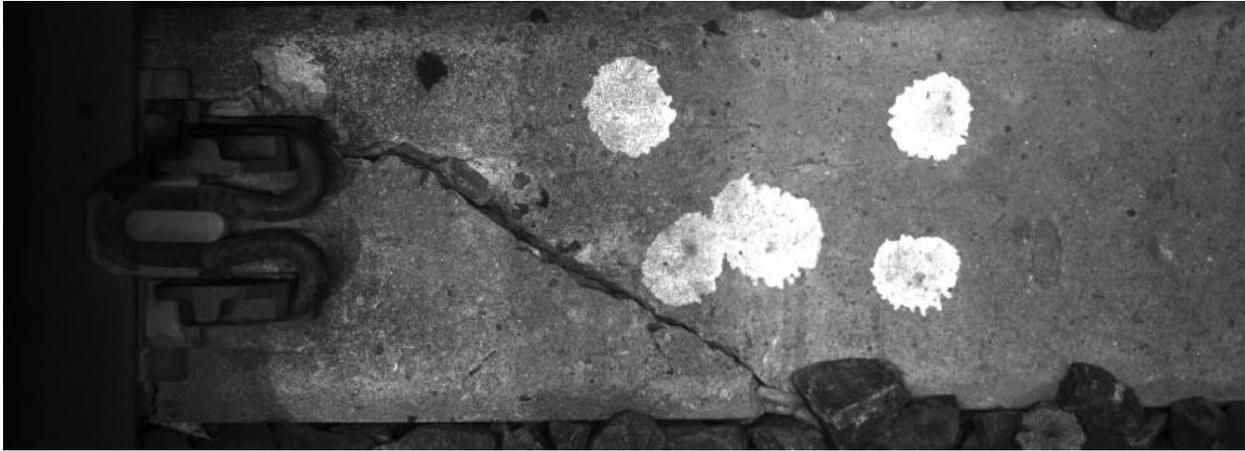
Figure A-7. Example of a Typical Other Crack Type (Large)

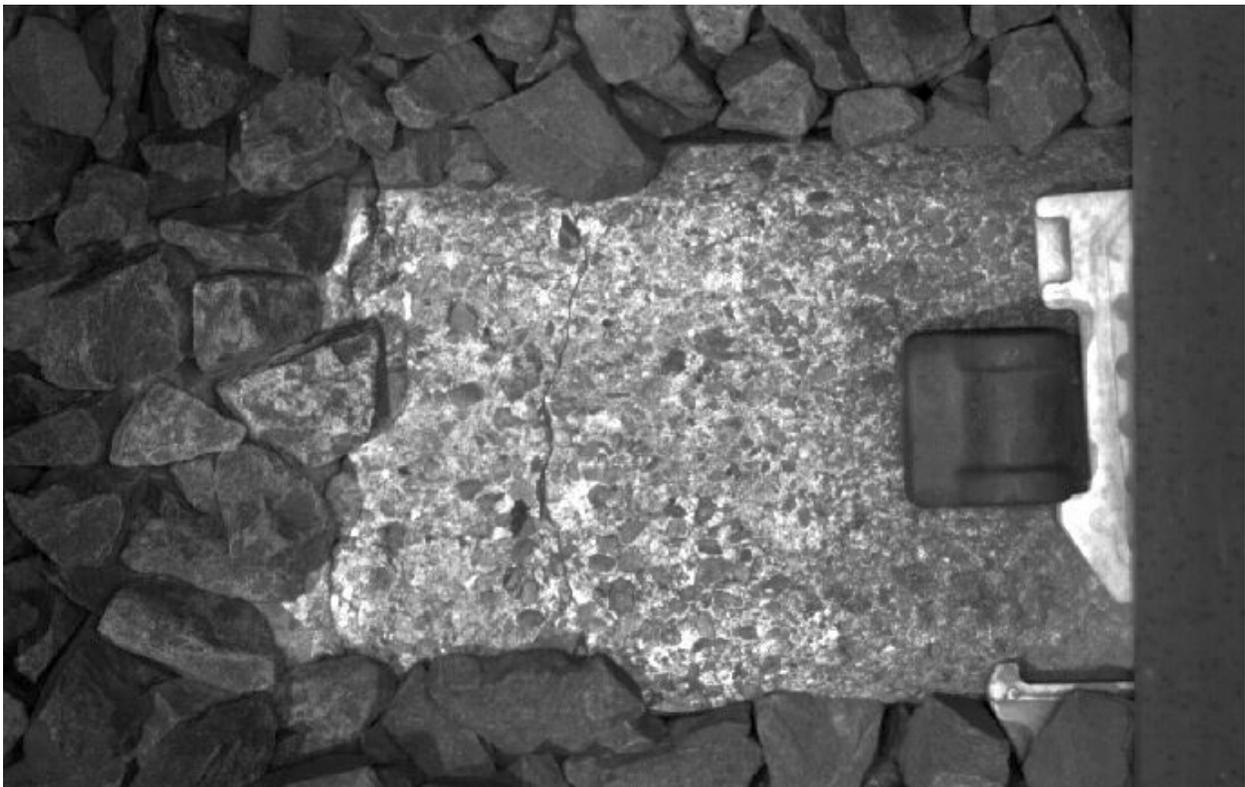
Figure A-8. Example of a Typical Mid Shoulder Crack

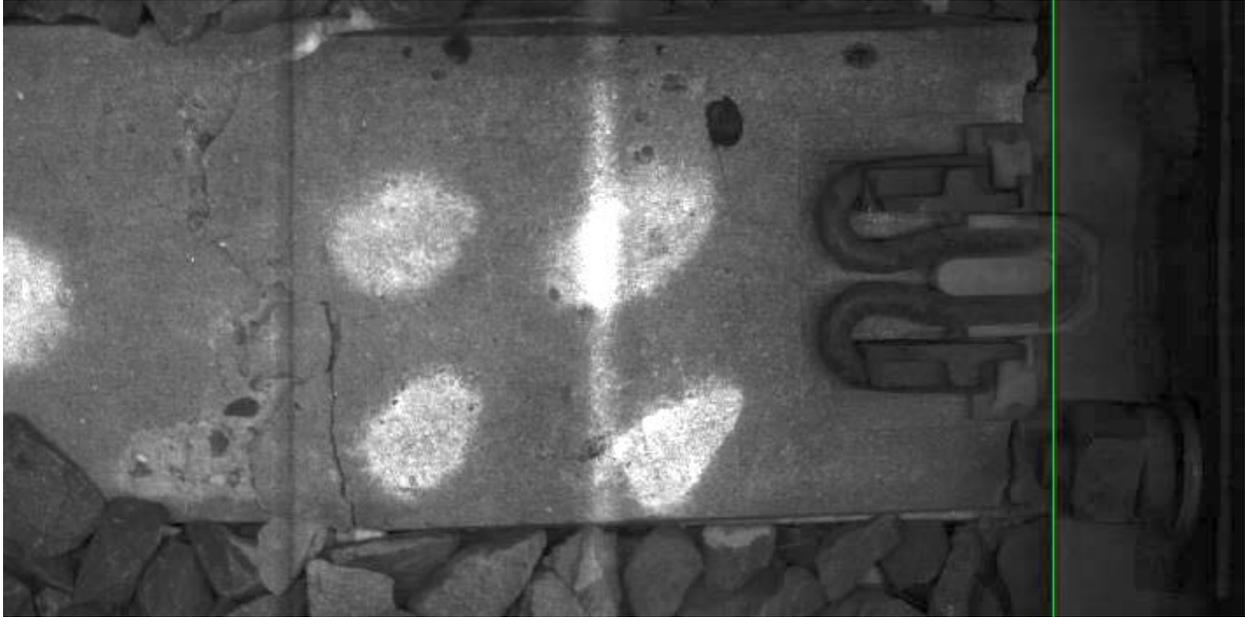
Figure A-9. Example of a Typical Mid Gauge Crack

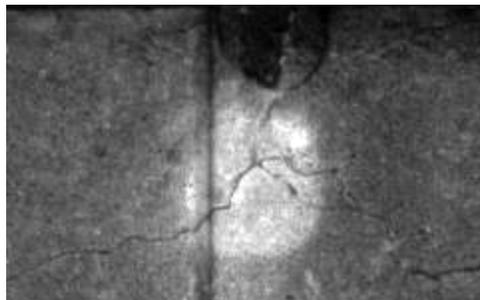
Figure A-10. Example of a Typical Spider Crack

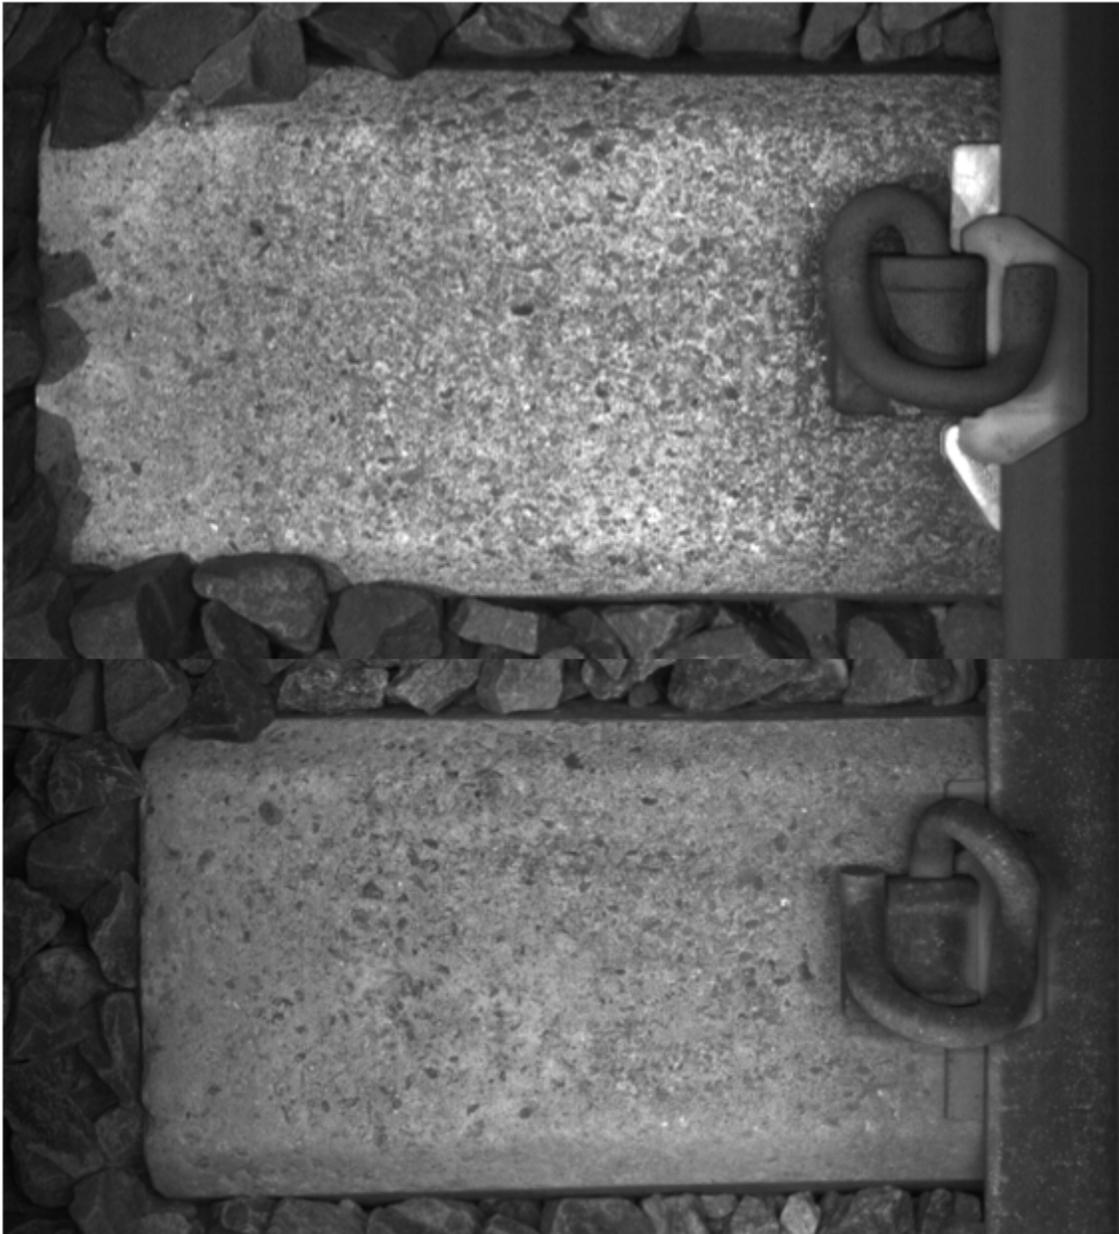
Figure B-1. Two Tie Shoulders in Excellent Condition—Tie Grade = 1

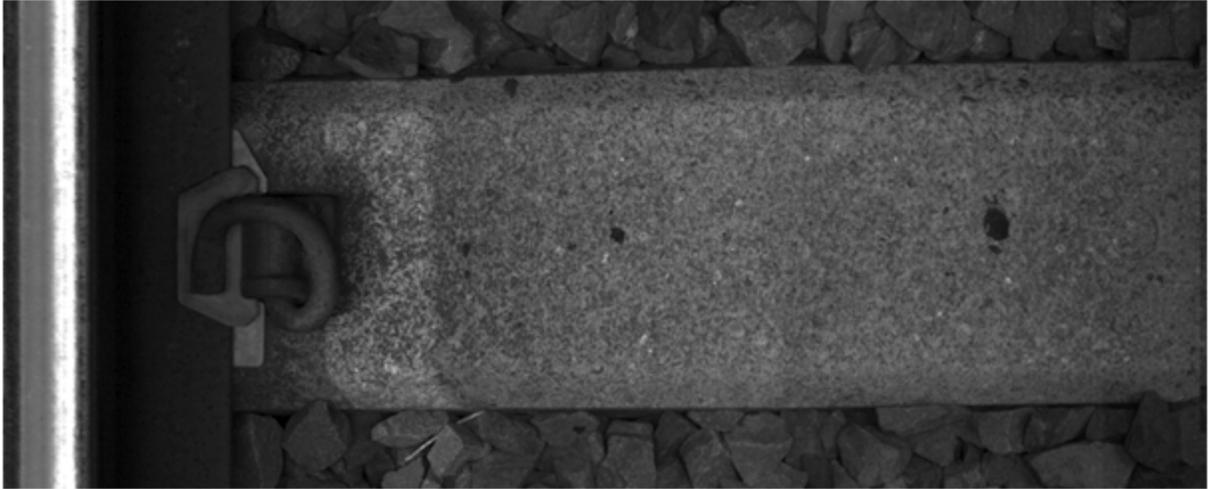
Figure B-2. Section of Tie Between the Rails in Excellent Condition —Tie Grade = 1

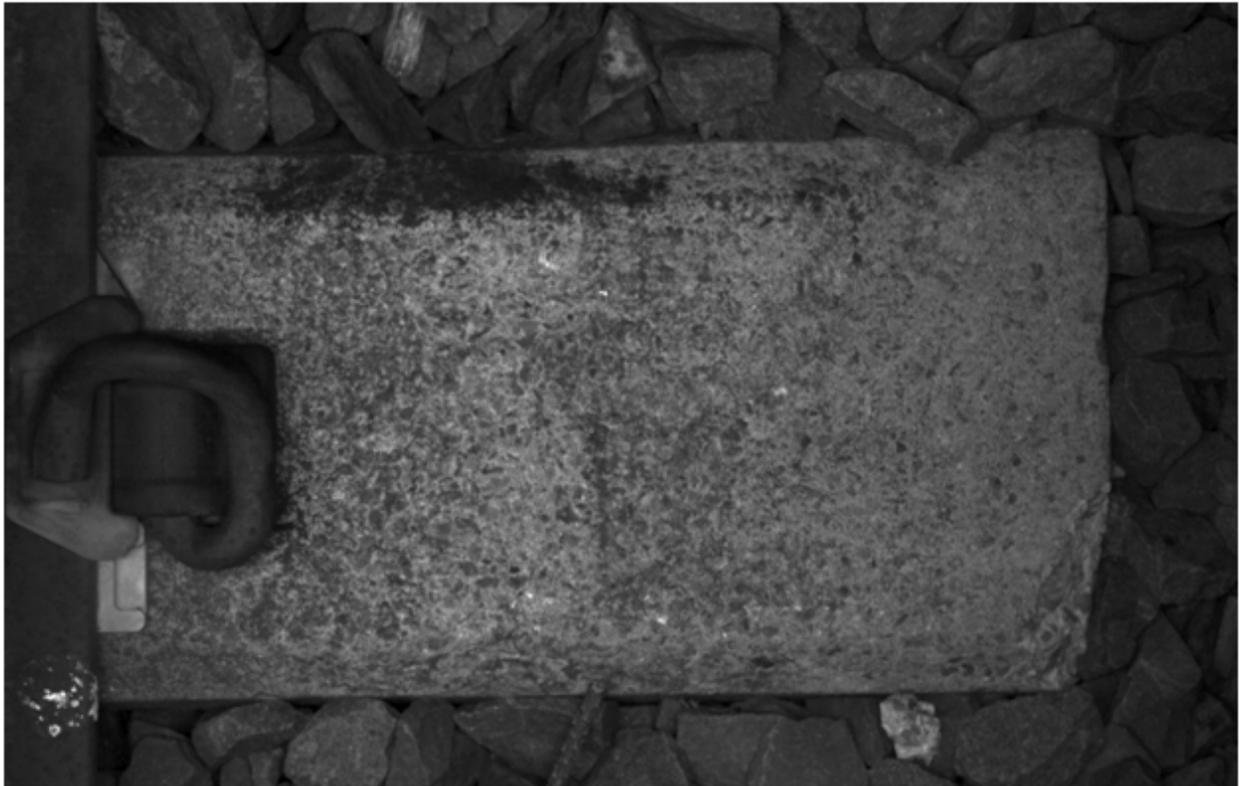
Figure B-3. Tie Shoulder with Minor Chip on One Corner—Tie Grade = 1

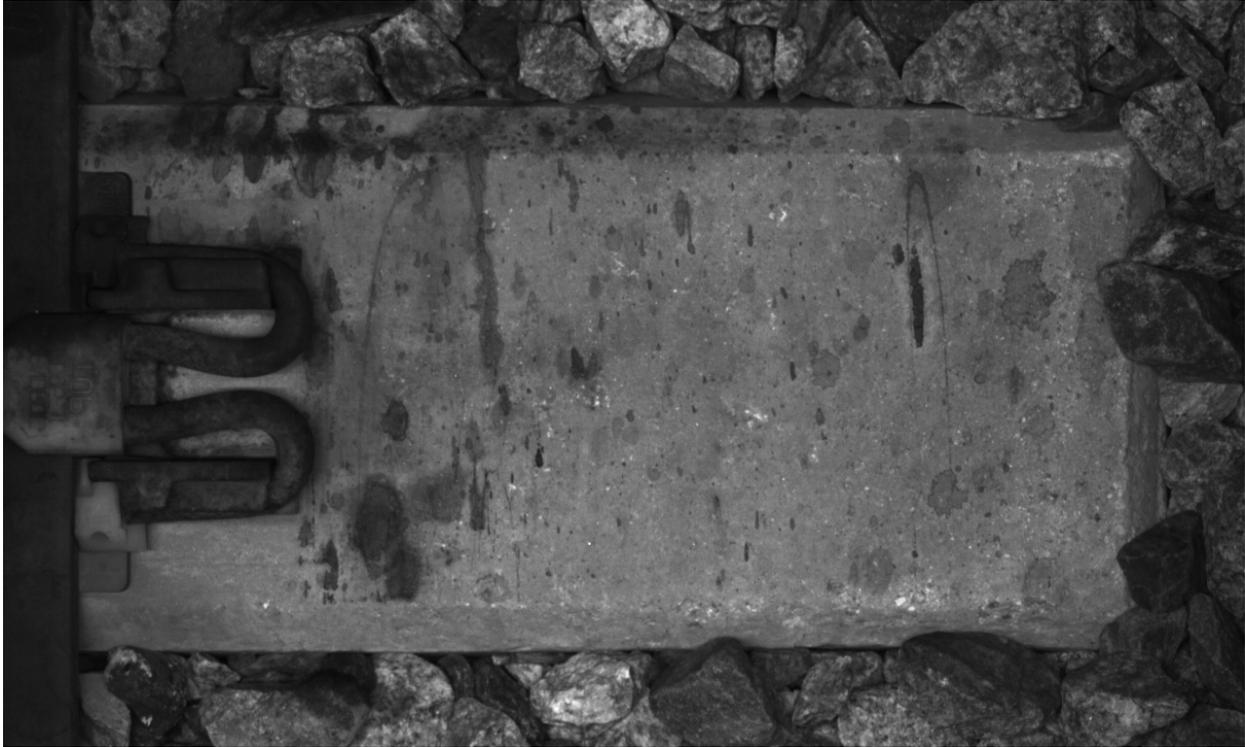
Figure B-4. Tie Shoulder with Surface Contamination—Tie Grade = 1

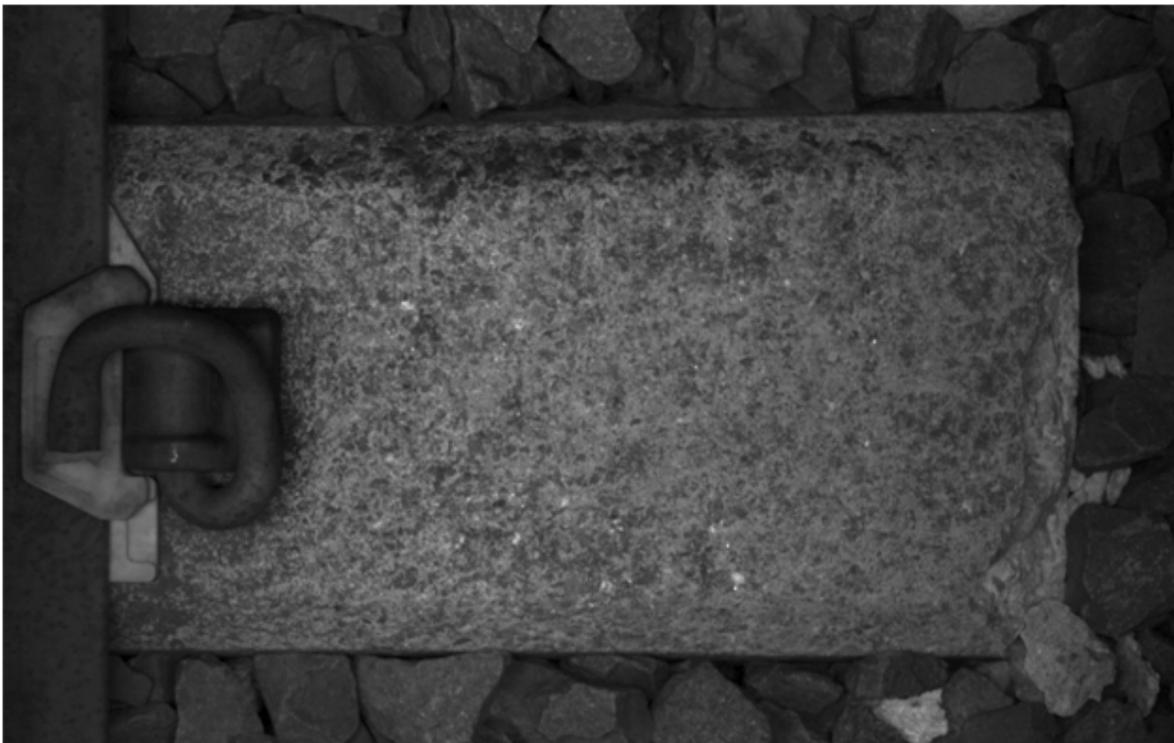
Figure B-5. Tie Shoulder Exhibiting Preliminary Signs of Crumbling Impacting Less Than 10 Percent of Shoulder—Tie Grade = 1

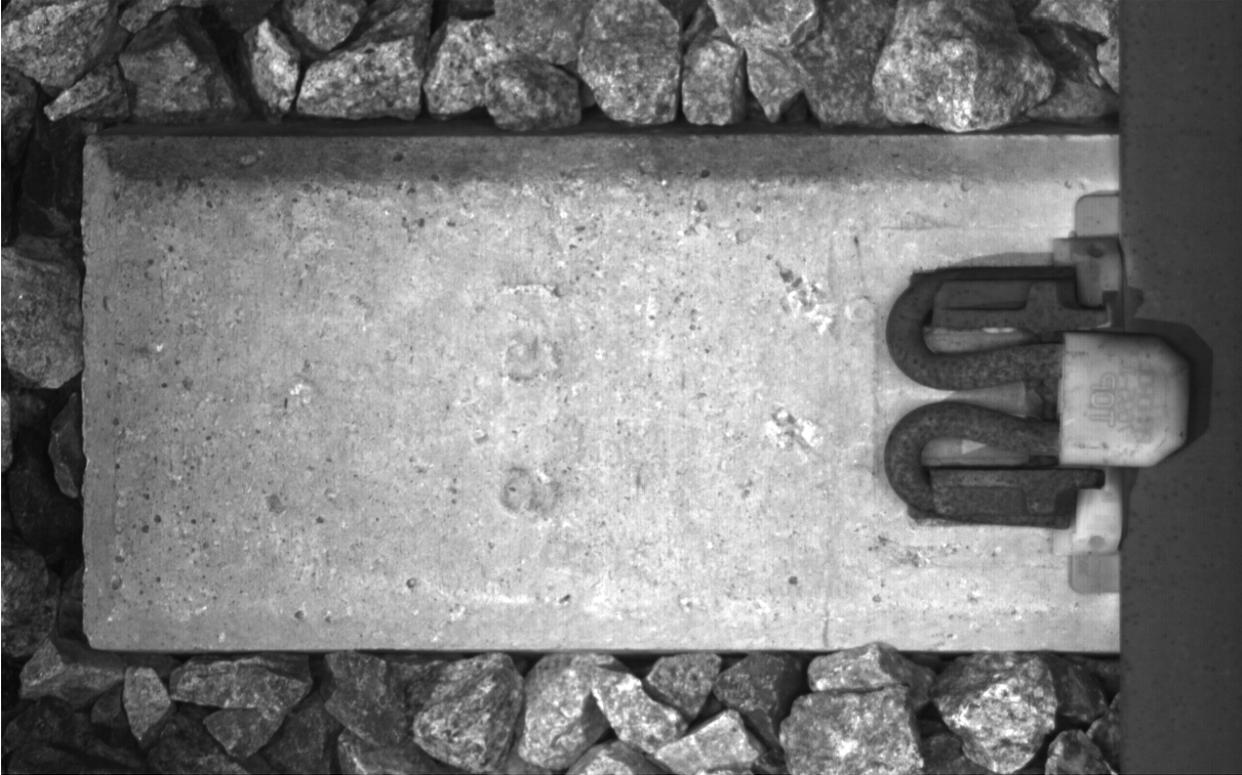
Figure B-6. Tie Shoulder with Inconsequential Surface Irregularities—Tie Grade = 1

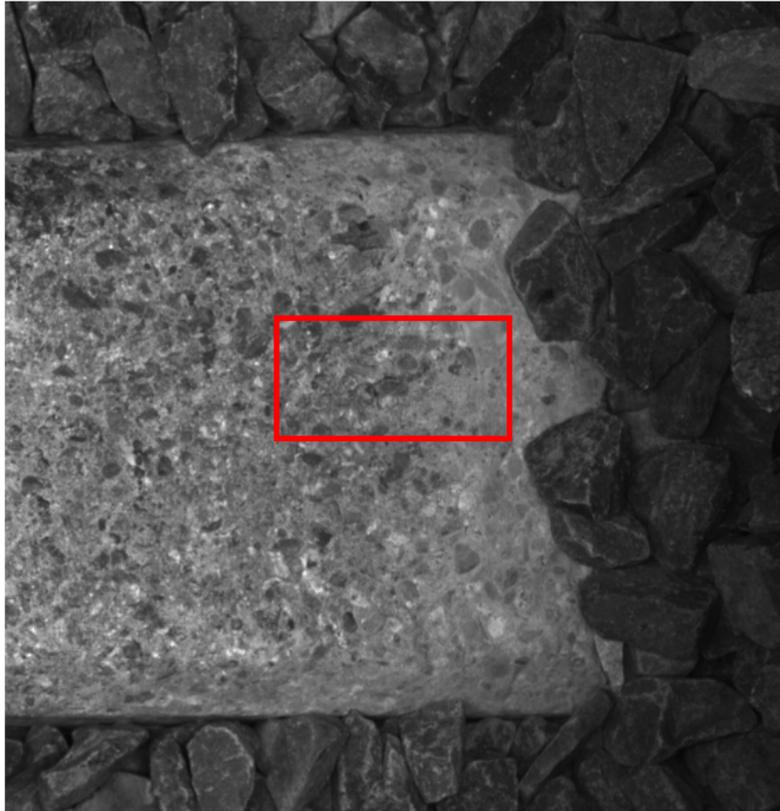
Figure B-7. Early-Stage Hairline Crack with Estimated Potential to Reach a Rail Seat Zone—Tie Grade 2

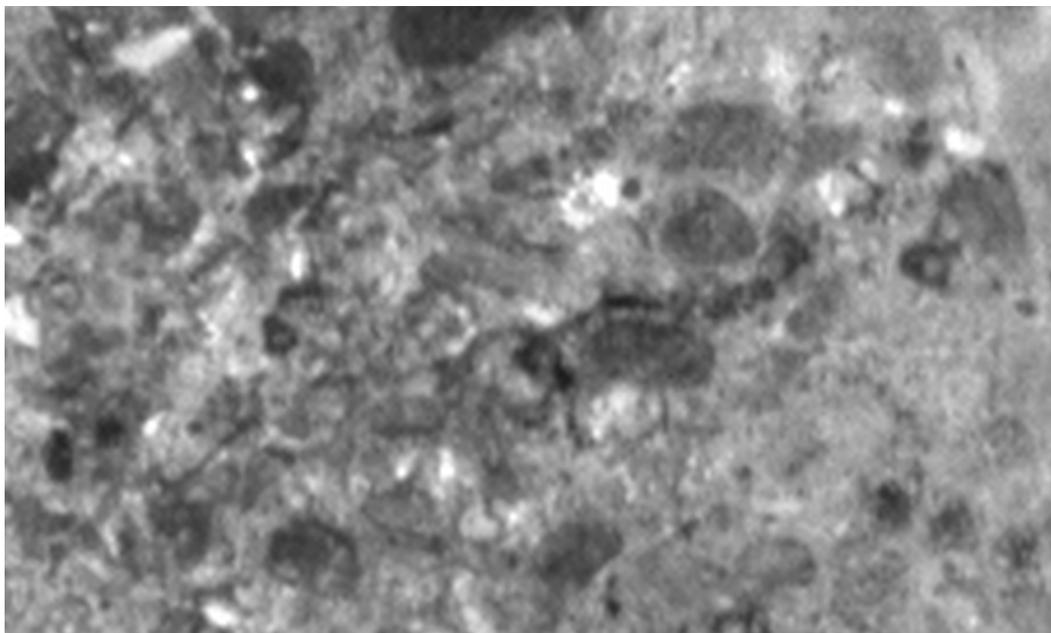
Figure B-8. Close-Up View of Early Stage Crack Shown in Figure B-7

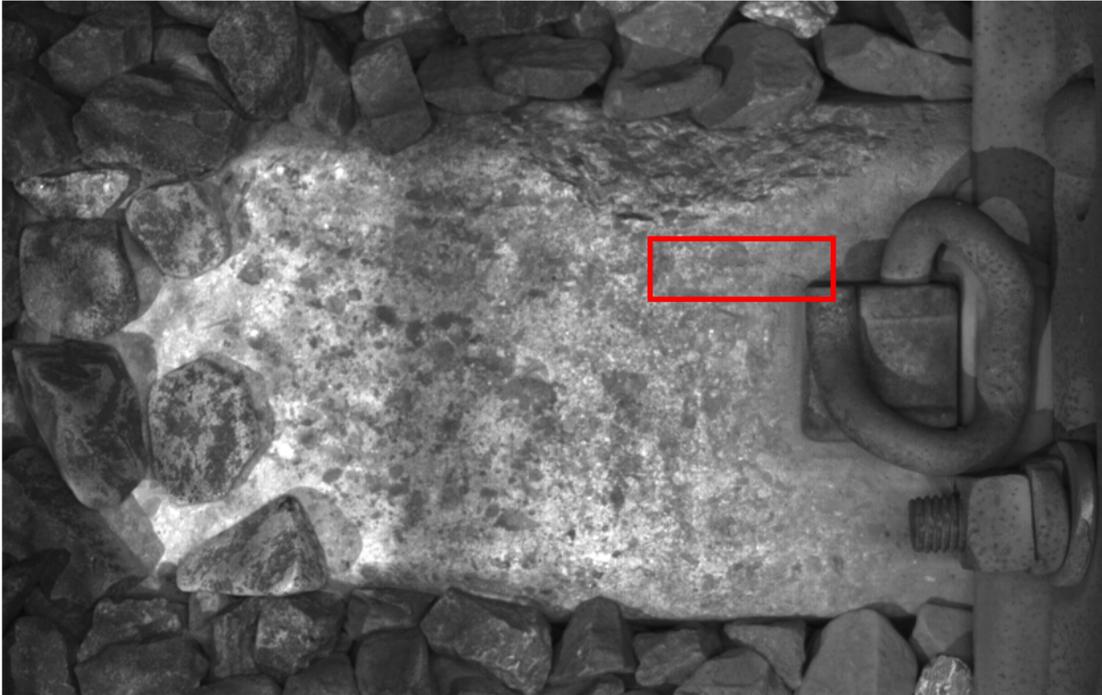
Figure B-9. Tie Chip Not Reducing Width of Rail Seat Zone by More Than 1 Inch, One Rail Seat Zone Impacted by a Crack, and Total Crack Length Less Than 9 Inches—Tie Grade 2

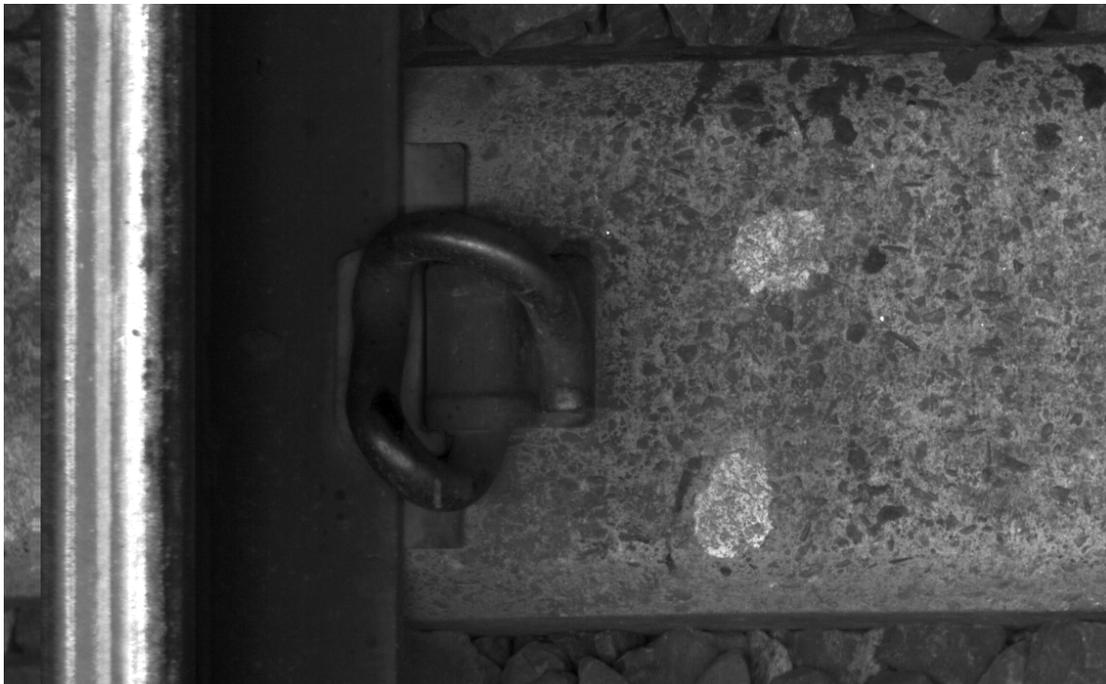
Figure B-10. Marking Between the Rails (Two White Dots) Applied by Amtrak to Indicate a Tie Grade 2 for the Tie Shown in Figure B-9

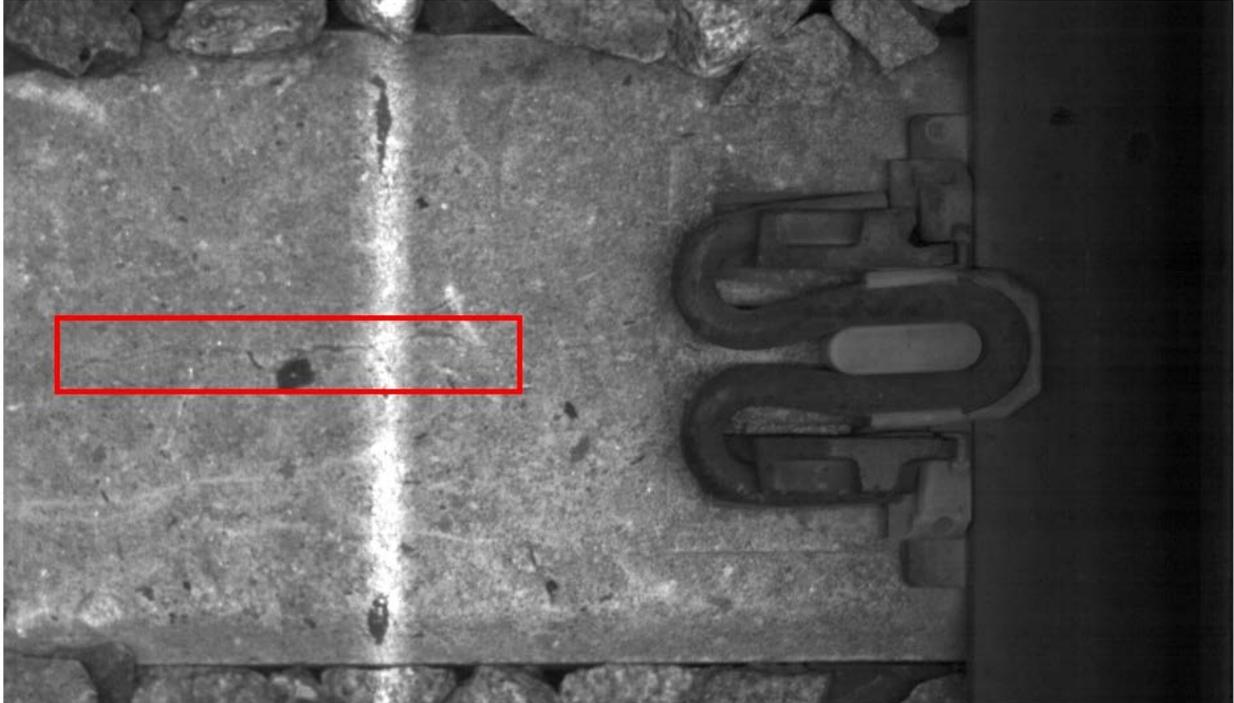
Figure B-11. Longitudinal Hairline Crack Between the Rails, Total Length Less Than 9 Inches—Tie Grade = 2 (This Tie is on the Border Between Grades 2 and 3)

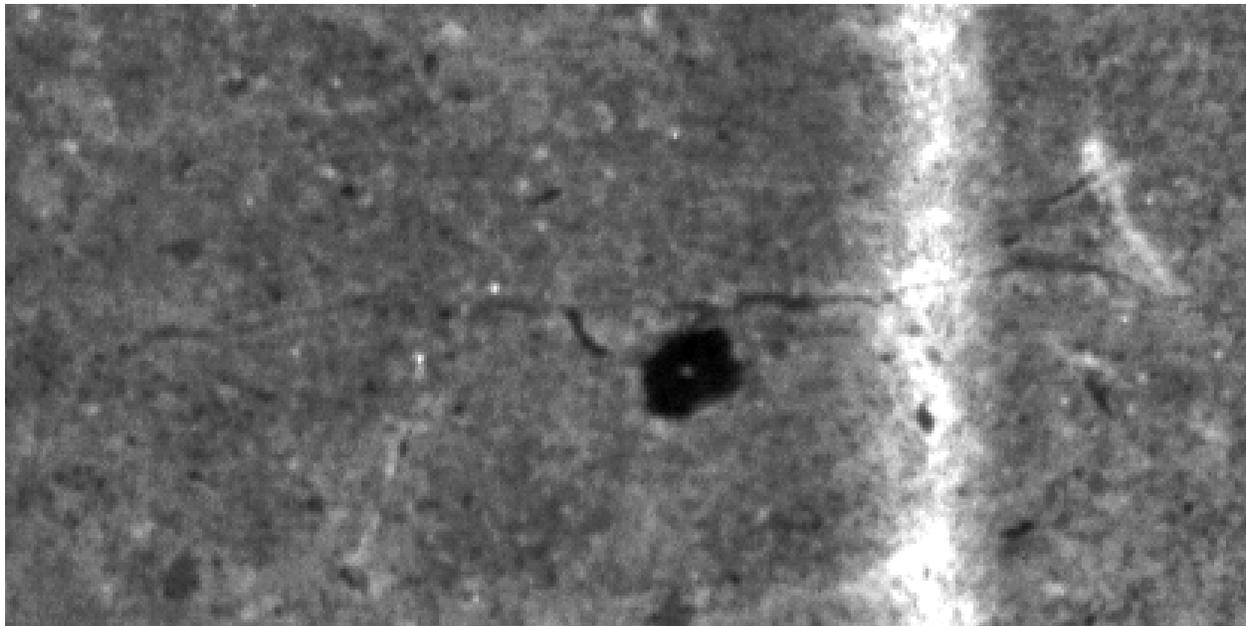
Figure B-12. Enlarged View of Hairline Crack Shown in Figure B-11

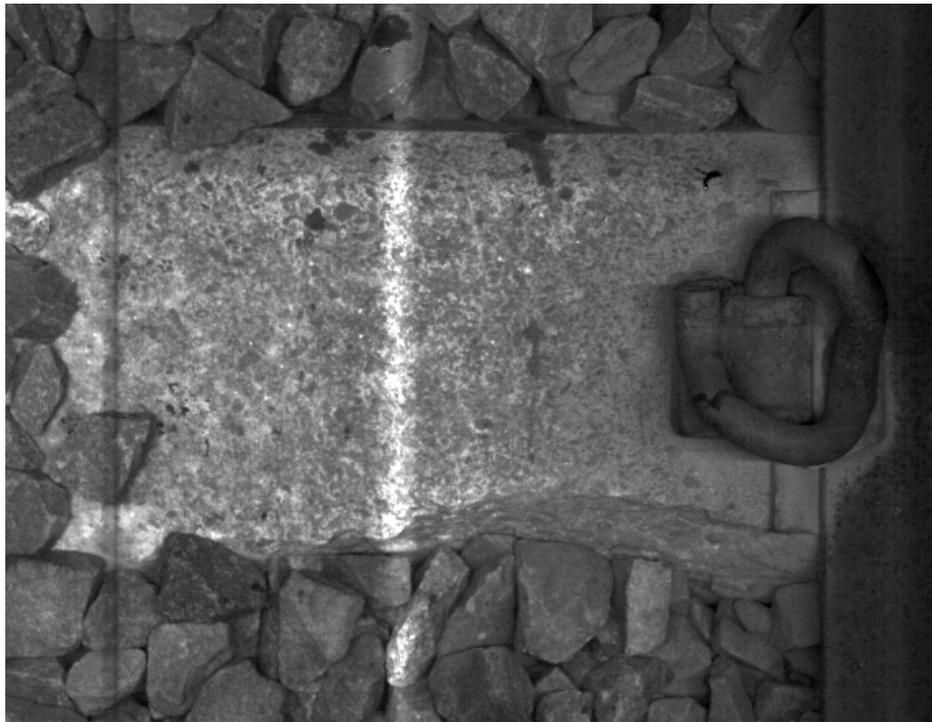
Figure B-13. Nonconformance Reducing Tie Width in Rail Seat Zone by More Than 1 Inch but Less Than 2 Inches—Tie Grade = 3

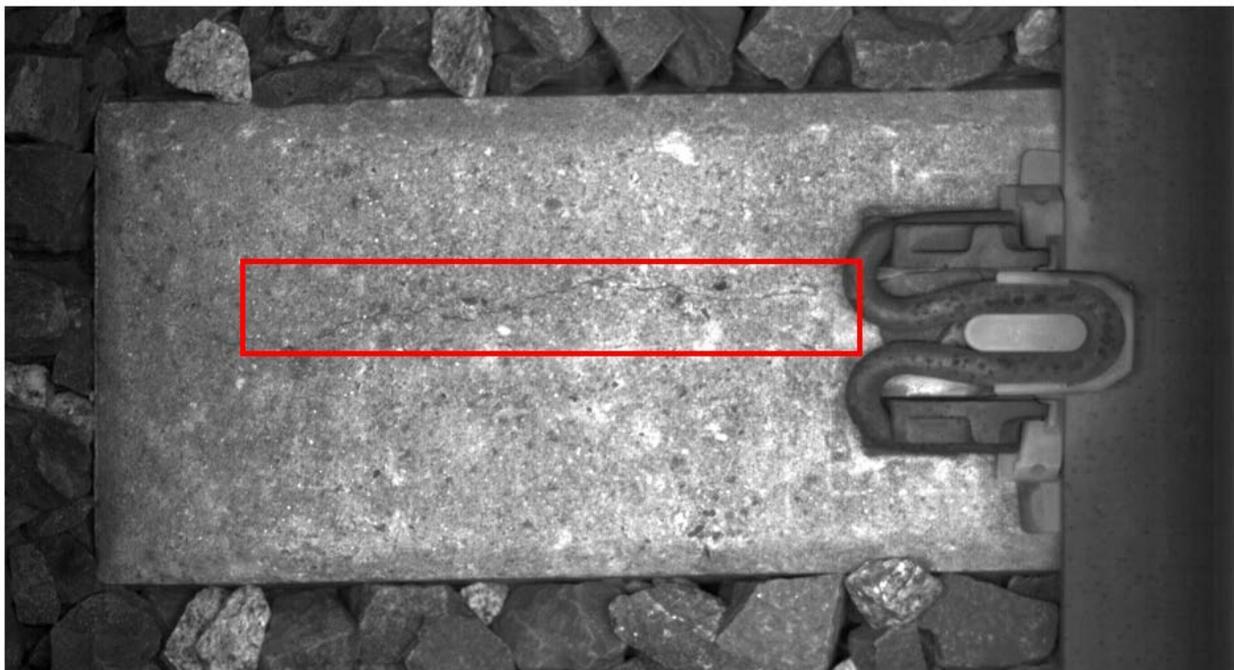
Figure B-14. Tie with Center Crack, Total Crack Length Greater Than 9 Inches—Tie Grade = 3

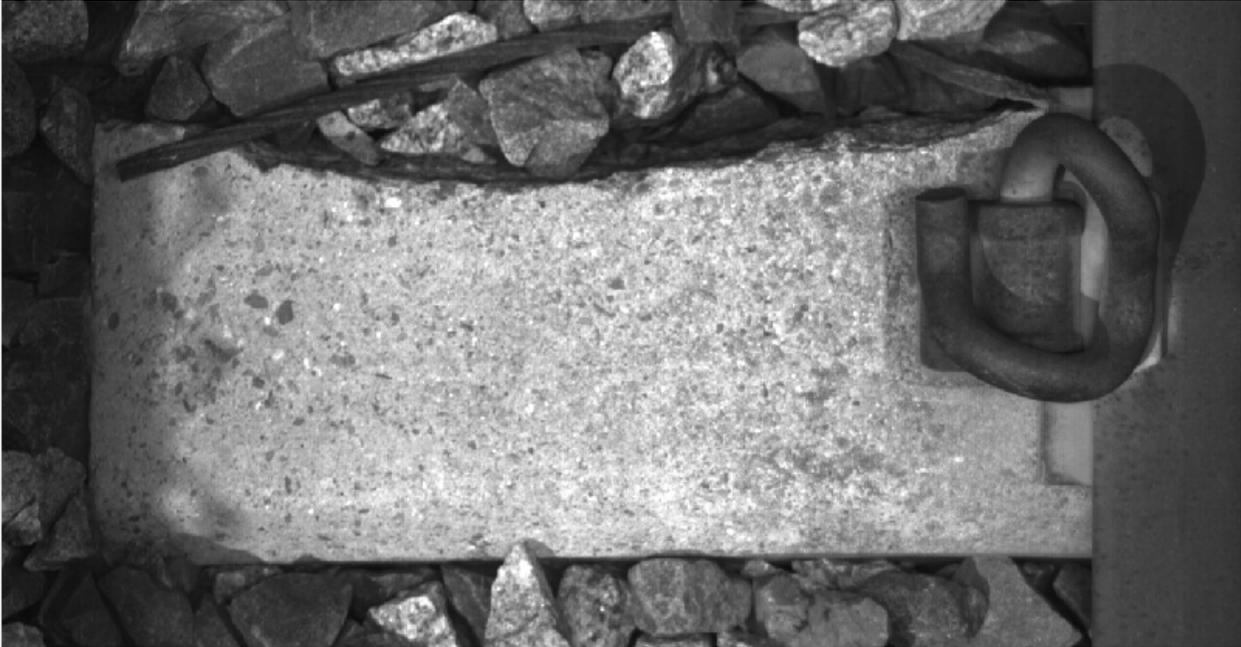
Figure B-15. Tie with One Pre-Tensioning Wire Exposure Site—Tie Grade = 4

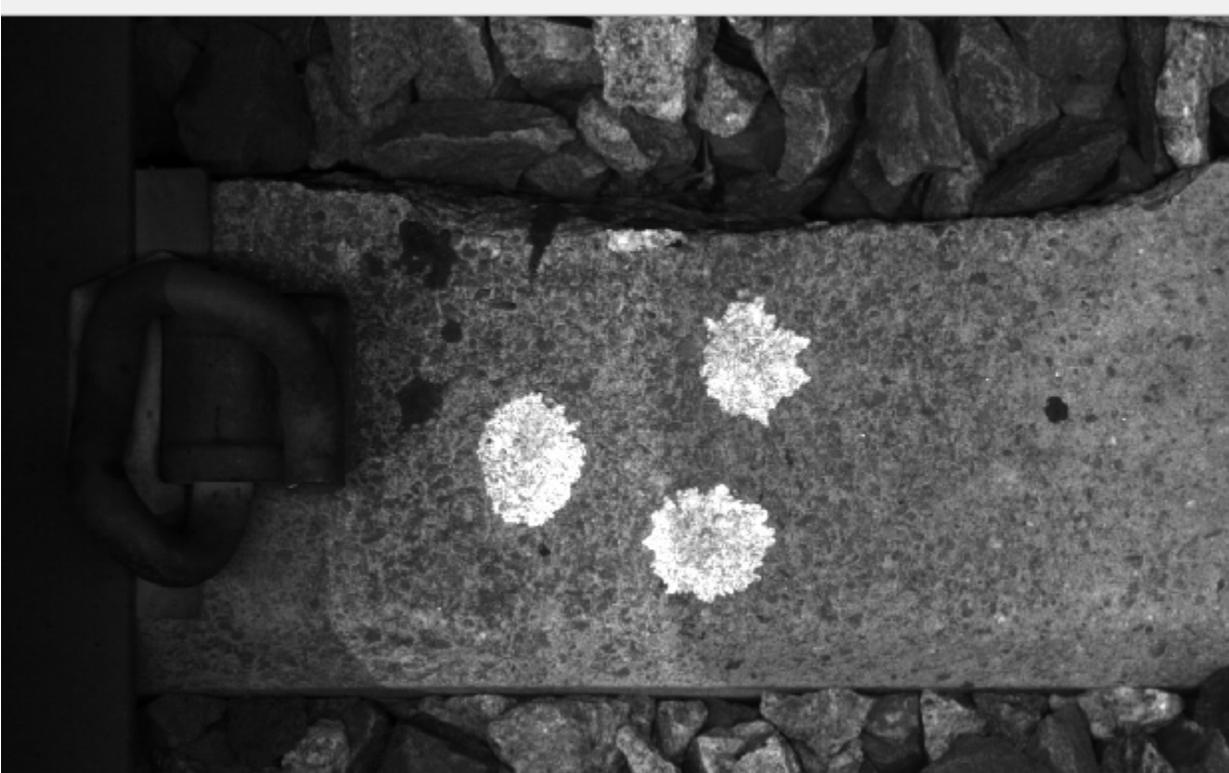
Figure B-16. Tie Width Reduced by More Than 2 Inches Between the Rails—Tie Grade = 4
