Evaluation of the Degradation of Concrete Ties Using Machine Vision Technology on High-Speed Rail Corridors

1. AGENCY USE ONLY (Leave blank)		2. REPORT DATE July 2018	3. REPORT TYPE AND DATES COVERED Technical Report – 2011	
4. TITLE AND SUBTITLE Evaluation of the Degradation of Concrete Ties Using Machine Vision Technology on High-Speed Rail Corridors			5. FUNDING NUMBERS DTFR53-12-C-00003

6. AUTHOR(S) Herbert J. Henderson; Eric T. Sherrock				
7. PERFORMING ORGANIZATION NAME(S) AND ADDRESS(ES) ENSCO, Inc. 5400 Port Royal Road Springfield, VA 22151			8. PERFORMING ORGANIZATION REPORT NUMBER SERV-REPT-0000479 Rev B

9. SPONSORING/MONITORING AGENCY NAME(S) AND ADDRESS(ES) U.S. Department of Transportation Federal Railroad Administration Office of Railroad Policy and Development Office of Research, Development and Technology Washington, DC 20590			10. SPONSORING/MONITORING AGENCY REPORT NUMBER DOT/FRA/ORD-18/26

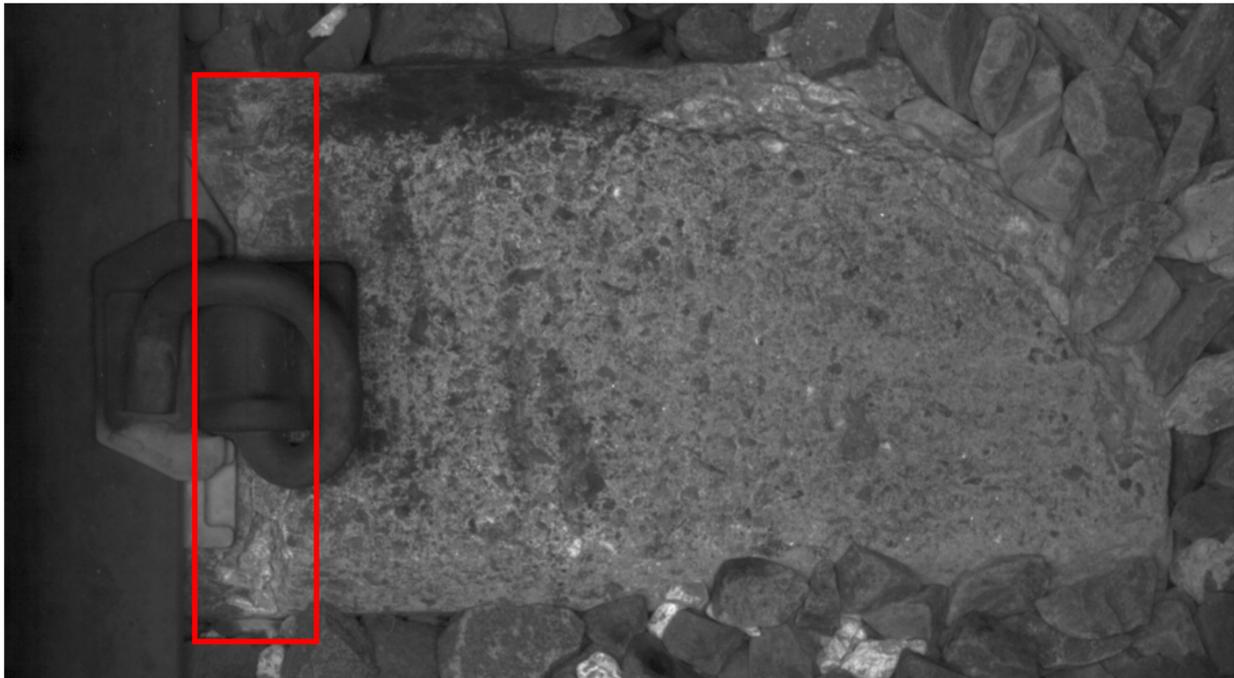
Figure B-18. Crack Passing Perpendicular to Tie Through Rail Seat Zone Spanning More Than 60 Percent of Tie's Width—Tie Grade = 5

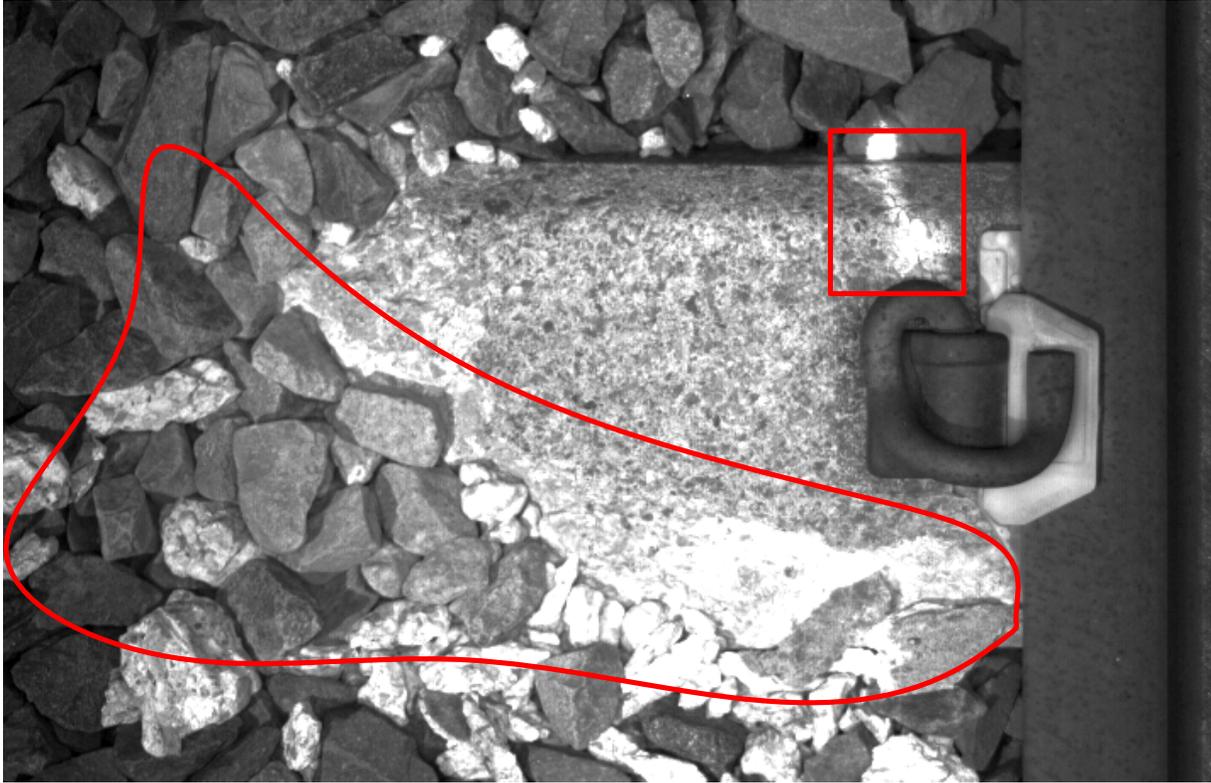
Figure B-19. More Than 60 Percent of Tie Shoulder in Crumbled State—Tie Grade = 5

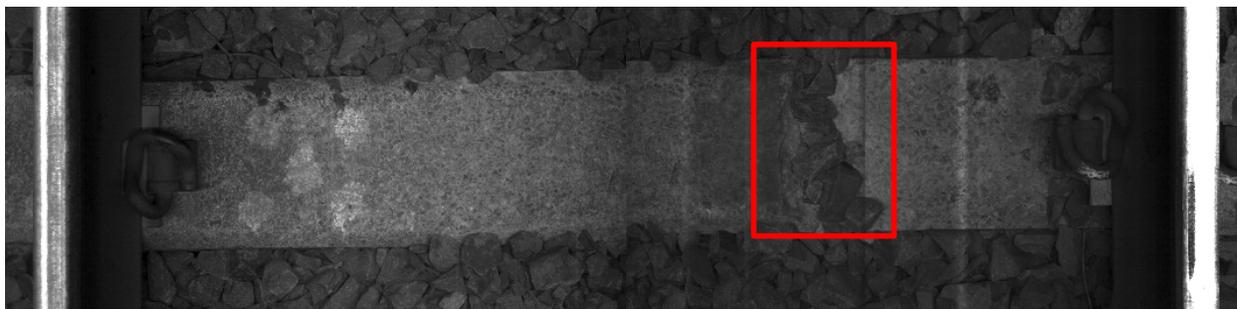
Figure B-20. Crack Perpendicular to Tie Between the Rails Spanning More Than 60 Percent of Tie's Width—Tie Grade = 5

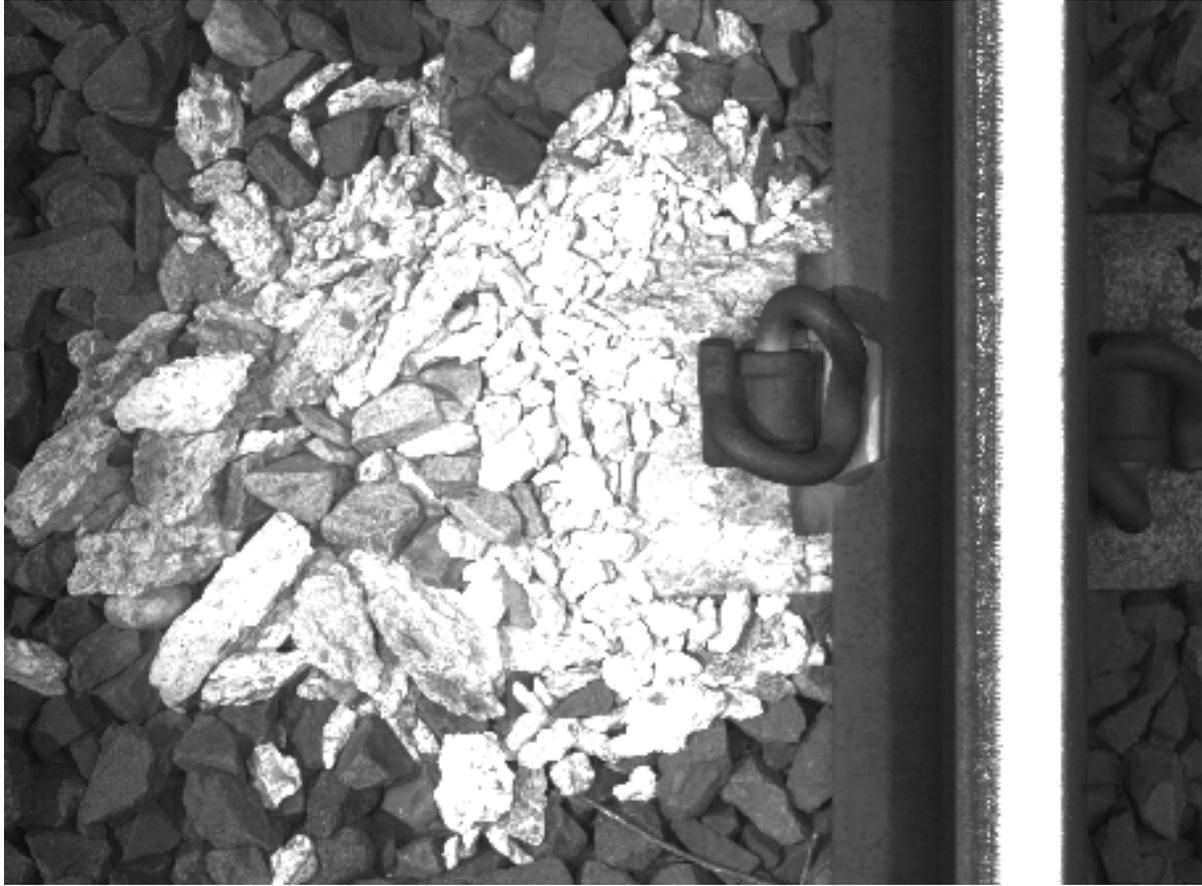
Figure B-21. More Than 60 Percent of Tie Shoulder in Crumbled State—Tie Grade = 5

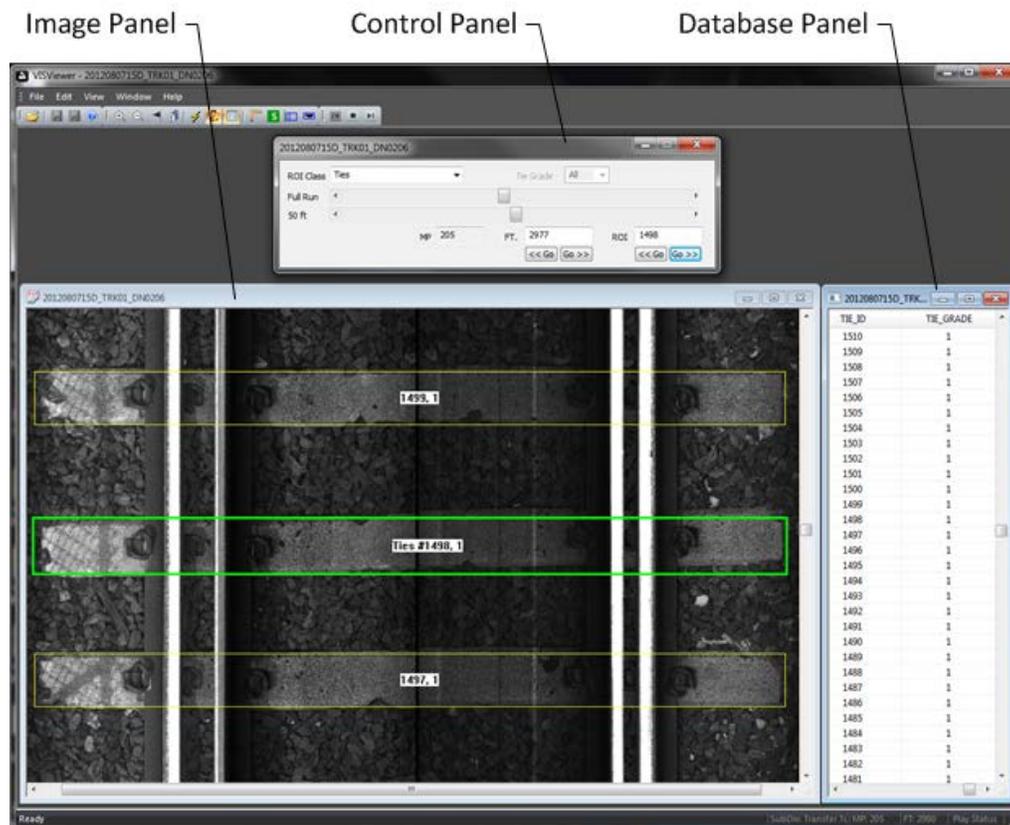
After the user launches the software and specifies a track bed image file, a view similar to Figure C-1 appears.

Figure C-1. Typical Screen Configuration Used When Locating Defects in Concrete Ties

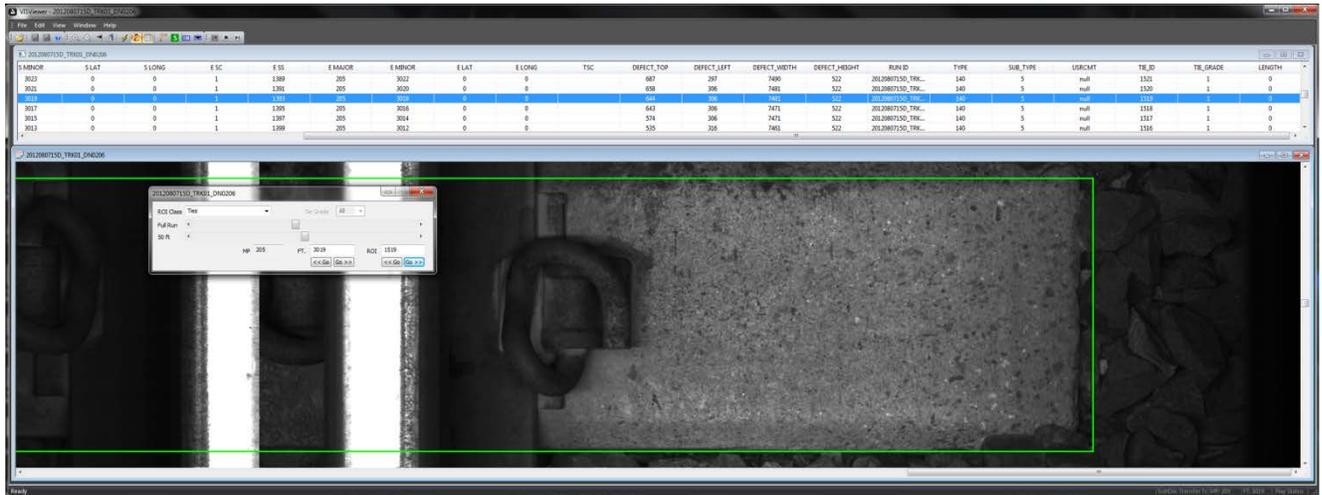
user to inspect an entire tie while zoomed in. After inspecting a given tie, a user will typically press either the up or down arrow key to automatically advance to the next tie. The ability to advance from one tie to the next is enabled by a pre-existing machine vision algorithm that automatically draws an approximate bounding box around each tie. The tie currently being evaluated (i.e., the active tie) is shown with a green border; all other ties are shown with a yellow border. Zooming and other operations, such as entering a tie grade, apply to the active tie.

Figure C-2. Typical Screen Configuration Used When Locating Defects in Concrete Ties

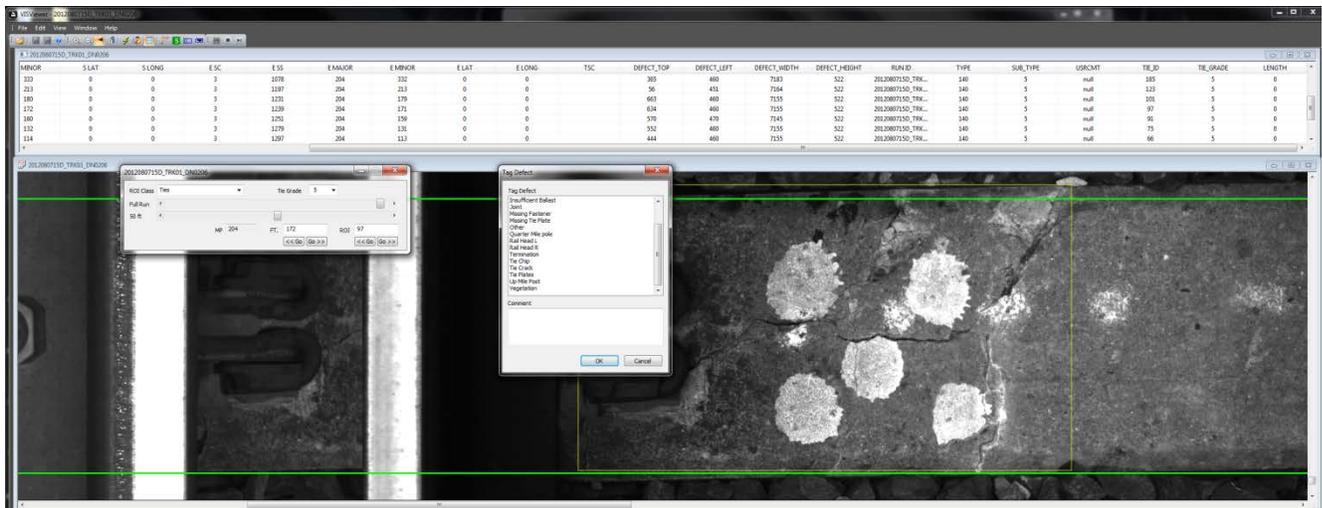
Figure C-3. Example of Marking a Cracked Tie Region with a Bounding Box Using the Subject Software

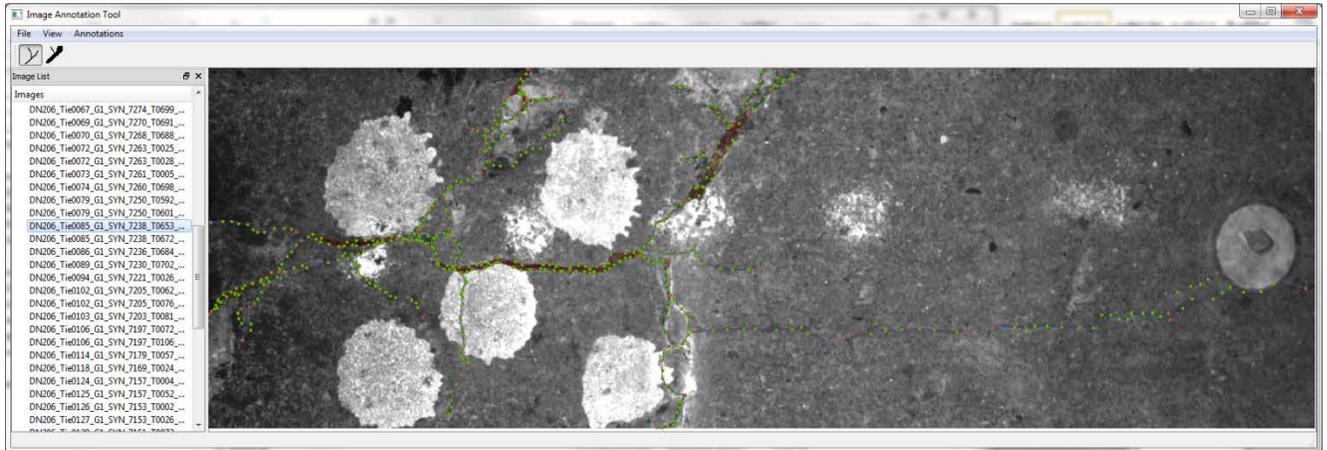
Figure C-4. Example Showing Human-Entered Outlines Around Cracks in a Defective Tie

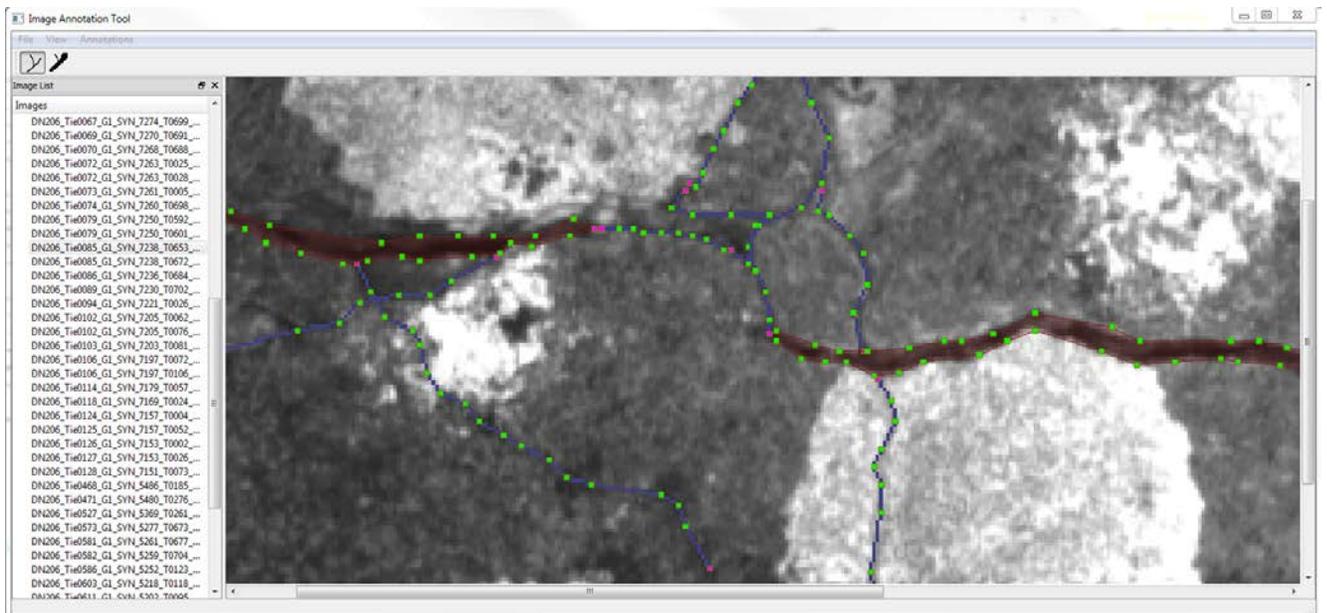
Figure C-5. Close-Up View of a Portion of the Cracked Tie Shown in Figure C-4

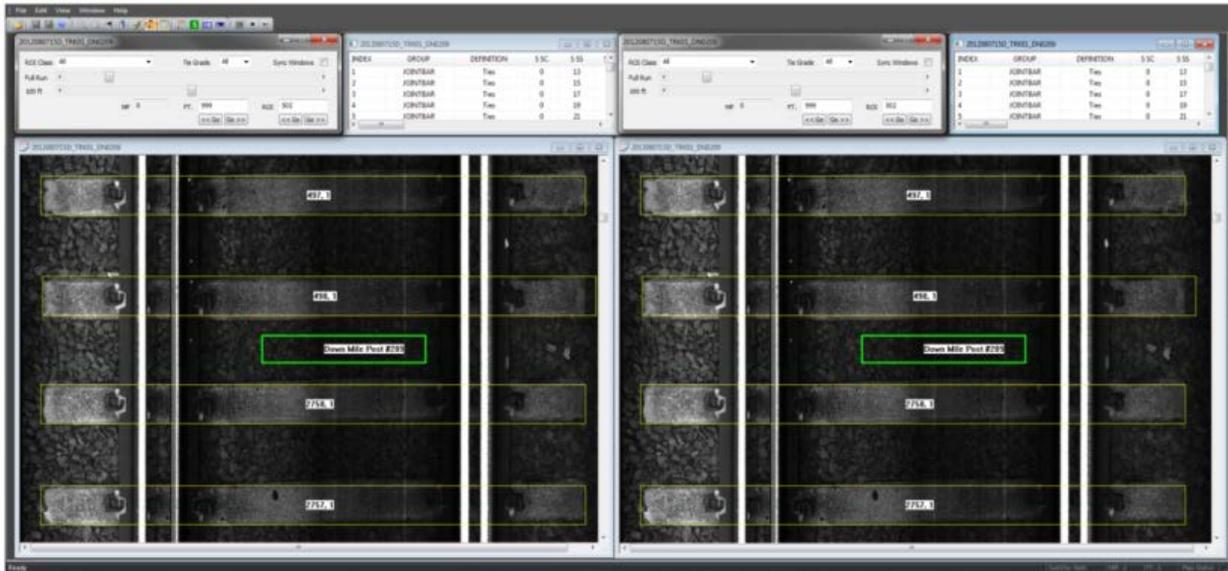
Figure C-7. Side-By-Side Track Bed Viewing Supported by the Phase 2 Software

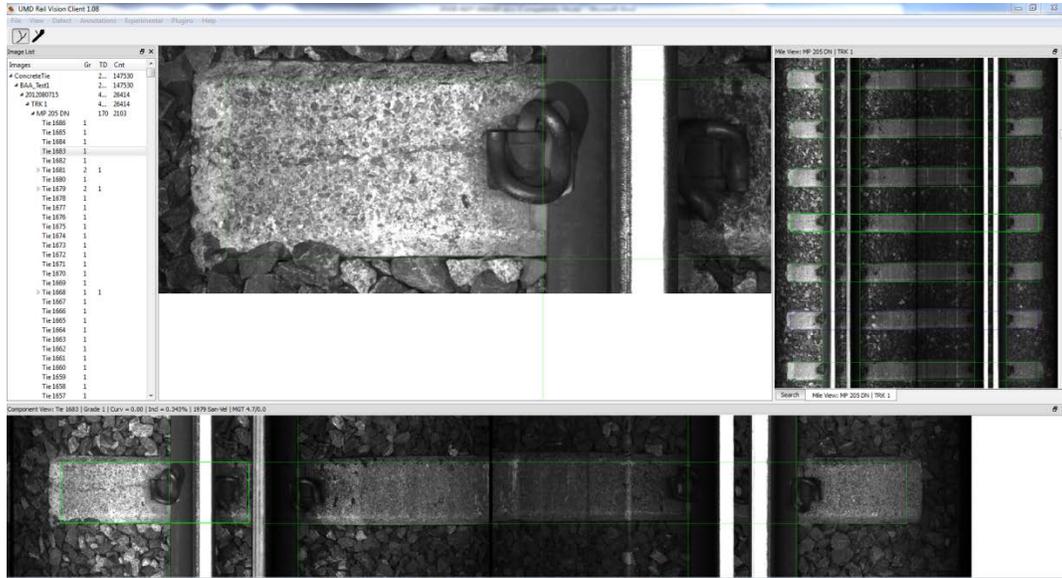
Figure C-8. GUI for University of Maryland Rail Vision Client Used in this Study to Annotate and Track Nonconformances

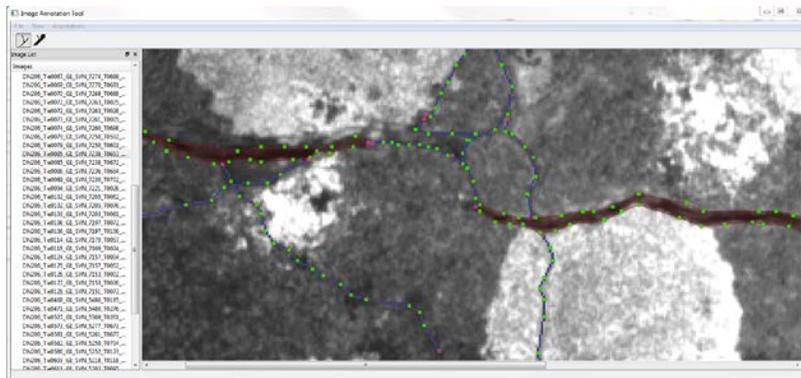
Figure C-9. Close-Up View of an Annotated Crack in a Concrete Tie
