U.S. Department of  
Transportation

Federal Railroad  
Administration

# Inspection of Concrete Ties Using Sonic/Ultrasonic Impact Velocity and Impact Echo Measurements

9. SPONSORING/MONITORING AGENCY NAME(S) AND ADDRESS(ES) U.S. Department of Transportation Federal Railroad Administration Office of Railroad Policy and Development Office of Research, Development and Technology Washington, DC 20590	10. SPONSORING/MONITORING AGENCY REPORT NUMBER  DOT/FRA/ORD-18/32
--	---

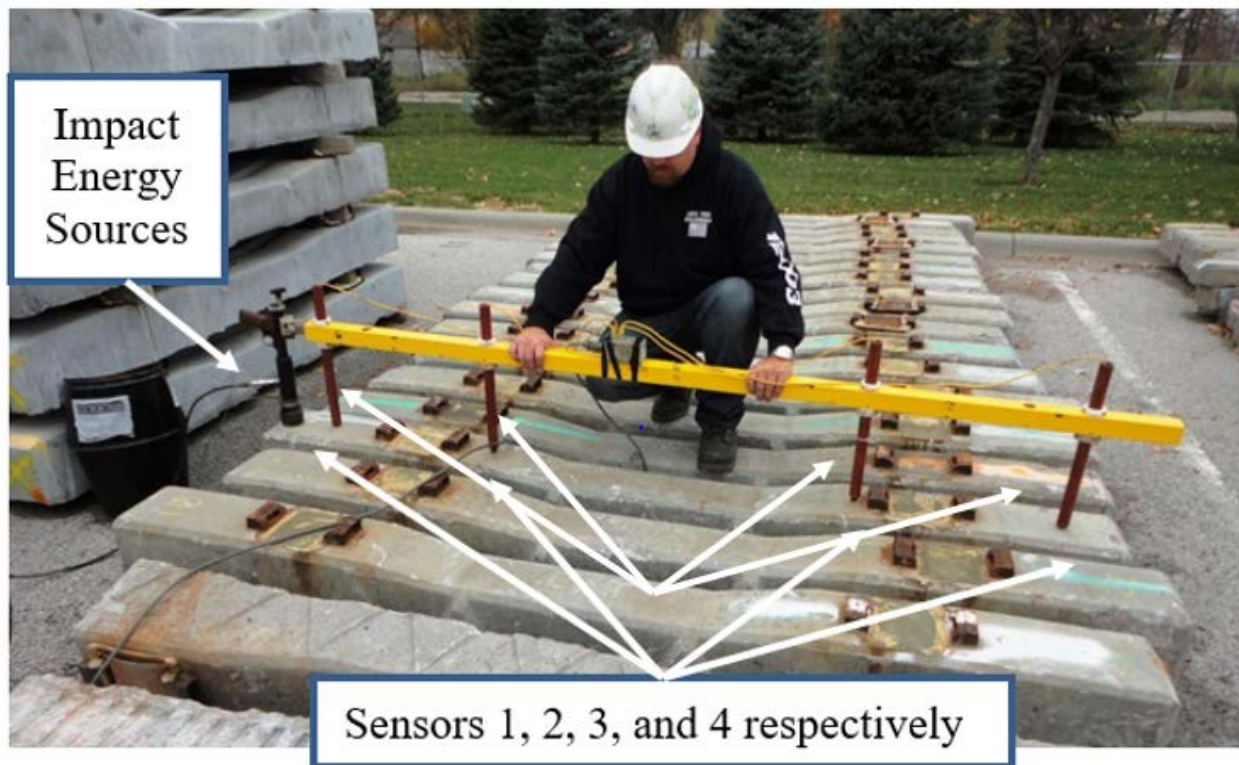
**Figure 2. Photo of Impact Energy Source and Sensor Array**

The handheld, prototype measurement beam is shown in Figure 2. To inspect a crosstie, the wave velocity is measured as the time of wave travel from the energy impact location to a linear array of sensors on the surface of the tie. Sensors are located on either side of the rail seat and energy impacts are independently generated at both ends of the tie. Data acquired by sensors 1 and 2, closest to the impact source, measures the condition of the tie from the energy impact location to the inside of the rail seat. Velocity data acquired at sensor 3 and 4, at the opposite end of the beam from the impact point, are used to evaluate for center vertical fractures. Tests are made at each end of the tie by flipping the measurement beam.

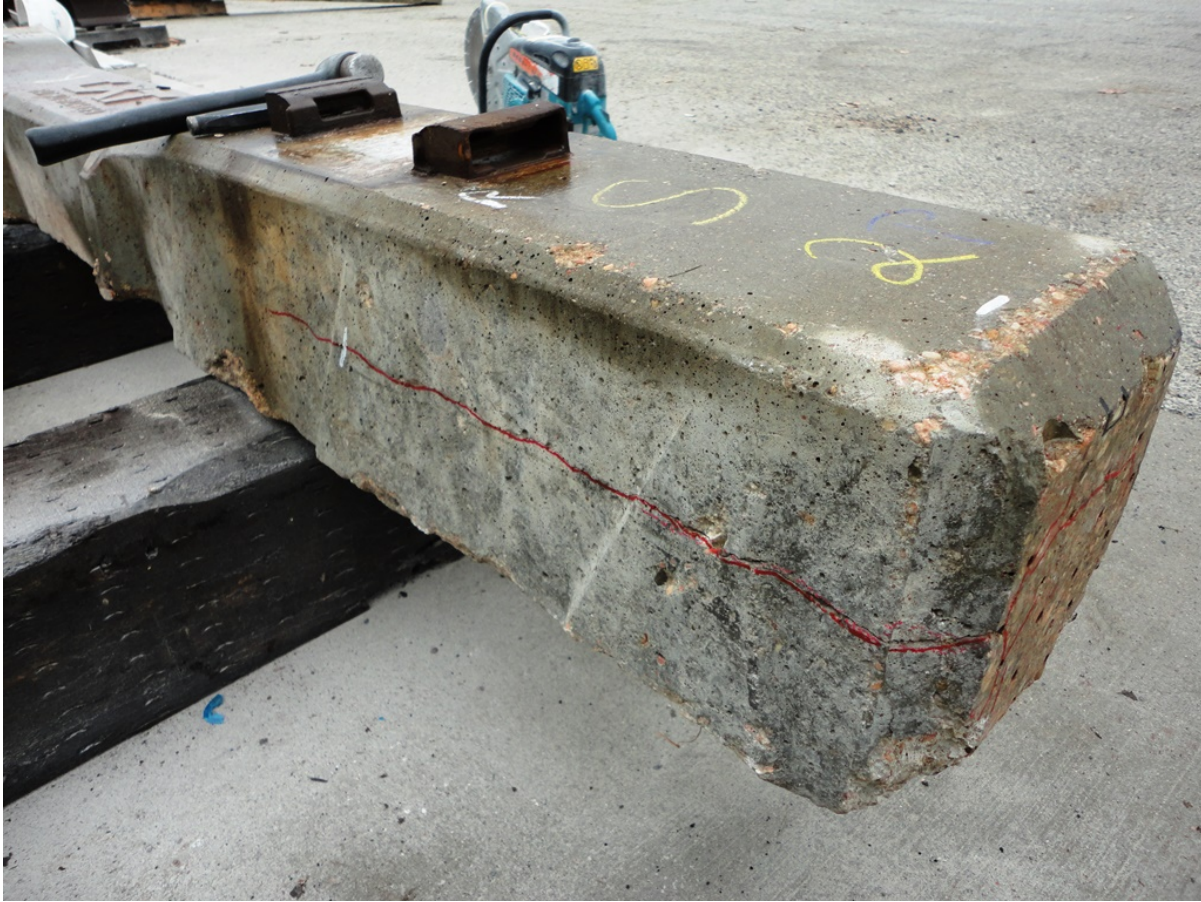
**Figure 4. Tie 2, South, Showing Horizontal Crack**

An evaluation of the inspection system was conducted at Union Pacific Railroad's (UP) Engineering Services, Inc. (ESI) facility in Omaha, NE, on October 21–23, 2012. Seventy-one ties at various stages of deterioration, ranging from new to falling apart, were tested using the device pictured in Figure 2. Each tie was marked with an identification number (1 to 71) and end direction (N-north end, S-south end). Visible exterior surface cracks were highlighted with red keel and ties with pulled pre-stressing wires labeled with a "P." Tie 2, south end, is shown in Figure 4.

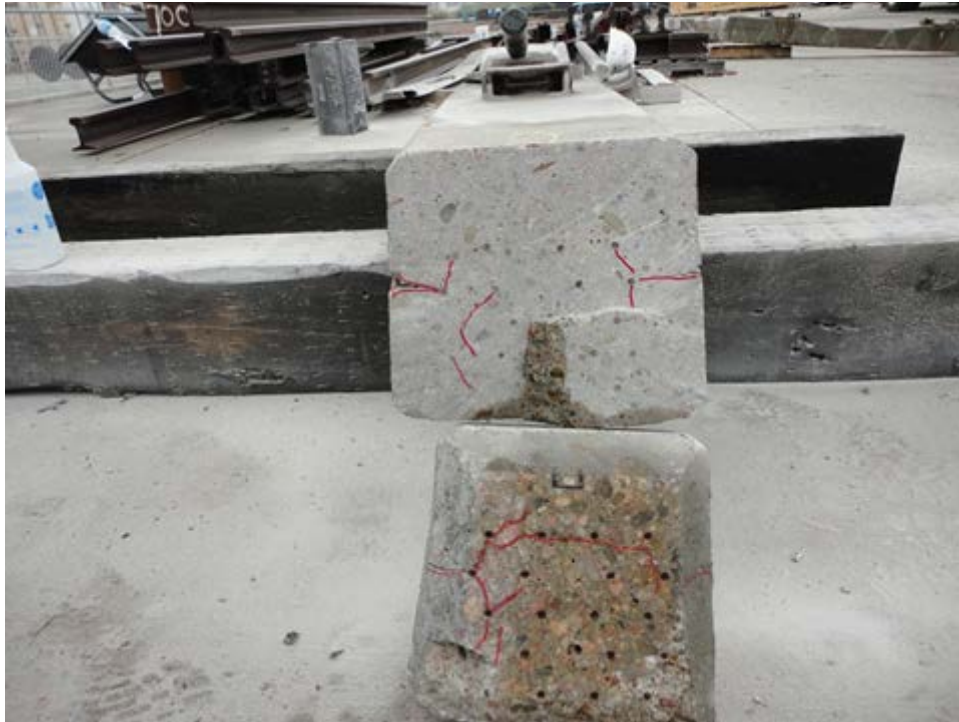
**Figure 6. Example of Internal Cracking**

Based on the test results, six tie ends were dissected and the internal cracking patterns were mapped, as shown in Figure 6.

Observations indicate that the pattern of crack propagation does not include cracking visible in the top surface until the side and cross-section cracks have progressed to a moderate stage of deterioration. The appearance of top cracks in a tie is an indication that the tie has significant internal cracking. The ties documented in this investigation demonstrate that by the time a crack is visible in the top chamfer and top surface to a length of several inches, the pattern of cracking along the sides of the tie and within the tie has progressed significantly. Appendix A contains a detailed report of the tie dissection activity.

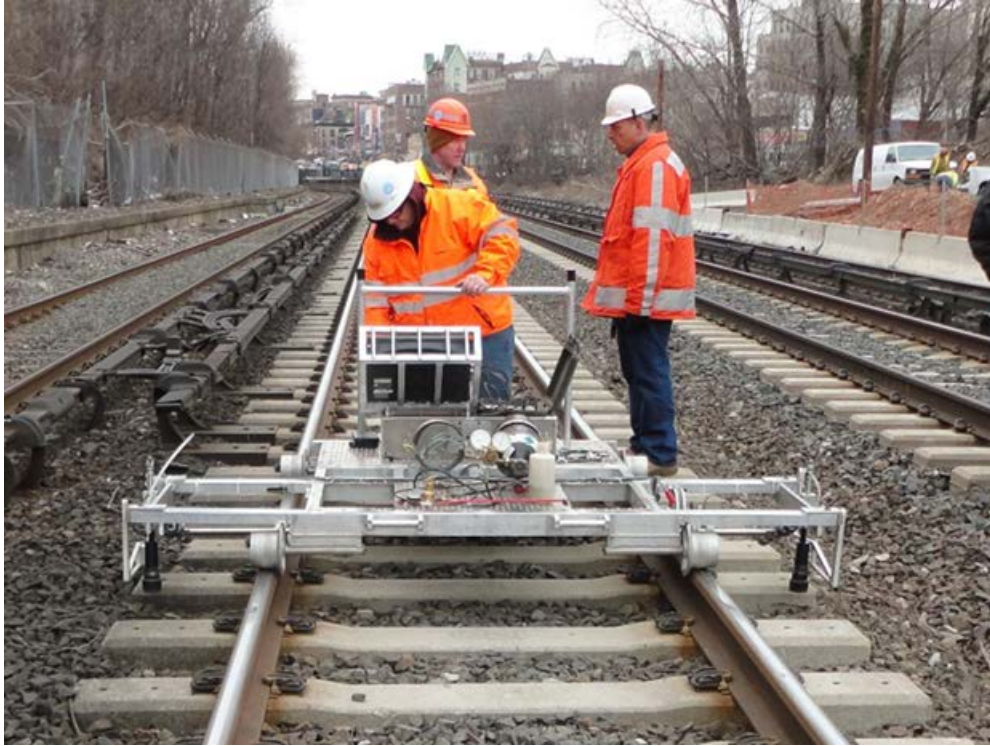
**Figure 8. ACTT-1 System on Metro-North Railroad**

To demonstrate that the IV and IE measurements can be made in a production mode, an on-rail ACTT-1 push carriage was built and tested, seen in Figure 8.

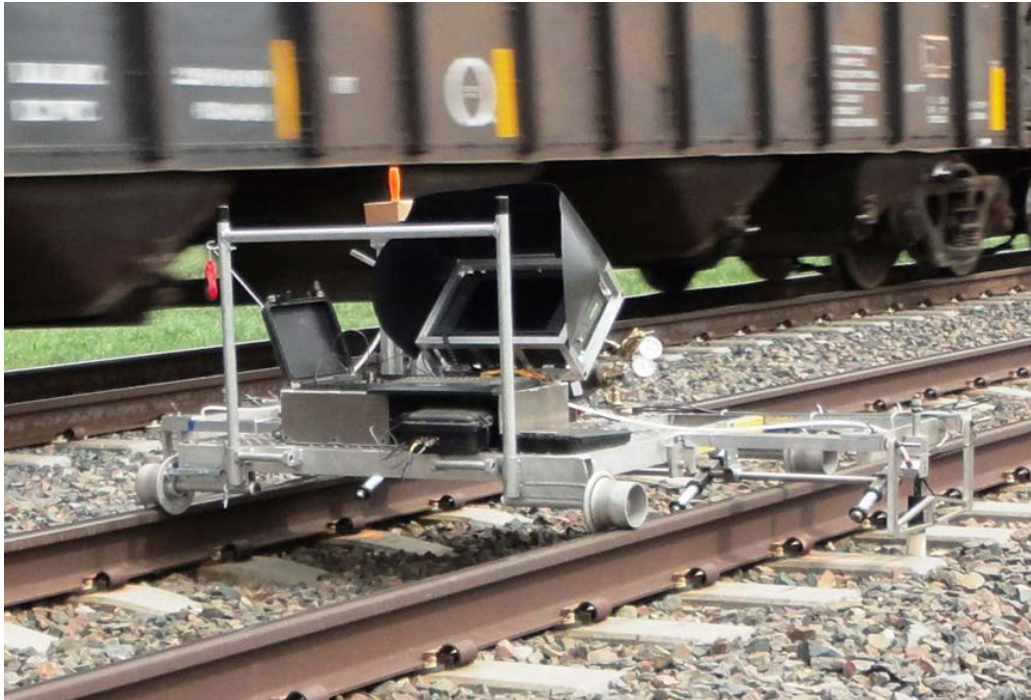
**Figure 9. ACTT-1 System on UP Track**

NDT completed an evaluation of the use of nondestructive PV and IE testing to rate in-service concrete cross-ties along a section of UP's line between Central City and Clark, NE, on May 20–22, 2013. Ninety-one ties were tested.

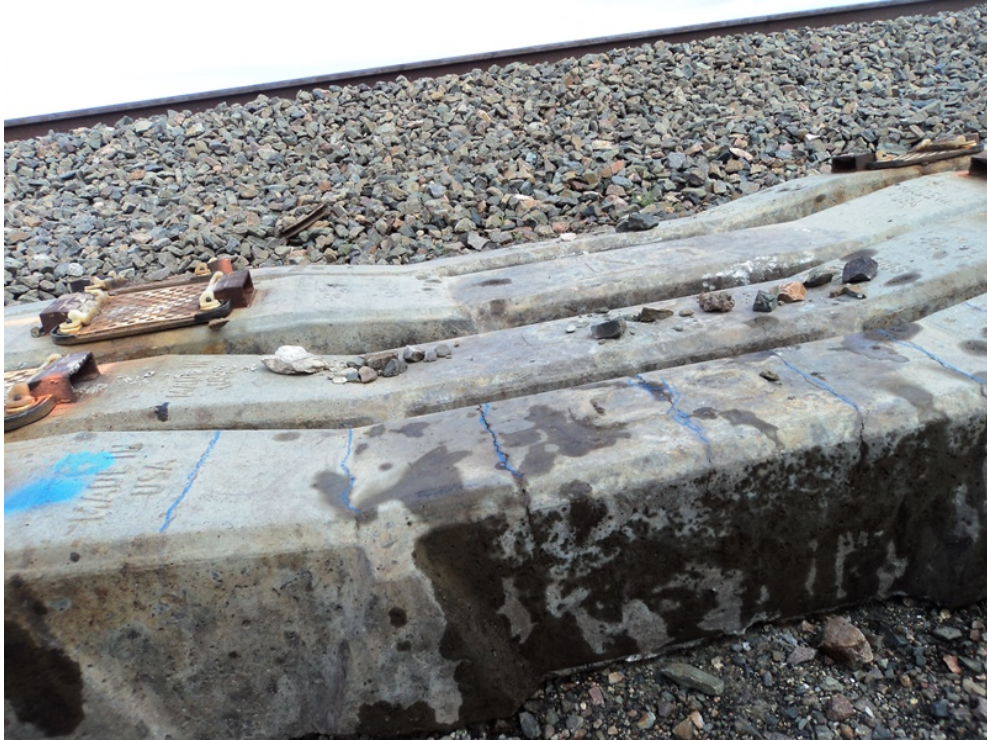
**Figure 11. UP Ties with Center Cracking**

Several ties with center cracking were tested. There was no significant drop in end to end wave velocity values with these ties. Close examination of some of these ties determined the center cracking, although extensive, does not extend the full thickness of the tie. Cracking did not propagate into the pre-stressed region of the tie, therefore, it is unlikely that IV data with the sensor spacing used for this testing will detect this cracking.

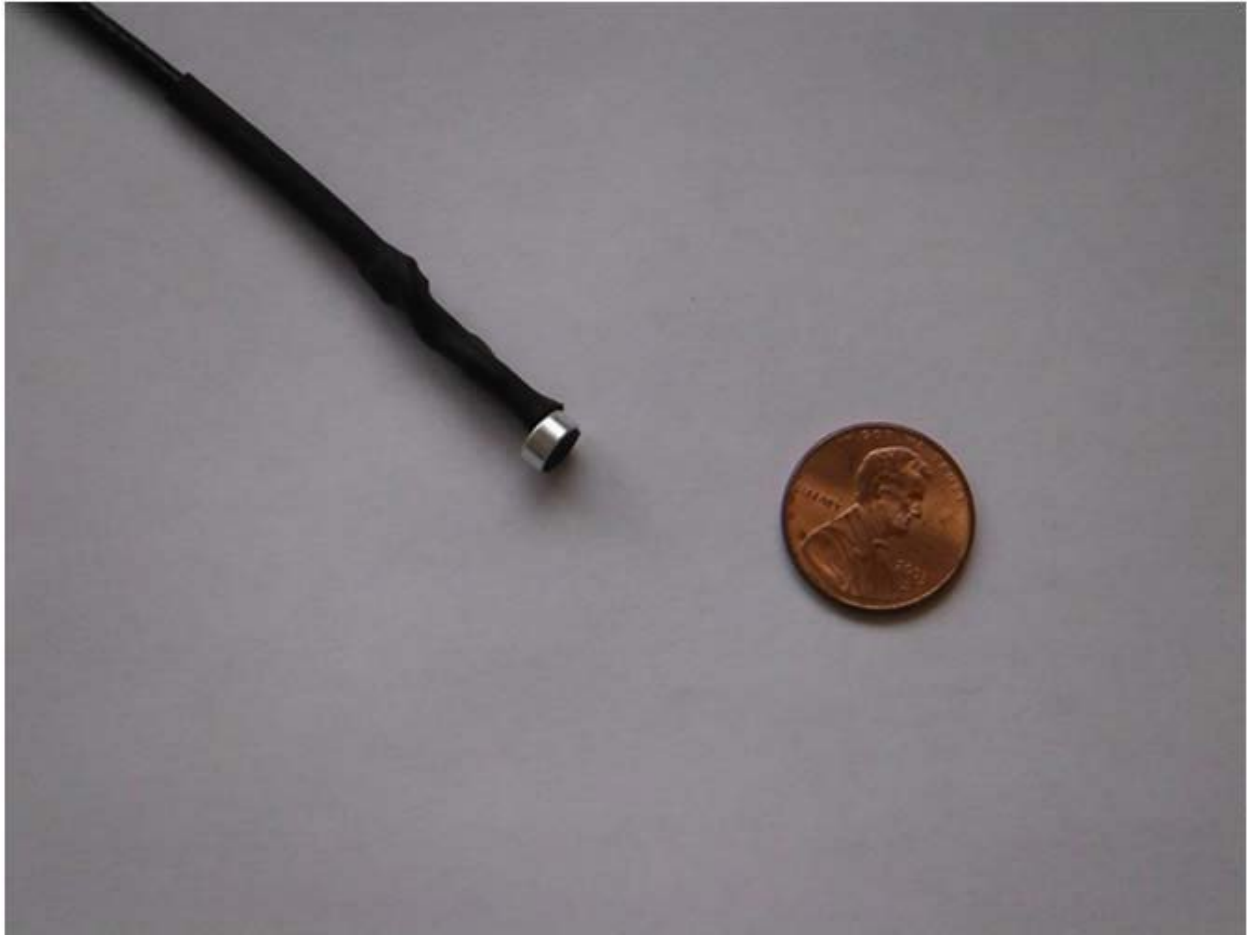
**Figure 13. Microphone Sensor**

determined that a microphone with a center frequency of 17 KHz with a sensitivity of -58 DBV/microbar and noise cancelling worked best. These microphones are small and readily available.

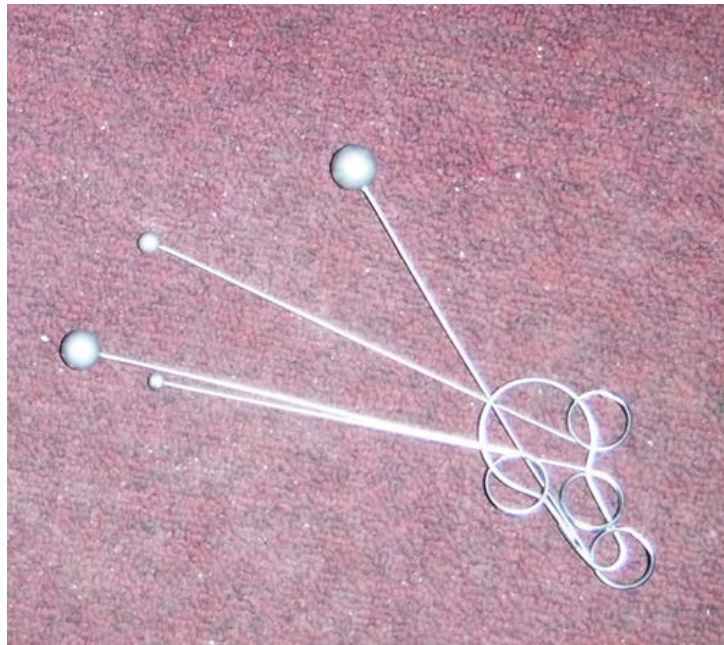
**Figure 17. Ball End Impactors**

Figure 17 provides an image of a set of impactors that were tested and found to produce a sharp, clean, reproducible signal. The small diameter (1/8) impactors did not have enough energy to produce a good signal and were difficult to work with. The large diameter balls produced a strong signal, but also produced spurious frequencies. The middle-sized impactors (3/8" and 5/16") had the best results.

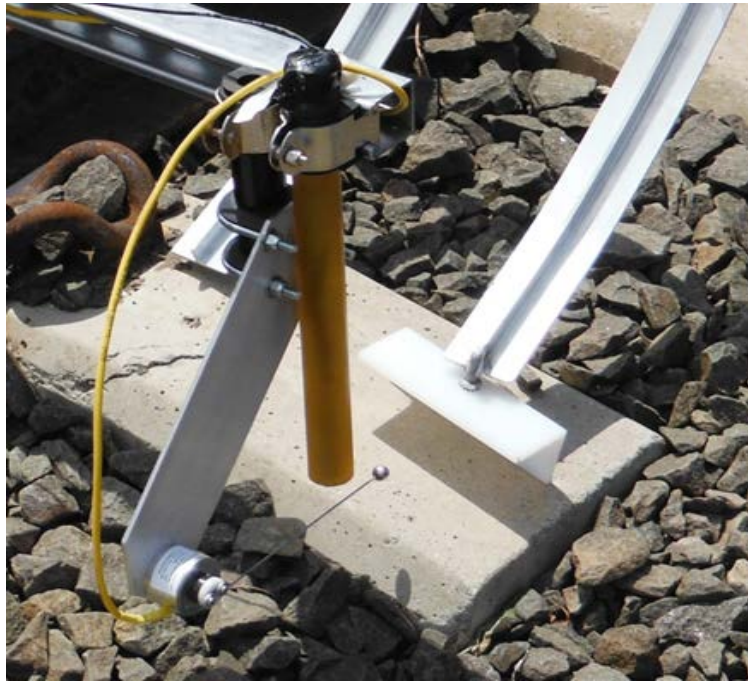
**Figure 18. Ball End “Tapper” Installed on ACTT-2**

An impactor (“tapper”) with a 3/8 diameter ball was mounted on a rotational solenoid and was found to be an ideal energy sources, as seen in Figure 18.

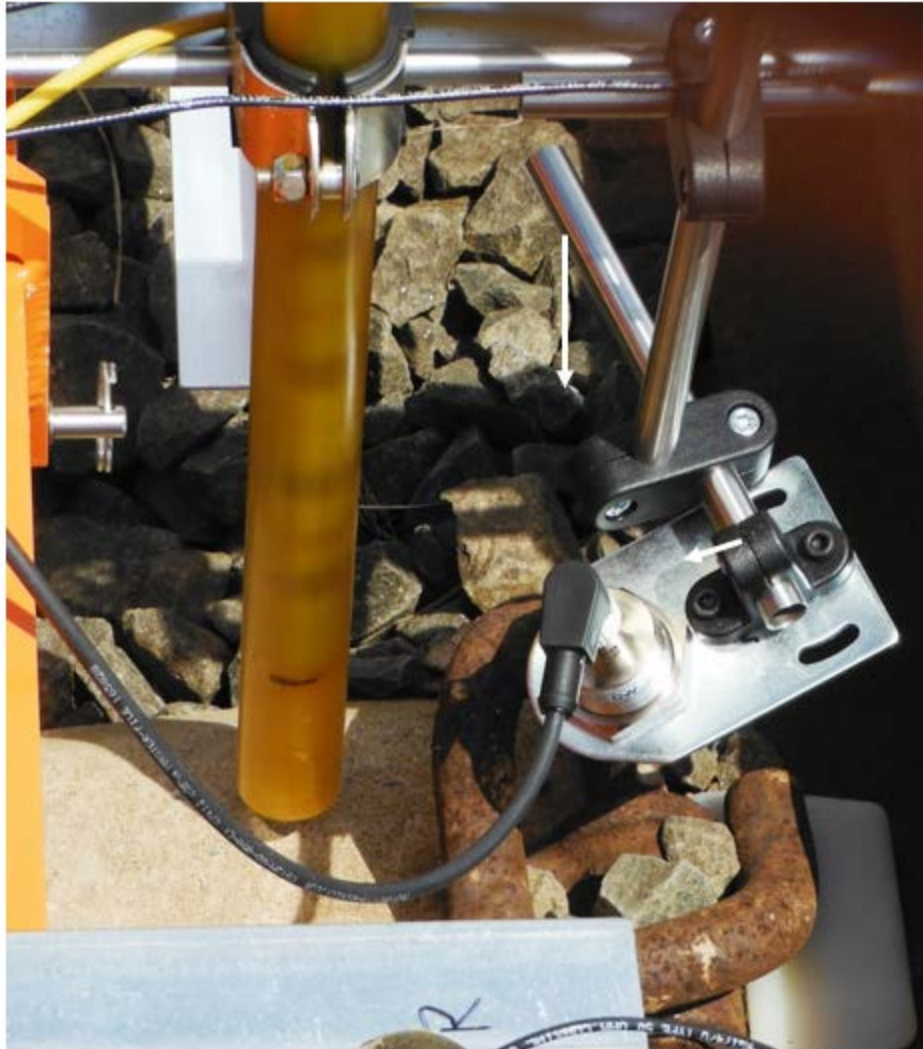
**Figure 19. Magnetic Proximity Switch Installed on ACTT-2**

Crossties that are misaligned or are not spaced evenly contribute to slowing data acquisition due to the system having to stop while the sensors realign with the crosstie. A magnetic proximity switch with an Arduino controller programed to activate the solenoid when it passes by a rail clips was determined to be a reasonable solution to positioning microphones and “tapper” energy source on each crosstie. The magnetic proximity switch, Arduino controller and rotational solenoid impactors were mounted on the ACTT-2 system and tested on-rail, as shown in Figure 19. The proximity switch with an Arduino controller system works reliably for speed of 3 to 5 mph and probably much higher.

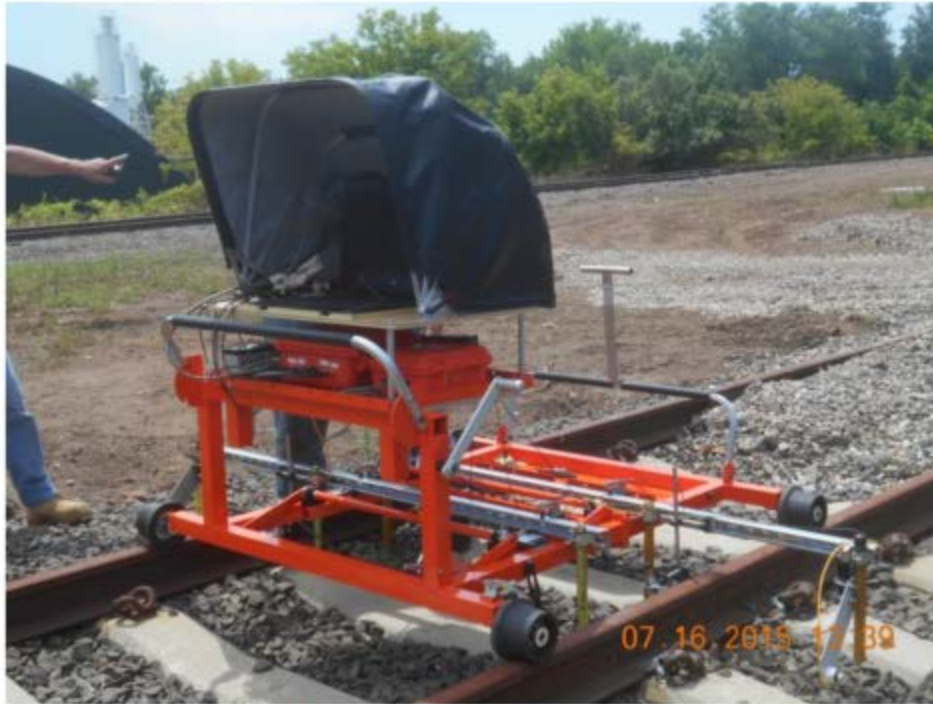
**Figure 21. ACTT-2 System On-Rail and Folded for Transport**

NDT built a new light weight carriage system utilizing the proximity switches, microphone sensors, “tapper” energy sources, and an on board computer to process data.

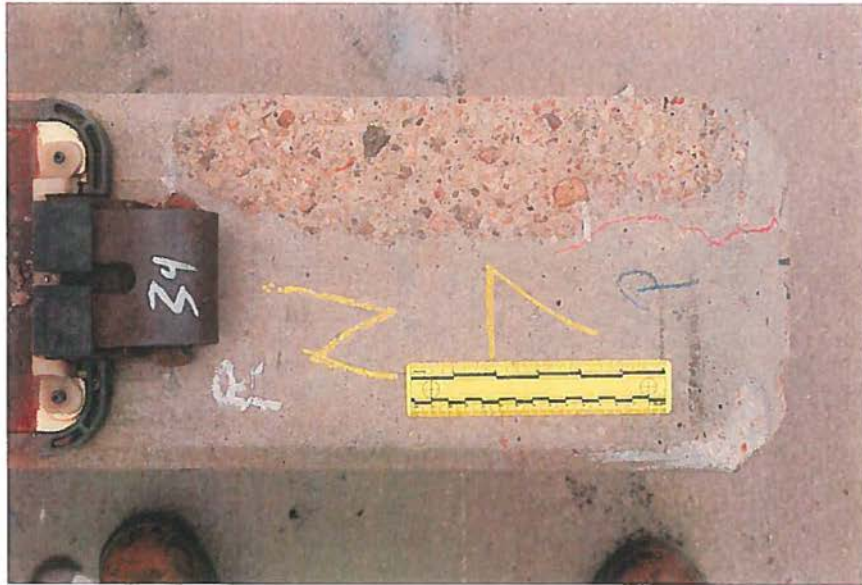
**Figure 4.** Top surface at north end of the NDT #7 rated by NDT as condition "5". L3672 102312 02

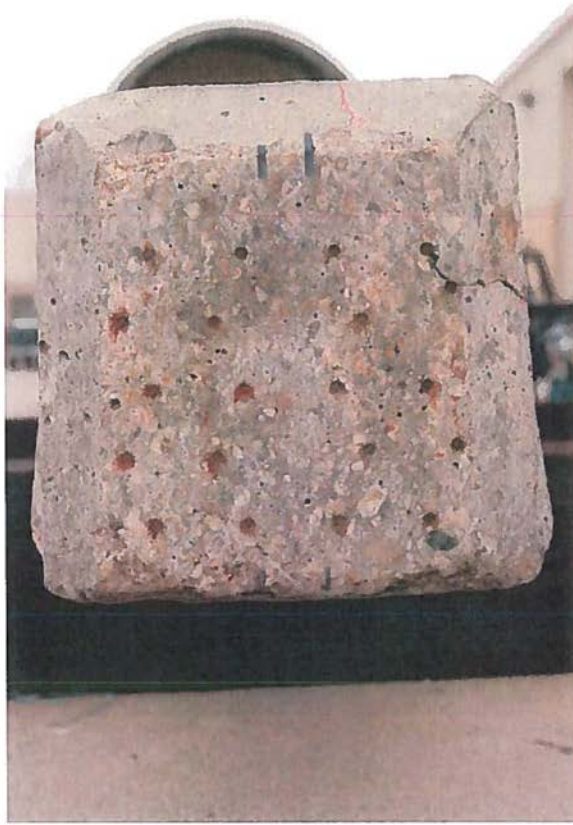
**Figure 6.** North end view of tie NDT #7 with retreated wire ends and visible crack at right. L3672 102312 04

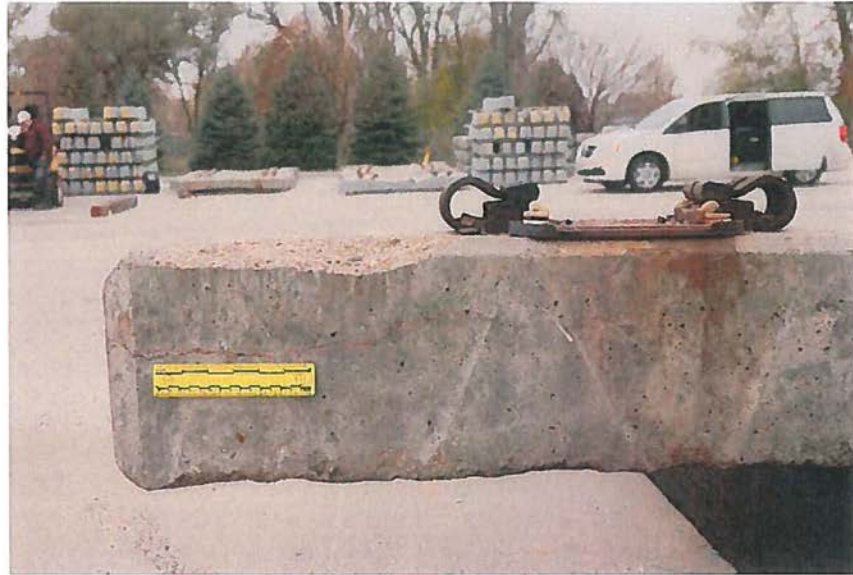
Figure 7. Side view of north end of the NDT #7, visible crack outlined in red.

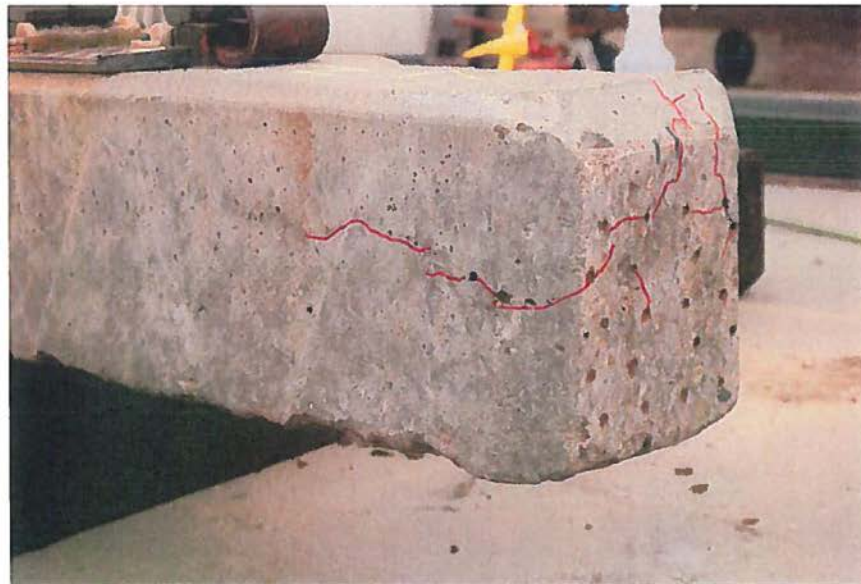
**Figure 12.** Oblique view of one side and north end of NDT #7 with all visible cracks outlined; side crack extends 8 inches from end. L3672 102312 23

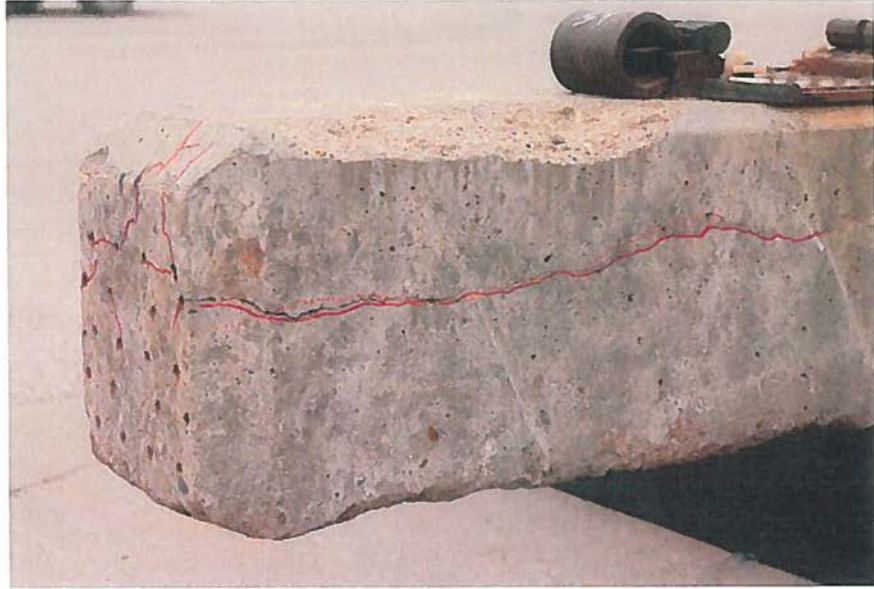
**Figure 13.** Oblique view showing north end and opposite side of tie with visible cracks outlined; side crack extends 15 inches from end. L.3672 102312.23

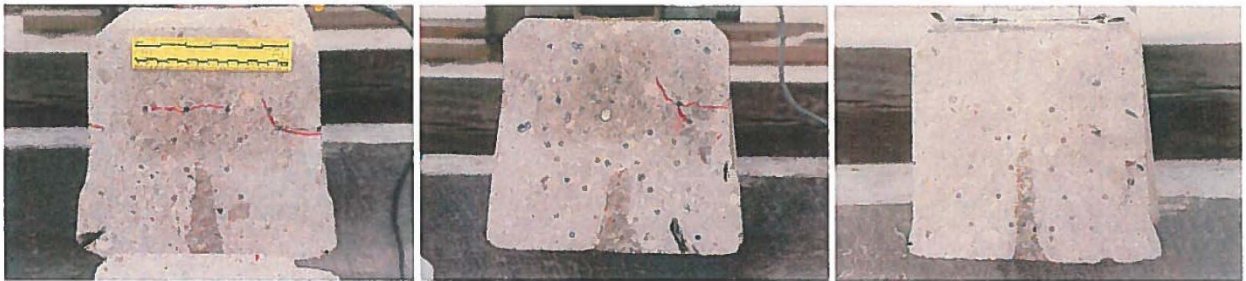
**Figure 14.** Cross-sections at saw cut locations on tie NDT #7 at 4 inches (left), 14 inches (center) and 21 inches (right) at center of rail pad, all visible cracks outlined in red.

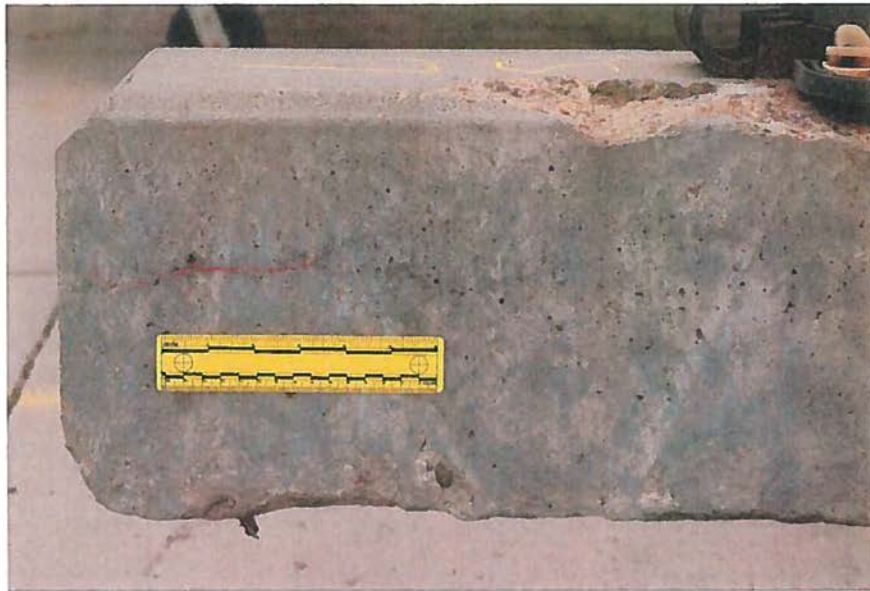
**Figure 19.** Closer view of side of tie NDT #7 at south end, outlined crack extends 6 inches from end. L3672 102312 13

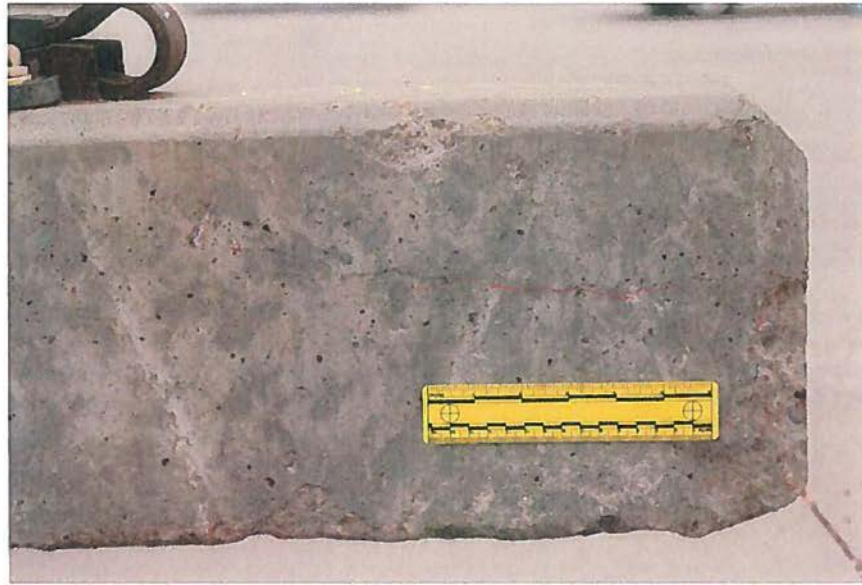
**Figure 21.** Closer view of opposite side of tie NDT #7 at south end, outlined crack extends 9 inches from end. L3672 102312 15

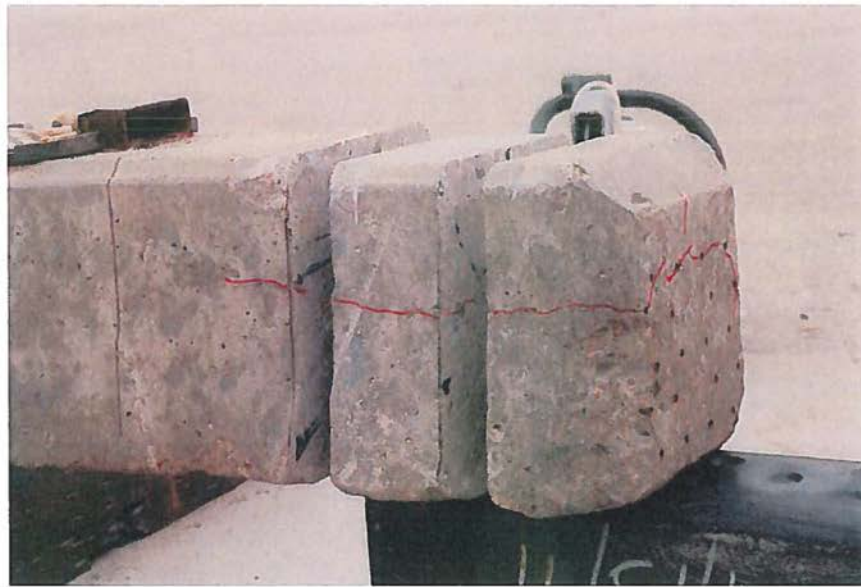
**Figure 22.** Oblique view of sections removed at 4 inches and 8 inches from south end of tie NDT #7 with cracks outlined in red. L3672 102312 19

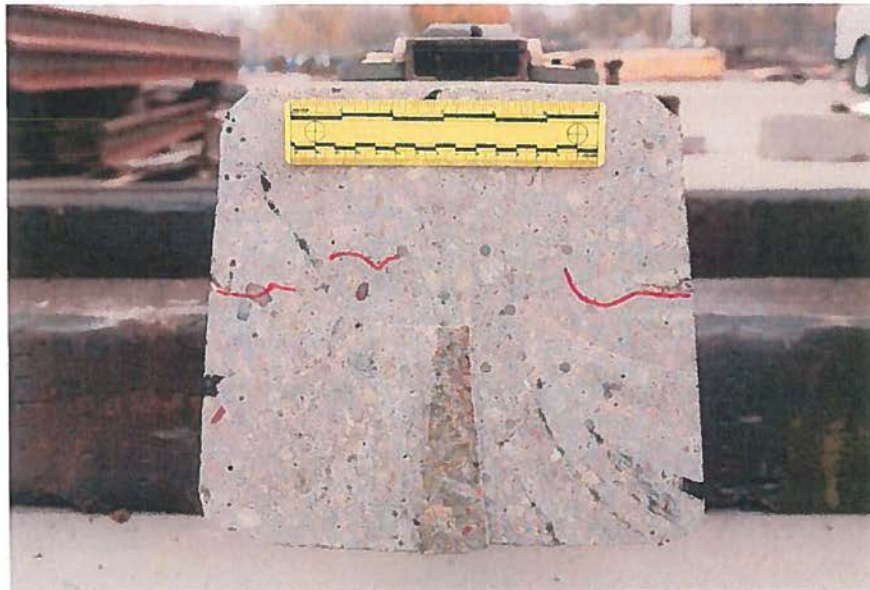
**Figure 24.** Cross-section of south end of tie NDT #7 at 4 inches from end with cracks outlined in red. L3672 102312 18

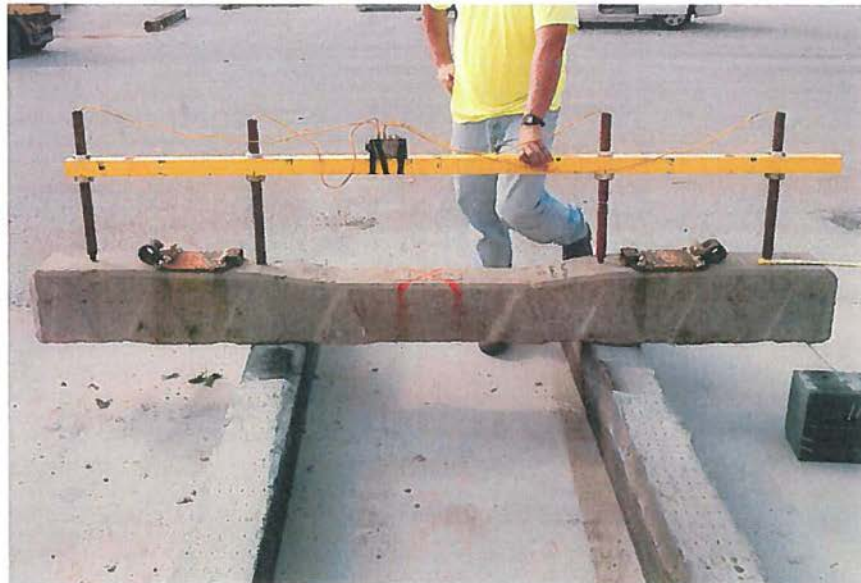
**Figure 26.** Tie NDT #69 with transducer array placed as employed in making impact echo recordings, rated by NDT as condition "2" both ends. L.3672 102312 30

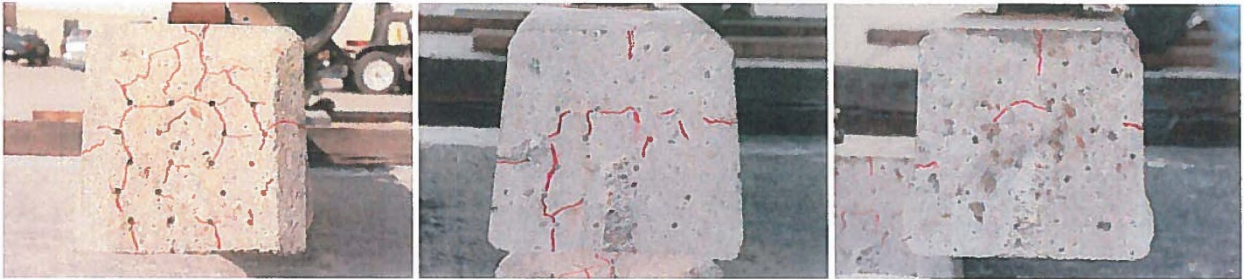
**Figure 30.** North end cross-sections of tie NDT #69 at exposed end (left), saw cut at 4 inches (center) and saw cut at 8 inches (right), all visible cracks outlined in red.

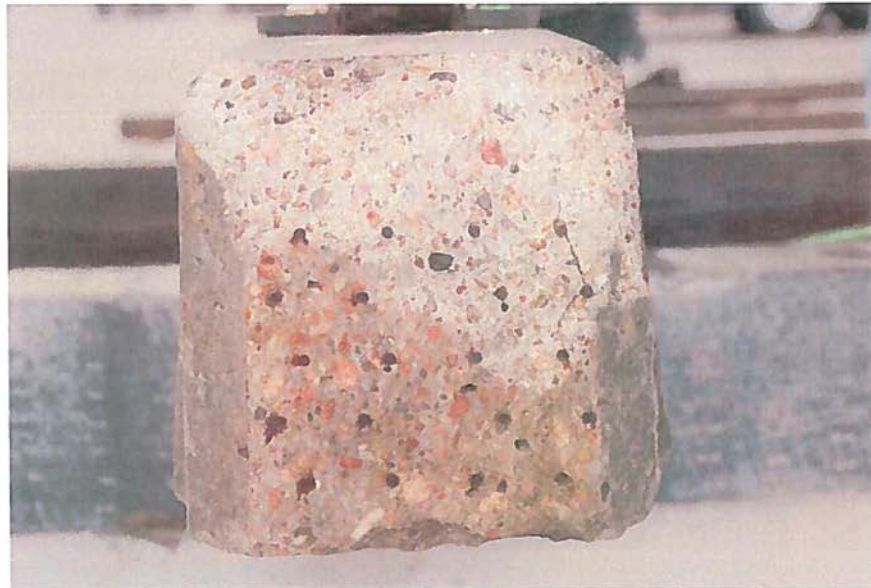
**Figure 40.** North end view of tie NDT #2, significant spalling at top chamfer.  
L3672 102312 48

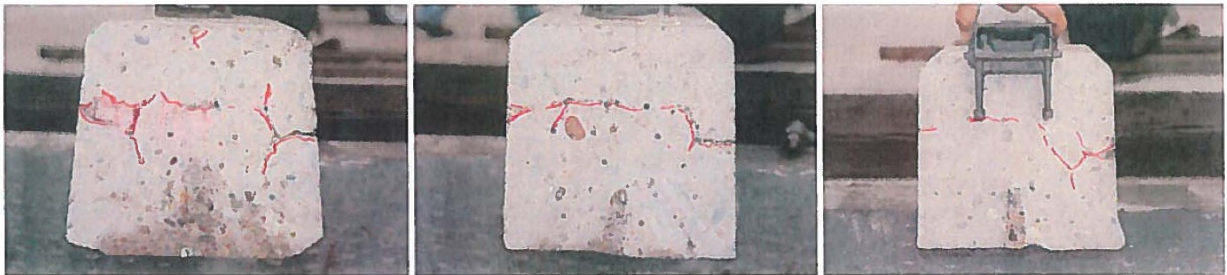
**Figure 48.** North end cross-sections of tie NDT #2 at saw cuts at 6 inches (left), 10 inches (center) and 21 inches at center of rail pad (right), all visible cracks outlined in red.

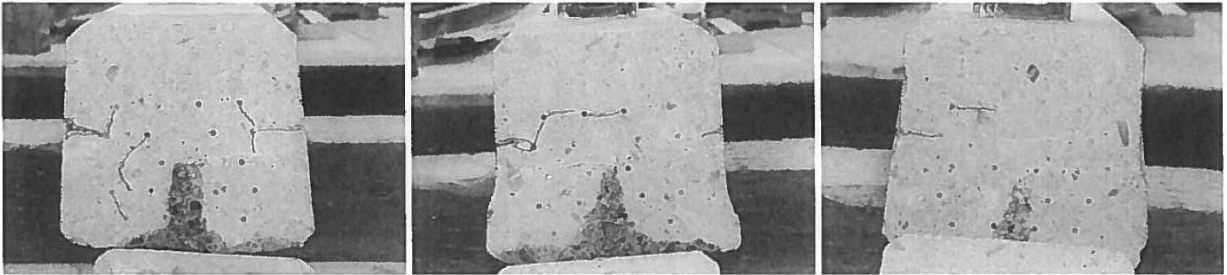
Figure 54. South end cross-sections of tie NDT #2 at saw cuts 4 inches (left), 8 inches (center) and 14 inches (right) from end, cracks outlined in red.

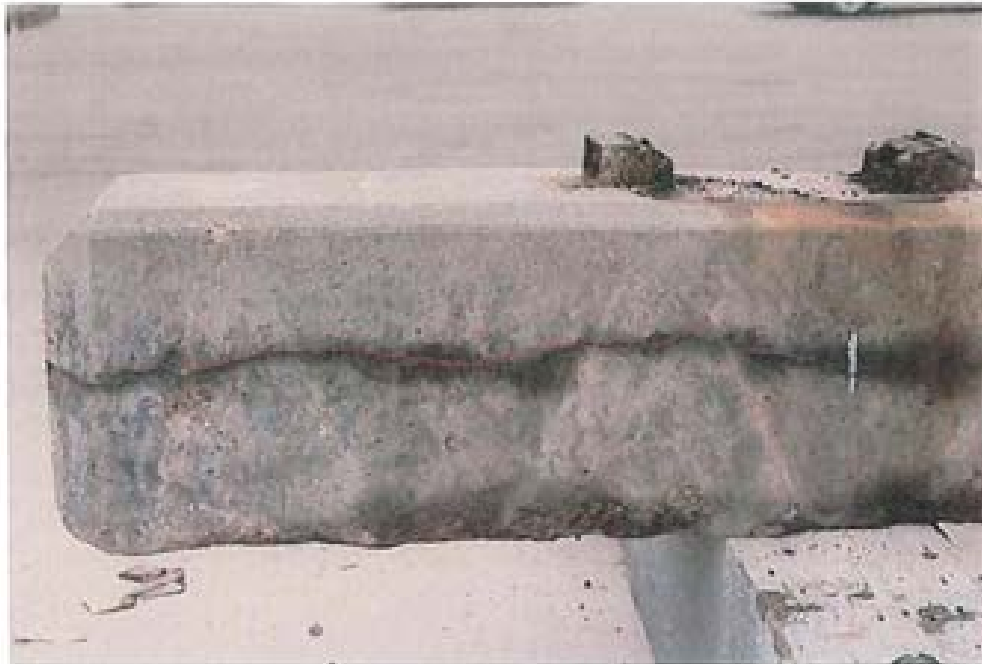
**Figure 57.** Side view of south end of tie NDT #1 with horizontal crack 21 inches long outlined in red. L3672 102512 74

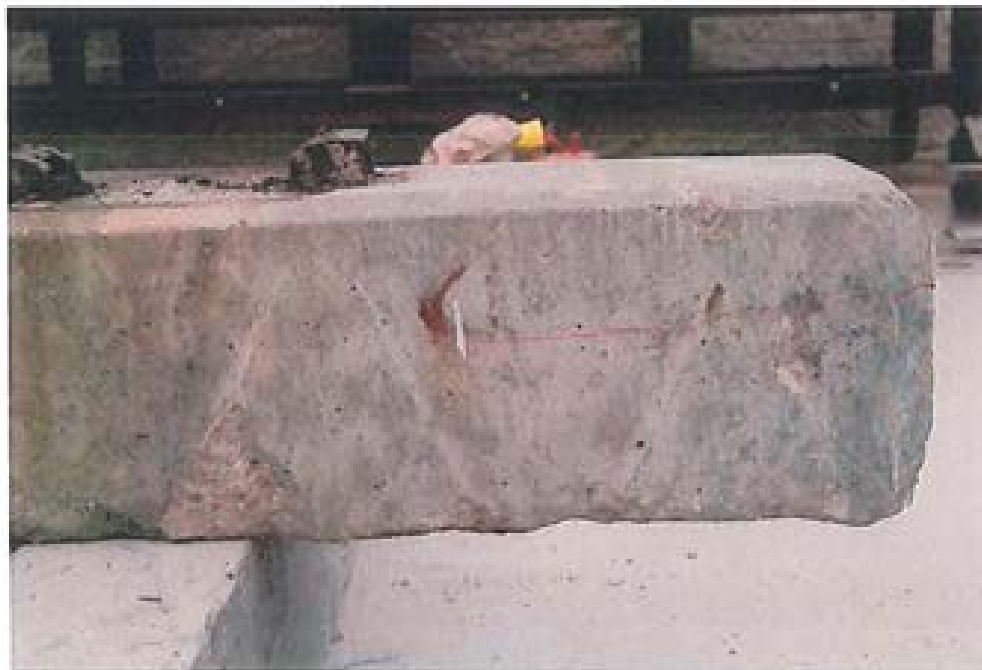
**Figure 58.** Opposite side view of south end of tie NDT #1 with horizontal crack 13 inches long outlined in red. L3672 102512 75

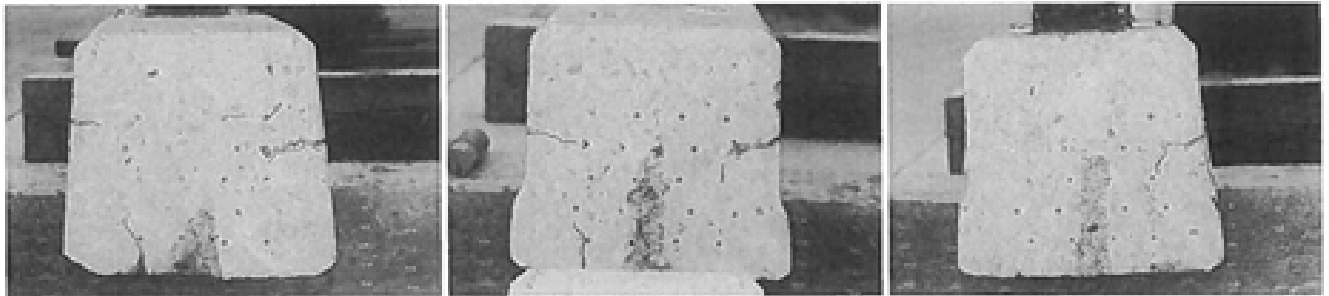
Figure 6-4. South end cross-sections of tie NDT #1 at saw cuts 4 inches (left), 8 inches (center) and 14 inches (right) from end, cracks outlined in red.
