# RSI-AAR Railroad Tank Car Safety Research and Test Project

FRA Hazmat Seminar - Houston, TX  
August 2018

# RSI – AAR Safety Project

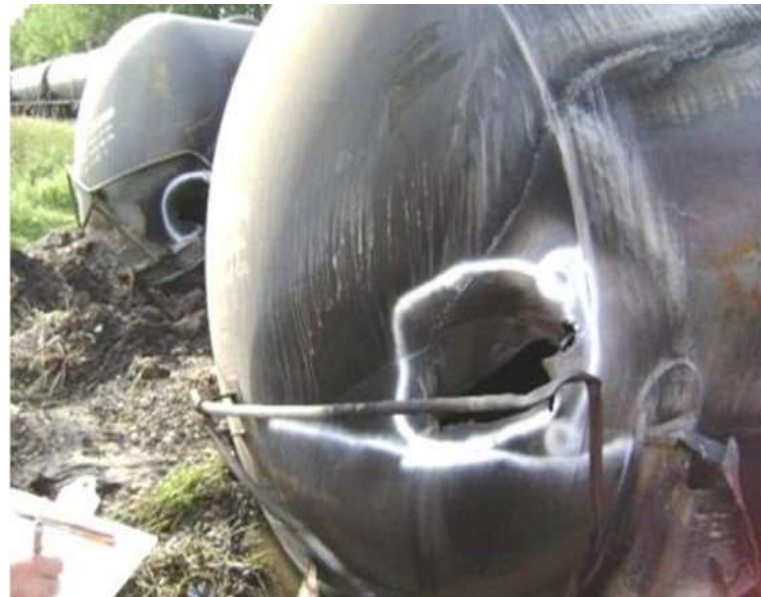
Majority of significant fires and explosions were caused by the couplers of adjacent cars impacting tank heads.

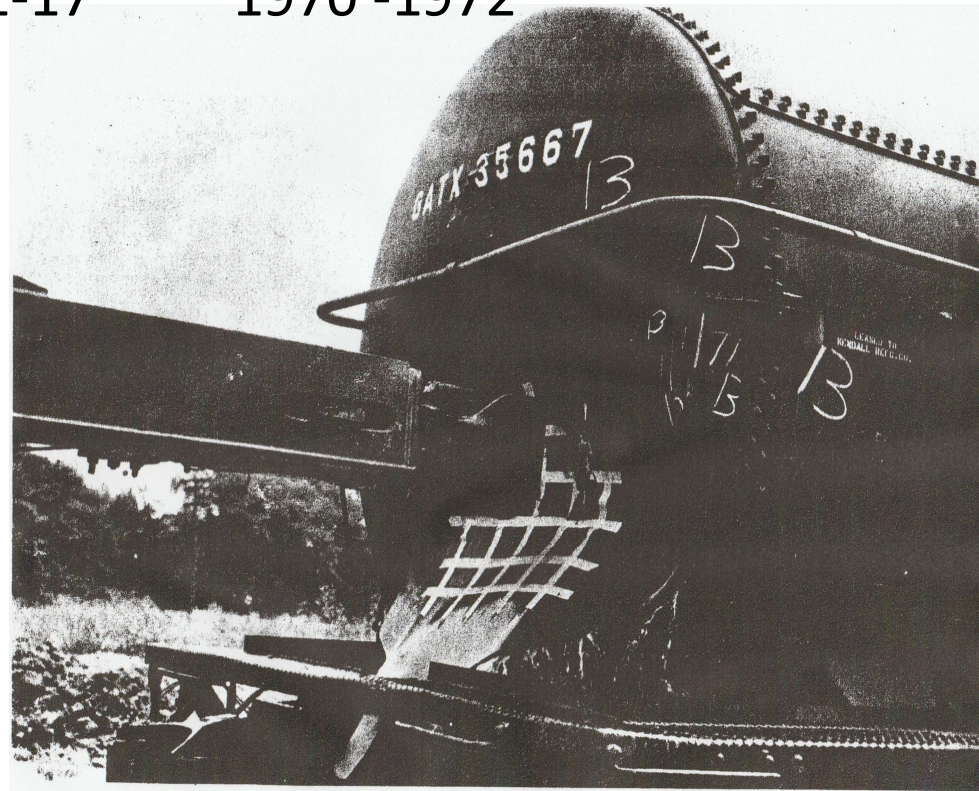
## Tank Car Head Study RA 05-1-17

- Drop weight test on 1/12 scale Heads
- 1/5 scale impact tests
- Full scale impact tests
  - Without head shields
  - With head shields

- Study estimated that ½” steel plate head shields would increase puncture speed by 100%

- Would have prevented 36% – 58% of head punctures that occurred to 112A tank cars between 1965 -1970

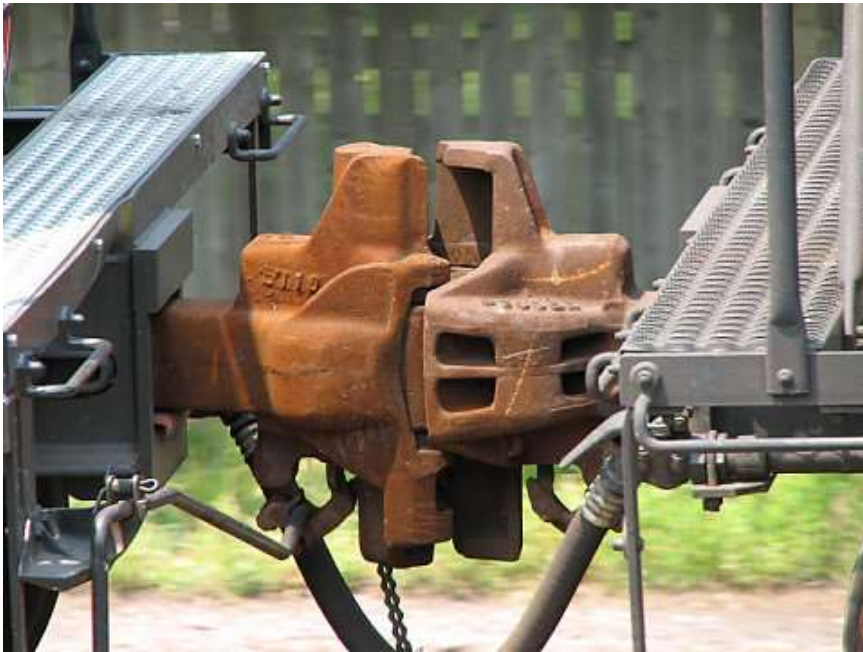
## Development of Double Shelf Couplers - 1974

- Accident analysis suggested that couplers of adjacent cars were one of the leading causes of shell punctures.
- Top and bottom coupler shelves considered as a solution to coupler disengagement during derailments.
- ASF initiated initial design and testing.
- Full scale testing of shelf couplers lead to redesign of shelves and recommendations
- Retrofit of all 112A tanks and new tank cars

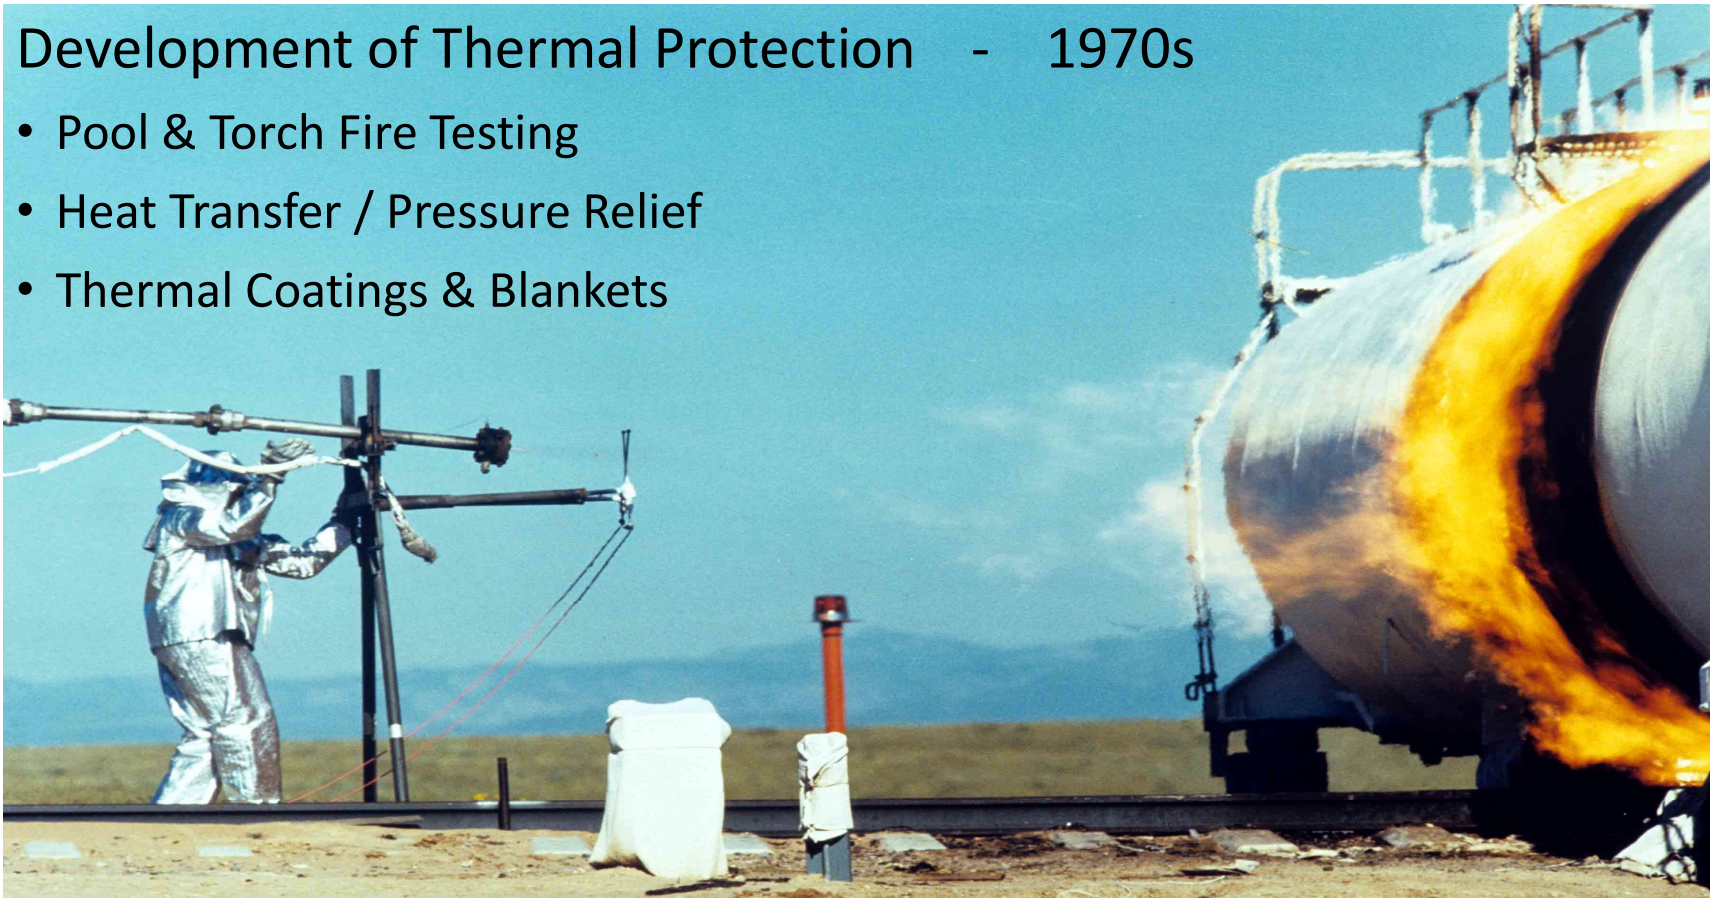
## Development of Thermal Protection - 1970s

- Pool & Torch Fire Testing
- Heat Transfer / Pressure Relief
- Thermal Coatings & Blankets

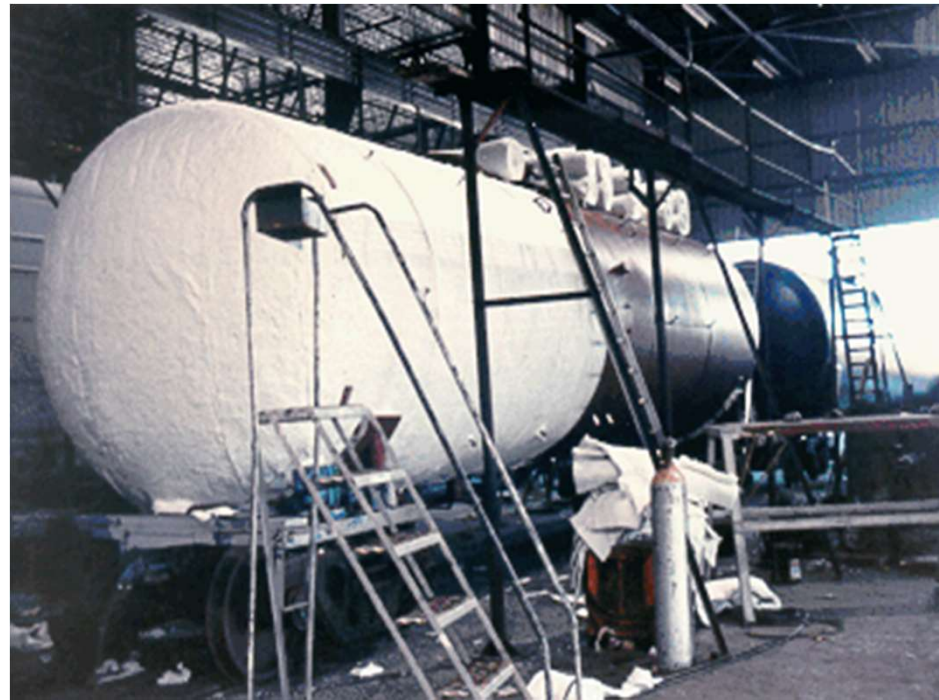
## HM-144 -

- Implemented 1977
- DOT 112 /114
- Flammable Compressed Gas
- Head Shields
- Shelf Couplers
- Thermal Protection
- Retrofit of 20,000 tank cars
- Estimated \$200 Million

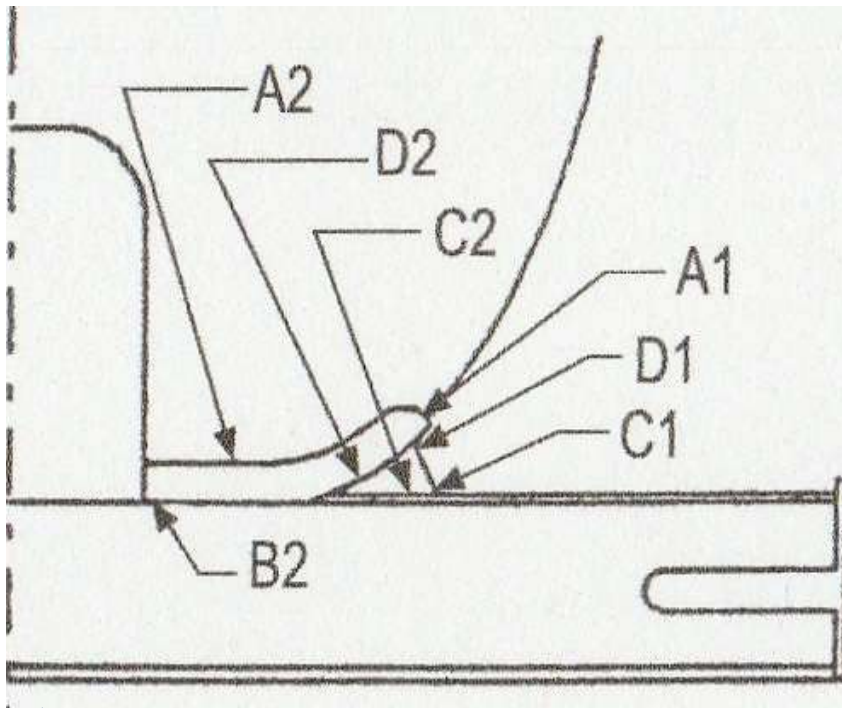
## Stub Sill Design and Inspection

← Point of Failure Moved Inboard

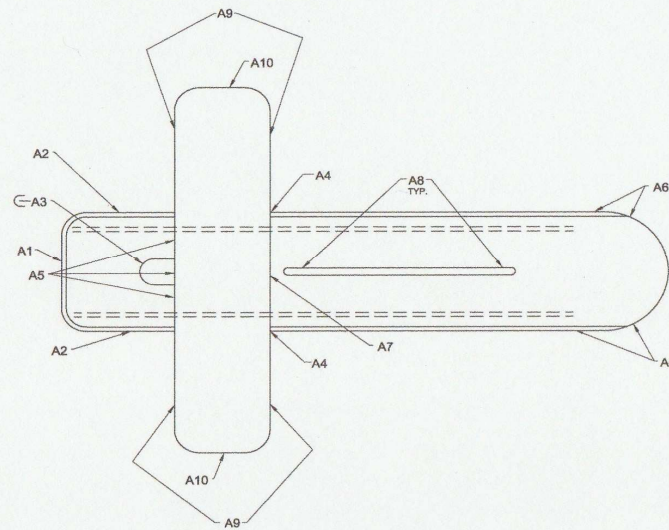
## Sketch/Description:

Code	Description	Location	Includes
A1	Outboard sill pad-to-tank transverse weld.	A- & B-Ends	Full length of weld, including portion around corner of pad.
A2	Front sill pad longitudinal welds.	AR, AL, BR, BL	Full length of weld to termination at bolster pad.
A3	Fillet weld in outboard sill pad-to-tank cutout.	A- & B-Ends	Full length of weld.
A4	Sill pad longitudinal weld.	AR, AL, BR, BL	6" of weld from termination.
A5	Outboard sill pad-to-bolster pad transverse weld.	A- & B-Ends	Full length of weld.
A6	Inboard termination of sill pad longitudinal welds.	AR, AL, BR, BL	Last 6" of weld to termination.
A7	Sill pad-to-bolster pad transverse weld.	A- & B-Ends	Full length of weld.
A8	Sill pad-to-tank slot welds.	A- & B-Ends (2 to 16 places per car)	Last 6" of weld at each end of slot.
A9	Bolster pad-to-tank transverse weld.	ARO, ARI, ALO, ALI, BRO, BRI, BLO, BLI	36" from junction with sill pad.
A10	Top of bolster pad longitudinal weld.	AR, AL, BR, BL	Full length of weld.

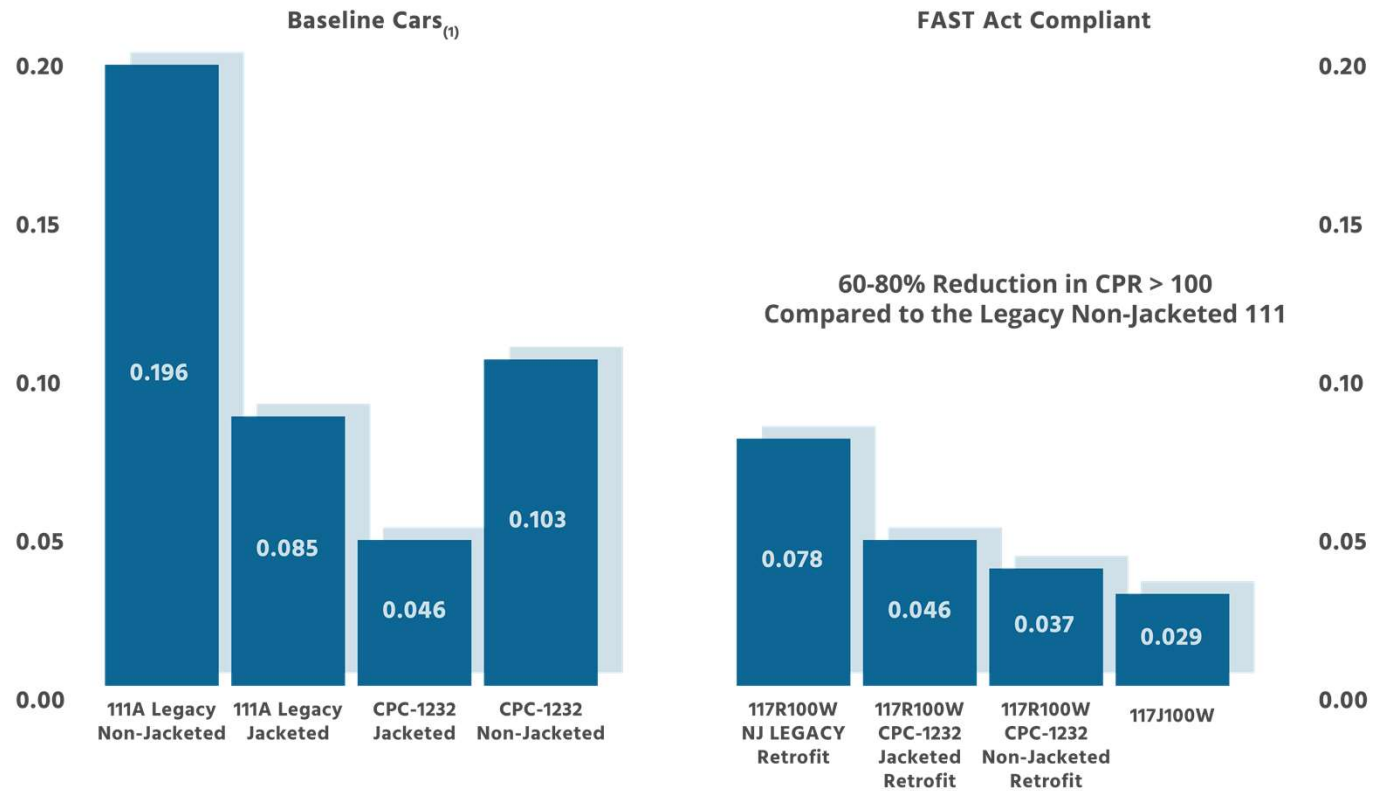
## RELATIVE CPR > 100 OF FLAMMABLE LIQUIDS CARS

(1) Baseline Cars - Includes tank cars authorized for flammable liquid transport prior to the FAST Act

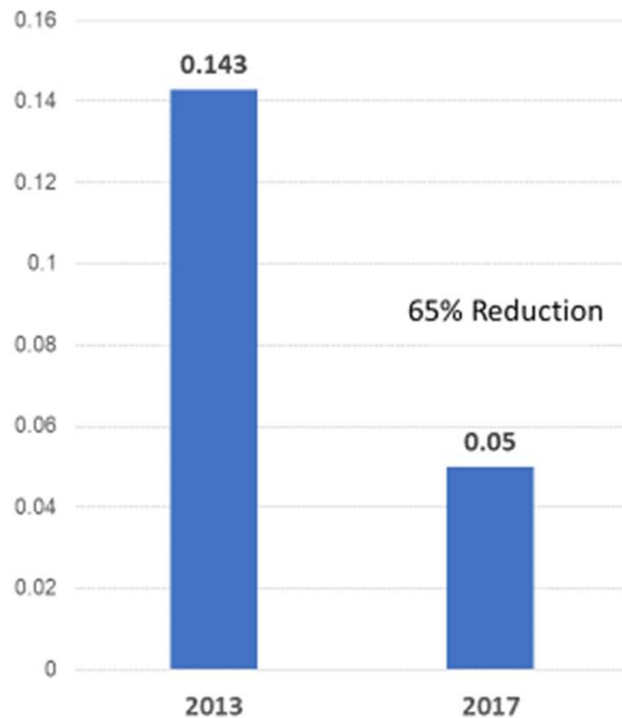
## Change In Average Fleet CPR $>_{100}$ for Crude Oil (2013 vs. 2017)

- 99.6% Reduction in DOT 111 Shipments
- 86% Reduction in Non-Jacketed CPC-1232 Shipments
- 272% Increase in Jacketed CPC-1232 Shipments
- 31% of Crude Oil Shipments in 117J, 117R and 120J Specification Tanks
- 3/1/2018 Deadline for DOT 111 Removal

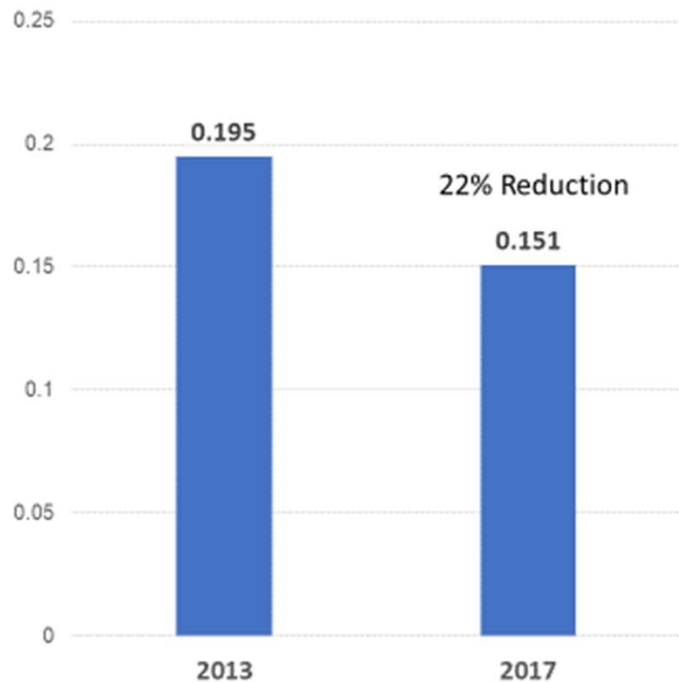
## Change In Average Fleet CPR <sub>>100</sub> for Ethanol (2013 vs. 2017)

- Total Shipments Increased by 22%
- 15% Reduction in DOT 111 Shipments
- CPC-1232 shipments Increased by 1220%
- 10% of Shipments Made by CPC-1232 Tanks
- Use of DOT 117 & 120 Car specifications Increased to 21% of Shipments
- 5/1/2023 Deadline for DOT 111 Removal

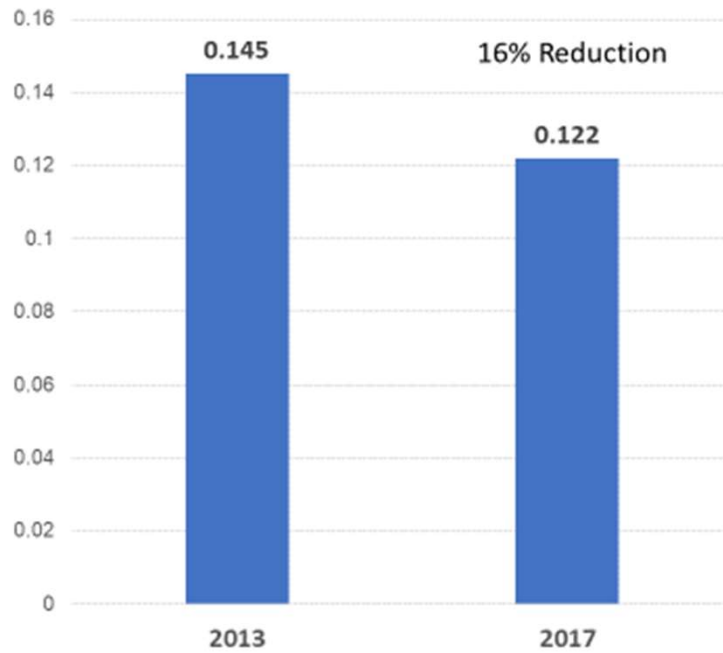
Change In Average Fleet CPR > 100 for Other Flammable Liquids (2013 vs. 2017)

- Total Shipments Increased by 32%
- 3% Reduction in DOT 111 Shipments
- Use of CPC-1232 Specification Tanks Increased by 433%
- 24% of Shipments Made by CPC-1232 Tanks
- DOT 117/120 Specification Tanks Made over 23K Shipments or 7% of Total Shipments
- 5/1/2025 Deadline for DOT 111 Removal (packing group I)
- 5/1/2029 Deadline for DOT 111 Removal (packing group II & III)

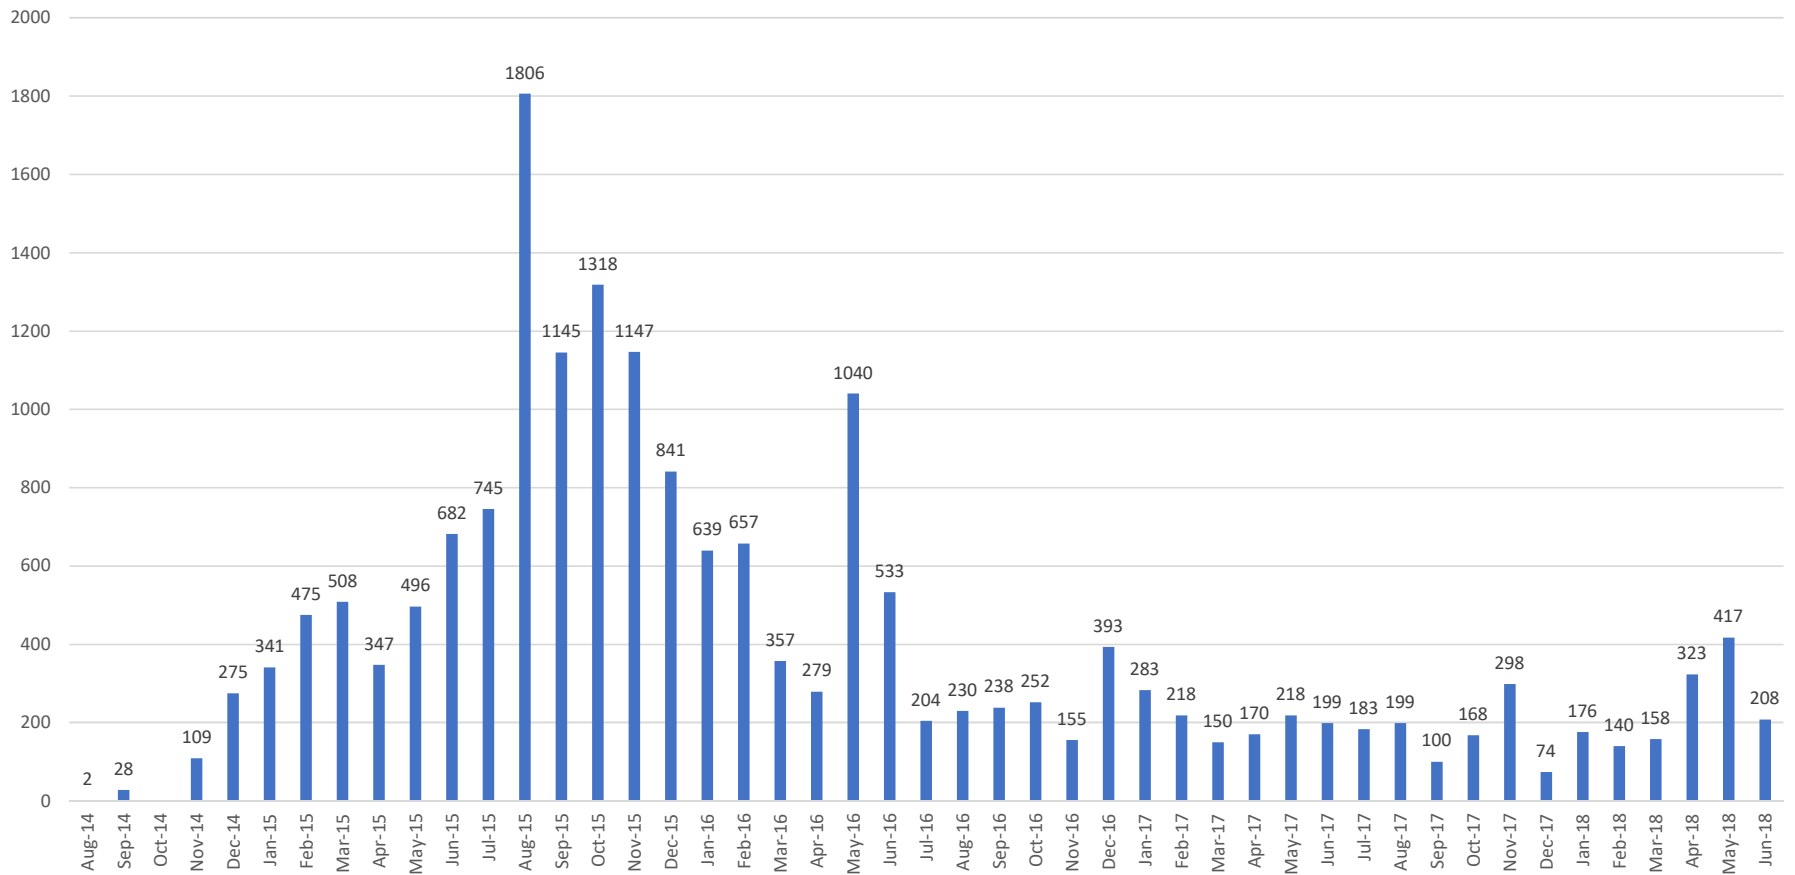
# DOT 117J & 120J200 Monthly Production

Based on 7/1/2018 UMLER File

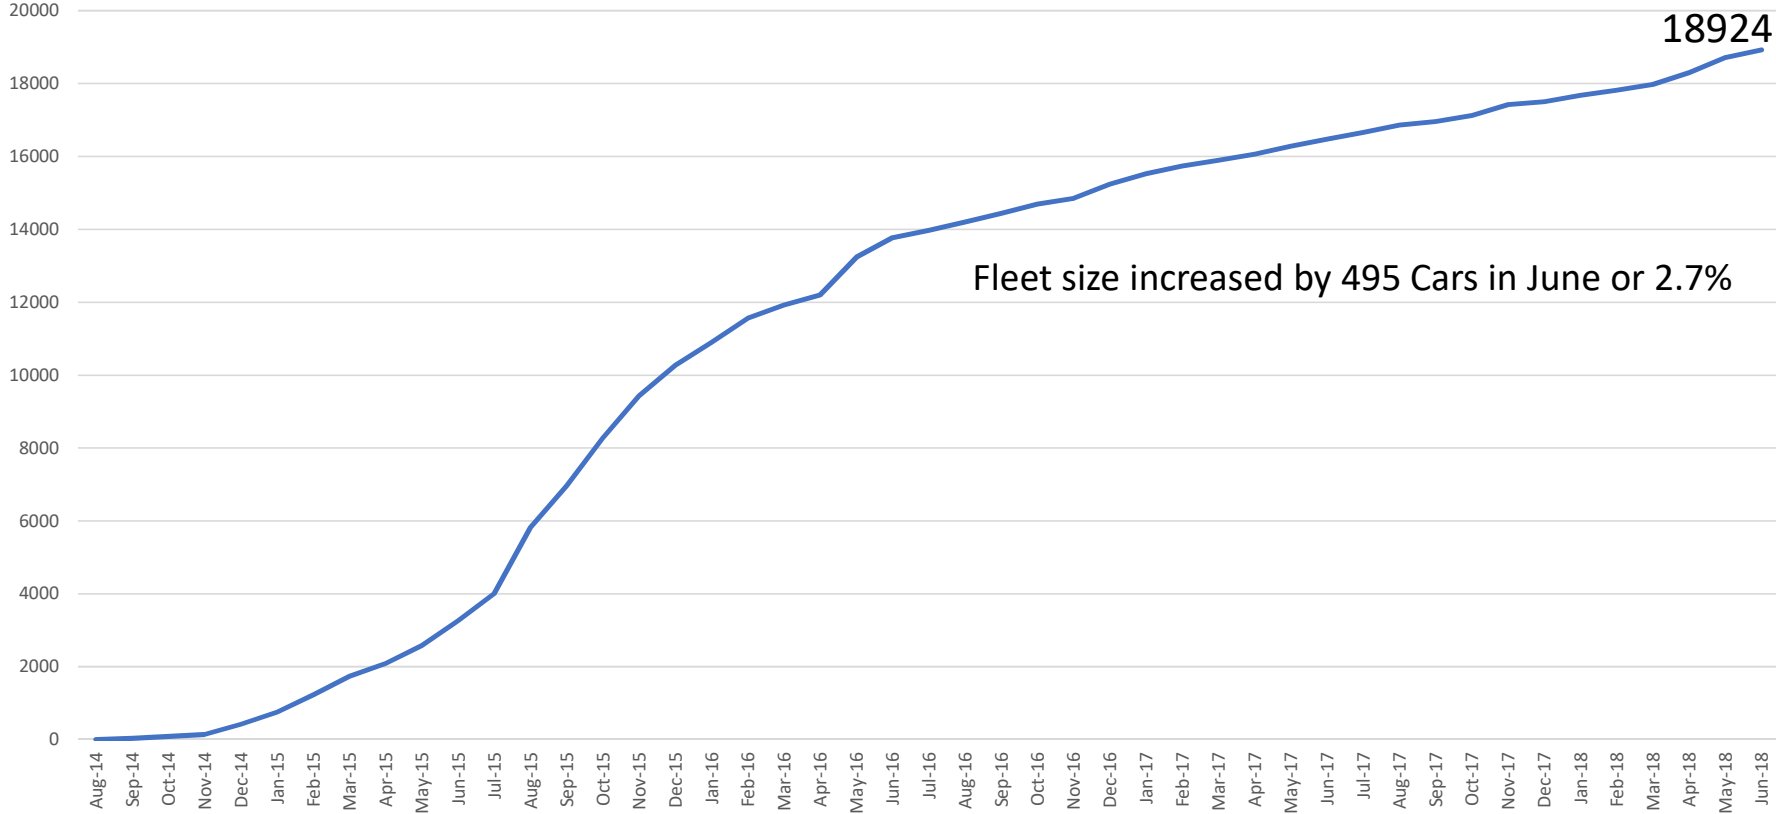
# DOT 117J & 120J200 Fleet Growth

Based on 7/1/2018 UMLER

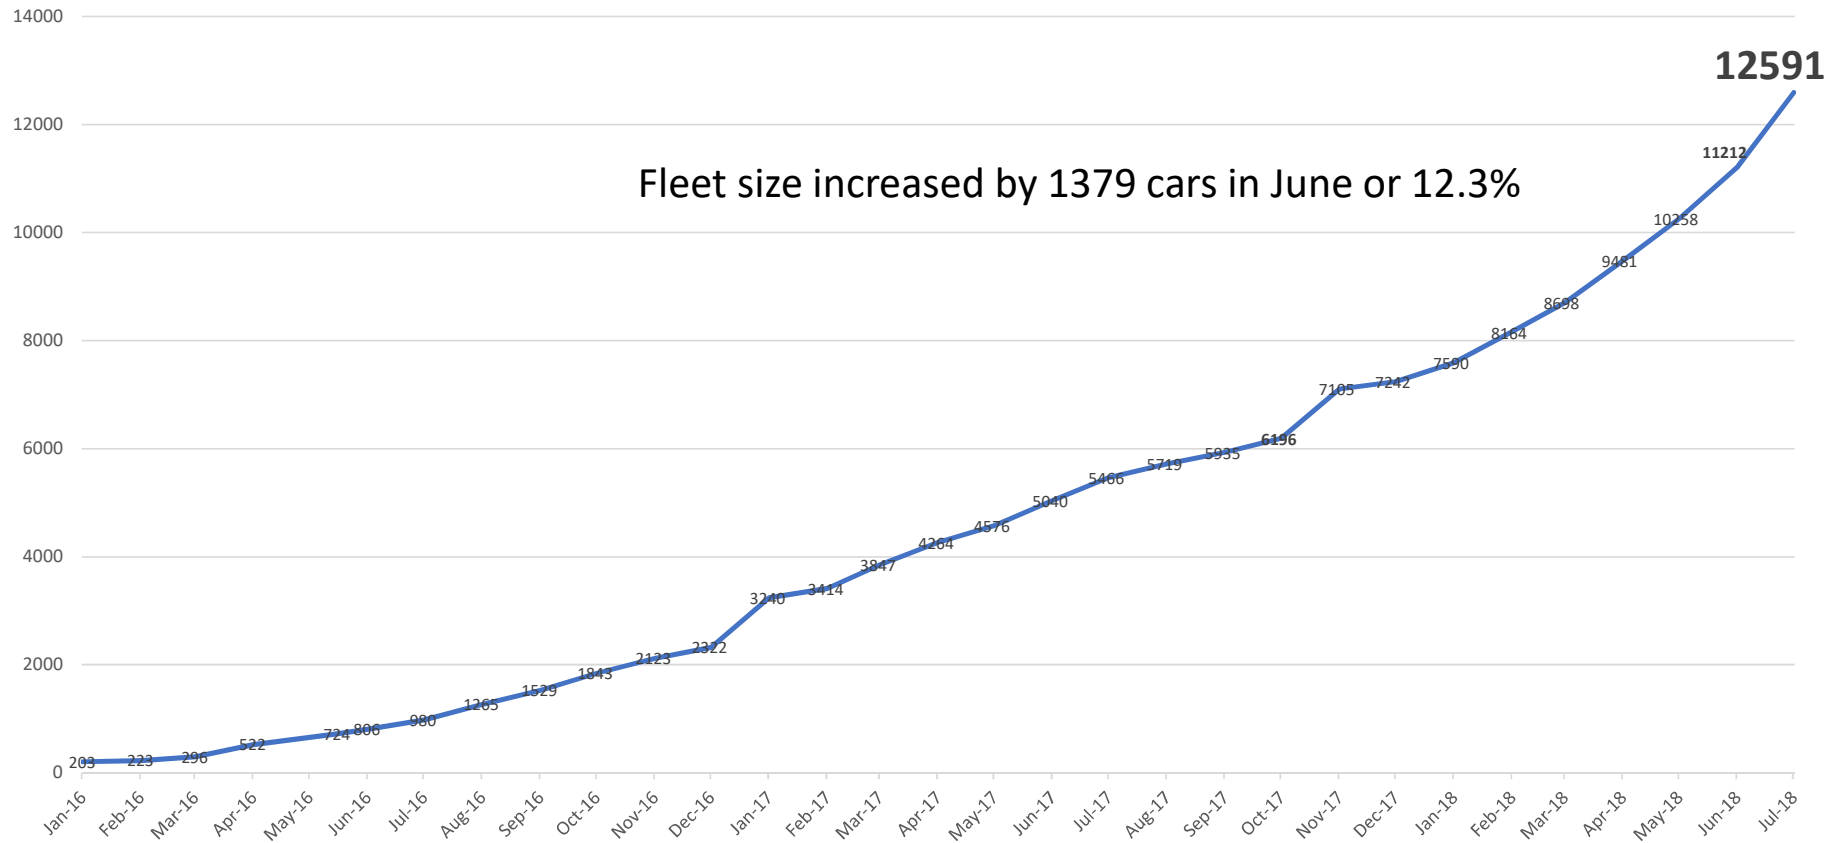
# DOT 117R Fleet Growth

Based on 7/1/2018 UMLER

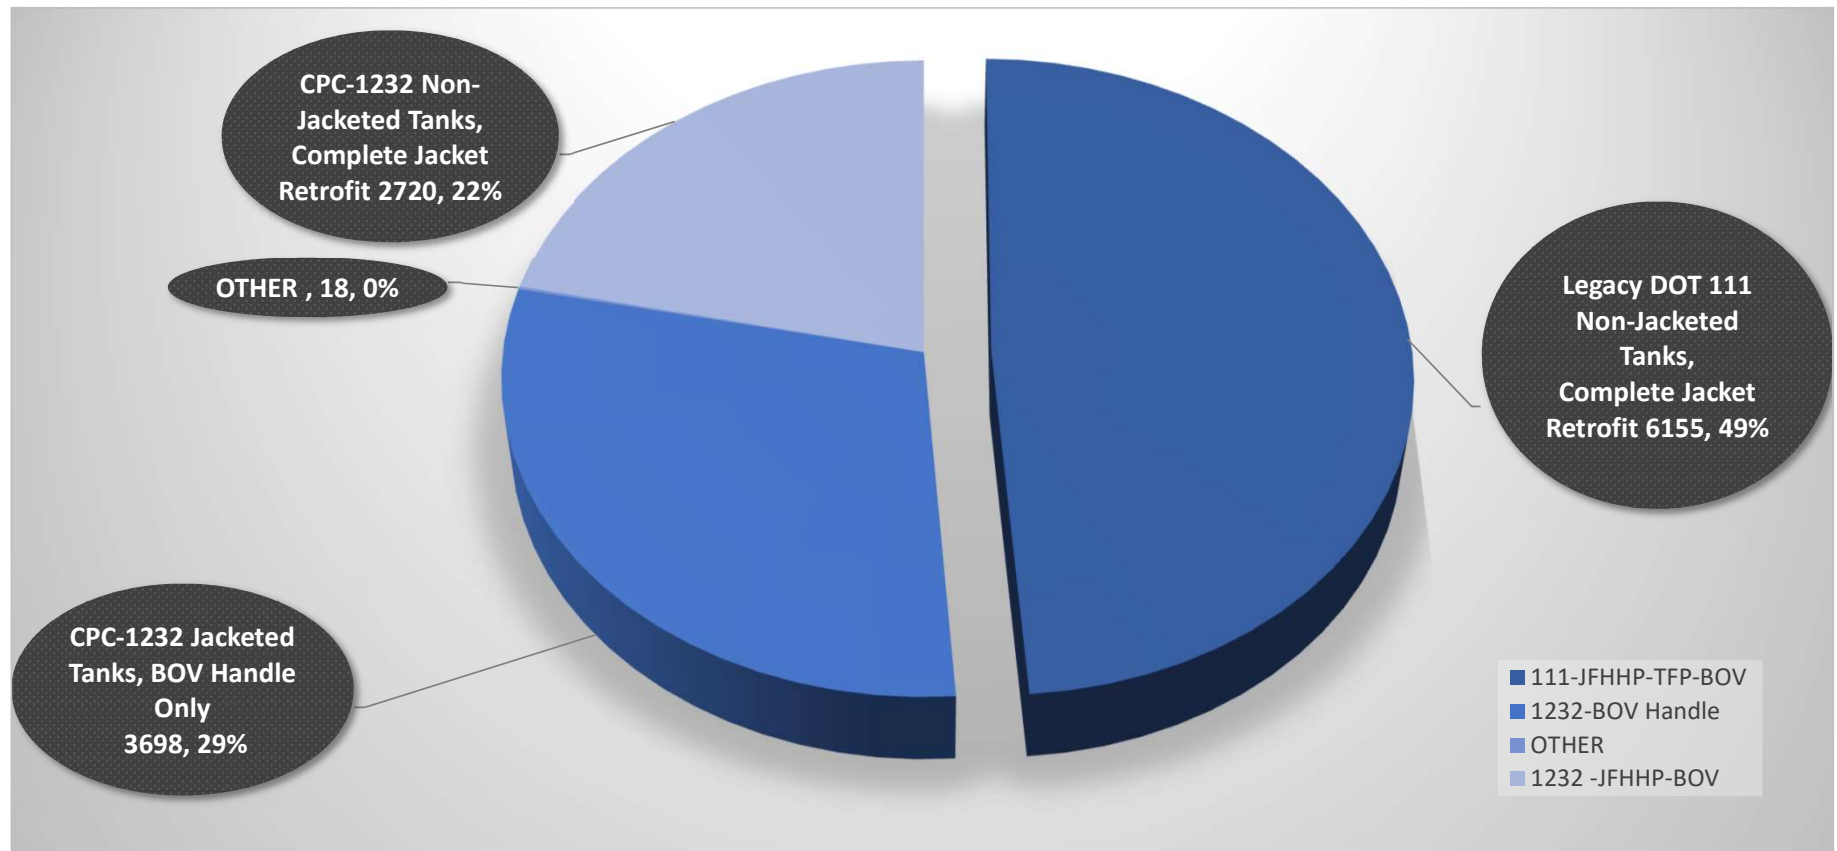
# DOT 117R Fleet Composition

Based on 7/1/2018 UMLER
