## **Evaluation of Fiber Optic Broken Rail Detection Systems**

1. AGENCY USE ONLY (Leave blank)		2. REPORT DATE November 2018	3. REPORT TYPE AND DATES COVERED Technical Report - May 7, 2015, to January 16, 2018	
4. TITLE AND SUBTITLE Evaluation of Fiber Optic Broken Rail Detection Systems			5. FUNDING NUMBERS  Task Order 0005

9. SPONSORING/MONITORING AGENCY NAME(S) AND ADDRESS(ES) U.S. Department of Transportation Federal Railroad Administration Office of Railroad Policy and Development Office of Research, Development and Technology Washington, DC 20590			10. SPONSORING/MONITORING AGENCY REPORT NUMBER  DOT/FRA/ORD-18/37

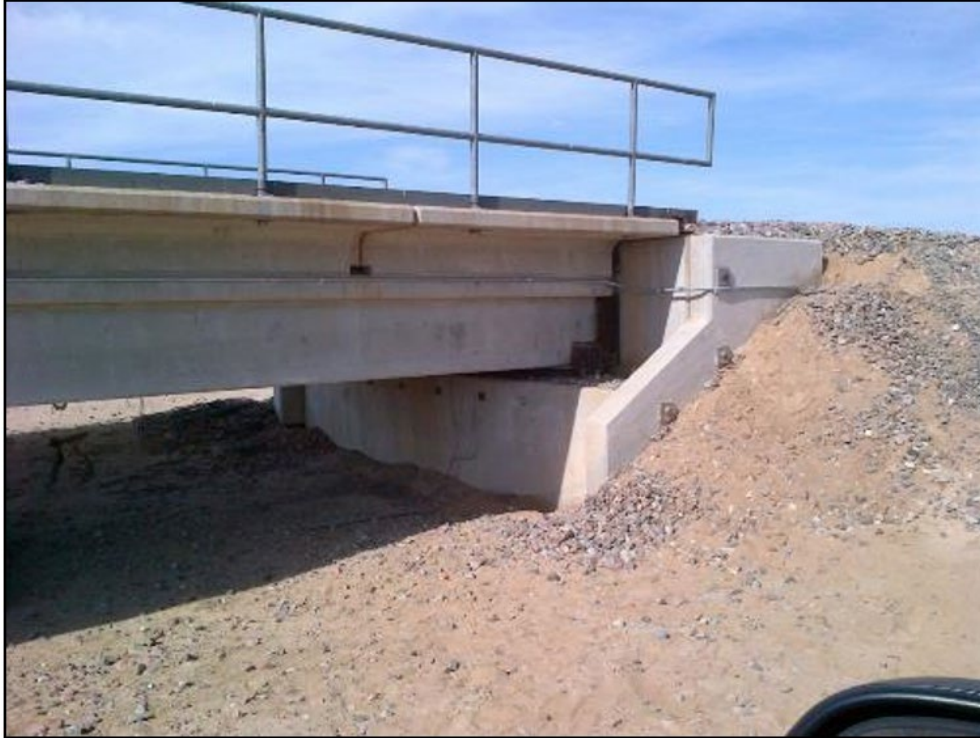
**Figure 4. HTL Bridge with Fiber Optic Conduit**

There are three bridges on the HTL, two precast concrete and one steel in composition. Each of the bridge spans hosts a different set of test objectives and materials. After studying railroad bridge fiber optic transition methods used on revenue service lines, TCI concluded that the use of a small diameter ridged steel conduit affixed to the lower side of the bridge ballast curb (see Figure 4) was the most practical installation method to use. This installation method coincidentally also provides a secure connection between the bridge structure and the fiber optic cable allowing for a usable amount of acoustic coupling.

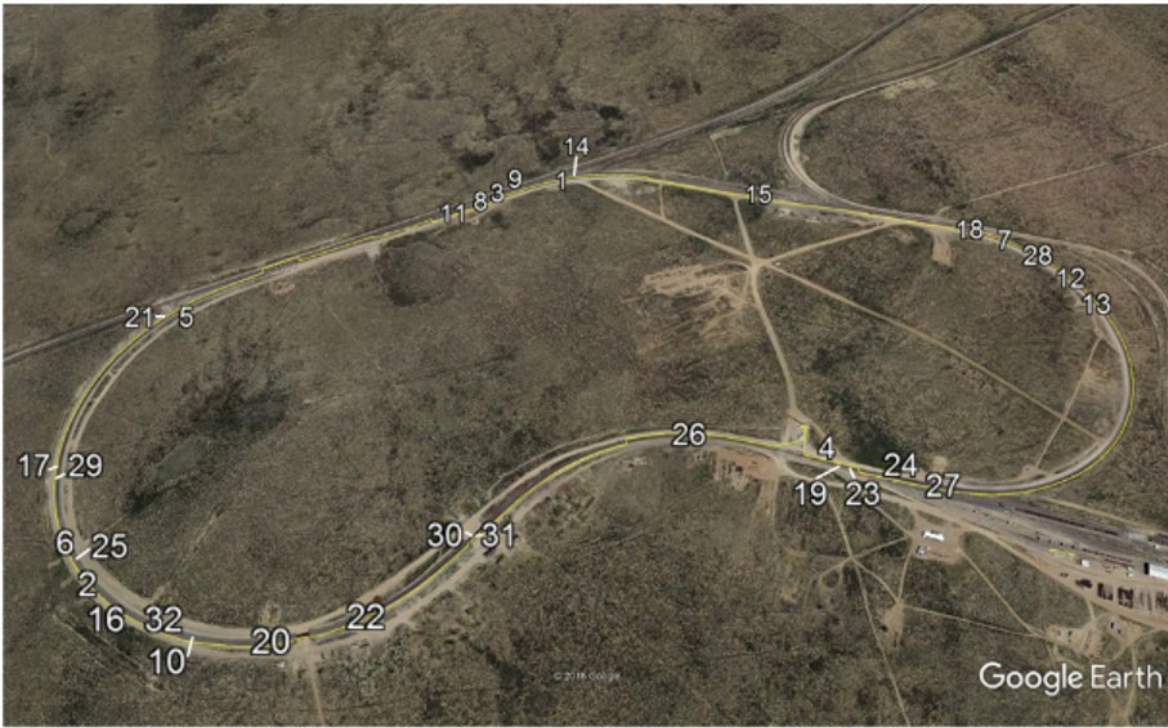
**Figure 5. HTL with Broken Rail Locations**

During the calibration and evaluation period, 35 broken rails were documented. Three of these events had to be removed from consideration. Two of the breaks that were removed occurred in a location where there is no fiber optic cable alongside the track (beginning of section 9). The other break that had to be removed occurred when the fiber optic DAS systems were not running. Figure 5 illustrates the layout of the fiber and the location of the remaining 32 broken rail events that were recorded during the calibration and evaluation period. A subset of these broken rails was used for the evaluation of each system, depending on the evaluation start date and the daily recording state of each system.

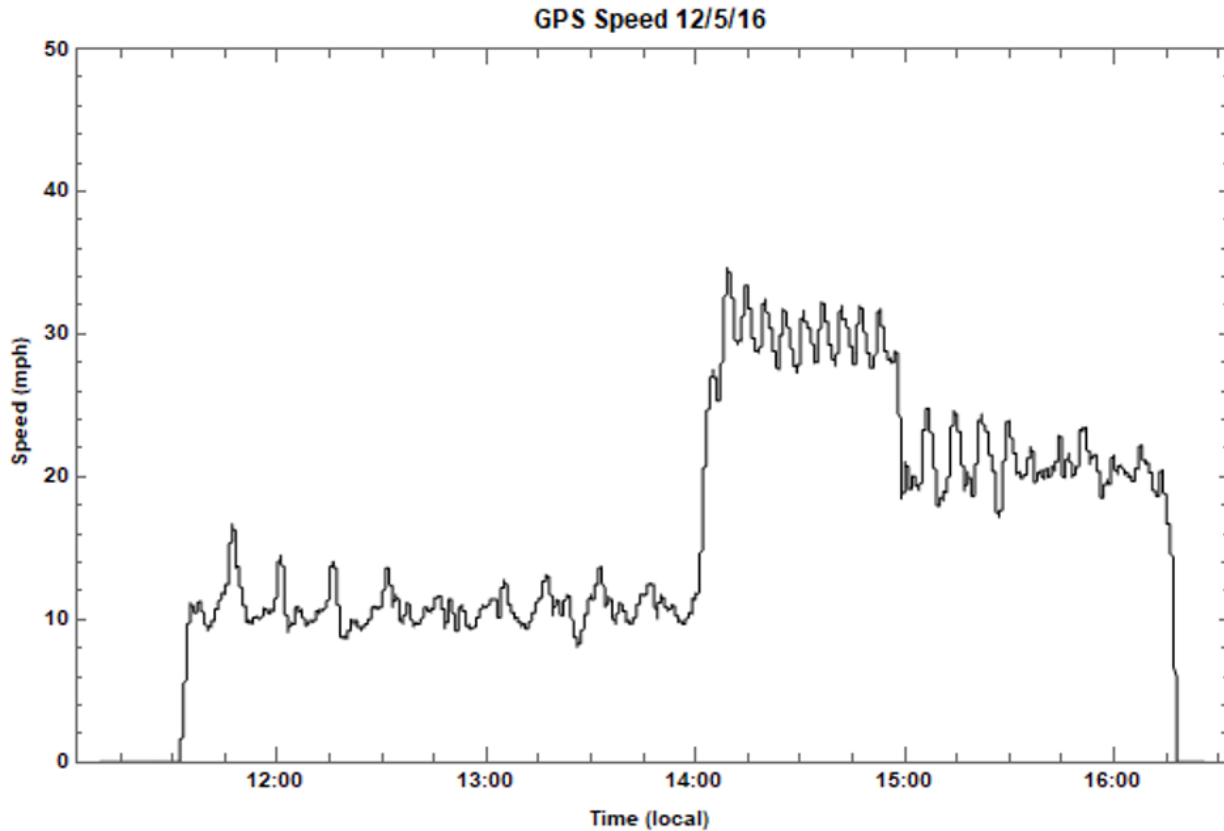
**Figure 12. Locomotive GPS Speed**

Given that the FAST train normally operates at a constant average speed of 40 mph, it was important to see how the systems performed while monitoring a train at speeds other than 40 mph, as well as during train acceleration and deceleration. This was the focus of testing on December 5, 2016. The locomotive of the FAST train was equipped with a GPS receiver. [Figure 12](#) details the speed plot of the train during testing that day, obtained from the GPS data. The test plan called for the train to proceed at approximately 10 mph, 30 mph, and 20 mph for 10 consecutive laps around the HTL at each speed. Alarms from each system were monitored in the back office and used to determine if speed changes or operating at different speeds resulted in additional broken rail alarms. No broken rails were experienced on this day of testing.

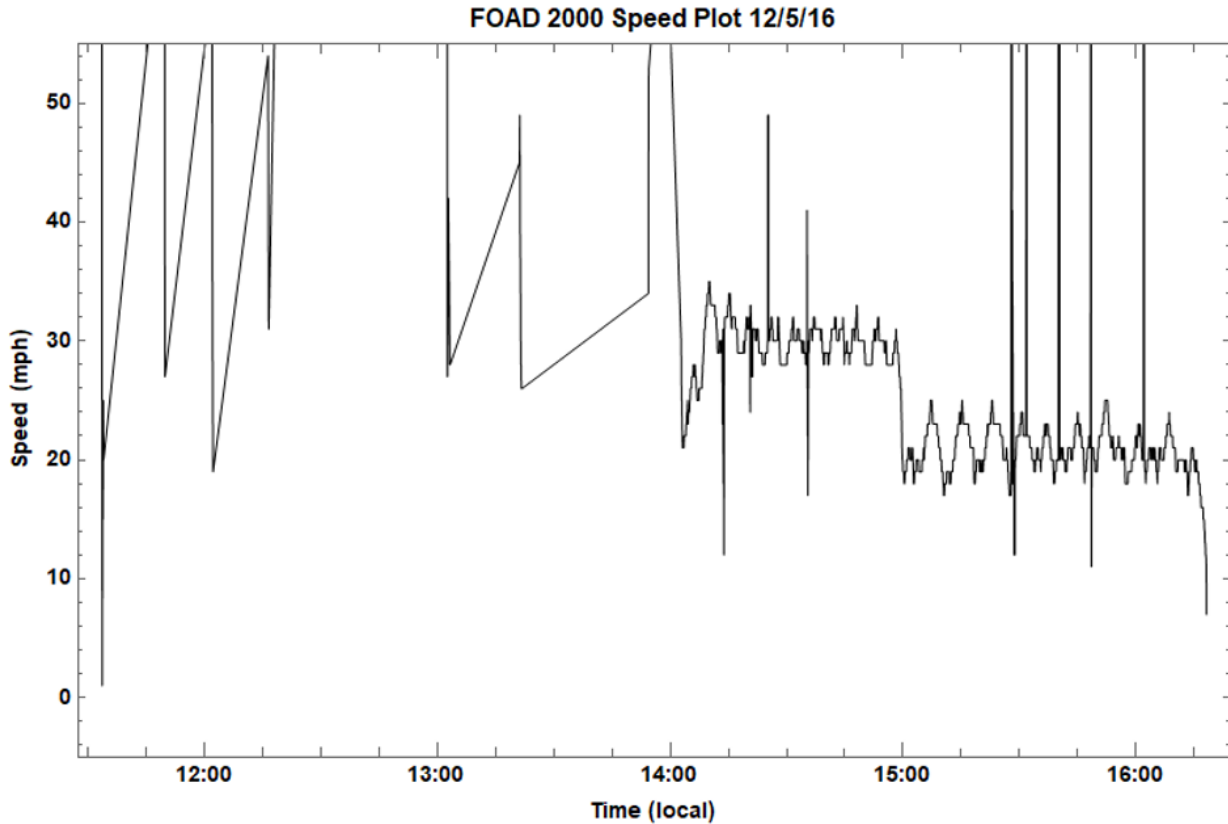
**Figure 13. Speed Plot for DAS System 2000**

During this day of testing, DAS 2000 had no broken rail alarms. Therefore, it appears the varying speed did not directly result in additional broken rail detection false alarms. However, because the system needs to track the train and determine its speed to perform broken rail detection, it is important to note that the speed data from this system, depicted in [Figure 13](#), shows that the system had issues tracking the train's speed when it was traveling at 10 mph, meaning DAS system 2000 may not be able to provide broken rail detection at slower speeds in its current configuration.

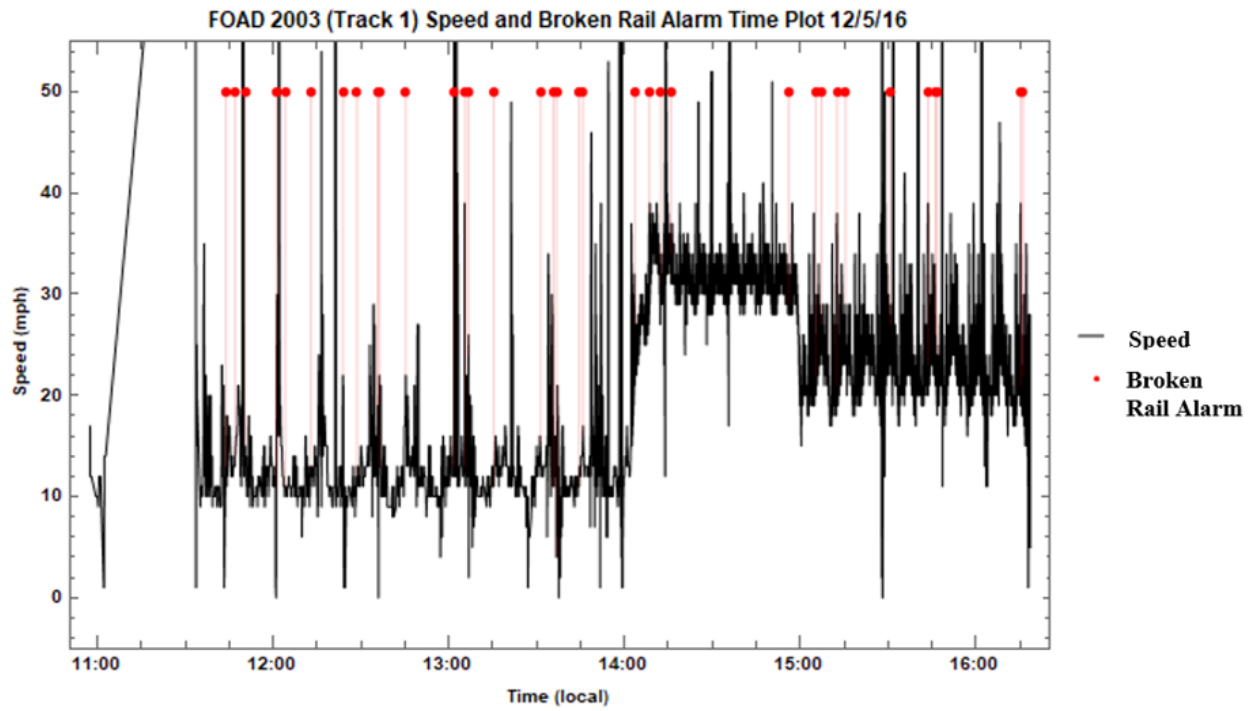
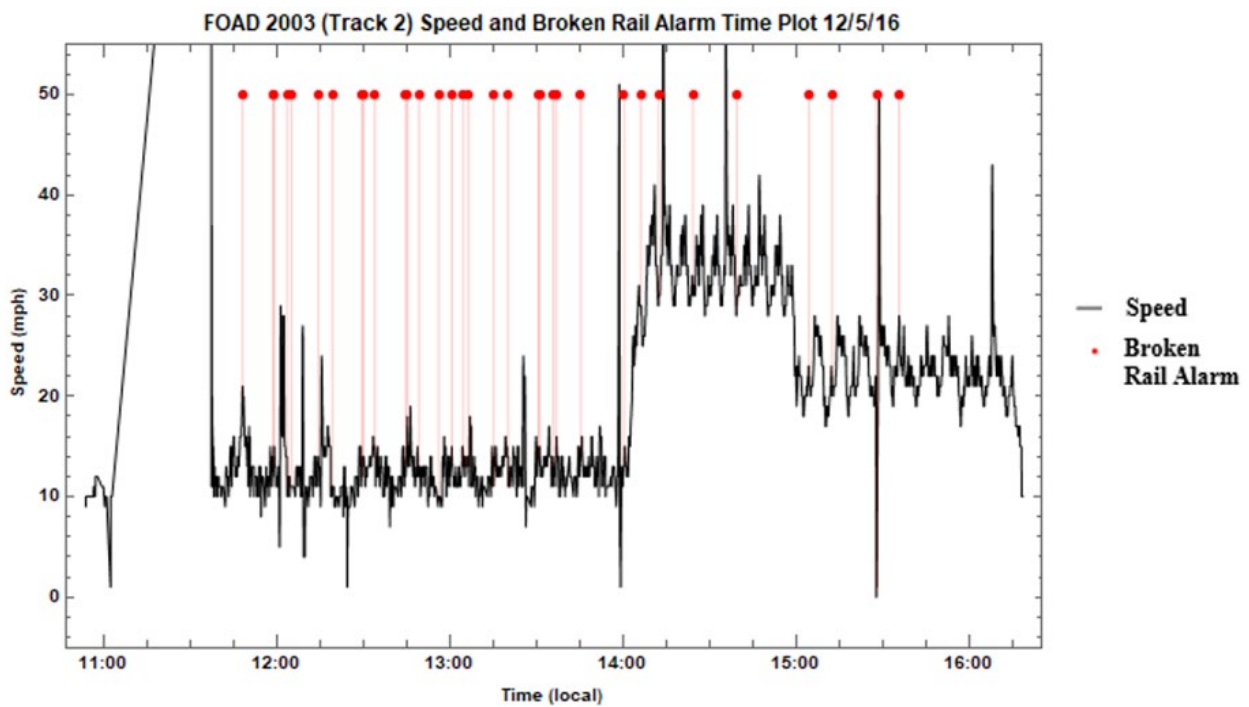
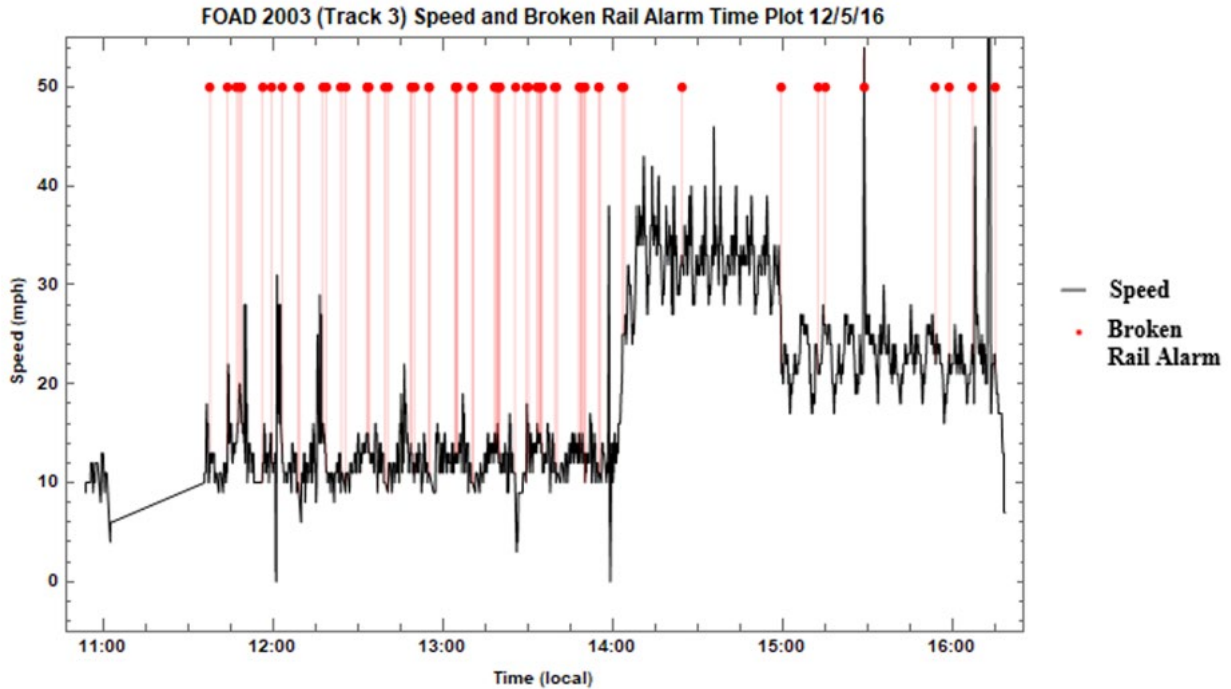
DAS System 2003 did produce false positive broken rail alarms during the speed testing. Plots of broken rail alarms and speed for loops 1, 2, and 3 are shown in [Figure 14](#) through [Figure 16](#), respectively. Looking at the total number of alarms at each speed, in [Figure 14](#), through [Figure 16](#), there is a trend of a higher rate of alarms when operating at lower constant average speeds than at the higher constant average speeds. Furthermore, looking at the number of false alarms during the 30 laps of speed testing, the number of false alarms per 100 train miles for loops 1, 2, and 3 are 38.27 false alarms per 100 train miles, 40.74 false alarms per 100 train miles, and 61.73 false alarms per 100 train miles, respectively. Over the whole trial, DAS 2003 had a false positive rate ranging from 4.96 to 6.37 false alarms per 100 train miles for the FAST train operating mostly at a constant average speed of 40 mph. Therefore, it appears the varying speed testing did result in additional broken rail detection false alarms for DAS 2003.

Figure 14. Speed Plot for DAS System 2003 Loop 1

Figure 15. Speed Plot for DAS System 2003 Loop 2

**Figure 16. Speed Plot for DAS System 2003 Loop 3**

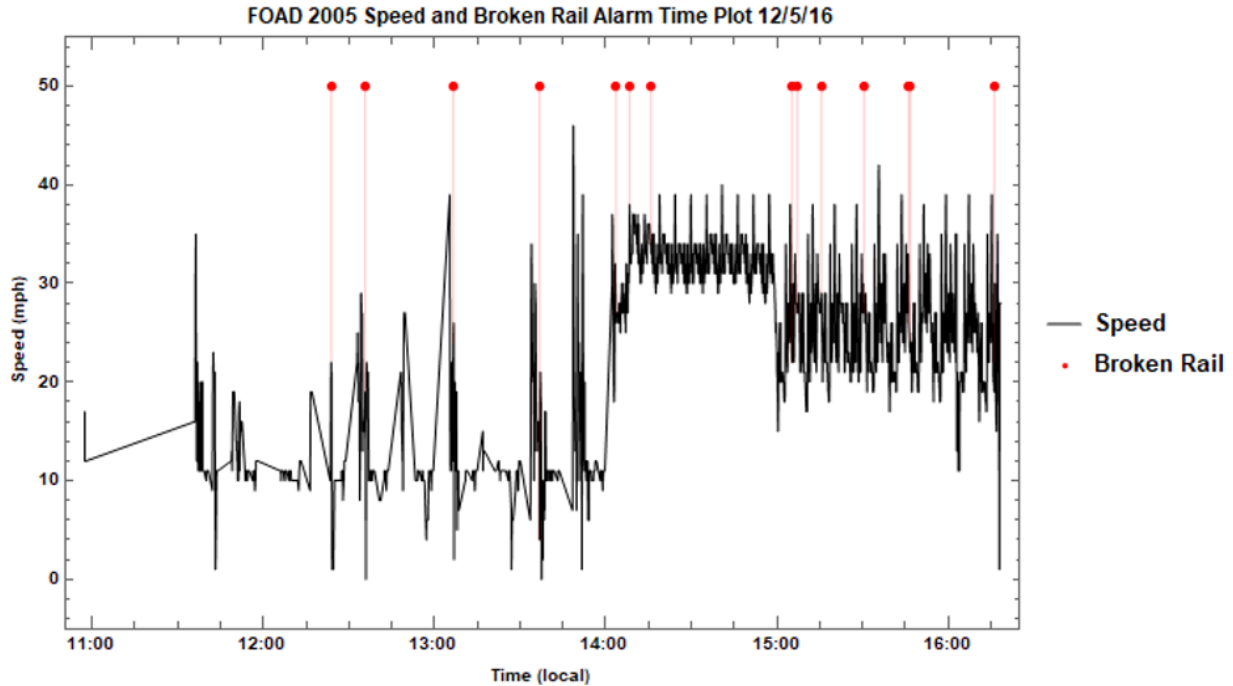
**Figure 17. Speed Plot for DAS System 2005**

DAS system 2005 also produced false positive broken rail alarms during the speed testing. [Figure 17](#) shows a plot of broken rail alarms and speed reported by DAS system 2005. Looking at the number of false alarms during the 30 laps of speed testing, the number of false alarms per 100 train miles is 17.28 false alarms per 100 train miles. Over the whole trial, DAS 2005 had a false positive rate of 4.37 false alarms per 100 train miles for the FAST train operating mostly at a constant average speed of 40 mph. Therefore, it appears the varying speed testing did result in additional broken rail detection false alarms for DAS 2005.
