Re: Response to Petition for Reconsideration filed in Docket No. FRA-2018-0091;
Approval of BNSF Railway Company Test Program to Evaluate Automated
Track Inspection Technologies

This report documents the Federal Railroad Administration's (FRA) Office of Research, Development and Technology's (RD&T) successful development and demonstration of autonomous track geometry measurement system (ATGMS) technology. FRA is currently developing autonomous inspection technologies with the objective of improving railroad safety through enhanced conditional awareness. Autonomous track inspection is a process of inspecting the track from revenue trains using unattended instruments, with minimal direct involvement from operators. This technology allows dramatically increased inspection frequencies at reduced cost, when compared to traditional manned methods. Widespread use of autonomous inspection technology has the potential to increase the timeliness of track defect detection and remediation, thus improving the safety of the nation's rail system.

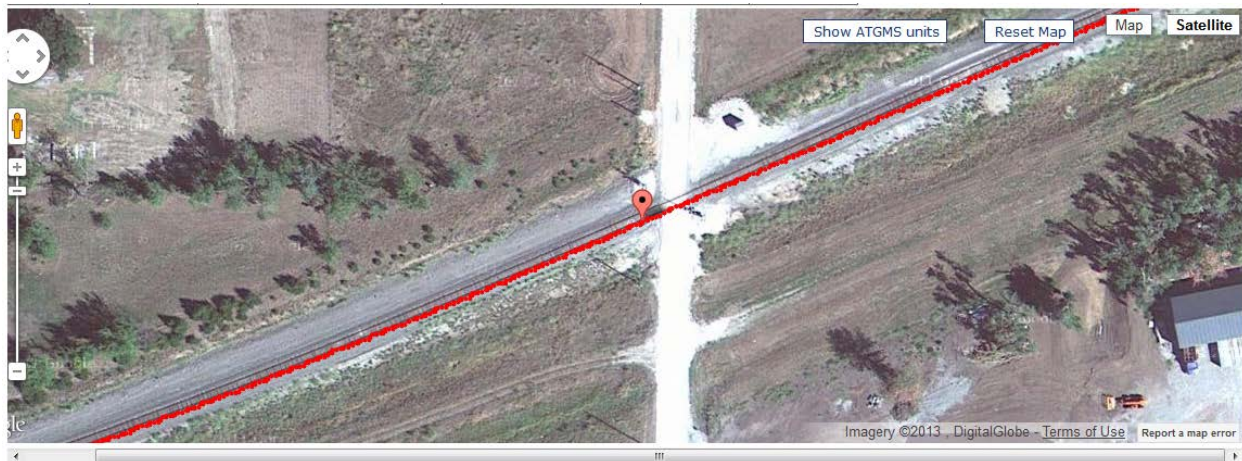
Figure 7: Remote Editor Console Map View

- **Map** displays a Google™ Maps screen showing the location for the selected data for overall assessment and confirmation of individual track designation (see Figure 7).

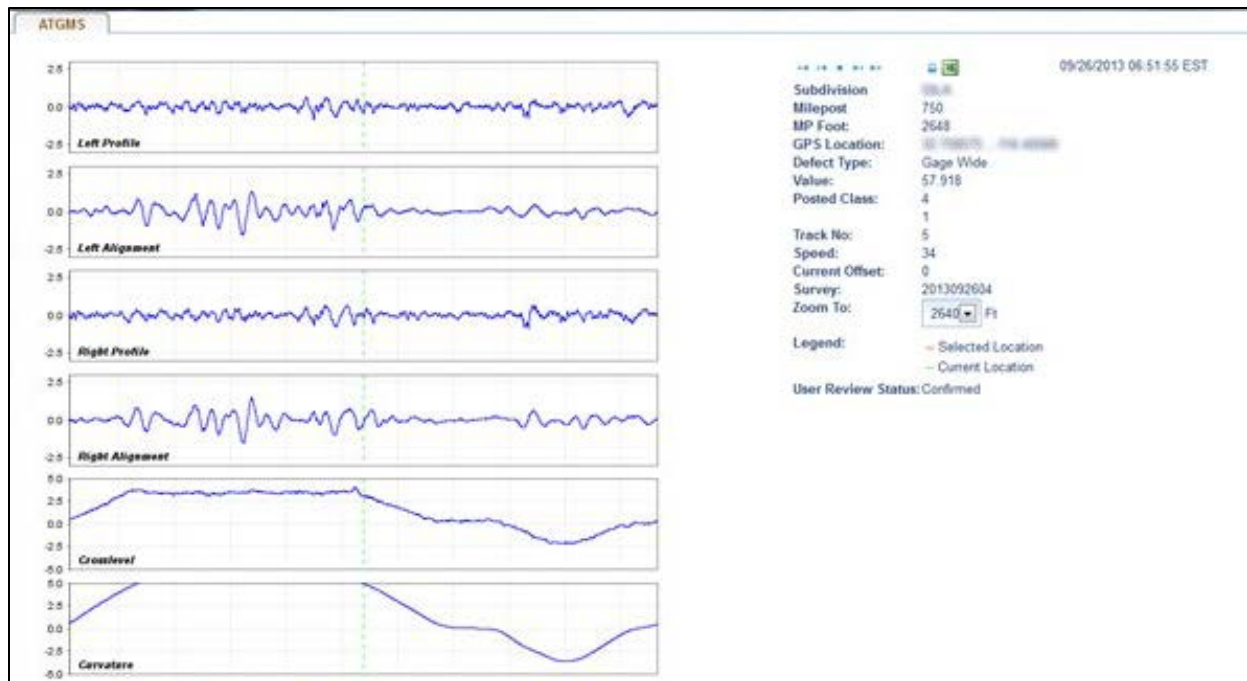
Figure 8: Remote Editor Console Strip Chart

- **Strip Chart** displays a separate window in which a foot-by-foot illustration of the selected survey data is provided (see Figure 8).

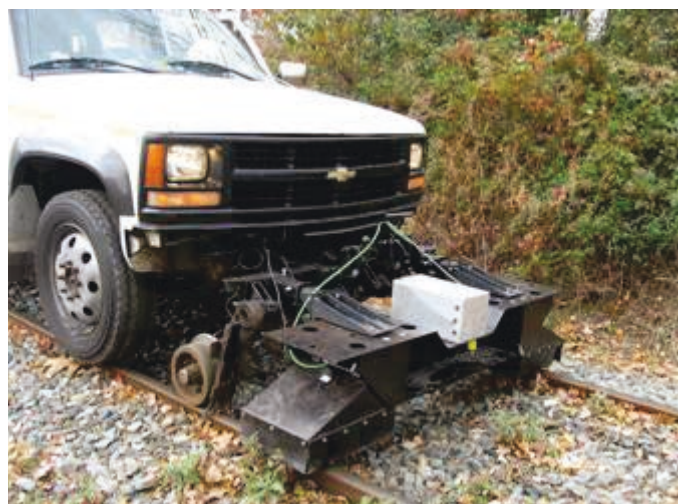
Figure 11: ATGMS Proof of Concept Testing on a High-Rail Vehicle

ENSCO evaluated the early ATGMS proof of concept prototype on hi-rail vehicles as shown in Figure 11. Initial tests of the prototype system showed the potential for autonomous data collection, processing, detection, and reporting of geometry exceptions via a commercial cellular connection.

The first ATGMS proof of concept field test performed in March 2006 verified the overall system capabilities to properly collect and transmit track geometry data. Although successful in generating selected verifiable geometry results, this test highlighted the need for improving several technologies essential to autonomous performance and overall robustness of ATGMS including automatic determination of track class as well as self-identification and correction of sensor issues. Further field testing conducted in early May 2007 evaluated software remedies for detecting track class and vehicle direction of travel, dynamic sensor calibration based on long-term averages collected on tangent track, and corrected output of fiber optic gyroscopes based on filtered GPS data. Final field testing with the hi-rail vehicle in late May 2007 evaluated integration of a custom inertial measurement unit using standard sensors to address issues observed with the fiber optic gyroscopes and to verify software modifications improving track geometry calculations, including the determination of track class based on survey speed.

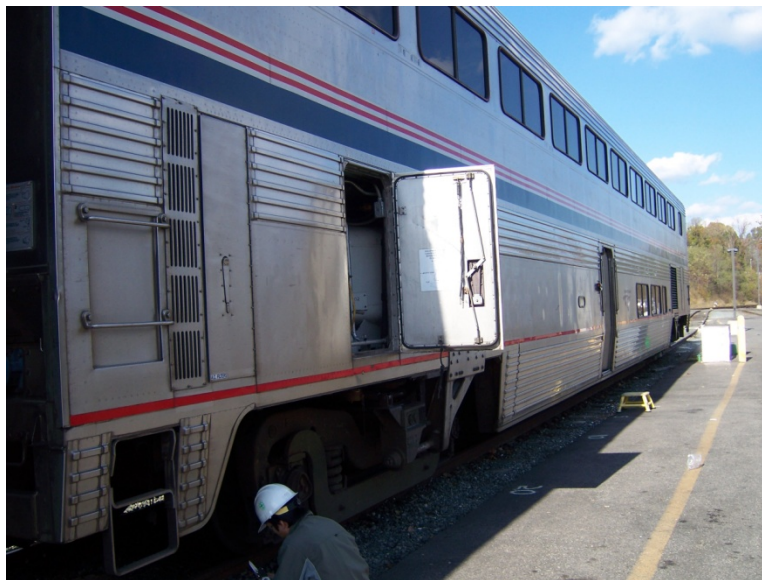
Figure 12: Stage 1 ATGMS Host Vehicle, Amtrak Car 39000

Tests on the hi-rail vehicle showed the viability of a fully equipped ATGMS employing cellular communication, and established the foundation for a long-term pilot program. The first pilot program, initiated in January 2008, focused on the evaluation of ATGMS on Amtrak Car 39000, a Superliner II sleeper car (Figure 12) in revenue service operation on Amtrak's Auto Train service between Lorton, VA, and Sanford, FL, over CSX track. The test bed on the Amtrak revenue vehicle fits the ideal operational scenario for initial use of the ATGMS repetitive operation of the test platform over a fixed route and availability of Head End Power (HEP) onboard the vehicle.

ATGMS operated on Amtrak Car 39000 from January 2008 to March 2011. During that time, ATGMS surveyed almost 460,000 miles of track, an average of approximately 153,000 miles per year. This extensive testing allowed identification of system deficiencies, facilitating design modifications that moved ATGMS toward increased robustness and reliability. Repetitively operating ATGMS on the 855-mile Lorton to Sanford route advanced testing procedures and established guidelines for subsequent ATGMS development stages. ENSCO analyzed track geometry data collected by ATGMS for consistency among the repeated runs and compared

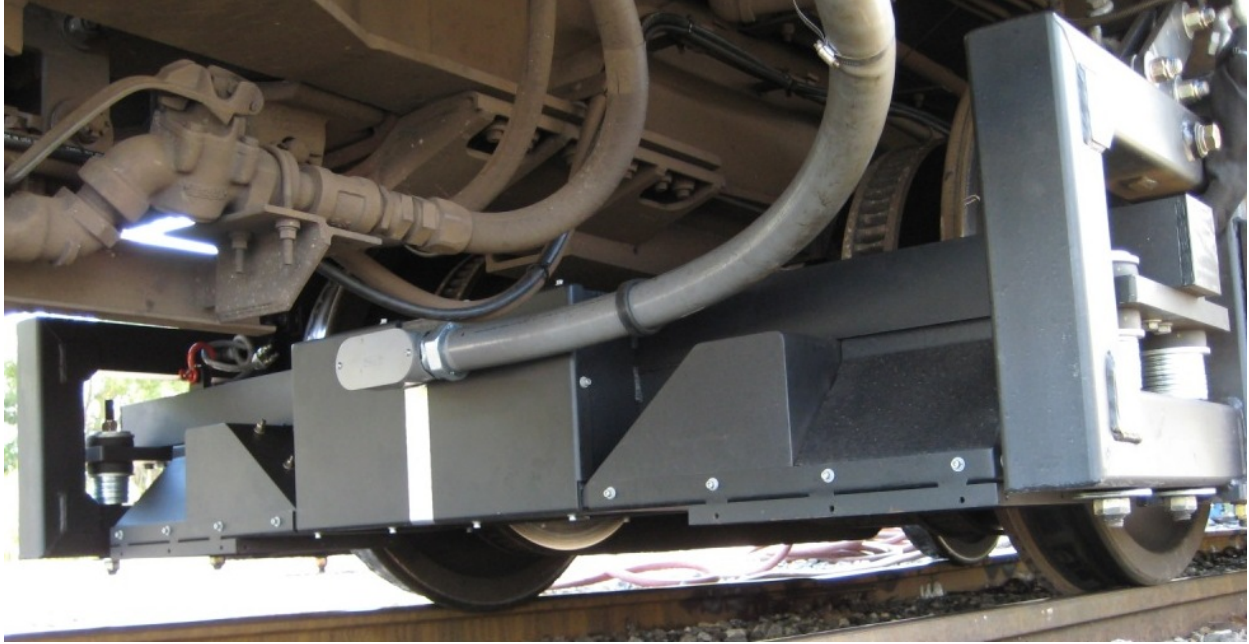
The measurement beam was mounted to the A-End truck. Mechanical mounting fixtures were designed to withstand 25g vertical and 15g lateral shocks over fatigue life cycles consistent with Amtrak requirements. It should be noted, however, that the final design of the truck-mounted beam required removal of the measurement beam and mounting brackets from the truck frame in advance of any wheel or axle maintenance activities—an issue that would negatively impact the long-term viability of this design approach. Final installations of the externally mounted equipment are shown in Figure 13 and Figure 14.

Figure 13: Stage 1 ATGMS Measurement Beam on Amtrak Car 39000

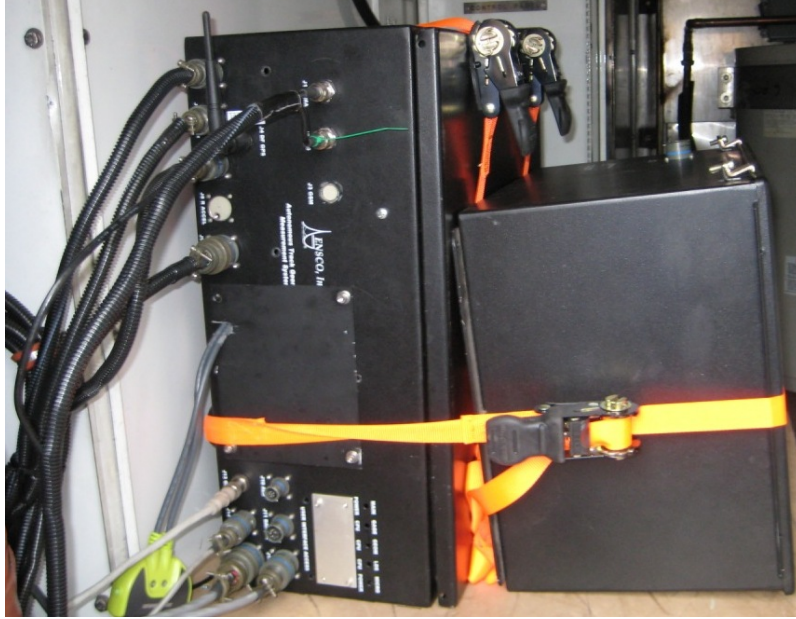
Figure 15: Stage 1 ATGMS Electronics on Amtrak Car 39000

GPS location and linear distance measurement subsystems were updated to accurately mark track geometry measurements with location information. Signal processing and communication hardware were housed in enclosures that were temporarily installed in an equipment locker (Figure 15). HEP was used to power ATGMS.

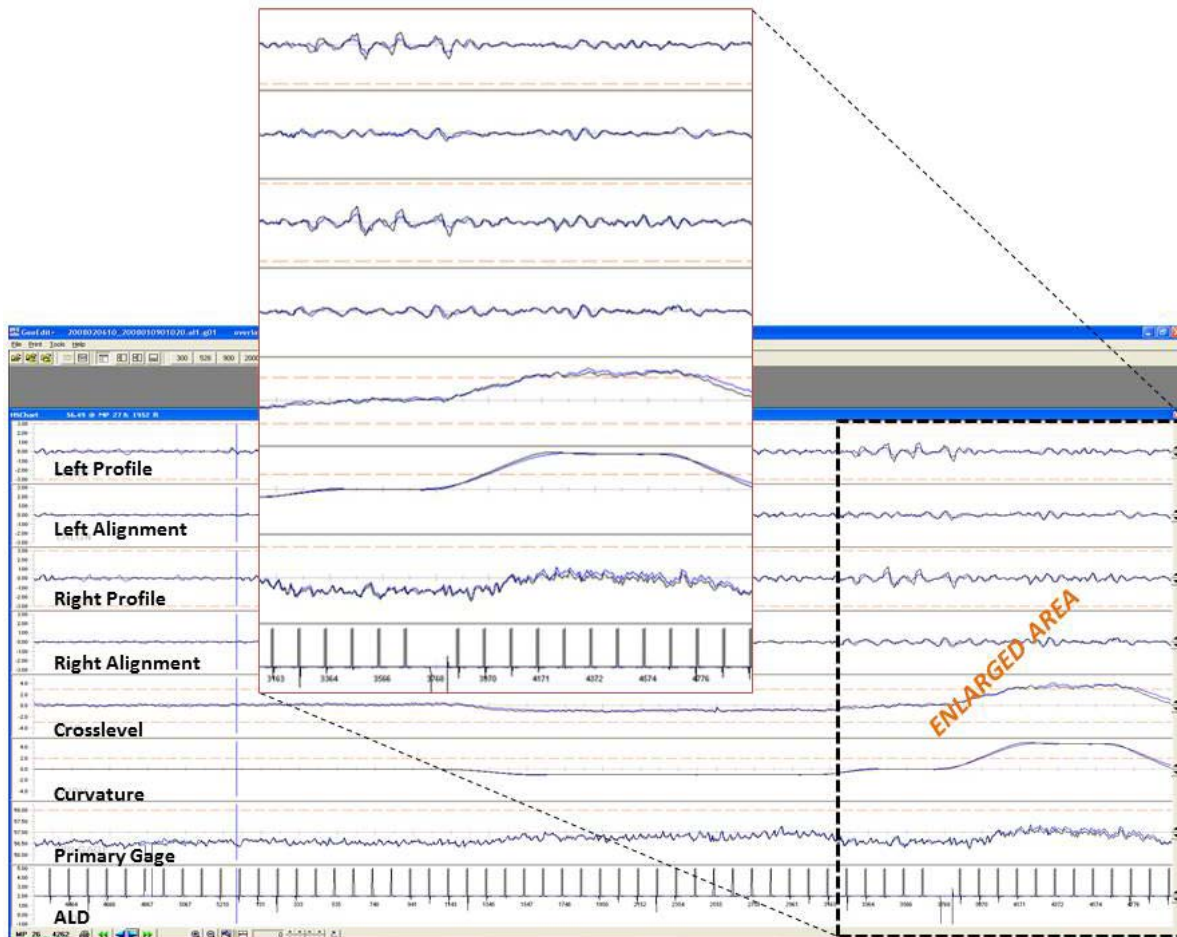
A strip chart overlay comparison of the data collected by ATGMS and the manned DOTX 220 in February 2008 is shown in Figure 19.

Figure 19: Track Geometry Data Overlay of ATGMS and DOTX 220, February 2008

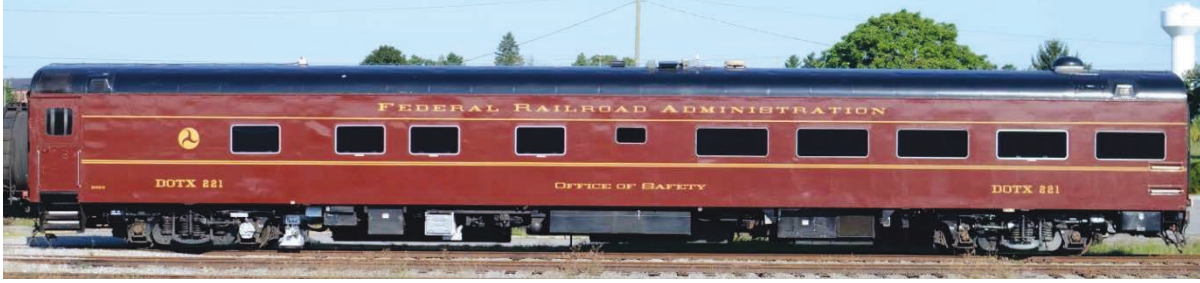
Figure 20: Stage 2 ATGMS Host Vehicle—DOTX 221

Stage 2 tested the ATGMS under long distance, revenue service operating conditions. ENSCO removed FRA's ATGMS from the Amtrak Superliner II and installed it on DOTX 221 (Figure 20, following inspection and refurbishment of the system. DOTX 221 is a sleeper-lounge car operated by FRA as a crew car during cross-country surveys on passenger train routes.

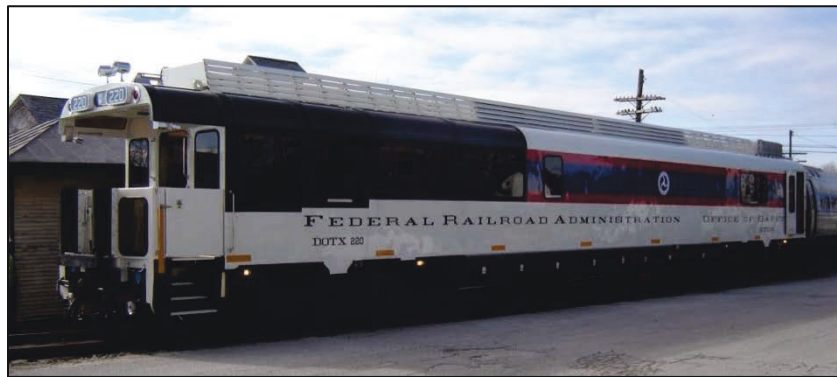
Figure 21: ATIP Manned Geometry Inspection Vehicle—DOTX 220

DOTX 221 operated in consist with FRA's DOTX 220 manned inspection vehicle (Figure 21) during ATIP surveys conducted over Amtrak passenger routes between fall 2011 and spring 2013. Tandem operation provided the opportunity to perform direct comparisons of foot-by-foot measurement and exception data collected with both systems. The operating scenario also enabled the DOTX 220 crew to conduct regular inspections of ATGMS and address any minor issues during cross-country operations.

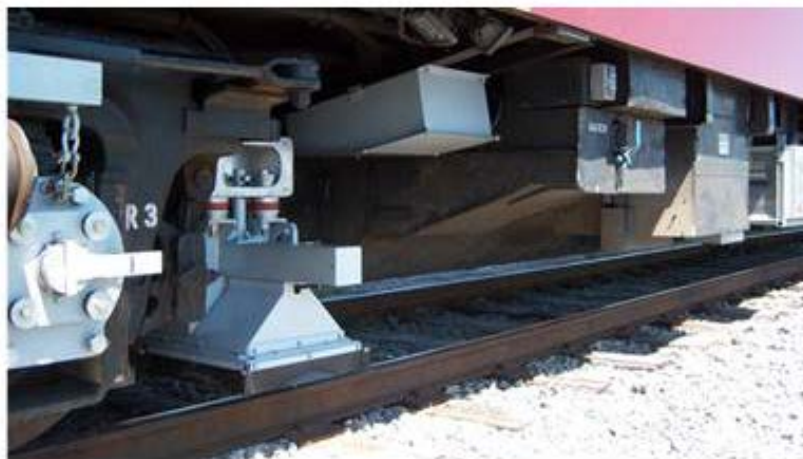
Figure 24: ATGMS Installation on DOTX 221

Figure 23 is a schematic of the ATGMS configuration on DOTX 221 and Figure 24 shows the final installation of ATGMS on DOTX 221. The ATGMS was commissioned by undergoing repeatability testing on Norfolk Southern Corporation's Lurgan Branch between Shippensburg, PA, and Mount Holly Springs, PA.

For the DOTX 221 installation, ENSCO mounted ATGMS electronics on the exterior of the vehicle. A ruggedized, weather-sealed enclosure was selected to house the Signal Conditioning Unit (SCU), an Uninterruptable Power Supply (UPS), and a communications network switch.

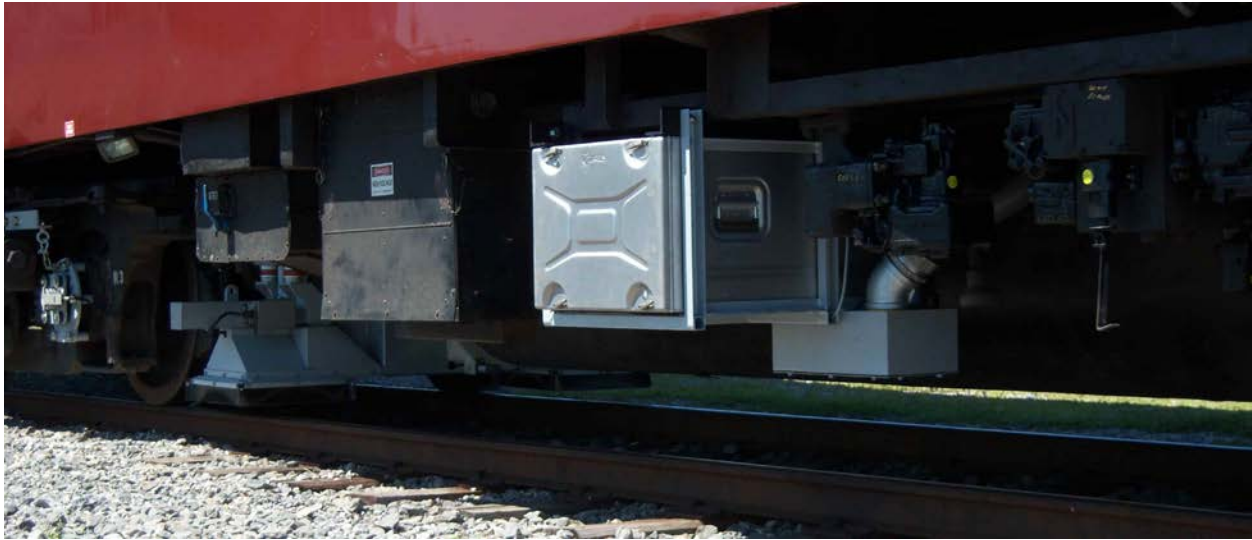
Figure 25: ATGMS Electronics Box on DOTX 221

The electronics enclosure support structure (Figure 25) was designed to withstand vehicle acceleration forces and allow mounting near the vehicle brake rack.

Power to the electronics box was supplied by a transformer installed in the electrical cabinet to convert train-line 480VAC to 120VAC and an automatic power transfer switch installed to automatically switch ATGMS power to DOTX 221's backup generator when train-line power was not available.

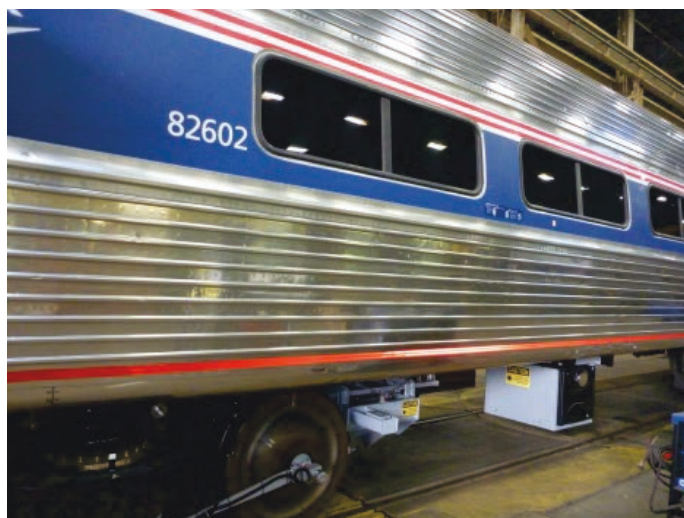
Figure 28: Stage 3 ATGMS Host Vehicle, Amtrak 82602

Working in partnership with FRA, Amtrak offered use of Amfleet I passenger car 82602 as the host vehicle for the carbody-mounted ATGMS. The vehicle is shown in Figure 28.

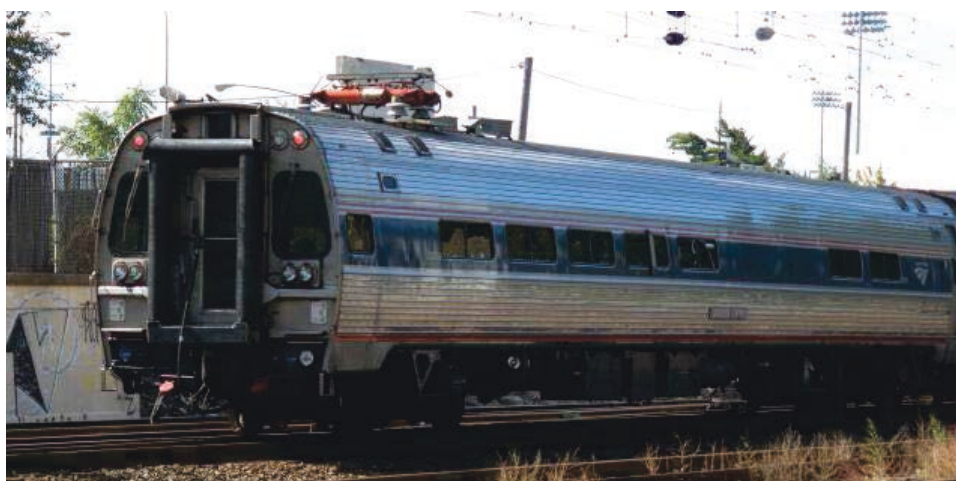
Figure 29: Amtrak's Manned Inspection Vehicle, Amtrak 10002

Selection of Amtrak's 82602 as the host vehicle was based on its ability to provide HEP to ATGMS and joint operations on the NEC with Amtrak's track inspection vehicle designated as 10002. Amtrak's 10002, shown in Figure 29, carries a truck-mounted track geometry measurement system and is manned by a typical operations crew.

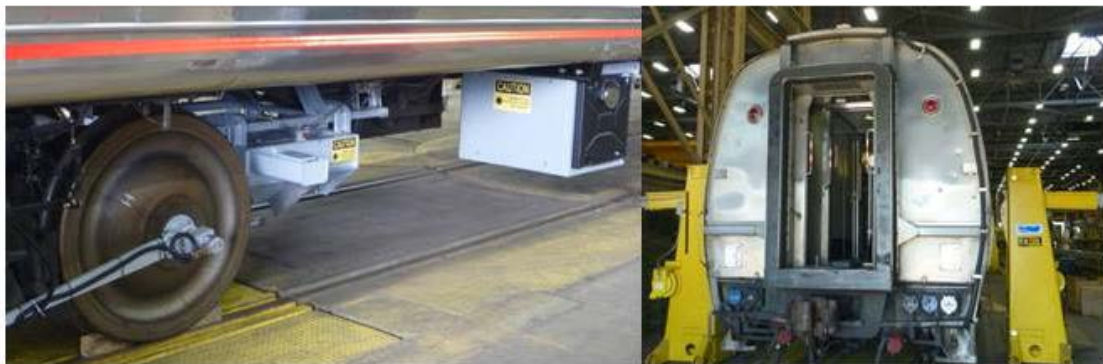
Figure 38: Stage 3 Carbody-Mounted ATGMS Installation, Amtrak's 82602

Detailed stress analyses were conducted on all mechanical components. ENSCO installed the components presented in this section at Amtrak's Ivy City Maintenance Facility under the supervision of Amtrak personnel. GPS and cellular antennae were mounted on the roof of the host Amfleet I railcar at the A-end of the car as close to the car's centerline as possible. Figure 37 depicts the final layout of ATGMS components on Amtrak Car 82602; photographs of the installation are provided in Figure 38.

Installation of the carbody-mounted ATGMS on Amtrak's 82602 was completed and accepted in August 2012. The system was commissioned immediately following installation by undergoing standard geometry car repeatability tests.

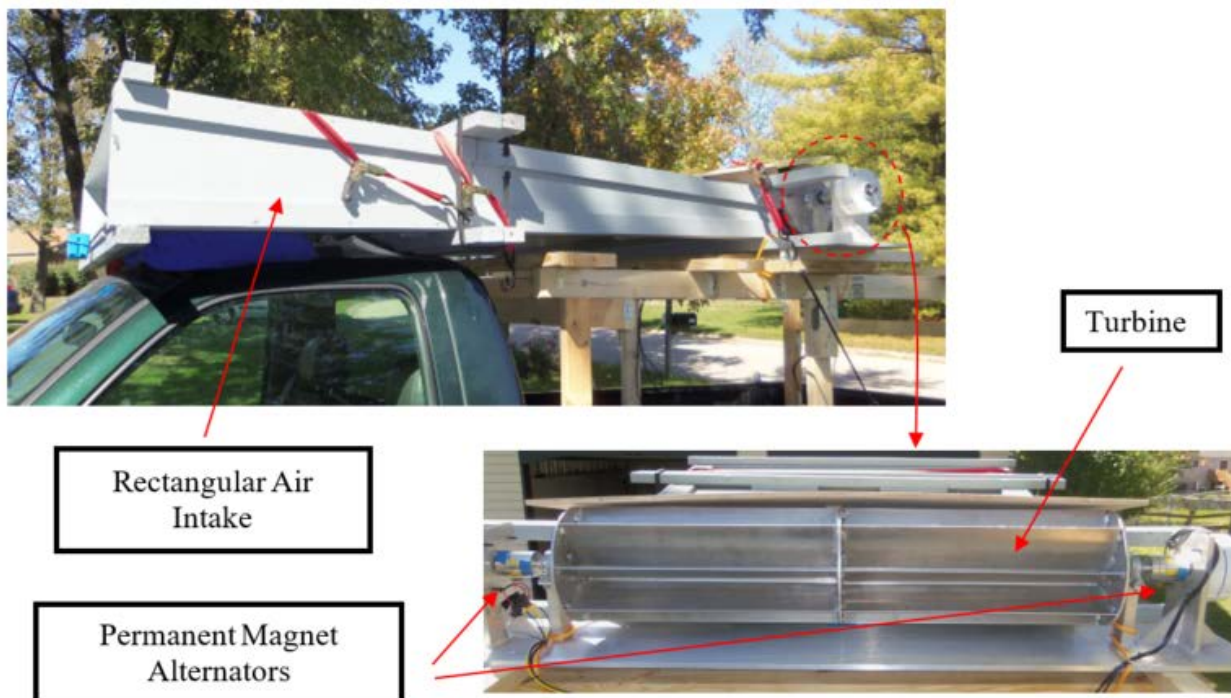
New Way Solutions evaluated two types of wind turbines for railroad applications. The first design consisted of a rectangular air intake and a horizontally configured turbine with permanent magnet alternators (PMA) installed on each end of the turbine as shown in Figure 39. An axial turbine with a conical air intake prototype, as shown in Figure 40, was also evaluated. Over-the-road tests conducted in the fall of 2011 involving mounting the turbine arrangements on a pick-up truck to test the power generation as a function of air speed and wind direction at speeds up to 70 mph.

Figure 39: Horizontal Turbine and Rectangular Air Intake Configuration Prototype

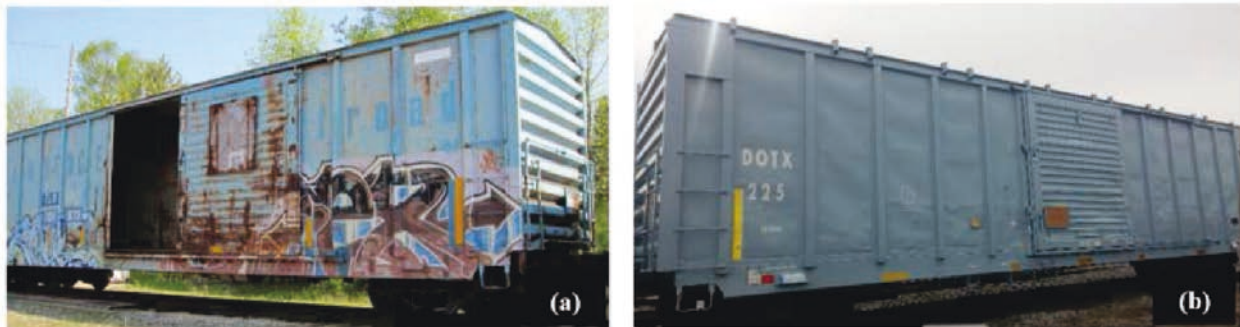
Figure 42: FRA's Freight Boxcar DOTX 225

The box car, DOTX 225, was purchased from Escanaba and Lake Superior Railroad (ELS) and refurbished and modified for ATGMS in October 2015. Images of the vehicle prior to and after refurbishment are provided in Figure 42. The vehicle was delivered to ENSCO's Chambersburg, PA, maintenance facility in February 2016 for system installation and testing.

(a) As purchased from ELS.

(b) Upon completion of refurbishment.

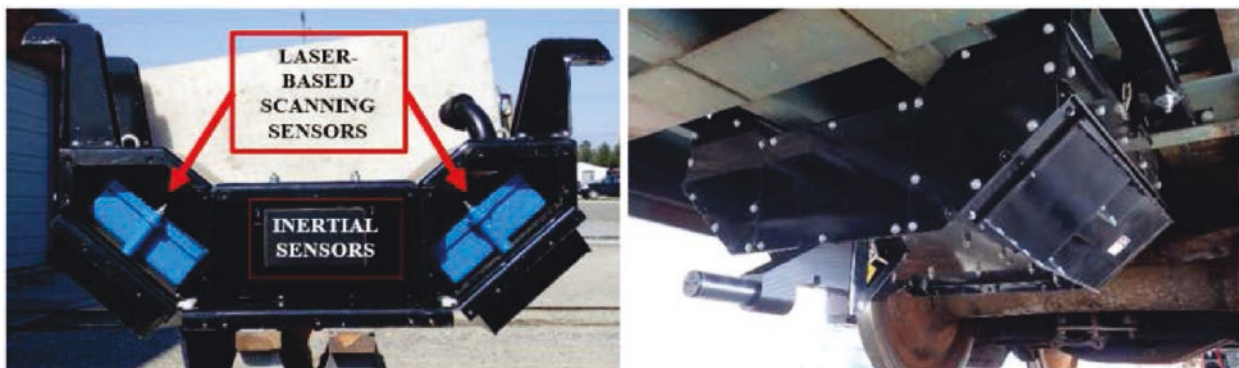
Figure 45: DOTX 225 Geometry Measurement Beam

The freight ATGMS was outfitted with the latest ATGMS beam configuration. The track geometry measurement system now employs digital signal processing techniques to reduce the signal noise and increase sensor stability. These improvements resulted in a more reliable and robust system. The digital system has a lower power draw as compared with the prior analog signal processing unit and the inertial sensors were consolidated into a single sensor package. The measurement beam is shown in Figure 45.

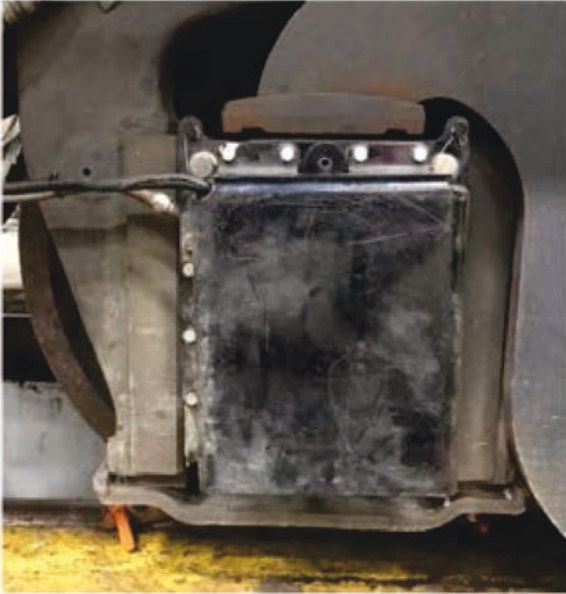
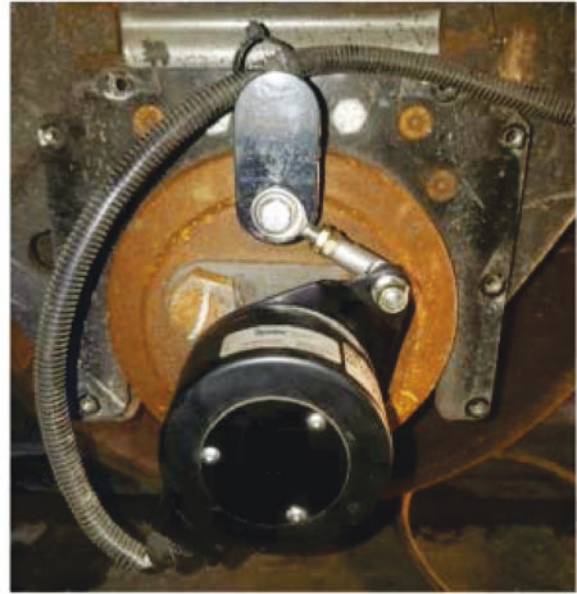
Figure 46: Tachometer Installation

The tachometer assembly was mounted on the left side of axle 2 on the A-end truck. A modified end cap with a built-in axle spike was installed by ELS in preparation for the tachometer installation. The tachometer design, shown in Figure 46, includes a tether to allow for lateral movement of the axle and a cover to protect the assembly from weather and impacts.

(a) Rock Cover

(b) Tachometer with Tether

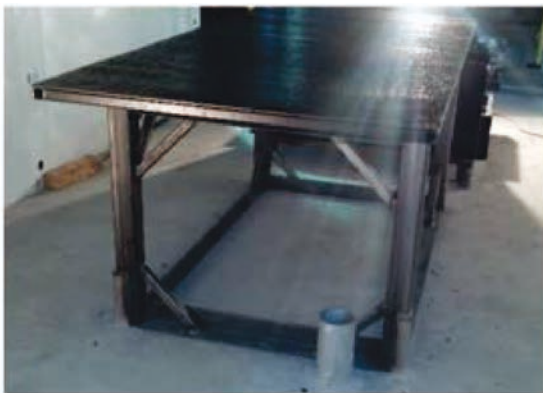
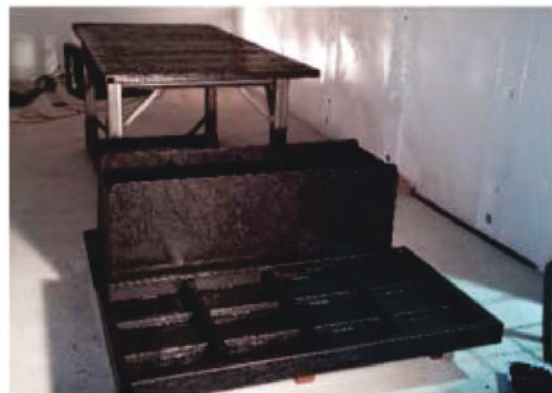
Figure 47: Electronic Table and Battery Pallet

ENSCO designed and fabricated a work table and electronics pallet to withstand significant force. The control components of the solar power system and the computer rack used in Stage 3 were installed on the work table inside the vehicle. The battery bank and fuel cell were installed on a customized battery pallet. The final installations of the table and battery pallet are shown in Figure 47.

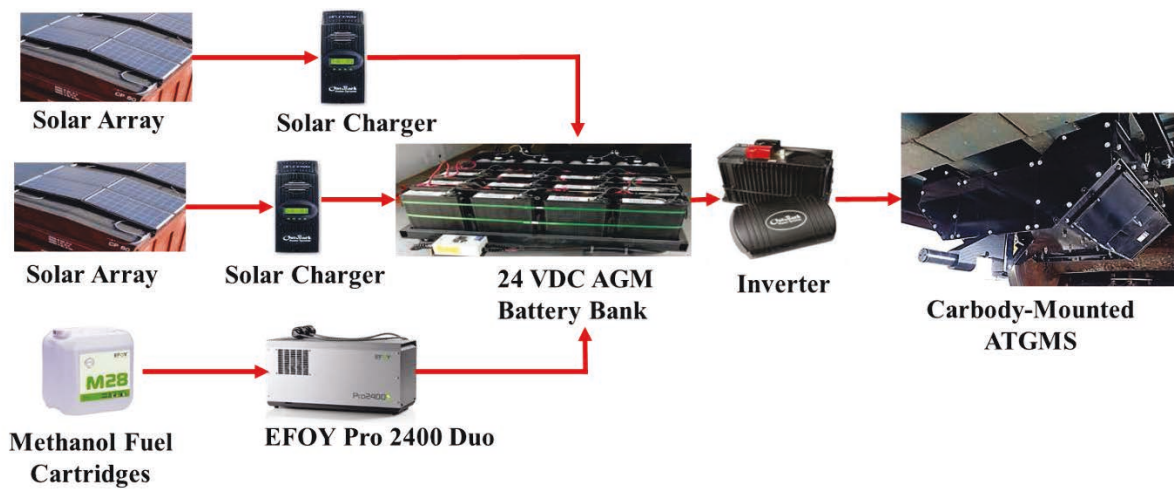
Figure 48: DOTX 225 ATGMS Power System Architecture

DOTX 225 was equipped with a power system that employed both solar energy and direct methanol fuel cell technology as its primary and secondary power sources charging the ATGMS battery system. A schematic of the system architecture is illustrated in Figure 48. The power system consisted of 12 140W, 17.5V, 8A solar panels and a 110W EFOY Pro 2400 Duo methanol fuel cell with four cartridges powering a 24V battery bank consisting of 12 6V AGM batteries with a total power capacity of 22 kWh. The average load on the system was approximately 130 watts. Each solar charge controller controlled one six panel array of solar cells. Figure 49 shows the solar panels and other roof-mounted equipment including GPS and cellular antennas. Communications with the charge controllers, the charger/inverter and the methanol fuel cell were configured through a communications hub to enable remote monitoring and control of all components of the electrical system.

The power system performed without any issues during the 9-month demonstration. The solar charging system kept the batteries adequately charged with minimal need for the secondary fuel cell. In total, the fuel cell ran for 15 hours and consumed less than 1 liter of methanol. An illustration of the energy harvesting and usage throughout a 24-hour period is shown in Figure 50

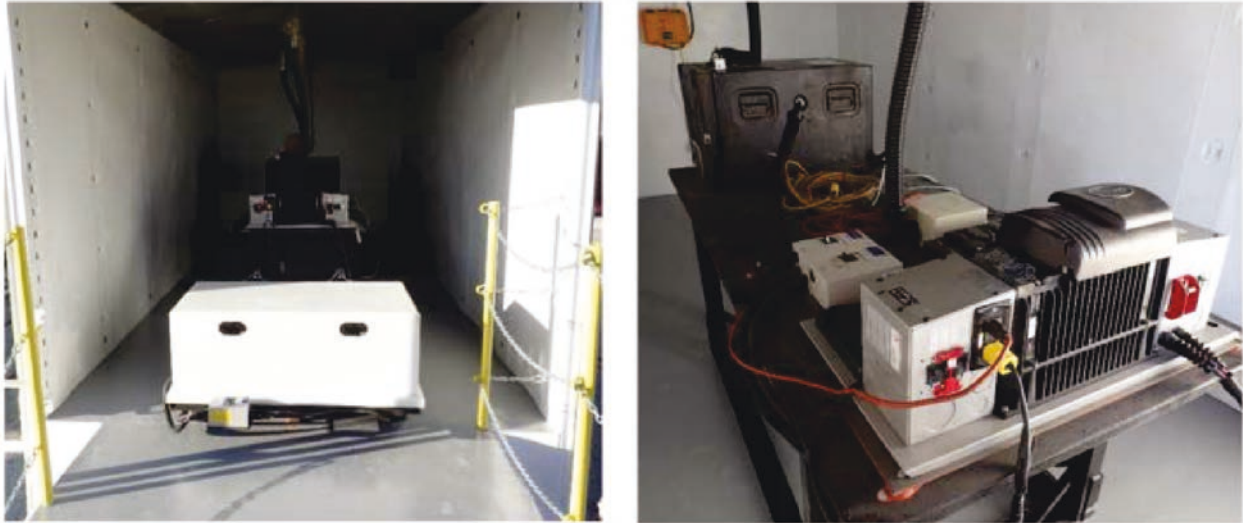
Figure 51: Freight ATGMS Power System Installation

Installation of the measurement and power systems took place at ENSCO’s Chambersburg maintenance facility between March 1 and March 30, 2016. Photographs of the power system are provided in Figure 51. Prior to releasing the vehicle for freight demonstration, the car underwent calibration and reproducibility analysis to verify the ATGMS performance. The

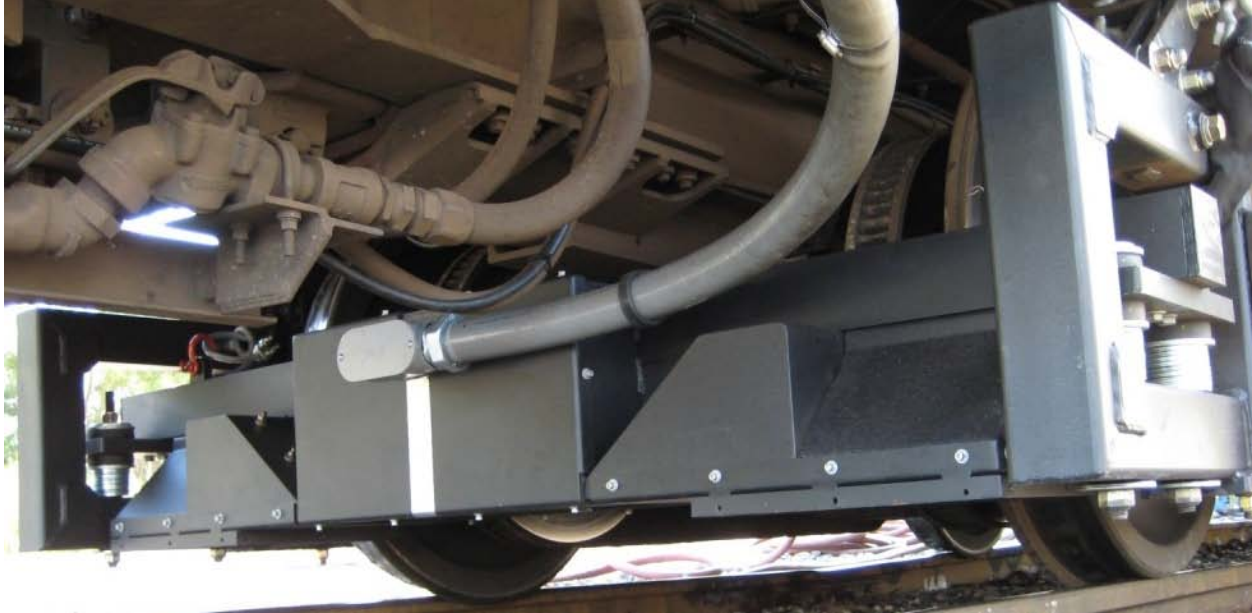
Figure 2. FRA's Truck-Mounted Pilot ATGMS on Amtrak Superliner 39000

The first stage centered on the creation of the basic elements of a ruggedized pilot ATGMS. Commercial, off-the-shelf equipment was employed to facilitate early development and evaluation. The original Data Collection Module was designed to alert stakeholders to areas of concern. The system was configured to measure track geometry, analyze the measurements for any locations exceeding established limits, and transmit “exception reports” to the server for storage and transmission to survey stakeholders. Early efforts focused on the creation of automated filters employing a variety of statistics-based algorithms and logic rules to identify and eliminate “false” exceptions. The pilot ATGMS was operated over CSX track between Lorton, VA, and Sanford, FL, on Amtrak 39000, a Superliner II railcar, in revenue service operations within Amtrak’s Auto Train service; an illustration of the measurement equipment located under the vehicle is included as Figure 2. Between January 2008 and March 2011, ATGMS surveyed almost 460,000 miles of track, an average of approximately 153,000 miles per year. This extensive testing allowed identification of system problems and limitations, facilitating design modifications that moved the technology towards increased robustness and reliability.

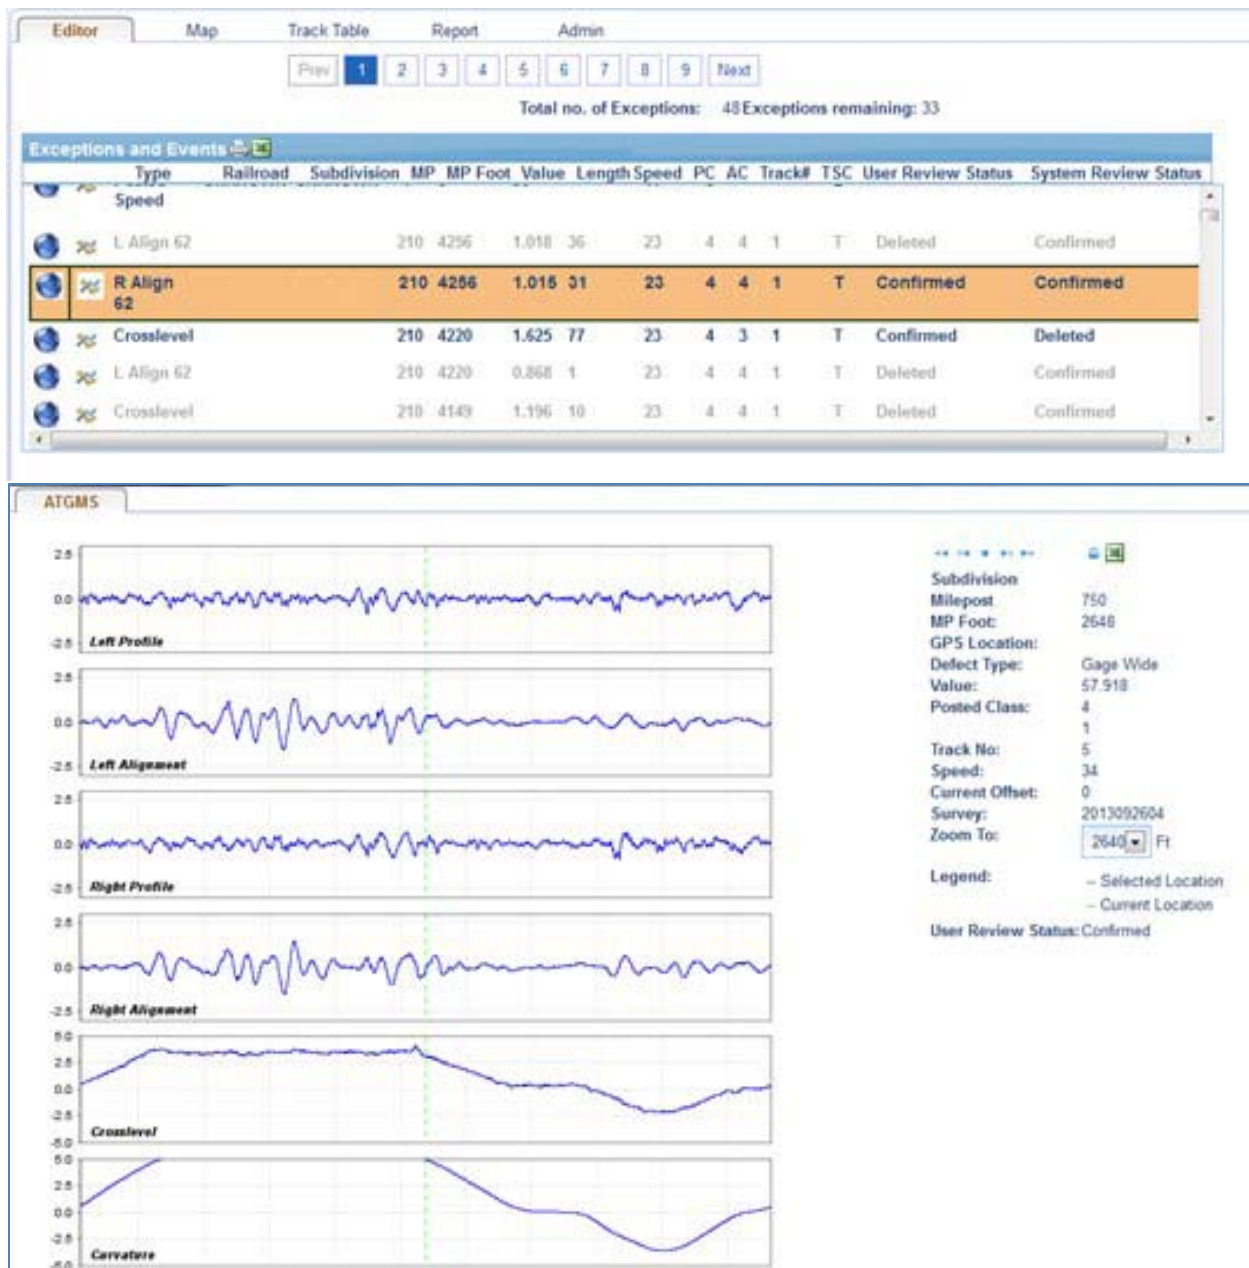
Figure 4. Displays Available within Remote Editor Desk Console

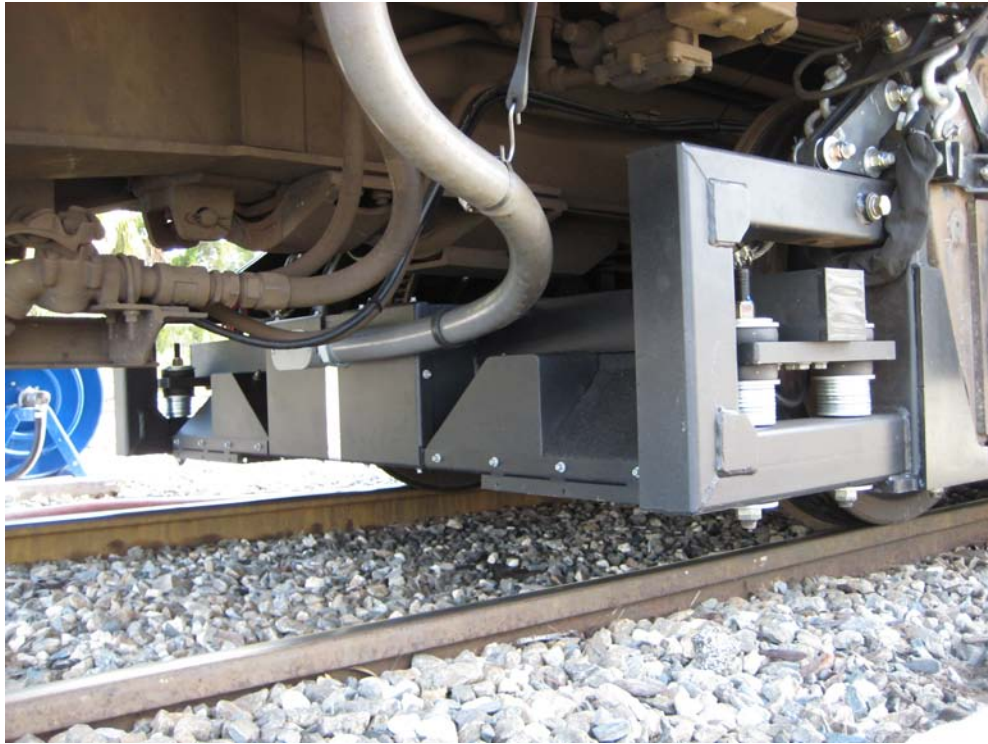
Figure 3. FRA ATGMS Installation on Amtrak Superliner II in Auto Train Service

The FRA commenced a pilot program in 2008 involving the use of an Autonomous Track Geometry Measurement System (ATGMS) on Amtrak's Auto Train operating between Virginia and Florida on CSX Transportation track to evaluate such implementation issues. The FRA's ATGMS, the instrumentation beam of which is pictured in Figure 3, was installed on an Amtrak Superliner II sleeper car in January 2008 and introduced into revenue service on Amtrak's Auto Train service immediately following installation. Amtrak's Auto Train runs daily on CSX-owned track between Lorton, VA, near Washington, DC, and Sanford, FL, a distance of 855 miles. From the time of its initial use until its removal in March 2011, the FRA's ATGMS unit surveyed close to 460,000 miles of track, an average of approximately 153,000 miles per year.

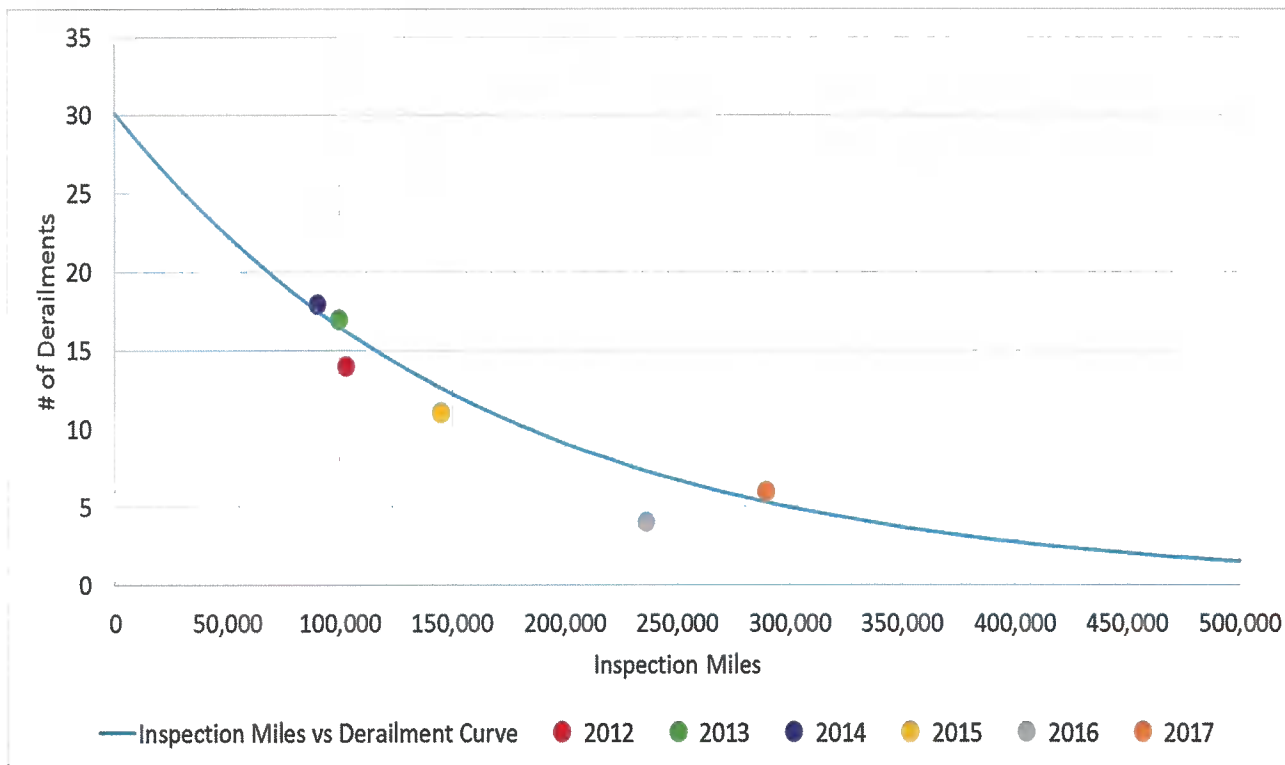
Track Geometry Car Inspection Miles & Number of Derailments
