TIMBER CROSSTIE SPIKE FASTENER FAILURE INVESTIGATION

SUMMARY

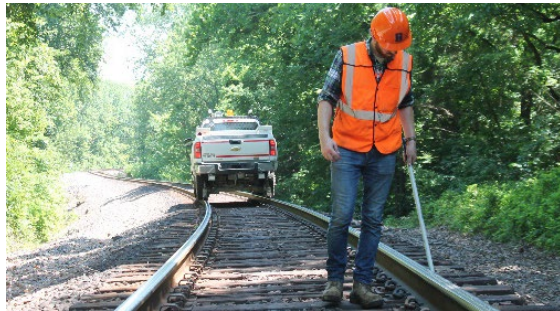
Field interviews shed light on the amount of time maintenance-of-way crews spend on locating and fixing broken spikes (Figure 4). Railroads rely on manual methods performed by experienced personnel to locate broken spikes before they lead to defective conditions. At present, there is no reliable, automated inspection method for identifying broken spikes.

Figure 4. Spike inspection methods involve walking curves and tapping each spike

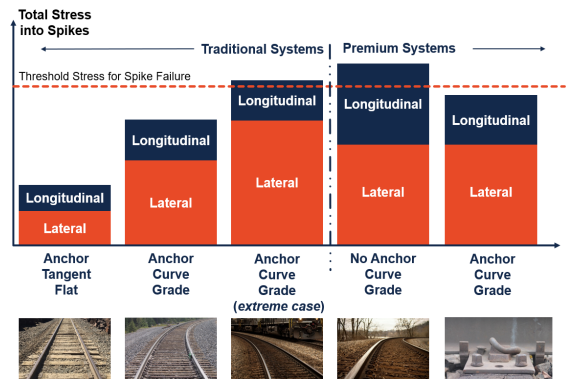
Researchers developed a set of mechanistic hypotheses about the causes of spike breakage based on the results of the literature review, survey, and field visit data. As shown in Figure 5, in a traditional fastening system with cut spikes and anchors, spike stresses tend to increase with greater curvature (lateral forces), and in extreme cases this may cause spike breakage. It is theorized that premium fastening systems further increase spike stress because

they do not use rail anchors to transfer longitudinal load into the ties. The longitudinal force is carried by the fasteners. Finally, premium fasteners are thought to be stiffer in both the lateral and longitudinal directions, further increasing spike stress by reducing the number of ties over which loads are distributed.

Figure 5. Hypothetical graph showing relation of spike stress to curvature, grade, and fastener type
