U.S. Department of
Transportation

Federal Railroad
Administration

Effect of Photo Enforcement-Based Education on Vehicle Driver Behavior at a Highway-Rail Grade Crossing

Office of Research,
Development
and Technology
Washington, DC 20590

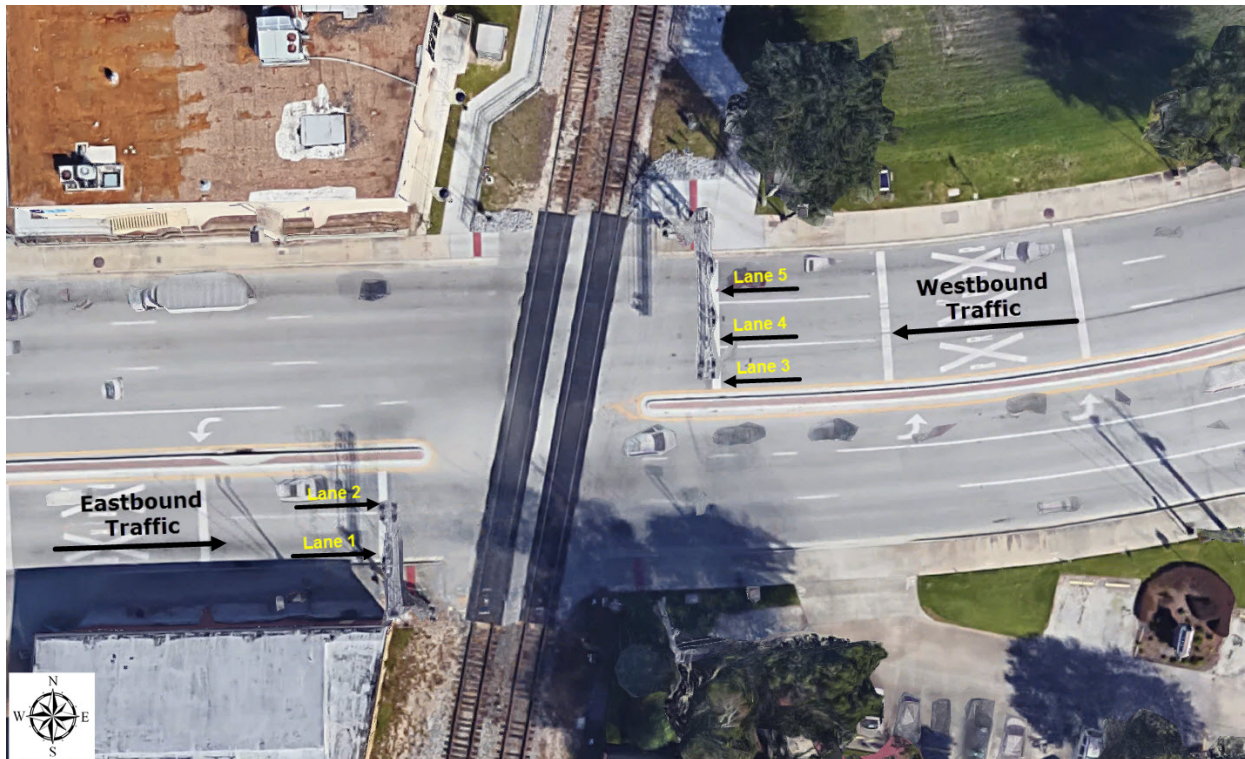
Figure 2. Lane Coding Scheme for East Princeton Street Grade Crossing

There are three lanes of traffic that intersect the crossing in the westbound direction. The inner most lane (lane 3) splits into two lanes immediately after the crossing with the innermost lane becoming a left-turn-only lane onto North Orange Avenue. The signalized intersection at North Orange Avenue is located approximately 260 feet west of the crossing. The traffic lights at the intersection are interconnected (advanced preemption) with the crossing signals allowing traffic to clear the crossing during an activation. Figure 2 shows the 5 lanes that intersect with the crossing and Figure 3 shows Google street view on approach to the crossing in westbound direction.

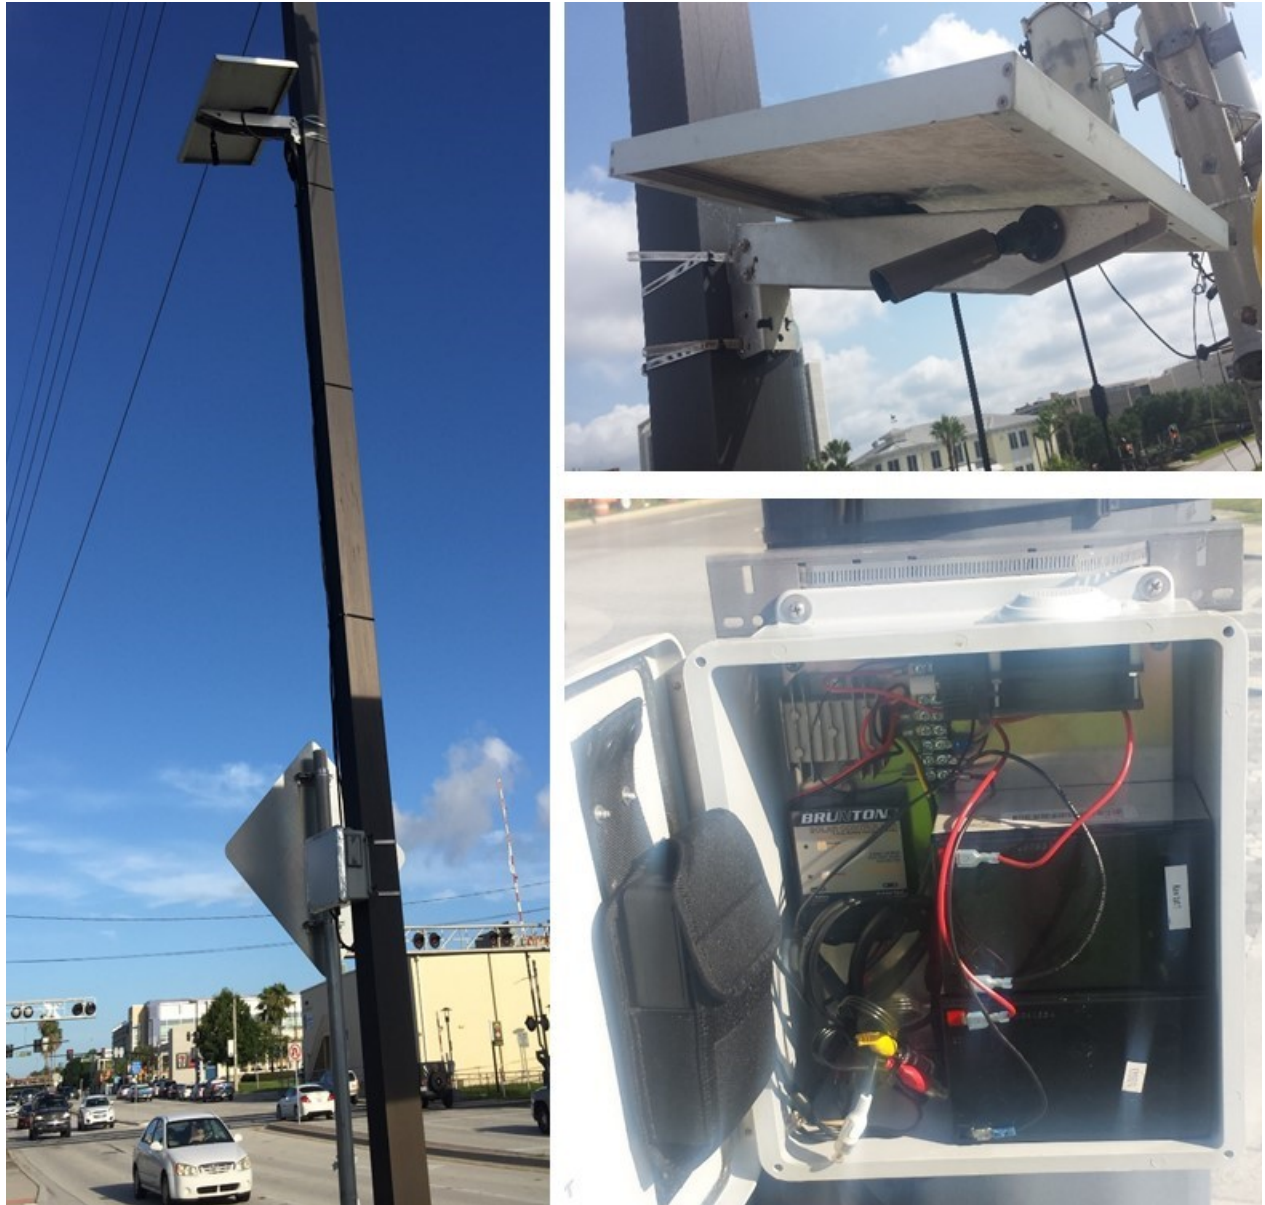
Figure 5. Video Data Collection System at East Princeton Street

A video-based data collection system consisting of a solar panel, a camera, and a digital video recorder along with supporting hardware contained in a utility box was used to collect video of vehicles travelling in both directions at the East Princeton Street grade crossing. [Figure 5](#) shows pictures of the data collection system installed at the East Princeton Street grade crossing.

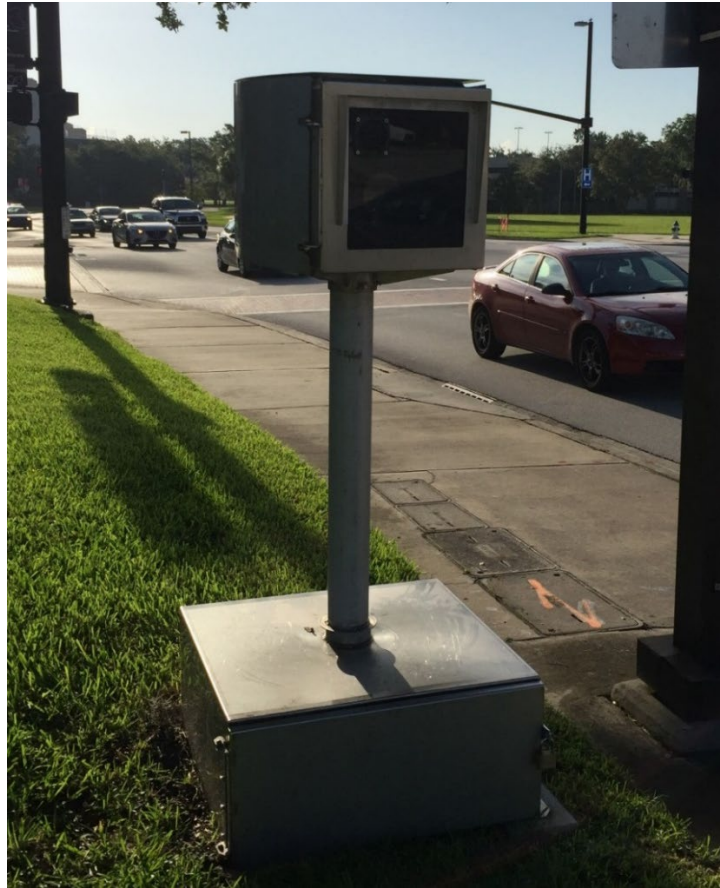
Figure 7. Photo Enforcement System at East Princeton Street

The photo enforcement system captured violations for westbound traffic only. However, signage alerting drivers of the photo enforcement was installed for both directions of traffic. The signage for the westbound traffic was placed on an existing pole on the sidewalk located approximately 65 feet before the crossing stop line and the signage for the eastbound traffic was placed on a pole on the sidewalk located approximately 45 feet before the crossing stop line. The signage

was developed in collaboration with the City, FRA, and the Volpe Center. Images of the Sensys photo enforcement system and signage installation are shown in [Figure 7](#) and [Figure 8](#), respectively.

The photo enforcement system at the East Princeton street grade crossing is activated when a vehicle fails to stop before traversing the crossing during the gate descend phase, resulting in a Type II violation. Several photos and video recordings of the violation are captured by the system and uploaded onto a secure password protected website. A city staffer then reviews the video and determines whether to issue a warning notice to the vehicle owner. The warning notice looks very similar to an actual citation sent out by the City for red light violations but states very

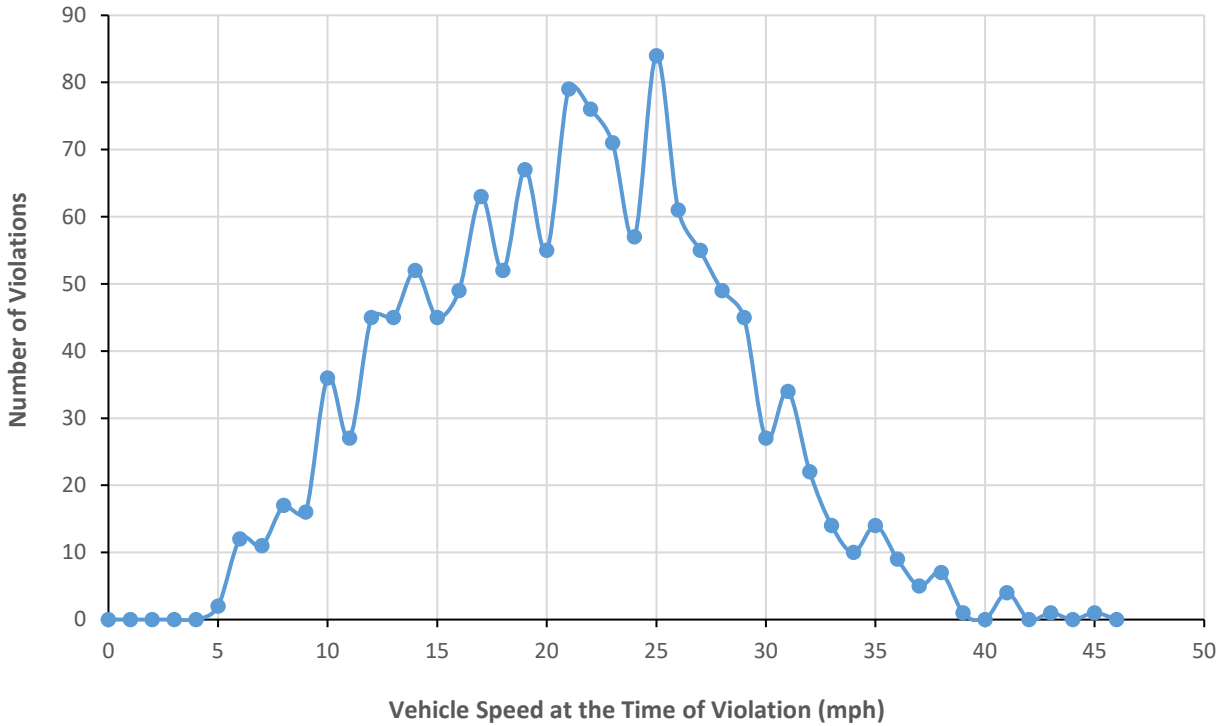
Figure 10. Distribution of Violations by Vehicle Speed

Vehicle Speed at Time of Violation: The photo enforcement system recorded the speed at the time a vehicle committed a descending gate violation. [Figure 10](#) shows the distribution of the violation notices by the speed at the time of violation. The speed ranged from 5.1 mph to 45 mph, with an average speed 21.2 mph. Of the 1,320 total violations, 1,198 (90.8 percent) had recorded speeds less than or equal to the 30-mph posted speed limit at the crossing.

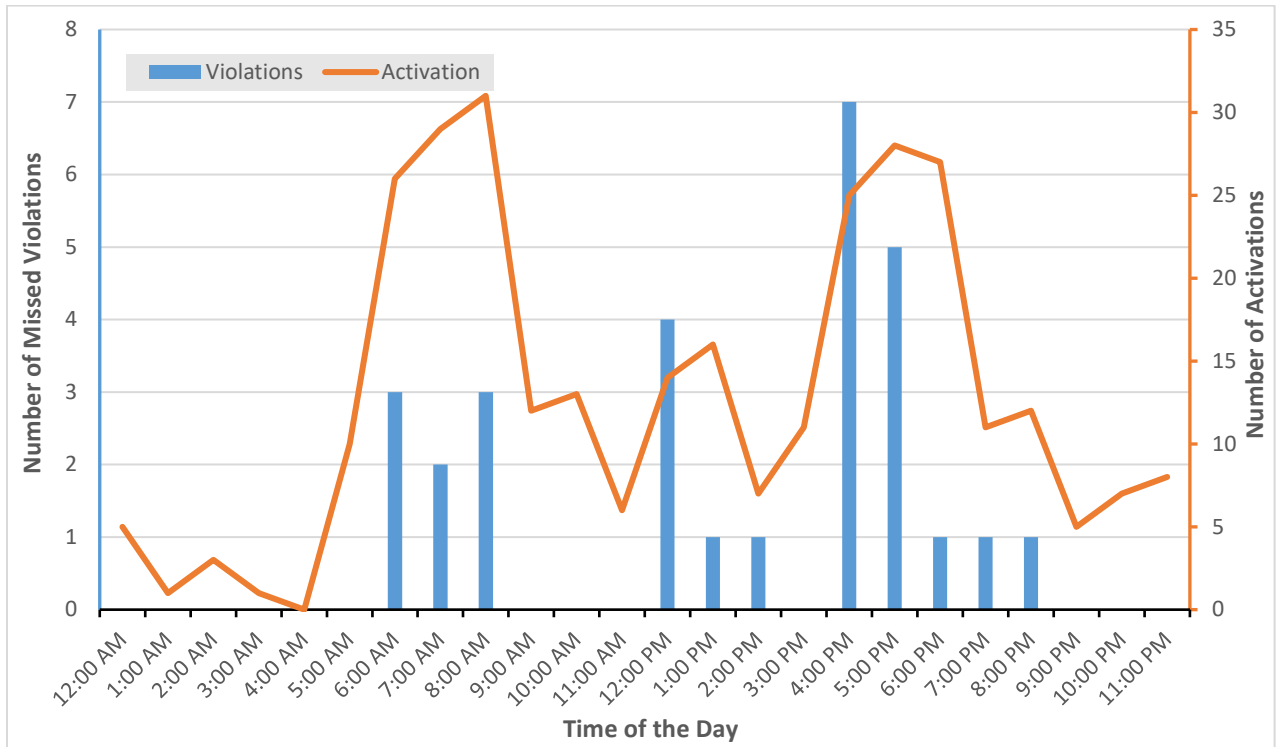
Figure 14. Distribution of Missed Detections by Time of Day

The 29 missing violations occurred over all 5 days and at all times of the day. [Figure 14](#) shows the distribution of the 29 missing violations by time of the day. As can be seen, the majority of the missed detections occurred during the afternoon rush hour, from 4:00 p.m. to 6:00 p.m. Of the 29 missing violations, 5 were coded at the same time as when the gate started to descend and 13 were coded within 1 second of gate descend time. Some of the missing violations could have been because a large vehicle was stopped in the outermost lane (lane 5), causing the sensor line-

of-sight to be blocked, resulting in missed detections. As mentioned earlier in the report, the photo enforcement system is approximately only 44 inches tall.

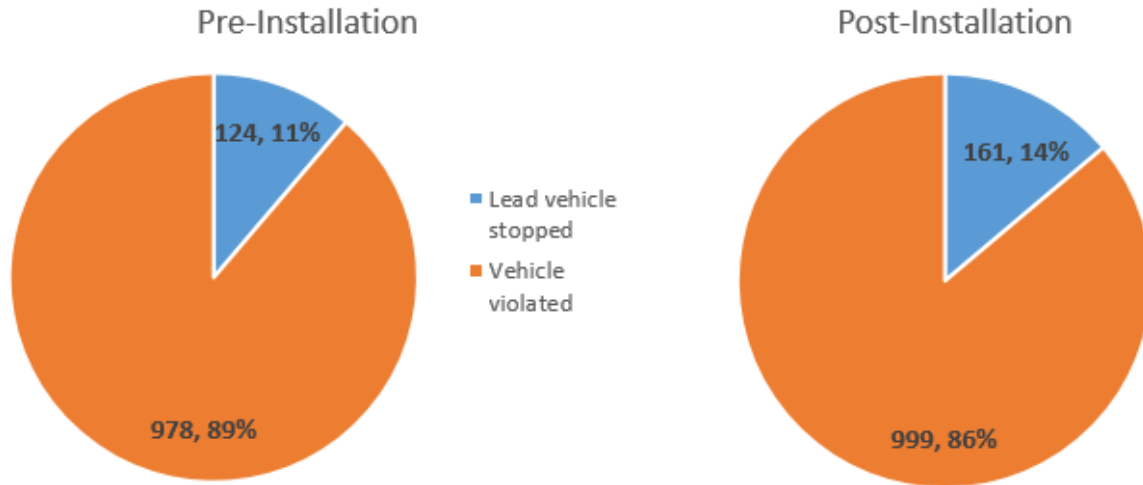
Figure 19. Vehicle Actions during Flashing Lights Phase

Figure 19 shows the distribution of vehicle actions during the flashing lights phase for pre- and post-installation periods. Occurrences of lead vehicles stopped during this phase increased from 124 (11 percent) to 161 (14 percent) from pre- to post-installation.

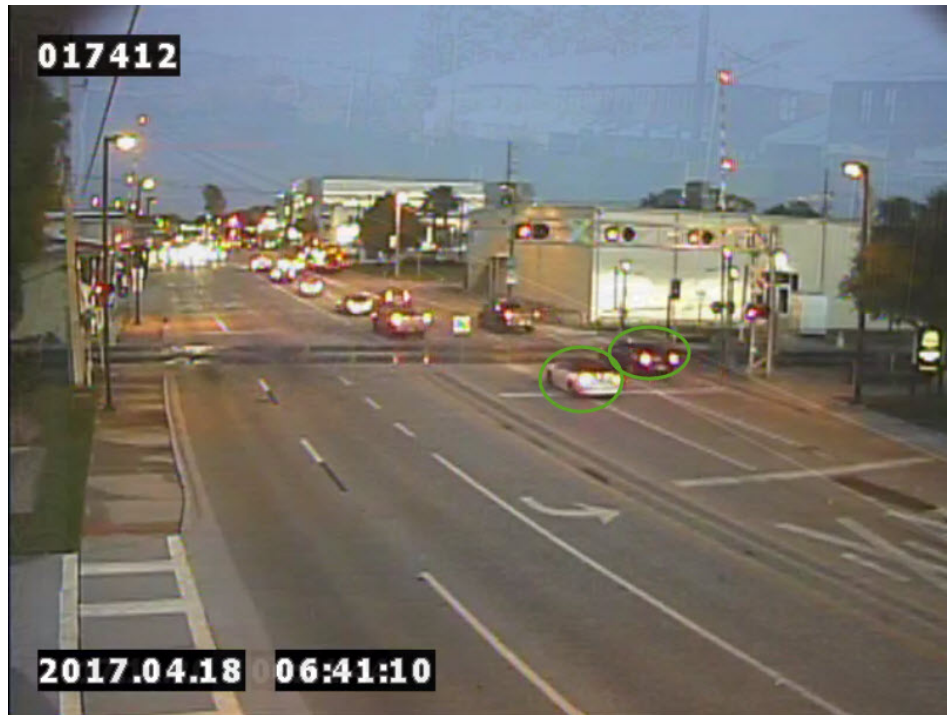
Figure 20. Example of Type I Violations in Westbound Direction (Green Circles)

An example of Type I violations is shown in Figure 20. In Figure 20, the two vehicles (circled in green) committed a Type I violation by traversing the crossing during the flashing lights phase at 06:41:10. The crossing activation occurred at 06:41:08.

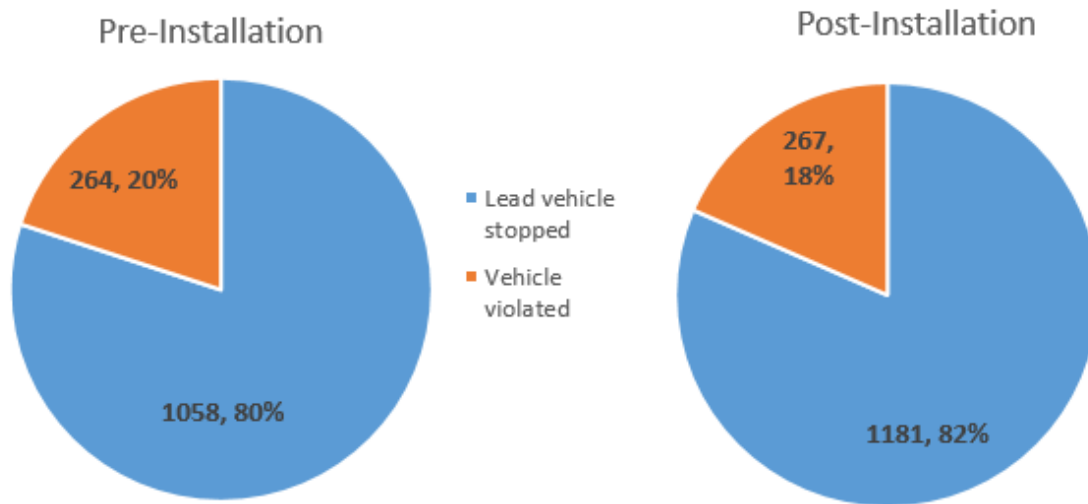
Figure 21. Vehicle Actions during Gate Descend Phase

[Figure 21](#) shows the distribution of vehicle actions during the gate descend phase. Occurrences of lead vehicles stopped during this phase increased from 1,058 (80 percent) to 1,181 (82 percent) from pre- to post-installation.

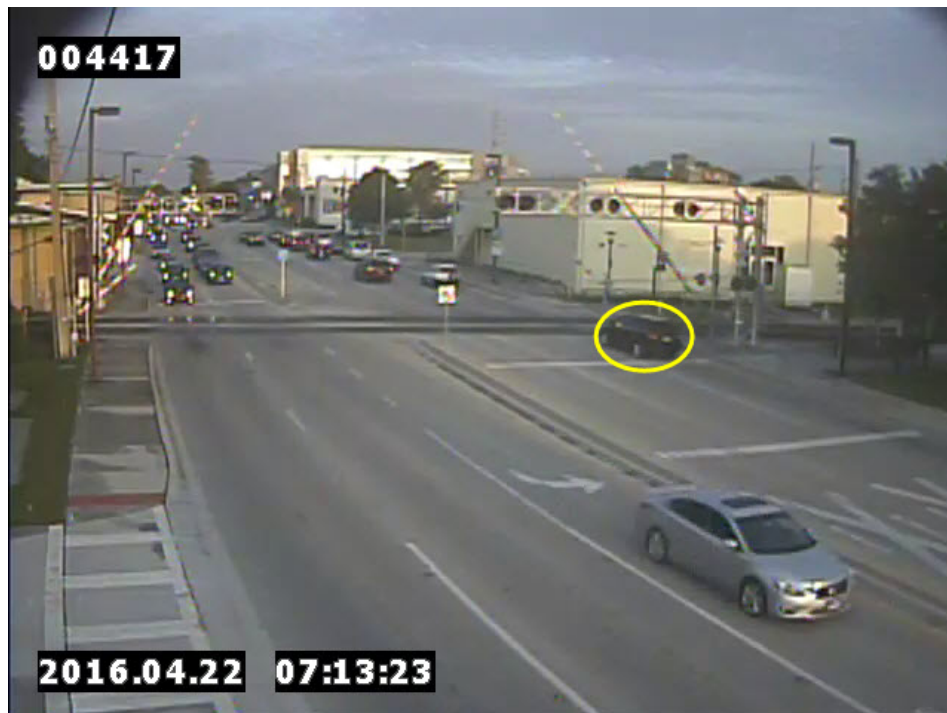
Figure 22. Example of Type II Violation in Westbound Direction (Yellow Circle)

An example of a Type II violation is shown in Figure 22. In [Figure 22](#), the vehicle (circled in yellow) committed a Type II violation by traversing the crossing during the gate descent phase at 07:13:23. The crossing activation occurred a full 8 seconds prior at 07:13:15.

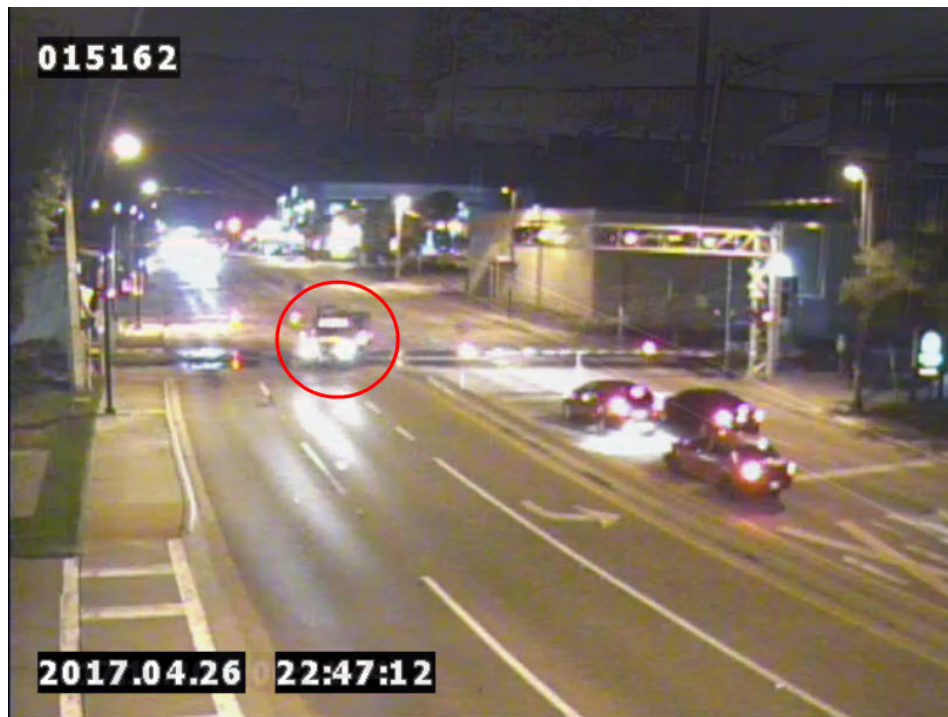
Figure 23. Example of Type III Violation in Eastbound Direction (Red Circle)

Type III Violations: Type III violations occur when vehicles traverse the crossing while the gates are in the horizontal position. There were total of two Type III violations, one during the pre-installation period and another during post-installation period.

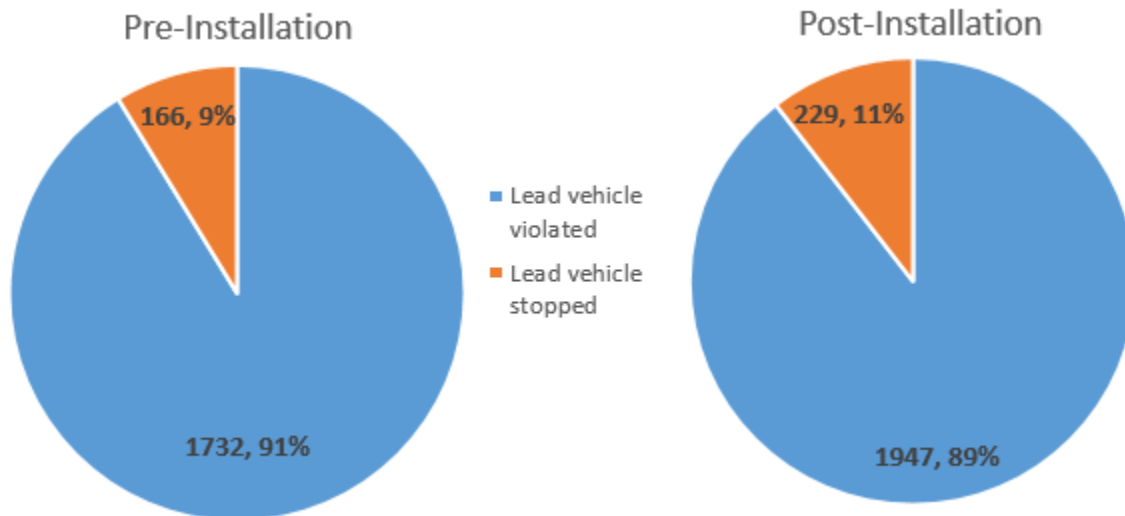
Figure 24. Lead Vehicle Actions during Gate Ascend Phase

distribution of lead vehicle actions during the gate ascending phase. As can be seen, occurrences of lead vehicles stopped during this phase increased from 166 (9 percent) to 229 (11 percent) from pre- to post-installation.

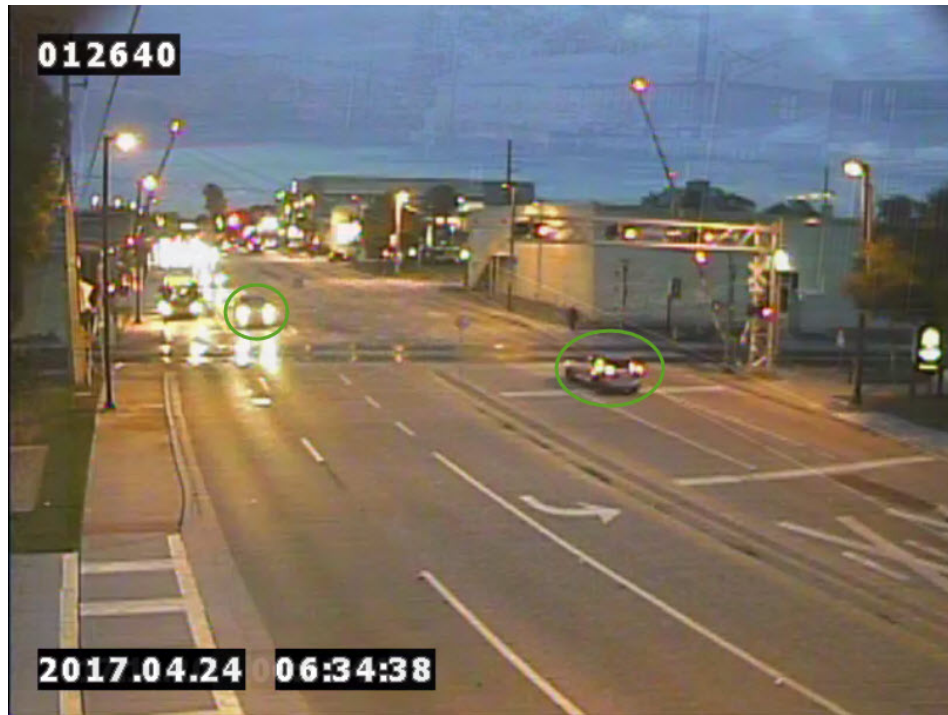
Figure 25. Example of Type IV Violations (Green Circles)

An example of Type IV violations is shown in [Figure 25](#), where the two vehicles (circled in green) committed a Type IV violation by traversing the crossing during the gates ascent phase at 06:34:38. The crossing activation ended about 1 second later at 06:34:39.

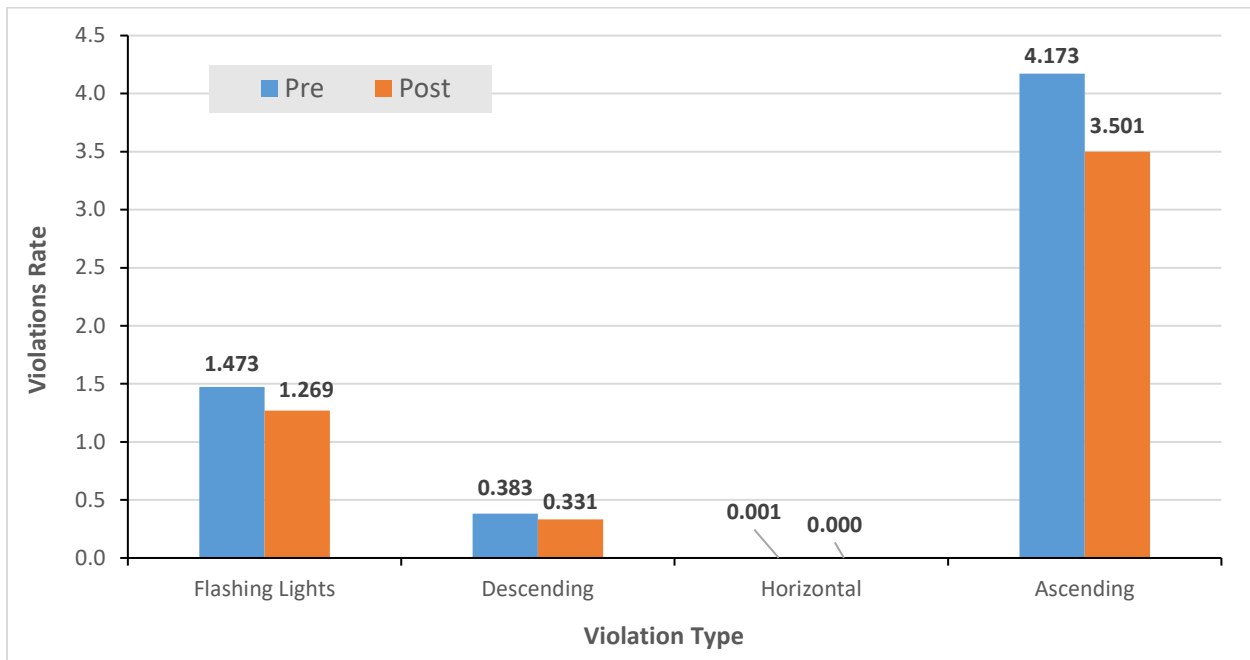
Figure 26. Violation Rate by Violation Type

The photo enforcement-based driver education program was effective at changing driver behavior around the East Princeton Street grade crossing. The average hourly rate of violations per activation decreased from 6.0297 before to 5.1004 after the photo enforcement program was implemented. This added up to a 15.4 percent reduction in the grade crossing violation rate over the evaluation period. Additionally, all four violation types experienced a reduction in violation rate after the implementation of the photo enforcement-based driver education program. The average hourly rate of violations per activation during the flashing lights phase decreased 13.9 percent, from 1.473 to 1.269; the average hourly rate of violations per activation during the descending gate phase decreased 13.5 percent, from 0.383 to 0.0331; the average hourly rate of violations per activation during the horizontal gate phase decreased 100 percent, from 0.001 to 0; and the average hourly rate of violations per activation during the ascending gate phase decreased 16.1 percent, from 4.173 to 3.501. These changes in average hourly rate of violations per activation can be seen graphically in [Figure 26](#).
