Effectiveness of LED-Enhanced Signs in Reducing Incidents of Vehicles Stopping on Tracks

1. AGENCY USE ONLY (Leave blank)		2. REPORT DATE June 2019		3. REPORT TYPE AND DATES COVERED Technical Report March 2019 – April 2019
4. TITLE AND SUBTITLE Effectiveness of LED-Enhanced Signs in Reducing Incidents of Vehicles Stopping on Tracks			5. FUNDING NUMBERS RR97A8-SD600

6. AUTHOR(S) William Baron and Marco daSilva				
7. PERFORMING ORGANIZATION NAME(S) AND ADDRESS(ES) U.S. Department of Transportation Office of the Assistant Secretary for Research and Technology John A. Volpe National Transportation Systems Center 55 Broadway Cambridge, MA 02142			8. PERFORMING ORGANIZATION REPORT NUMBER DOT-VNTSC-FRA-19-06

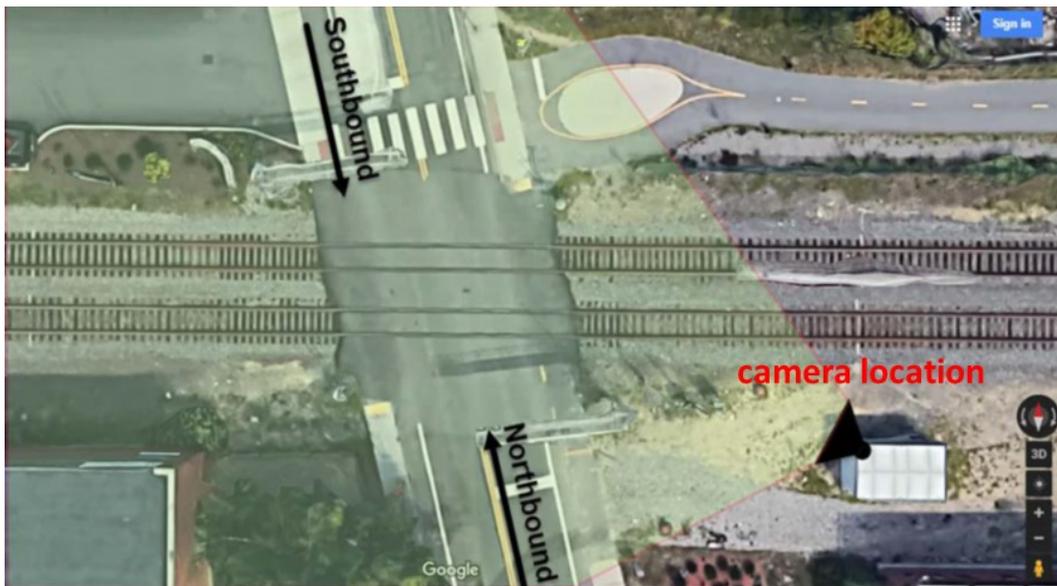
Figure 2. Aerial View of Brighton St. Crossing

Brighton Street in Belmont is a two-lane municipal road that is heavily trafficked at rush hour, with most traffic heading southbound in the morning and northbound in the afternoon. While the nearest traffic signals are about 2,000 feet away in each direction, left-turning traffic due to nearby schools and businesses, along with numerous crosswalks and bus stops, often cause traffic to back up onto the tracks during peak commuting times. The annual average daily traffic (AADT) for Brighton Street is 16,900 vehicles. The MBTA Commuter Rail Fitchburg line uses the tracks which cross Brighton Street, with an average of 38 trains per day [6]. Figure 2 shows the crossing used for the research study.

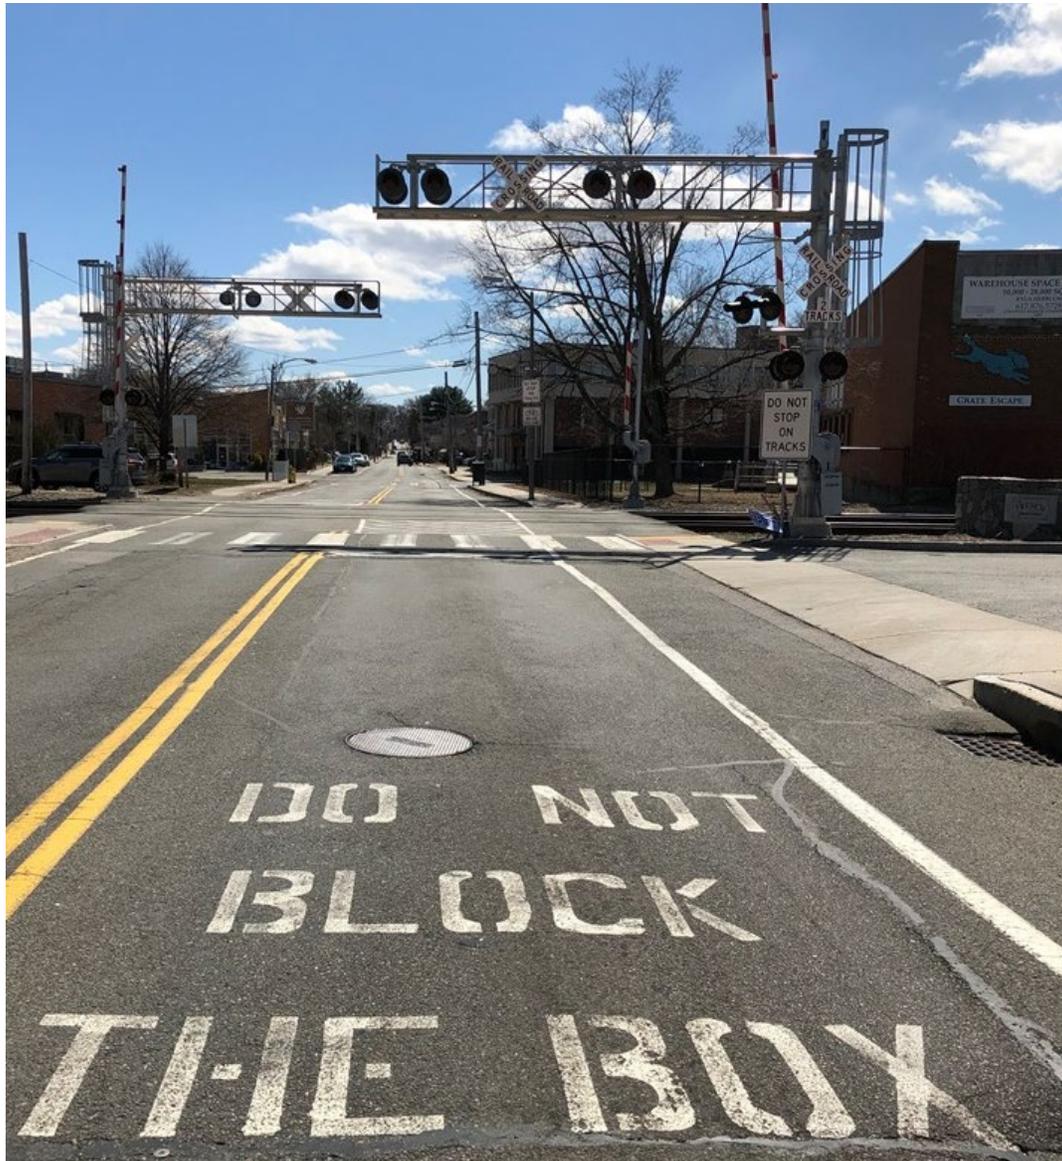
Figure 3. Southbound Approach to the Brighton St. Grade Crossing

There is one lane of traffic in the southbound direction, which traverses a crosswalk immediately before the grade crossing, shown in [Figure 3](#).

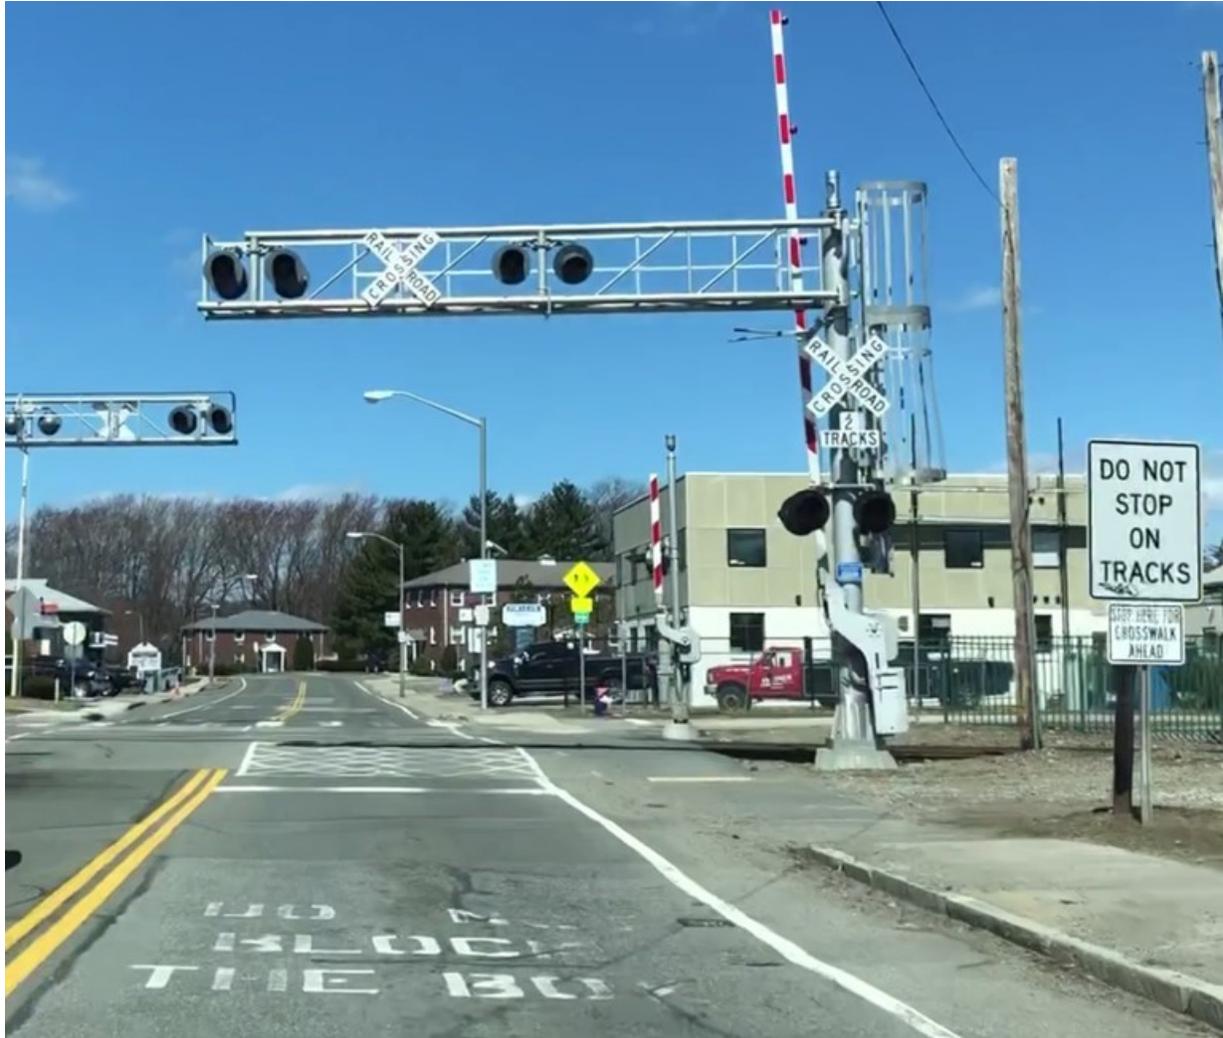
Figure 4. Northbound Approach to the Brighton St. Grade Crossing

There is one lane of traffic in the northbound direction. The crosswalk is immediately after the grade crossing in this direction. A picture of the northbound approach is shown in [Figure 4](#).

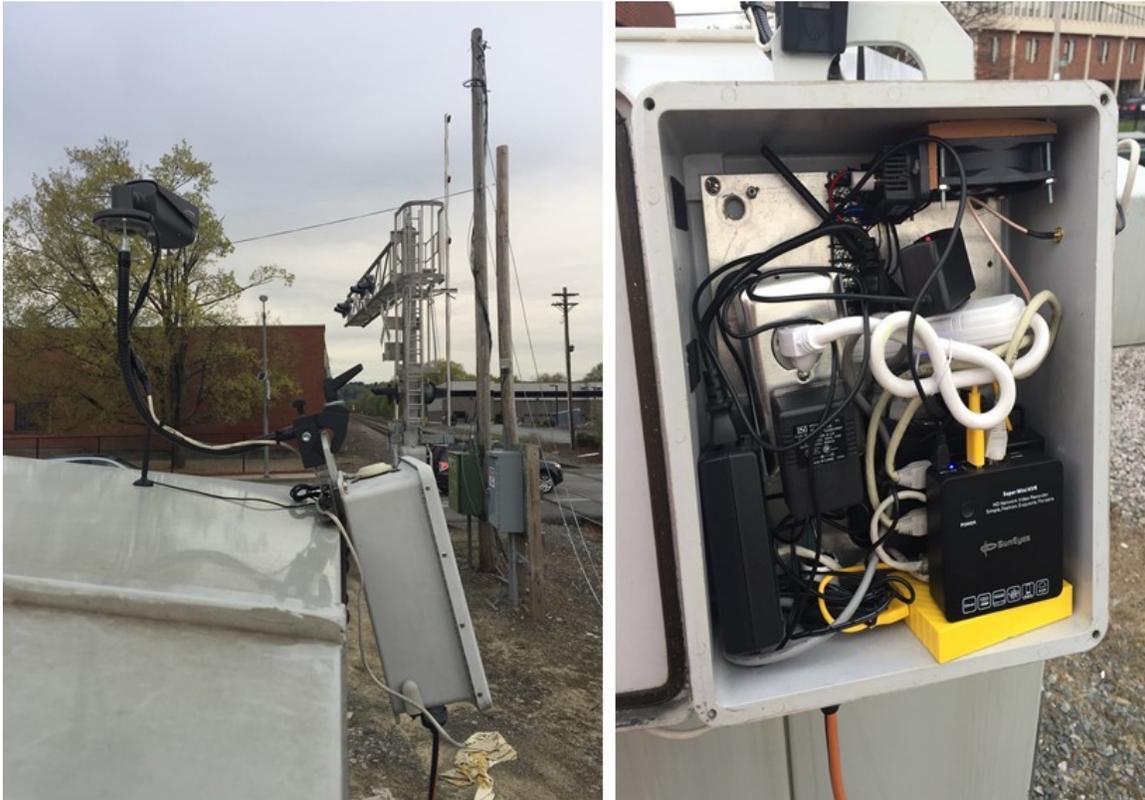
The MBTA and its operator, Keolis Commuter Services, authorized the Volpe Center to attach a video camera and weatherproof enclosure containing a digital video recorder along with supporting hardware to the outside of their Brighton Street bungalow, as shown in [Figure 5](#), to collect the necessary research data. The MBTA also provided AC power to the system from the bungalow.

Video data was collected using a Speco Technologies 3 Megapixel IP camera, model number O3VFBM. It was recorded on a SunEyes Super Mini Network Video Recorder (NVR), model number N6200-8E, using a Western Digital My Passport 4TB USB external hard drive. The

Figure 5. Video Data Capture Equipment at the Brighton St. Crossing

Video data was collected using the high-definition video camera with a varifocal lens set to its widest angle, which provided a view of all five zones in both directions. It should be noted that only about 8 feet of Zone 1 in the northbound direction was visible in the pre-installation video dataset. The camera was adjusted at the time the LED-enhanced signs were installed to show the full 12 feet of that zone.

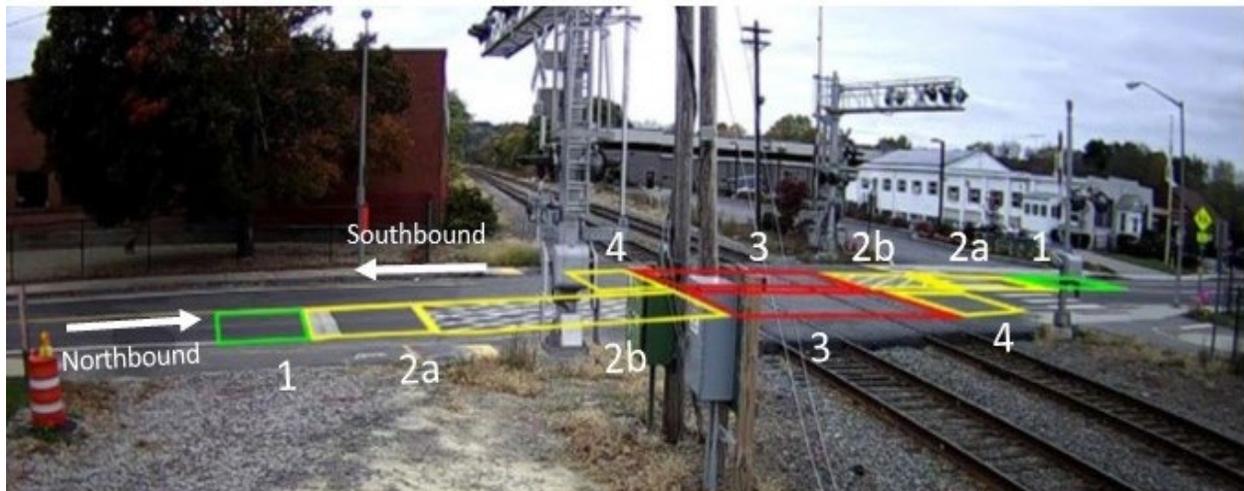
Figure 6. Definition of Grade Crossing Zones

Driver stopping behavior was coded based on five possible zones in each direction in which a motorist could come to a complete stop. These zones are shown in [Figure 6](#).

The five zones over the crossing represent different levels of danger if the motorist comes to a full stop in that zone:

- Zone 1 (not dangerous): A motorist who stops in Zone 1 has stopped before the stop line where the gate descends during an activation. Motorists stopping in this zone are behaving safely.
- Zone 2a (not dangerous): A motorist who stops in Zone 2a has stopped after the stop line, but before the crosshatch pavement markings and gate.
- Zone 2b (moderately dangerous): A motorist who stops in Zone 2b has stopped on the crosshatch pavement markings, but before the tracks. Vehicles stopping in Zone 2b could be struck by a descending gate, but most likely not struck by a train unless very close to the outer rail, where they could be struck by the train's overhang.

- Zone 3 (very dangerous): A motorist who stops in Zone 3 has stopped in the most dangerous part of the crossing—the track area. In this zone, a train and vehicle could collide.
- Zone 4 (moderately dangerous): A motorist who stops in Zone 4 has stopped past but adjacent to the track area. Motorists stopping in Zone 4 would not be struck by a train, but may not be aware that they have cleared the tracks.

Generally, the zone recorded was where the front bumper of the vehicle was located when it came to a complete stop. However, if any part of the vehicle was in Zone 3, it was recorded as Zone 3. If the rear bumper stopped in Zone 4, it was recorded as Zone 4.

- Zone 3
- Zone 2b
- Zone 4
- Zone 2a
- Zone 1

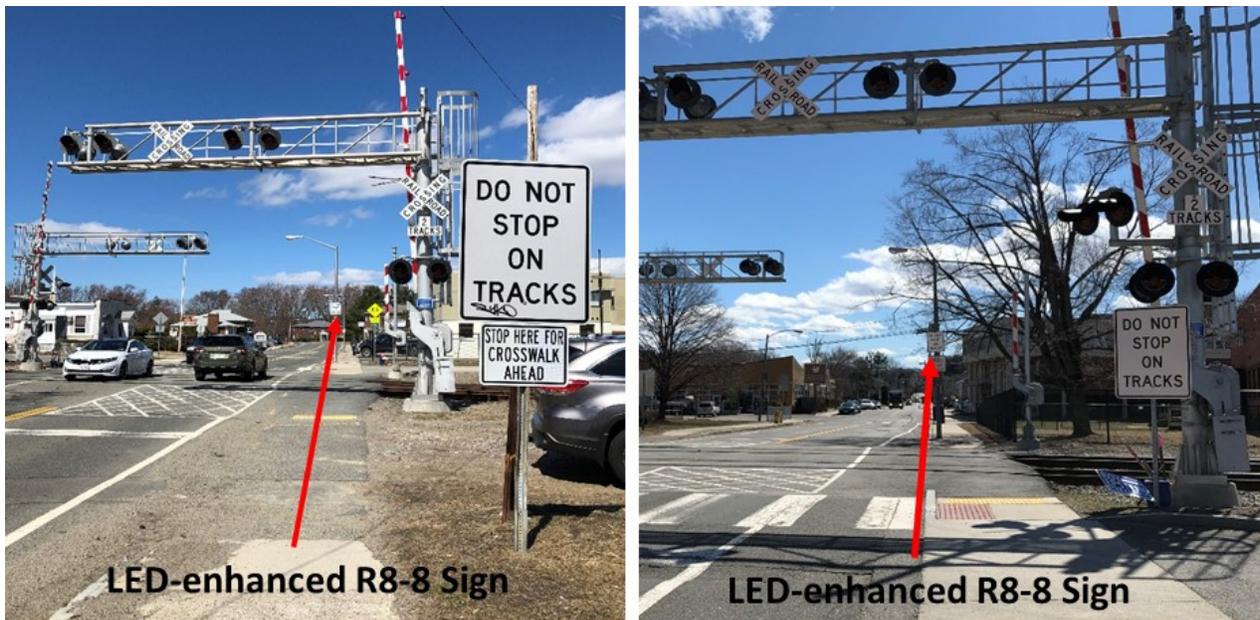
The signs used in this study were standard R8-8 signs that read "DO NOT STOP ON TRACKS." The Volpe Center decided to use LED-enhanced signs manufactured by two different companies to compare ease of installation, LED brightness, and durability. One sign was manufactured by Traffic and Parking Control Company ([TAPCO](#)), and the other by Traffic Safety Corporation ([TSC](#)). The signs look identical, and are both 24 inches by 30 inches. The MUTCD guidance states that the sign "should be located on the right-hand side of the highway on either the near or far side of the grade crossing, depending upon which position provides better visibility to approaching drivers" [9]. The Belmont Street crossing had existing R8-8 signs on the near side of the crossing in each direction, as previously shown in Figure 3 and Figure 4. The signs were larger, 36 inches by 48 inches, a size typically used on highways. The northbound sign has a second sign below it reading "STOP HERE FOR CROSSWALK AHEAD." The Volpe Center installed the LED-enhanced signs on the exit side of the crossing in each direction, mounted high enough to provide good visibility on both sides of the crossing, as shown in Figure 7. The existing signs on the approach sides were left in place.

Figure 7. Brighton St. Crossing Northbound Approach (left) and Southbound Approach (right)

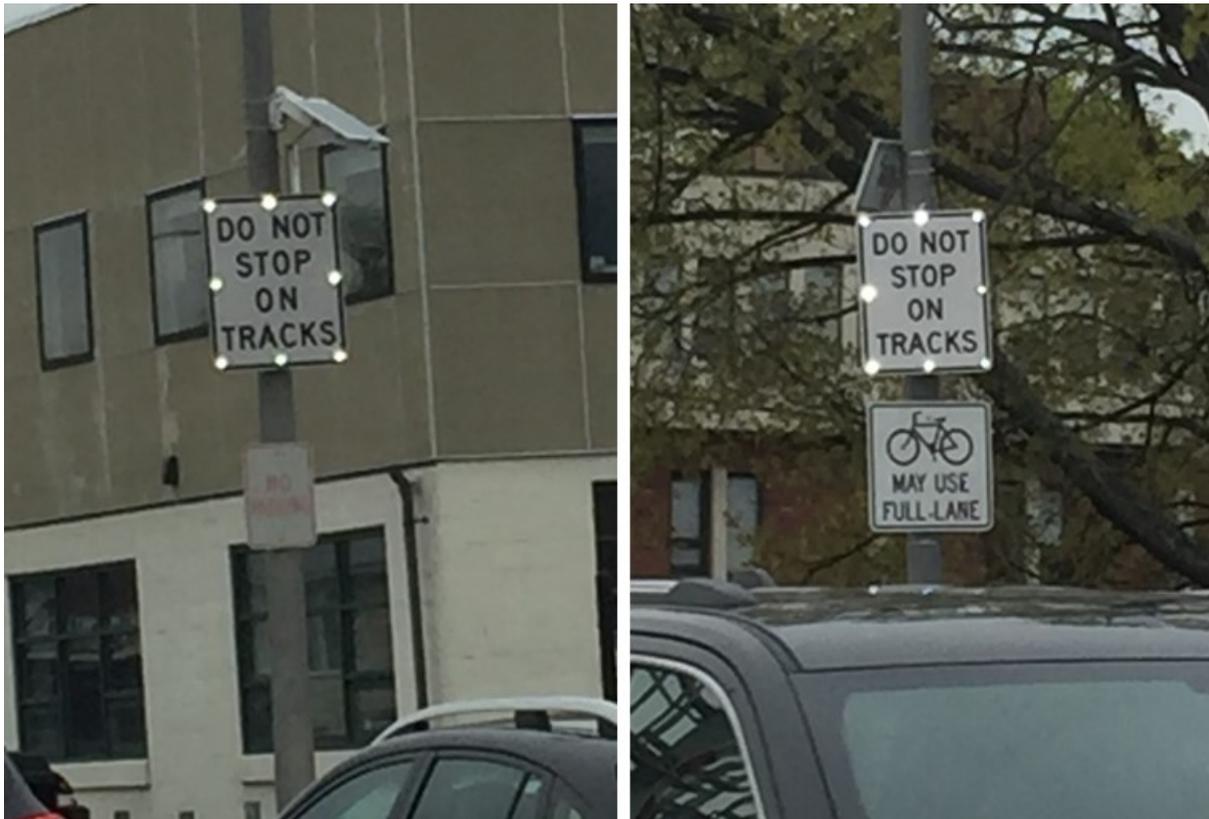
The LEDs of the TAPCO sign were significantly brighter than those used in the TSC sign. This mattered little after dark, when both signs appeared to flash brightly. However, in bright sunshine, the TAPCO sign was substantially more noticeable due to the brighter LEDs. Both signs had their LEDs aimed toward the roadway, so they appeared brighter from a distance than they did directly beneath the sign. The difference in luminosity can be seen in the two distance shots in [Figure 8](#) and from directly beneath the signs in [Figure 9](#), below. The photos were taken within a few minutes of each other, near dusk. However, differences in the way the camera adjusted for ambient light, as well as the way each sign's LEDs were focused, affected the way the LEDs appear in photographs.

Figure 8. TAPCO (left) and TSC (right) Signs from Approximately 90 Feet

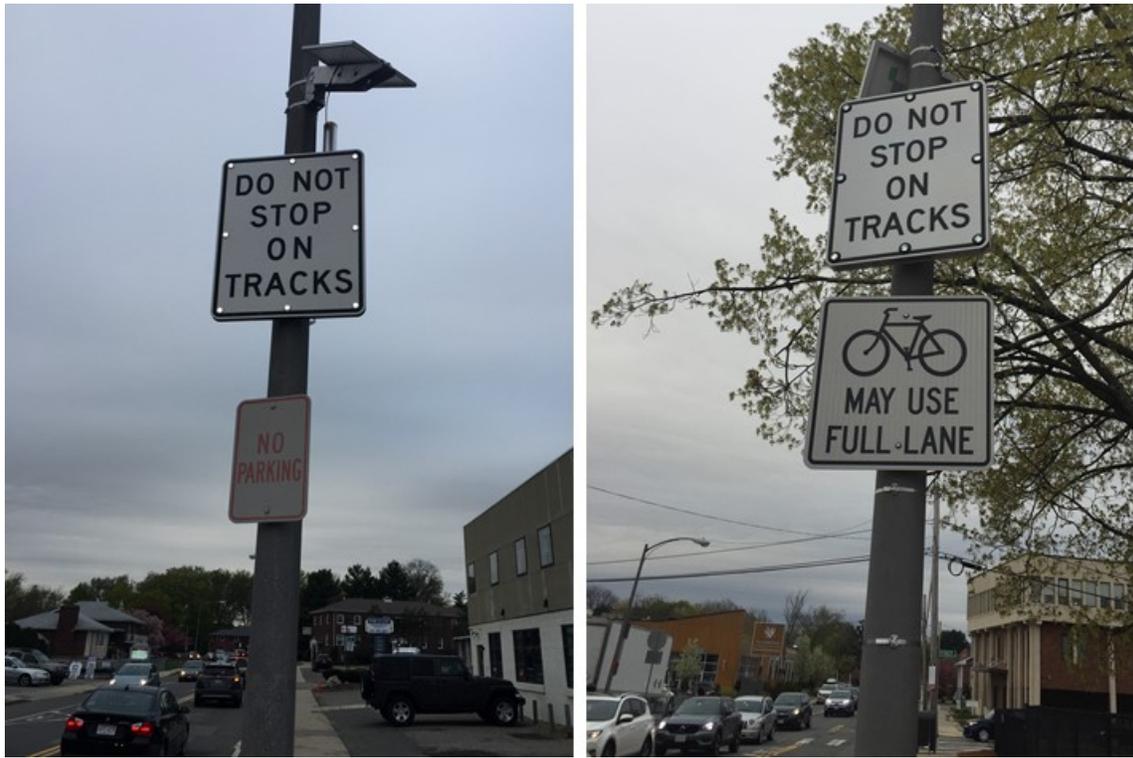
Figure 9. TAPCO (left) and TSC (right) Signs from Approximately 10 Feet

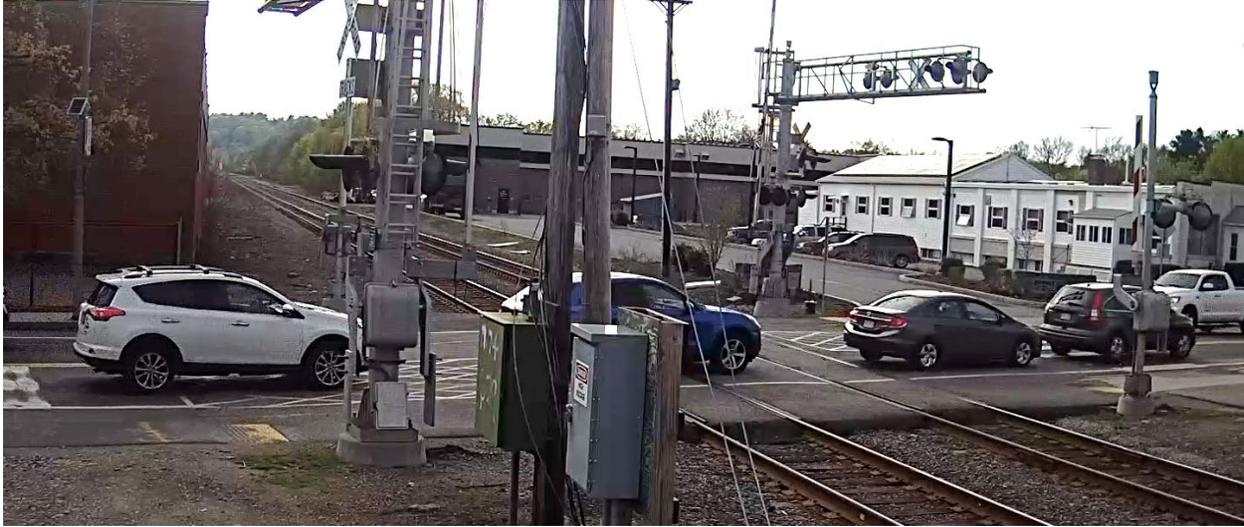
Clearly, far more northbound vehicles stopped in one of the violation zones than in the southbound direction. This was the case with those stopping in Zone 3 (directly on the tracks) as well, which was the area of primary concern. However, regardless of direction, roughly 30 percent of all vehicles that stopped in one of the violation zones stopped in Zone 3. An example of how the traffic often stopped during times of high congestion is shown in [Figure 10](#), clearly showing the blue vehicle stopped in Zone 3.

Figure 10. Northbound Vehicles Stopping on Tracks Due to Congestion

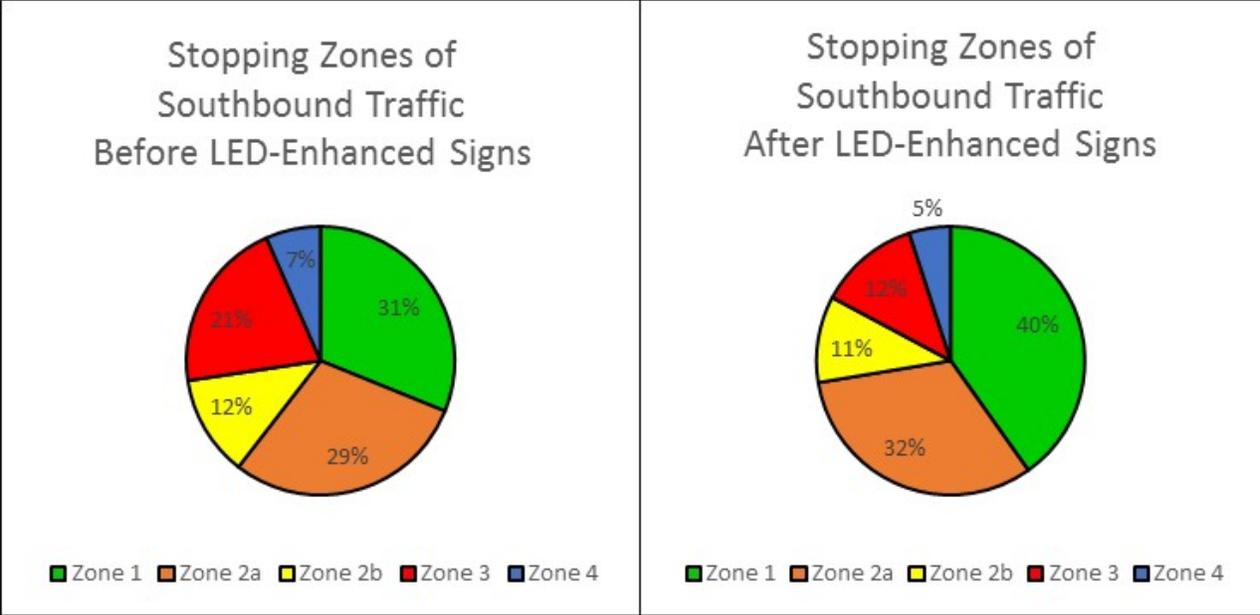
In comparing the zones in which vehicles tended to stop, the Volpe Center focused on the southbound traffic because it had more certain Zone 1 data. [Figure 11](#) below shows graphically how the tendency for vehicles to stop in Zone 3 decreased, and that frequency of vehicles stopping in Zone 1 increased after the LED-enhanced signs were installed. In fact, the frequency of vehicles stopping in Zone 3 was reduced by 41.2 percent after the signs were installed.

Figure 11. Comparison of Driver Stopping Behavior by Zone Before and After Installation of the LED Signs

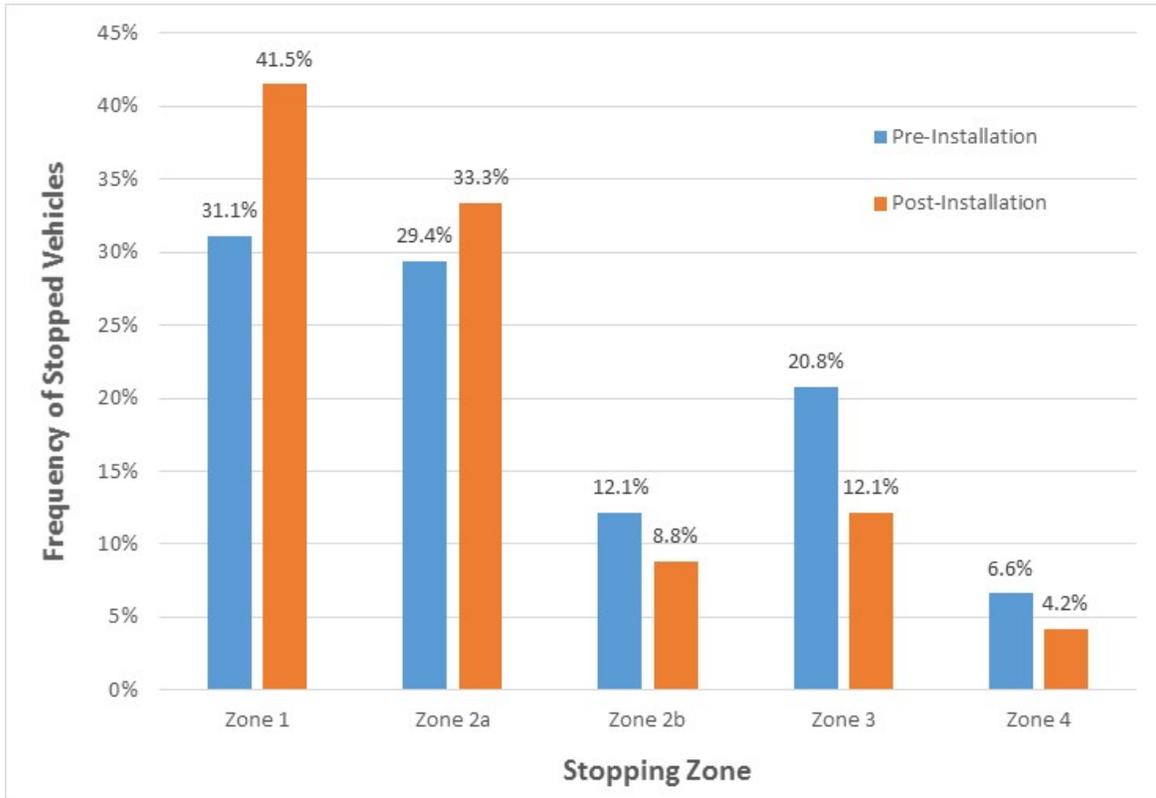
For southbound traffic, the installation of the LED-enhanced signage had a profound impact in reducing the number of vehicles that came to stop on the tracks. A chi-square test of independence showed a significant difference between the pre- and post-installation conditions ($\chi^2 = 22.9001$, $df = 4$, $p < 0.01$). These changes included a 41.5 percent reduction in motorists

stopping in Zone 3 (from 94/453 to 55/453), a 36.7 percent reduction in motorists stopping in Zone 4 (from 30/453 to 19/453), and a 33.3 percent increase in motorists stopping appropriately in Zone 1 (from 141/453 to 188/453). Figure 12 shows the frequency of vehicles stopped per zone in the southbound direction before and after the installation of the LED-enhanced signs. This comparison shows that the LED-enhanced signs had a profound impact in reducing the number of vehicles that stopped on the tracks.

Figure 12. Frequency of Southbound Vehicles Stopping by Zone

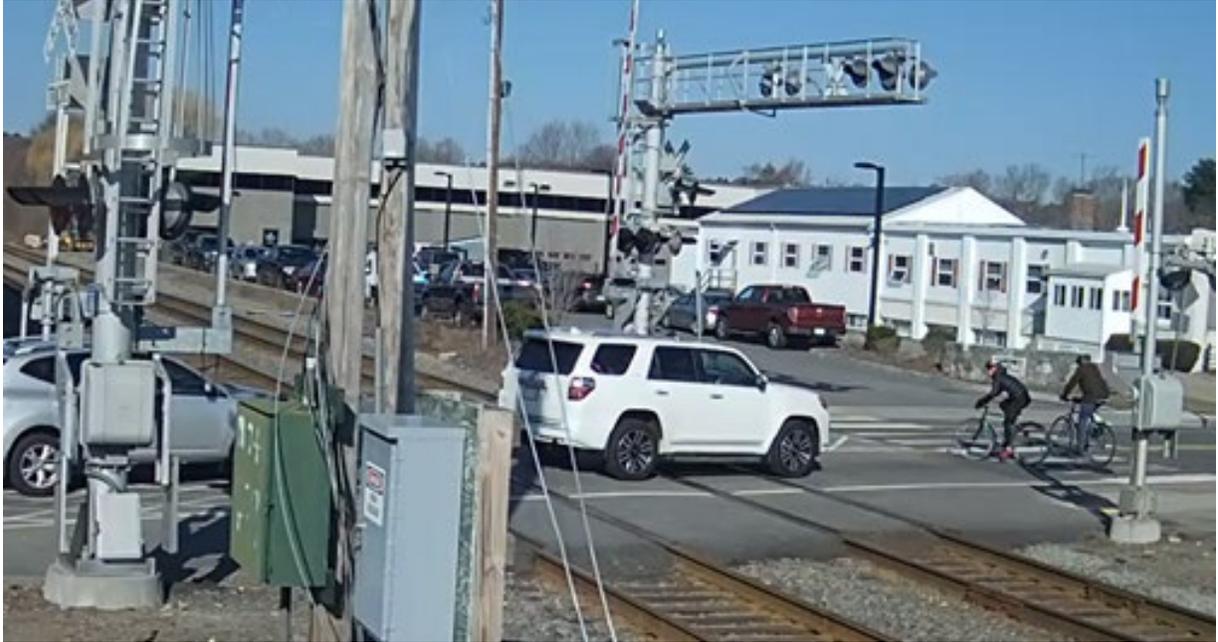
The statistics also showed that at this crossing, far more vehicles stopped on the tracks in the northbound direction than in the southbound direction. In reviewing the video, one reason for this was clear: Many drivers did not see pedestrians or bicyclists attempting to cross at the crosswalk until they were already within one of the violation zones, so they stopped near or on the tracks to allow them to cross. In fact, 81 of the 223 (36.3 percent) of the vehicles that stopped in Zone 3 (directly on the tracks) in the northbound direction in the pre-installation phase did so to allow a bicyclist or pedestrian to cross the roadway. This number was relatively unaffected by the presence of the LED-enhanced signs. In the post-installation phase, this number was a very similar 89 out of 225, or 39.6 percent. However, this condition rarely trapped these vehicles on the tracks. The pedestrians and bicyclists tended to pass quickly and vehicles could proceed without significant delay. On the other hand, those that stopped on the tracks due to traffic congestion were sometimes trapped there for significant amounts of time, and had limited options for getting off the tracks when trains approached. An example of northbound vehicles stopping for bicyclists in the crosswalk is shown in Figure 13.

Figure 13. Example of Northbound Vehicles Stopping on Tracks Due to Bicyclists
