**Federal Railroad
Administration**

Detection of Concrete Tie Rail Seat Deterioration

1. AGENCY USE ONLY (Leave blank)		2. REPORT DATE September 2019	3. REPORT TYPE AND DATES COVERED Technical Report March 1, 2013 - December 31, 2016	
4. TITLE AND SUBTITLE Detection of Concrete Tie Rail Seat Deterioration			5. FUNDING NUMBERS DTFR53-11-D-00008L Task Order 333

9. SPONSORING/MONITORING AGENCY NAME(S) AND ADDRESS(ES) U.S. Department of Transportation Federal Railroad Administration Office of Railroad Policy and Development Office of Research, Development and Technology Washington, DC 20590			10. SPONSORING/MONITORING AGENCY REPORT NUMBER DOT/FRA/ORD-19/33

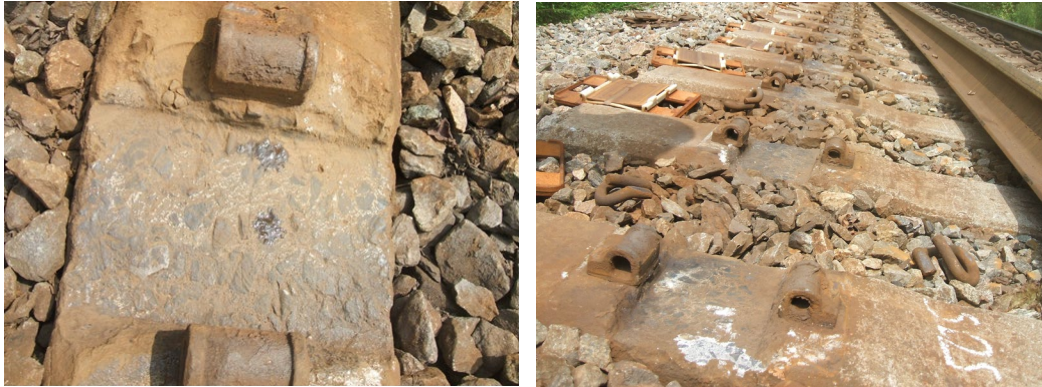
Figure 1. Rail Seat Deterioration

Rail seat deterioration (RSD) of concrete ties is manifested by the loss of concrete tie material under the rail seat area and, in extreme cases, can result in loss of rail clip holding power (toe load), negative (outward) rail cant, gage widening, and rail rollover [1]. [Figure 1](#) shows an example of RSD.

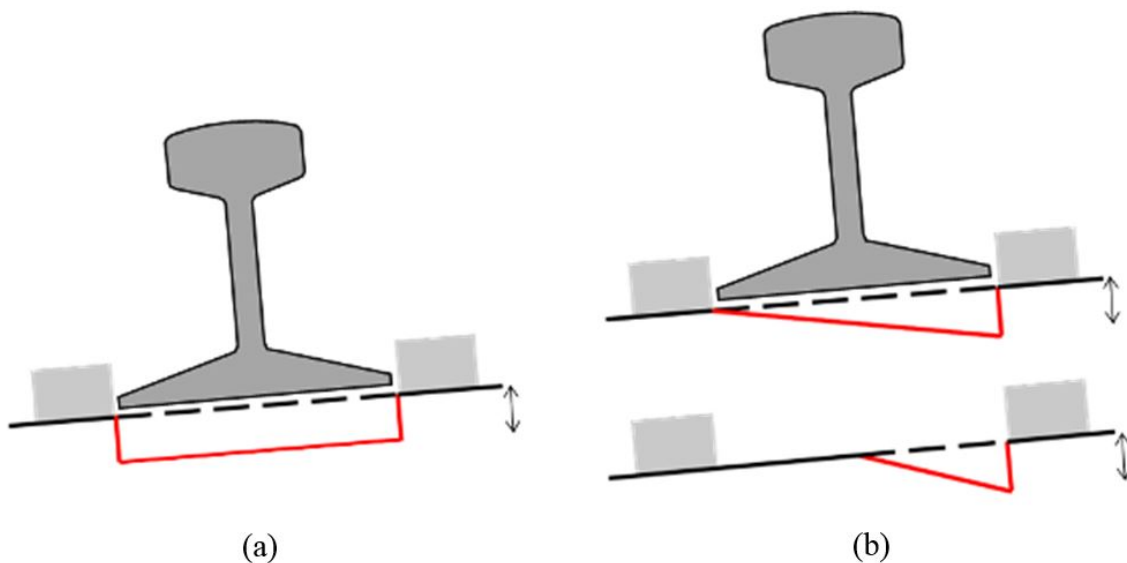
Figure 2. Two Distinct Modes of RSD—(a) Uniform and (b) Triangular, Including Half-Triangular

Two distinct modes of RSD were identified: uniform (also termed vertical) and triangular, as Figure 2 shows.

Uniform deterioration is generally more consistent in depth across the rail seat area, and associated with tangent track. The triangular mode results in wedge-shaped deterioration, with more deterioration toward the field side of the rail seat. The deterioration may affect all, or only a portion of, the rail seat area. The latter, termed “half-triangular,” is a type of RSD included in the study after discussions between the TTCI research team and researchers from Volpe National Transportation Systems Center (Volpe). Triangular RSD is typically associated with curves where higher applied lateral loads can generate higher stresses on the field side of the high rail

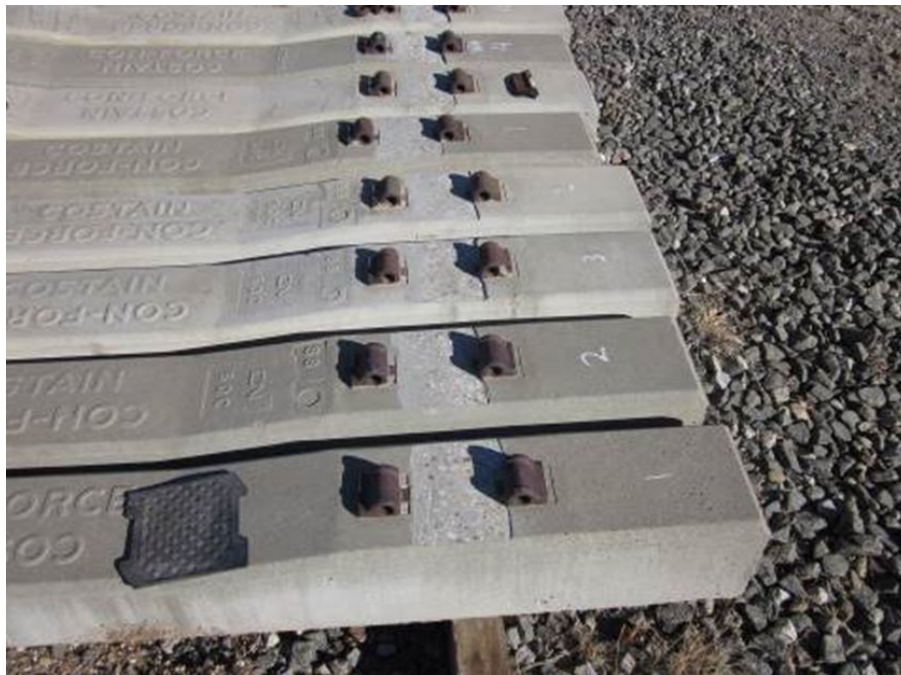
Figure 3. Rail Seats Ground to Simulate Triangular RSD before Installation at FAST (0 MGT)

Twelve test ties were installed in the 5-degree curve. Eight of the 12 ties were ground to simulate full triangular RSD in a manner similar to the ties tested in the laboratory. The depth of grinding at the field-side shoulder of the ties ranged from 0.625 inch to 0.25 inch with the center two ties having the deepest grinding. The 2 ties at each end of the 12 were not ground. The 12 test ties were Con-Force Costain CN 60C designs with e-clip shoulders. [Figure 3](#) shows the eight ground rail seats before the ties were installed at FAST. [Figure 4](#) shows a detailed view of a rail seat ground with 0.1875-inch depth of triangular RSD.

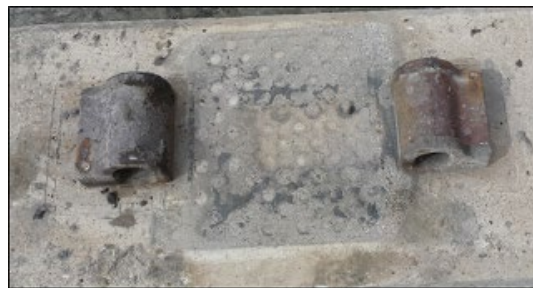
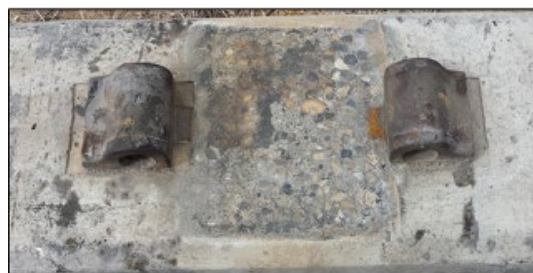
Figure 5. Rail Seats from the FAST installation. (a) Unground Rail Seat after 375 MGT, and (b) Tie with 0.25-inch Ground Rail Seat after 375 MGT

The condition of the ties was photo documented before the ties were installed, and when the ties were removed after accumulating 375 MGT. [Figure 5](#) shows photos of two rail seats after 375 MGT—one that had not been ground at 0 MGT ([Figure 5a](#)), and one that initially had 0.25-inch of triangular RSD ground in ([Figure 5b](#)).

The surface conditions of the ground and unground ties before and after the test were similar. To quantify material loss, depth measurements of the rail seats were taken before and after tonnage accumulation. Depth measurements were taken at 32 different locations along the width of the rail seat (from shoulder to shoulder along the length of the tie) using a linear variable displacement transducer (LVDT) and a custom depth gage fixture shown in Figure 6.

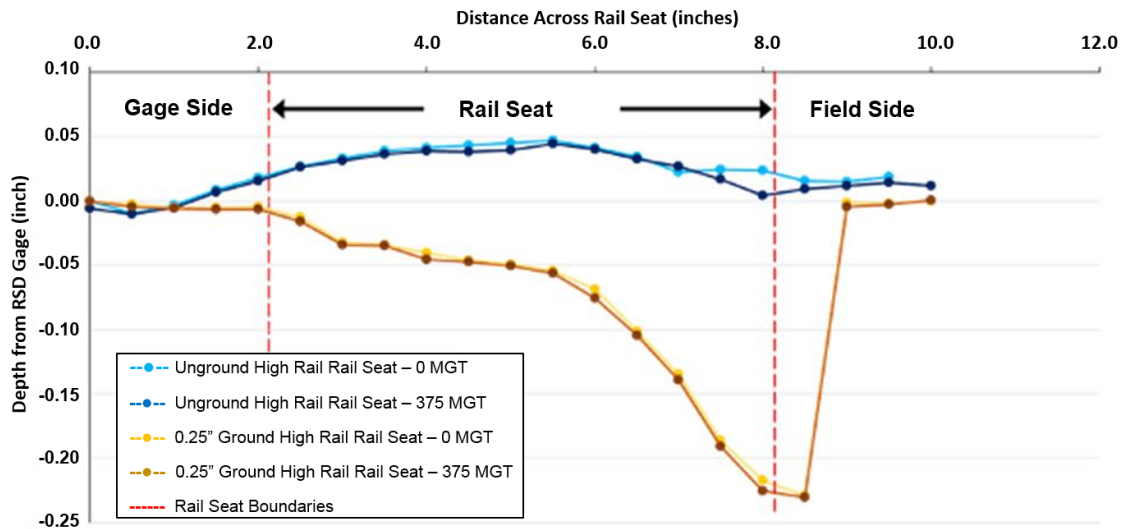
Figure 7. Transverse Profiles across Two Rail Seats at 0 MGT and 375 MGT of Accumulated Tonnage at FAST

All 12 test ties, whether ground or unground, exhibited only minor material loss and RSD. Figure 7 shows rail seat profiles measured at 0 and 375 MGT for two ties—one that was not ground, and one that was ground to a depth of 0.25-inch on the field side. The slope of the ground rail seat is steeper on the field side than it is on the gage side. There was some variability in the grinding, as there is in actual RSD. Each series represents a depth profile across the width of the rail seat.

The maximum change in depth measured after 375 MGT was less than 0.02 inch, and the changes in measured depths were similar for the tie that was not ground and for the tie that was ground, indicating insignificant development of RSD or RSD growth. Results were similar for the other 10 ties in the test zone. This result aligns with previous observations at FAST, namely, that RSD has not presented itself as a typical failure mode of concrete ties in the loading environment at FAST. Moreover, as installed, the presence of preexisting RSD did not appear to initiate additional degradation of the rail seat. Moisture on the rail seat has been purported to accelerate the development of RSD. With the arid climate in Pueblo, CO, this study (and historical observations) appear to confirm that moister environments are more conducive to RSD development than the overbalanced speed and high lateral loads characteristic of FAST operations in a dry environment. In addition, the ties, shoulders, and concrete were in good condition when installed at FAST. Ties that had weathered or were produced with lower strength concrete might have performed differently. The effect of concrete quality control in the concrete tie manufacturing process on RSD development is not clear.

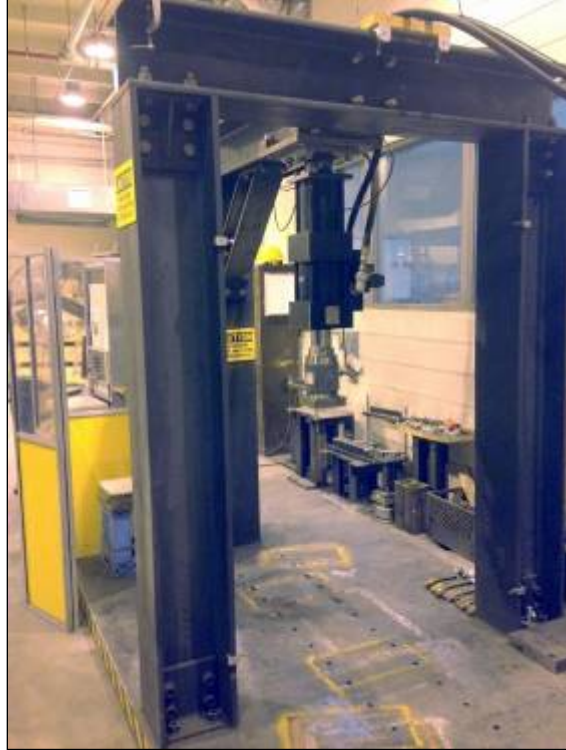
Figure 14. Three-Post Load Frame

Laboratory testing was conducted on TTCI's Three-Post Load Frame. The load frame consists of a 50,000-pound vertical servo-controlled MTS actuator and controller (Figure 14). The actuator has an integrated load cell and LVDT. Custom fixtures were constructed for each test to provide sufficient restraint of the tie sections. Additional LVDTs were also used to measure rail displacements as indicated. All testing was conducted at ambient room temperature (70 °F +/-10 °F).

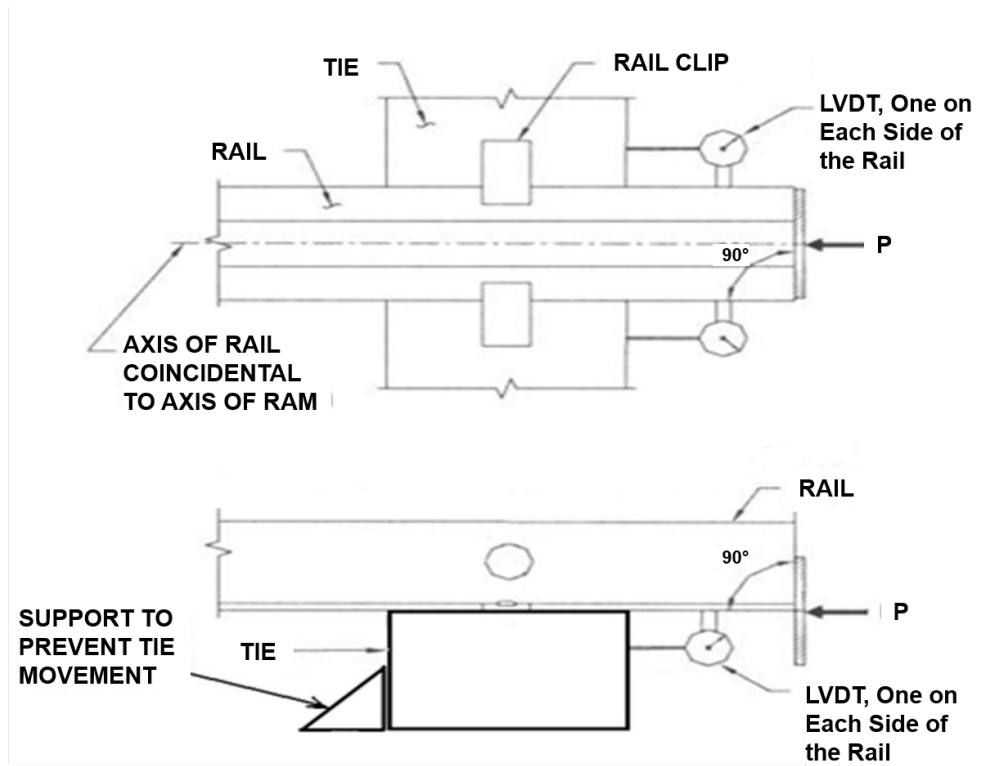
Figure 15. Rail Longitudinal Restraint Test Setup [9]

[Figure 15](#) shows a schematic of the test setup [9]. [Figure 16](#) shows a picture of the test setup and fixture used to restrain the tie section.

The tie section was fastened to the base of the fixture, and a short length of 136RE rail base was clipped to the tie using the SAFELOK I fastening system components and recommended installation procedure. The following instrumentation channels were collected:

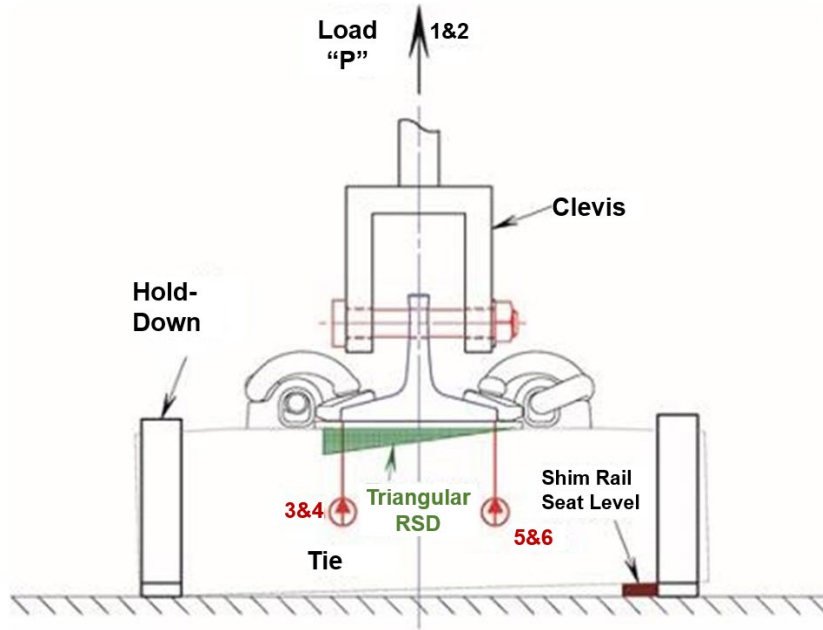
Figure 17. Test Assembly and Load Application (Shown for Triangular RSD)

Figure 17 shows a schematic of the test setup. Figure 18 shows a photo of the test setup and fixture used to restrain the tie section. For this test, a single tie section was fastened to the test fixture and a short length of 136RE rail was clipped to the tie using standard SAFELOK I fastening system components and manufacturer recommended installation procedures. The rail fixture used had a 1.5-inch diameter hole drilled in the web. The rail was connected to the actuator with a shear pin and clevis, as Figure 17 shows.

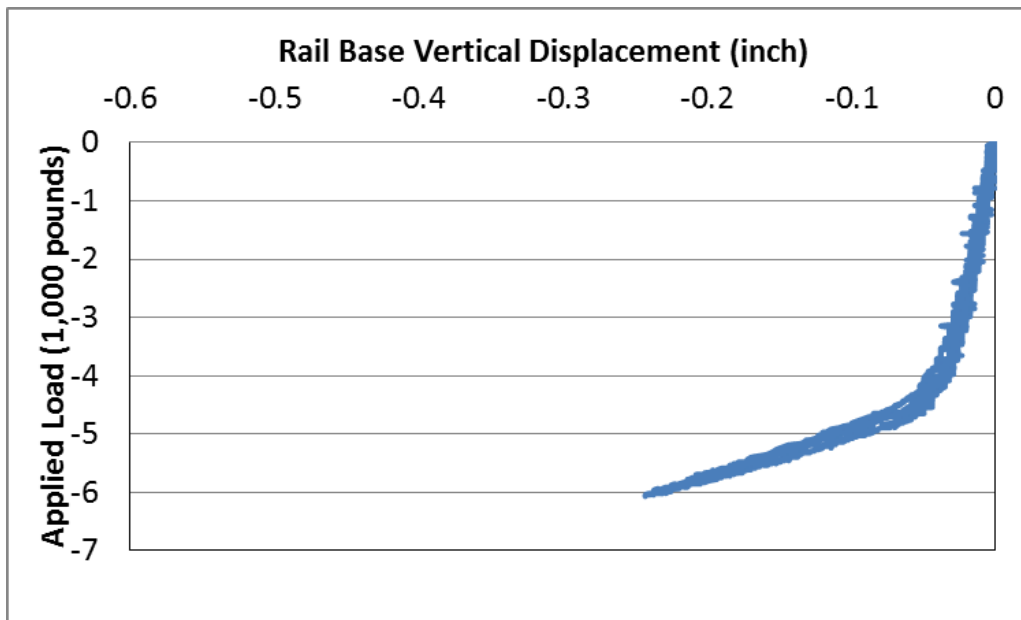
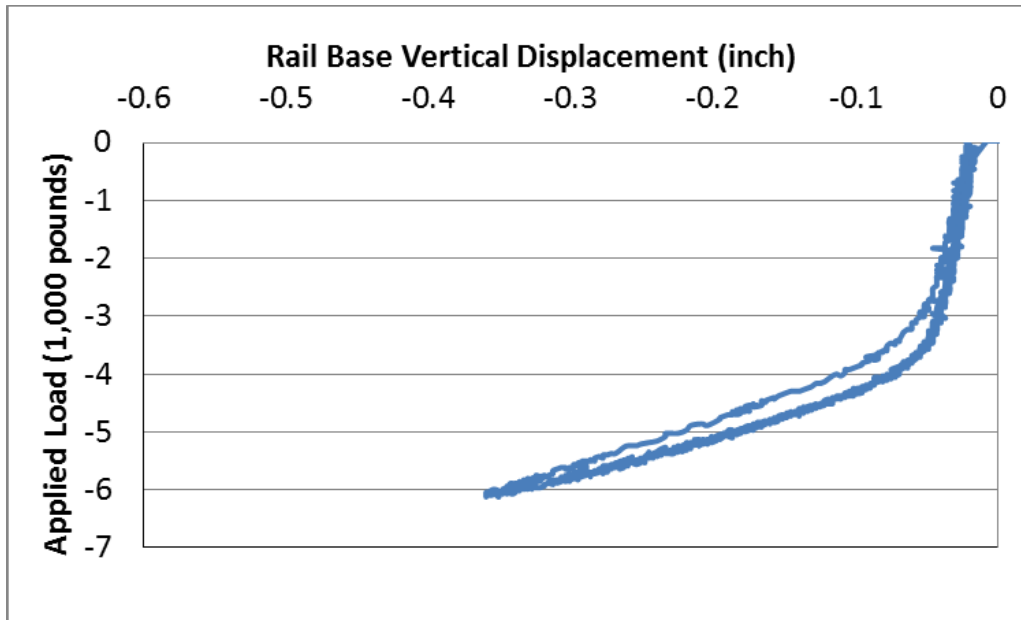
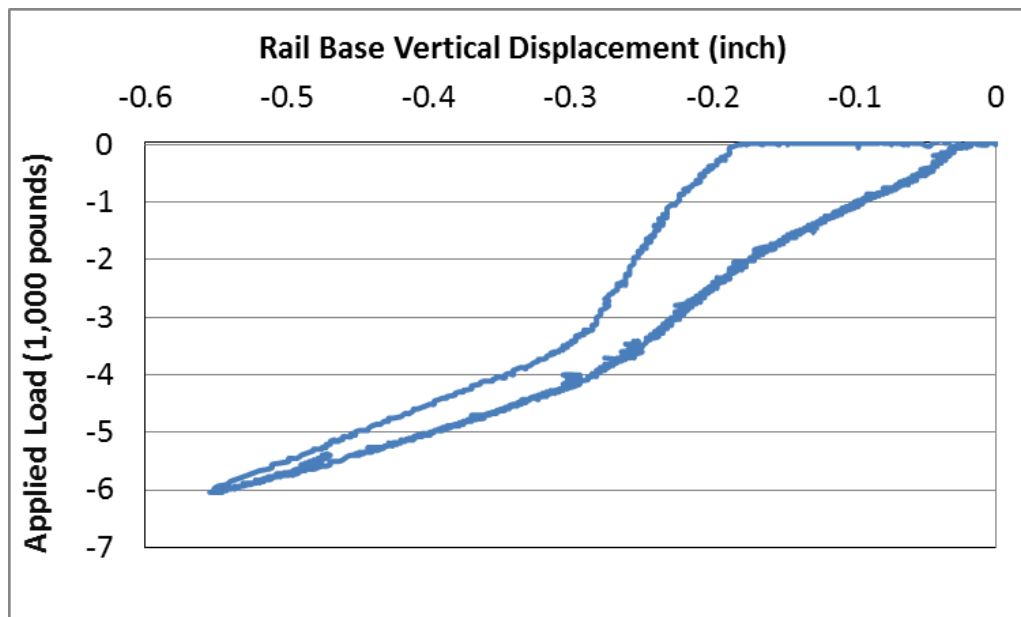
Figure 19, Figure 20, and Figure 21 show the applied tensile load versus rail vertical displacement curves for the non-deteriorated concrete tie, 0.125-inch uniform RSD, and 0.5-inch uniform RSD cases, respectively. The hysteresis after unloading is shown for each case.

Results suggest that as uniform RSD magnitude increases, the clip toe load decreases. Higher magnitudes of uniform RSD resulted in lower uplift forces required to reach the AREMA defined threshold of 0.05 inch of vertical displacement.

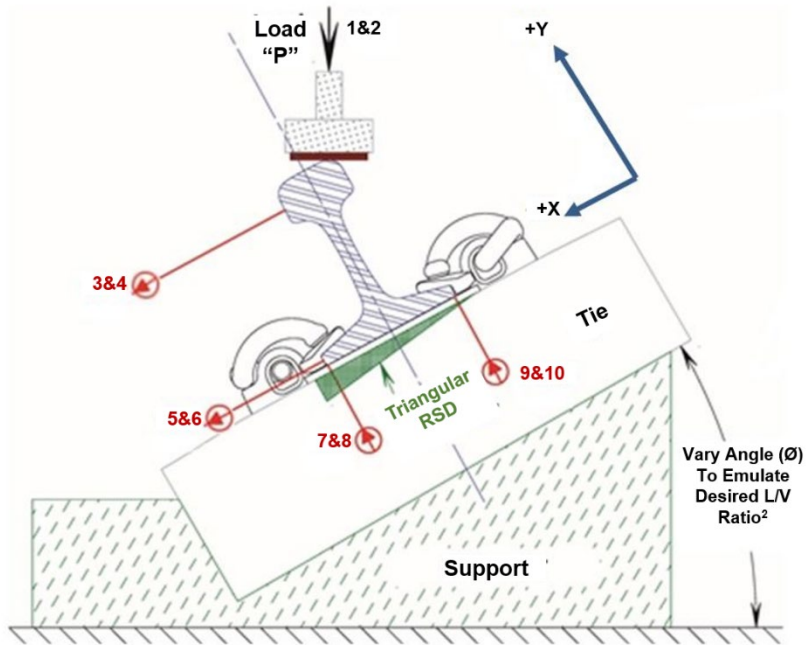
Figure 22. Lateral/Vertical Compliance Test Setup (Shown for Triangular RSD)

Figure 22 shows a schematic of the test setup for triangular RSD. Figure 23 shows a photo of the test setup and fixture used to restrain the tie section.

For this test, a single tie section was fastened to the test fixture and a short length (approximately 1 foot) of 136RE rail was clipped to the tie using standard SAFELOK I fastening system components and manufacturer recommended installation procedures. The fixture shown in [Figure 23](#) allowed the angle of the tie to be varied to produce varying L/V ratios. A spherical compression platen was used to apply load to the railhead, through a point approximately 0.50 inch in from the gage side and 0.625 inch from the top of the railhead. This location is also used to define the load application point for AREMA Chapter 30 Test 6 – Wear/Deterioration.

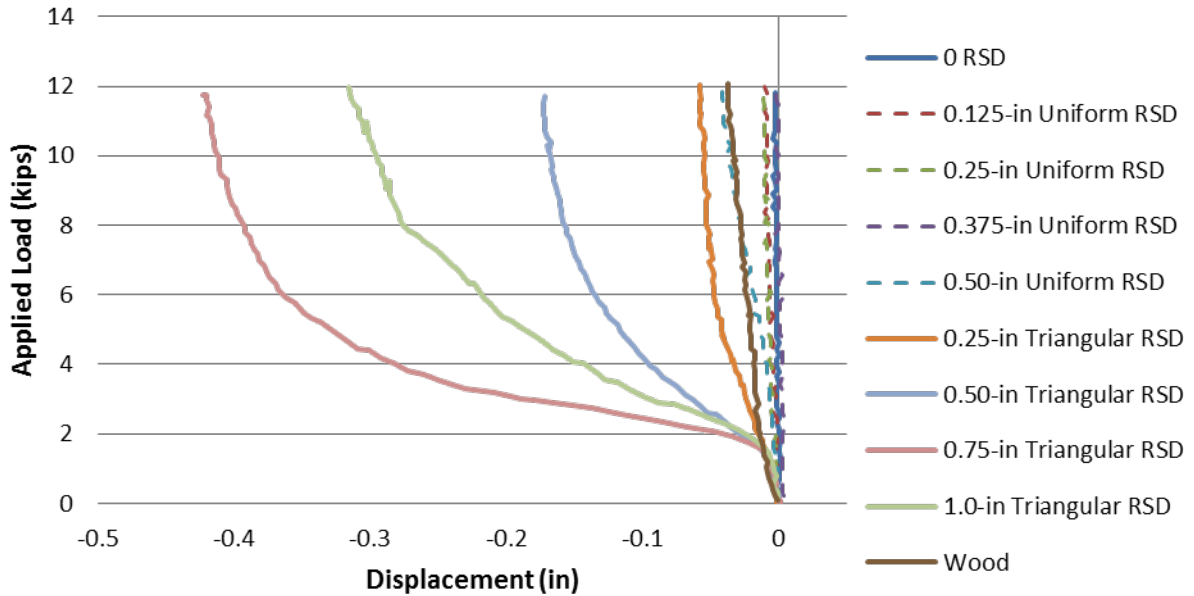
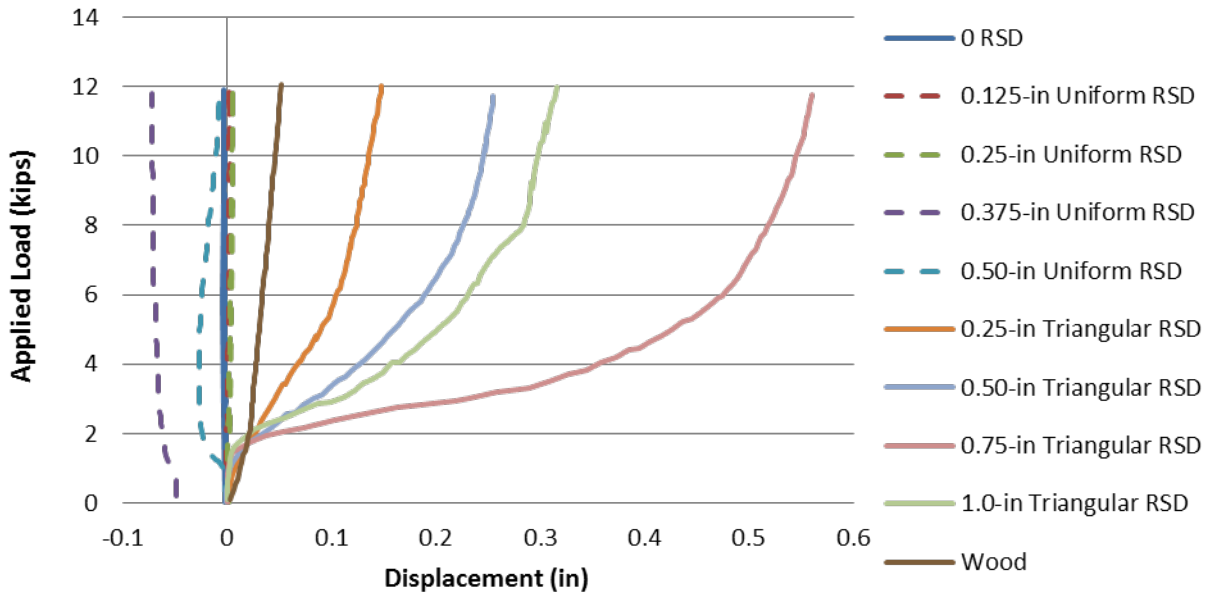
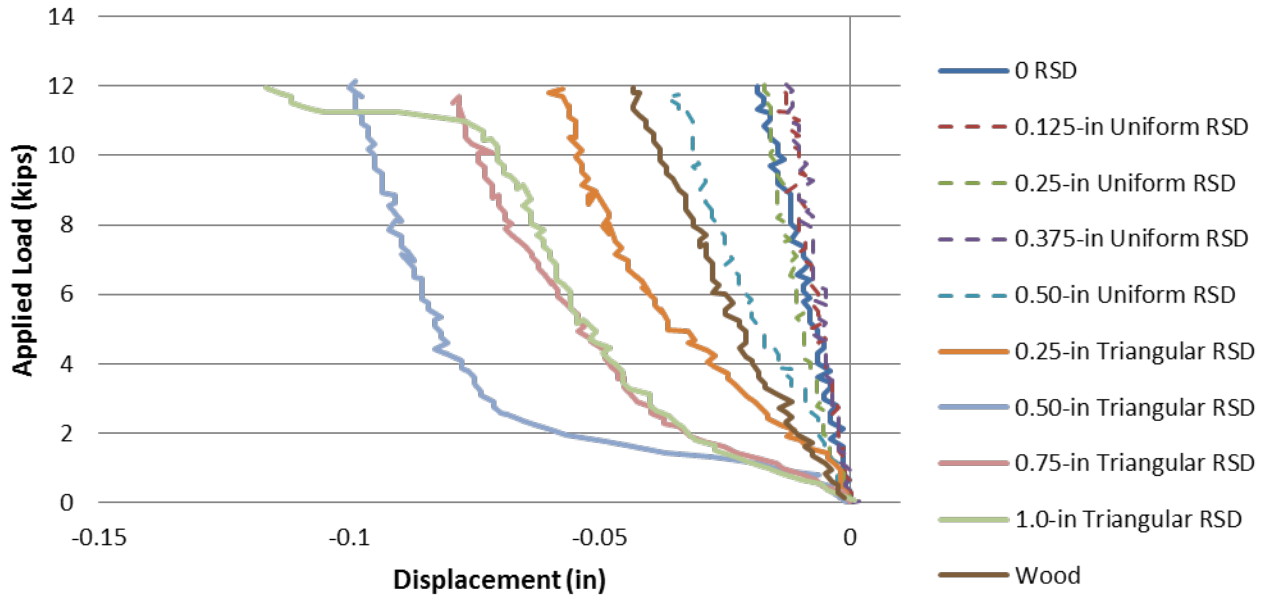
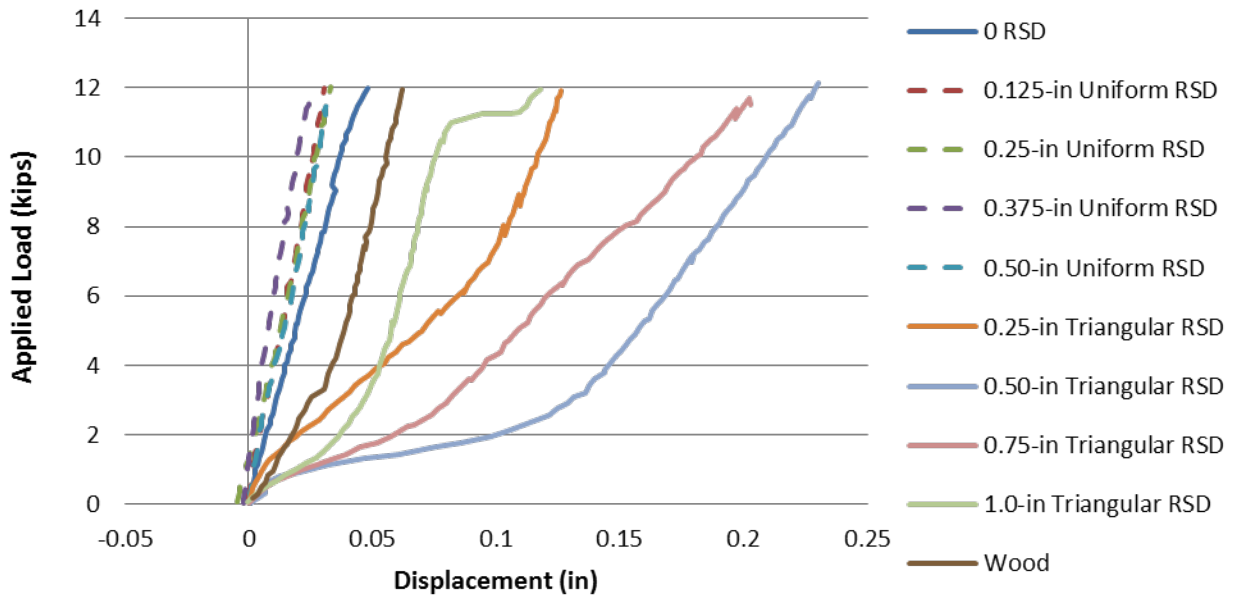
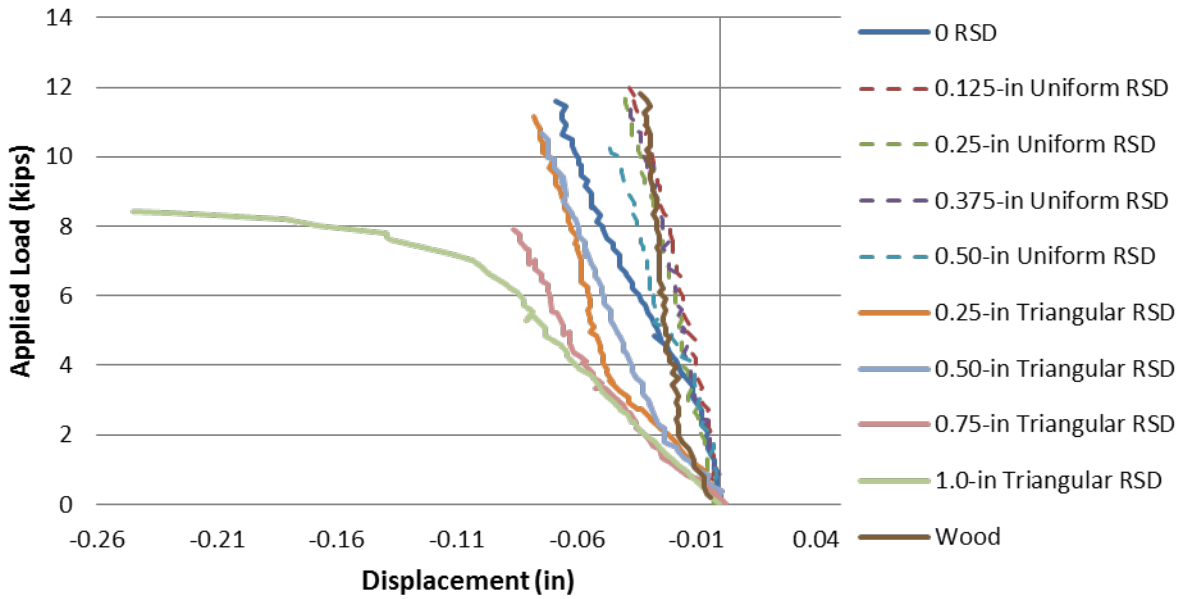
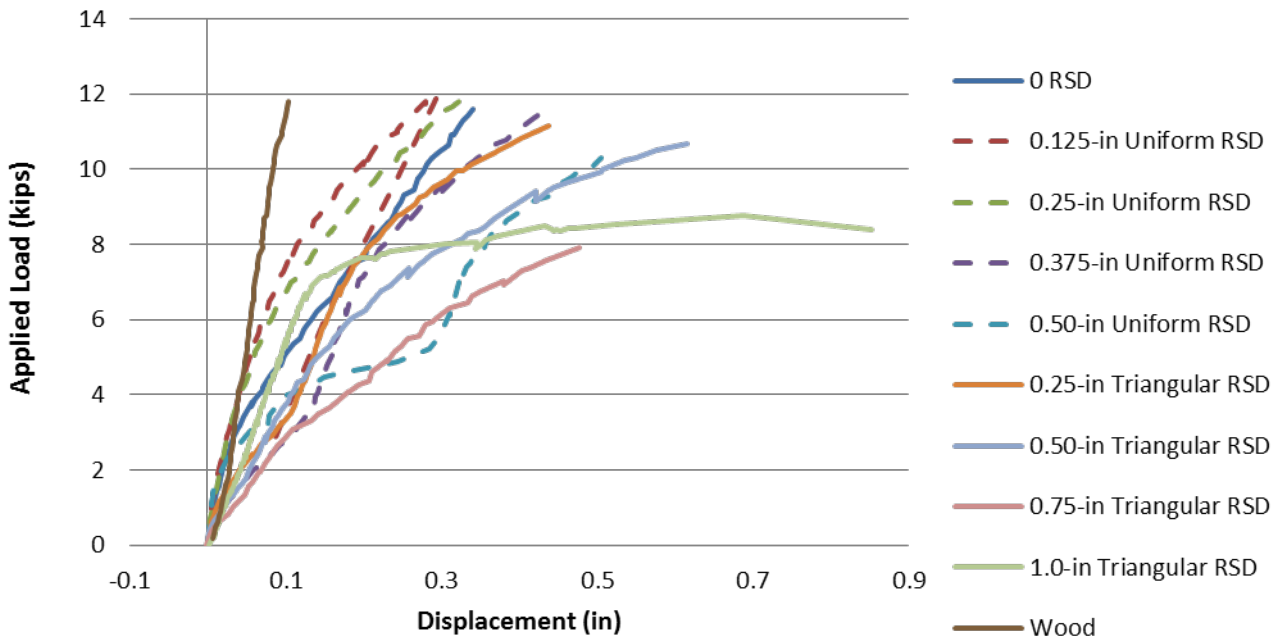
Figure 24 through Figure 29 show the field side rail vertical displacement and railhead lateral (gauge widening) displacements for the various L/V ratios. The figures are presented in order of increasing L/V ratio. Two graphs (one for Uniform and the other for Triangular—side by side for Figure 24 through Figure 29).

As expected, triangular RSD generated higher field side vertical displacements and railhead lateral displacements than similar magnitudes of uniform RSD. As triangular RSD depth was increased, higher field side vertical displacements were observed. The effect of uniform RSD depth on vertical field side displacements or lateral railhead displacements was less apparent. Results show that the wood tie sample behaved similarly to the uniform RSD cases except under the highest L/V ratio of 1.0.

The gage side fastener failed for the 1-inch triangular RSD tie section under the 1.0 L/V ratio case. This resulted in the large field side vertical and railhead lateral displacements that were observed. The 1-inch triangular RSD tie generally showed less field side vertical and railhead lateral displacement than some of the less severe triangular RSD samples, namely the 0.75-inch and 0.5-inch triangular RSD cases. This result was unexpected. One of the compliance tests was

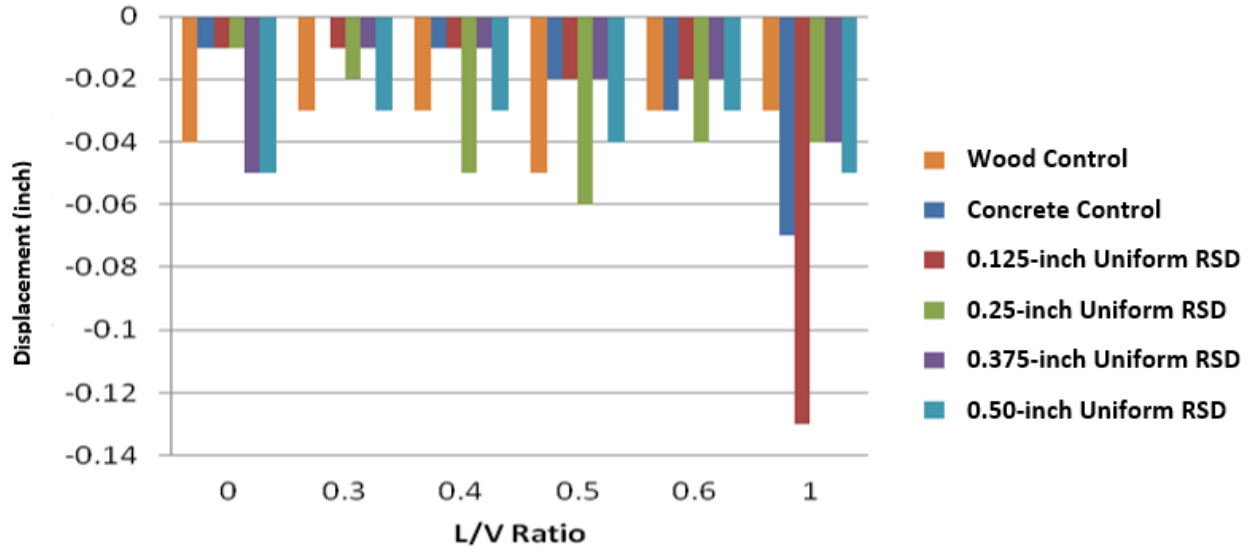
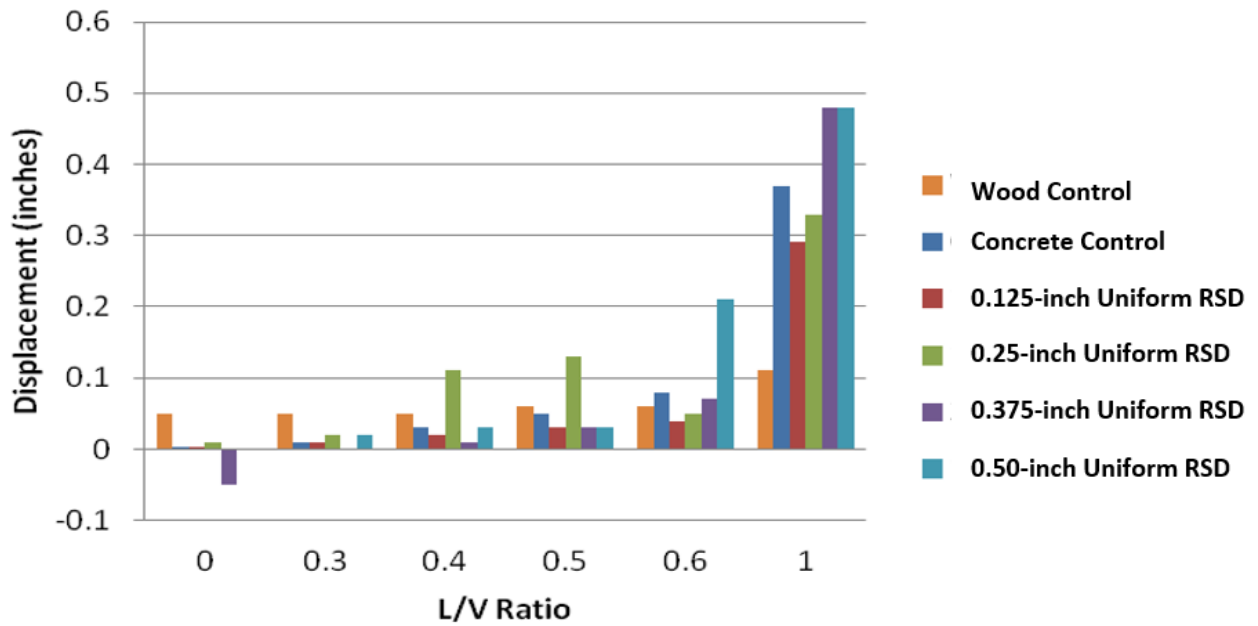
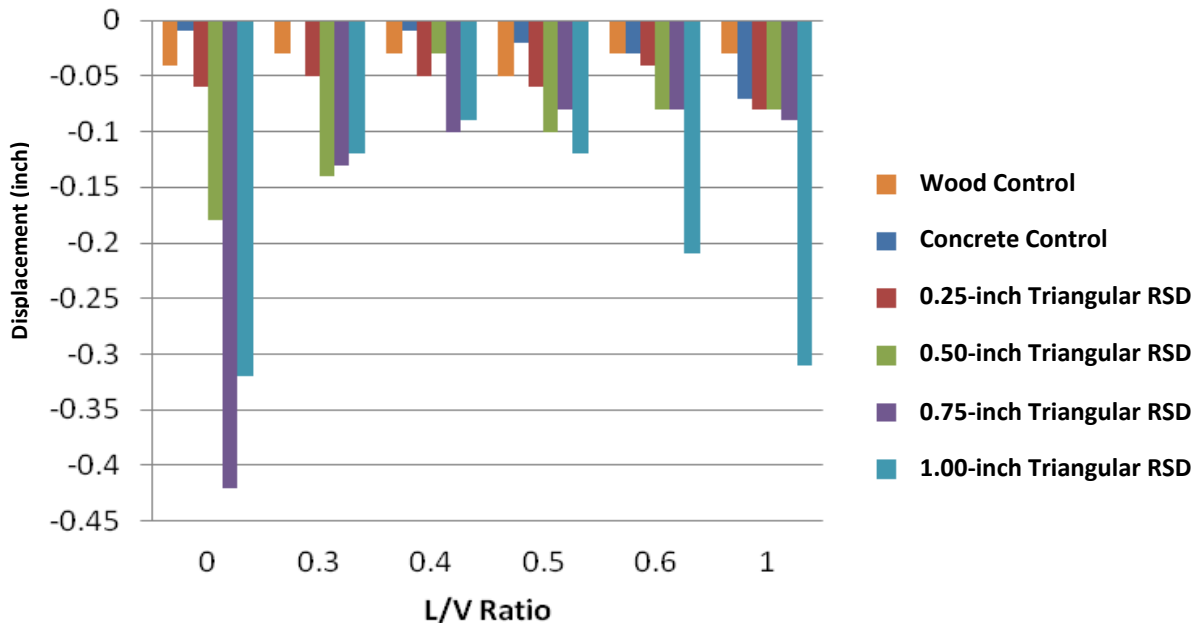
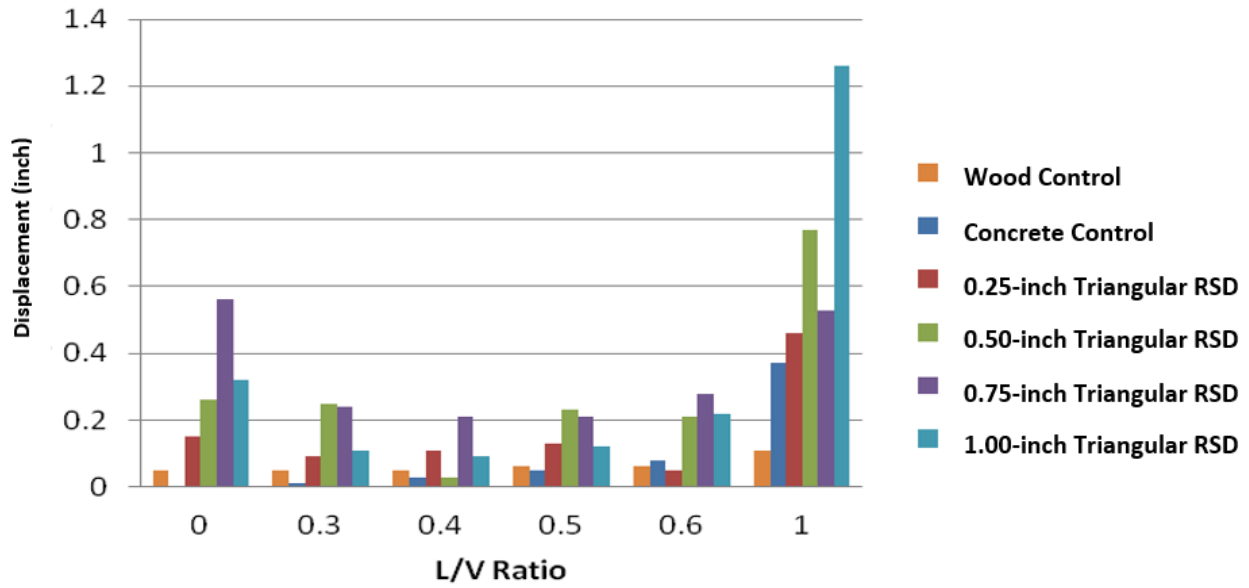
Figure 30 through Figure 33 display lateral railhead and vertical field side displacement for the various RSD conditions.

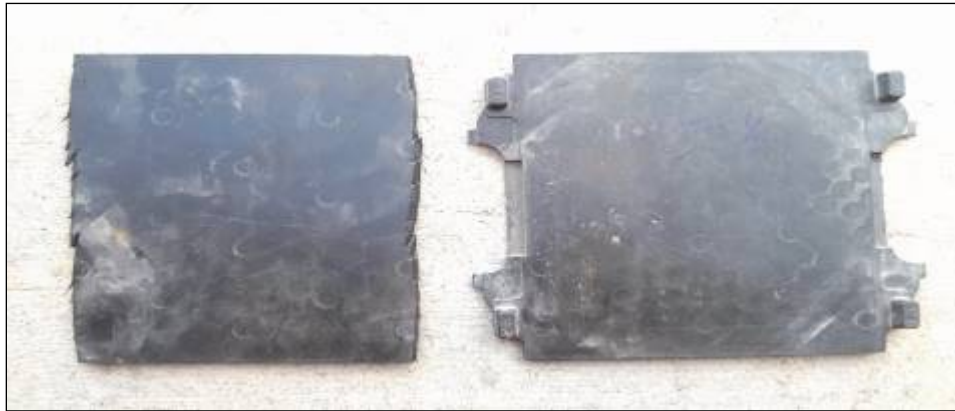
Figure 34. Cut Pad Simulating Deterioration (left) and Uncut Pad (right)

To demonstrate the effect that initial rail position was having on the system, triangular and uniform RSD test ties were set up again with two different pad conditions, one simulating a deteriorated pad, and a new pad, as was used throughout laboratory testing. [Figure 34](#) shows these two pads.

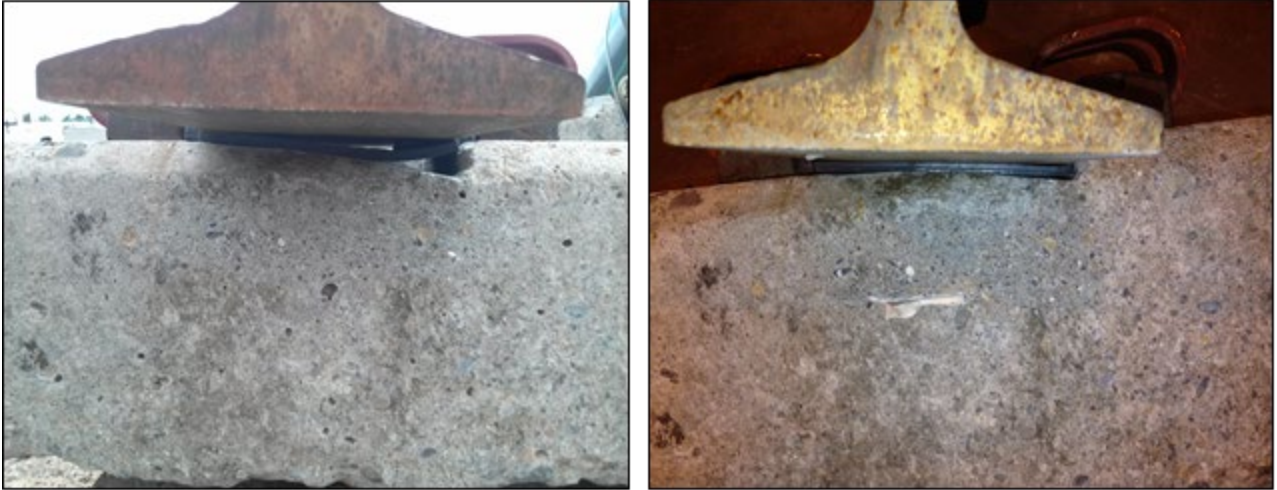
Figure 35. Using a New Rail Pad, Rail Before (left) and after (right) Lateral/Vertical Compliance Test

The same lateral/vertical compliance test regime was conducted. [Figure 35](#) shows the difference observed before (left) and after (right) loading suggests that the tie pad influenced the test results by supporting the rail over the RSD initially before loading. After the load was applied, the rail clearly seated deeper into the RSD. Since the rail was not reset after each L/V test case, the rail was likely starting in a different location each time a new test was performed. Worn or modified pads might better replicate in-situ RSD conditions. However, rail temperature and the effects of adjacent ties may also prevent the rail from fully seating in the RSD profile and thus affect the initial position of the rail before it is loaded.

Lateral/vertical compliance testing in the laboratory and GRMS testing indicated the importance of the initial position of the rail before loading. During laboratory testing, it was shown that the rail may or may not fully seat into severe triangular RSD depending on the condition of the pad. All laboratory tests were conducted with a short piece of rail on a single tie. Thus, torsional resistance, the effect of adjacent ties, or rail temperature were not considered in laboratory testing. Lower torsional resistance, or warmer rail temperatures may contribute to the rail fully seating in a triangular RSD profile on the high rail of a curve. Conversely, colder temperatures or lower torsional resistance may influence the rail base in resting outside of the RSD profile. These variables may change over time and may affect the initial, unloaded position of the rail as well as how it behaves under loading. Thus, for GRMS, the initial position of the rail, such as measured in the unloaded gage and unloaded cant channels, should be considered in addition to the channels measured under loading (loaded gage and loaded cant) when inspecting for RSD.

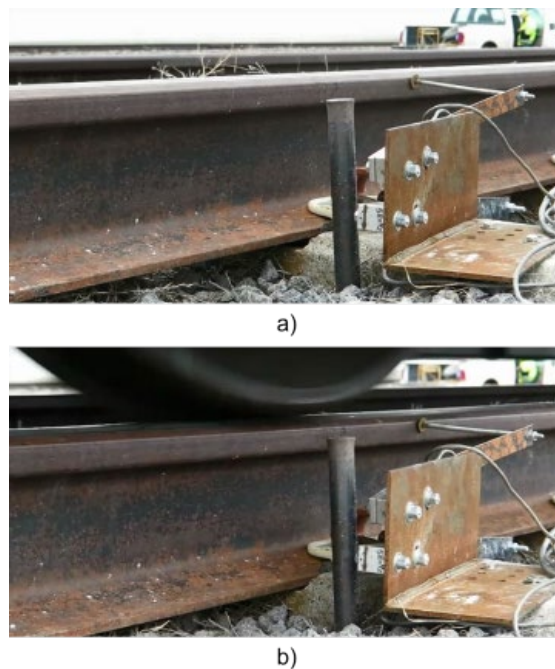
Figure 38. TLV GRMS Testing over Tie 10 of Zone 3 (0.75-inch Full Triangular RSD when: (a) Unloaded and (b) Loaded with 33-kip Vertical and 18-kip Lateral Wheel Load

Figure 38 compares the relative displacement of the rail head between the unloaded condition (Figure 38a) and at the moment the TLV's load axle, applying 33-kip vertical and 18-kip lateral loading, was directly over Tie 10 of Zone 3 or the heavy triangular RSD zone (Figure 38b).

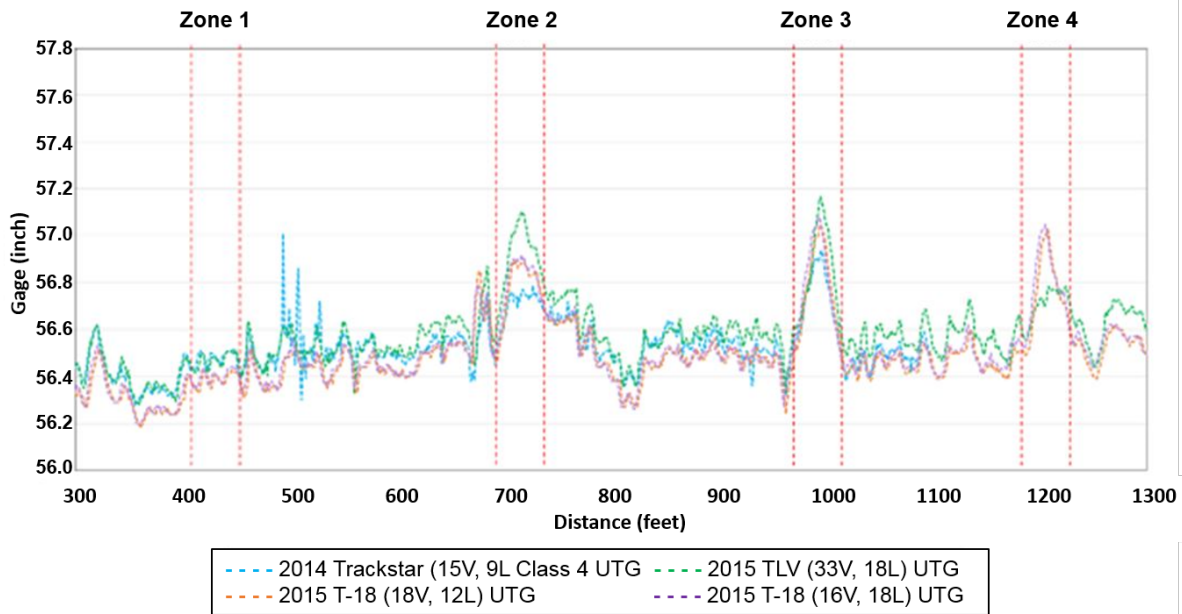
Figure 39. Unloaded Track Gage (UTG) Measurements from the Three GRMS Vehicles Tested with Varying Load Magnitudes and L/V Ratios

Figure 39 shows the unloaded gage measurements taken from the three GRMS systems tested. The Holland TrackSTAR vehicle tested before the addition of Zone 4. Figure 40 shows the loaded gage measurements taken from the three GRMS systems tested.

The TLV, while not applying the highest L/V ratio of loading, produced magnitudes of gage widening similar to the two T-18 runs (with higher L/V ratios) shown. The TrackSTAR vehicle appeared to produce the lowest amount of gage widening of the test cases. It should be noted that results from the loaded gage channel of the TrackSTAR test and the unloaded gage channel of the TLV were similar likely due to the much higher static axle loads of the TLV. Higher vertical loads appear to better “seat” the rail into full triangular RSD and subsequently cause gage widening. The higher vertical loads (combined with the relatively low L/V of 0.55) of the TLV however, produced less gage widening in the half triangular test zone relative to higher L/V runs. These results suggest that higher vertical loads as well as higher L/V ratios should be considered depending on the type and magnitude of RSD that may be present.

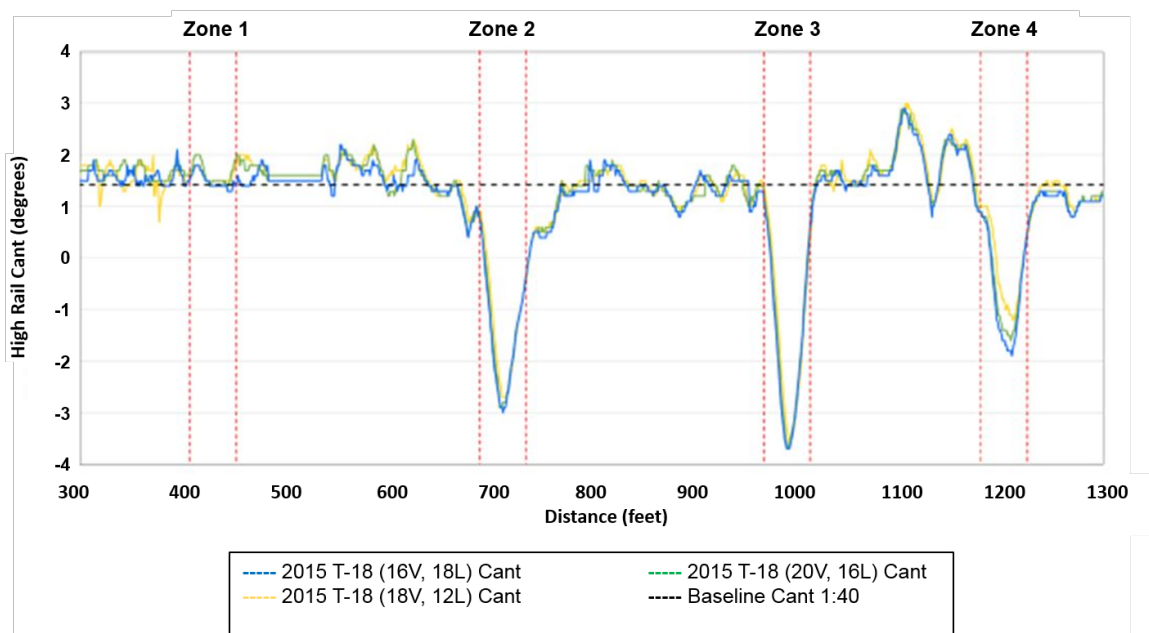
Figure 41. Loaded Cant Measurements from T-18 GRMS Runs at Three Different Load Magnitudes and L/V Ratios

Additionally, the T-18 was used to record loaded high rail cant through the test zones. Figure 41 shows the loaded high rail cant measurements taken from three different T-18 GRMS runs at three different load magnitudes and L/V ratios.

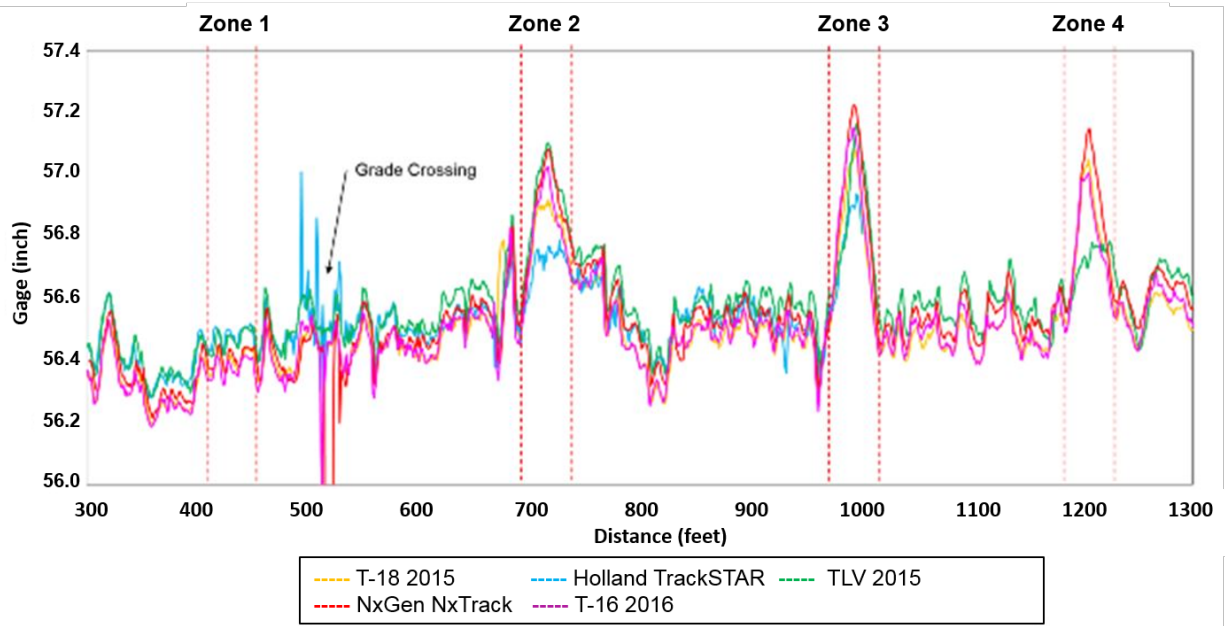
Figure 42. Track Gage as Measured by Five Different Track Geometry Vehicles that Tested Over the RSD Zones

gage channel, or unloaded gage channel on the GRMS vehicles were aligned and analyzed as potential indicators of RSD. Figure 42 shows the gage channel for a selection of the track geometry systems that were tested.

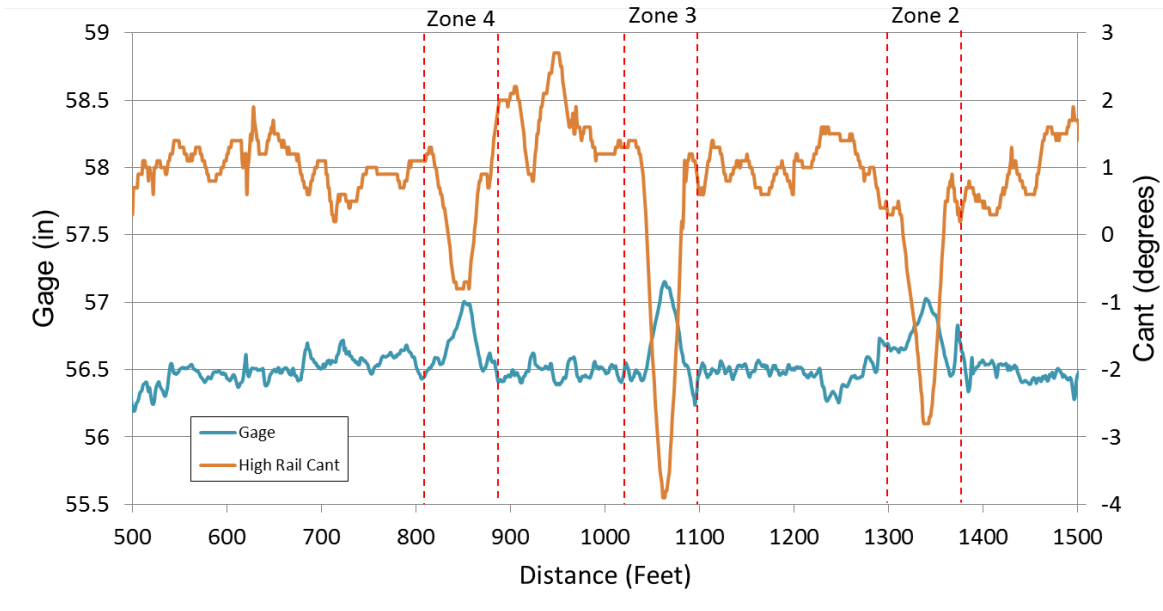
Figure 43. Track Gage Overlaid against Measured High Rail Cant by the T-16 in the Three Triangular RSD Zones

Figure 43 shows the unloaded gage channel overlaid against the unloaded cant channel from T-16 testing in 2016. It shows the direct relationship between the unloaded cant and unloaded gage that were recorded (identified each zone in plot below in Figure 43). Note that the T-16 test run for the data in Figure 43 was made in reverse.
