**Federal Railroad
Administration**

Detection of Concrete Tie Rail Seat Deterioration

1. AGENCY USE ONLY (Leave blank)		2. REPORT DATE September 2019	3. REPORT TYPE AND DATES COVERED Technical Report March 1, 2013 - December 31, 2016	
4. TITLE AND SUBTITLE Detection of Concrete Tie Rail Seat Deterioration			5. FUNDING NUMBERS DTFR53-11-D-00008L Task Order 333

9. SPONSORING/MONITORING AGENCY NAME(S) AND ADDRESS(ES) U.S. Department of Transportation Federal Railroad Administration Office of Railroad Policy and Development Office of Research, Development and Technology Washington, DC 20590			10. SPONSORING/MONITORING AGENCY REPORT NUMBER DOT/FRA/ORD-19/33

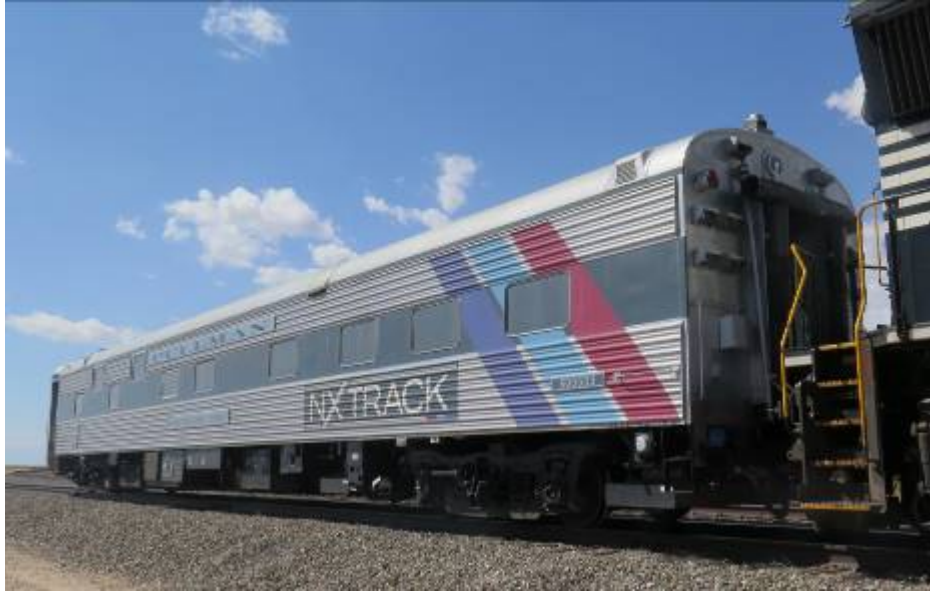
Figure 44. NxGen and NxTrack Track Geometry and Machine Vision Vehicle

In addition to their track geometry measurement system, NxGen was provided the opportunity to use their machine vision-based inspection system to inspect the RSD zones during the same test runs. Figure 44 shows the NxTrack car during testing. Figure 45 shows three images from the system’s video for an inspection run over the RSD zones. Figure 45c shows a slightly oblique angle of the high rail, field side fastener on Tie 10 of Zone 3, the Heavy, Full Triangular RSD. This camera angle is typically used by the system to inspect joint bars. However, it is evident from this image that the rail is sitting farther into the rail seat than would be typical for a non-RSD affected rail seat (note the top of the rail base flush with the concrete tie surface). These images and other track geometry data collected during testing may be used by NxGen for development of an image processing algorithm potentially capable of sensing RSD during a typical track inspection.
