Locomotive Collision Test #5
**Inline Collision of a Freight Locomotive with an
Unloaded Flat Car**

Test #5: Set-Up

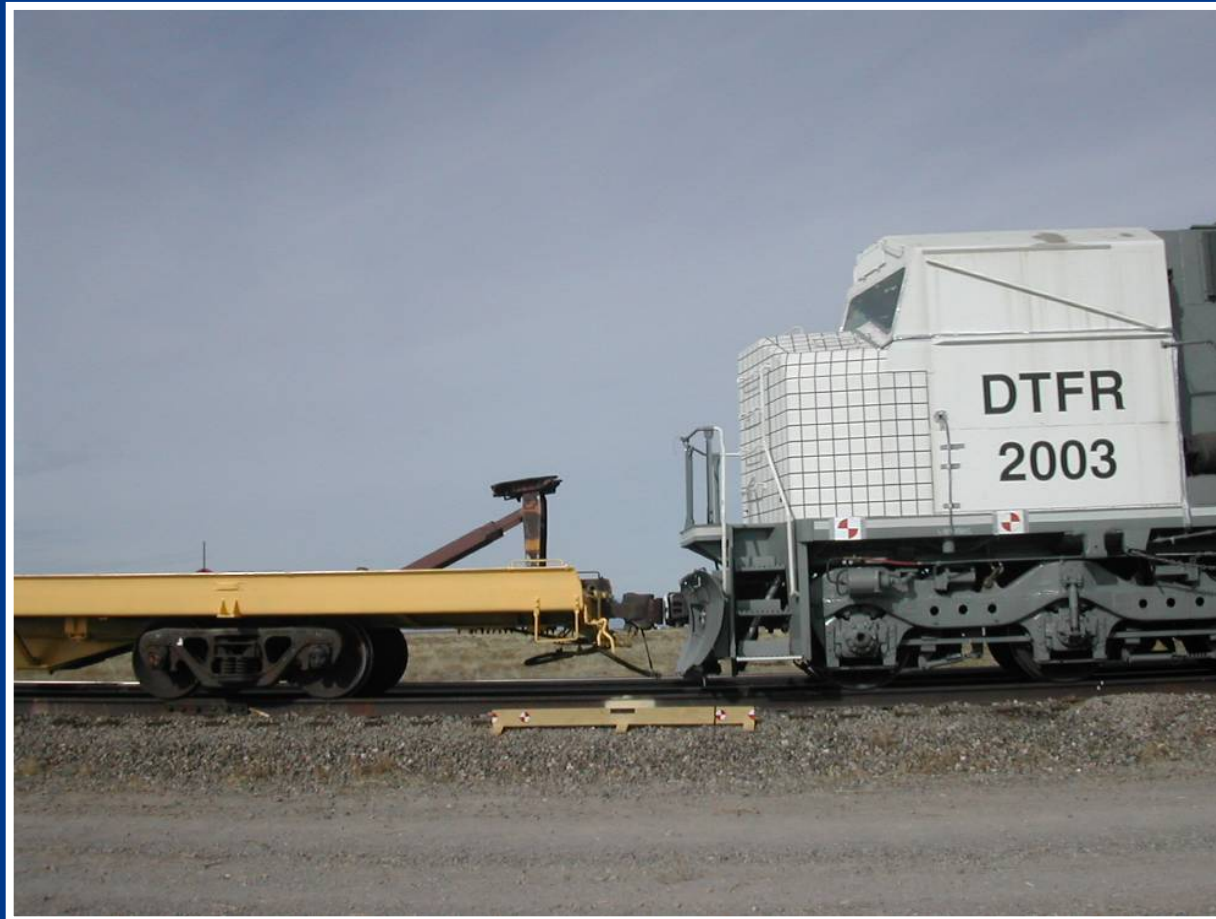
2 Loaded Hopper cars

Test Locomotive
(SD-45, front end
converted to SD-70)

Unloaded
Flat Car

~30 Loaded Hopper Cars

Collision Speed - 40 mph

Bullet Consist

Target Consist

~40 mph

Stationary

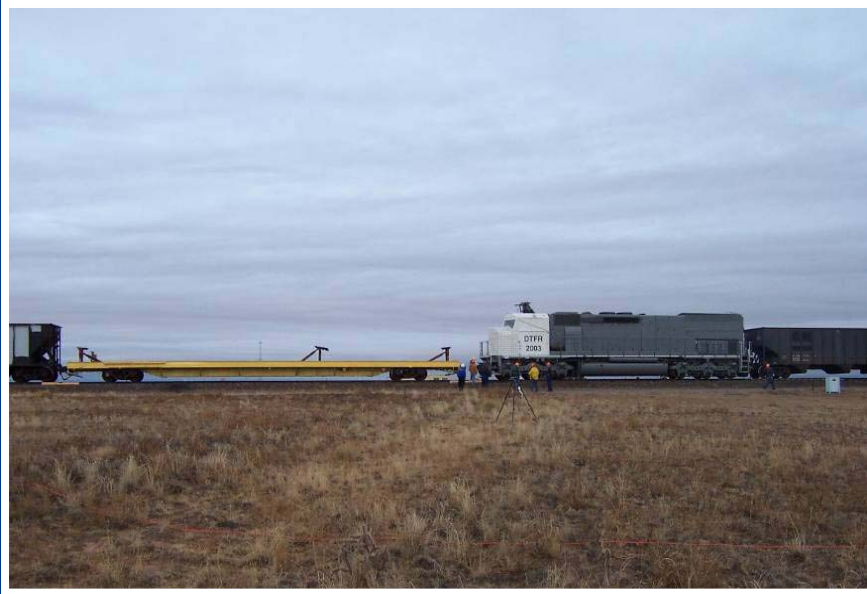
Locomotive consist alignment with
flat car consist

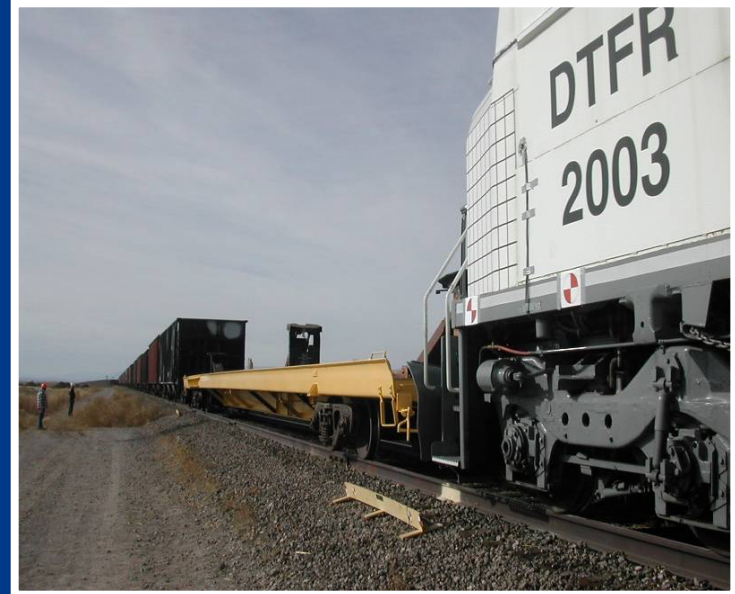
Height of flat car deck is below the
base of the locomotive anticlimber

- What did we learn from this test?
 - The flat car did not buckle as anticipated
 - The flat car overrode the hopper car
 - The behavior of the flat car was different from that of the car in the Phoenixville, PA accident (August 23, 1996)
 - This is attributed to the test flat car having friction draft gears with a relatively small stroke compared to the Phoenixville scenario which had end of car cushions with a longer stroke
 - The anticlimber prevented the flat car from climbing up the face of the locomotive

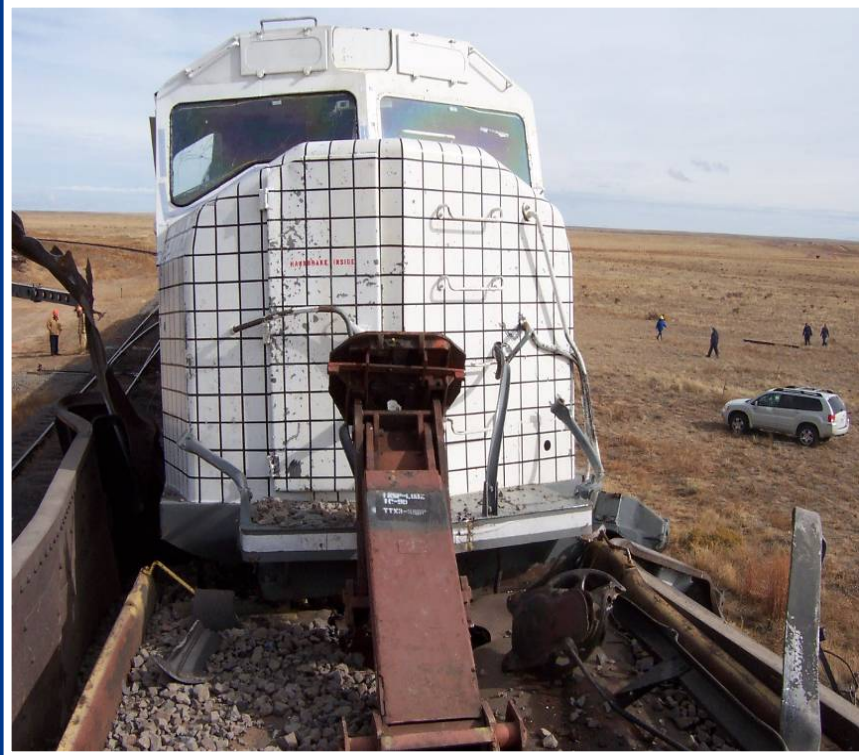
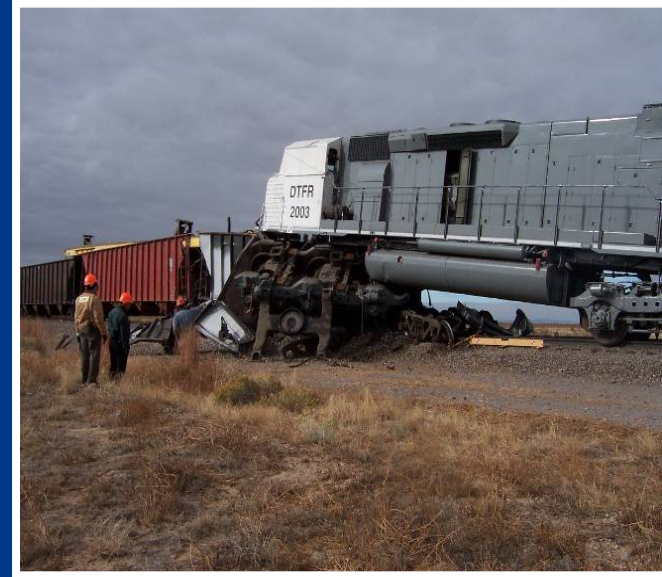
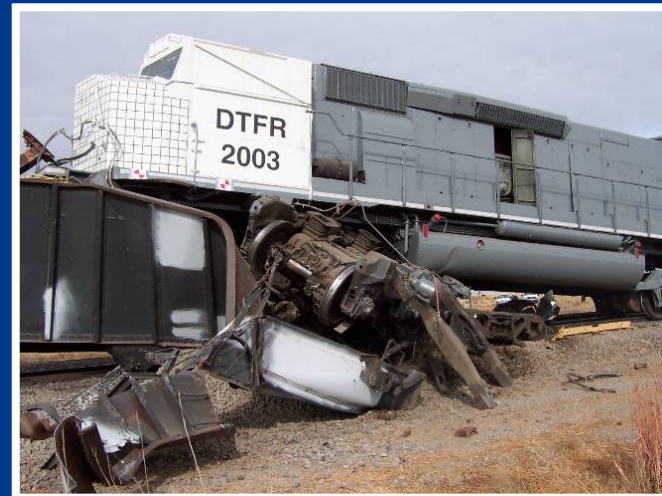
- Locomotive was lifted up from its front truck
- Cab, hood, and anticlimber not significantly damaged

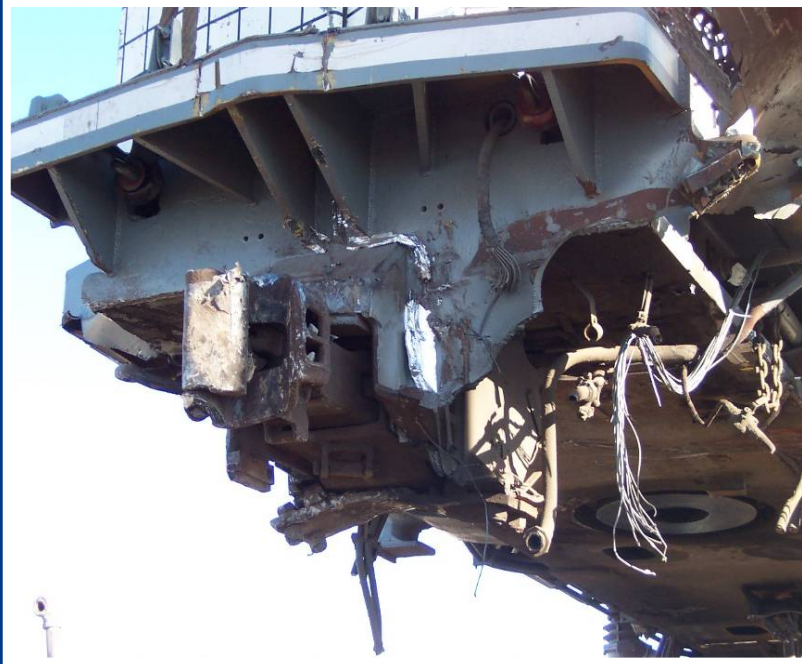
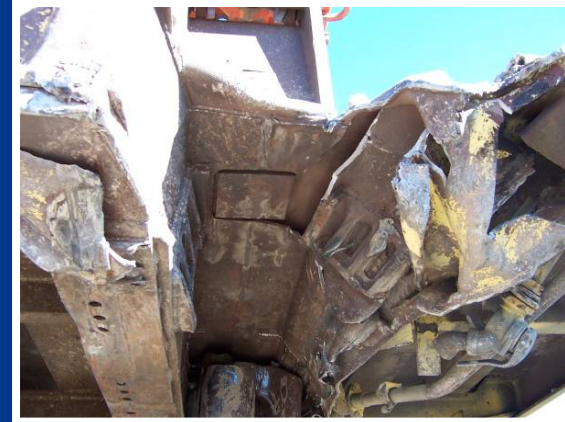
Impact end draft pocket

- Failure of the flat car's draft stops allowed the locomotive to push the flat car forward and into the hopper car
