Single Passenger Rail Car Impact Test Volume II: Summary of Occupant Protection Program

Rail Passenger Equipment Collision Tests

DOT/FRA/ORD-00/02.2
DOT-VNTSC-FRA-00-02

Final Report
March 2000

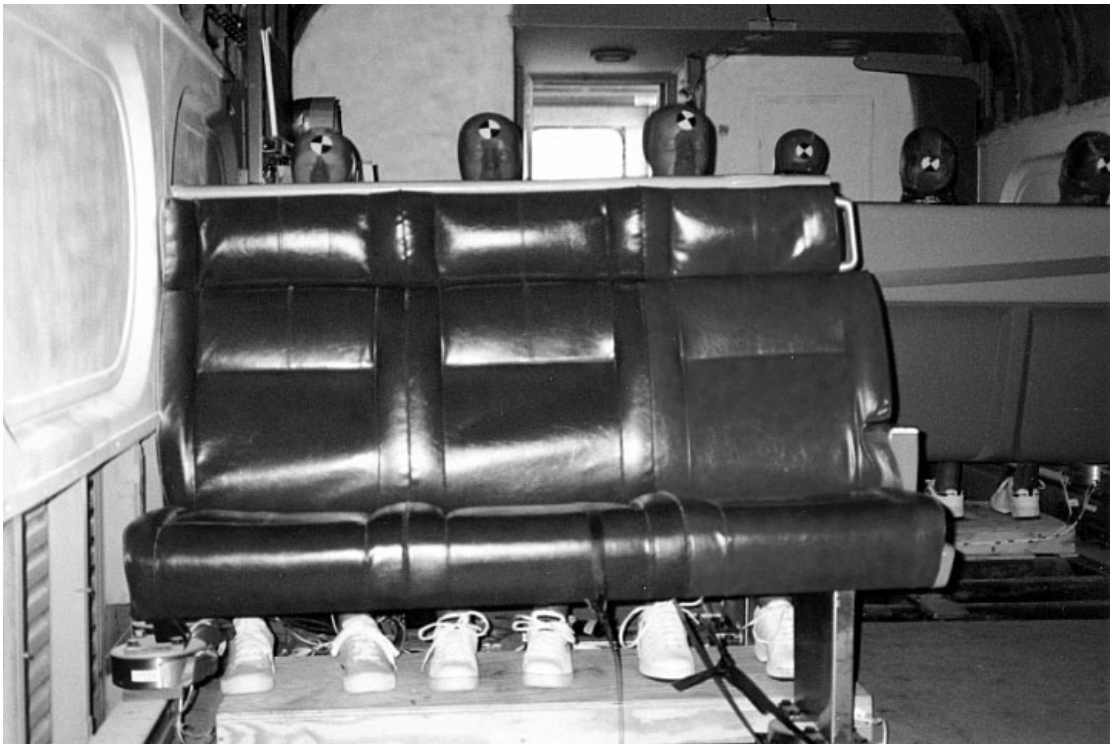
Figure 2. Pre-Test Photo of Experiment No. 1 – Row-to-Row Commuter Seats

The seats were bolted onto retrofitted steel bars (2.00 in. x 0.75 in.) that replaced the original wooden floor. These steel bars represented the retrofit floor design in SEPTA's Silverliner 3 rail car. Two floor load cells were installed between the seat pedestal and the steel floor bar. At the wall mounting points, two load cells were installed between the seat attachment and the heater guard – a lip that extends horizontally from the wall of the car. The rear-row seat was similarly installed, but instead of load cells, spacer blocks of equivalent height were used.

The focus of this experiment was on the head/neck forces experienced by the front-facing occupants, and the reaction load at the seat attachment points. A pre-test photo of Experiment 1 is shown in Figure 2.

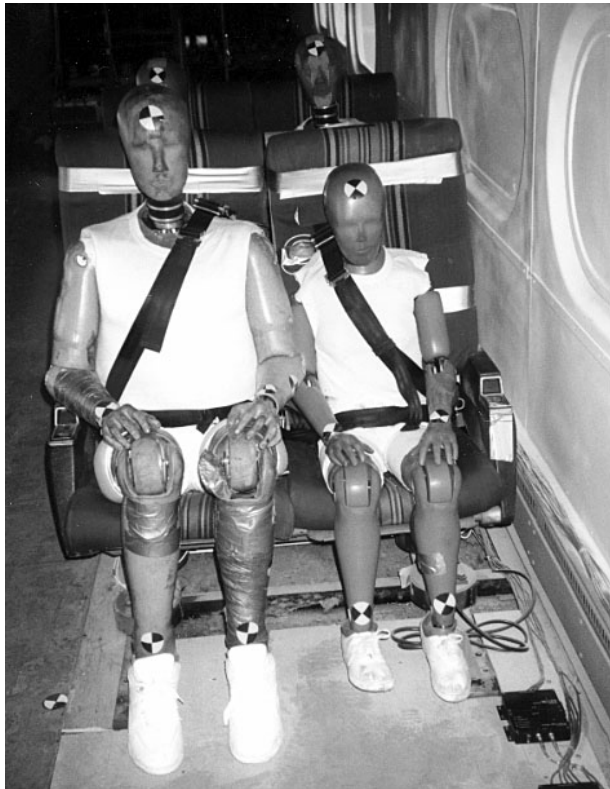
Figure 3. Pre-Test Photo of Experiment No. 2 – Row-to-Row Amtrak Seats with Restraints

Experiment No. 2 consisted of two row-to-row two-place passenger intercity seats provided by Amtrak. These intercity seats were manufactured by AMI of Colorado Springs, Colorado, and the front-row seats were modified with lap and shoulder belts. The seat back panel and hinge-point between the seat pan and the seat back were both strengthened to bear the load of the lap and shoulder belts, as well as the load of unrestrained occupants impacting the seat from behind. Energy-absorbing devices were also incorporated into the modified seat to bear some of the impact load. The two original seat pedestals were replaced with higher strength pedestals. The rear seat was occupied by two unrestrained 95th-percentile ATDs, and the front seat was occupied by two restrained ATDs (a 5th-percentile in the window seat and a 95th-percentile in the aisle seat).

The Amtrak seats were floor mounted and bolted onto steel bars (2.00 in. x 0.75 in.) that replaced the original wooden floor. Two floor load cells were installed between each seat pedestal and the steel bars to which they were attached. The rear row seat was similarly installed, but instead of load cells, spacer blocks of equivalent height were used.

The focus of this experiment was on the rear-seat occupants impacting the front-row seat occupied with restrained ATDs, and observing the reaction of the front-row seat, the restrained occupants in this seat, and the unrestrained ATDs impacting the seat from behind. A pre-test photo of Experiment 2 is shown in Figure 3.

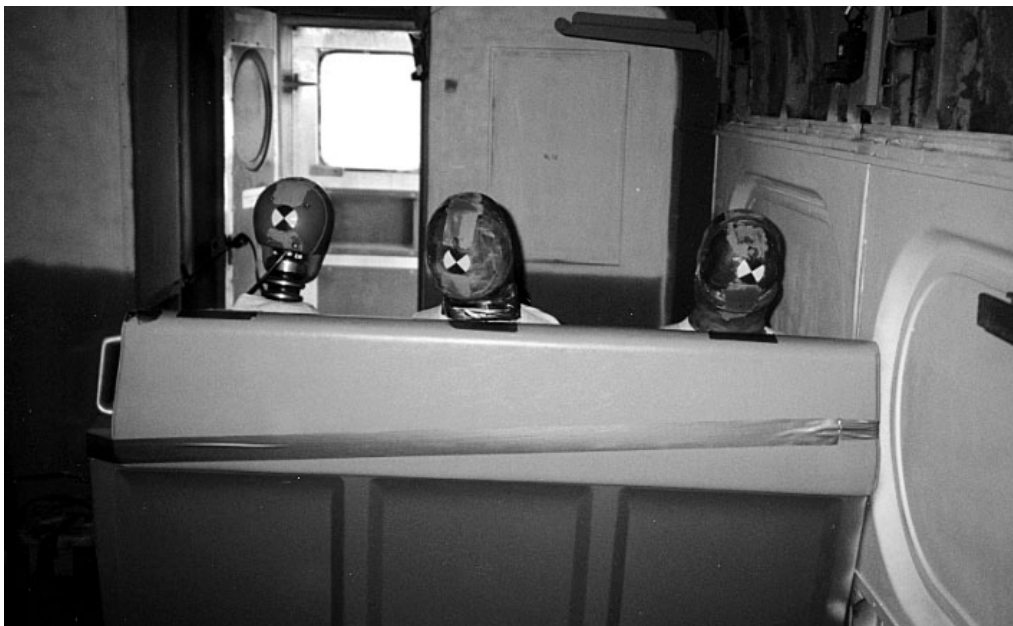
Figure 4. Pre-Test Photo of Experiment No. 3 – Rear-Facing Commuter Seat

Experiment No. 3 consisted of a single, rear-facing M-style commuter seat. This rear-facing seat was occupied by unrestrained ATDs – one Hybrid III 95th-percentile male ATD in the aisle seat and two 95th-percentile ATDs, manufactured by GARD, in the middle and window seats. It was later determined that while these GARD ATDs represented the 95th-percentile male population in size, they only represented the 50th-percentile male population by weight (172 lb).

This seat was installed exactly like the front-row seat of Experiment No. 1. Two floor load cells were installed between the seat pedestal and the steel floor beam. At the wall mount, two load cells were installed between the seat attachment and the heater guard.

The focus of this experiment was the crash pulse and the applied force of the seated occupants and the reaction of the seat. The head/neck reaction of the occupants also was observed. A pre-test photo of Experiment 3 is shown in Figure 4.

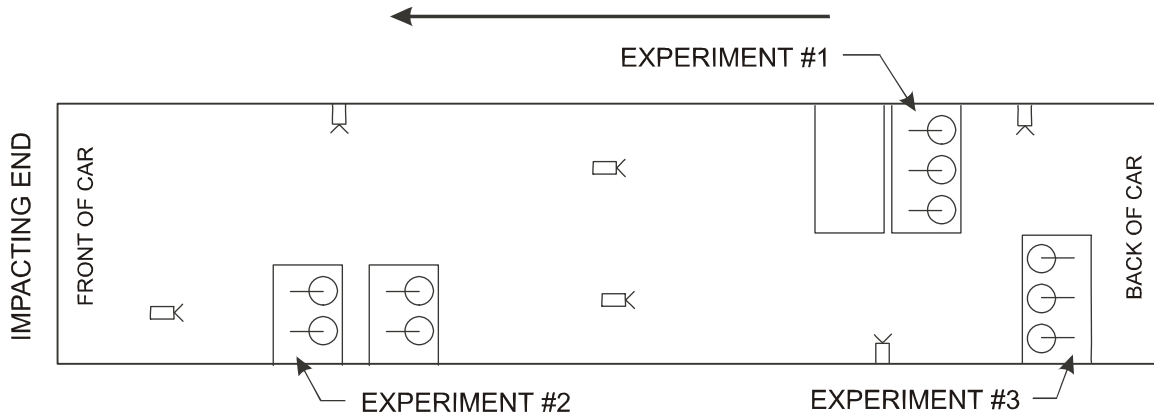
Experiment No. 1 was installed approximately 36 in. forward of the rear-facing seat (Experiment No. 3) which was installed 24 in. from the rear body bolster. The seats in Experiment No. 1 were installed 32 in. apart. Experiment No. 2 was installed toward the front of the car, approximately 40 in. from the front body bolster with a 41-in. seat pitch. Figure 5 is a layout of the seat experiments in the rail car.

Figure 5. Rail Car Seat Experiment Layout for Test No. 1

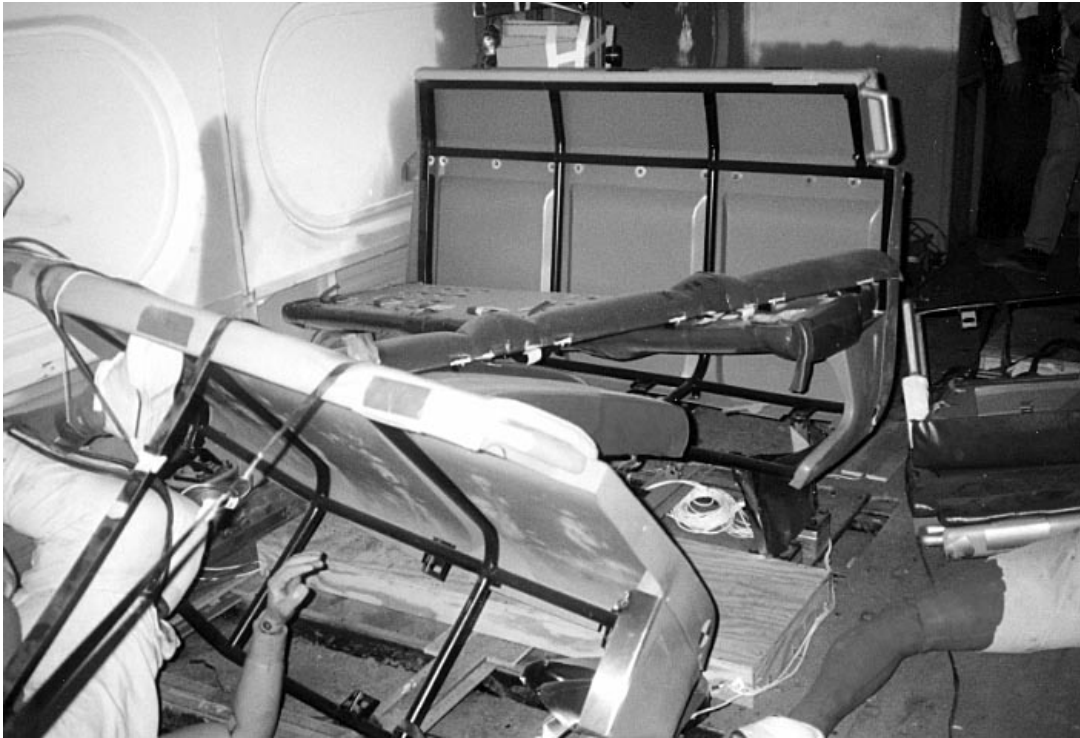
Gross failure of the seat pedestal in Experiment No. 1 allowed the seat to be pushed out of the way, resulting in a complete loss of occupant compartmentalization (see Figure 6). Overall, the measured occupant injuries were low because the seat offered little or no restraint value and the ATDs were tethered. There were no further obstacles for the occupant to impact before landing on the floor. The Hybrid III 50th-percentile ATD in the rear window seat was instrumented, and recorded a lower neck extension moment that exceeded the injury criterion.

Figure 6. Experiment No. 1 – Loss of Passenger Compartmentalization

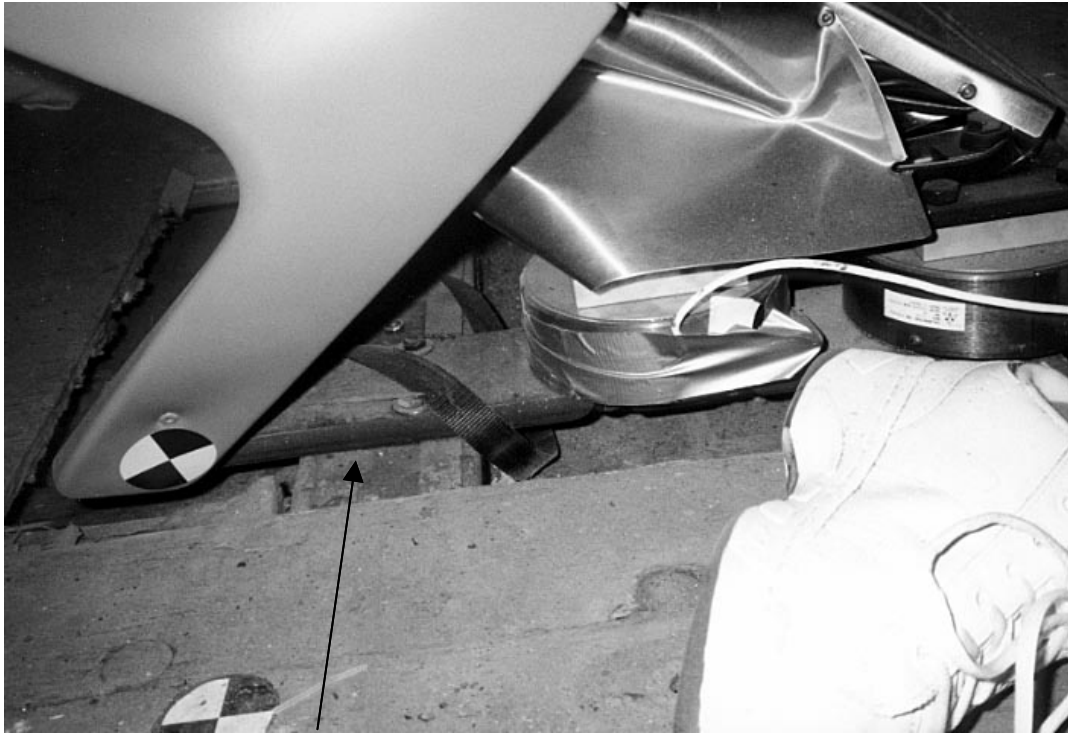
The front-row seat pedestal deformed completely forward, causing the seat to rotate forward until the front edge of the seat pan contacted the floor (Figure 7). The seat deformation was severe, occurring in the frame at the seat/pan hinge (Figure 8). The floor attachments to the pedestal remained intact. The side wall attachment brackets on the side frame of the seat separated at the weld seam, leaving the attachment on the side wall intact (Figure 8). The front-row seat cushions detached.

Figure 7. Experiment No. 1 – Front-Row Seat Pedestal Collapse and Seat Deformation

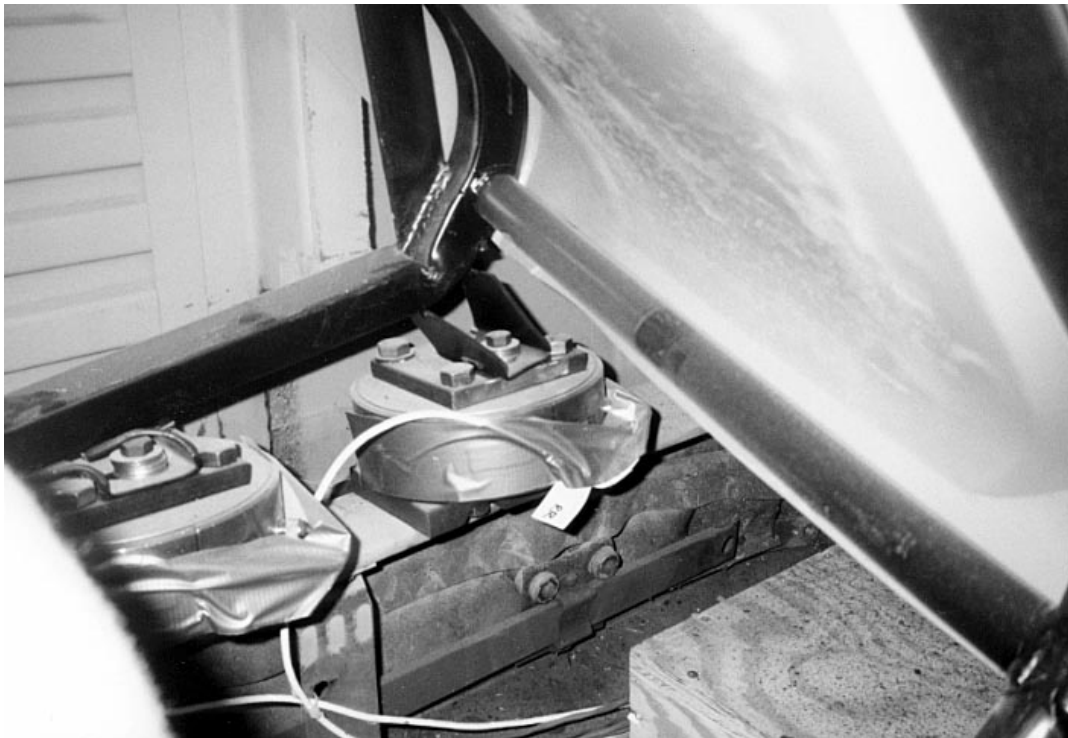
Figure 8. Experiment No. 1 – Front-Row Seat Frame Deformation and Weld Seam Failure

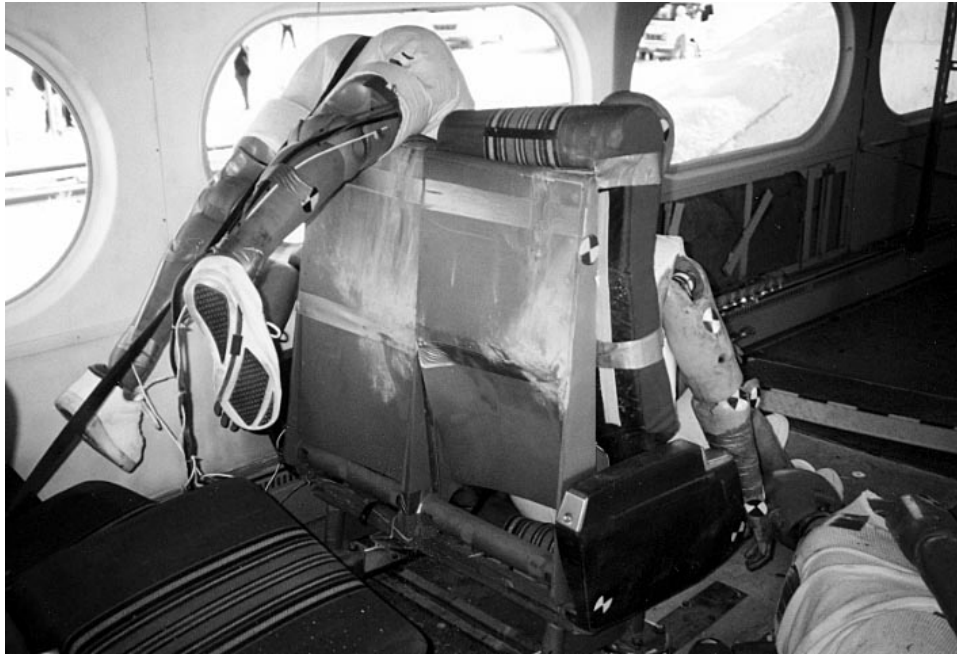
The forward motion of the front-seat back panel was somewhat controlled by the energy-absorbers at the seat back/pan hinge. The front-seat back panel appeared to deform under the impact load of the rear occupant's knees (Figure 10). The longitudinal metal bars to which the seat was attached were both severely deformed as a result of the load transferred to them from the seat (Figure 11). The modified seat performed exceptionally well under the circumstances. The seat frame and pedestals did not deform, so the seat can be easily refurbished with new seat backs for use in future testing.

Figure 9. Experiment No. 2 – ATD Not Compartmentalized

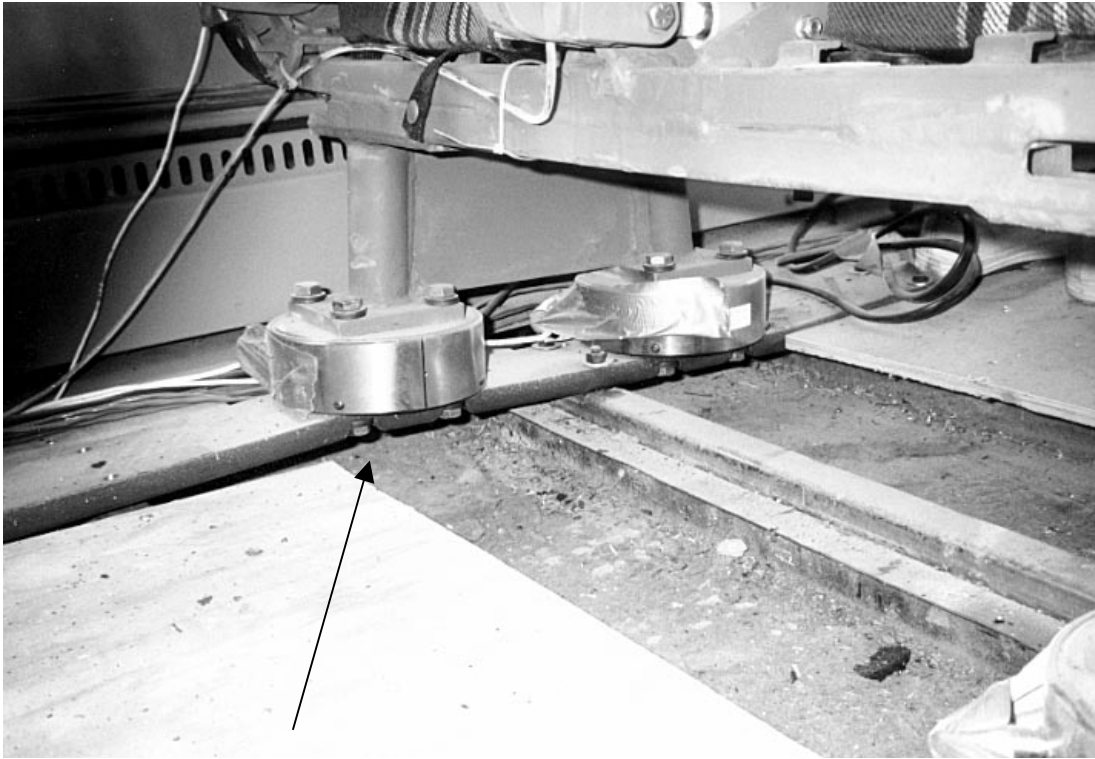
Figure 11. Experiment No. 2 – Metal Floor Attachment Bar Deformed Under Load

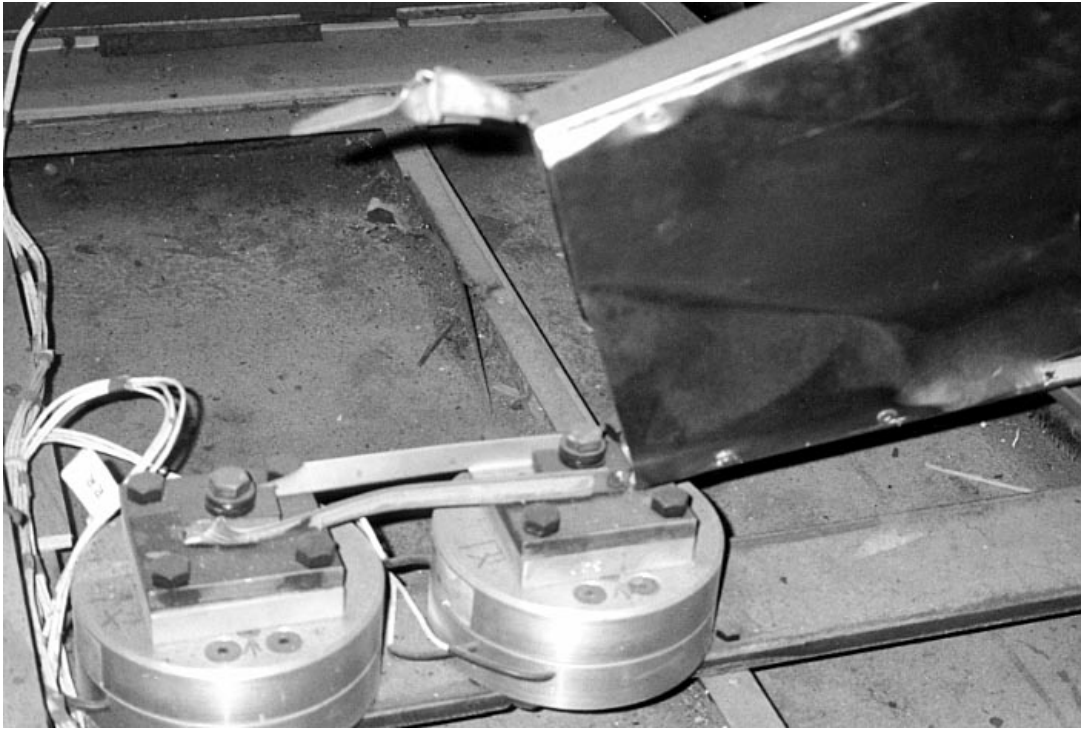
Gross failure of the seat pedestal and the attachment fittings allowed the seat to rotate backward (toward the impact direction), resulting in a loss of occupant compartmentalization. The 95th-percentile ATD in the aisle seat was instrumented and recorded a shear neck load that exceeded the injury criterion. It is likely that the 95th-percentile ATD in the aisle seat created a high moment about the pedestal and side wall attachment, causing increased rotation about these

The seat offered minimal resistance to the inertial loads; i.e., the pedestal was sheared off near the floor attachment at the aft end (Figure 12), while the bolts attaching the pedestal to the load cell mount remained intact. The pedestal failure caused the seat to rotate backward and failed the weld seams on the side wall mounts (Figure 13).

Figure 12. Experiment No. 3 – Seat Pedestal Sheared Near the Floor Attachment

attachments. Replacing the existing pedestal with a stronger pedestal and improving the weld at the side wall attachment should improve the seat’s attachment to the rail car.

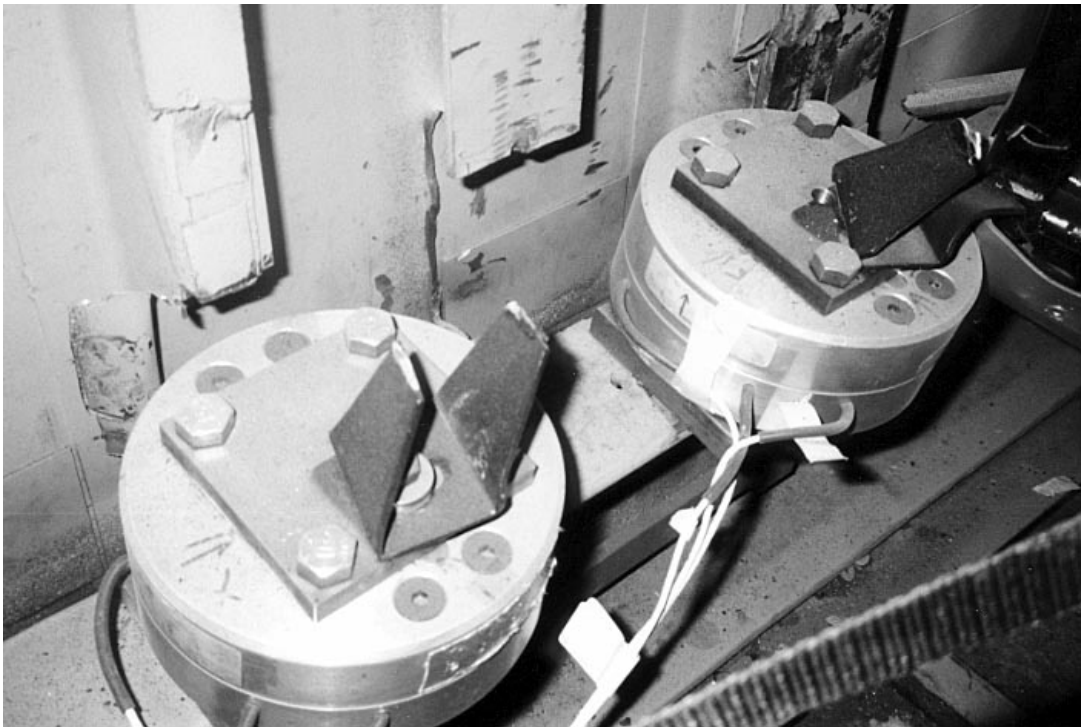
Figure 13. Experiment No. 3 – Failed Weld Seams at the Side Wall Mounts
