Freight Car Reflectorization

Safety of Highway-Railroad Grade Crossings

DOT/FRA/ORD-98/11
DOT-VNTSC-FRA-97-2

Final Report
January 1999

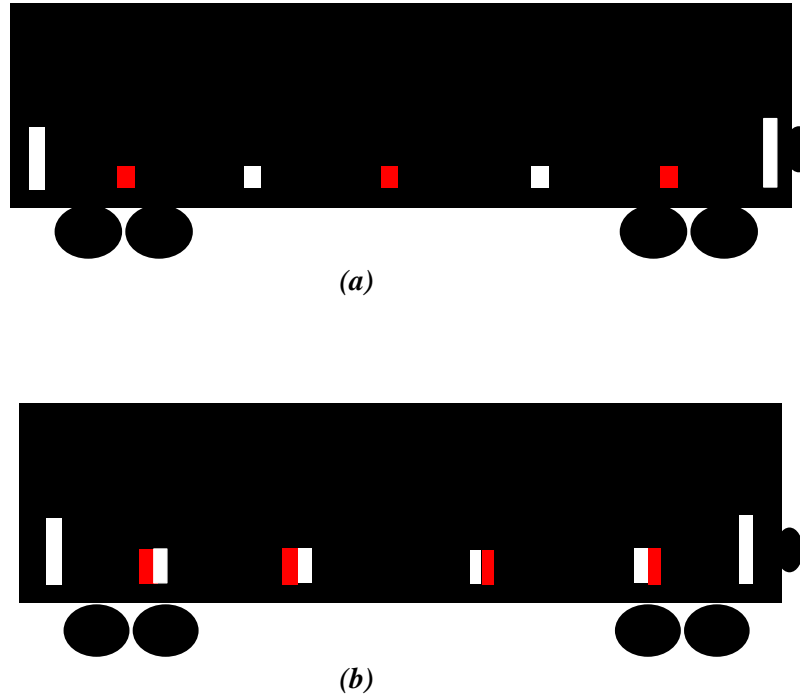
Both designs use red and white reflectors in combination, as suggested by the human factors recommendations, and are mounted vertically to permit an increase in their size. Figure ES-1(a) depicts a more conservative design than Figure ES-1(b) in terms of the amount of material required. Based on the suggested configuration, the cost of material and maintenance will not be significantly increased.

Figure ES-1. Suggested Improved Reflector Patterns on a Typical Freight Car

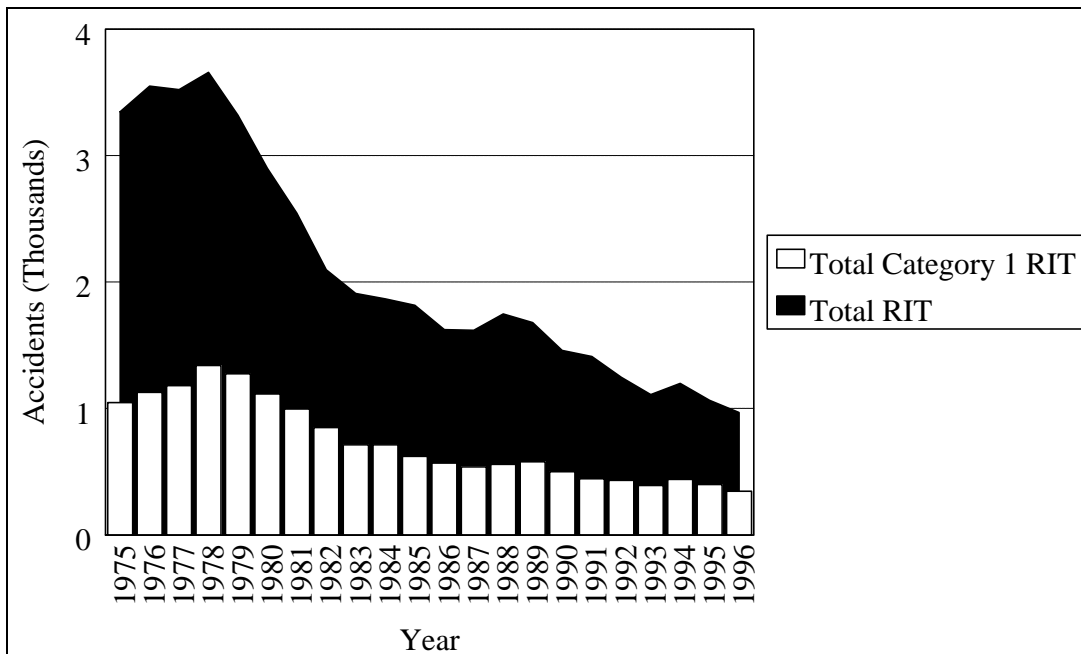
While all RIT accidents are *potentially* affected by reflectorization, those RIT accidents that result from the highway vehicle striking the train after the lead unit has entered the crossing are more likely preventable by reflectorization. Accidents involving the highway vehicle striking the train after the lead unit are referred to as Category 1 RIT accidents. Figure 1-3 shows the trend of Category 1 RIT accidents in relation to total RIT accidents. Category 1 RIT accidents represent an average of 35.4% of total RIT accidents and 9.2% of total crossing accidents.

Figure 1-3. Trend in Total Category 1 Accidents versus Total RIT Accidents (1975–1996)

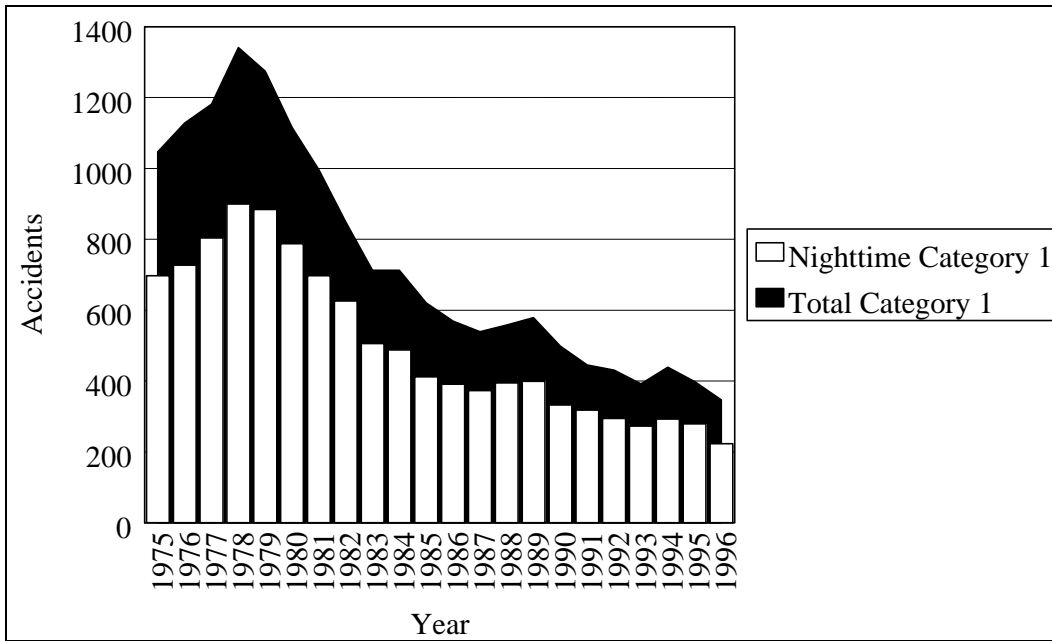
Reflectorization is assumed to be most effective in reducing nighttime Category 1 RIT accidents. Figure 1-4 shows the trend in nighttime versus total Category 1 RIT accidents. Nighttime Category 1 accidents represent an average of 69.7% of Category 1 RIT accidents and 6.4% of total crossing accidents. As can be noted from these statistics, the frequency of nighttime Category 1 RIT accidents is significantly greater than the daytime frequency, in spite of a generally lower volume of highway traffic at night. This strongly supports the assumption that nighttime driving and the resulting diminished visibility of trains is a contributing factor to RIT accidents.

Figure 1-4. Trend in Nighttime Category 1 RIT Accidents versus Total Category 1 RIT Accidents (1975–1996)

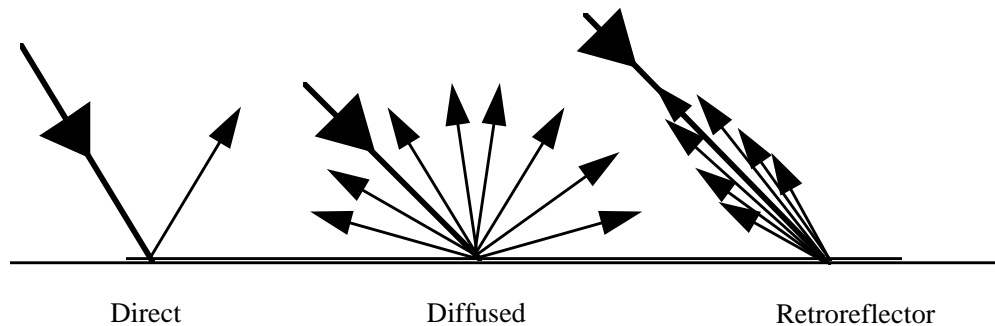
Retroreflectors, as the name implies, direct the reflected light in the general direction of the light source. Retroreflectors are used on items such as trucks, automobiles, bicycles, and roadway signs. The American Society for Testing and Materials (ASTM) defines retroreflection as “reflection in which radiation is returned in directions close to the direction from which it came, this property being maintained over wide variations of the direction of the incident (source) radiation” (ASTM 1981).

Figure 2-1. Types of Reflectors

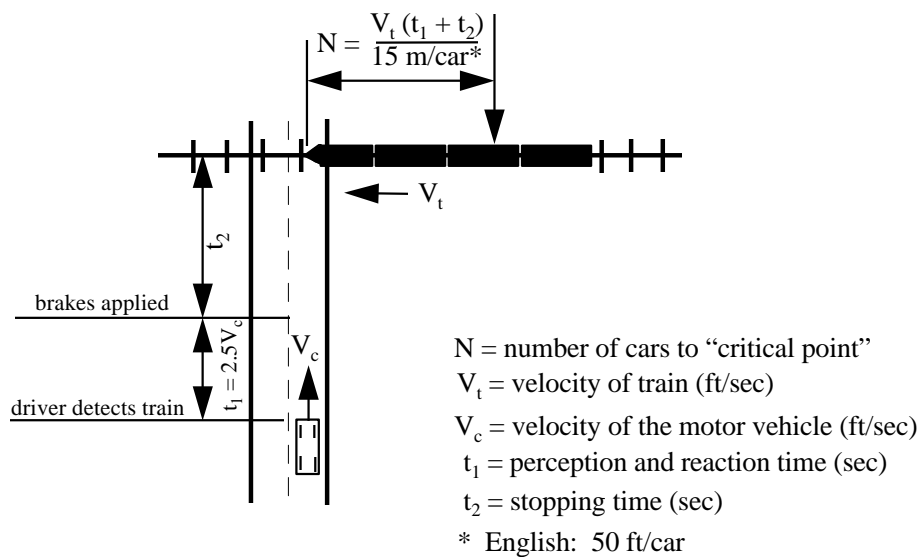
McGinnis (1979) conducted a study that determined the type of railroad crossing accident that would benefit from reflectorization. McGinnis obtained his data from the 1975 FRA Grade Crossing Accident file (now called the RAIRS database). These 12,000 reports were categorized relative to a “critical point.” McGinnis provided a relationship between vehicle stopping distance and a critical point on the train. The determination of the “critical point” is based on variables such as the speed of the train, the speed of the vehicle, and the pavement conditions (see Figure 3-1). In summary, the critical point is the location on the train where a vehicle strikes it, and indicates the accident could have been avoided had its presence been detected. The McGinnis research assigned the accidents to four categories. Category 1 accidents occur when the motor vehicle runs into the side of the train after a “critical point” beyond the lead unit. Category 2 accidents occur when the motor vehicle hits the side of the lead unit of the train. Category 3 accidents occur when the motor vehicle hits the side of the train before the critical point of the train is reached. Category 4 accidents occur when the motor vehicle is hit by the train. Many accidents classified as Category 1 were those that could have been avoided if the driver could have stopped safely, having visually detected the train’s presence.

Figure 3-1. Relationship between “Critical Point” on Train and Perception/Reaction and Stopping

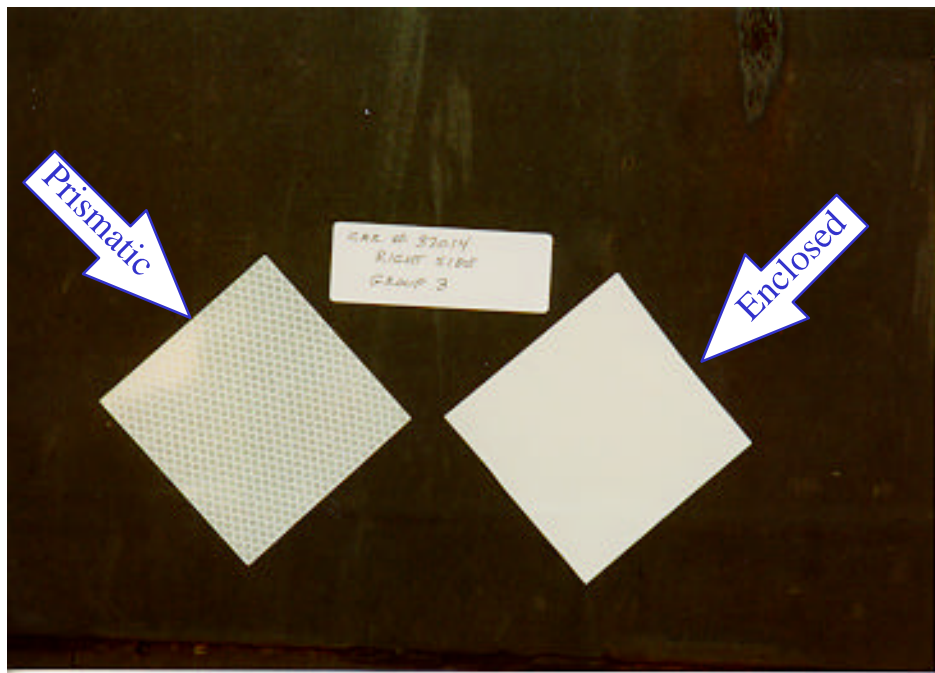
Figure 4-2. Full and Close-Up Views of Prismatic and Enclosed Lens Materials

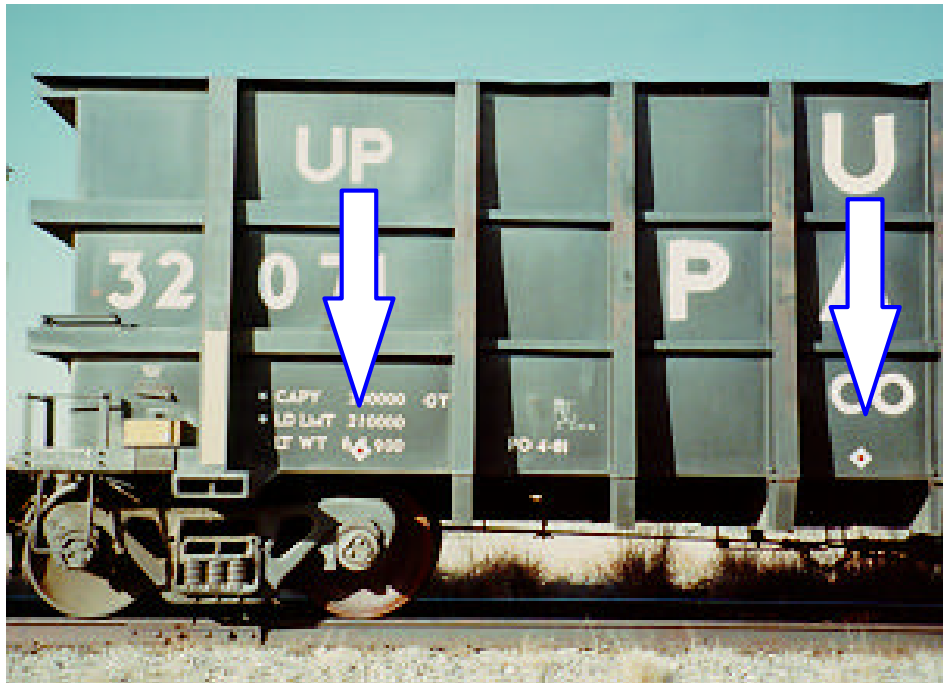
Figure 4-7. Full and Close-Up Views of Red-on-White Diamonds

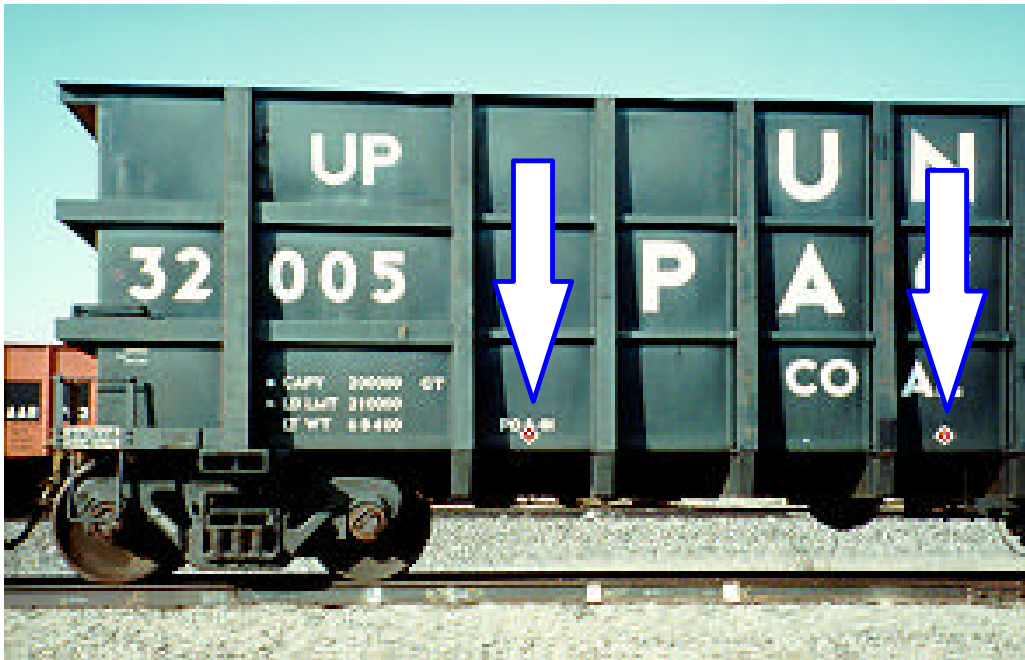
Figure 4-8. Full and Close-Up Views of White-Red-White Diamonds

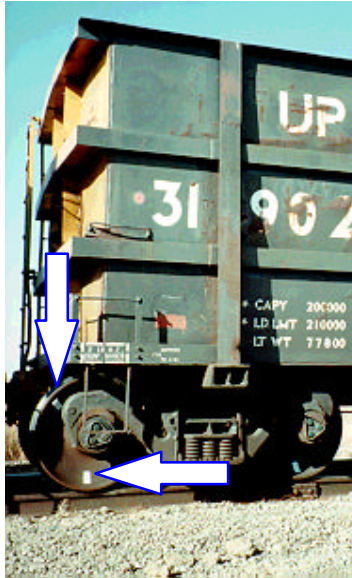
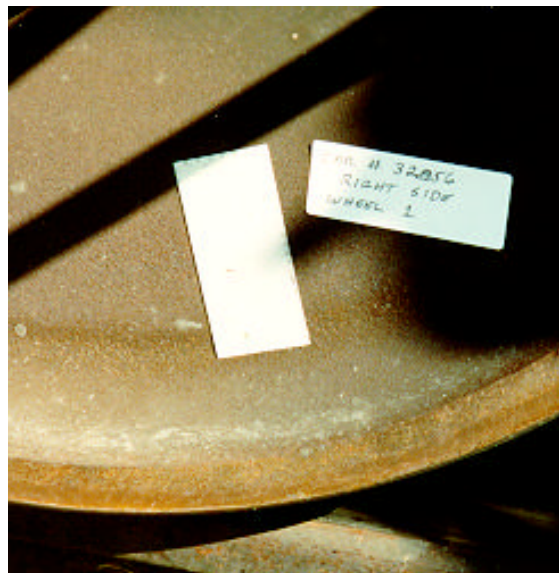
Five of the freight cars had 2 or 3 prismatic type decals, each 4 inches by 2 inches, located on each wheel plate at either a 90-, 120- (see Figure 4-9), or 180-degree separation. The decals were white, red, or a combination of both.

Figure 4-9. Full and Close-Up Views of White Wheel Plate Decals at 120-Degree Spacing

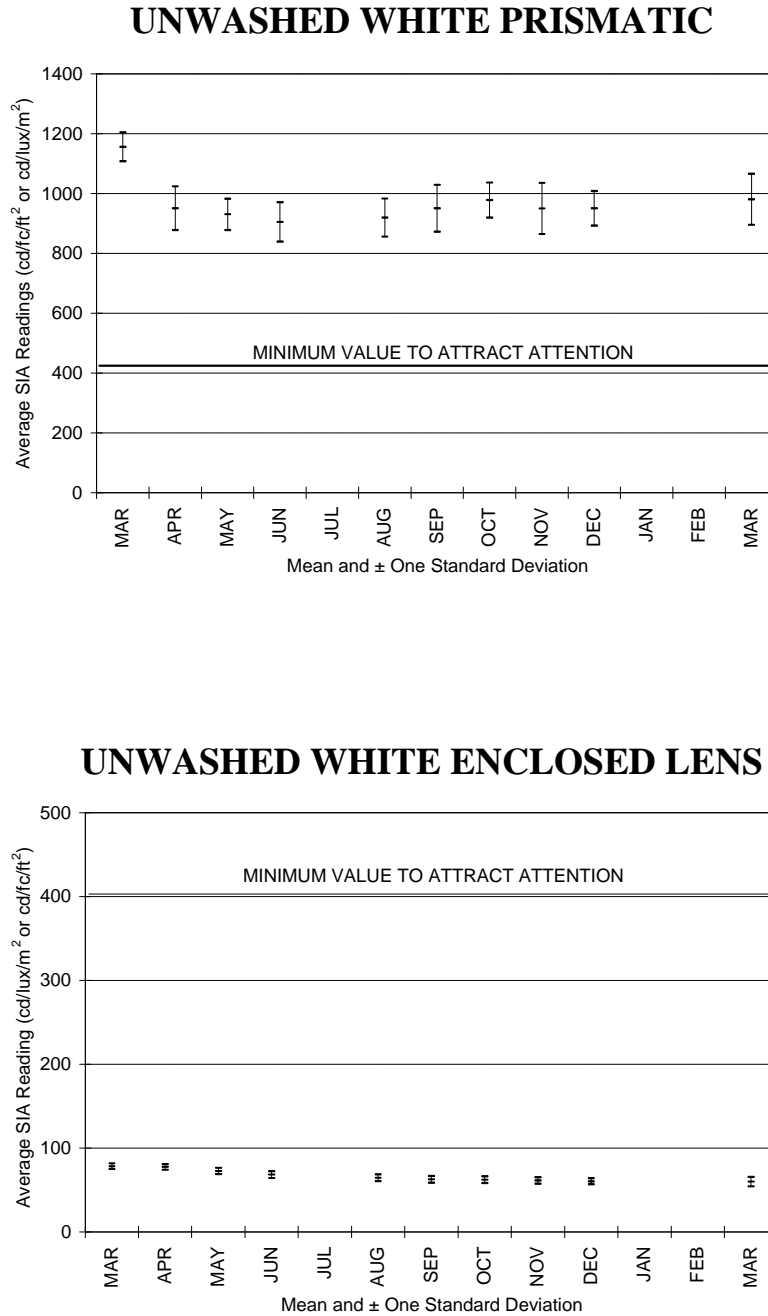
From the data presented in Figures 4-11 and 4-12, it is obvious that the white prismatic material has a much higher SIA value or coefficient of retroreflection than the older encapsulated lens type, which was used in the 1982 tests.

Figure 4-11. Unwashed Prismatic vs. Unwashed Enclosed Lens (Mean and One Standard Deviation)

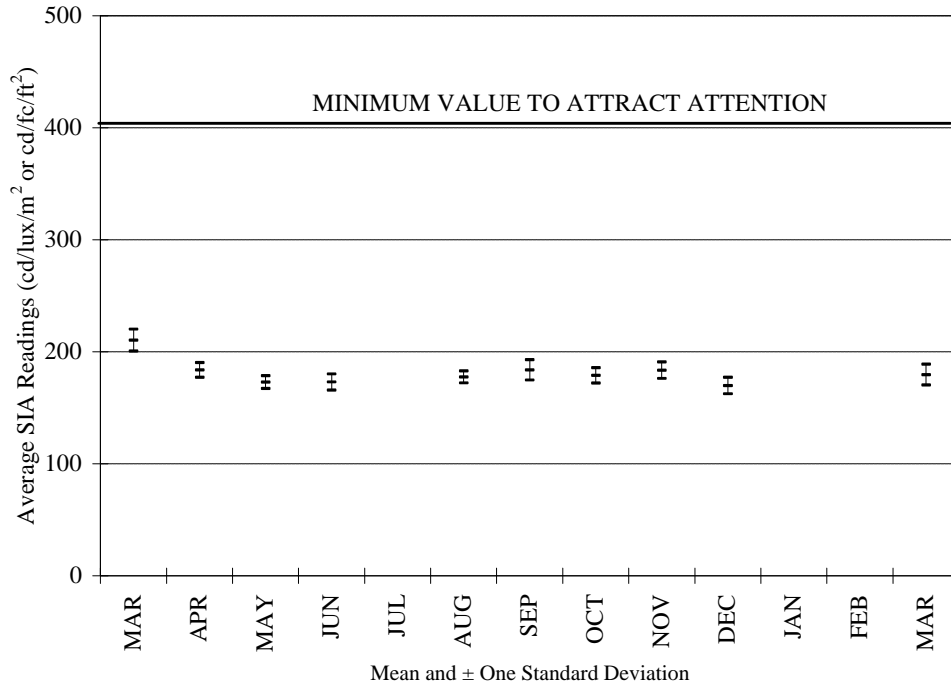
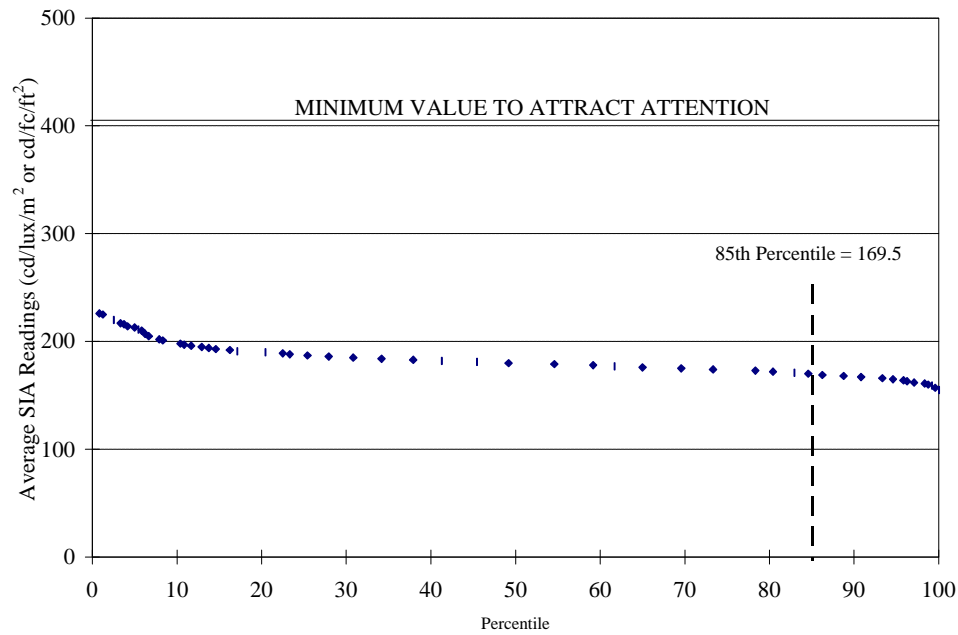
Figure 4-13. Unwashed Red Prismatic (Mean and One Standard Deviation and Percentiles)

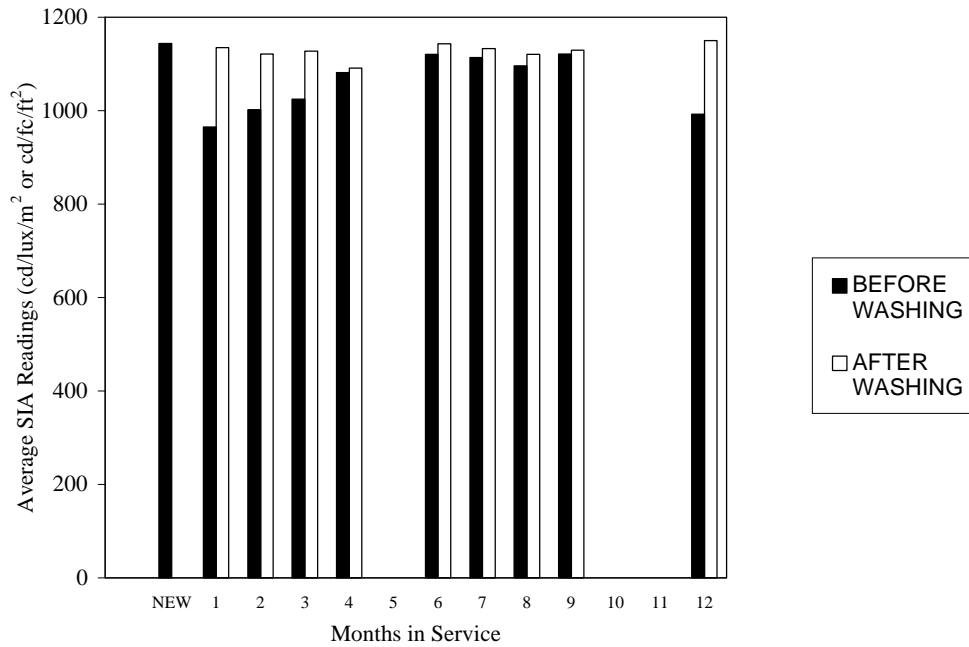
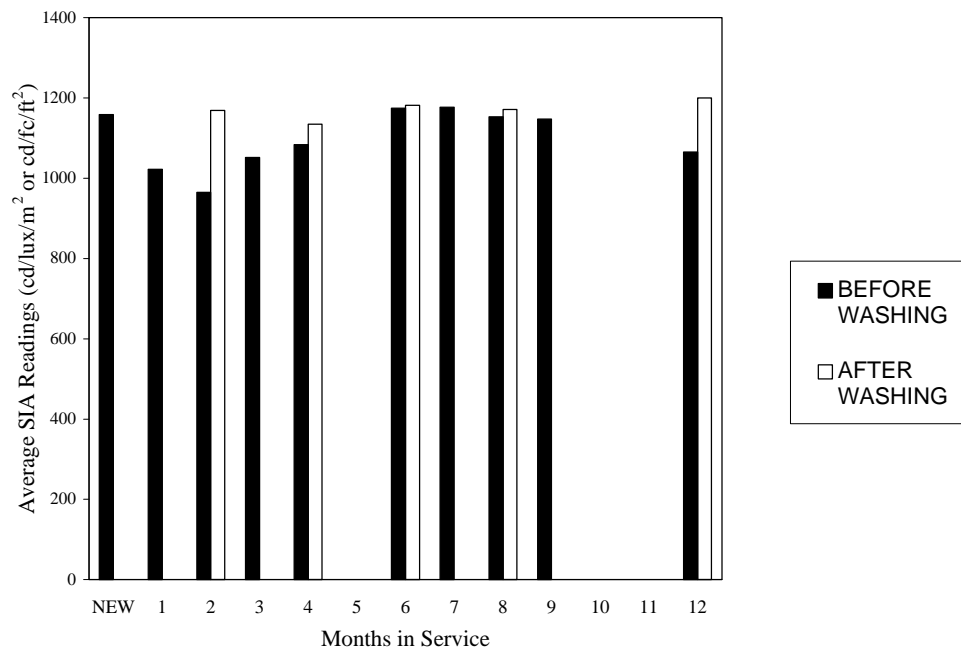
Figure 4-15. SIA of Prismatic Decals with One- and Two-Month Washing Cycles

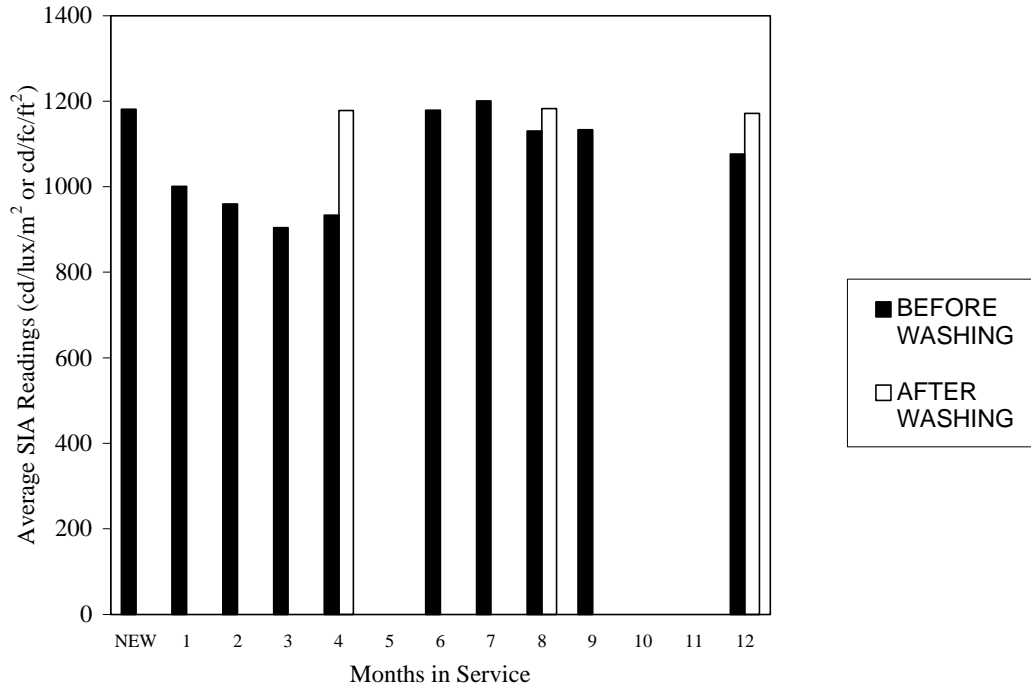
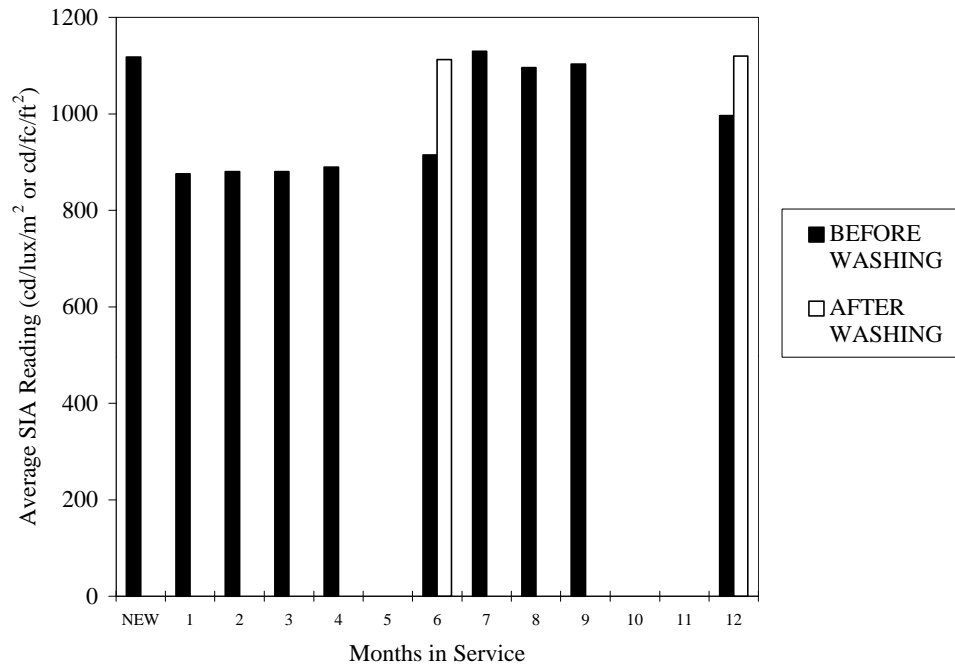
Figure 4-16. SIA of Decals with Four- and Six-Month Washing Cycles

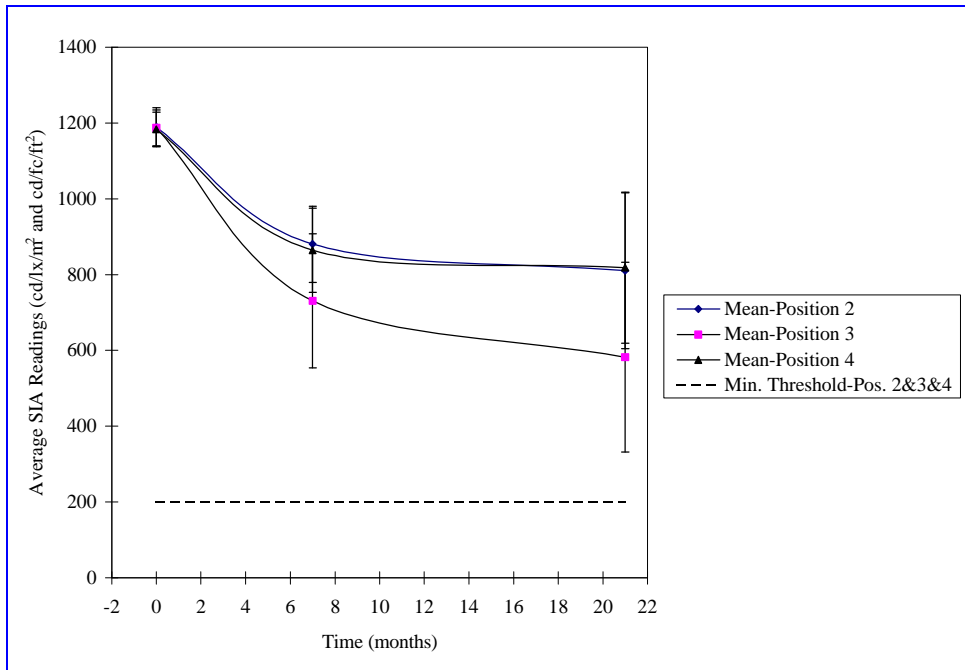
Figure 5-1. Alaska Tank Cars – Degradation of Positions 2, 3, and 4

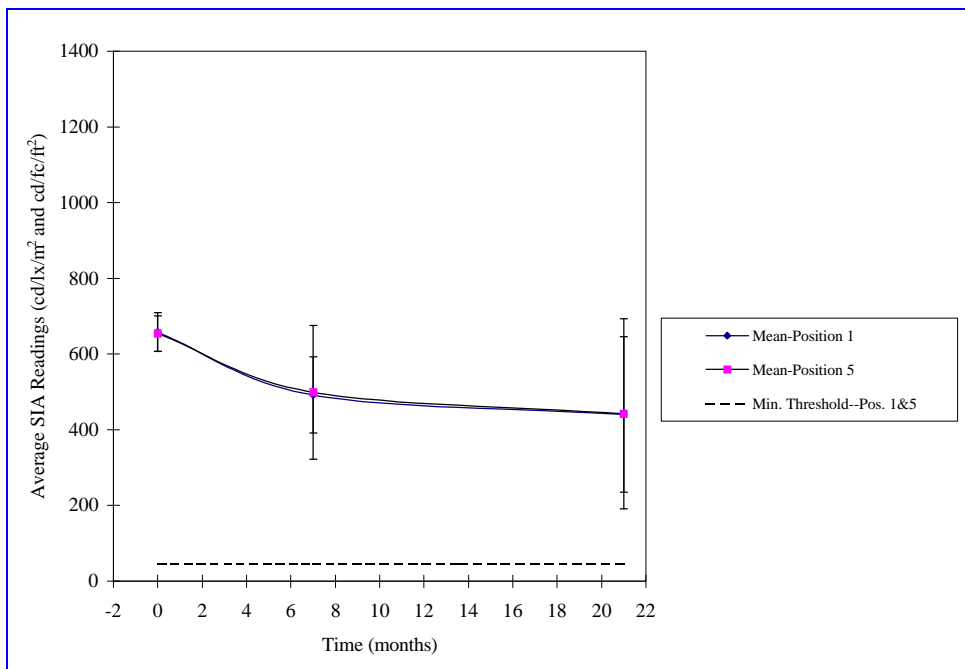
Figure 5-2. Alaska Tank Cars – Degradation of Positions 1 and 5

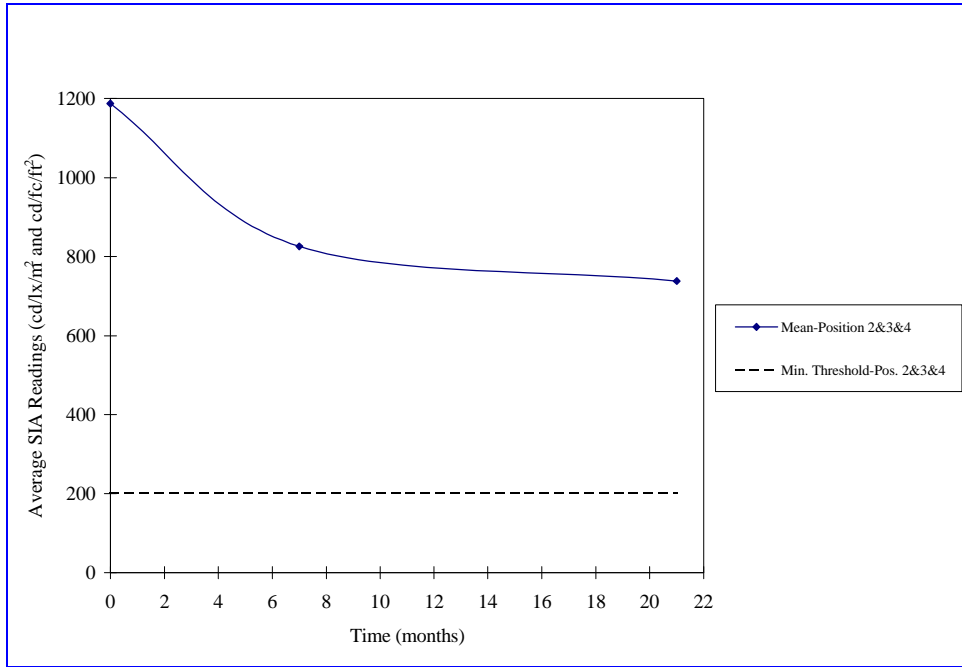
Figure 5-3. Alaska Tank Cars – Mean Degradation Trend for Positions 2, 3, and 4

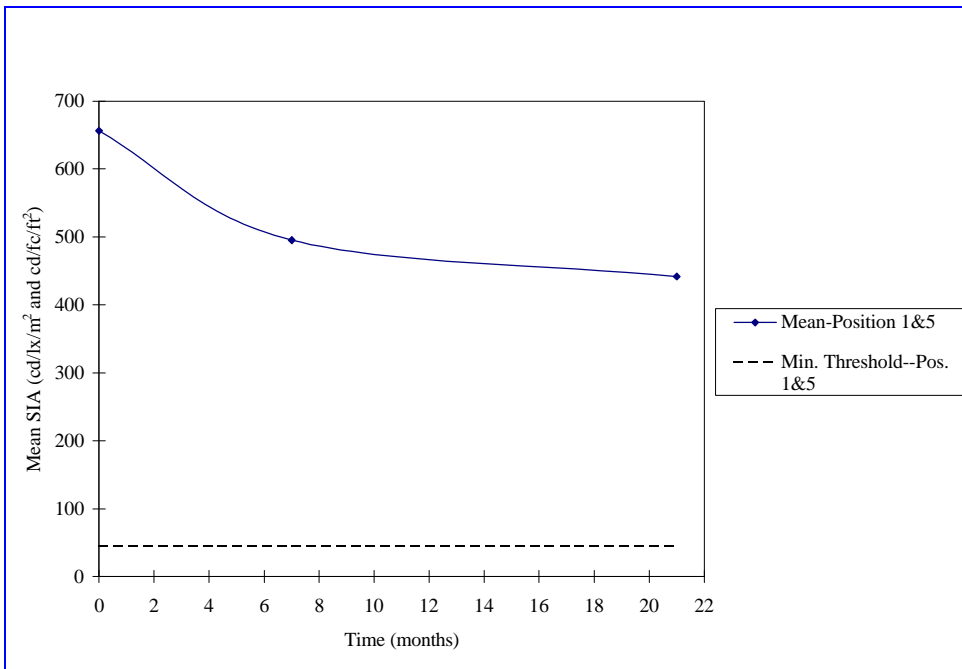
Figure 5-4. Alaska Tank Cars – Mean Degradation Trend for Positions 1 and 5

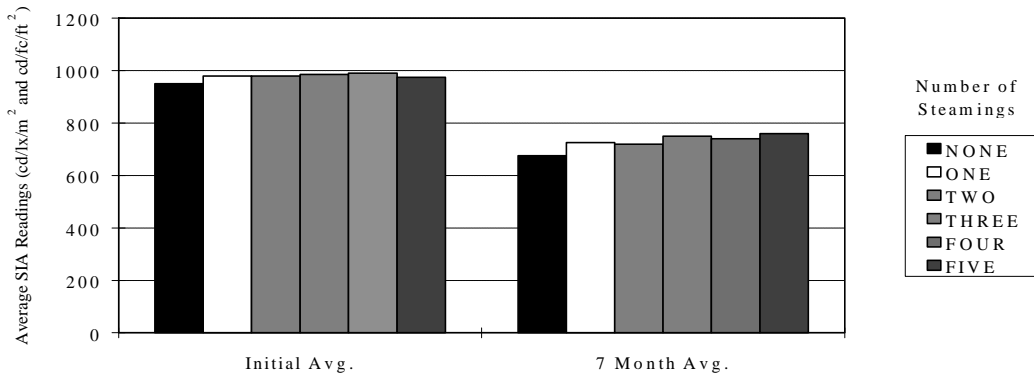
Natural Environmental and Operational Effects. The natural environmental conditions in the State of Alaska can be severe, but no effects on the reflectors' brightness have been indicated. As noted by the degradation rate figures, the reflectors placed in a position where they may encounter gasoline products (i.e., under the filler cap, which is located at Position 3 in Figure 5-1) degraded more rapidly than the others did. Another effect that has been noted for the Alaska tank cars is the response of the reflectors to internal steam cleaning of the tank cars. Figure 5-5 shows the SIA values for tank cars (initially and after 7 months) that have been steamed cleaned. Figure 5-6 indicates an 8% increase in the reflector intensities after 21 months between tank cars not steamed and tank cars steamed 5 times.

Figure 5-5. Seven-Month SIA Readings for Tank Cars

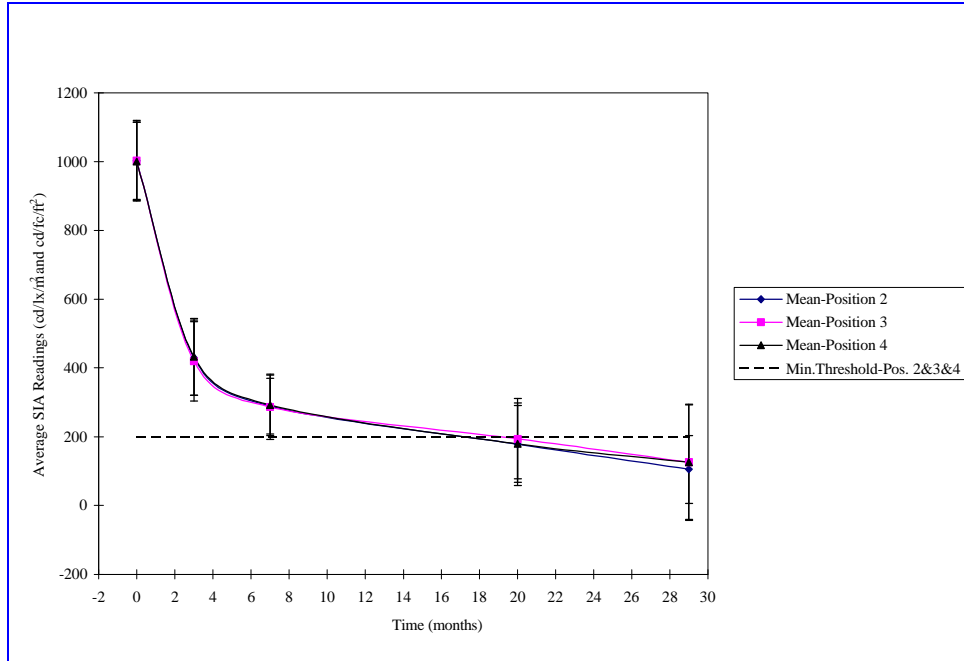
Figure 5-7. NS Double Stack Cars – Degradation of Positions 2, 3, and 4

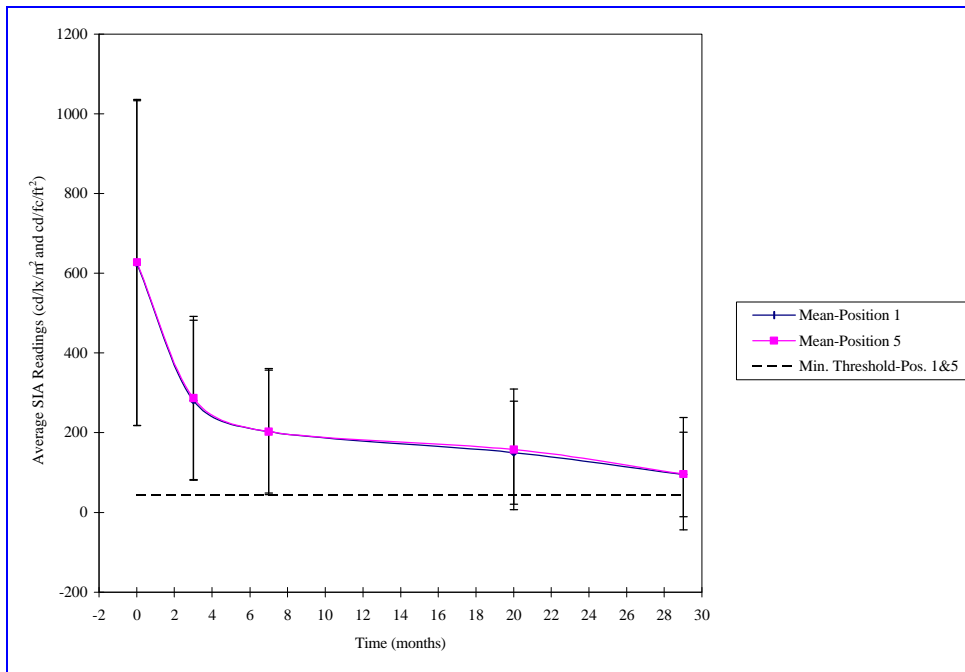
Figure 5-8. NS Double Stack Cars – Degradation of Positions 1 and 5

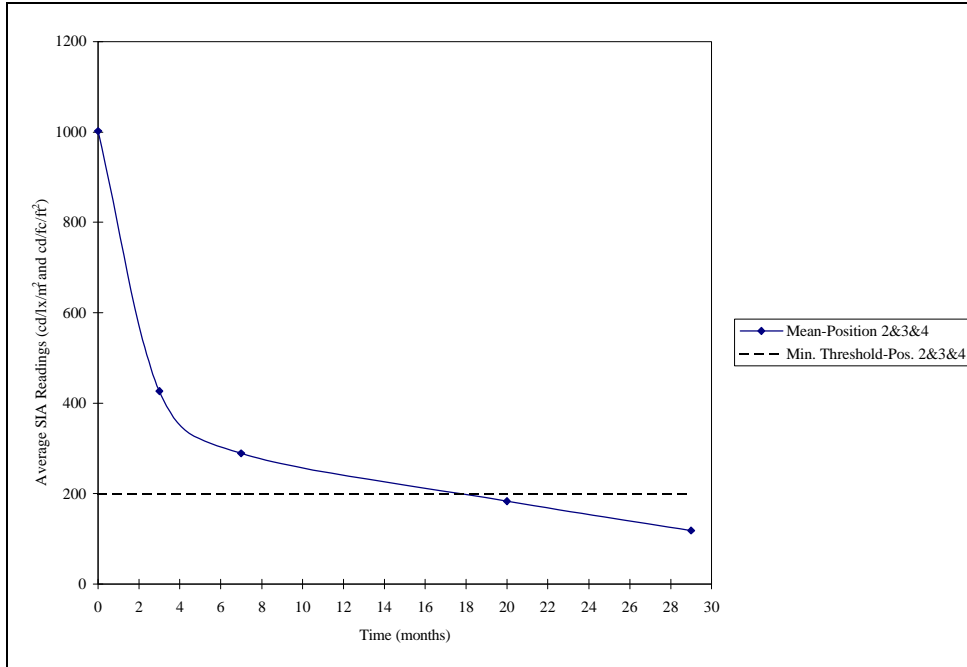
Figure 5-9. NS Double Stack Cars – Mean Degradation Trend for Positions 2, 3, and 4

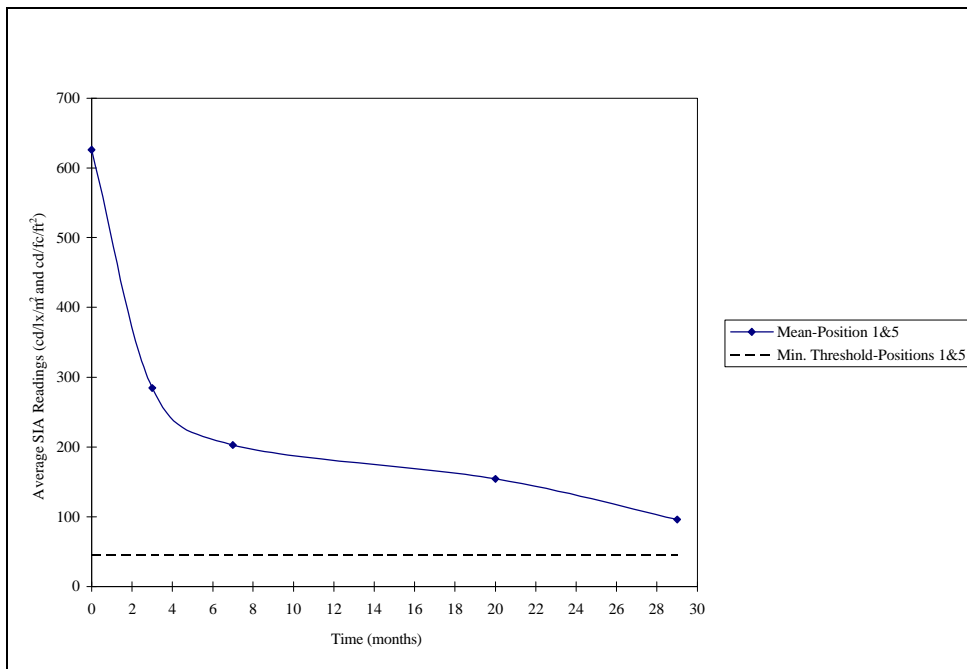
Figure 5-10. NS Double Stack Cars – Mean Degradation Trend for Positions 1 and 5

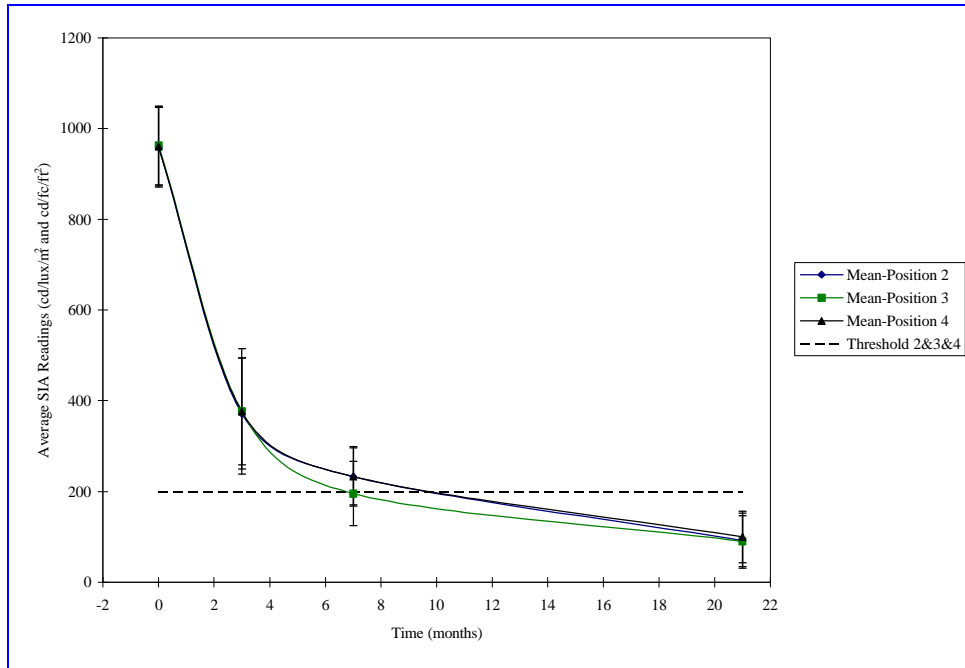
severe degradation rate of all the fleets tested. Based on the sharp decline of Positions 2, 3, and 4 in less than 6 months, it is suggested a reflector should not be placed under the sill level.

Figure 5-11. NS Hopper Cars – Degradation of Positions 2, 3, and 4

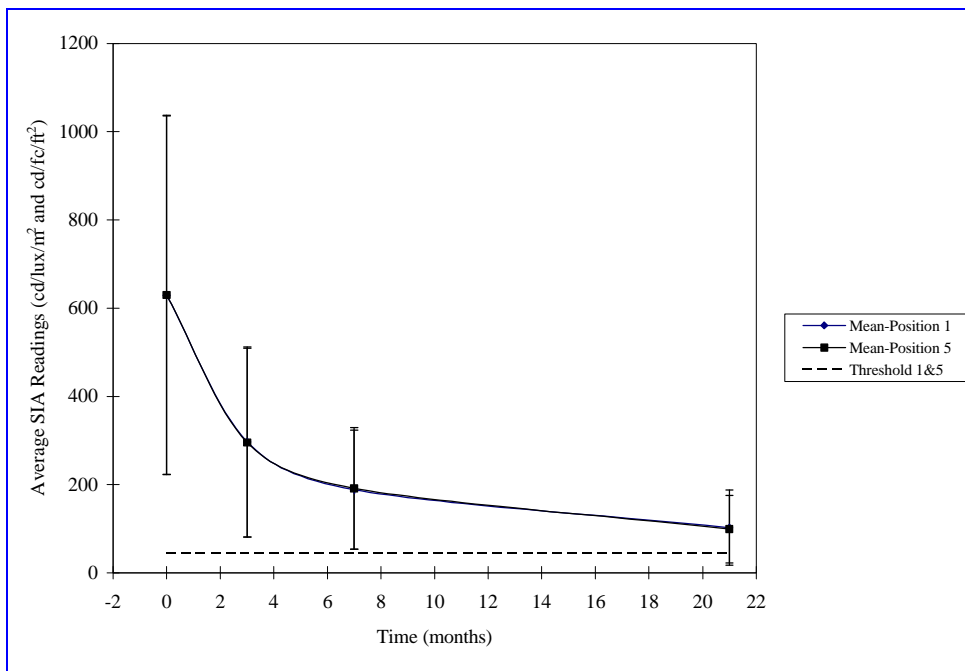
Figure 5-12. NS Hopper Cars – Degradation of Positions 1 and 5

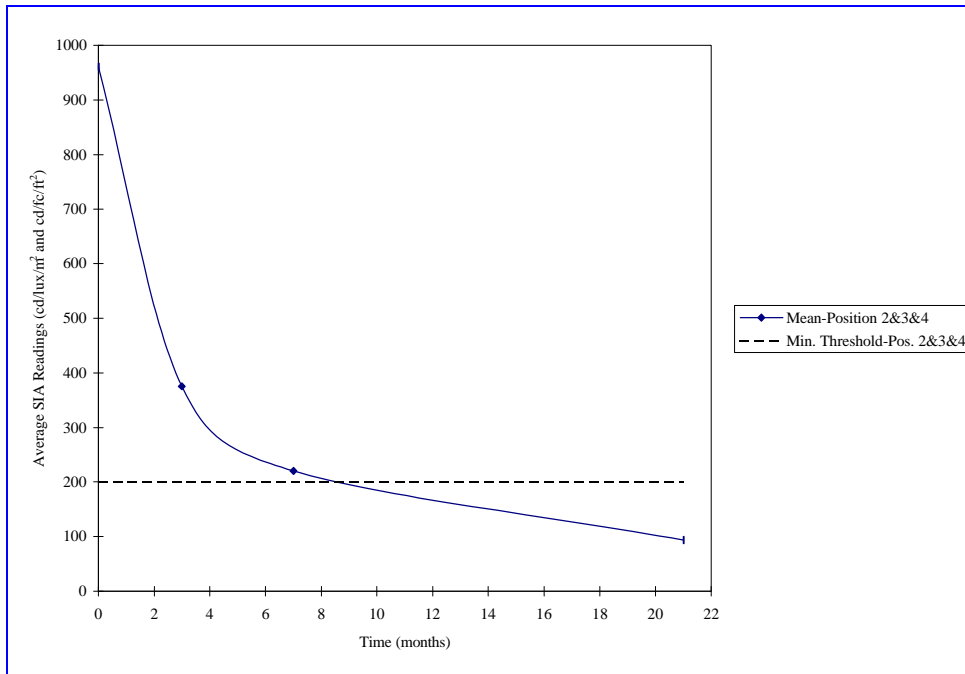
Figure 5-13. NS Hopper Cars – Mean Degradation Trend for Positions 2, 3, and 4

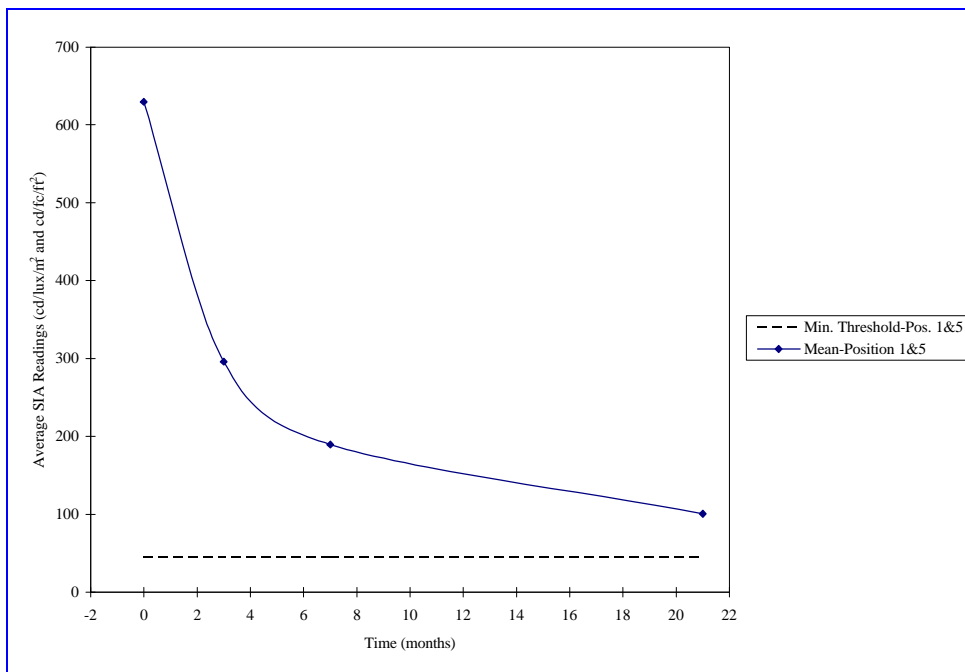
Figure 5-14. NS Hopper Cars – Mean Degradation Trend for Positions 1 and 5

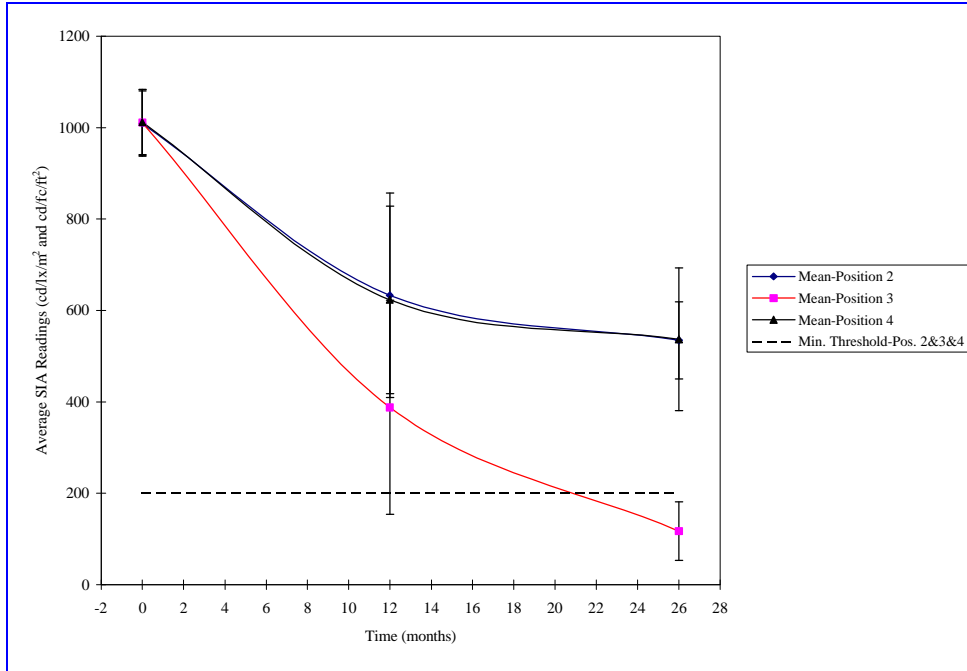
Figure 5-15. NS Box Cars – Degradation of Positions 2, 3, and 4

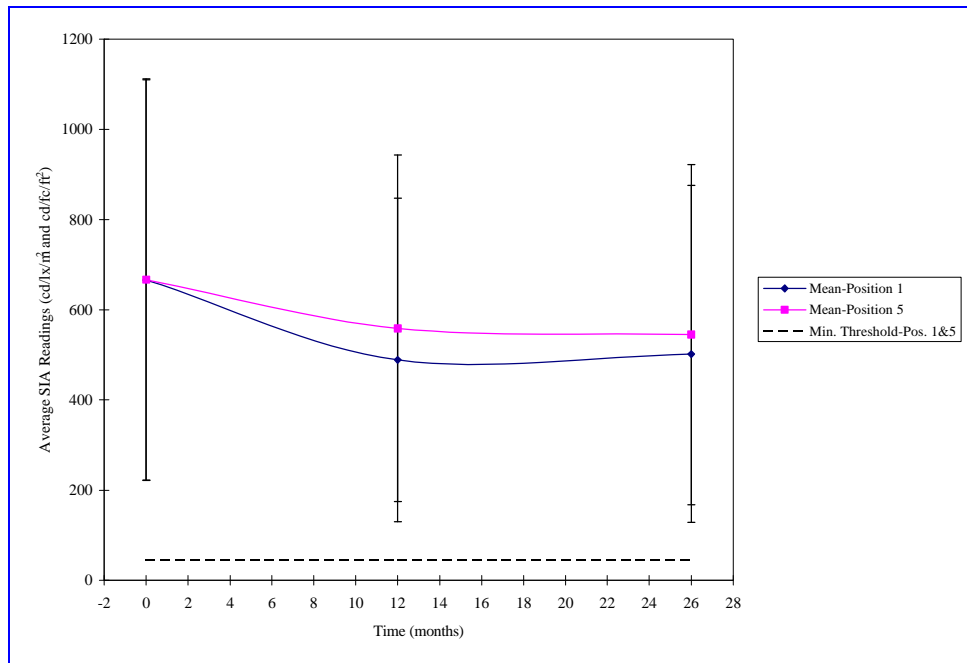
Figure 5-16. NS Box Cars – Degradation of Positions 1 and 5

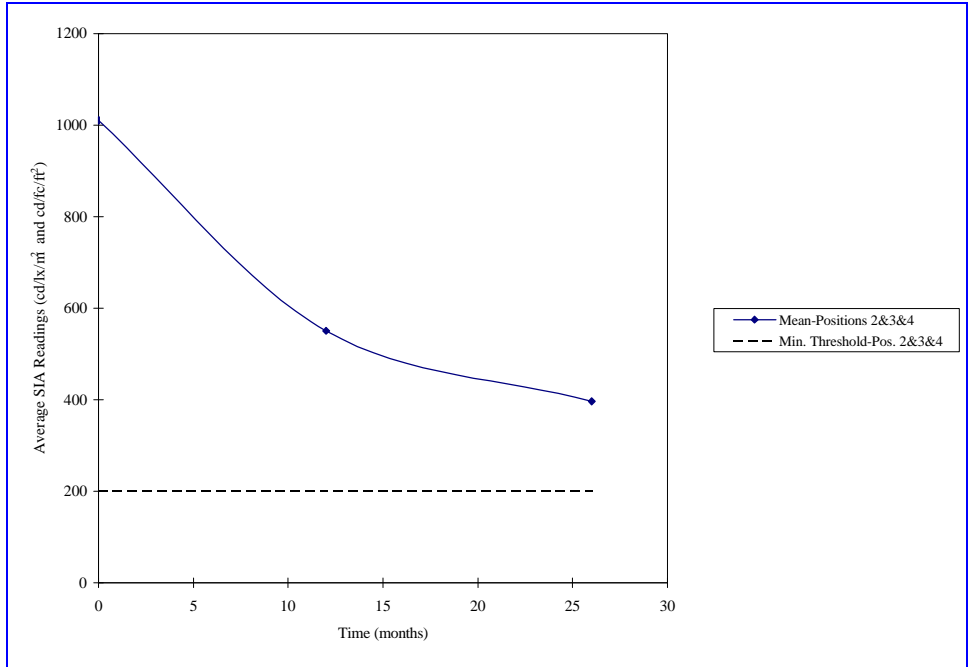
Figure 5-17. NS Box Cars – Mean Degradation Trend for Positions 2, 3, and 4

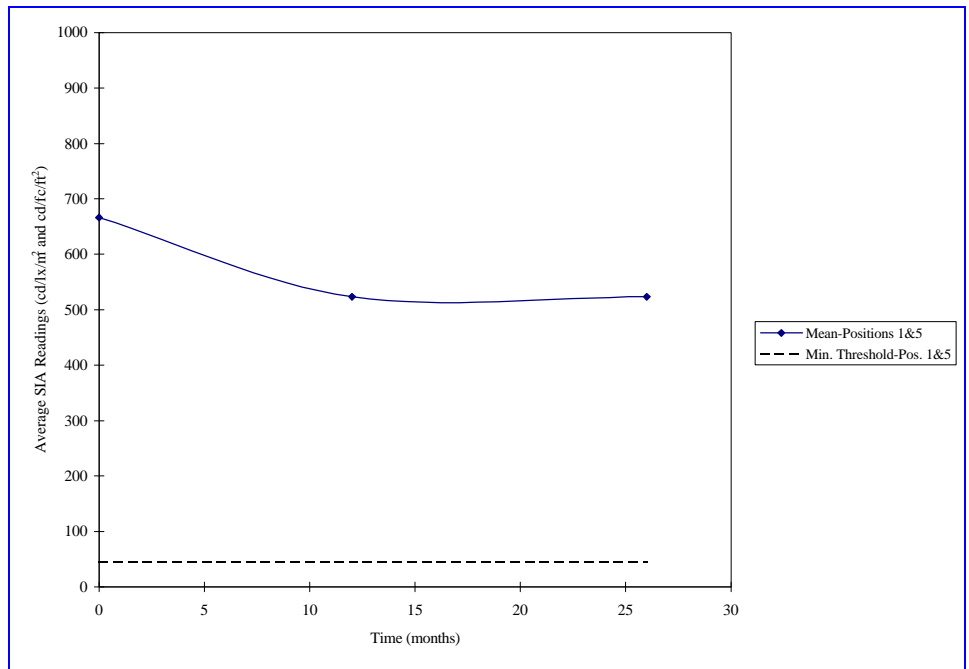
Figure 5-18. NS Box Cars – Mean Degradation Trend for Positions 1 and 5
