Freight Car Reflectorization

Safety of Highway-Railroad Grade Crossings

DOT/FRA/ORD-98/11
DOT-VNTSC-FRA-97-2

Final Report
January 1999

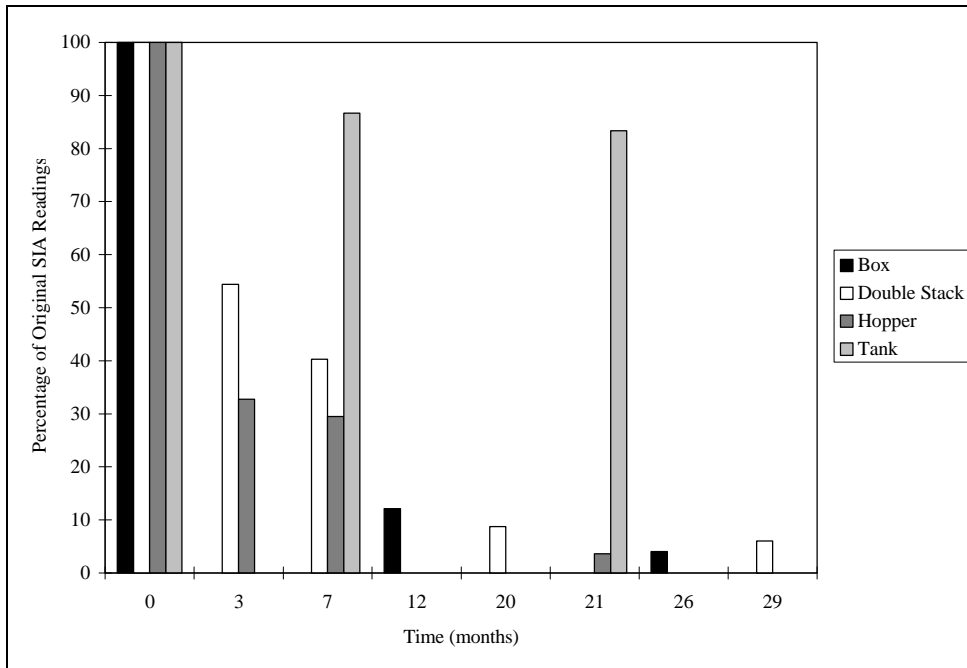
Figure 5-19. Comparative Degradation Rates for All Freight Car Types in Positions 1 and 5

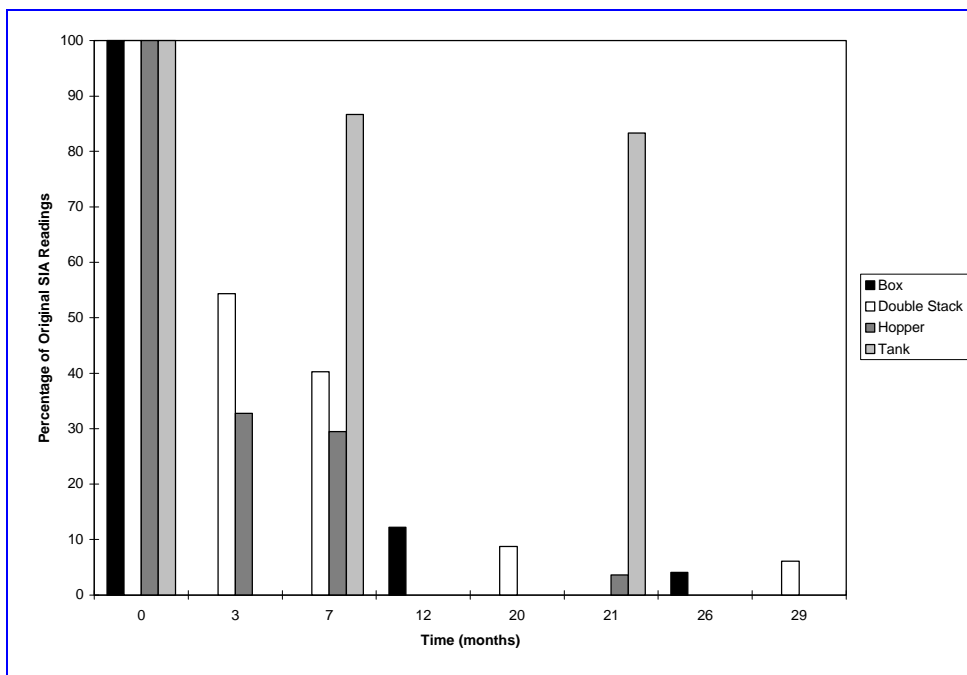
Figure 5-20. Comparative Degradation Rates for All Freight Car Types in Position 2

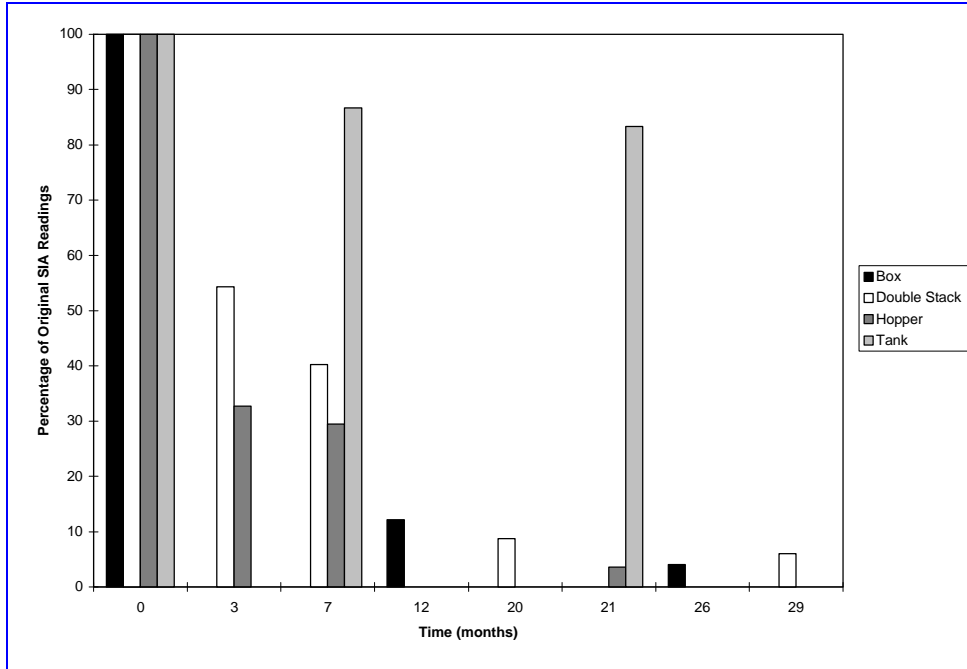
Figure 5-21. Comparative Degradation Rates for All Freight Car Types in Position 3

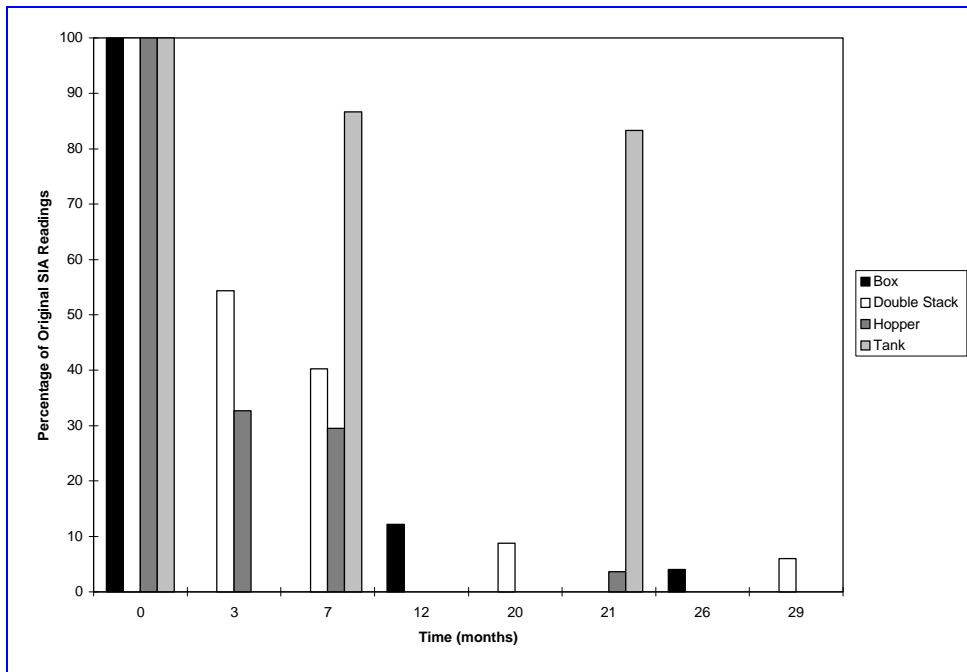
Figure 5-22. Comparative Degradation Rates for All Freight Car Types in Position 4

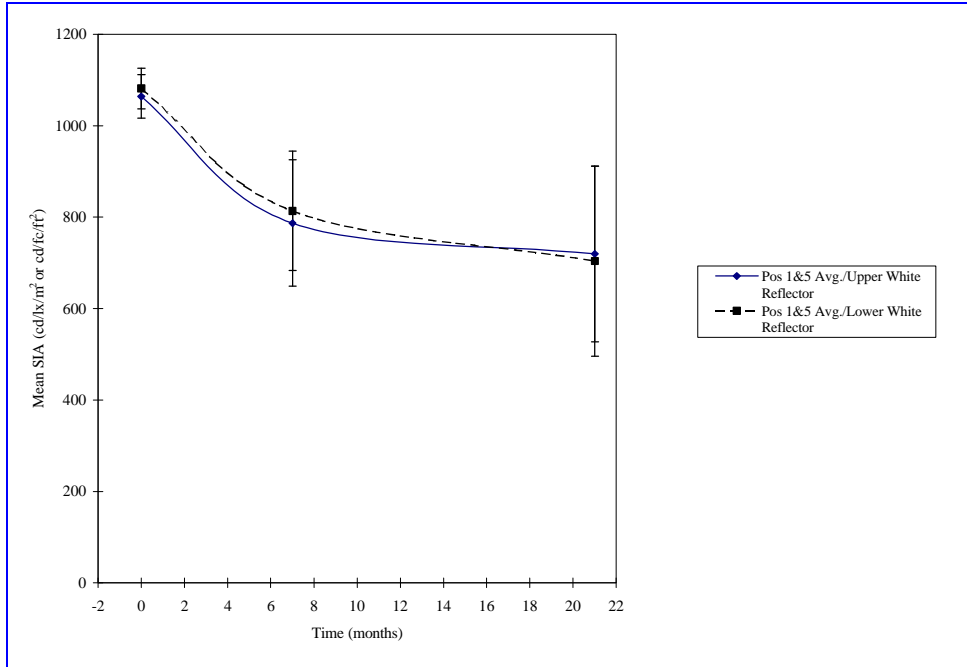
Figure 5-23. Tank Car – Upper and Lower White Reflector Degradation Rates

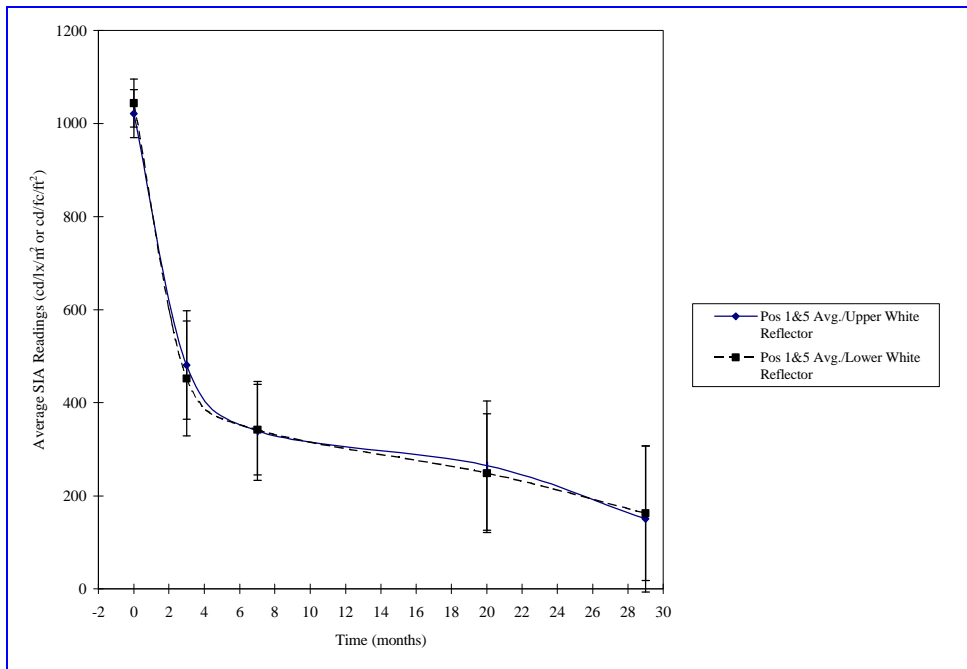
Figure 5-24. Double Stack Car – Upper and Lower White Reflector Degradation Rates

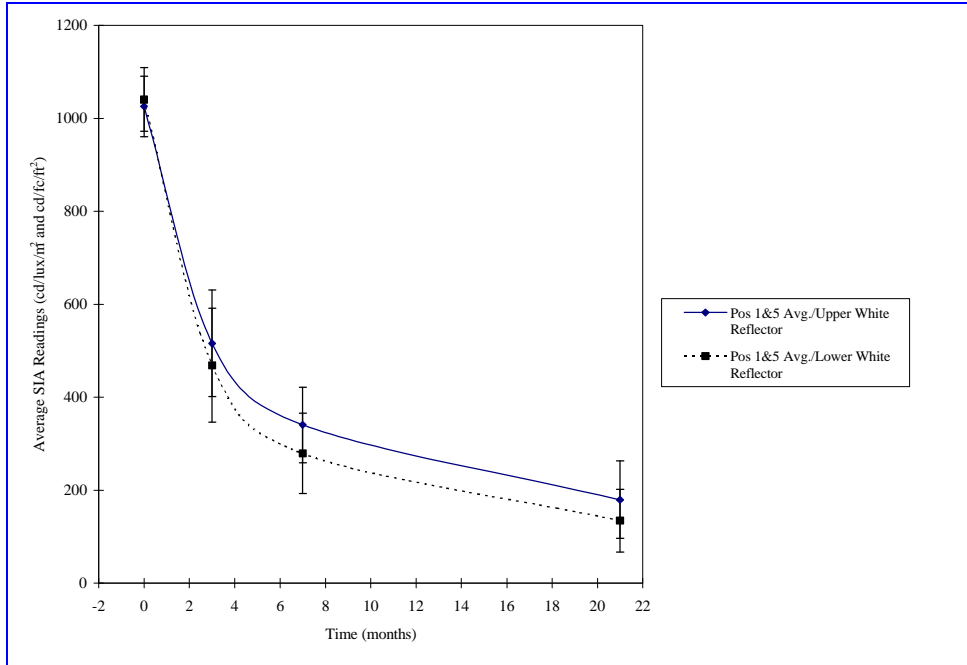
Figure 5-25. Hopper Car – Upper and Lower White Reflector Degradation Rates

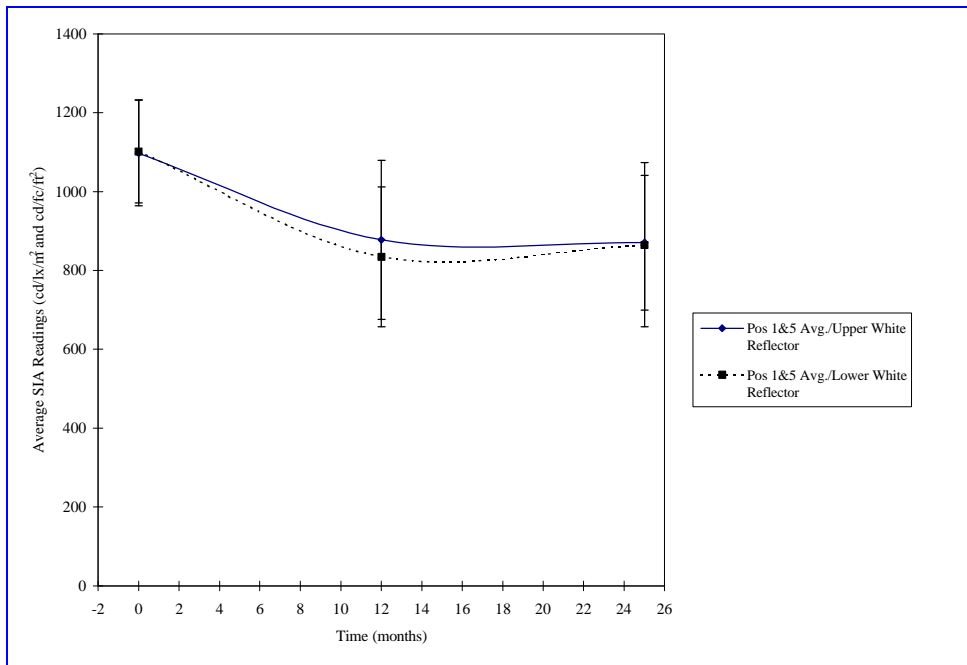
Figure 5-26. Box Car – Upper and Lower White Reflector Degradation Rates

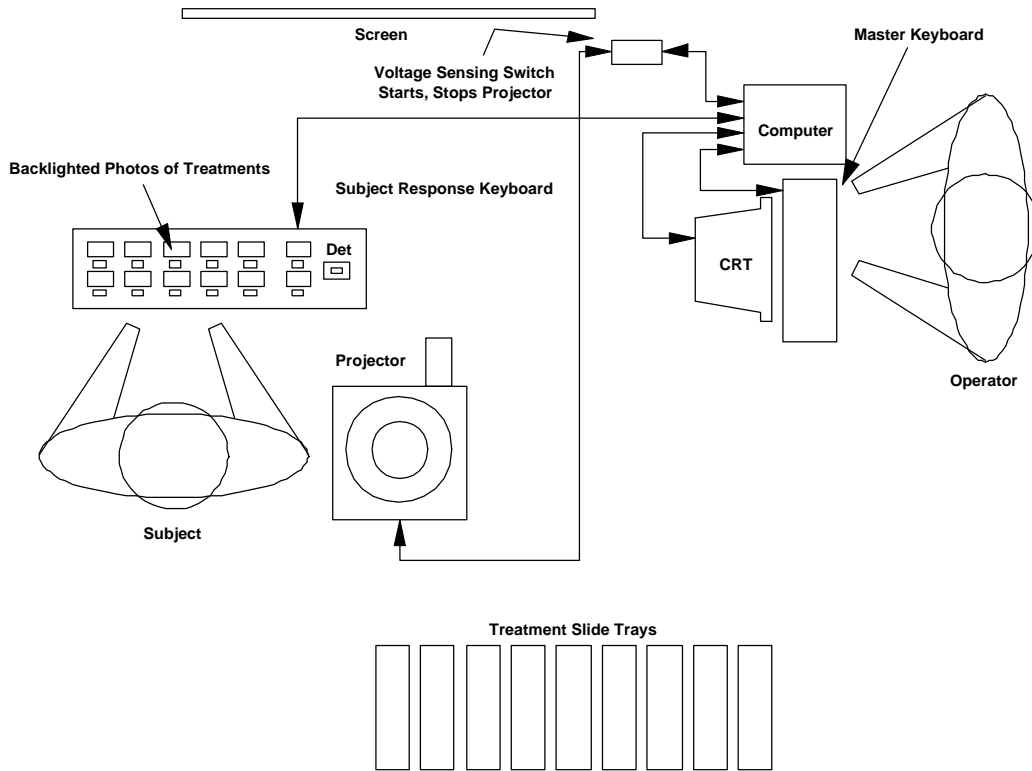
Apparatus. The experiment was conducted in a windowless room, where the ambient light level could be controlled. The presentation of the slides and the recording of the subject's responses was accomplished using an IBM Personal System/2, Model 50 microcomputer coupled to a Kodak model 4600 autofocus slide projector with an f/3.5 102 to 152 mm zoom lens. A special backlighted 12-key control panel was used to input the subjects' responses, and a standard keyboard was used by the laboratory assistant to control the experiment. A diagram of the system setup is shown in Figure 6-4, and the special keyboard is shown in Figure 6-5.

Figure 6-4. Layout of Experiment

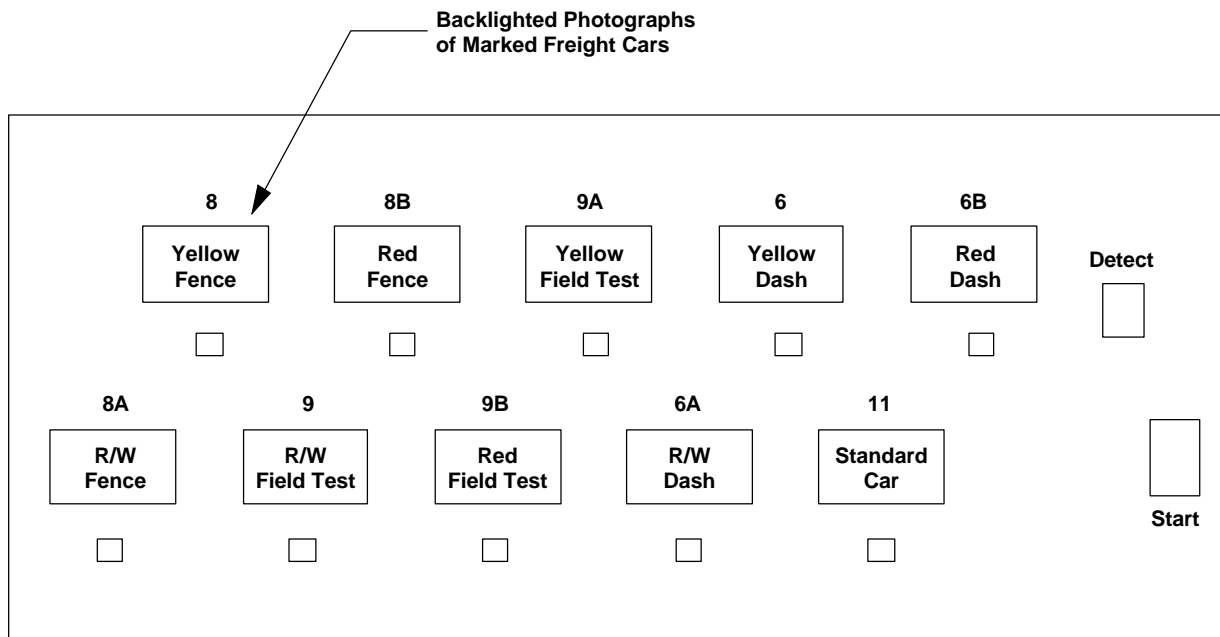
Figure 6-5. Keyboard Arrangement

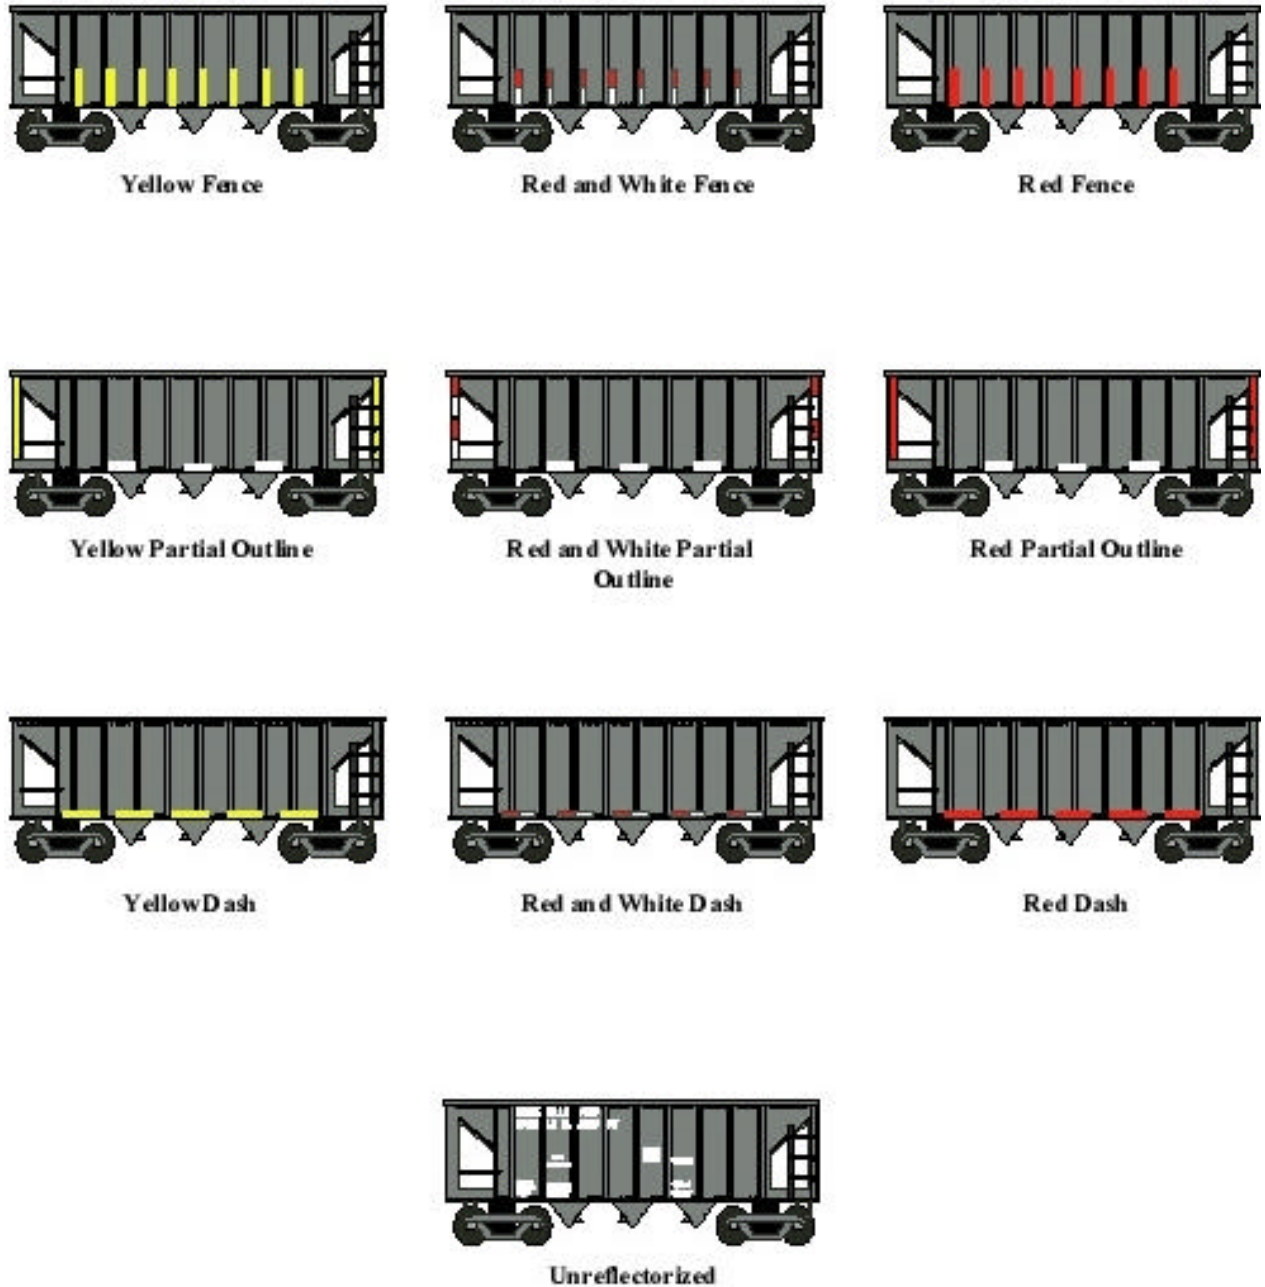
Figure 6-6. Nine Experimental Marking Designs

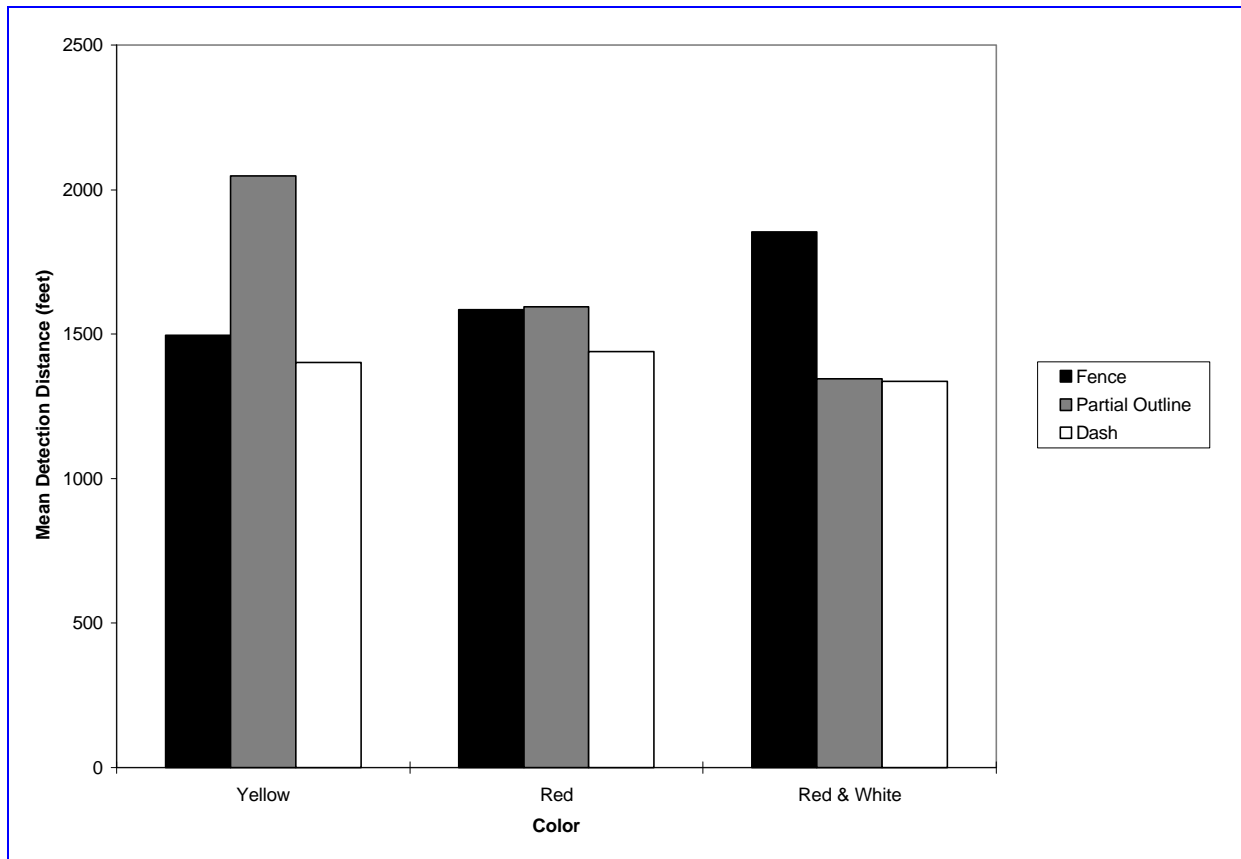
Figure 6-7 shows the interaction between color and pattern for detection distance. A statistically significant interaction was found between color and pattern, as shown in Table 6-3. It is evident in this case that the subjects exhibit the poorest detection performance across the three colors for the dash pattern, supporting the pattern effect described above. For both fluorescent yellow and red, the dash shows the lowest detectability. The differences between the dash and the other two patterns for both yellow and red were statistically significant. For the combined red-and-white

Figure 6-7. Effect of Color and Pattern on Detection Distance

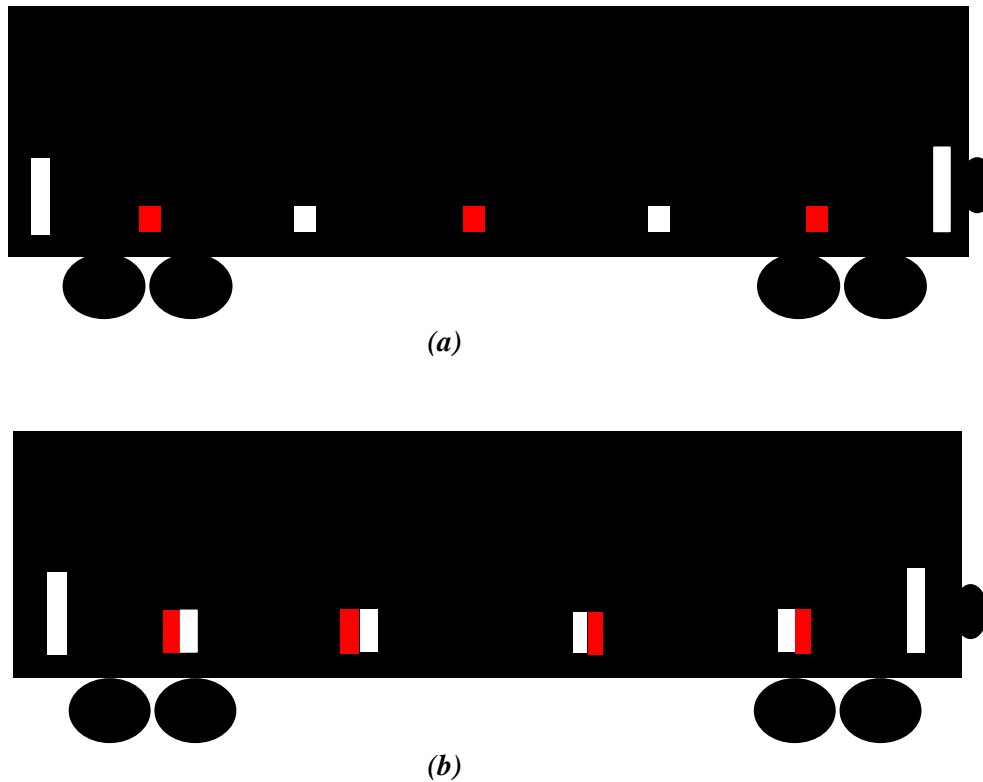
Both designs use red and white reflectors in combination, as suggested by the human factors recommendations, and are mounted vertically to permit an increase in their size. Figure 7-1(a) depicts a more conservative design than Figure 7-1(b) in terms of the amount of material required. Based on the suggested configuration, the cost of material and maintenance will not be significantly increased.

Figure 7-1. Suggested Improved Reflector Patterns on a Typical Freight Car

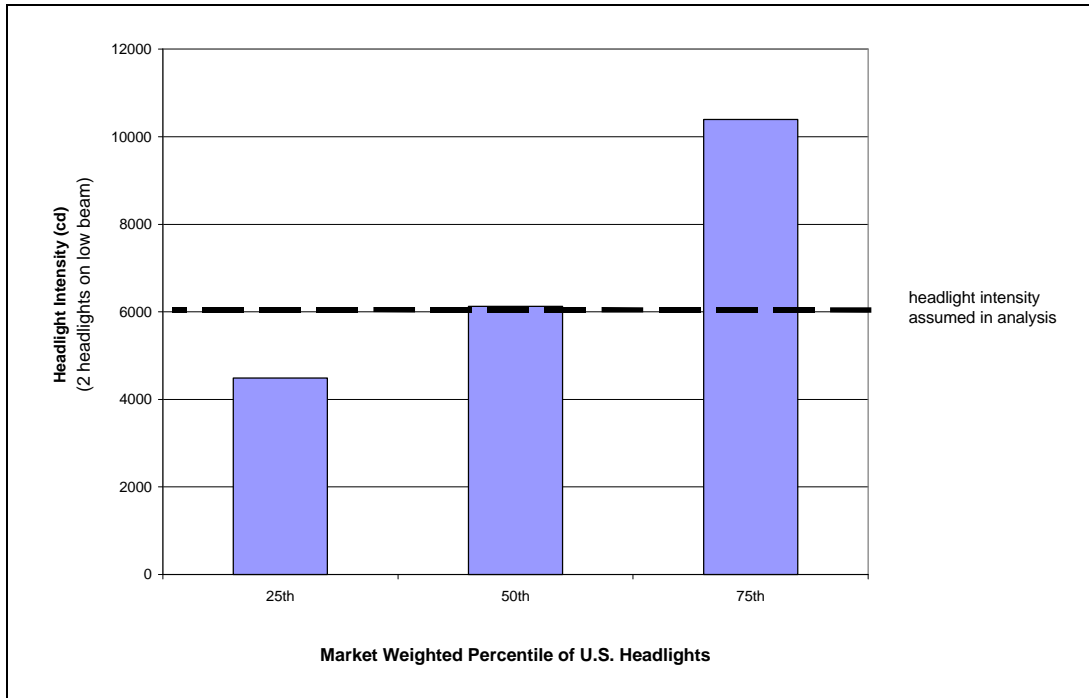
From a 1997 study done by the University of Michigan Transportation Research Institute, “A Market-Weighted Description of Low-Beam Headlighting Patterns in the U.S.,” a typical light output pattern was established for headlights currently used in the US. While the median headlamp exhibits luminous intensities consistent with estimates used in our previous study, the 25th percentile headlamp is roughly one third of this intensity (see Figure 1). Such low intensity headlights still maintain acceptable threshold SIA (*specific intensity per unit area*) values for all large reflectors tested in the in-service testing. In the case of the smaller reflectors, where degradation levels on some freight car reflectors were found to fall below the current threshold in the testing cycle, half the acceptable life cycle would result from the 25th percentile headlight intensity.

Figure 1. Light intensities from pairs of low beam headlights at freight car reflector location, from a market-weighted database of U.S. headlights (Savik, 1997)

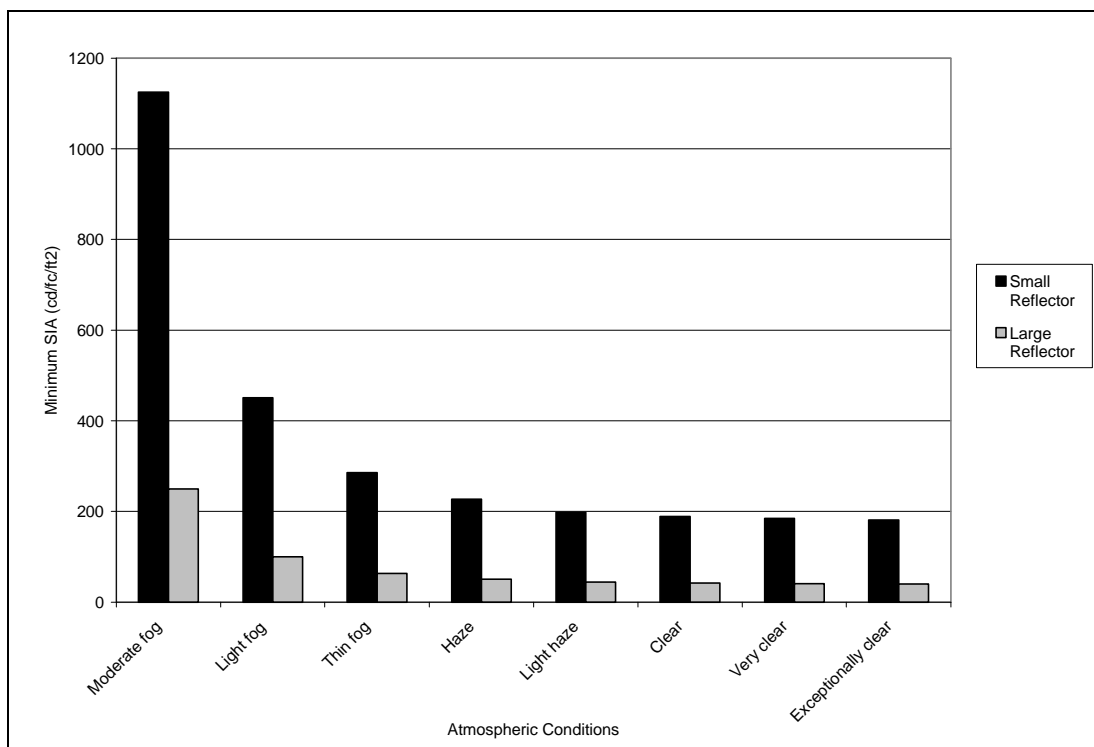
Changes in weather conditions alter the atmospheric transmissivity through which light must travel to reach the reflectors and return back to the eyes of the driver. Threshold SIA values, for tested reflectors in our previous study, were determined using an atmospheric transmissivity corresponding to conditions of light haze. Both the small and large reflectors recommended in that report, exhibit safe SIA values under conditions of clear skies, haze and thin fog. The large reflectors tested in the in-service test, performed with a safety margin that would allow adequate reflection, at the required detection distance, up to the condition of moderate fog. In thick fog, the visual threshold, recommended by the FAA and the IES Lighting Handbook, would occur at approximately 100-ft short of the 500-ft detection distance required for safe stopping from a vehicle speed of 50 mph. Through most conditions of reduced visibility, detection of larger reflectors may occur as much as fifty feet before that of the smaller reflector. Figure 2 shows how changes in atmospheric conditions affect the minimum SIA for both reflector sizes. The atmospheric transmissivity characteristic of each weather condition, as defined by the IES Lighting Handbook, can be found in the Appendix.

Figure 2. Effects of atmospheric conditions on minimum detection levels for both the small (4" x 8") and the large (4" x 36") reflectors.

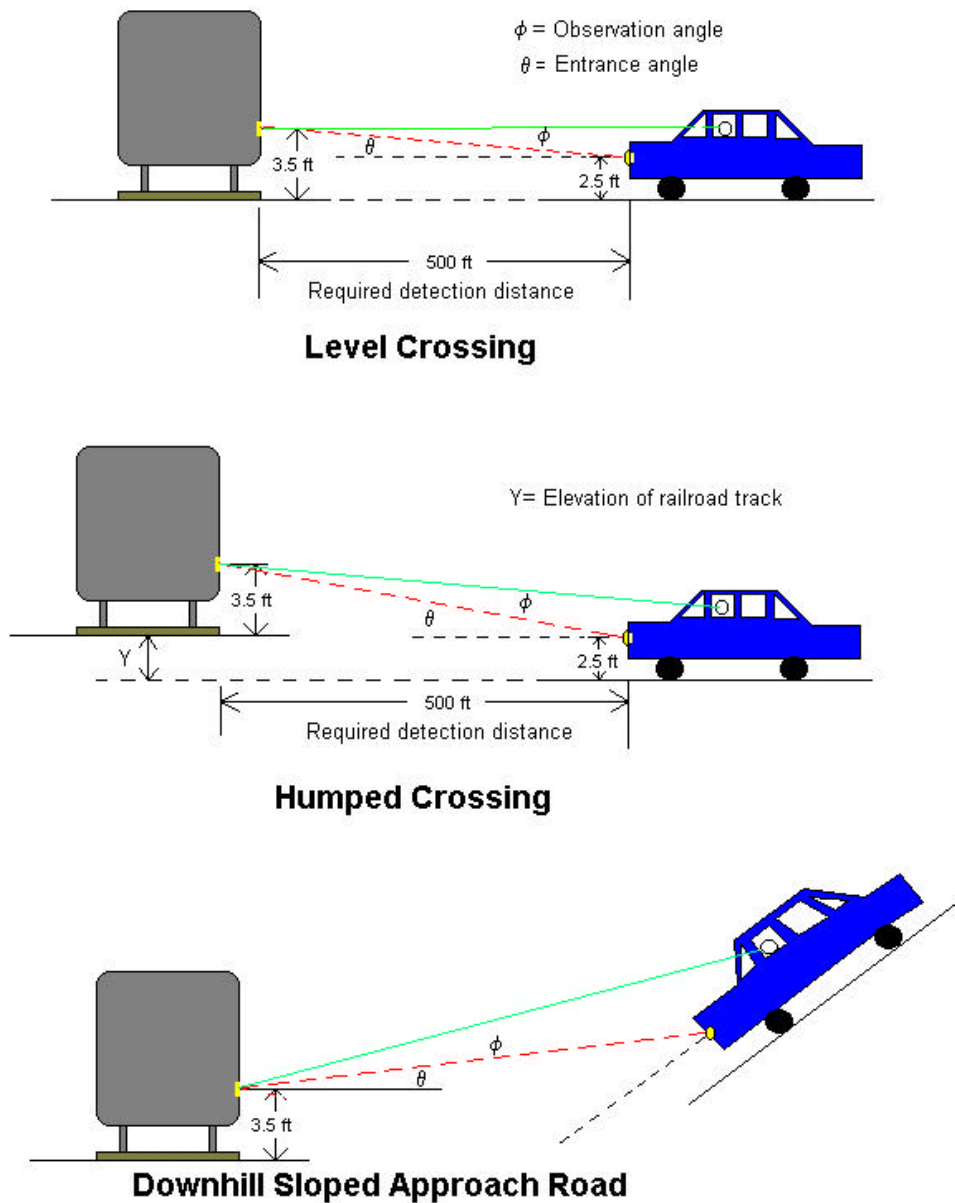
The crossing geometry used in our previous study, to establish reflector requirements, assumes that the road is level with the tracks and that the vehicle approaches perpendicular to the direction of the train (90° intersection). This situation obviously does not account for the common humped crossings or angled and curved approaches encountered in many highway-rail crossings. Reflector effectiveness is maximized as both the observation and entrance angles (as seen in Figure 3) approach zero. The closer the vehicle is to the crossing, the larger both of these angles become. The observation angle however has a greater effect on the reflectivity than does the entrance angle.

Figure 3. Side view of various highway-rail crossing geometry

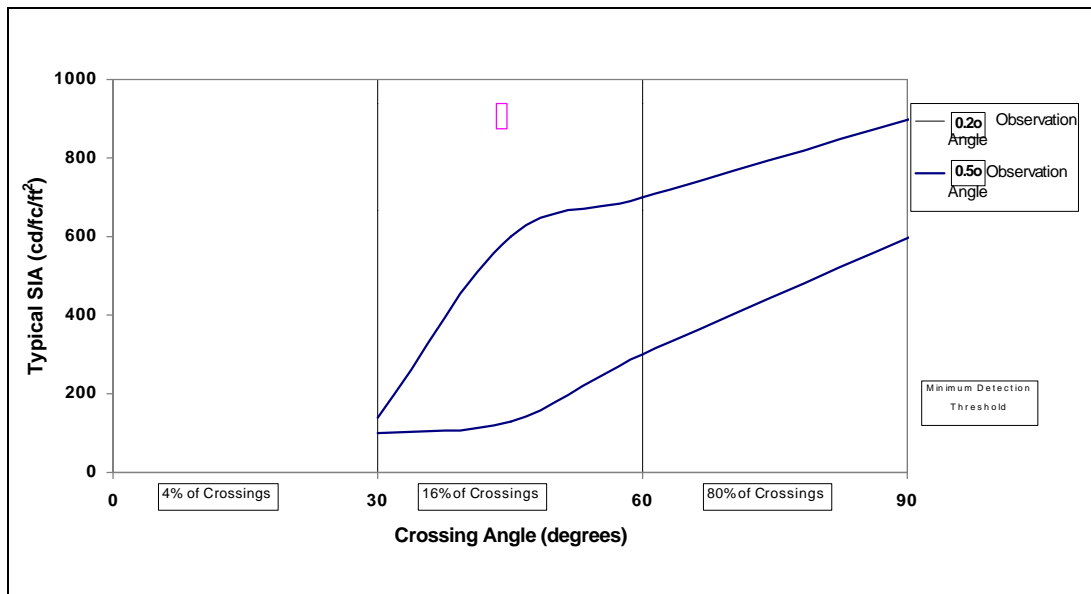
From specifications provided by one retroreflective material manufacturer, the average reflector performance as a function of crossing angle can be seen in Figures 6 and 7. Figure 6 shows the typical values for the coefficient of reflectivity for 3M's series 981 sheeting for the small 4" x 8" white retroreflectors. Figure 7 is averaged values for the red & white 4" x 36" sheeting. Both plots show values at observation angles of 0.2° and 0.5° . At the detection distance of 500 ft, the observation angle on a level road ranges from 0.15° for small passenger cars to 0.55° for cab-over-engine trucks, as the elevation from the driver to the headlight increases. (McGinnis, 1979)

Figure 6. Typical Coefficients of Retroreflection for 3M's 981 sheeting series as a function of grade crossing angle (white 4" x 8")

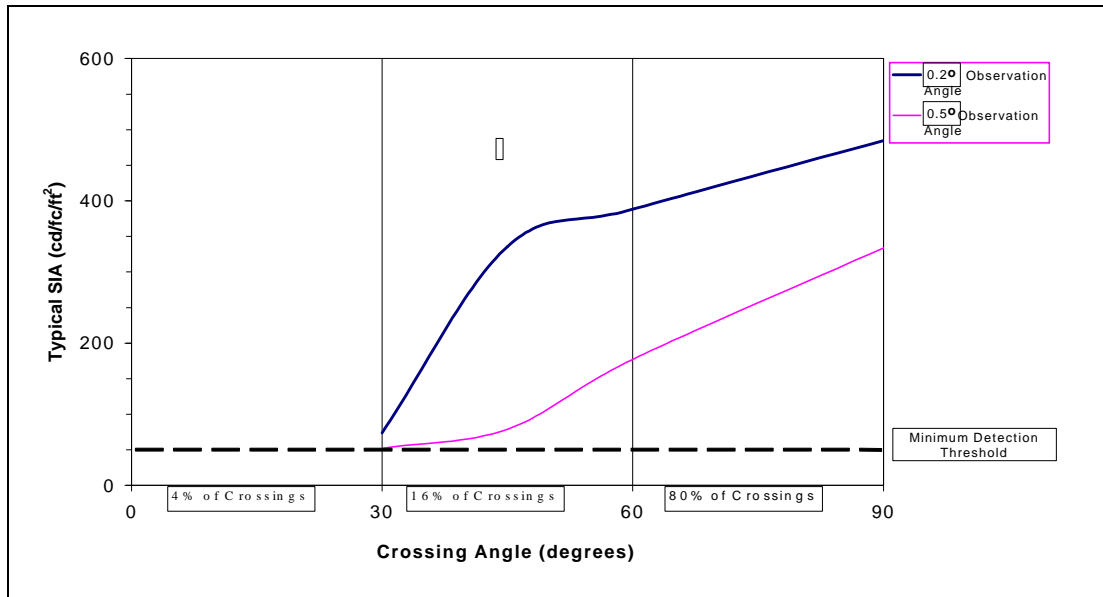
Figure 7. Typical Coefficients of Retroreflection for 3M's 981 sheeting series as a function of grade crossing angle (red & white 4" x 36")
